Re: Docket No. 160001-EI

Subject: **Failure Analysis of Titanium Tubing from 2A1 Condenser
Purchase Order No.: 02341346
Ref AR: 2025590**

Unit 2 Shutdown for 2A1 Condenser Tube Leak

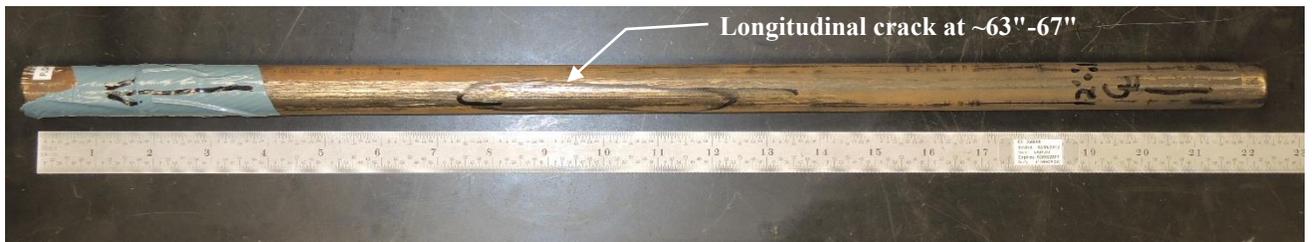
- T53 40"-55" - No visible cracking or damage
- T53 55"-77" - Visible longitudinal crack, approx. 4" long
- T53 77"-95" - No visible cracking or damage
- T50 435"-459" - No visible cracking or damage

Figure 2: Longitudinal Crack on Segment T53 55"-77"

The longitudinal crack on tube T53 was examined visually and using the stereomicroscope. The crack was relatively straight and continuous and was located along a shallow groove. Adherent deposits or scale partially covered the groove, indicating it was introduced during installation in the condenser.

The crack was located approximately 180° from the seam weld.

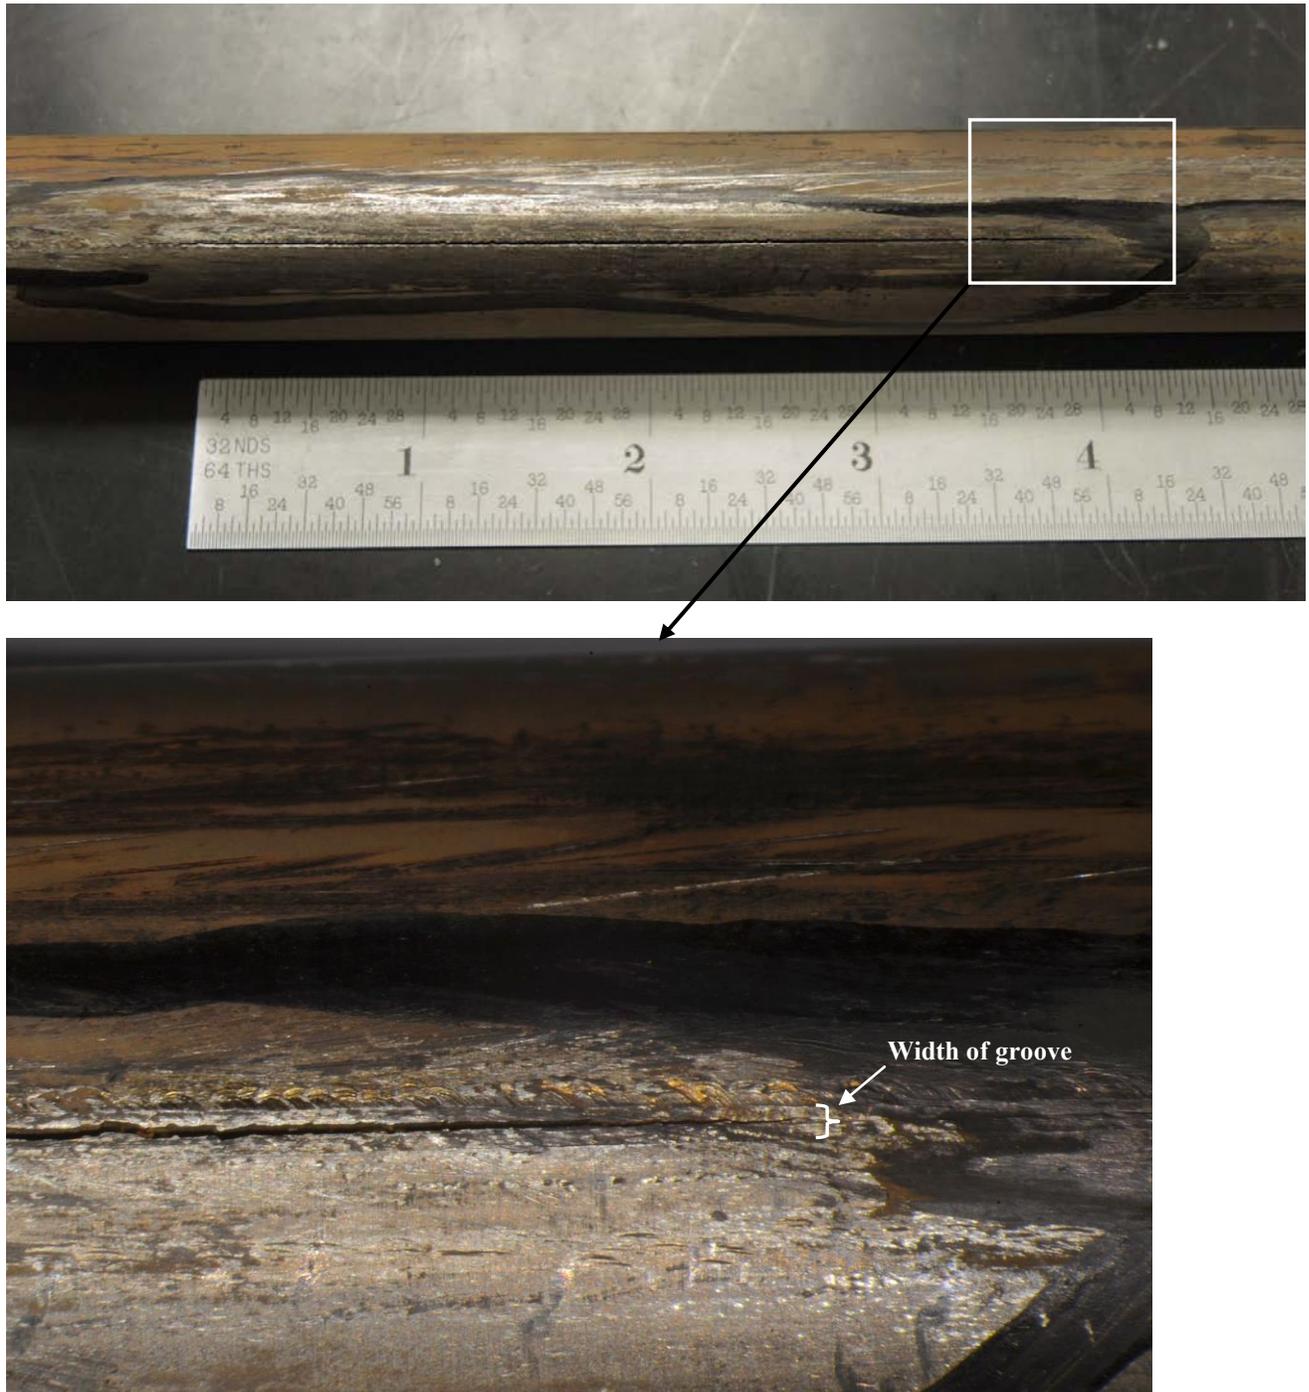
Figure 3: Sectioning of Segment T53 55"-77"

The portion containing the crack was sectioned beyond the crack tips and the crack was split open. Examination of the ID surface was performed. The ID surface exhibited some adherent white and orange deposits, such as shown below. No ID damage mechanisms (pitting, corrosion, erosion) were observed.

Samples of the deposits were analyzed and were consistent with waterborne deposits (Figure 14).

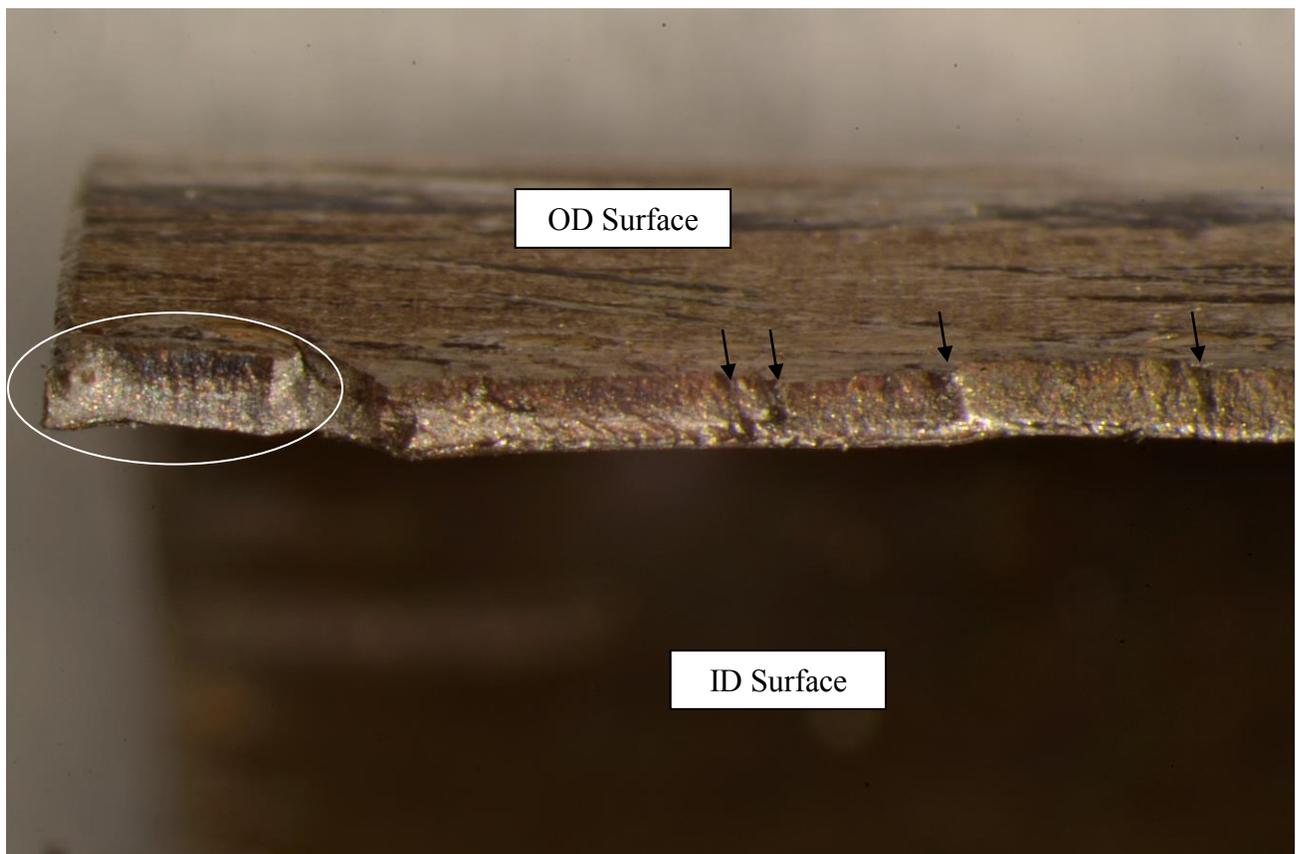
Figure 5: Fractography of Segment T53 55"-77"

The fracture surface was examined using the stereomicroscope. The photo below displays the fracture surface at the crack tip near 63". Ratchet marks, some of which are identified by arrows below, were visible along the OD edge of the fracture surface, indicating the cracking initiated on the OD surface. These marks are formed when competing crack fronts merge, suggesting the 4" long crack was formed by several short cracks that joined. This can also be seen on the left side of the photo, where a short crack (dark surface in circled area) that is approximately 50% through-wall is not connected to the main crack. The dark thumbnail feature at the OD surface is the short crack, and the bright metal represents an intact ligament that was broken in the lab to expose the fracture surface.

Note that the fracture surface of the through-wall crack was not uniformly discolored. This is consistent with a progressive cracking mechanism.

The photo below displays fracture surface at the crack tip near 67". This end of the crack displays additional evidence of progressive cracking with multiple, linked cracks. The arrows identify individual cracks that are not linked to the main through-wall crack.

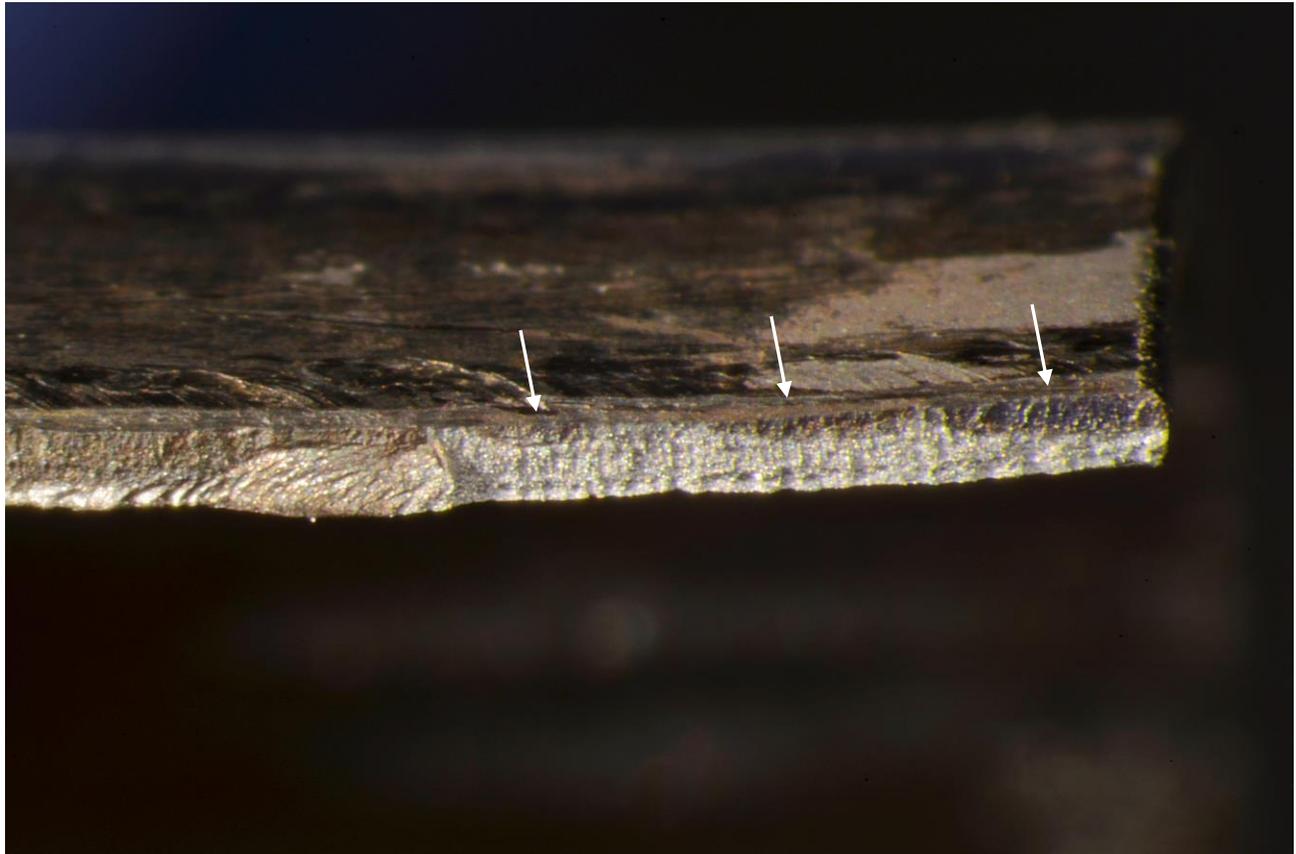
Figure 6: Fractography of Segment T53 55"-77"

A portion of the fracture surface near the crack tip at 67" was examined using the scanning electron microscope (SEM). The SEM photo below is representative of the fracture appearance. The fracture was transgranular and brittle.

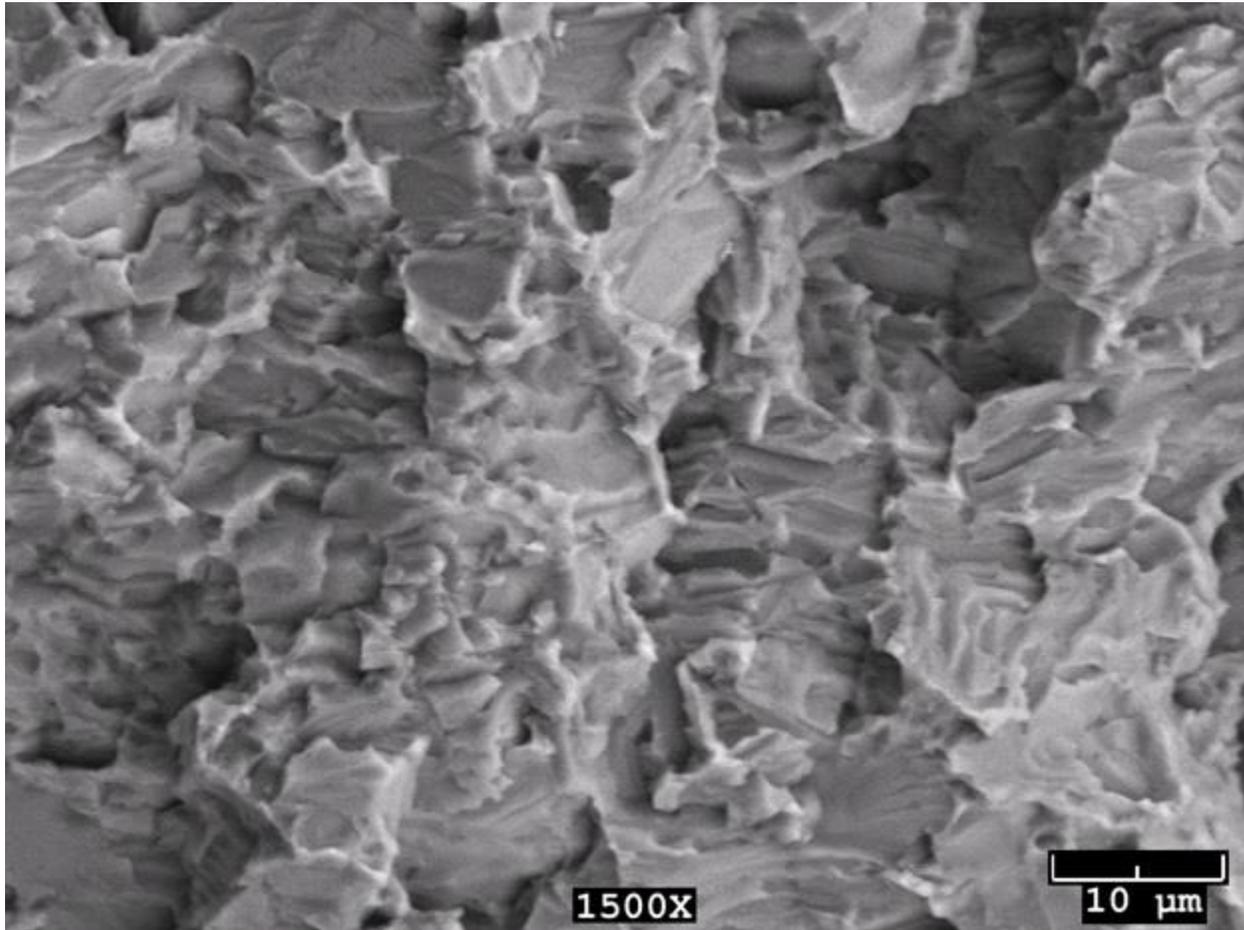
Figure 7: Fractography of Segment T53 55"-77"

The SEM photo below displays the right end of the fracture shown in Figure 5, which is a partially through-wall crack. The dashed line represents the transition from field fracture (above the line) to lab fracture (below the line).

The field fracture was brittle with some secondary cracking near the transition. The lab fracture was ductile. The boxed area is shown in Figure 8.

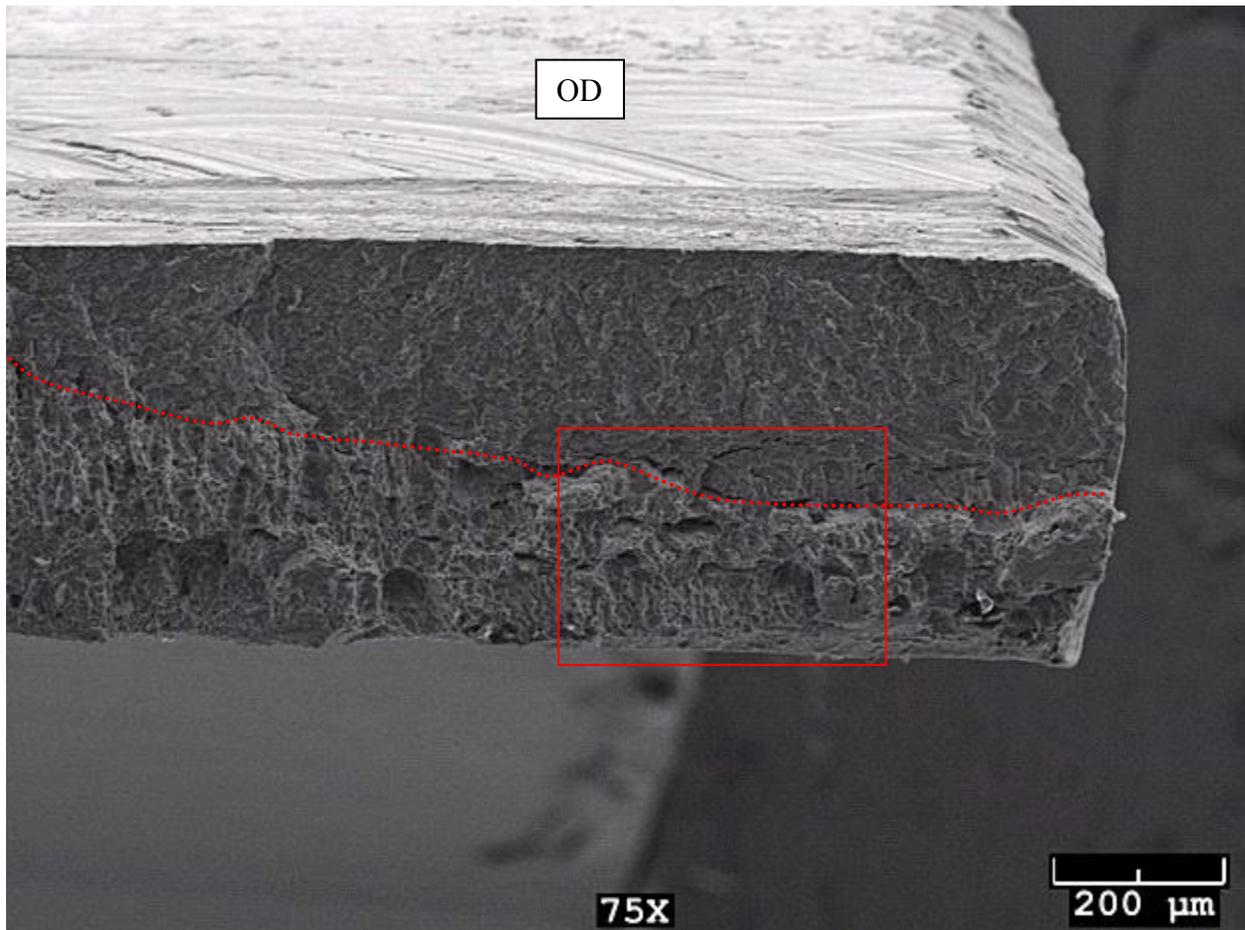
Figure 8: Fractography of Segment T53 55"-77"

A higher magnification image of the transition to lab fracture overload. The lab fracture was ductile.

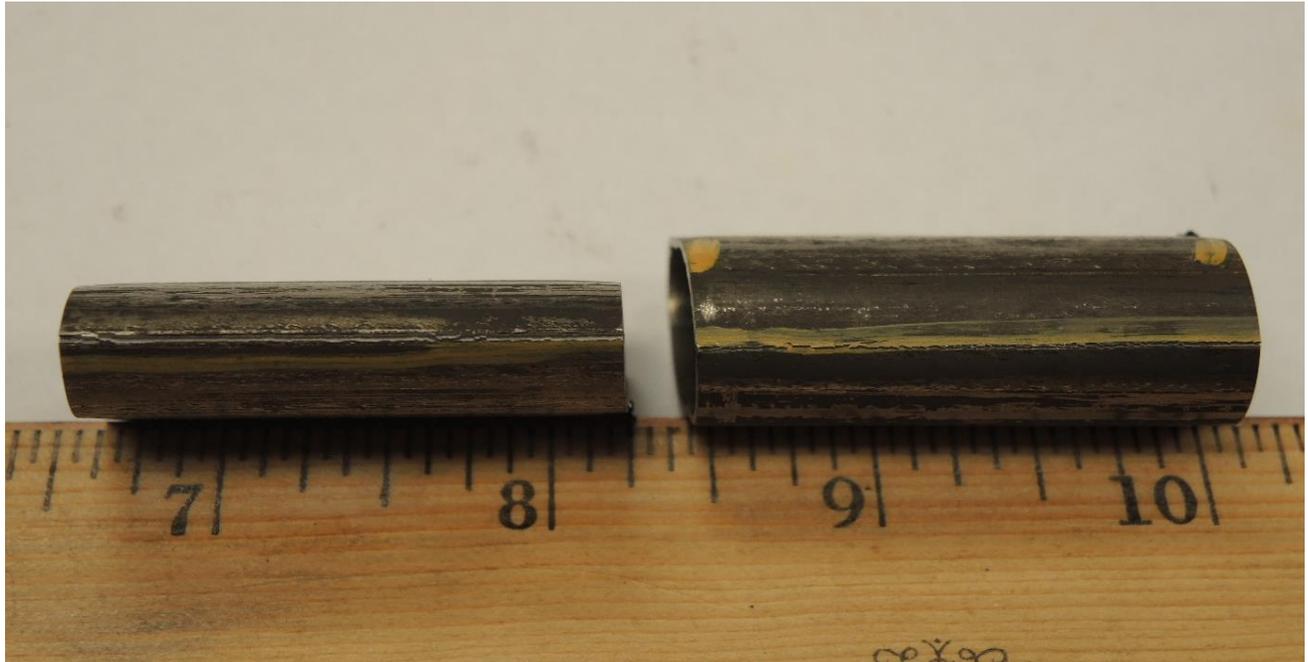
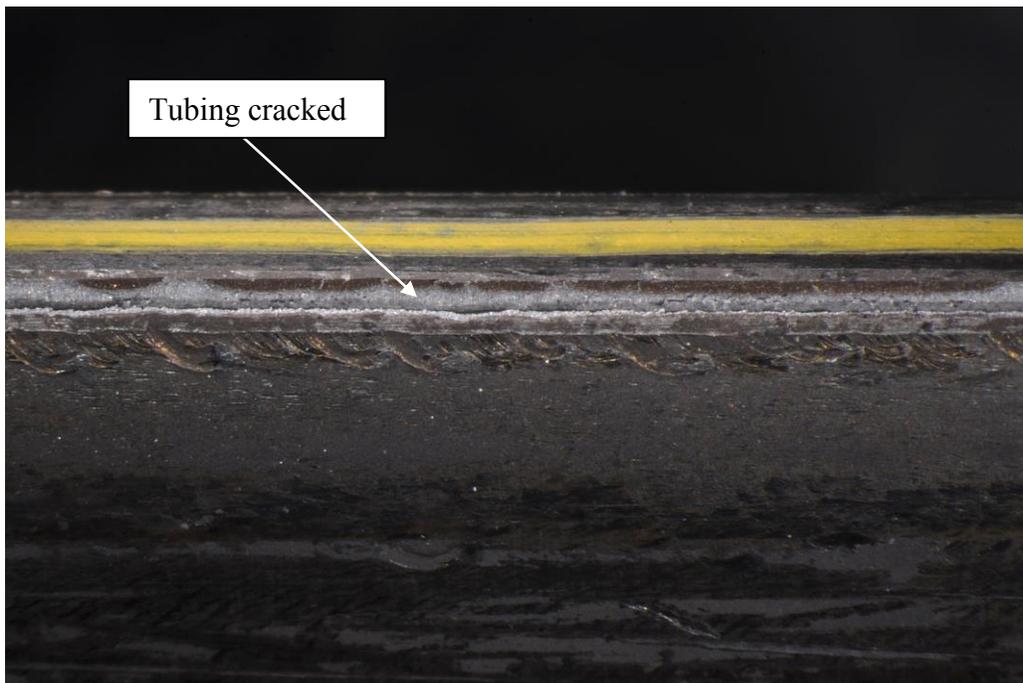
Figure 11: Inspection of Segment T50 435"-459"

Visible dye penetrant testing and stereomicroscope inspection of this tube segment did not identify any notable observations. The station was requested to provide additional information to analyze this tube segment, and the following was offered from the station's ECT Engineer:

Using this information, a 4" long piece centered at 440" was cut from the segment (the dashed lines below designate the cut locations). The ID was examined and no damage was observed. From the 4" long piece, three specimens were prepared: a ring was removed from the center (near 440") for metallography, and the remaining two lengths were used for flattening tests.

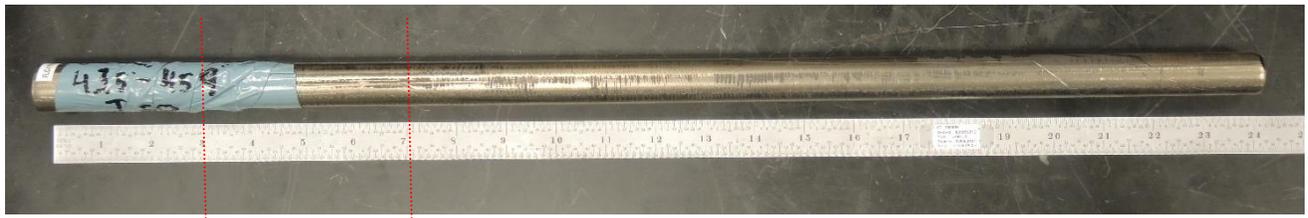
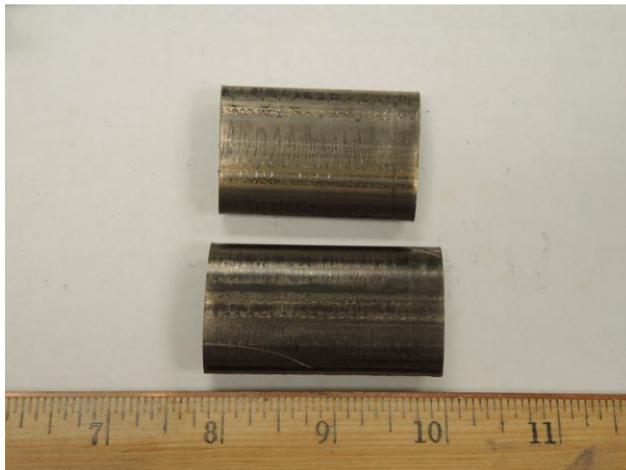
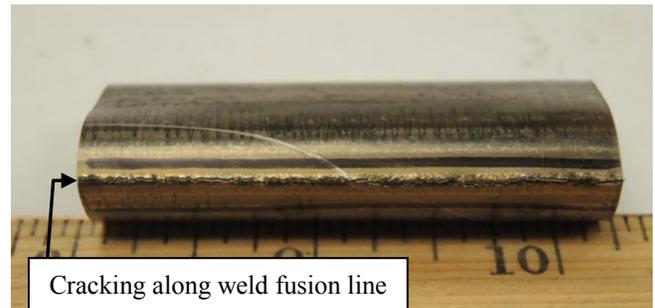
Flattening tests were conducted in the same manner used for tube T53. Shallow cracking was observed on the weld fusion line with the weld at 90°. No cracking was observed in the sample with the weld at 0°.

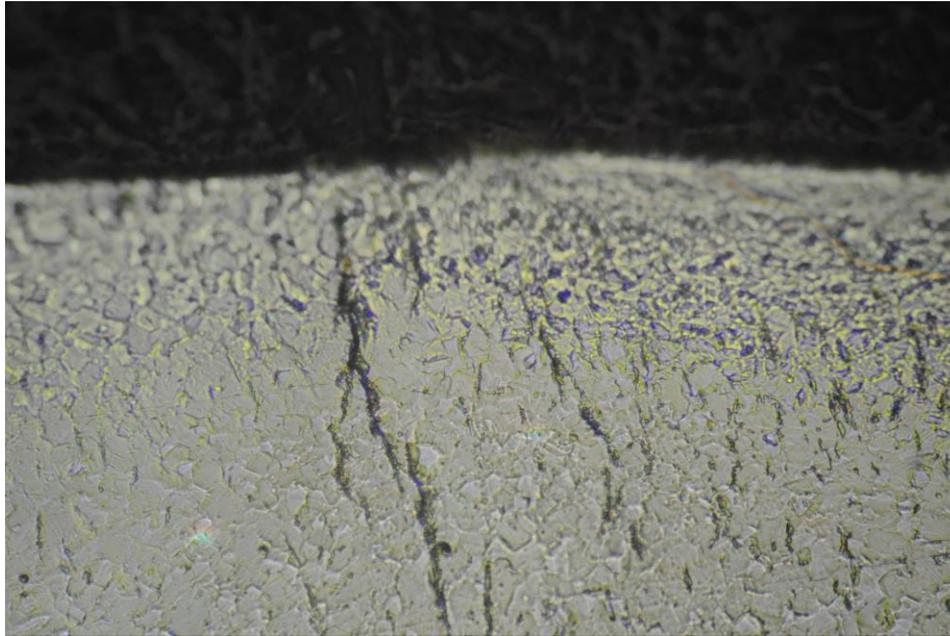
Figure 12: Metallography of Segment T50 435"-459"

A transverse metallurgical sample was prepared near the 440" location, or the center of the original ECT signal. The microstructure exhibited large hydride needles at the OD surface, though to a lesser degree than observed on tube T53.

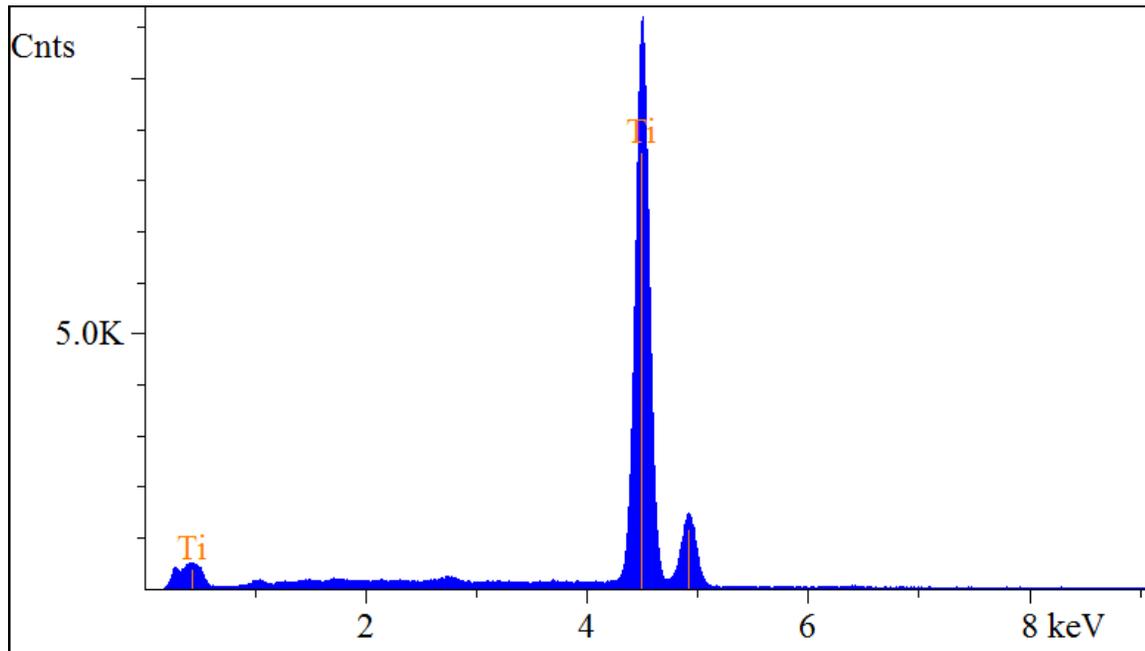
Figure 13: Chemical Analysis of Base Metal

The base metal was analyzed using energy dispersive X-ray spectroscopy (EDS). The EDS results were consistent CP titanium.

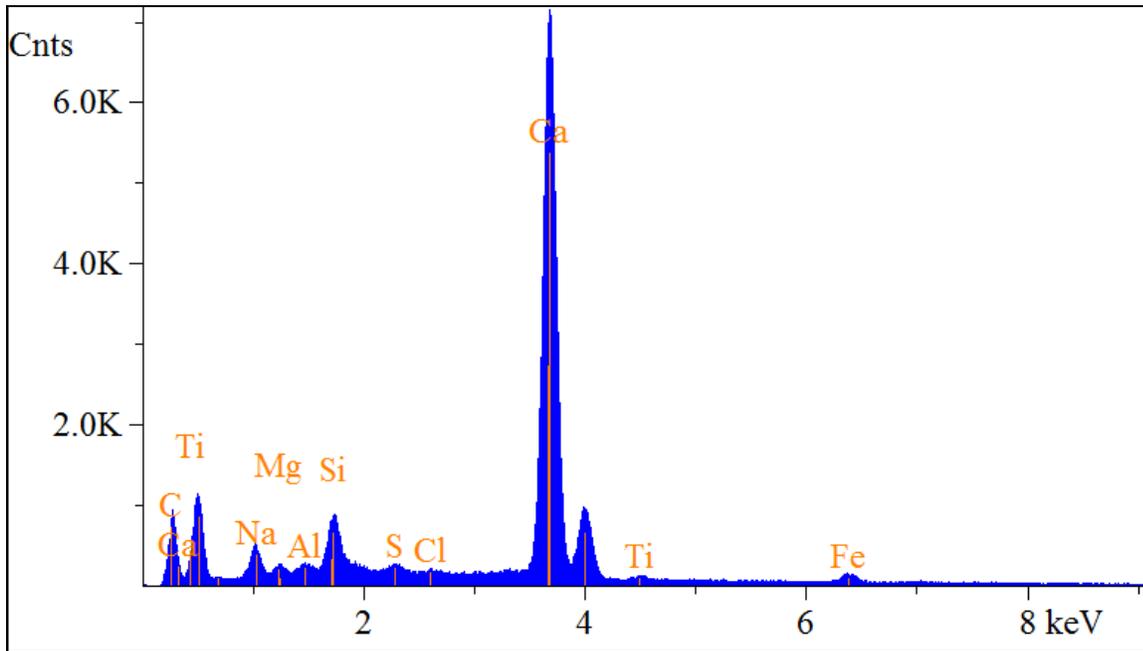
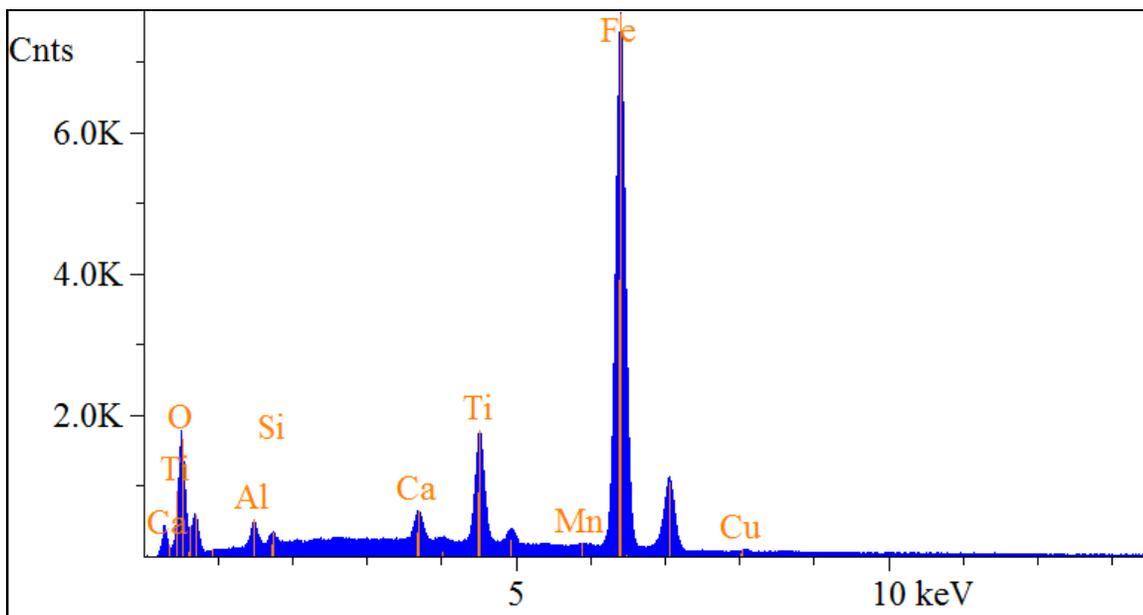
Figure 14: Chemical Analysis of Deposits

The white ID deposit consisted primarily of calcium. Minor amounts of carbon, silicon, aluminum, magnesium, sodium, sulfur, chlorine, iron, and oxygen were also detected. The results suggest the ID deposit consisted of calcium carbonate and waterborne minerals.

The brown OD deposit consisted primarily of iron. Minor amounts of calcium, manganese, copper, aluminum, silicon, and oxygen were also detected. The results were consistent with metal oxides (iron, copper) and minerals (aluminum, silicon, calcium).

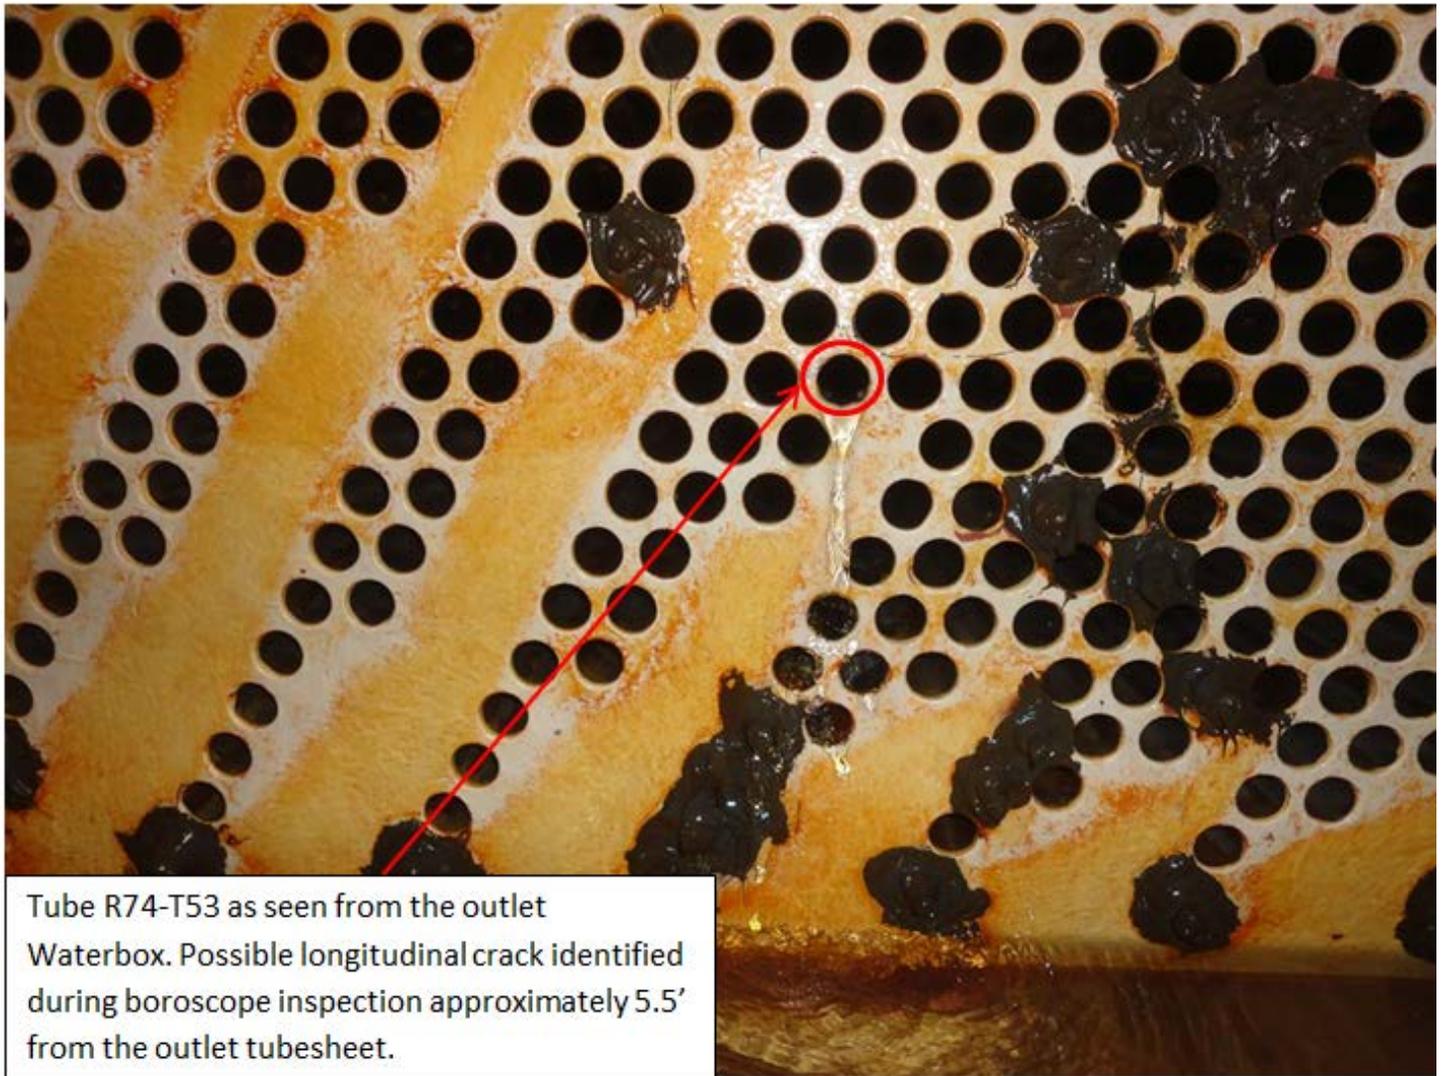
Figure 2: 2A1 lower bundle tube R74-T53 leaking during short notice outage hydrostatic test in February 2015 (Interim Root Cause Report).

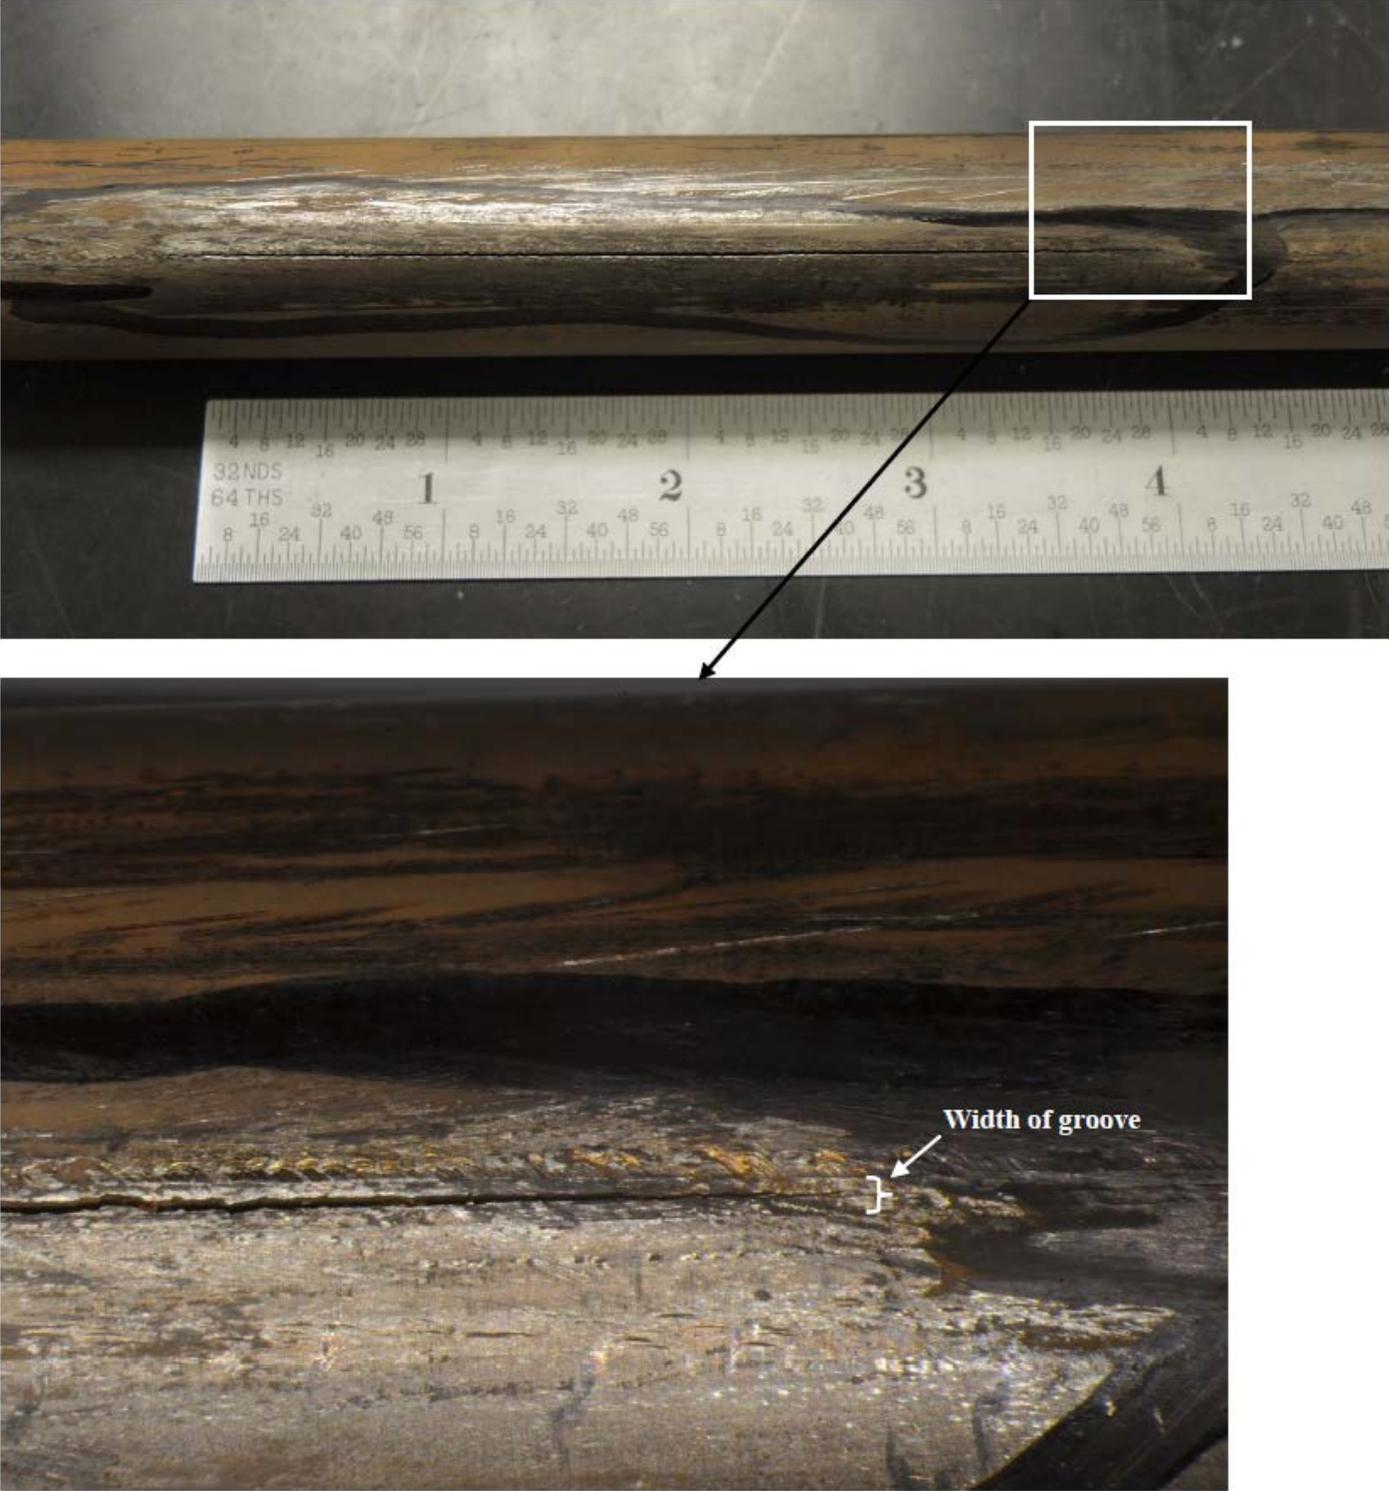
Figure 4: Metallurgy analysis of 2015 failed 2A1 lower bundle tube R74-T53 (D45).

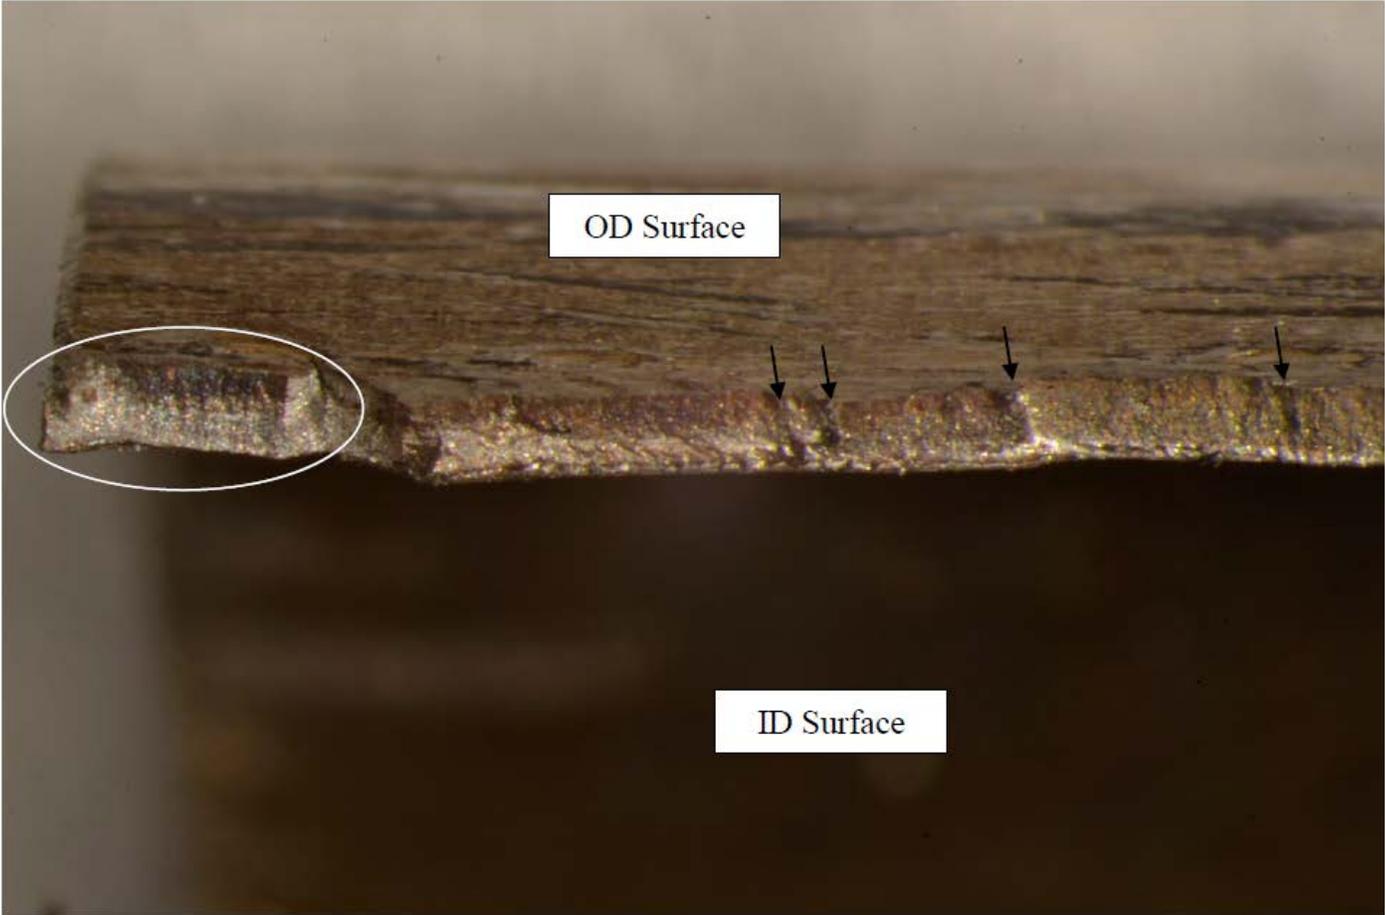
Figure 5: Metallurgy analysis of 2015 failed 2A1 lower bundle tube R74-T53 (D45).

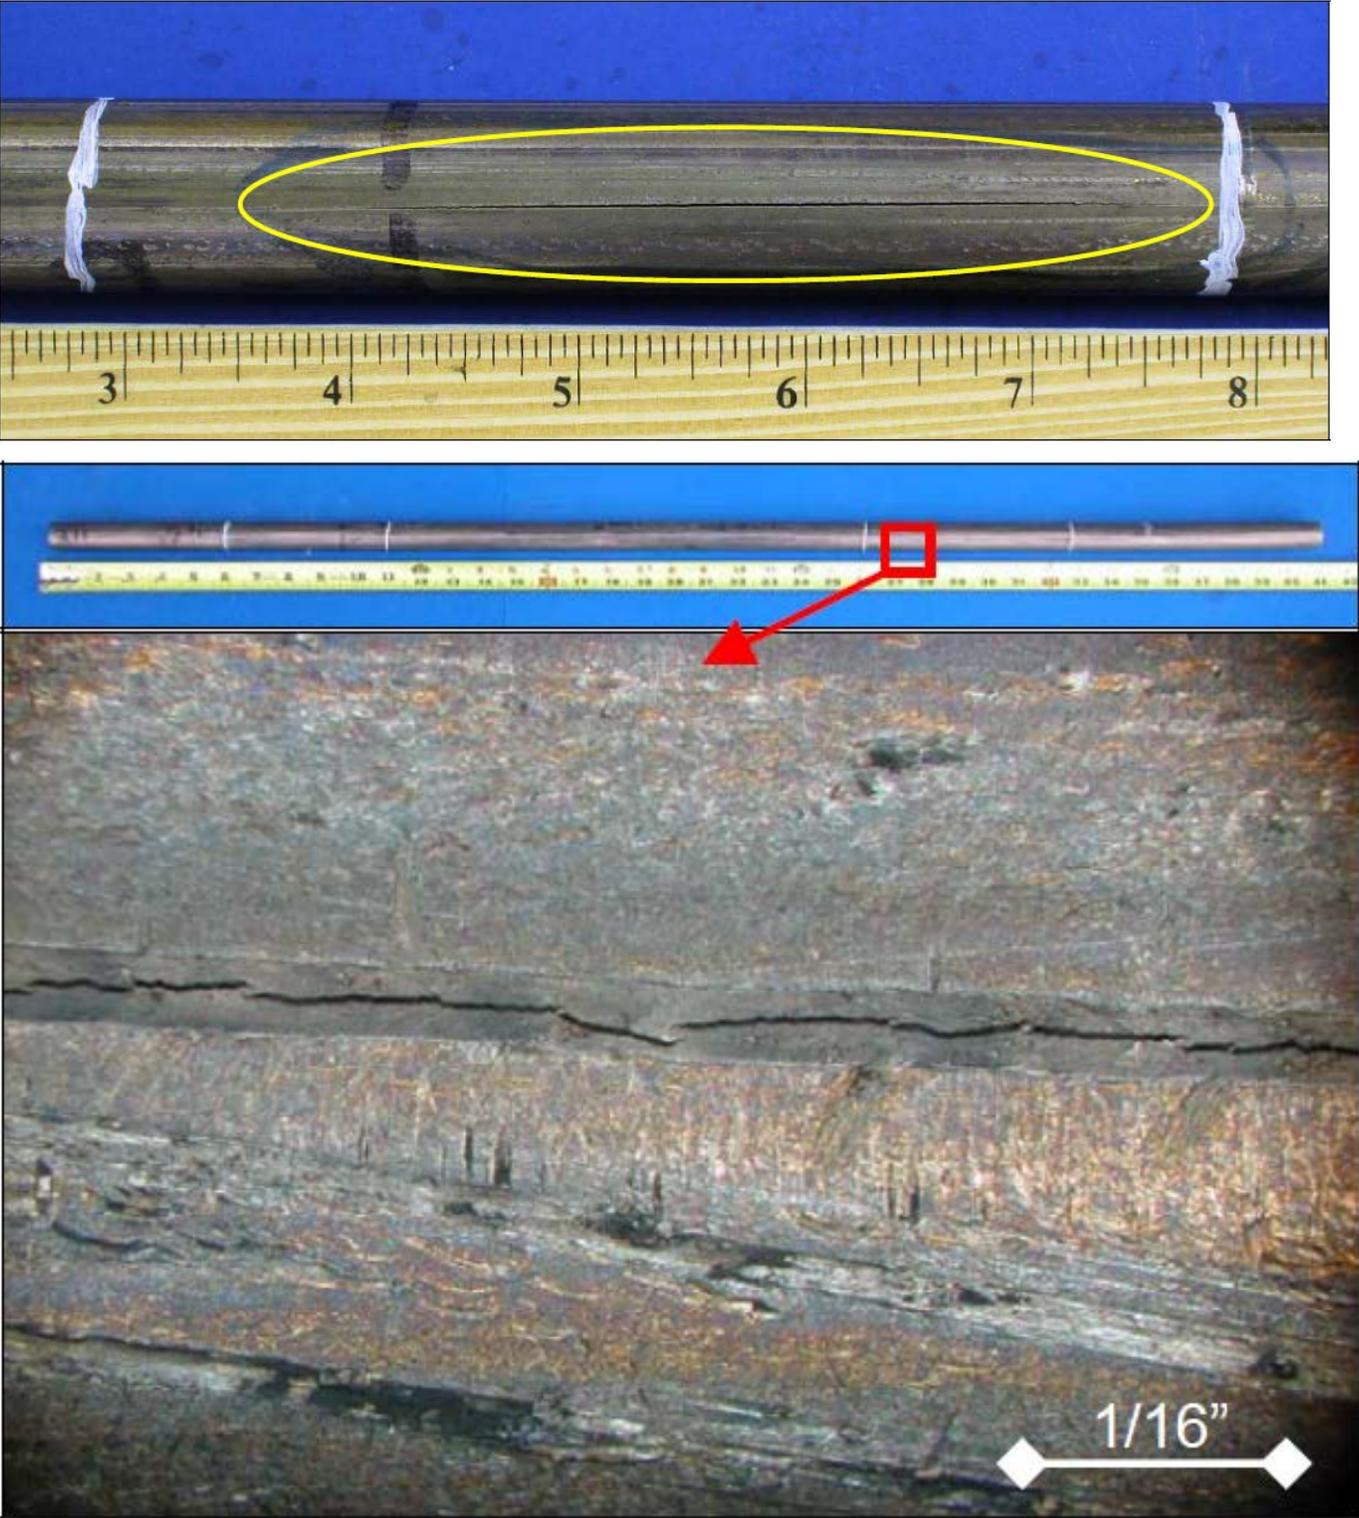
Figure 6: Metallurgy analysis of 2006 failed 2B2 lower bundle tube R76-T24 (D13).

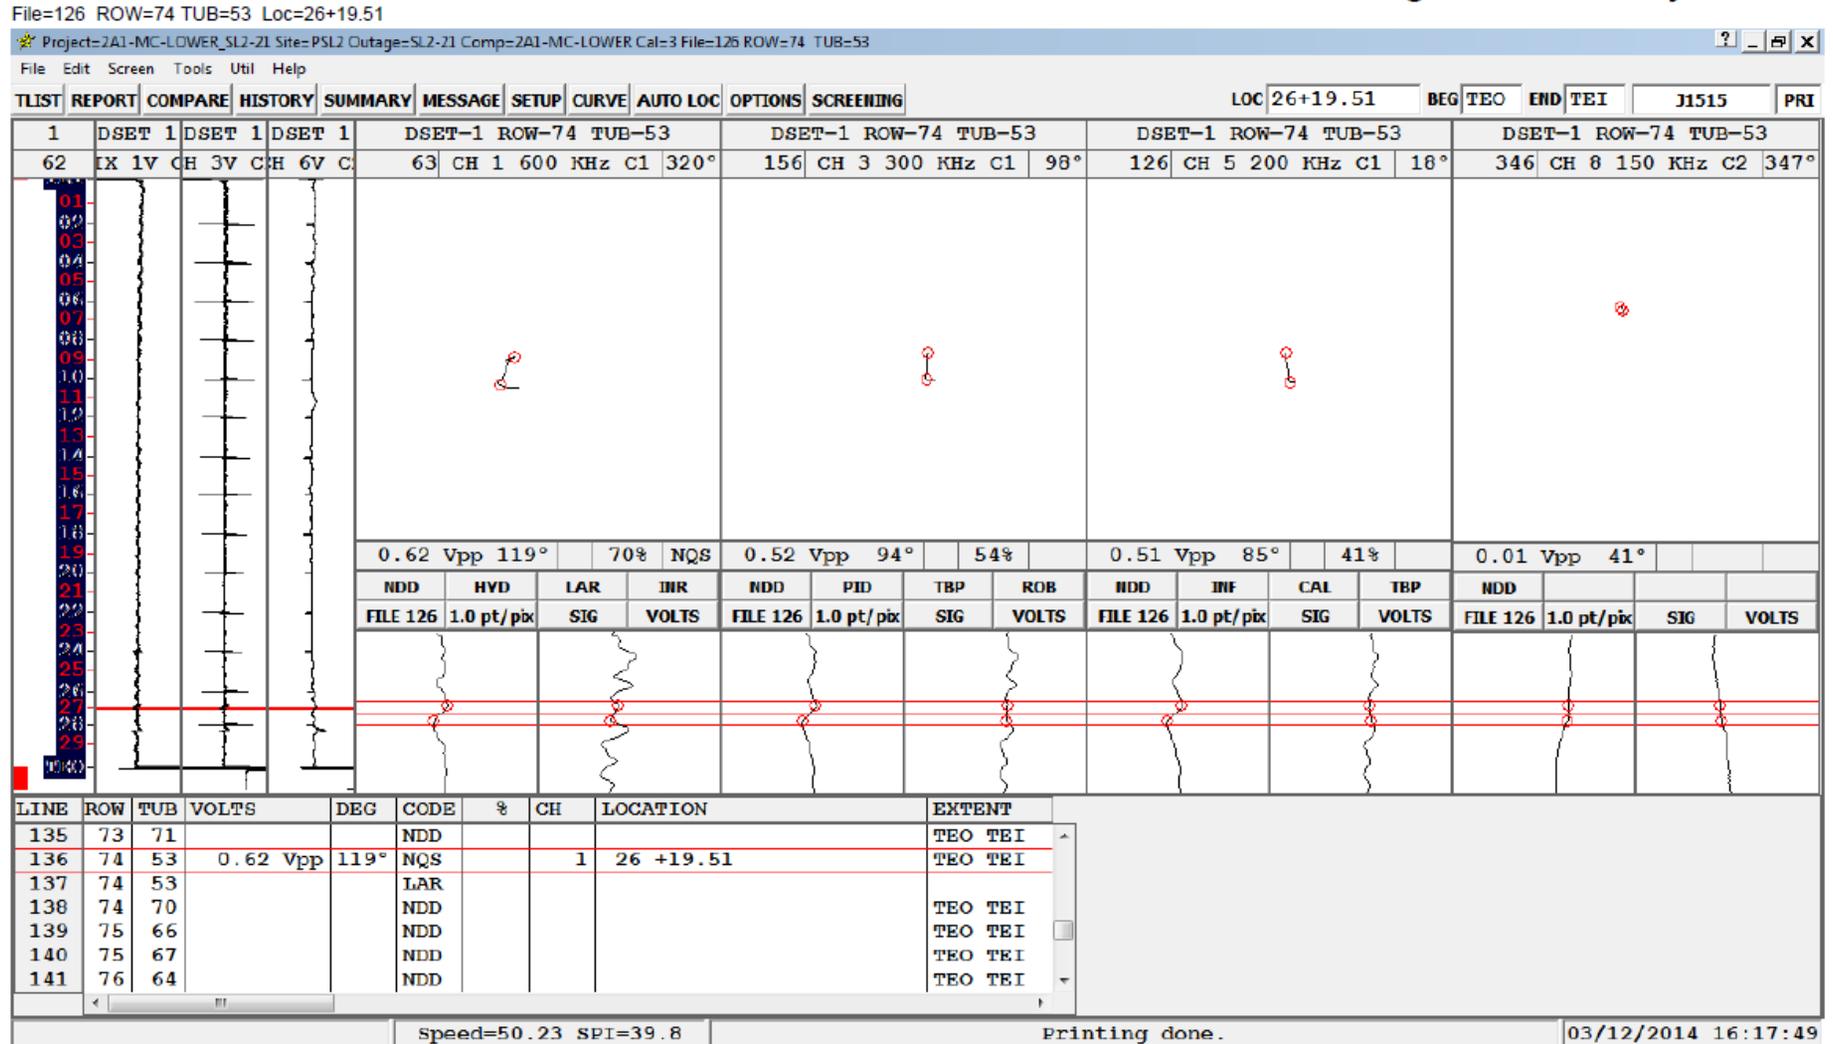
- Past installation defects in St. Lucie have illustrated non-quantifiable signals in eddy current examinations.
- The failure mechanism does not produce progressive tube-wall thinning. Historical data analysis revealed no change in the signal, further adding to the challenge of detecting tube failures prior to catastrophic rupture.
- The technology available to detect an outer-diameter defect is limited. Therefore, it is possible to have a defect and not be able to identify it.

**Non-quantifiable Signal (NQS)
No change from history**

Figure 8: SL2-21 (Spring 2014) ECT NQS signal of failed 2A1 lower bundle tube R74-T53 (D10).

| Area | Category | Corrective Action / Assignment | Responsible | Assignment Type | Due Date |
|---|---|--|---|---|---|
| RC-1: Poor workmanship during condenser construction resulted in an outer-diameter tube defect and subsequent tube failure. | Equipment | Plug all St. Lucie condenser tubes that have previously illustrated a non-quantifiable signal or indication (NQS/NQI) in eddy current testing and any other recommended suspect tubes from re-analysis of the Unit 1 and 2 eddy current baseline data from 2015 [Fleet Program Engineering (FPE/ECT)]. | Outage Management Bill Francis | CAPR | <u>Unit 1:</u> 10/9/2016 SL1-27 RFO WR 94135894 NAMS Assignment 2025590-21 <u>Unit 2:</u> 4/1/2017 SL2-23 RFO WR 94135895 NAMS Assignment 2025590-22 |
