Re: Docket No.: 20170215-EU

In re: Review of electric utility hurricane preparedness and restoration actions.

Hurricane Hermine

Hurricane Matthew

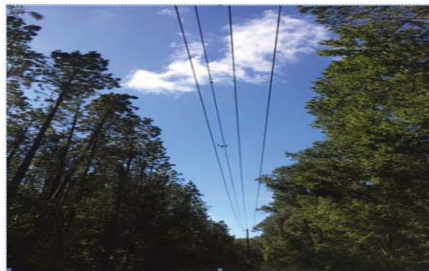
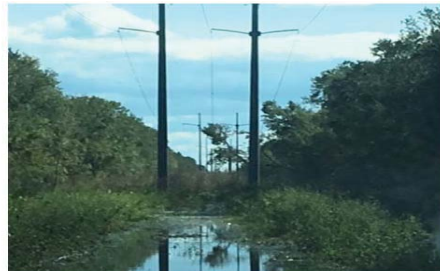
1 guy wire broken

2 OHGW down

1 pole base eroded by wave action

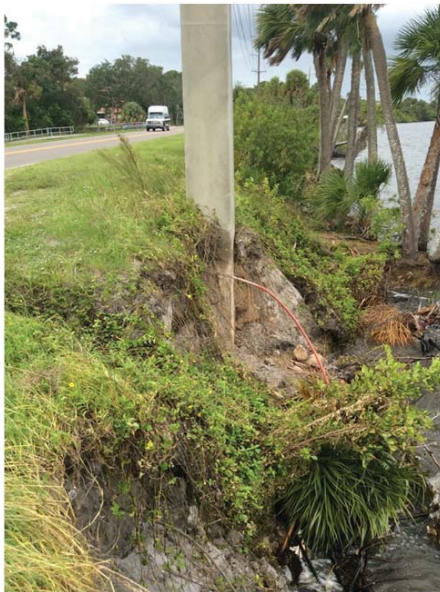
One transmission pole was replaced due to wave action washing out the foundation

This event did not cause an interruption

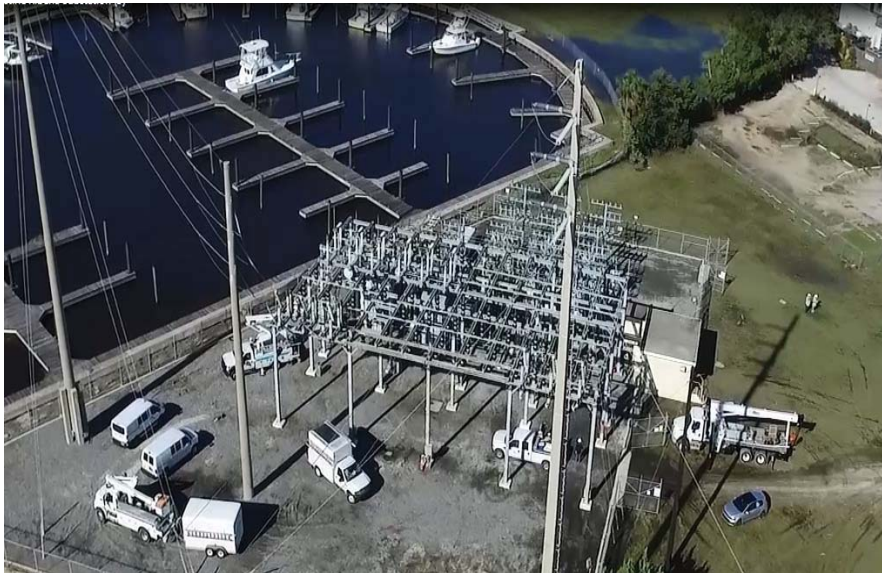
Damage was contained to the switch motor operators

2 line switches were impacted

2 transformer circuit switcher were impacted

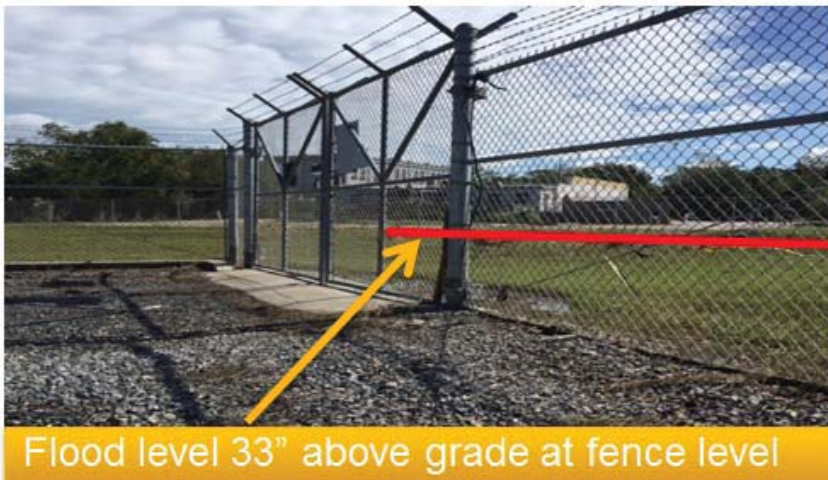
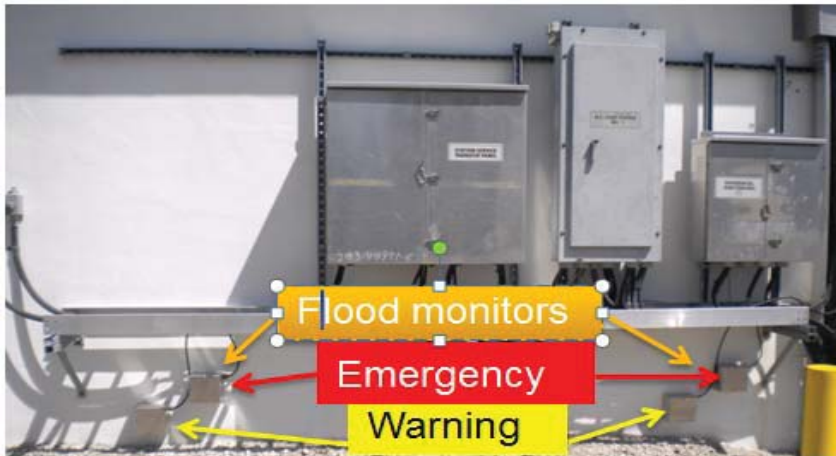
St. Augustine Case Study

Damage was contained to the switch motor operators

2 transformer circuit switches were impacted

Fault bus current transformer schemes (Transformer, Feeders, Regulators)

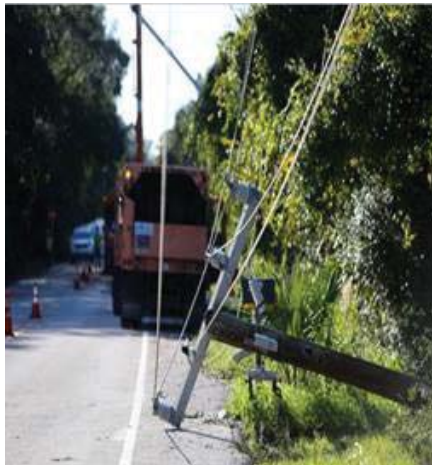
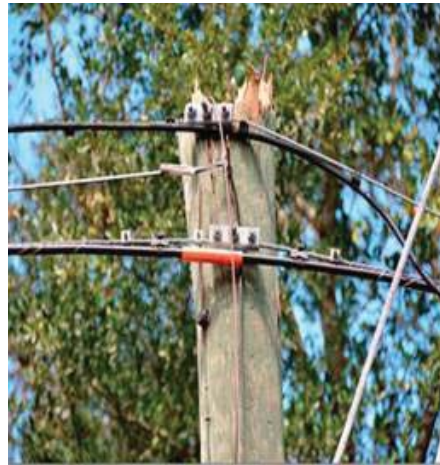
Poles down on Wildwood Drive

Below are pictures and a brief analysis of the concentration of pole failures on the 7.4 mile long non-harden Feeder 3742 in St. John's County. Estimated winds were approximately 65-75 mph in this location between 11am and 3pm. The poles experienced excessive loads due to trees in the lines which caused these poles to fail; they didn't fail directly because of wind.

There were 13 broken poles on Wildwood Drive (3.7mi). The majority of the poles were 40ft Class 3 wood poles in good condition that broke approximately 1/3 to 1/2 from the top of the pole; they were last inspected in 2015 with no strength or other rejects found. The poles broke due to large trees falling into the line. Distribution poles are naturally tapered, so it is not uncommon to have the point of maximum stress (and failure) 5ft or more above ground line for overloaded conditions (such as trees or debris in the lines), these poles broke even higher due to several factors. When a tree falls on a line, the wire experiences a sudden and very large increase in tension force in that span of wire. With the steel cross arm and triangular framing that we have on this line, these forces are transferred to the very tip of the pole. The foreign utility and guy wire attachments lower down on the pole can both restrain the pole and, like the ground, transfer some of the load from the pole. This restraint can move up the point of maximum stress (and thus failure) higher up the pole. The majority of these poles failed just above the foreign utility or guy wire. Internal defects in the pole (knots, etc.) can also cause the maximum stress location to change.

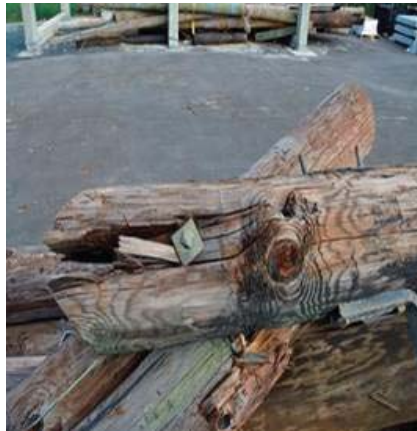
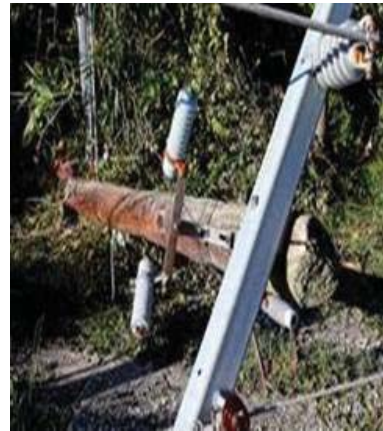
Rail Road Crossing

Two tall wood poles over a railroad crossing were both broken; east pole very close the top of the pole and west pole near the attachments near the top 1/3 of the pole. Both poles were creosote of unknown age. Inspection of these poles show they failed near the top due to trees falling on the line and the weakness at the aged top of pole when under the impact loads of trees falling on the lines and other poles failing.

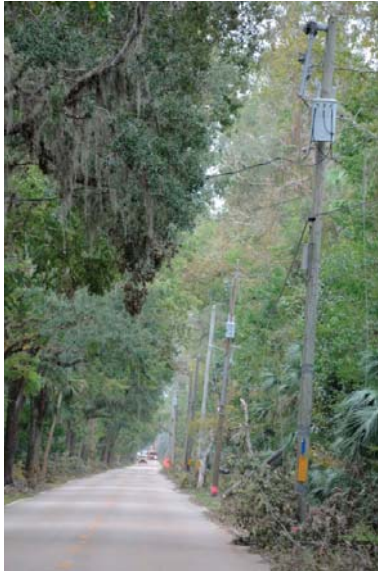
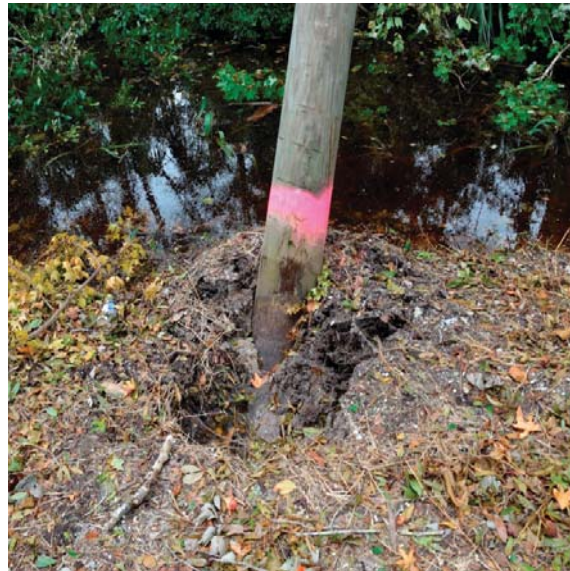
The non-hardened lateral along Maytown Road through the Turnbull Hammock Conservation Area in Volusia County was seriously impacted by Hurricane Matthew on October 07, 2016. The preliminary estimated winds were around 55-65 mph and occurred between 9am and 6pm. The poles and wires experienced excessive loads due to trees in the lines or adjacent pole failures. The poles did not fail due to excessive wind.

Numerous sections of wire were down, 3 poles were broken, and 24 poles had severe leaning along the three mile section of Maytown Road. The restoration effort required five poles which were replaced with stronger poles set deeper, FPL wire down and other damage was repaired and restored. Pull-offs and services to homes were restored as quickly as possible. The line section was re-energized at approximately 6:30am on October 12, 2016.

The failed poles were 40ft Class 4 or 5 wood poles. Two were owned by AT&T and one was owned by FPL. The line was last inspected in 2011.

The poles that were leaning the most had soft soil foundations. The rain from Hurricane Matthew saturated the soils so that the foundations failed before the poles did when the trees came down and broke the wire.

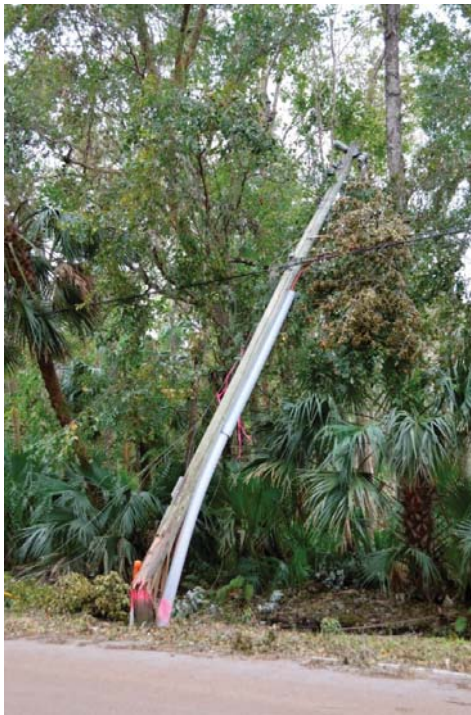
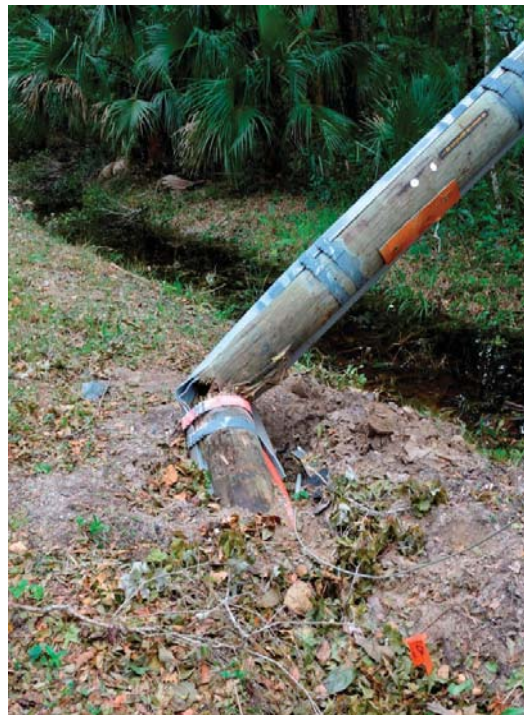
Maytown Road Lateral Case Study

The poles that failed had varying factors that caused the failure. All failed at or just above ground line. The root cause of the pole failures were the tree failures.

The AT&T pole with a pull-off to a home failed due to trees coming down on the lateral and on the pull-off to the home.

One AT&T pole that failed was in process of being replaced. The new pole had been installed and some but not all utilities had transferred their attachments to the new pole. The new pole did not fail. The old pole failed; it had significant ground line corrosion and had been reinforced

The FPL pole failed in-line due to being pulled along the line when wire broke due to tree failures. This pole was in good condition and broke just above ground line as would be expected.

Overall, the structures performed well given the loading placed on them by the tree failures.

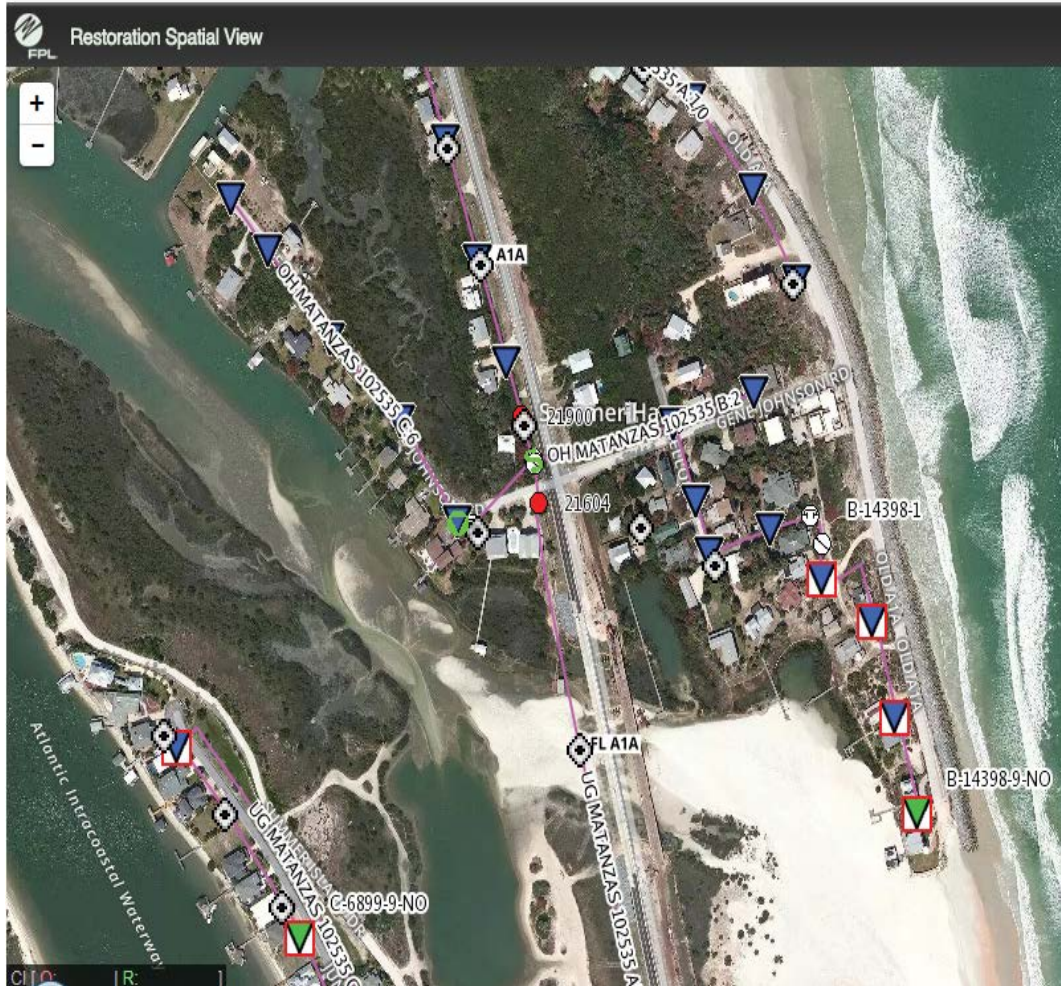
Matanzas Inlet Case Study

Matanzas Inlet is located just south of St. Augustine. The pad mounted equipment experienced severe effects of waves and scouring which resulted in the catastrophic failures of the equipment shown below. This type of failure can lead to extended restoration times.

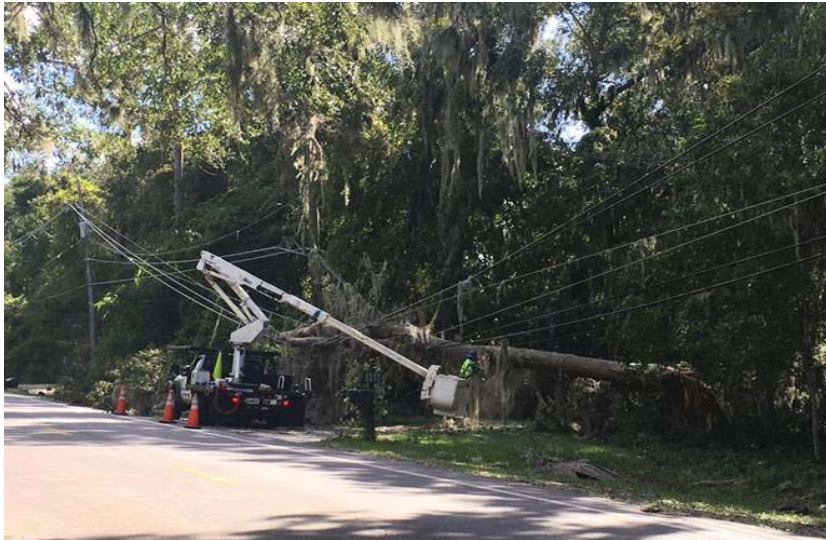
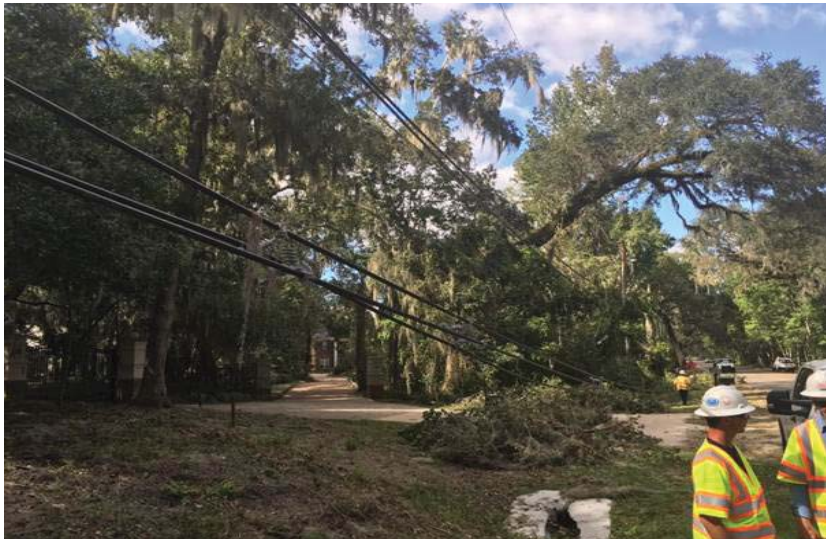
Riverton Feeder Case Study

Riverton 5761 experienced heavy winds and related tree damage. There were 4 areas each with multiple spans of Hendrix cable down or broken, 4 damaged/down poles (veg related), 20+ locations of vegetation and ~5 locations of broken Hendrix brackets/spacers. 12 line crews were engaged (around 50 line personnel from three different companies) and a sufficient amount of vegetation crews. This case is on SR 13 - scenic road along the St. John's River
