080701-TP

COMPOSITE EXHIBIT 1

"EMAIL CORRESPONDENCE AND PHOTOGRAPHS"

Wiring Takeover Problem - Grounding

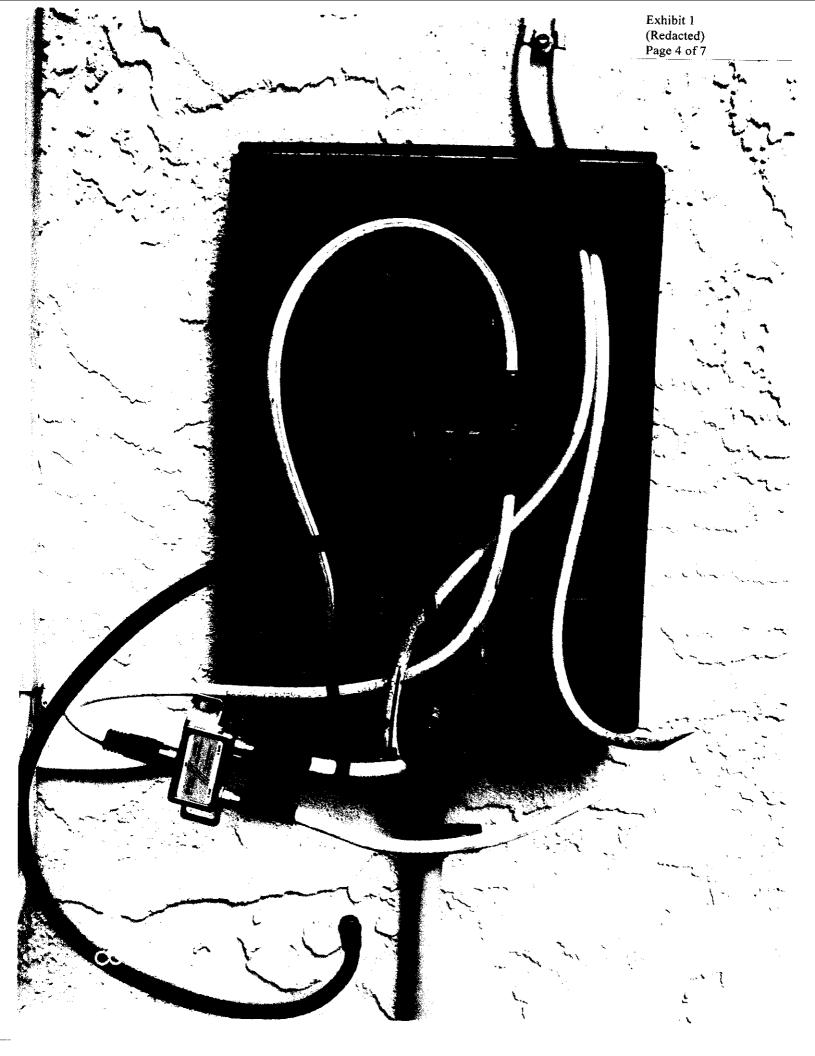
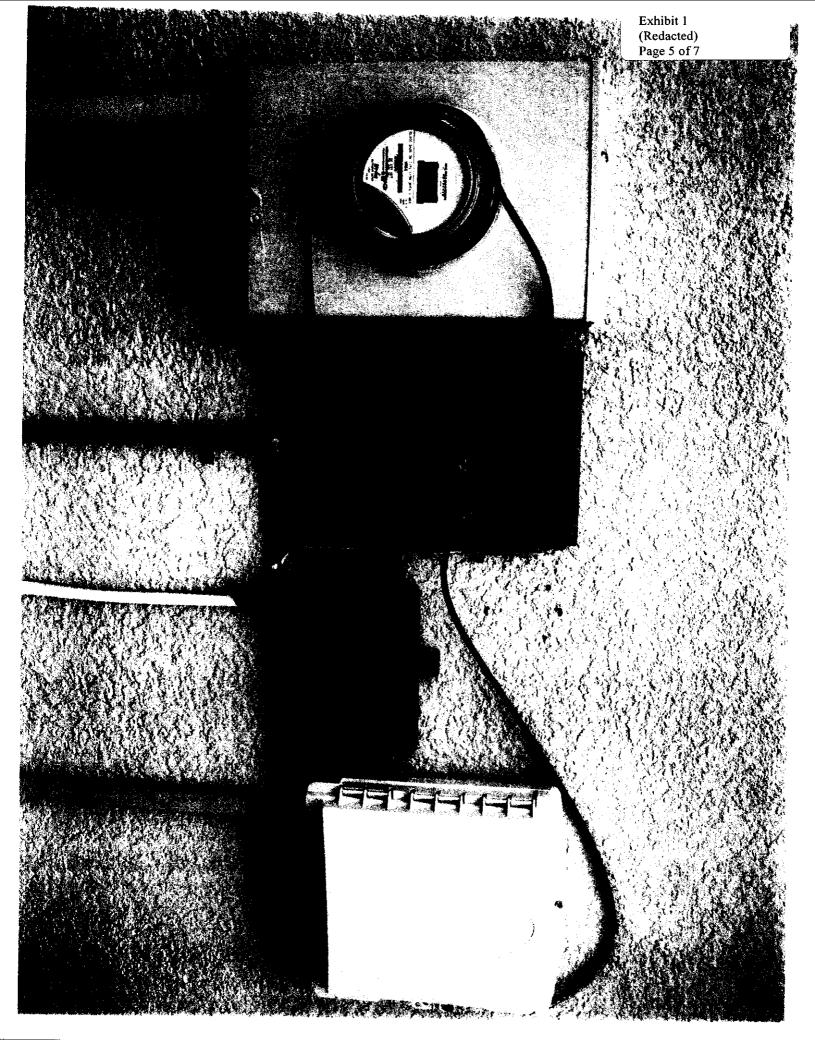
Attachments: verizon grounding 002.jpg; verizon grounding 003.jpg; verizon grounding 001.jpg

We are noticing this in all of our locations and wanted to bring this to your attention. When a Verizon installer is using our homerun wire instead of disconnecting the output wire to the CPE device the drop input wire in being disconnected, not being terminated and your drop is going through our ground block. This leaves our outside drop not grounded and puts liability on us if something happens to the customer. It also provides a very unsafe condition to our drop if it were to become energized by the power company. Please discuss the importance of this with your Managers / Supervisors so it can be corrected.

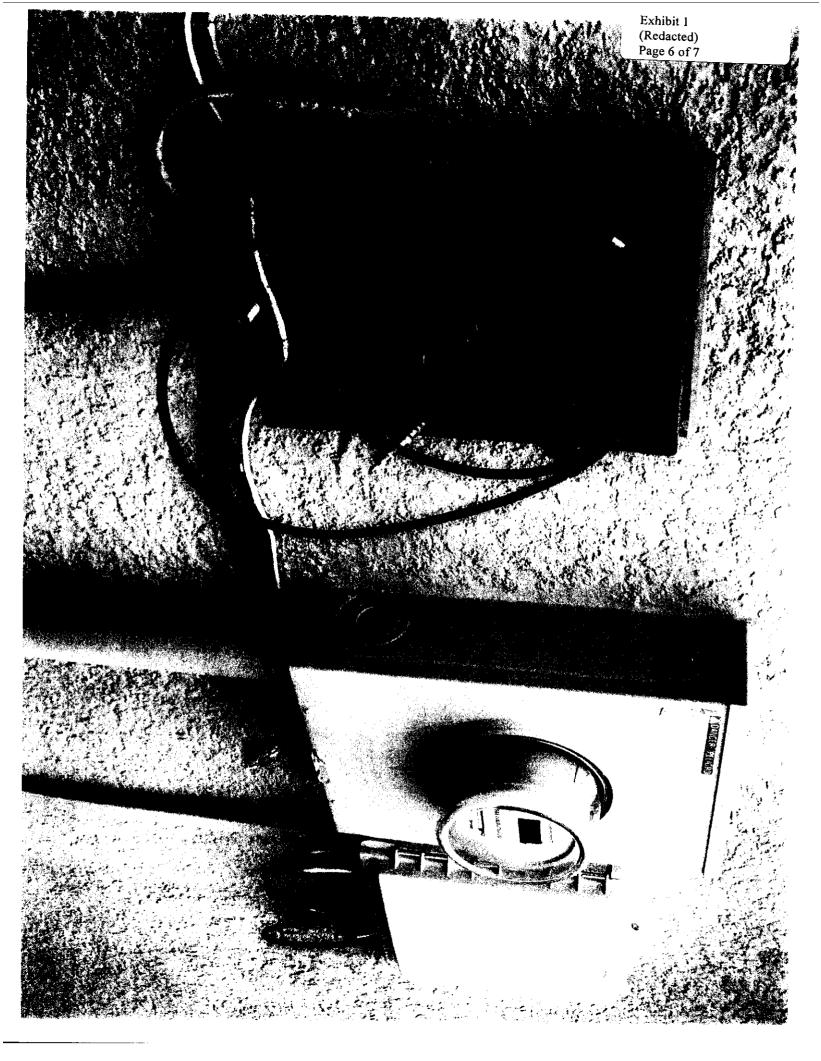
1st pix address is:

Here are two more examples of connection through our grounding device. This is troubling to me as the ones that we are finding are on take backs from Verizon to Bright House. I have to wonder how many more are this way serving your customers. Do you have a new contracting company doing installs? I can't believe this is recommended practice in connecting service as it is leaving our service drop ungrounded -
