Docket No: 20190001-EI

**FLORIDA POWER & LIGHT COMPANY’S REQUEST FOR CONFIDENTIAL
CLASSIFICATION OF INFORMATION PROVIDED IN RESPONSE TO THE
OFFICE OF PUBLIC COUNSEL’S FIRST REQUEST FOR PRODUCTION (No. 1)**

10) Minor damage to the insulation of two stator bars was noted after installation of bottom coils for the EPU modification [D23]. The coils with damage were located in slot #35 and slot #42 and repaired in place [D41]. No mention of any damage to bottom coil 17 was found.

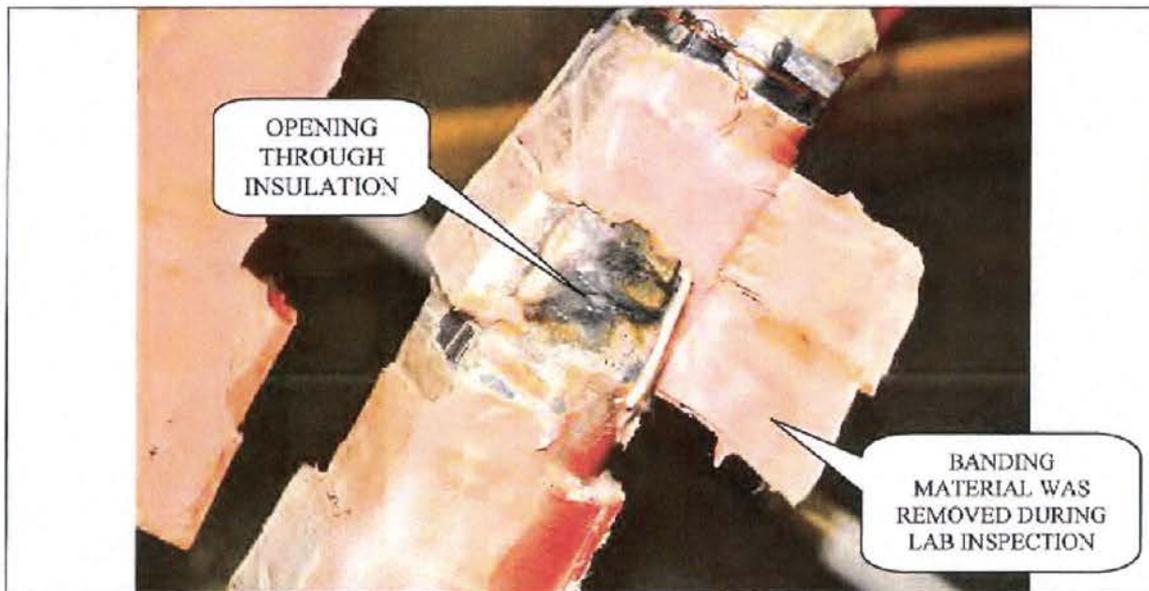
After examination of B17 it was observed [D38, O5] that the fault current track to ground followed a path along the OCP layer originating at a small opening through the insulation that was located under spacer banding material:
