**Re: Docket No. 20240001-EI**

Please find enclosed for filing in the above referenced docket the Direct Testimony and Exhibits of Richard Polich, P.E. This filing is being made via the Florida Public Service Commission's Web Based Electronic Filing portal.

1 **VI. ASSESSMENT OF OUTAGES AND DERATES IMPACT ON**  
2 **REPLACEMENT POWER COSTS**

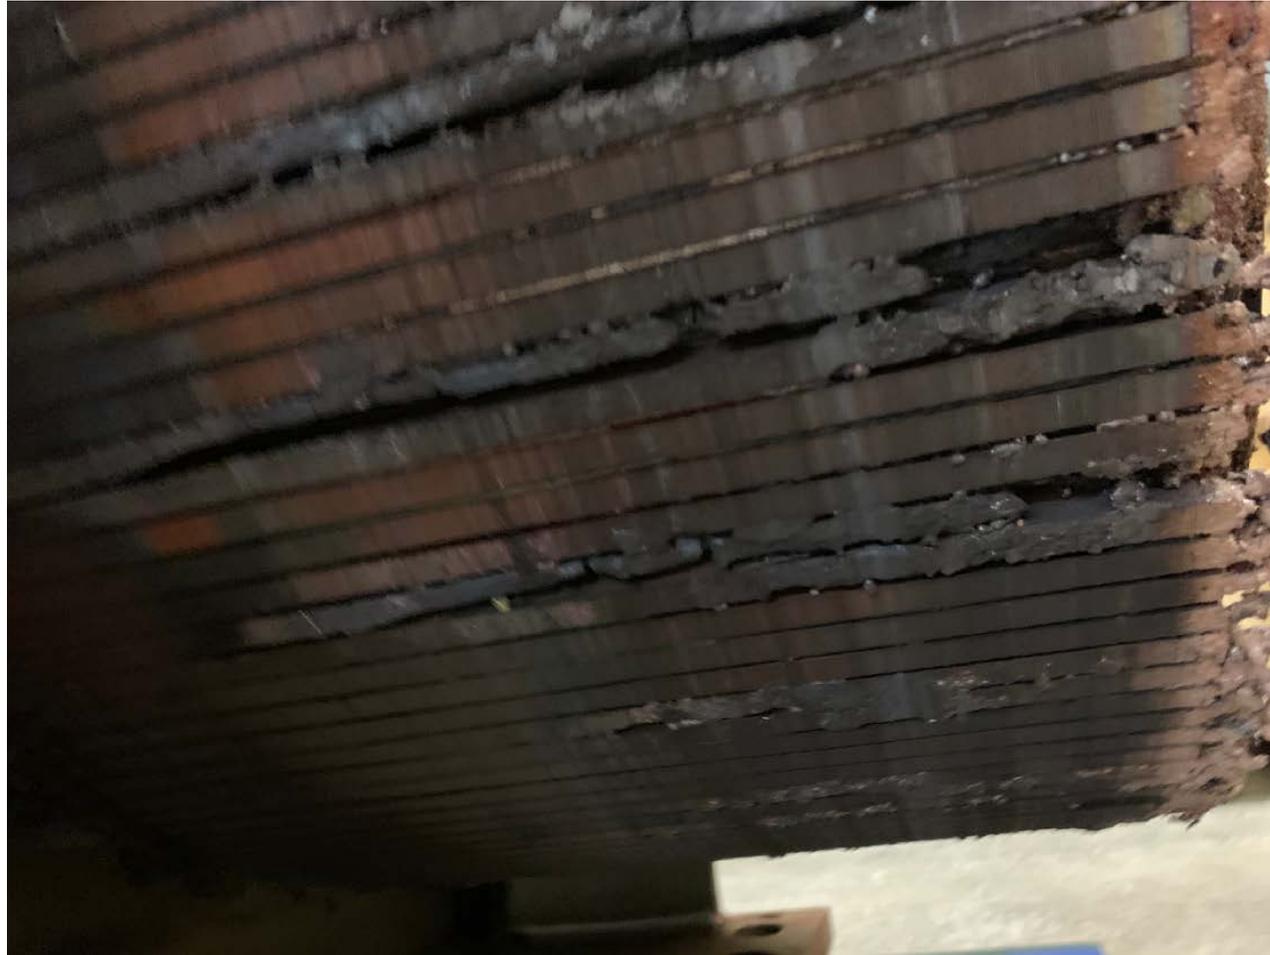
12 A. Upon disassembling the exciter the investigation revealed water intrusion and  
13 found that the PMG was damaged. The root cause team found the failure of the  
14 PMG was likely due to a culmination of age-related breakdown of the PMG stator  
15 winding insulation, along with water intrusion due to inadequate sealing of the

Fig. 6 PMG Stator Core – Coil Melt in Slots

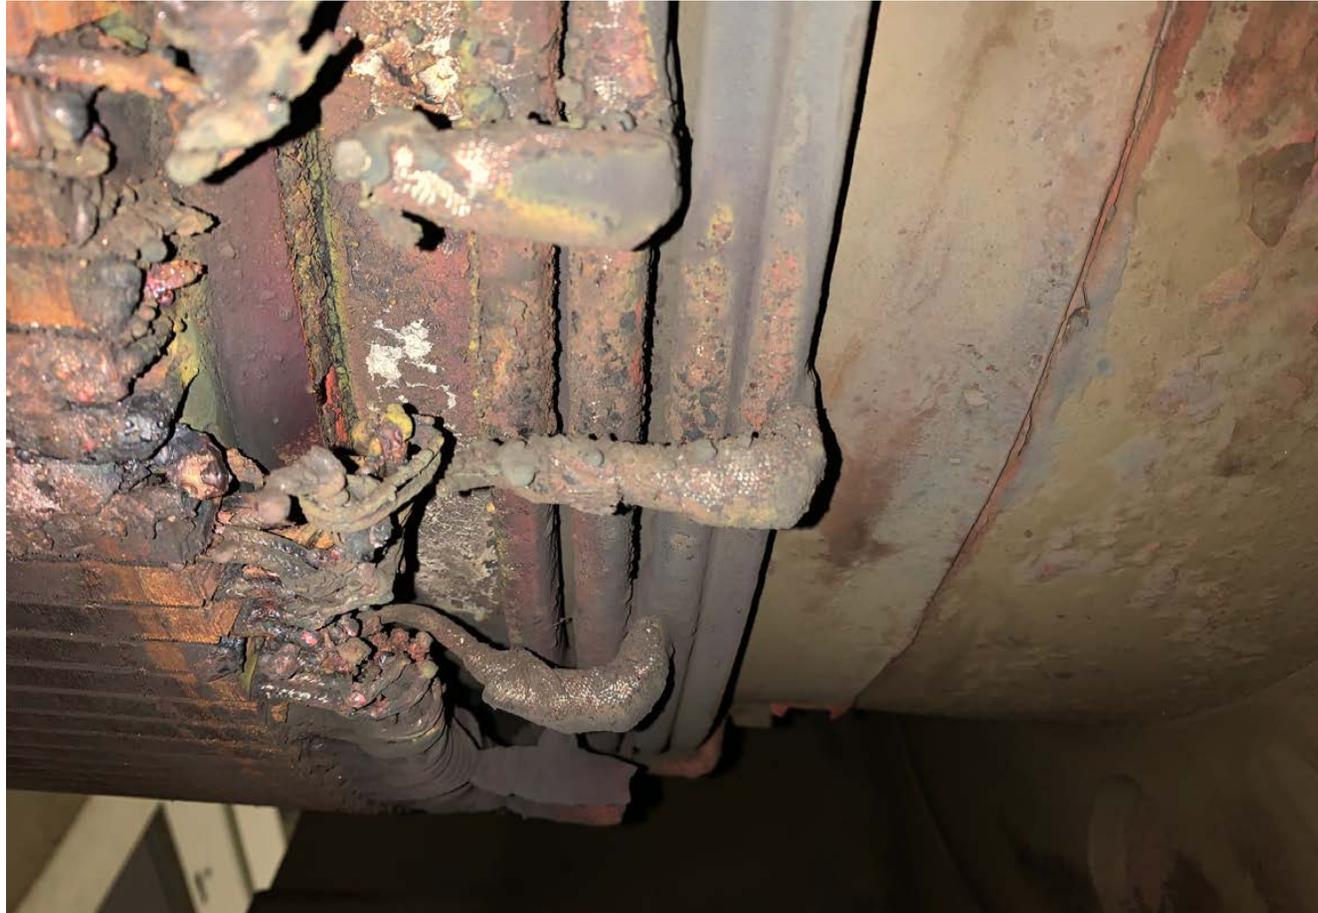
Fig. 7 PMG Stator Coil Connection Ring Failures

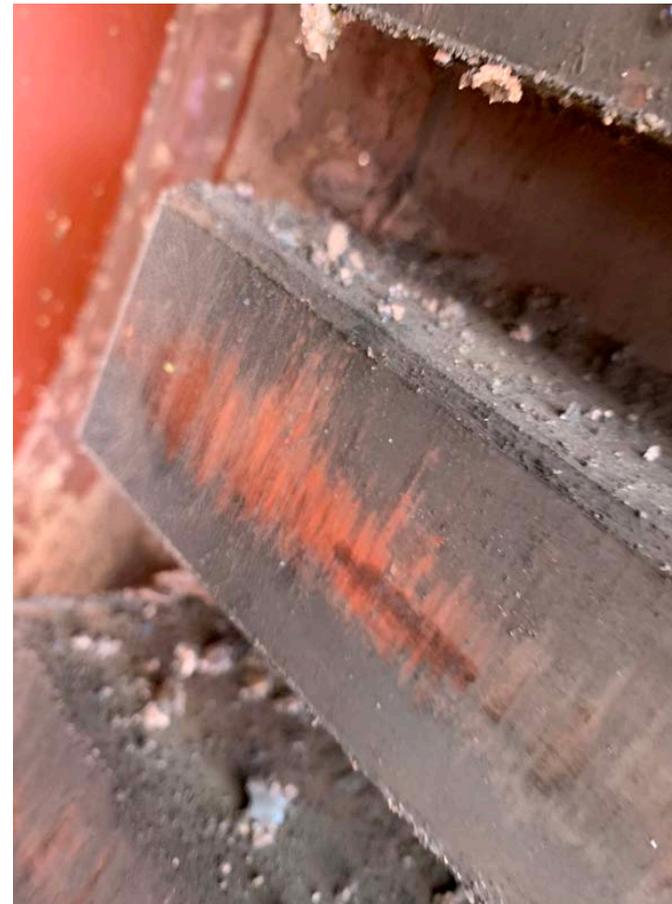
Fig. 9 PMG Magnet Rub

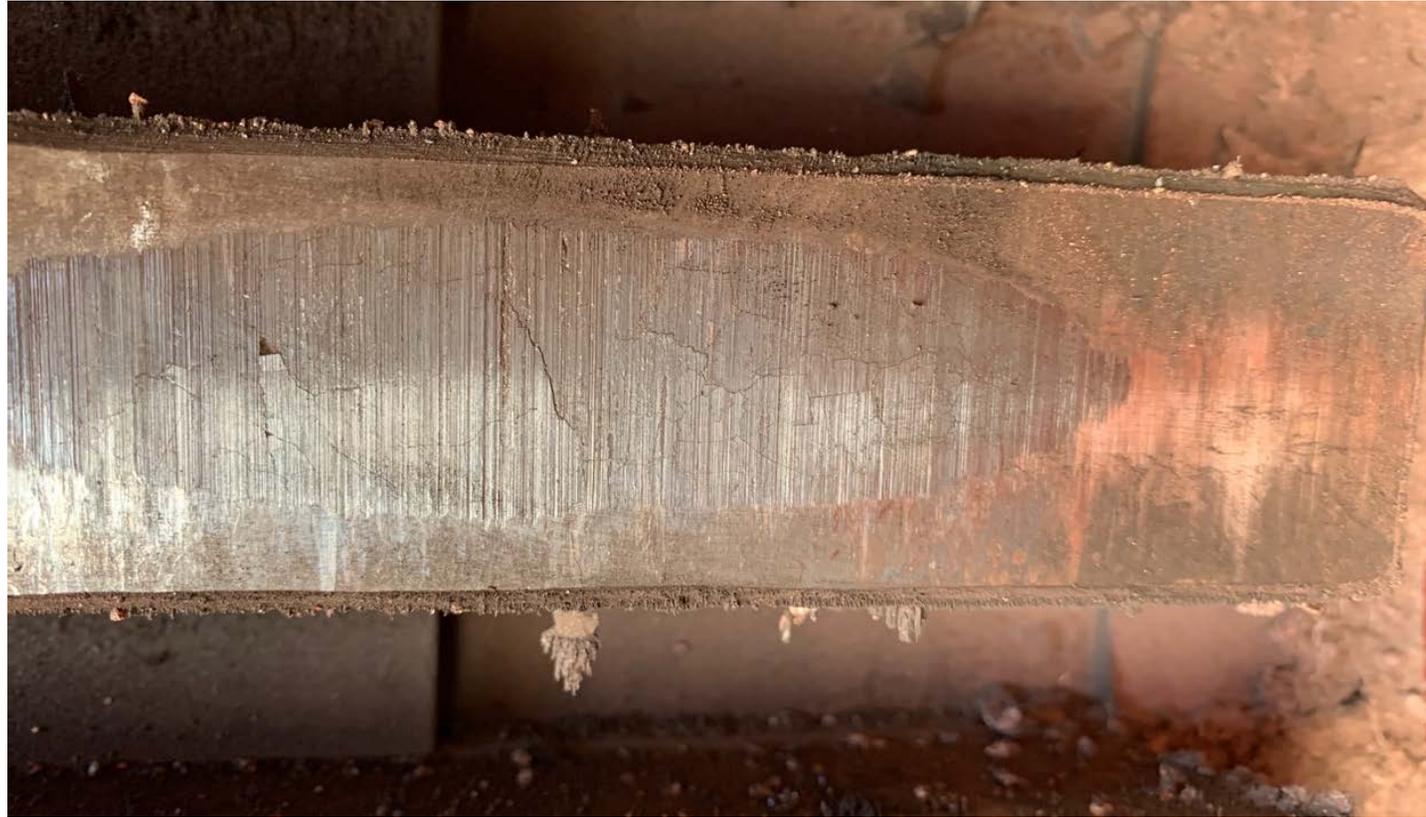
Fig. 10 PMG Magnet Cracking

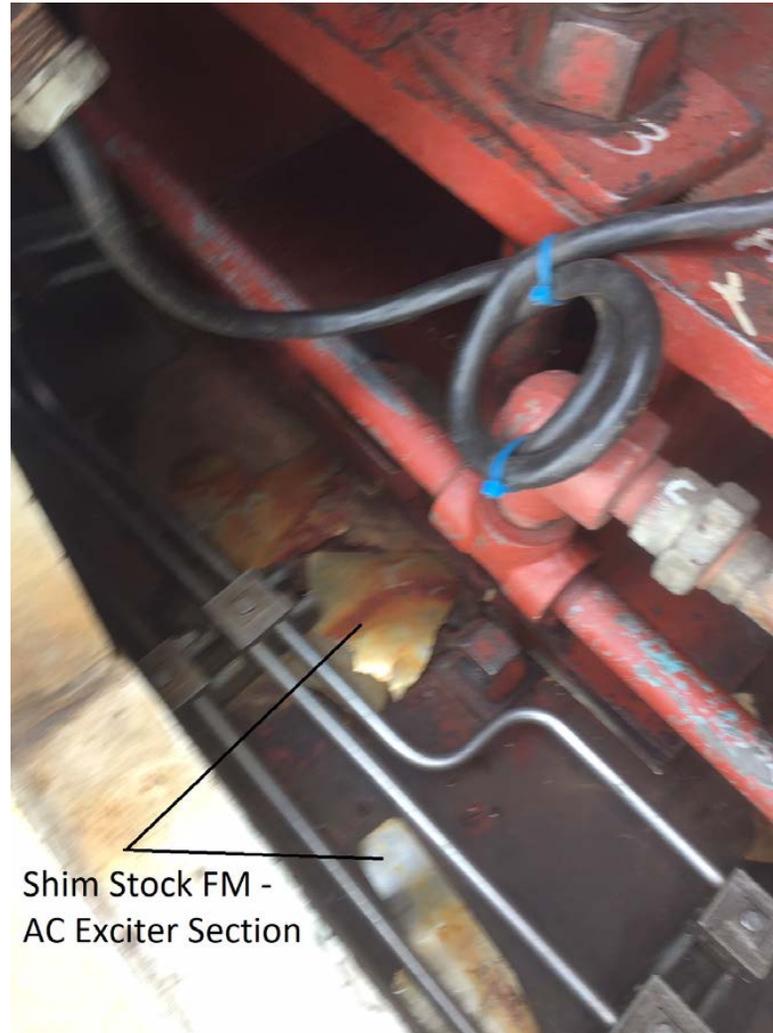
Fig. 11 Foreign Material (Shims) Found in AC Exciter Section

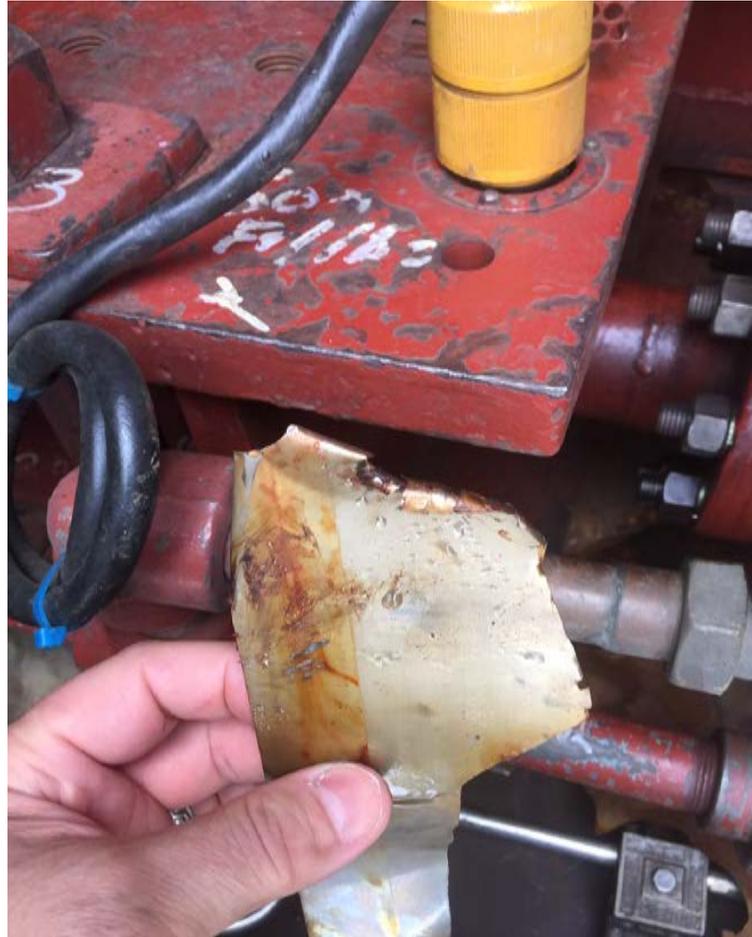
Fig. 12 Liberated Shim Stock Found in AC Exciter Section

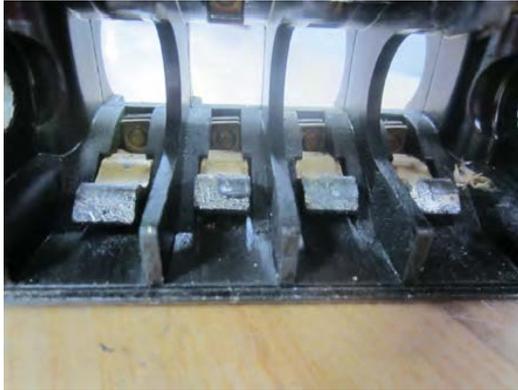
Left-Side Switch Stationary Contacts

The switch rotors were removed from each of the switches and the bottom stationary contact finger in each case had come loose from the terminal point as shown here (left-hand switch and right)

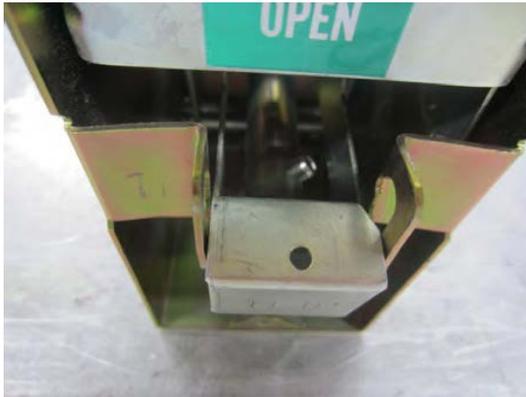
Bent Breaker Lock-Out Tabs

The breaker lock-out tabs on the front of the operating mechanism were found to be slightly bent, however the breaker operated without incident during all mechanical and electrical testing. If these tabs had been bent enough to prevent the Push to Trip button from fully returning to the reset position the linkage within the mechanism could prevent the breaker from closing or could cause a situation that the breaker might close, but not remain closed. These photos show that without the face plate attached to the operating mechanism the Push to Trip button is free to fall below its normal position. This is not a concern as it shows that the tabs are not tight enough to hold the Push to Trip button.

It is recommended that the breaker be handled outside the switchgear cubicle with additional care. The breaker lock-out tabs on the front of the operating mechanism can cause the breaker not to function properly. When a breaker is shipped from Westinghouse the breaker lock-out tabs will include an operating mechanism lock-out bar as shown below.

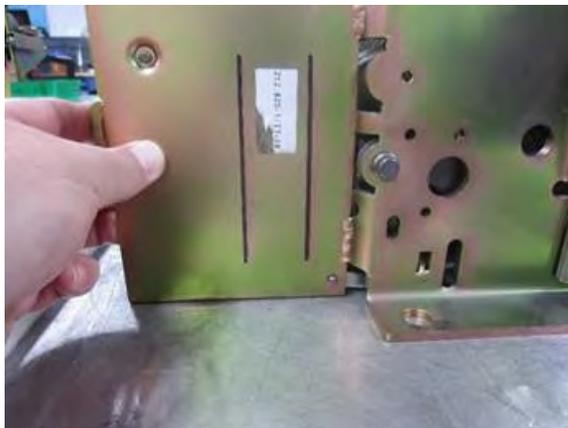
Operating Mechanism Inspection Hole

If the Push to Trip button is held in like shown below, or if the breaker lock-out tabs on the front of the operating mechanism are bent sufficiently to hold this button in the Push to Trip lever would make contact with the rear of the trip pan. This scenario could cause the breaker to be trip free and it would not close, or if the trip pan was only partially held down the breaker may have closed, but the operating mechanism trip faces may not have been completely seated and a shock in the area of the breaker cell could cause the breaker to open. Either of these cases could cause the breaker to open unexpectedly.
