Short title: St. Lucie 1 Generator Ground Fault Analysis

St. Lucie 1 Generator Ground Fault Analysis

Gary Griffith, PGD Technical Services Leader
Randal Kerkes, Principal Technical Services Specialist

July 11th 2019

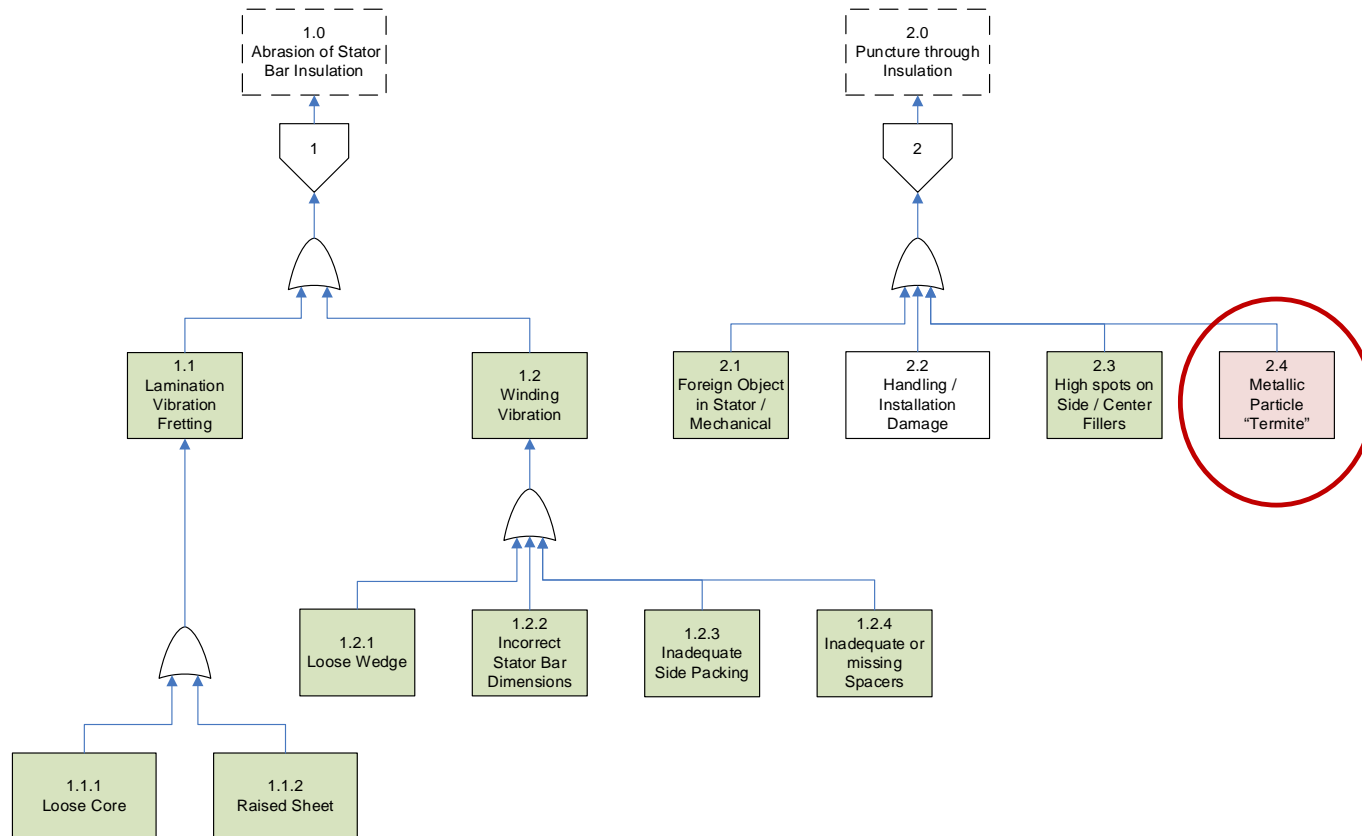
By Elimination of possible failure modes the most probable and verified by 3rd party consultant is a “Magnetic Termite”

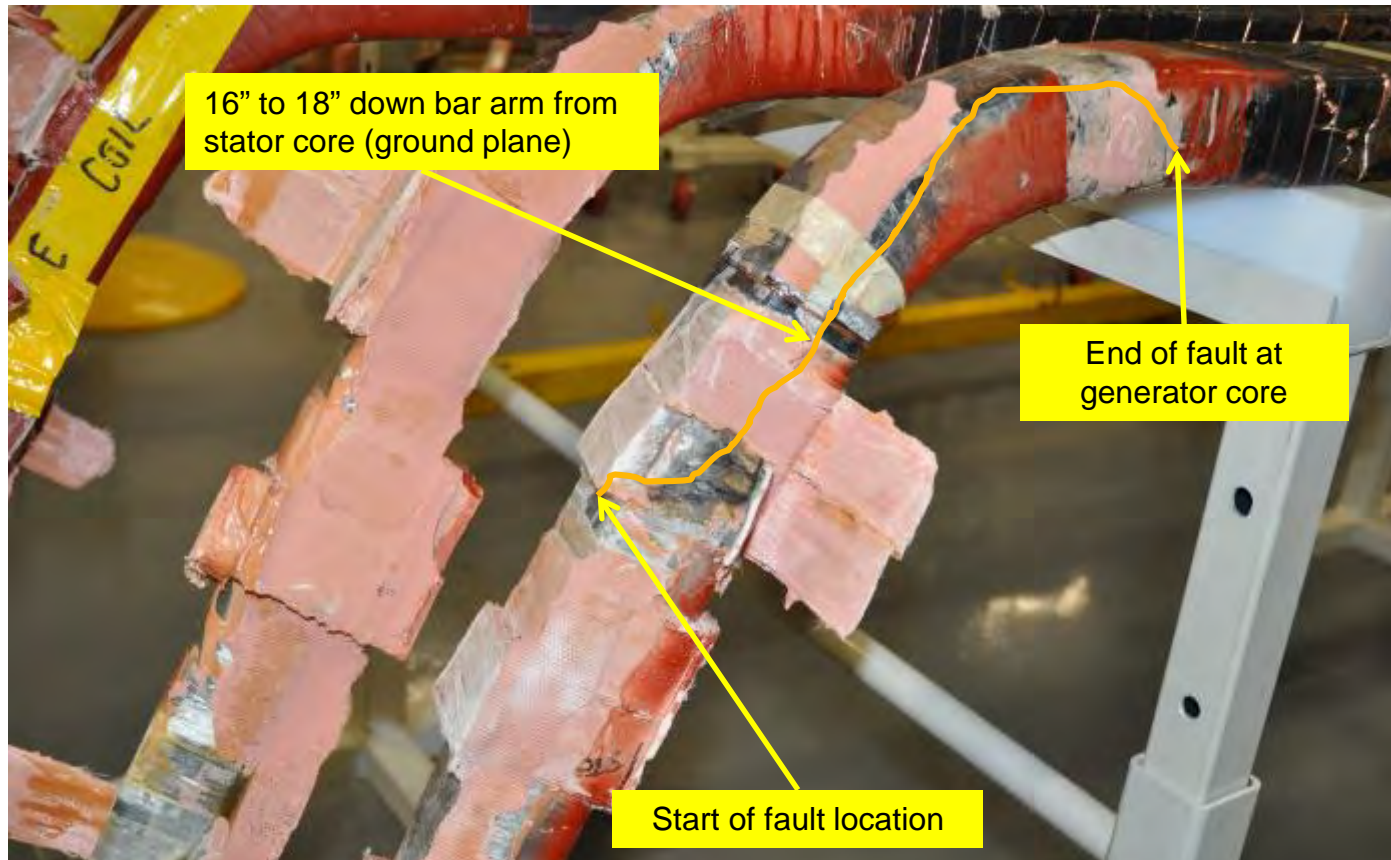
St. Lucie 1 Generator Ground Fault Path

Fault Initiation at Endwinding Leading to Core Finger Plate

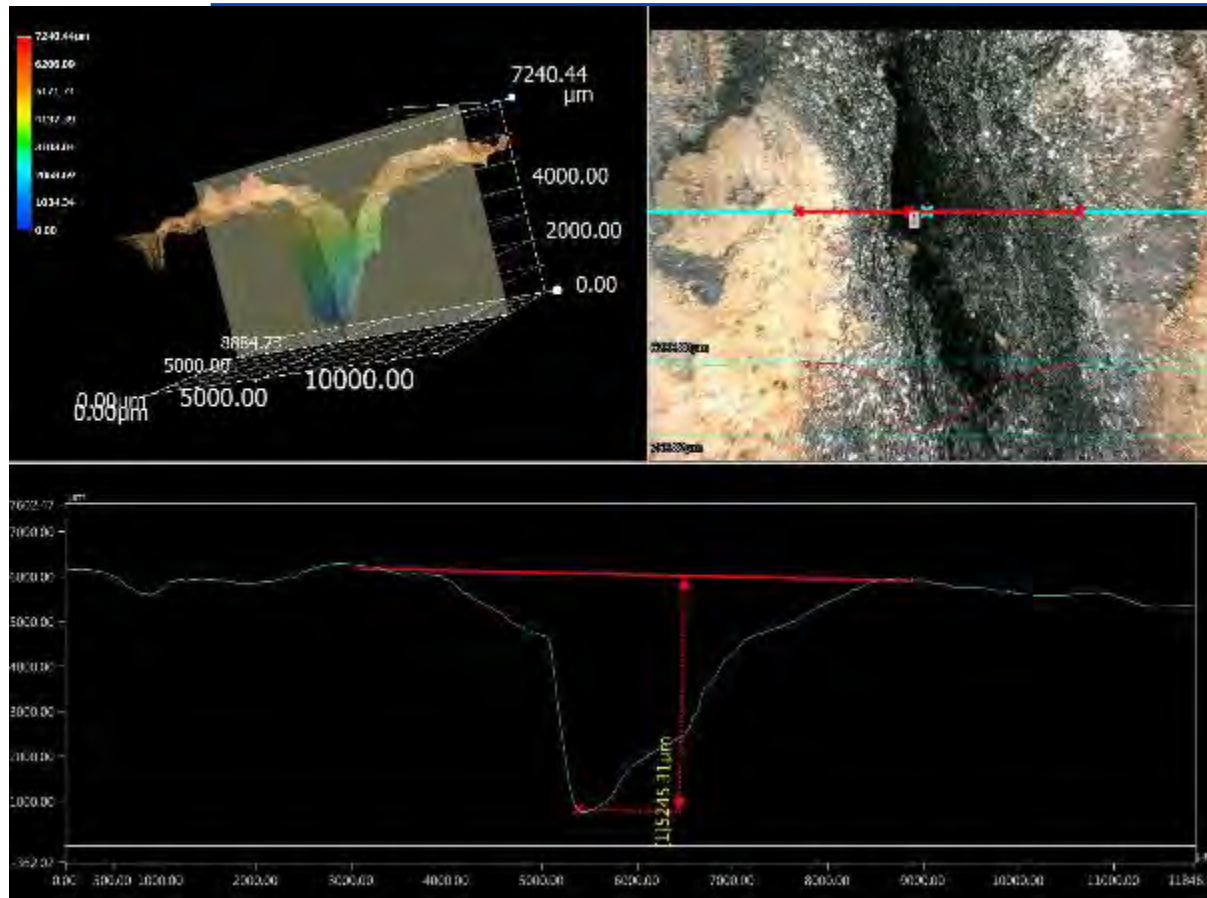
Failure straight down through insulation system

Failure mode characteristics of a Magnetic termite – 2.4 on refute matrix

**Failure mode characteristics of a “Magnetic Termite” – 2.4 on fault tree
Magnetic Termite relatively long term failure mode**

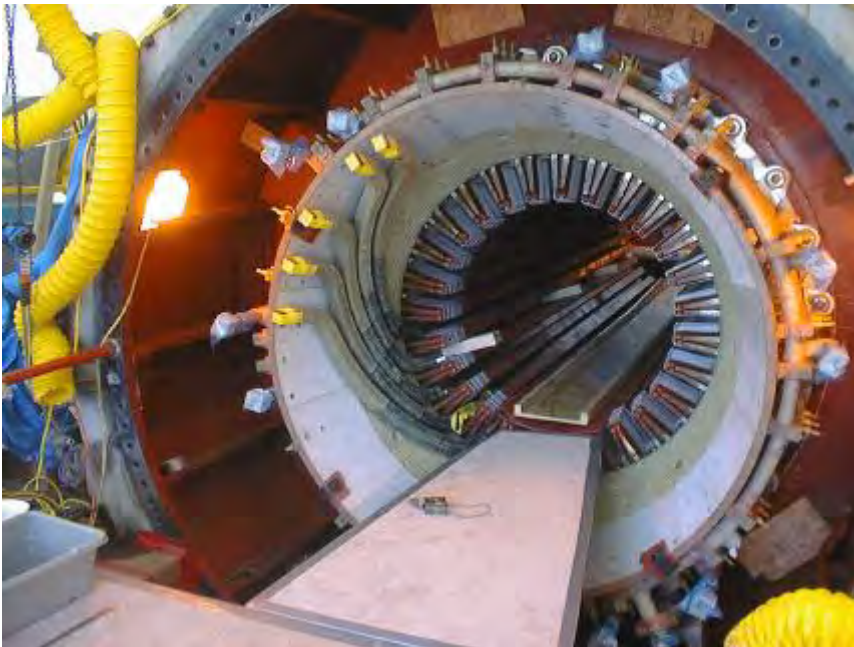
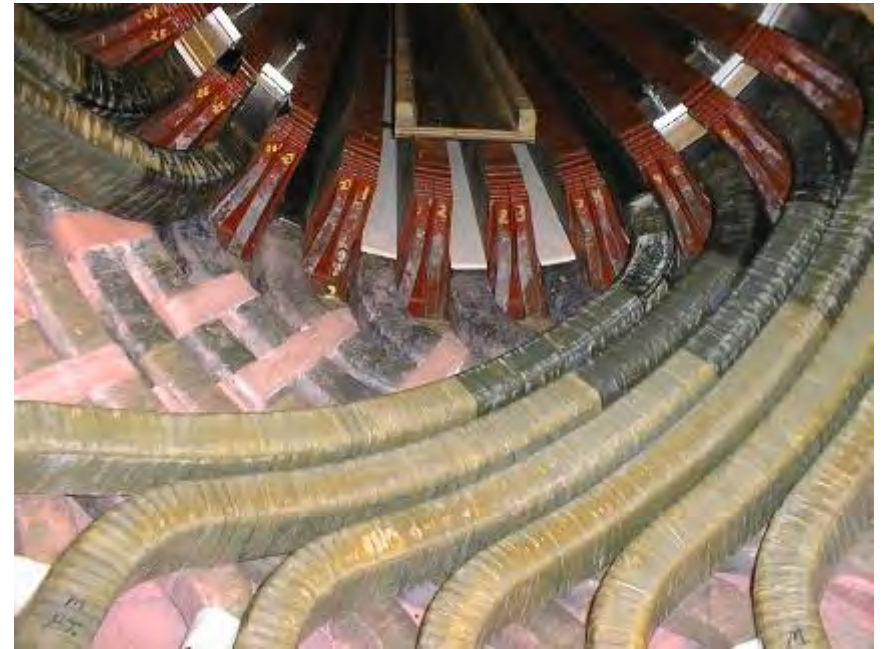
This is a Sanford STG which has the same endwinding support design as PSL-1

There is no practical method to inspect many areas of the winding for ‘termite’ activity, most of which may be under the top layer of the bar and thus invisible even if it was possible to inspect the whole winding

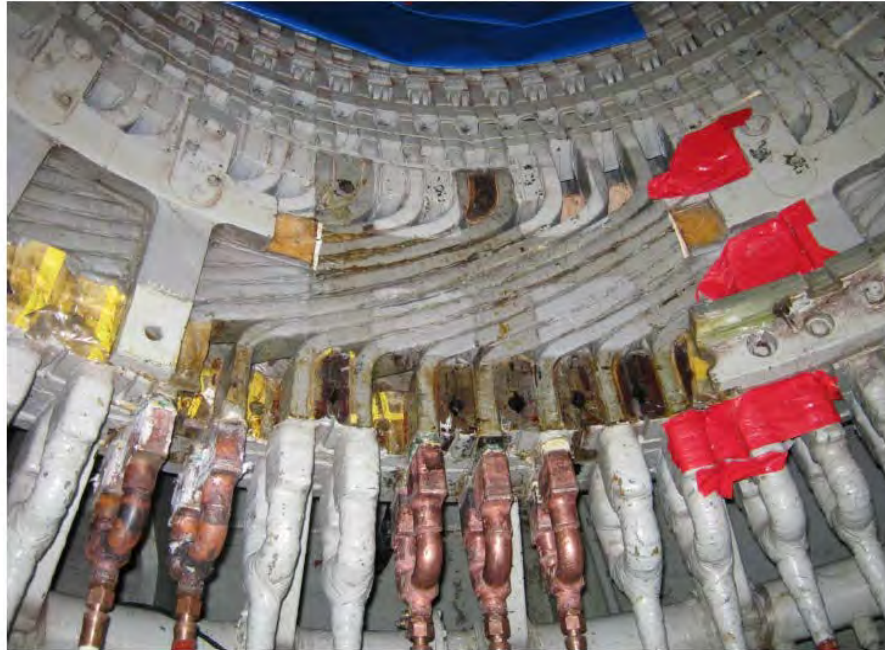
Fan baffle and cruciform removed

Failure under end winding supports similar to St. Lucie Unit 1

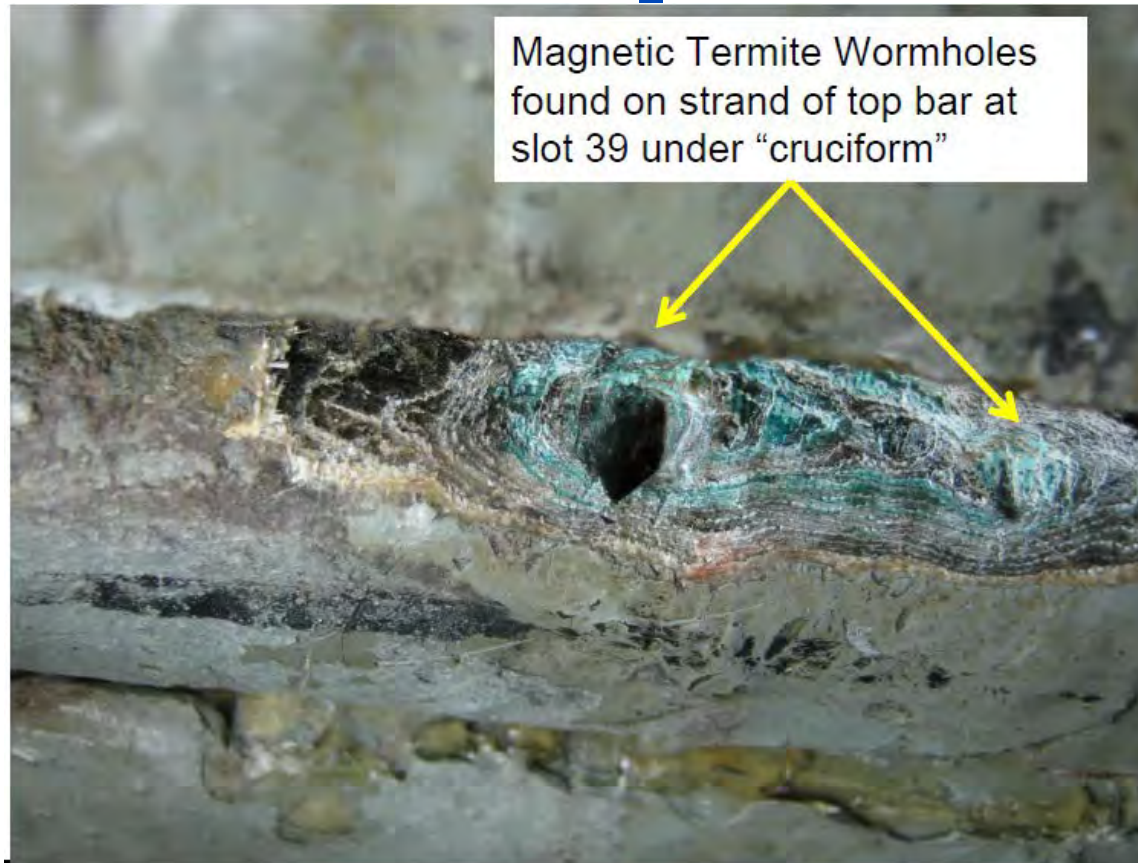
Failure opening in insulation similar to St. Lucie Unit 1

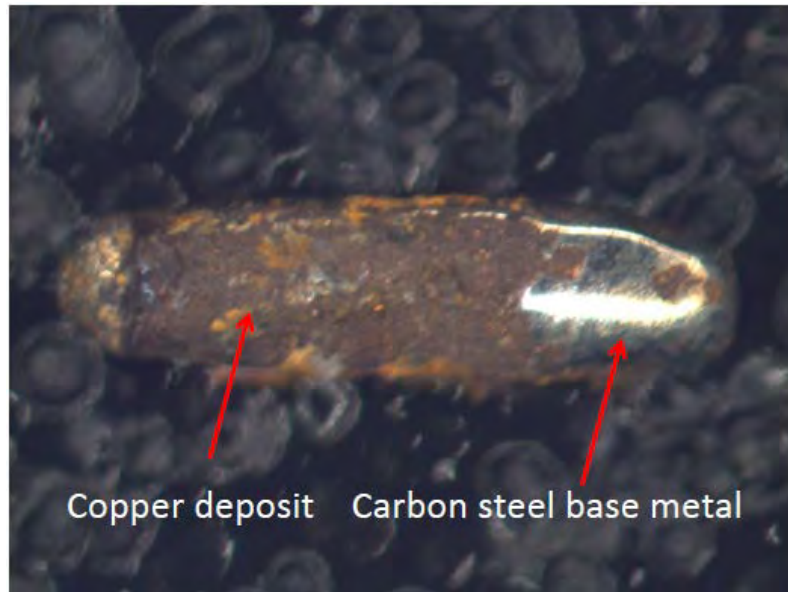
Particle is approx. 2.39 X 0.613 mm

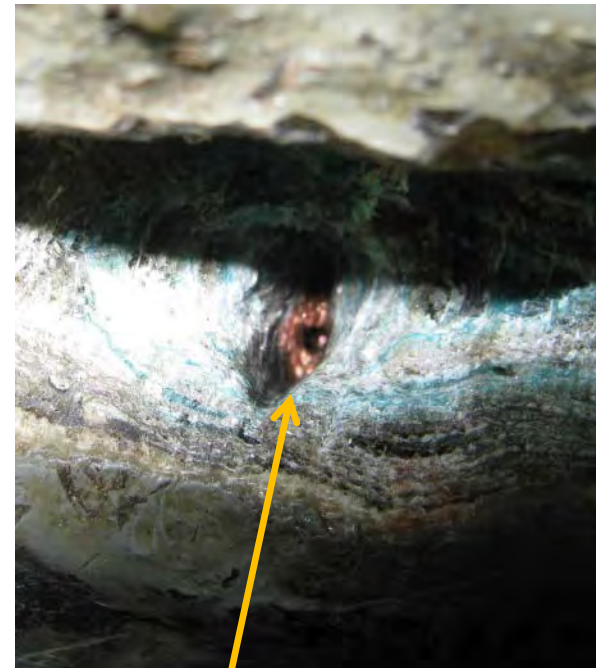
Magnetic Termite – worm hole

Failure opening in insulation similar to St. Lucie Unit 1 but, since there was no electrical fault, the particle was recovered

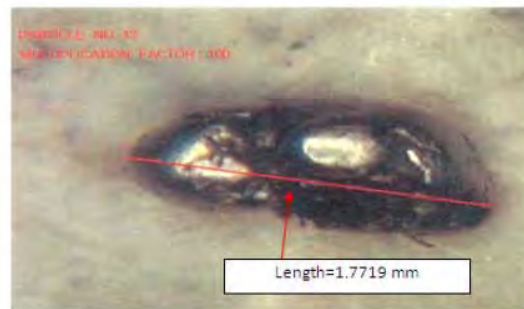
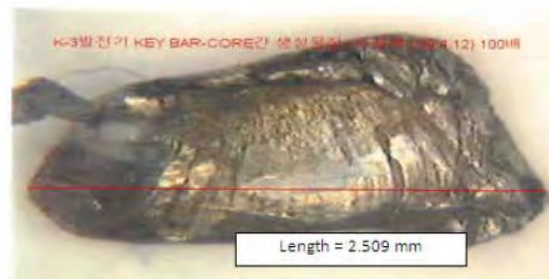
Particles from KoRi generator [lo carbon steel]

Magnetic termites failure mode documentation

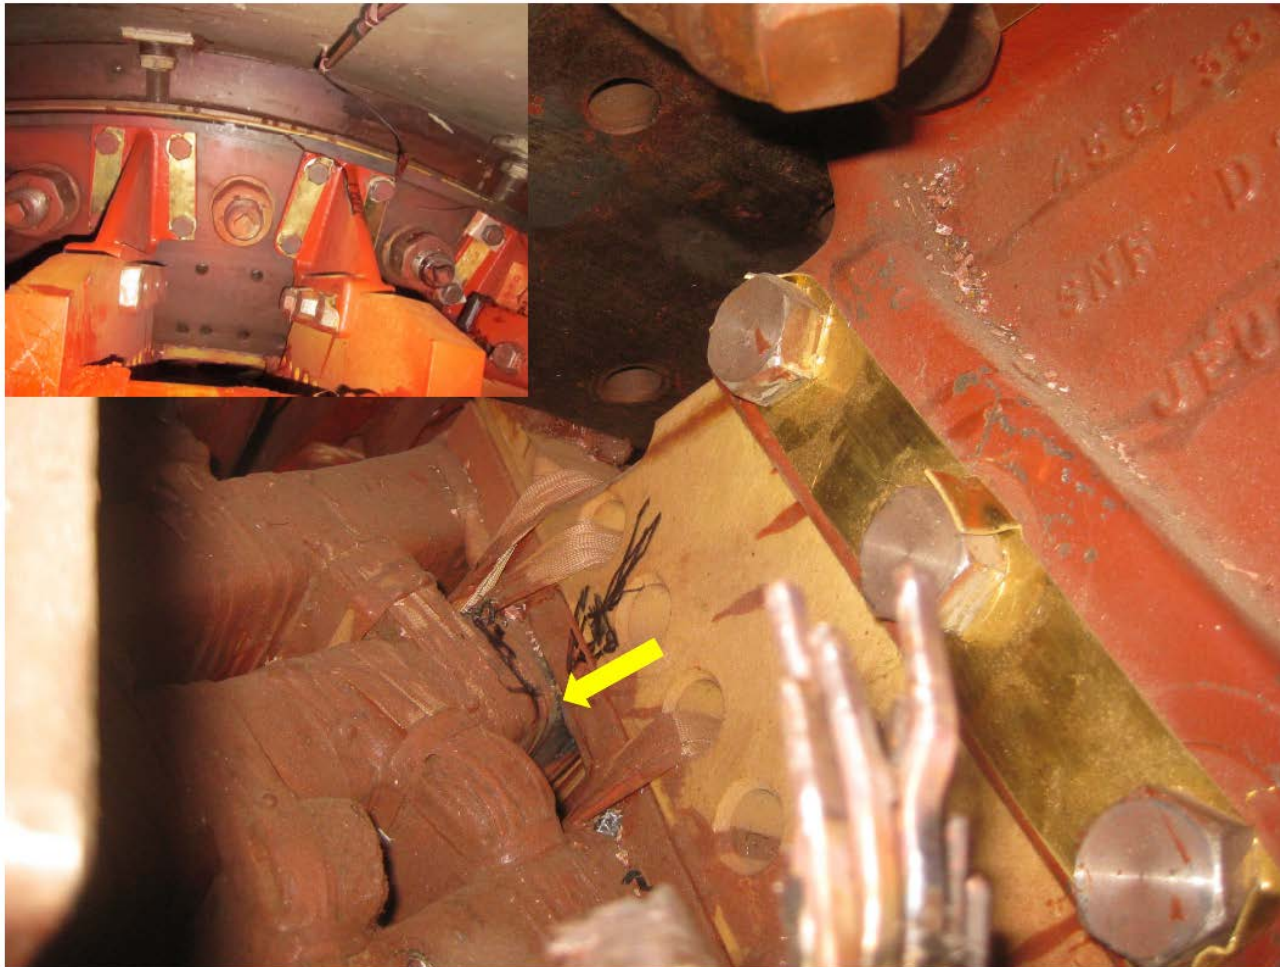
Bottom bar failure

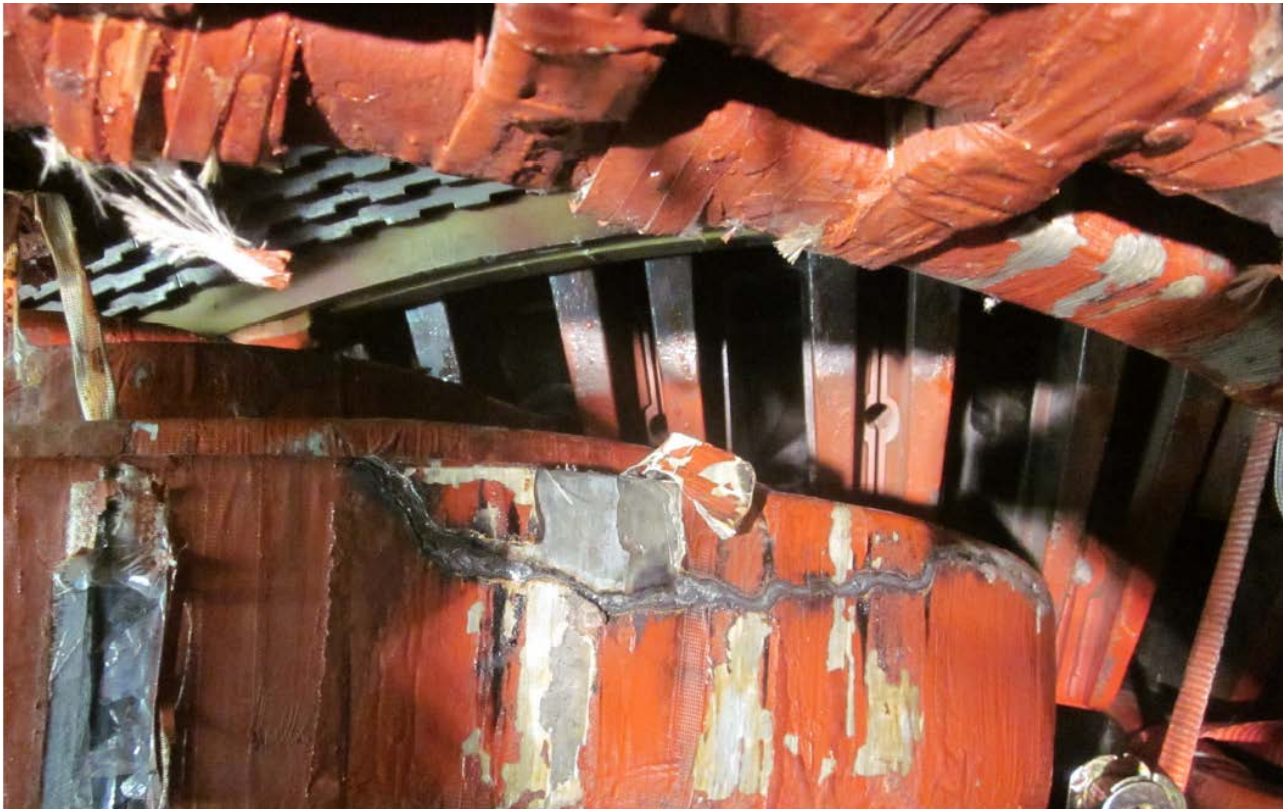
Failure mode identical to St. Lucie Unit 1 – tracking from insulation opening to ground over stator bar insulation

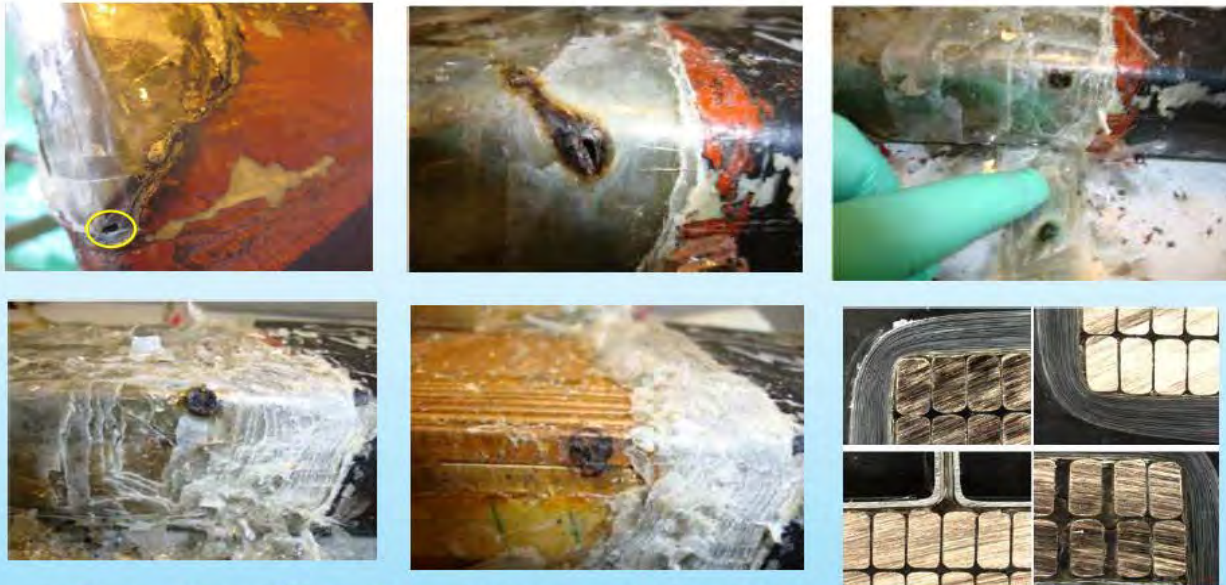
- General condition of insulation good given the age of the machine (37Y)
- Correct alignment and impregnation of insulation layers
- Breakdown channel goes straight through insulation layers
- No traces of partial discharge activity between insulation layers
- No foreign materials found

Exact failure mode as St. Lucie Unit 1

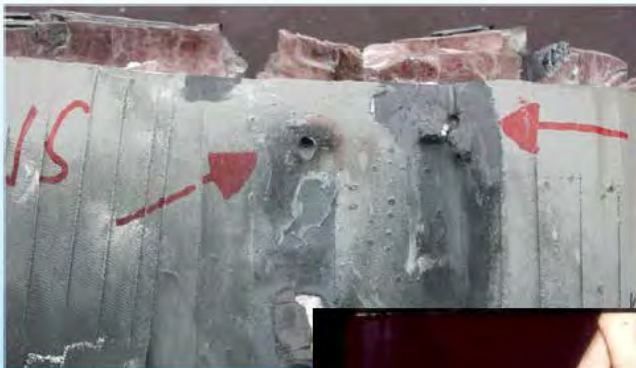
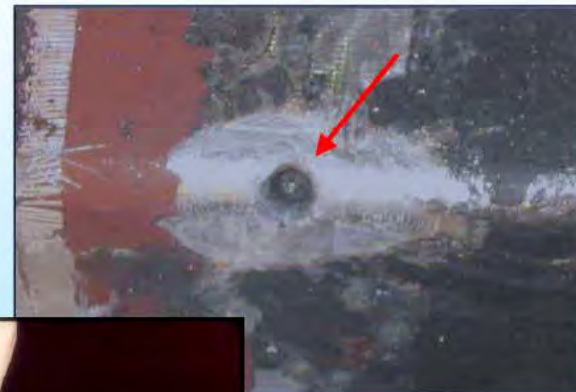
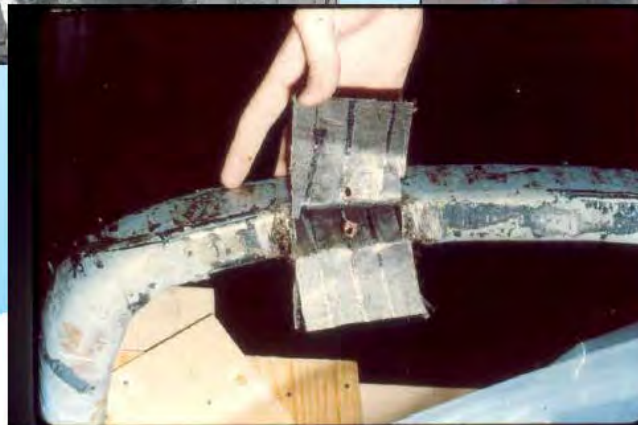
- Other examples of insulation failure caused by magnetic termites

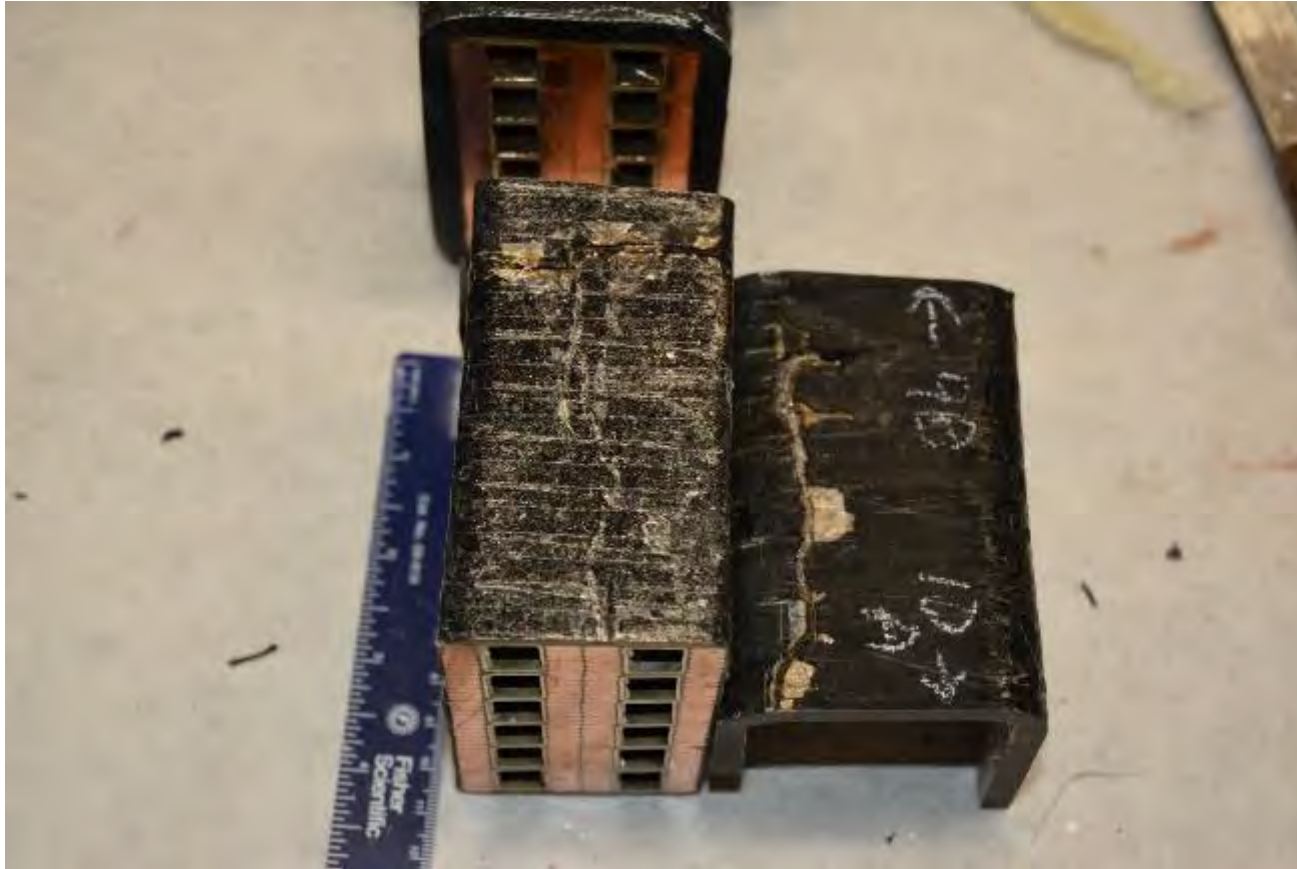
Separated insulation from ICP layer – Forensic process evaluating specimen for failure mode – none NOTED AT THIS TIME

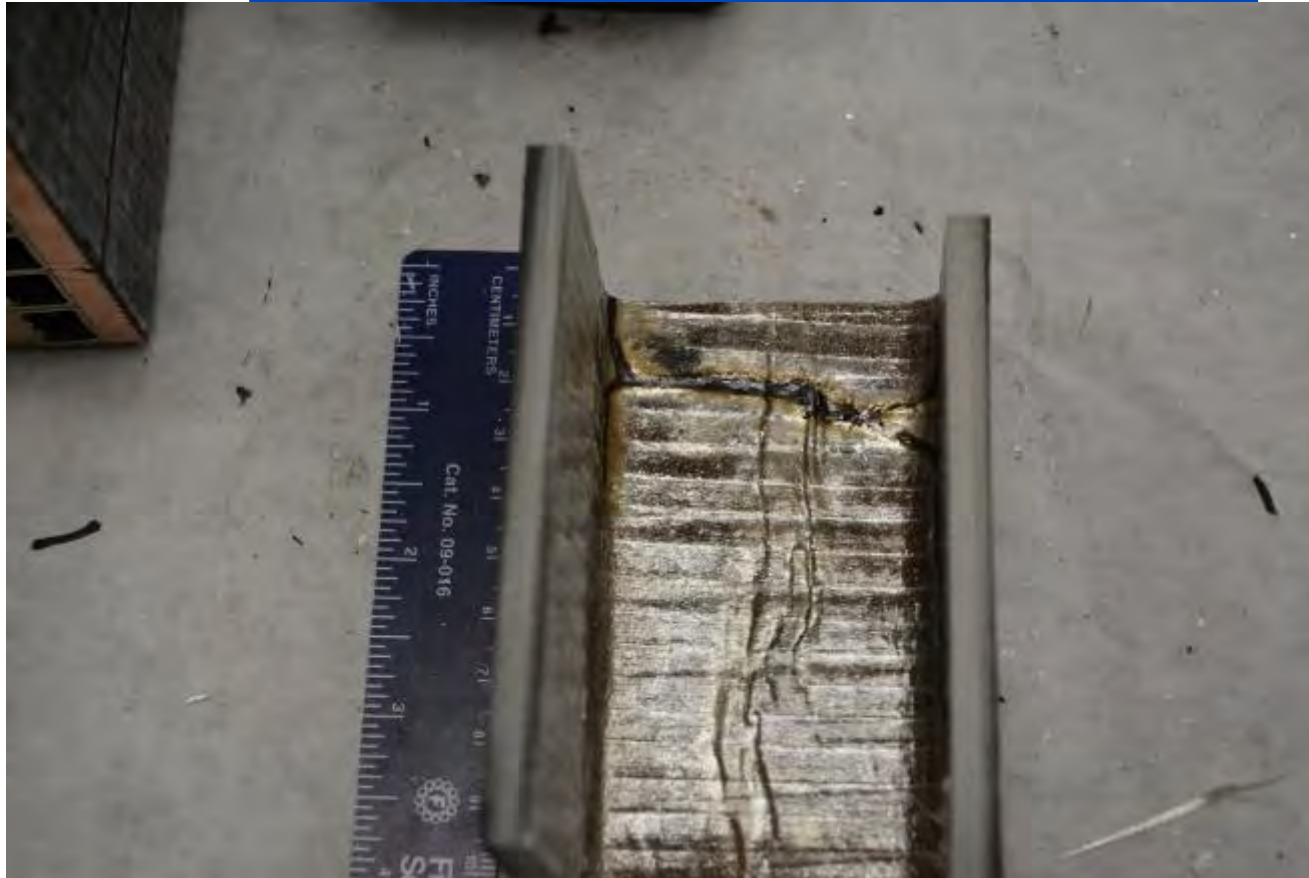
FAULT OPENING STRAIGHT DOWN DID NOT FOLLOW TAPE EDGS AS A NORMAL FAILURE MODE WOULD

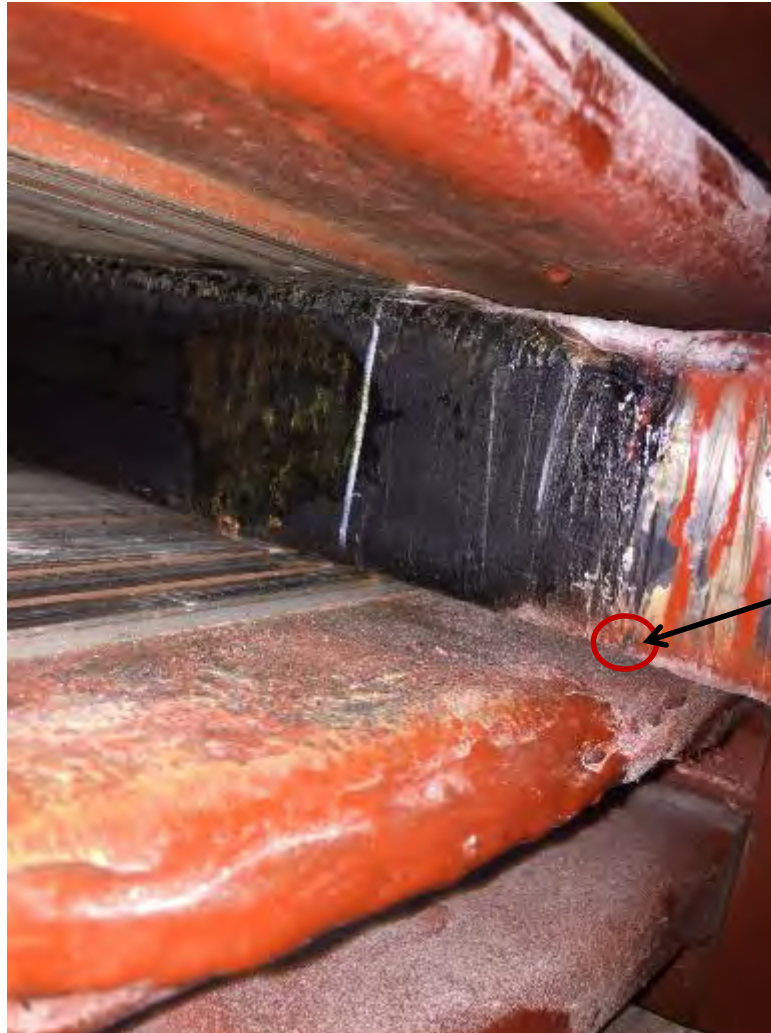
Discharge
site to ground
– Stator Core
Finger Plate

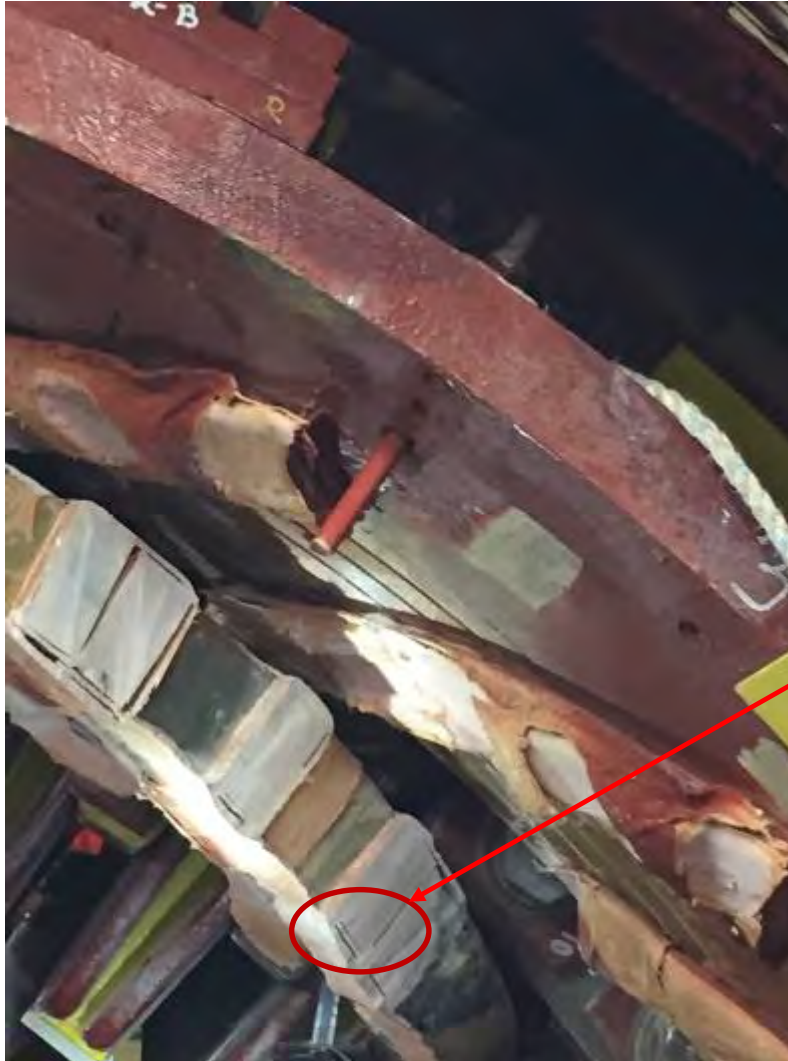
Extraction of Bottom
Bar 17 - Fault location
under blocking
Hidden from view by
blocking
