St. Lucie Station

Unit 1 Main Generator Ground Fault Root Cause Evaluation Report

Event Date: 04/25/2019

CR Number: 02312208

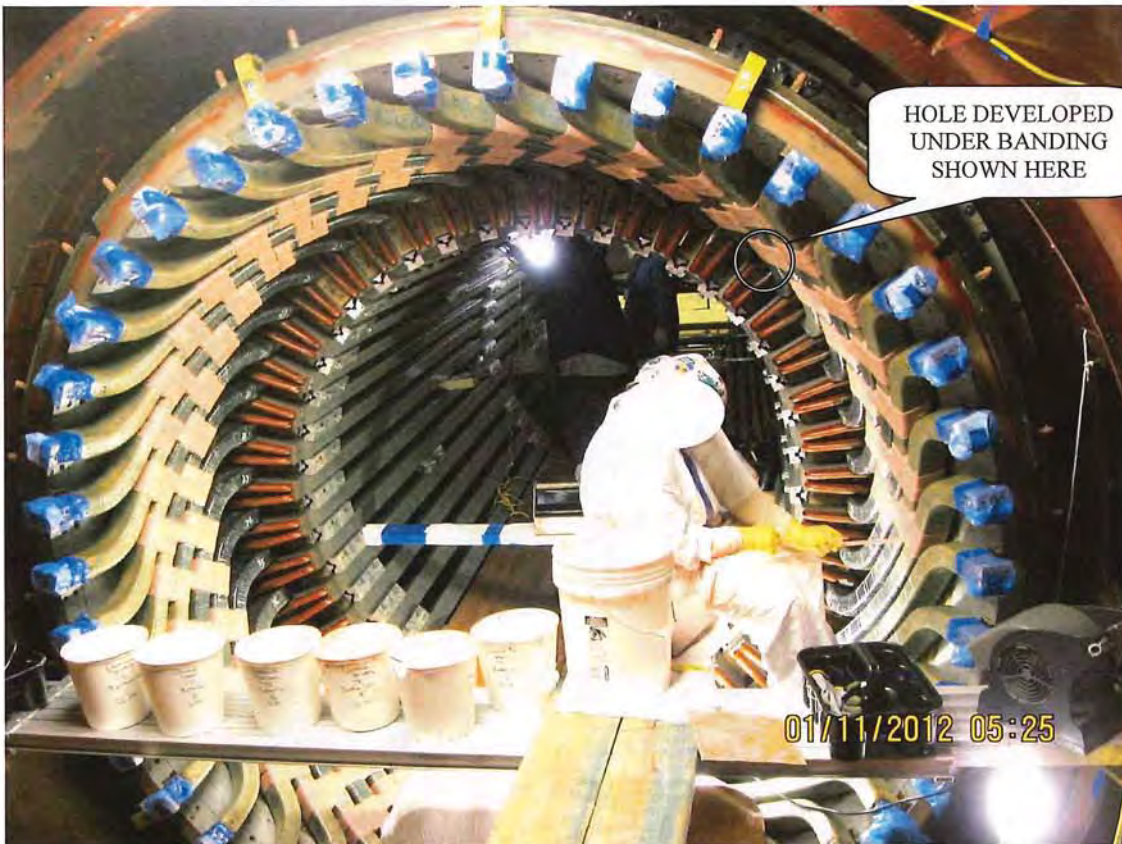
The small puncture in the insulation was located under banding material that was found intact and had been in place since the stator rewind in 2012. Therefore, all of these possible causes involve some occurrence prior to completion of the stator rewind in 2012. The stator was qualified with a high potential test after the rewind was completed. The unit subsequently operated for over 7 years.

Jan. 2012 - Wet Tie Banding of Bottom Bars at Turbine end of St Lucie Unit 1 Generator.

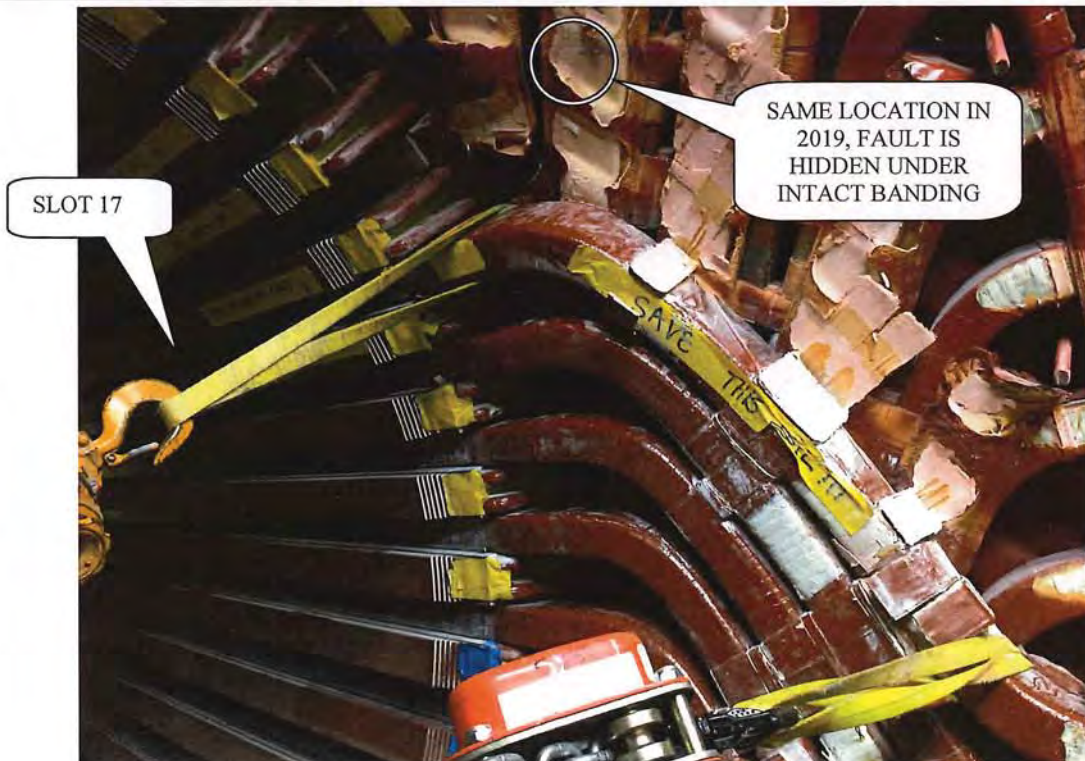
May 2019 - Removal of Top Bar in Slot 17.

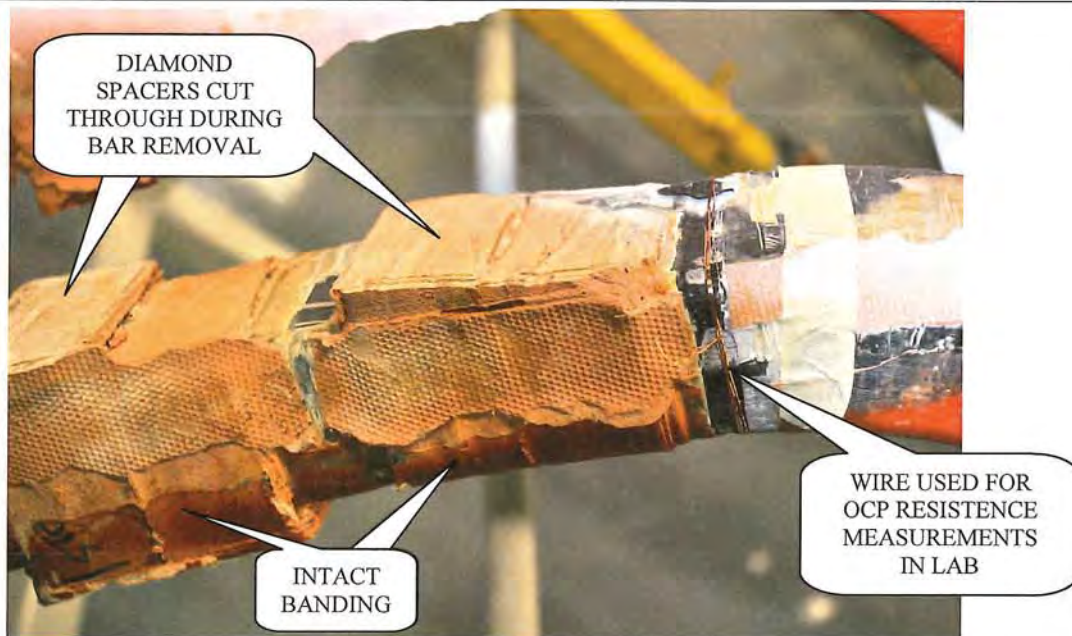
June 2019 – Intact banding material over B17 during lab inspection.

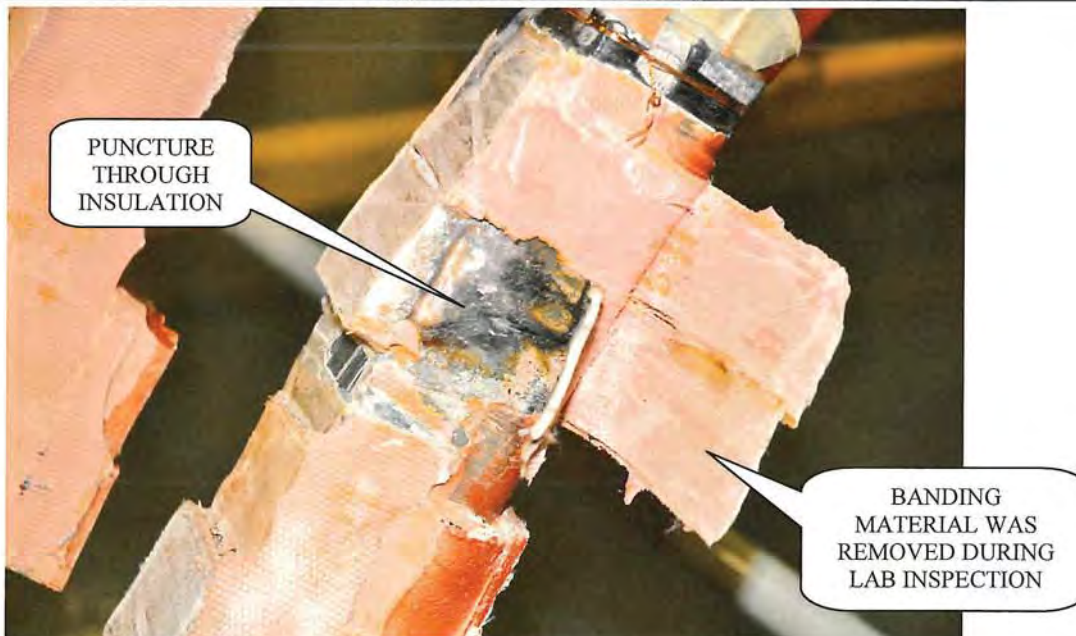
Examination of the fault current track and the insulation breach demonstrates that the fault was caused by a small puncture through the insulation. This small puncture is located on the turbine end outside of the stator slot and underneath a layer of structural banding material at the first diamond spacer. Available data is insufficient to determine a singular cause for the presence of this puncture; three possible causes hypothesized under the fault tree were neither refuted nor adequately supported:

June 2019 – Small puncture through insulation of B17 located during lab inspection.

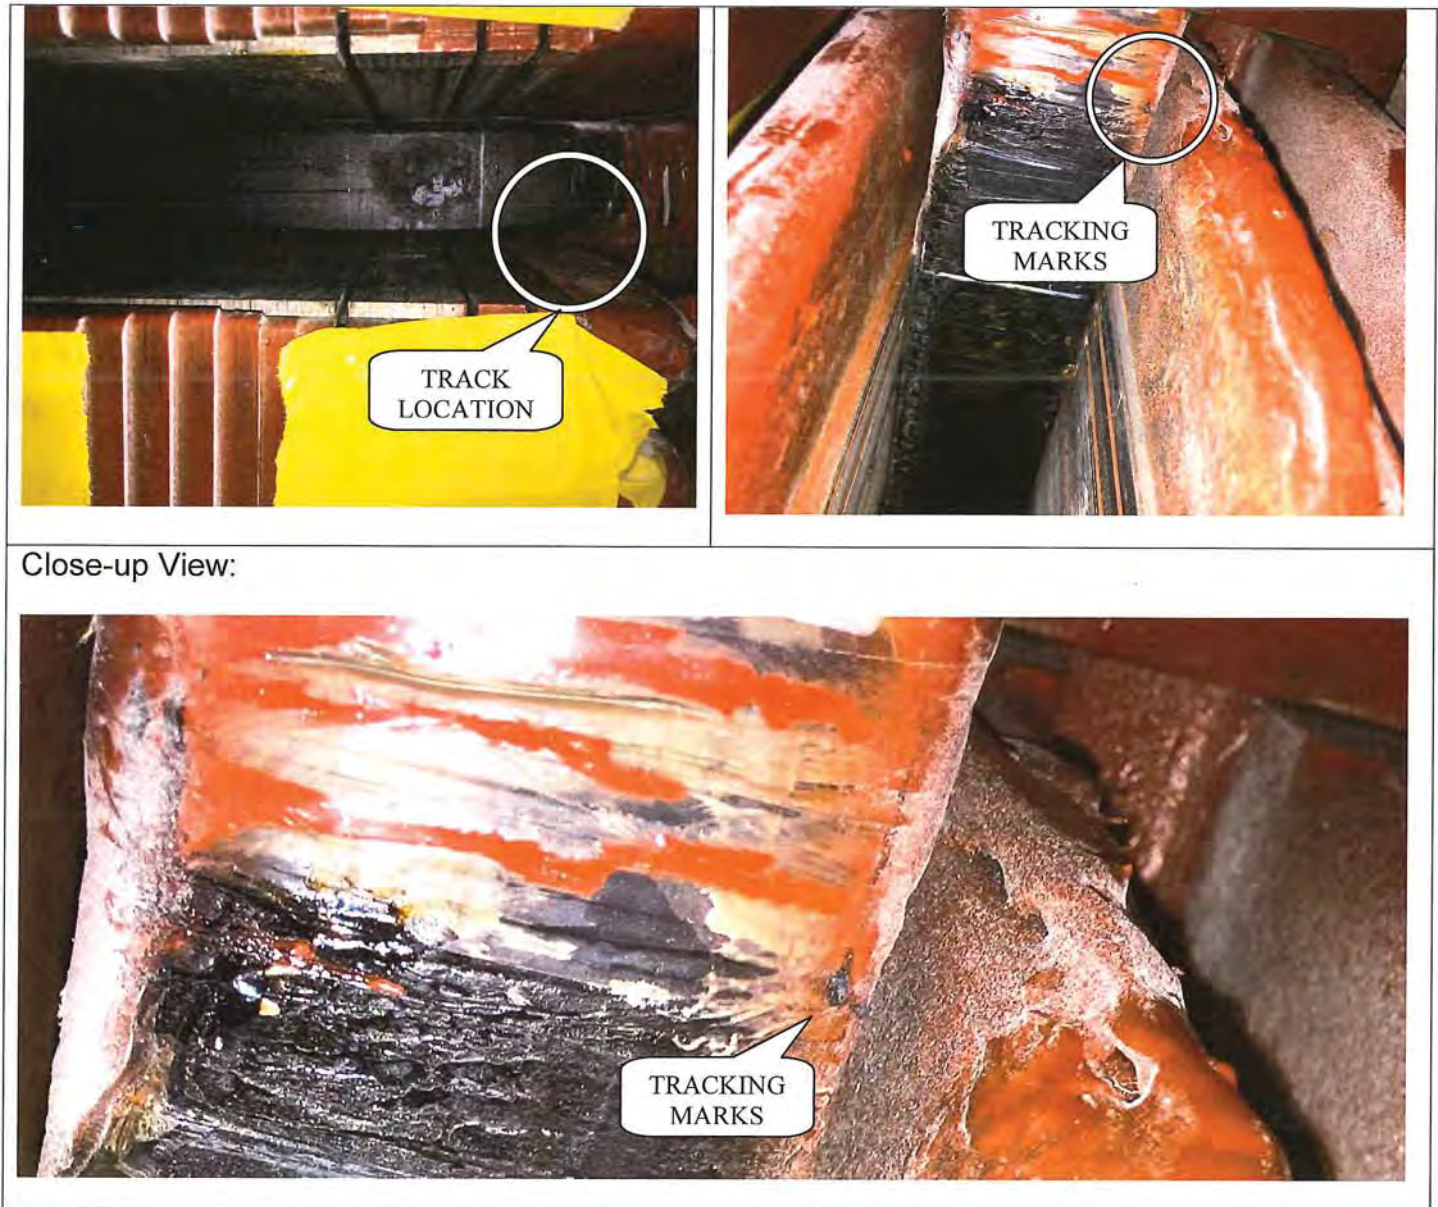
22) Stator Bar T17 was removed allowing in-situ inspection of bar B17 in the slot. At the time of inspection there was no obvious indication of the fault. [O2]

Several pictures taken during the inspection show an area subsequently confirmed to be the location of the fault current track to ground just outside of the slot in the stator core laminations. Subtle tracking marks are evident from close review as shown below, though they are somewhat obscured by the armor layer taping and paint applied at the end winding area.

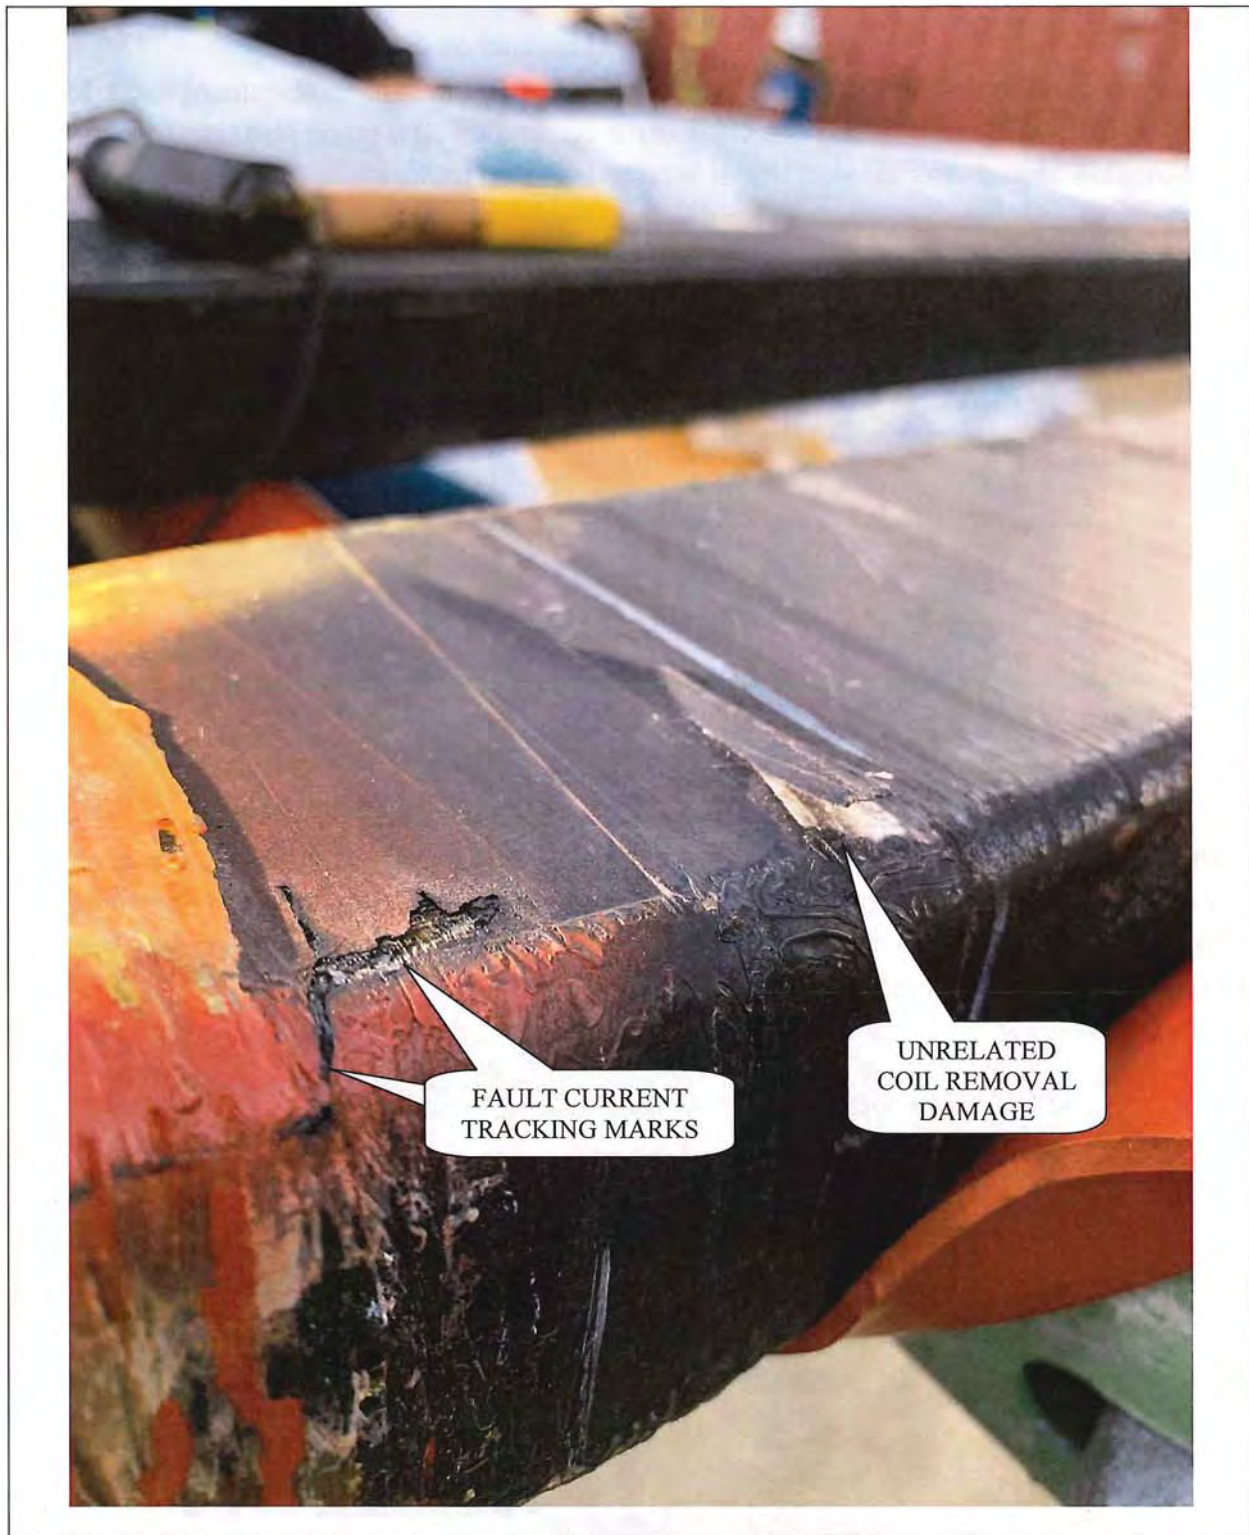
23) After stator bar B17 was carefully removed from the generator the area of the fault current track to ground was apparent from visual inspection [O3]

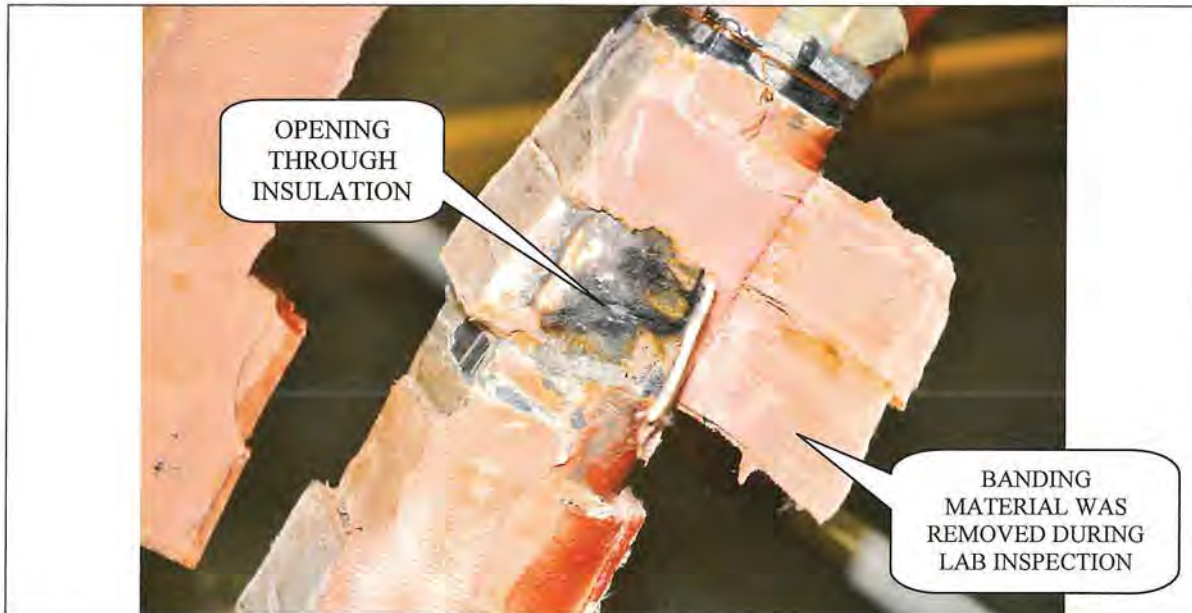
After examination of B17 it was observed [D38, O5] that the fault current track to ground followed a path along the OCP layer originating at a small opening through the insulation that was located under spacer banding material:
