# St. Lucie Station

## *Unit 1 Main Generator Ground Fault Interim Root Cause Evaluation Report*

**Event Date: 04/25/2019**

**CR Number: 02312208**

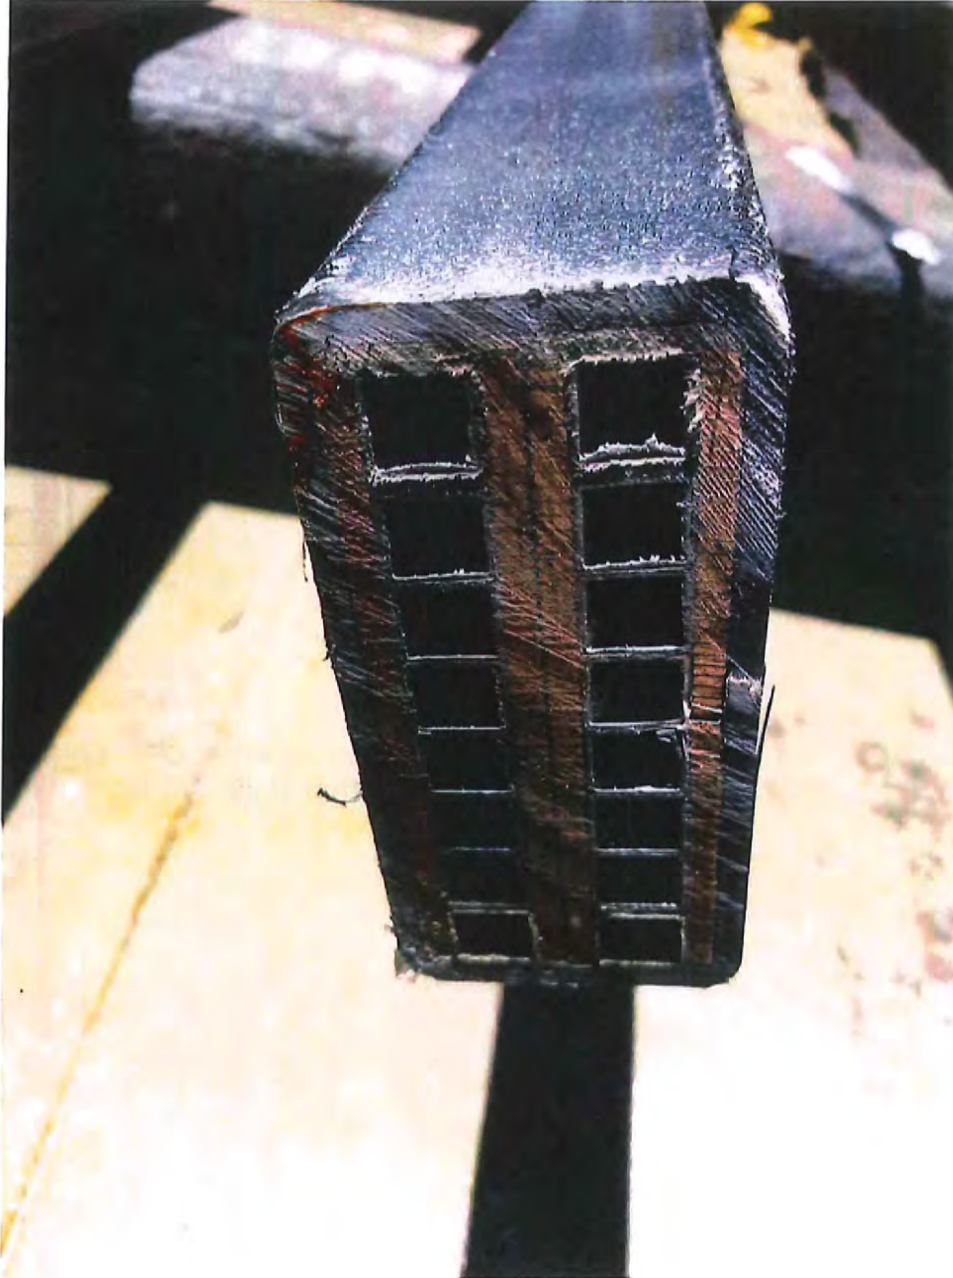
Figure 6 – Section of Stator Bar Removed from Unit 1 Generator 2019 Rewind

The field testing performed on the Phase C Generator Stator coils demonstrated that the ground fault was located in the bottom stator bar in slot 17 of the stator. The insulation failure resulted in a circuit path to ground from the inner corona protection (ICP) layer of the bar sufficient to operate the generator ground protective relaying. Care was used for removal of this stator bar during disassembly of the stator. Initial visual inspections and field resistance tests confirmed the fault occurred due to an insulation breach located just outside the stator slot on the turbine end. The breach has the appearance of crack in the underlying insulation. The surrounding OCP layer material was degraded and carbon tracking is noted along the adjacent surface areas.

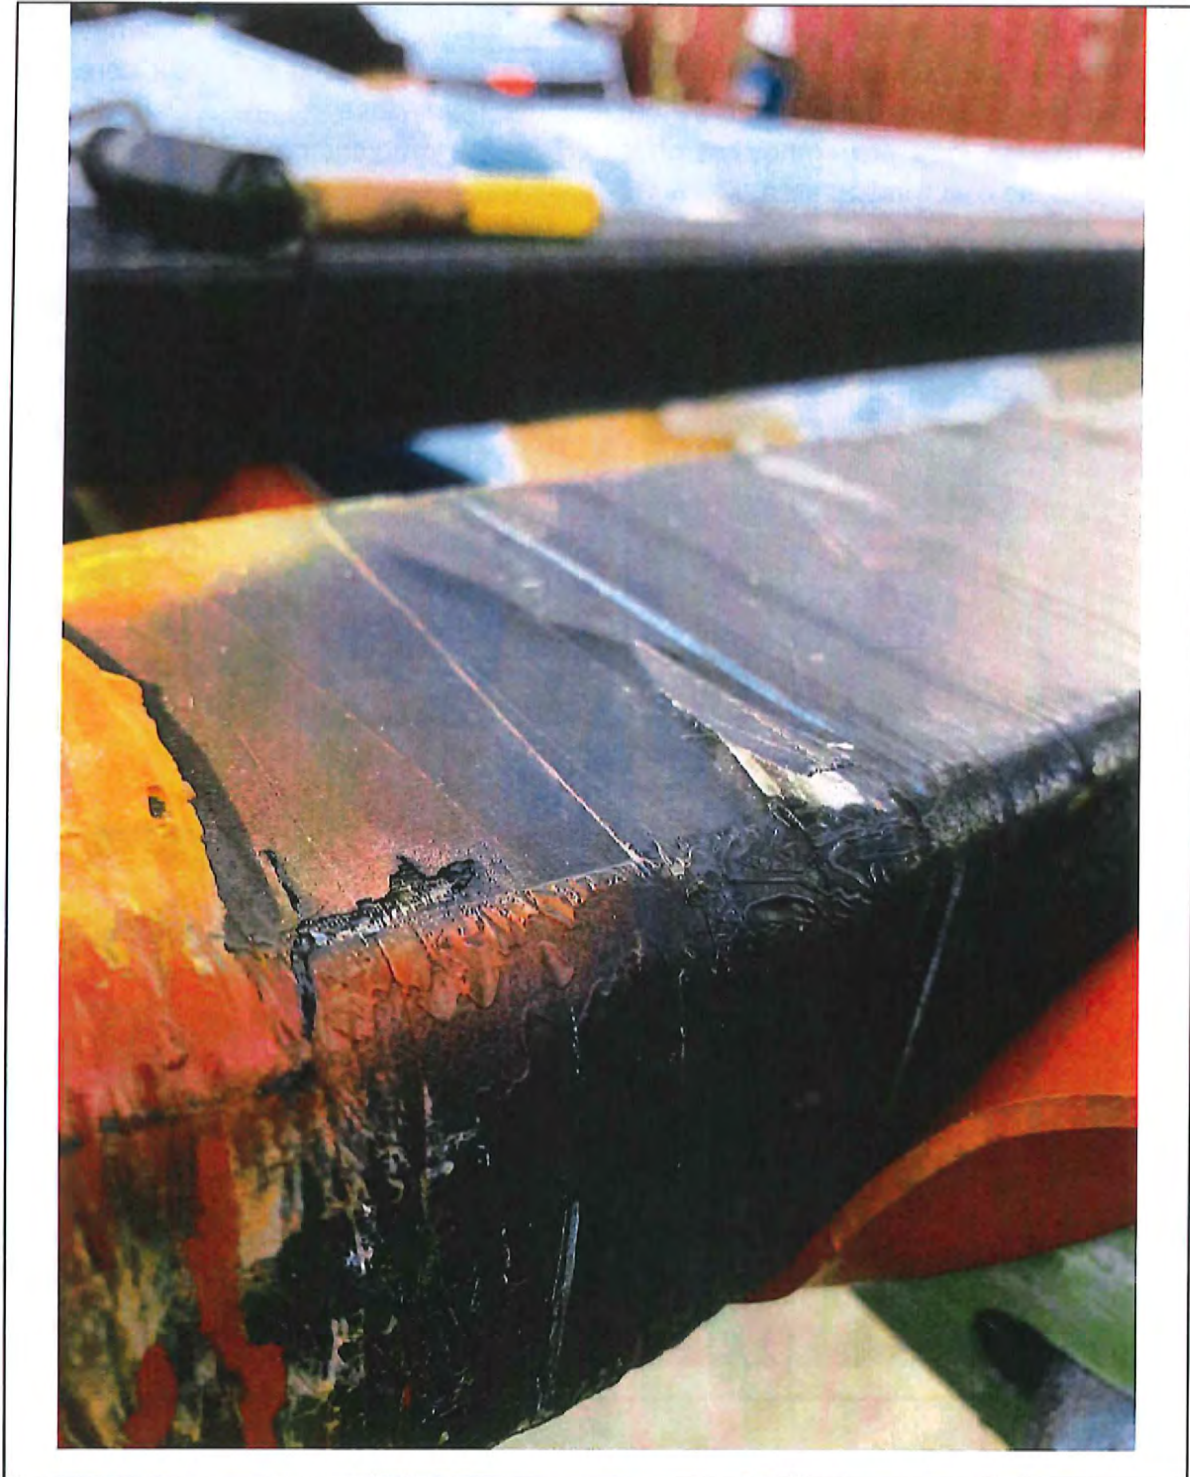
13)After stator bar B17 was carefully removed from the generator the area of the fault was apparent from visual inspection [O3]

Complete rewind of the Unit 1 generator to restore stator winding to serviceable condition.
