**TECO's Responses to OPC's First Set of
Interrogatories, Nos. 3-6, 15, 16, 18-19,
22-25. Including Supplemental for
Response No. 23.**

**TAMPA ELECTRIC COMPANY
DOCKET NO. 20220001-EI
OPC'S FIRST SET OF
INTERROGATORIES
INTERROGATORY NO. 3
BATES PAGE: 3
FILED: APRIL 8, 2022**

PK1 – Forced Major Outage High Potential
Date: 11/29/2021

Polk Power Station

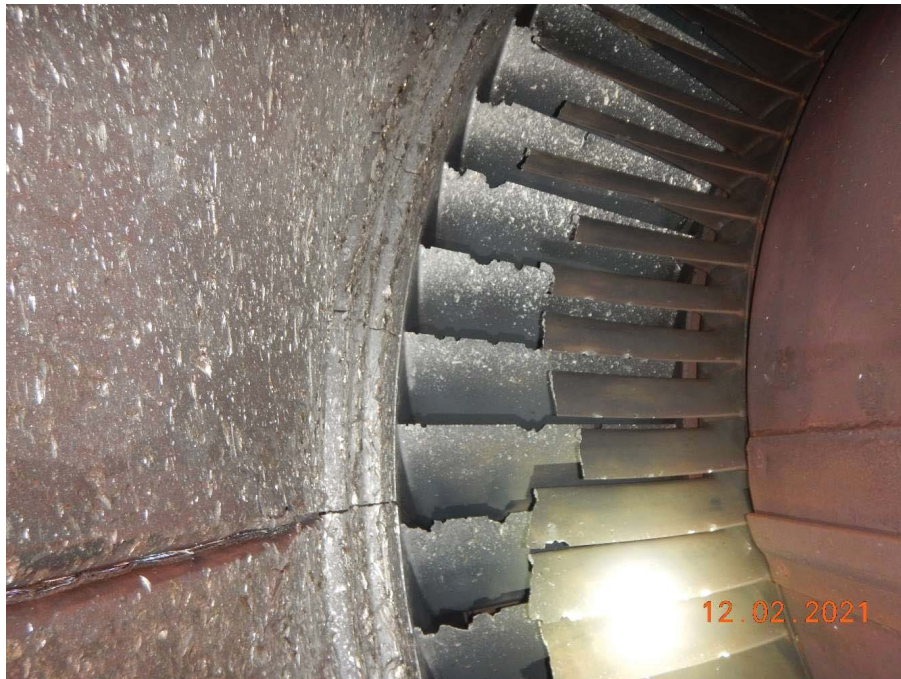
- No injuries occurred due to this event.
- 3rd stage buckets, nozzles, and shrouds were damaged, exhaust frame was damaged.
- 2nd stage Nozzles and buckets were replaced

- Several barriers were broken down to allow water to be ingested into the turbine
- Steam was able to leak by the syngas valves and create a reservoir of water in the P2 cavity and flare header
- During shut down water was able to then leak into the syngas header to allow water ingestion into CT1 while at FSNL operation.
- The flow around WW-23 was enough to push water from the syngas header into the turbine
- When water was introduced to the CT nozzles, the sudden expansion to steam significantly increased the system's mass flow, causing severe stress and catastrophic failure to the 3rd stage buckets

Figure 1 As-found condition 3rd Stage Buckets and Nozzles

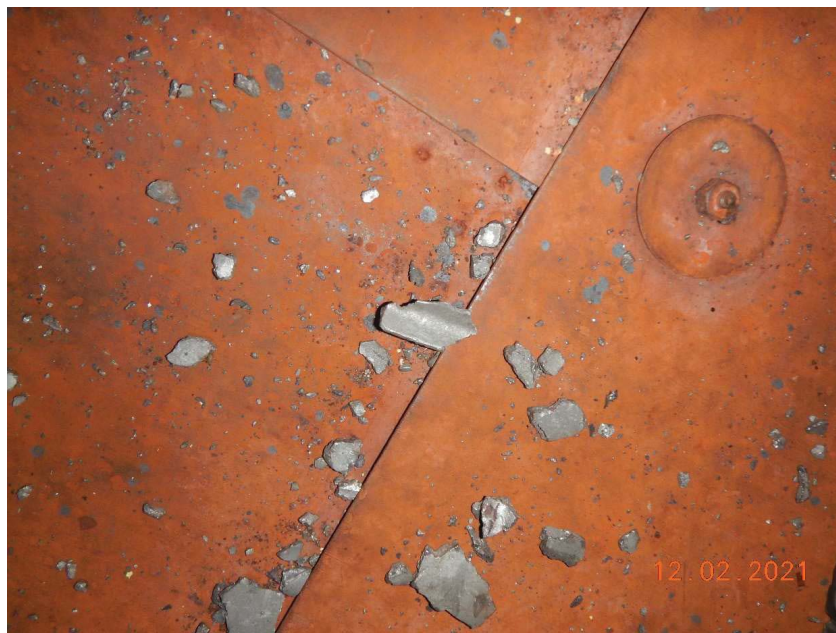
Figure 2 Metal fragments from 3rd stage buckets and nozzles

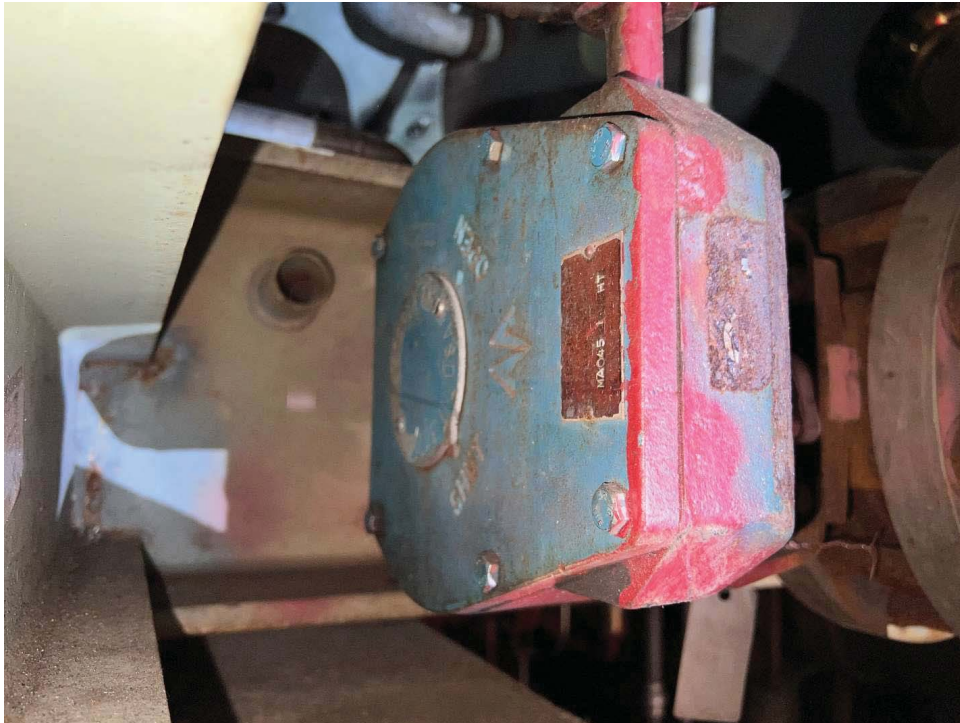
- The Syngas Block Valve (VS4-2) and Syngas Control Valve (VGC1) allowed steam injection to leak by which created a large reservoir of water with enough head pressure to leak back into the syngas header while unit was shut down. (If these valves were functioning as designed it would have eliminated the ability of a large reservoir of water to accumulate during operation.)
- Syngas Purge Air isolation valve (WW-23) did not seal properly allowing steam to back flow into the syngas line and leak past the block valves, ultimately building a water reservoir in the flare header

Figure 3 WW-23 Valve Compressor Discharge Syngas purge valve
