**TECO's Responses OPC's Third Request
to Produce Documents, No. 11.**

**TAMPA ELECTRIC COMPANY
DOCKET NO. 20220001-EI
OPC'S THIRD REQUEST FOR
PRODUCTION OF DOCUMENTS
DOCUMENT NO. 11
BATES PAGES: 1-1472
FILED: AUGUST 10, 2022**

PK1 – Forced Major Outage High Potential
Date: 11/29/2021

Polk Power Station

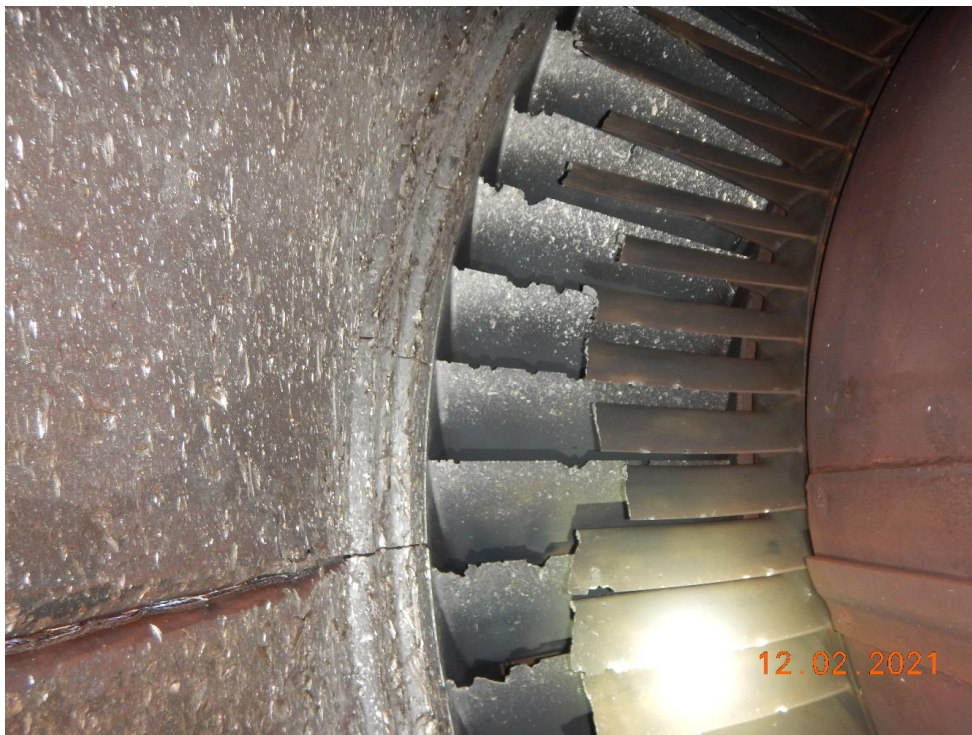
- No injuries occurred due to this event.
- 3rd stage buckets, nozzles, and shrouds were damaged, exhaust frame was damaged.
- 2nd stage Nozzles and buckets were replaced
- 1st stage Buckets were replaced
- Compressor blades and stators needed blending for minor tip curl and rubbing.
- Stage 16 Stator Vanes were replaced due to heavy rubs
- Bearing seals were replaced and hydrogen seals required inspection.
- Turbine/Generator bearings are planned on being inspected and refurbished if needed

- The flow around WW-23 was enough to push water from the syngas header into the turbine
- When water was introduced to the CT nozzles, the sudden expansion to steam significantly increased the system's mass flow, causing severe stress and catastrophic failure to the 3rd stage buckets

Figure 1 As-found condition 3rd Stage Buckets and Nozzles

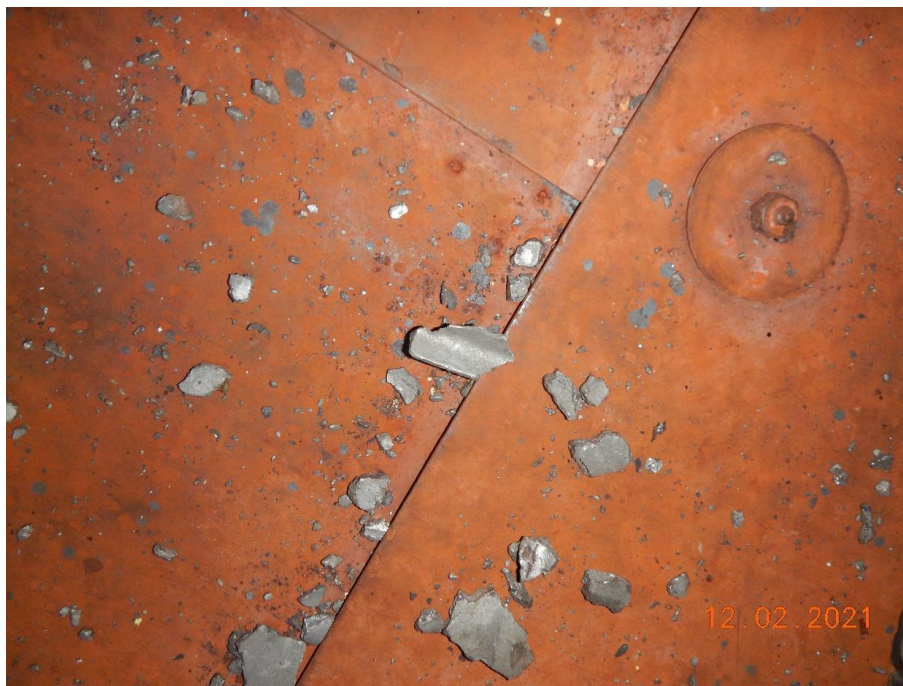
Figure 2 Metal fragments from 3rd stage buckets and nozzles

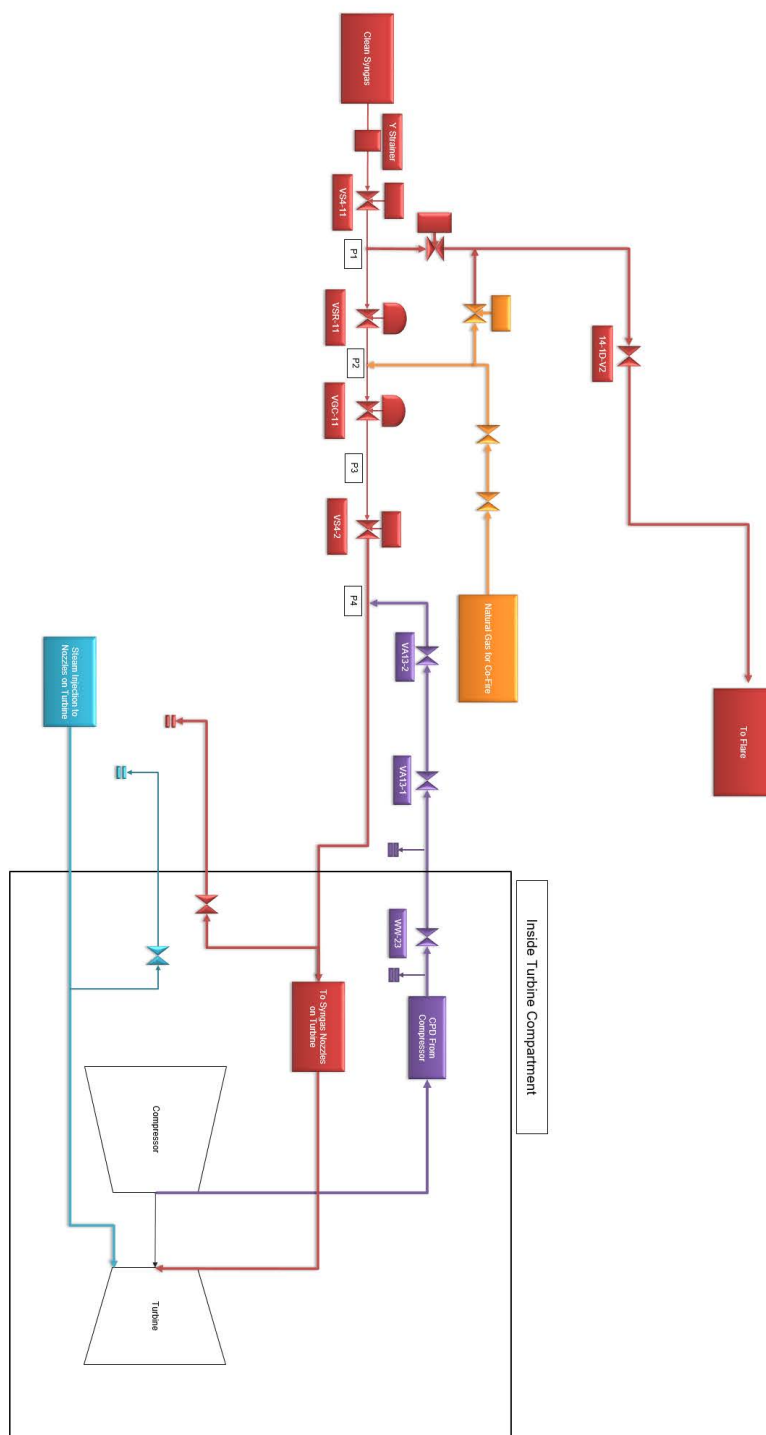
Figure 6 Sketch of system (also found Root Cause Tree under additional information)

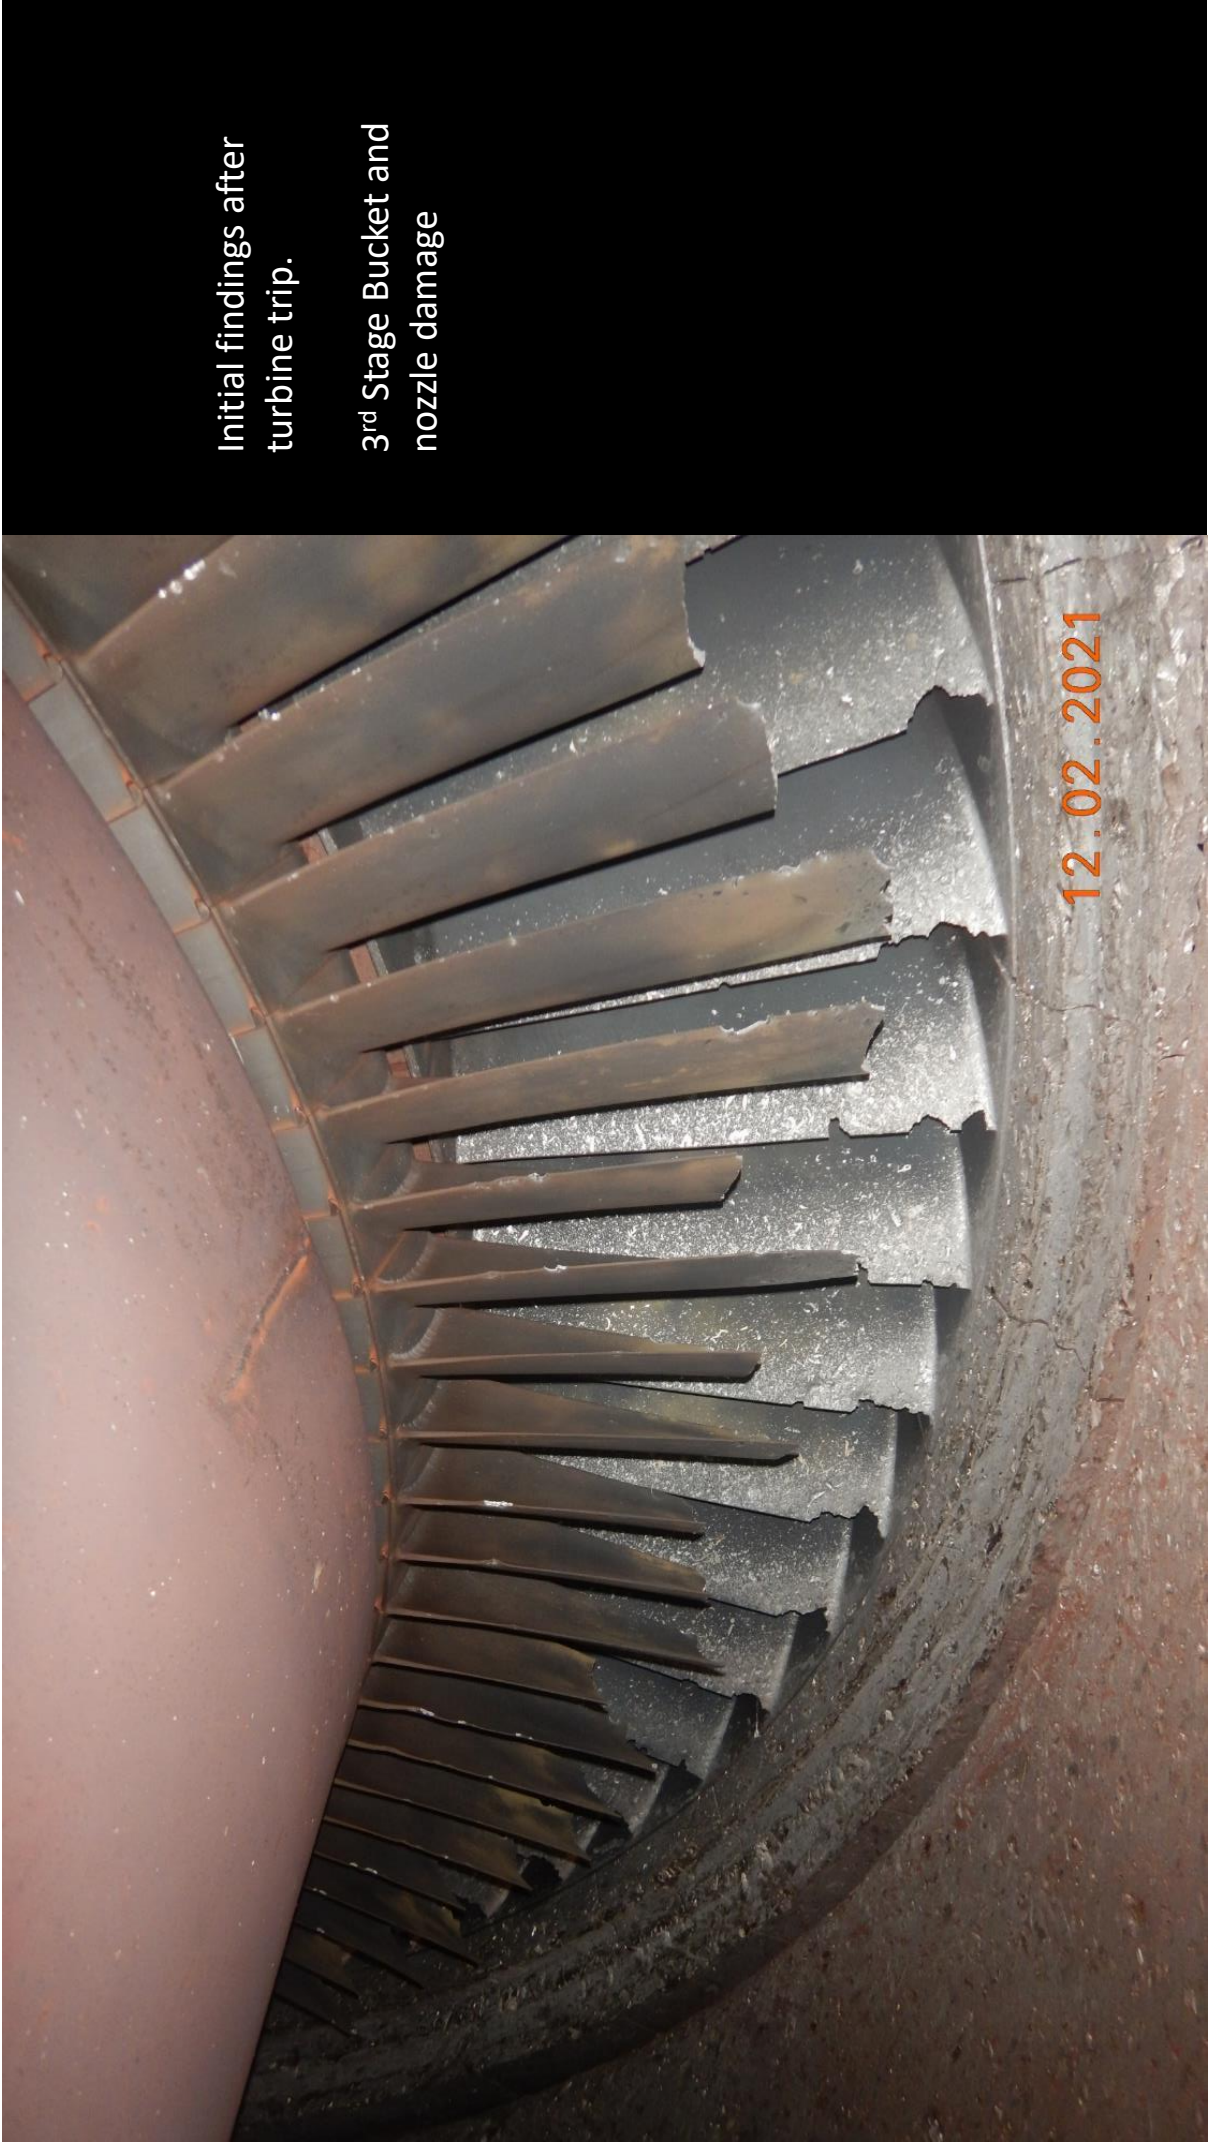
Initial findings after
turbine trip.

3rd Stage Bucket and
nozzle damage

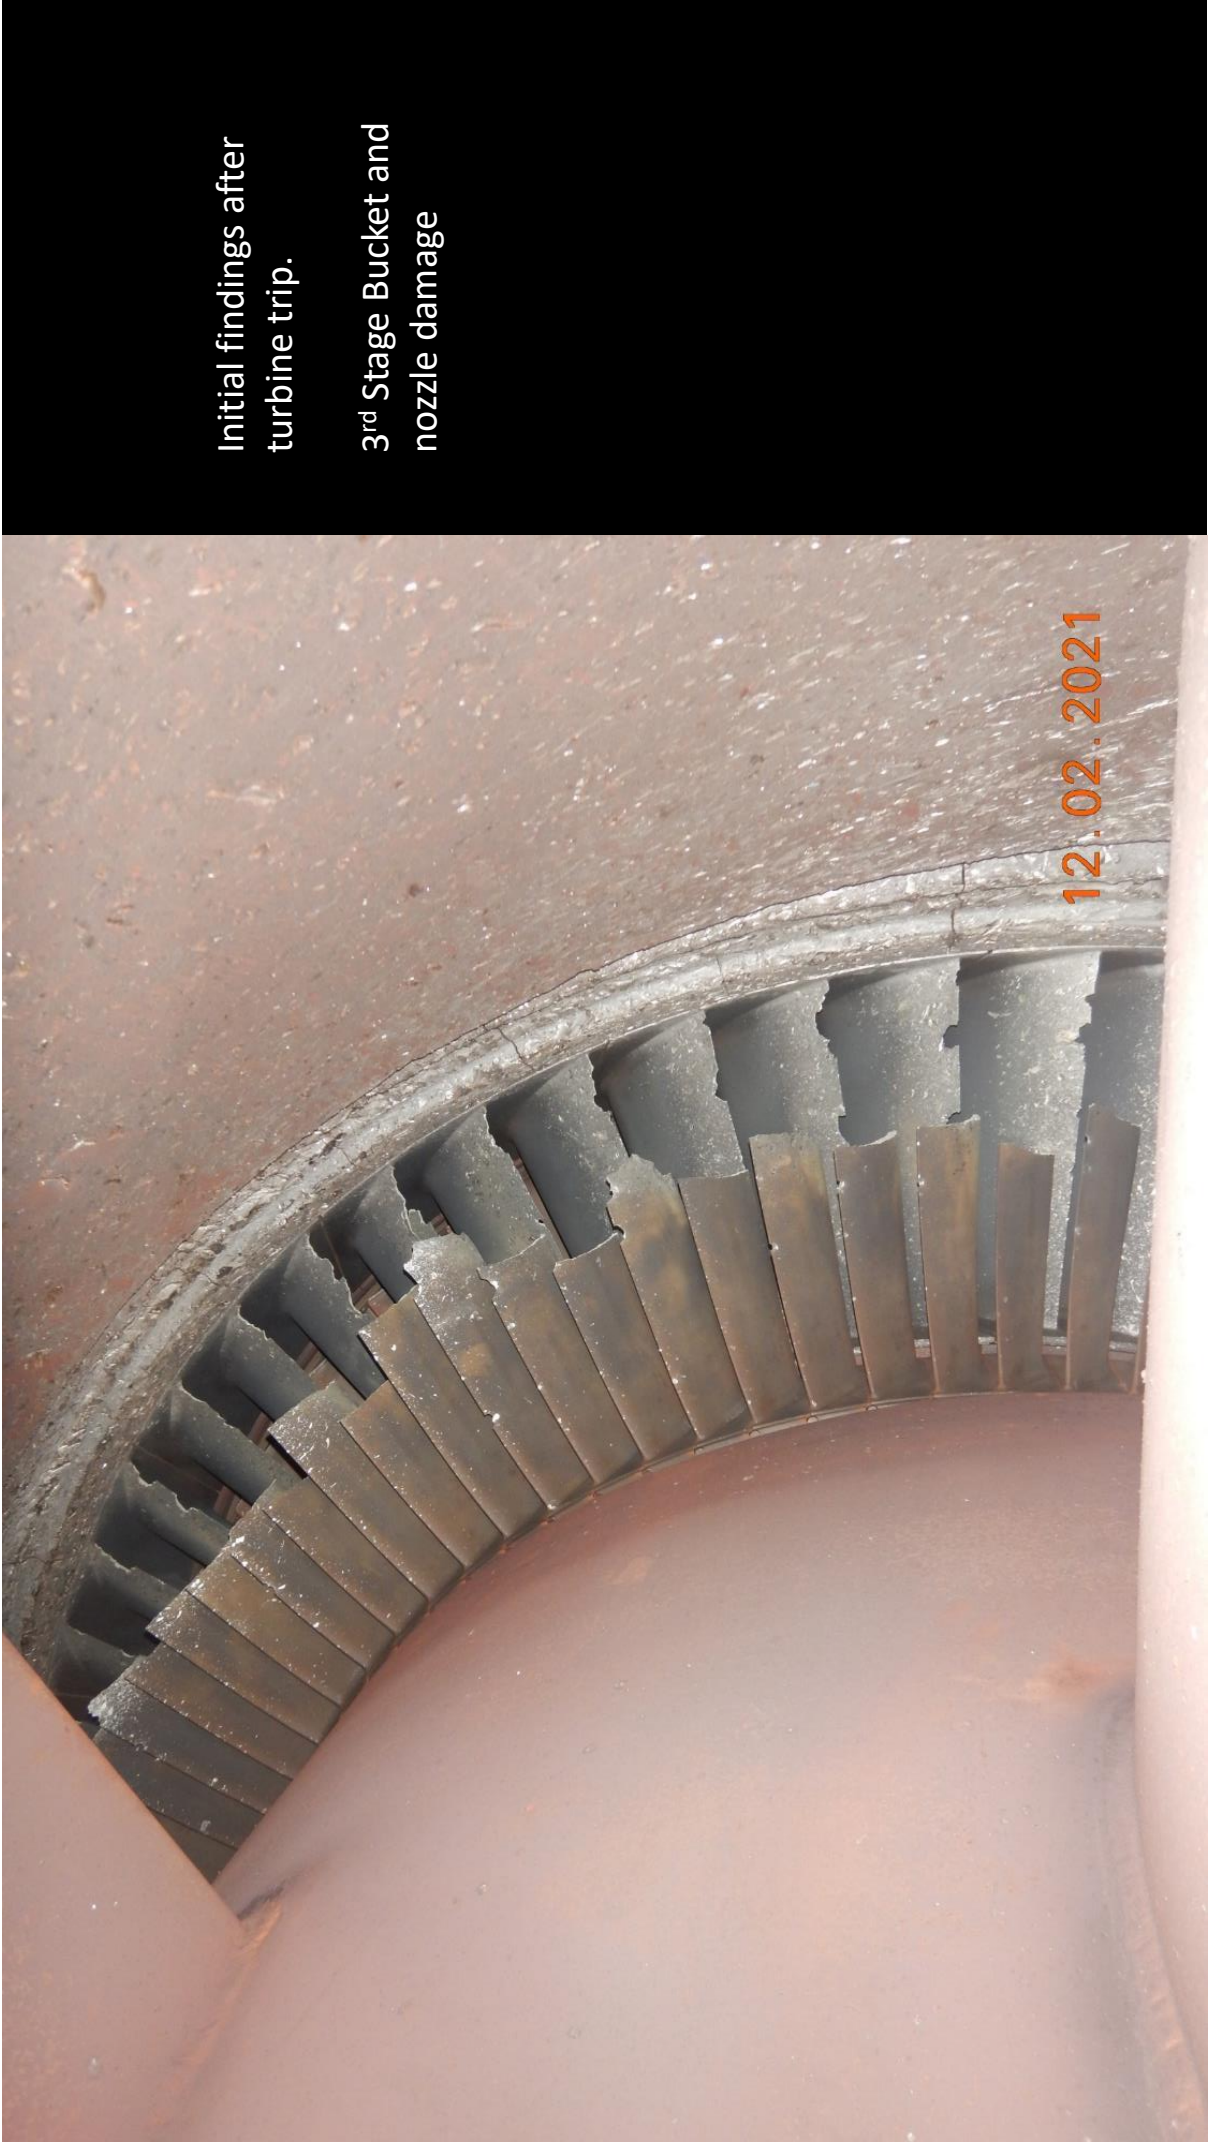
Initial findings after
turbine trip.

3rd Stage Bucket and
nozzle damage

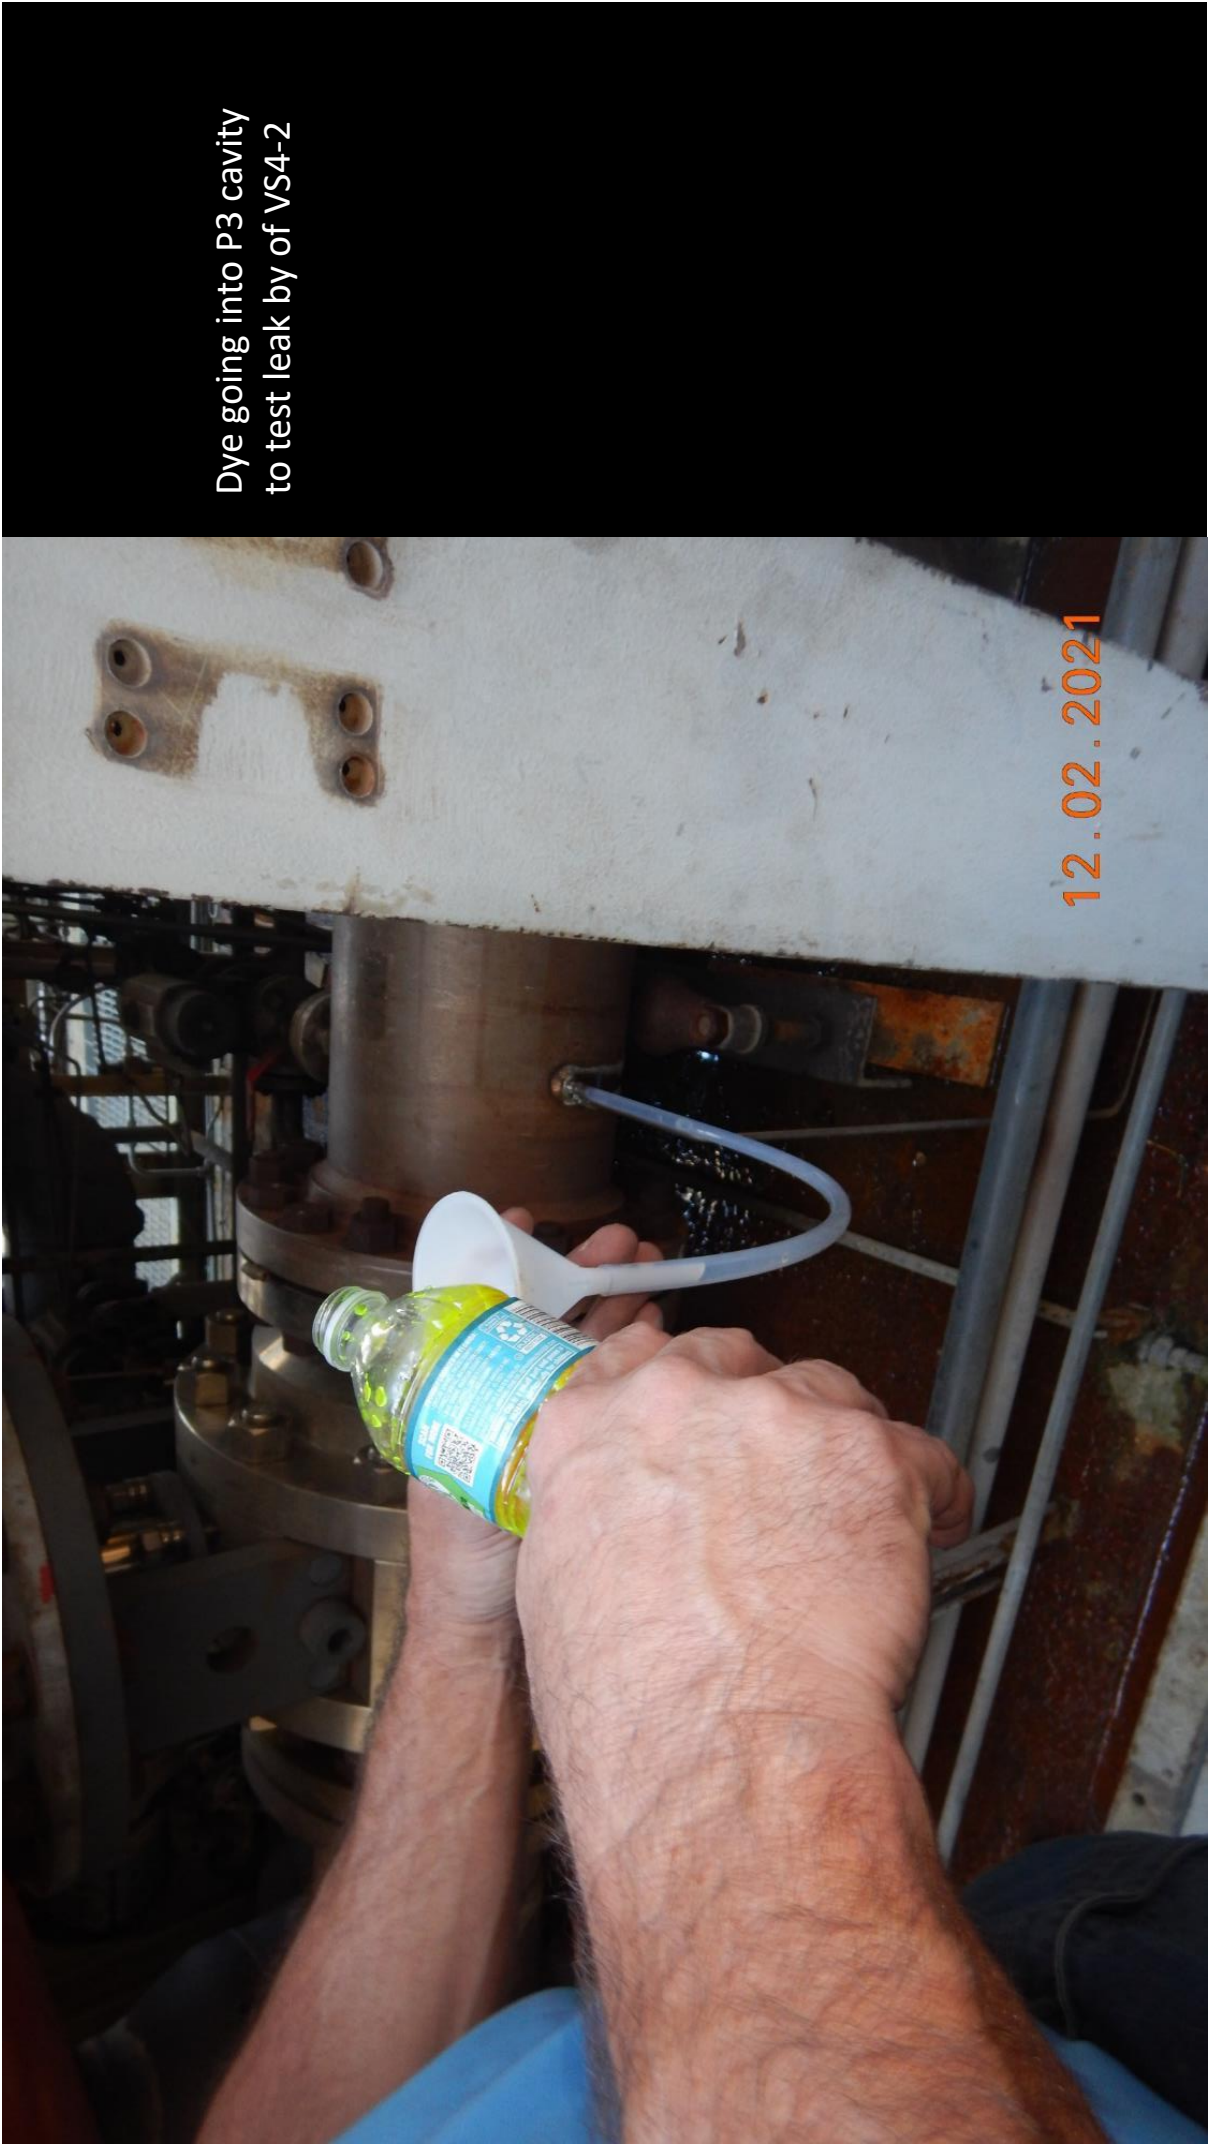
Dye going into P3 cavity
to test leak by of VS4-2

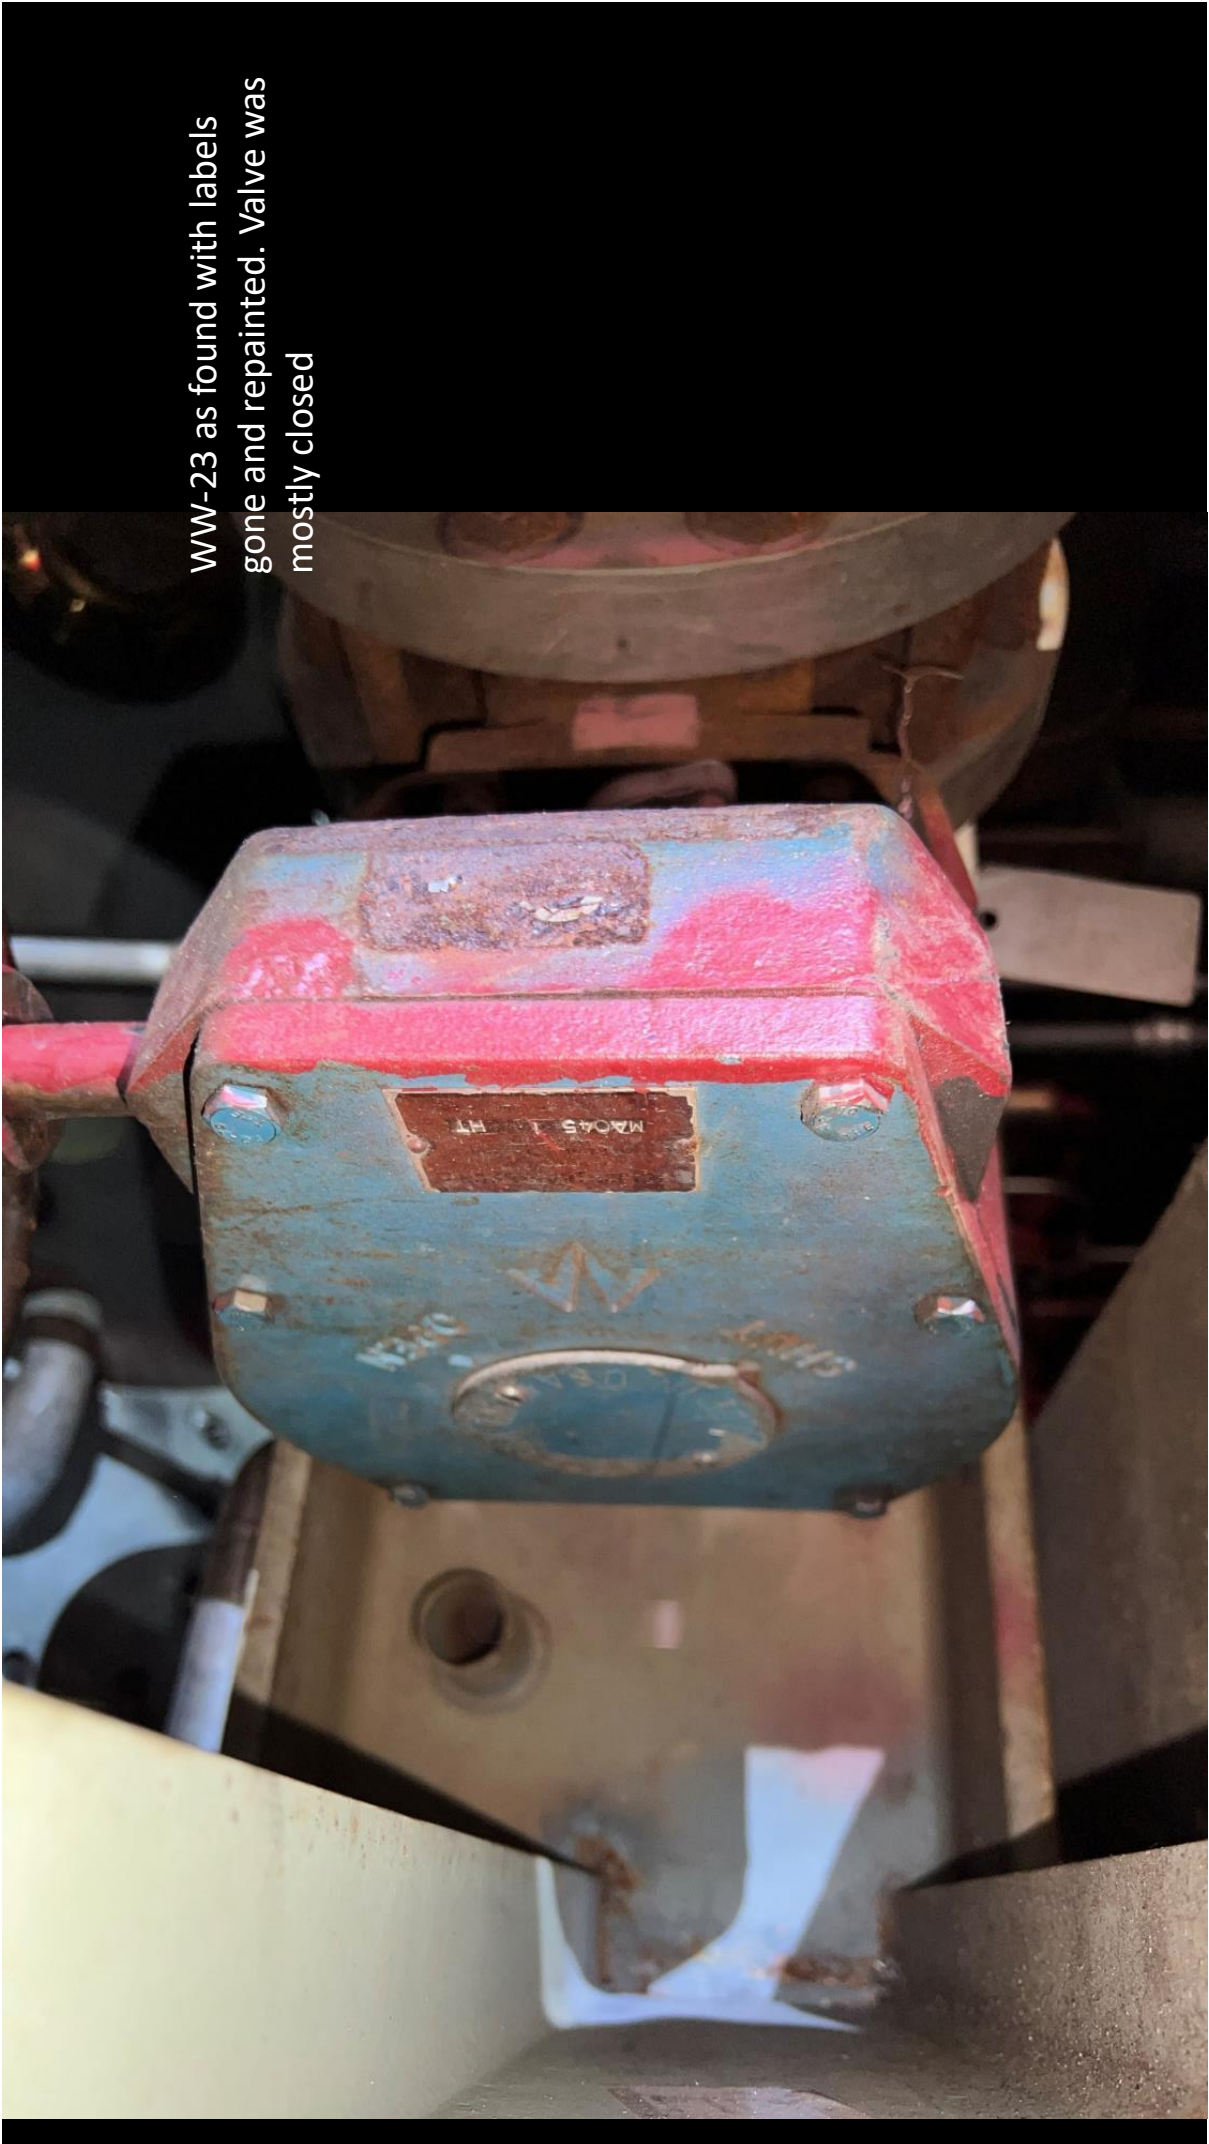
- Several barriers were broken down to allow water to be ingested into the turbine
- Steam was able to back flow through the syngas nozzle because the CPD isolation valve (WW-23) that provides cooling air to the syngas nozzles was mostly closed.
- Steam was able to leak by the syngas valves and create a reservoir of water in the P2 cavity and flare header
- During shut down water was able to then leak into the syngas header to allow water ingestion into CT1 while at FSNL operation.

WW-23 as found with labels
gone and repainted. Valve was
mostly closed

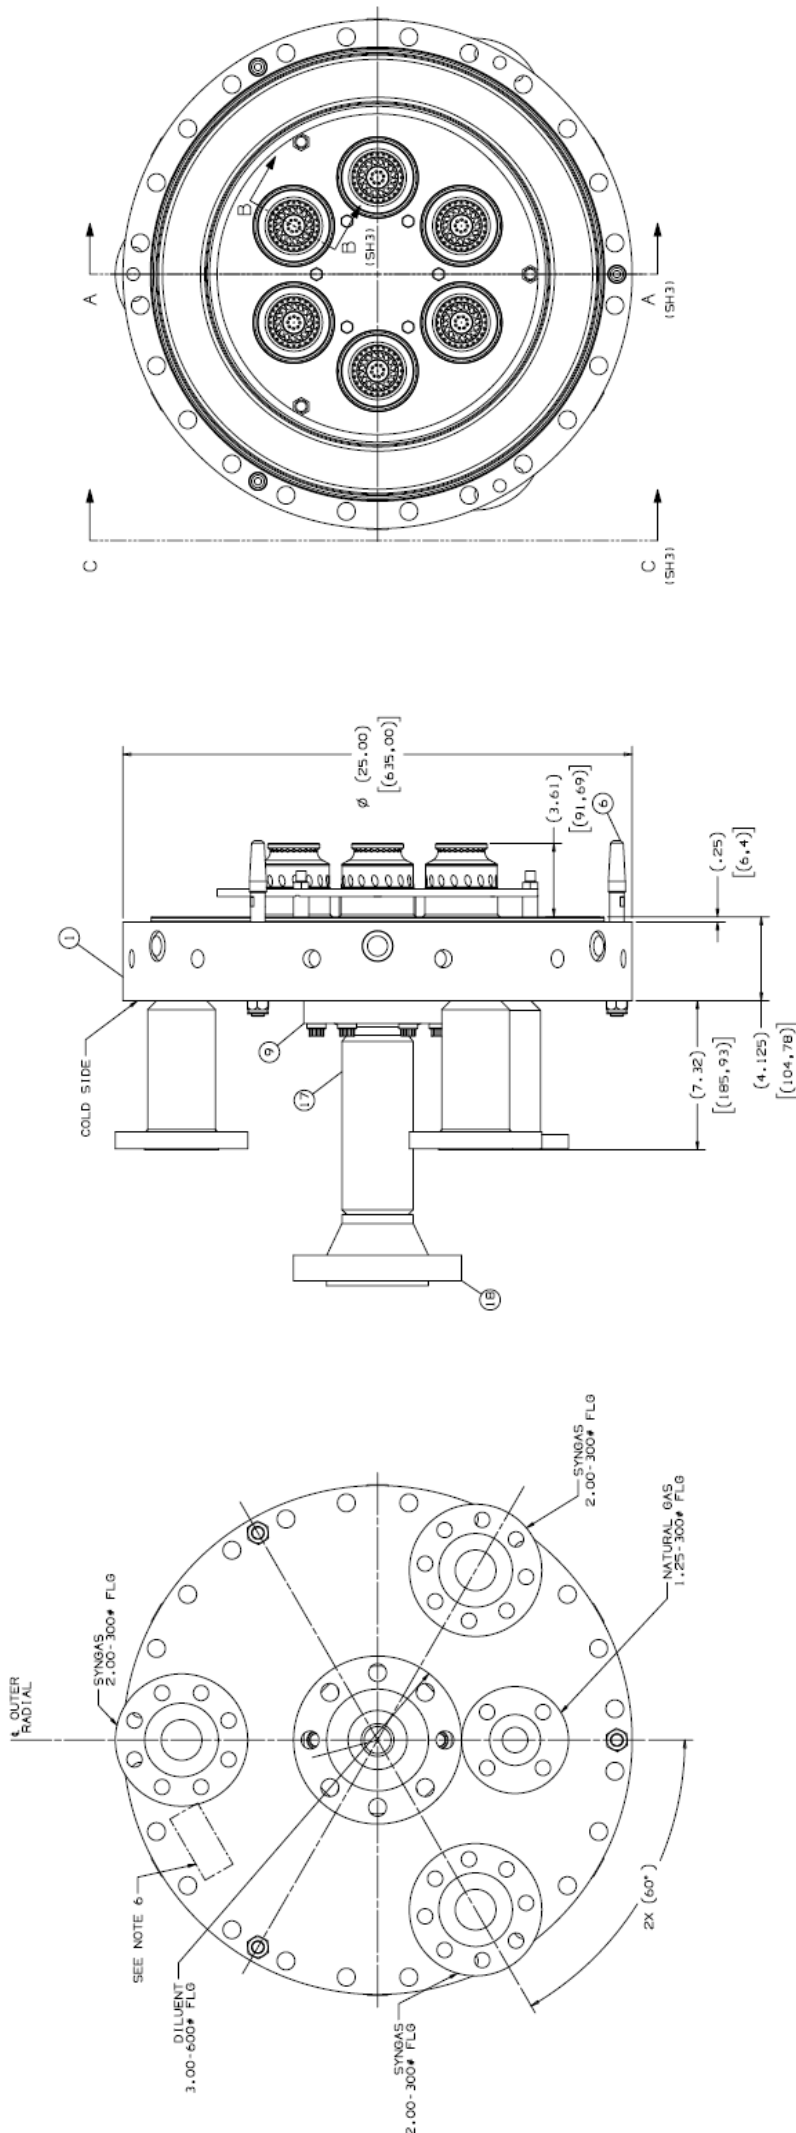
Diagram of End Cover— shows the diluent and syngas line tie to end cover to go to nozzles. There are 14 end covers per Unit

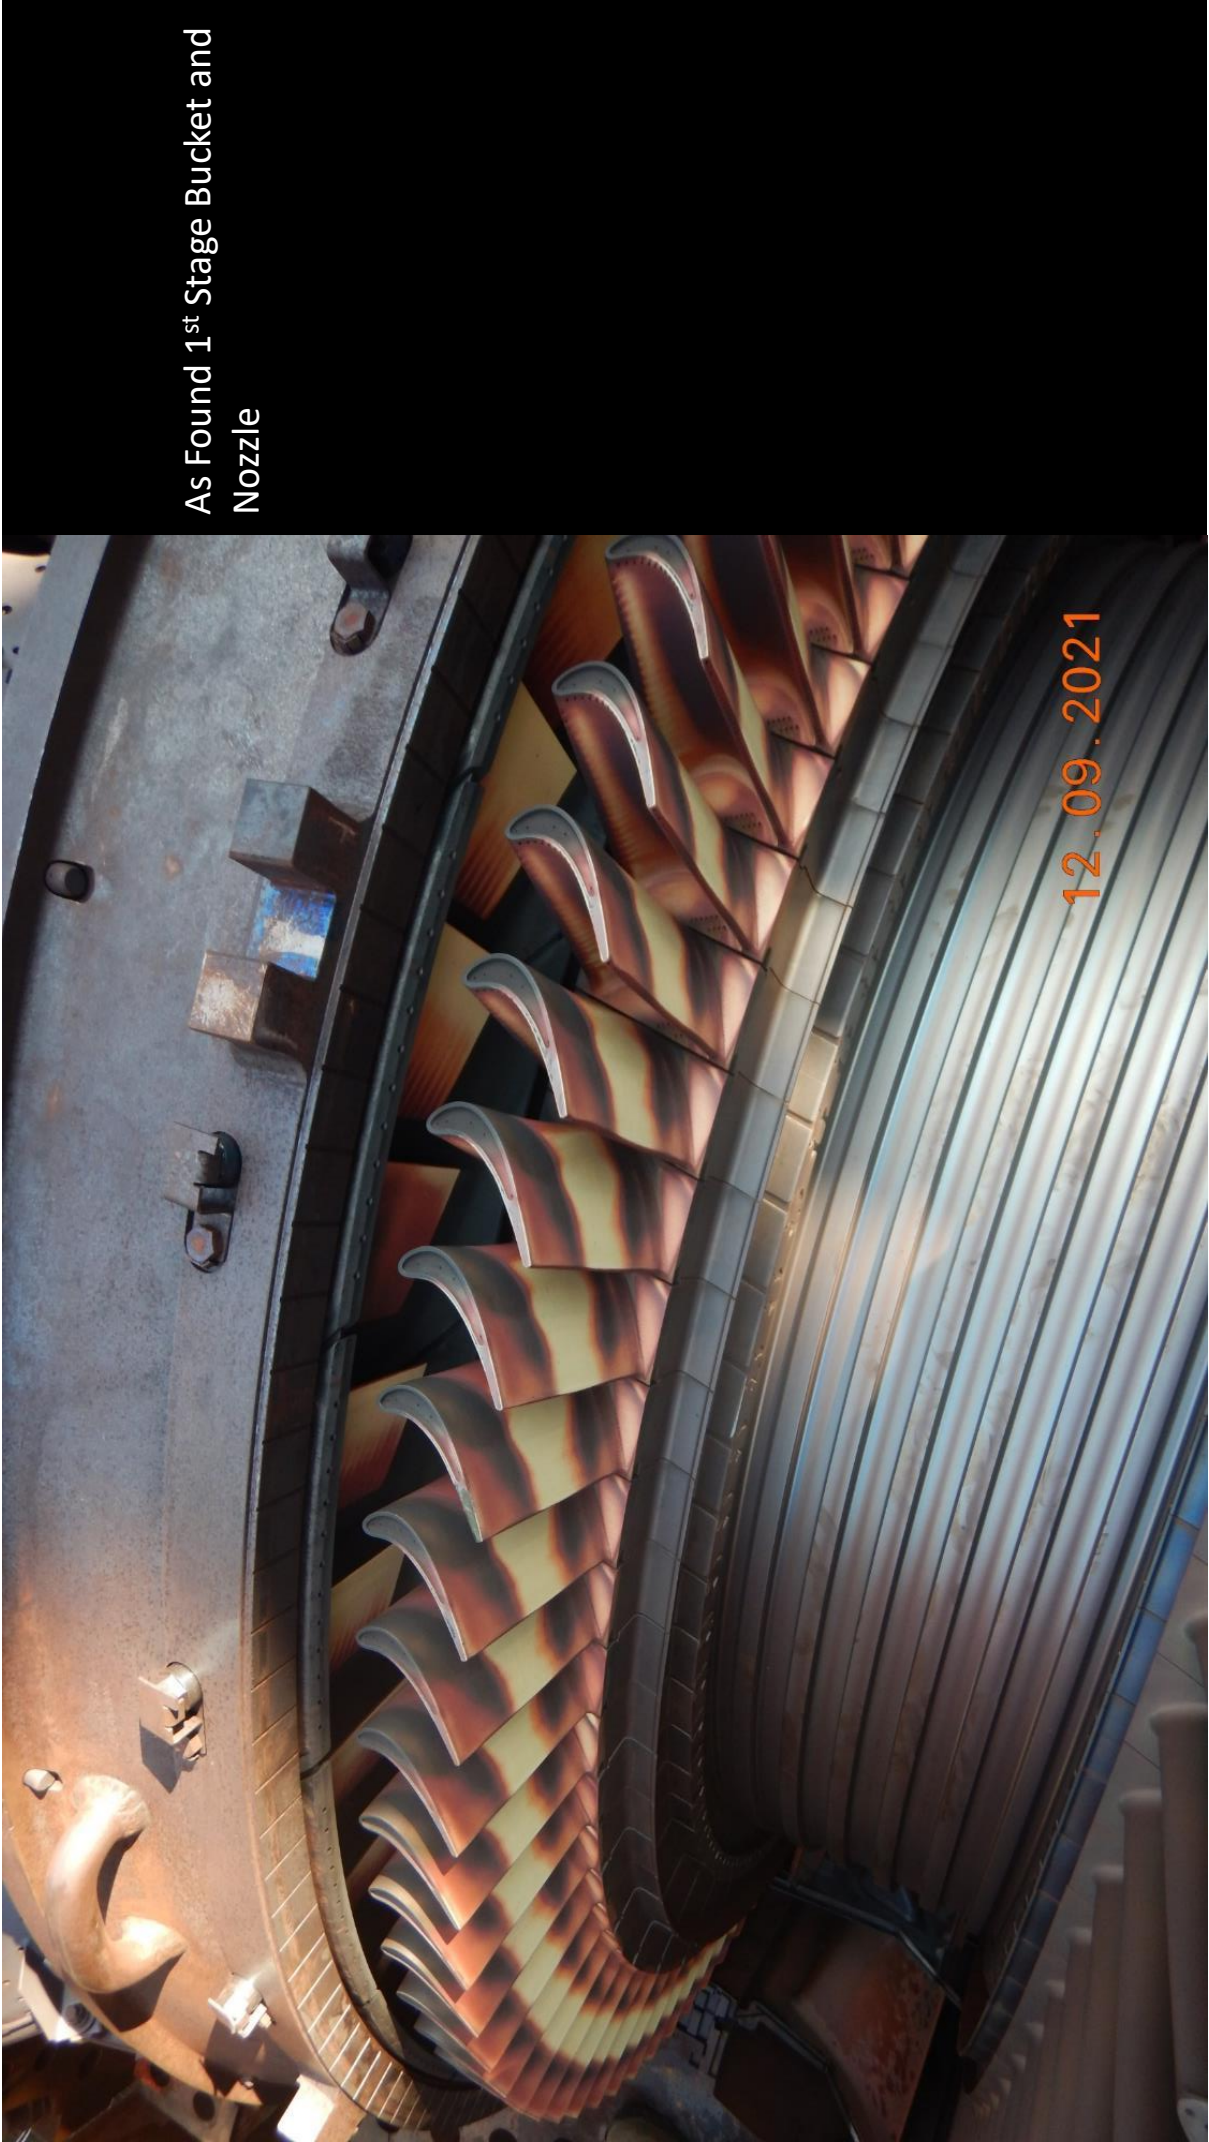
As Found 1st Stage Bucket and
Nozzle

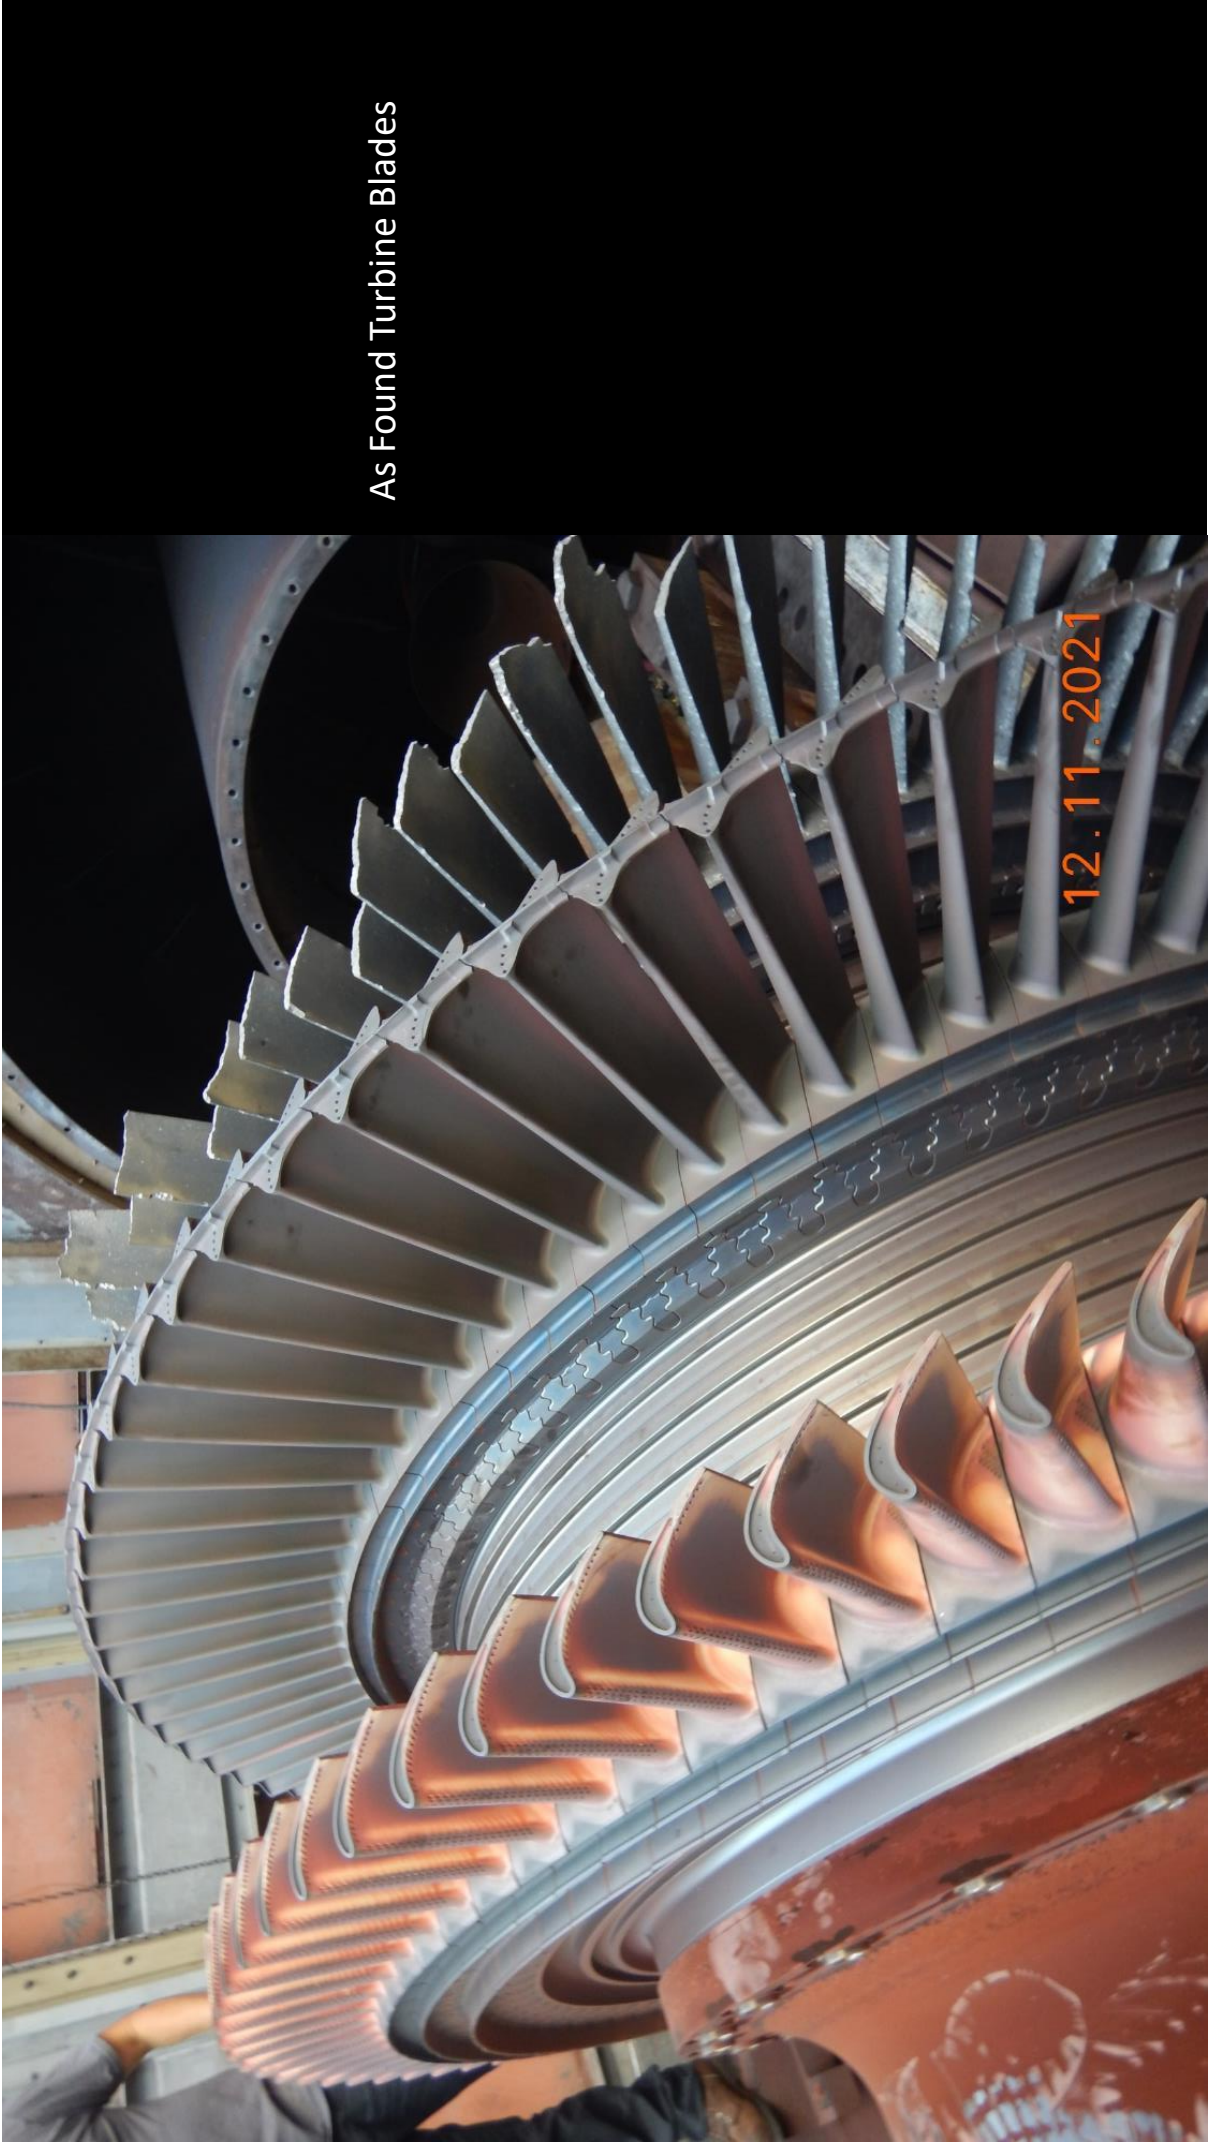
As Found Turbine Blades

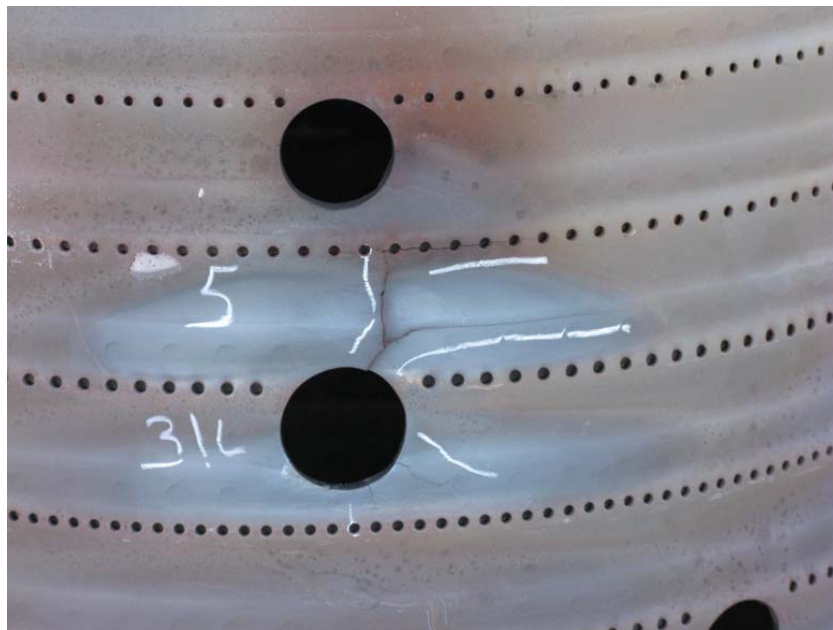
Typical Liner Cracks Found

All liners were replaced as part of the major inspection. These liners will be fully inspected when they go to a GE Service Shop for refurbishment.

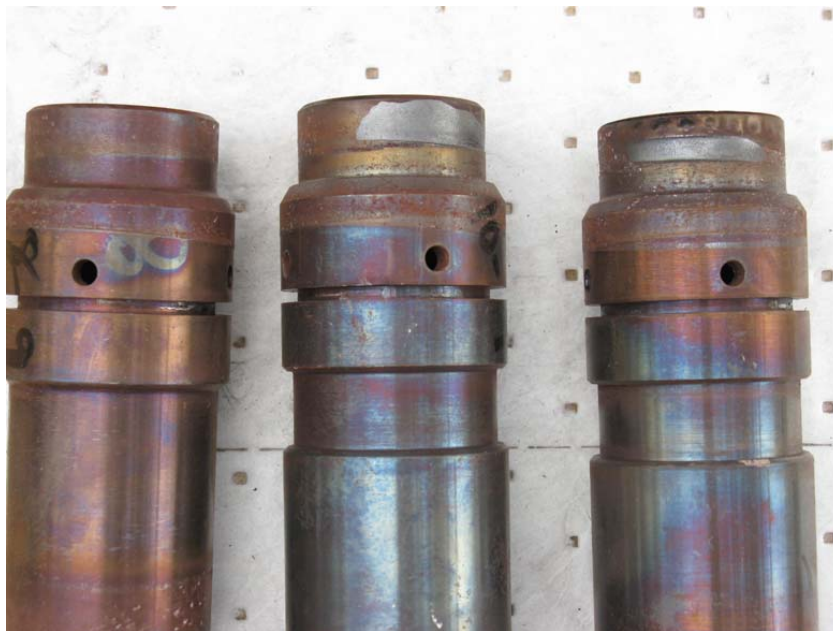
The crossfire tubes were removed and visually inspected for damage by GE. There was normal wear on the male and the female inner crossfire tubes where the tubes rest in the liner, as well as wear located in the slots where the retainers clip onto the crossfire tube. All of the inner crossfire tubes were replaced with new components. Refer to the data sheets in this report for further details.

Inner cross fire tube wear

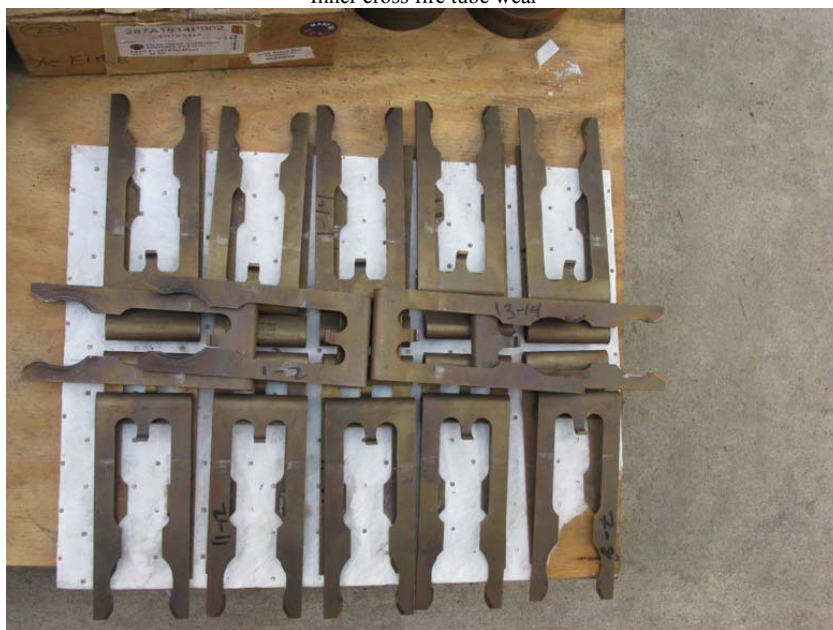
The retainers were removed and visually inspected for damage by GE. The wear on the retainer clips was found in the area where the crossfire tube is in constant contact with the clip. There were also cases where the retainer clips were bent. All retainers were replaced new components. Refer to the data sheets in this report for further details.

Retaining clips as found

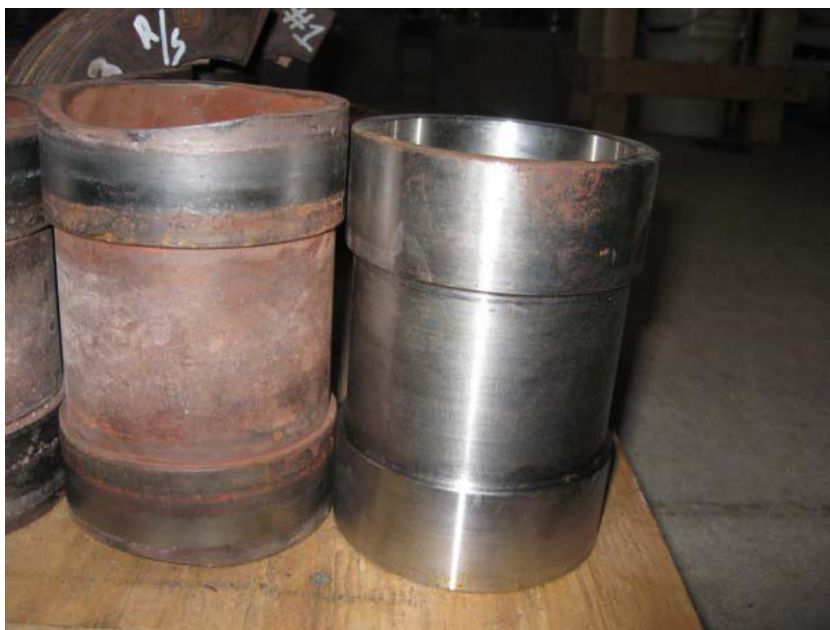
The outer crossfire tubes were removed and inspected. There were a few found to be incorrect parts and were replaced during the outage with the proper parts.

Outer crossfire tubes -- Note the different lengths

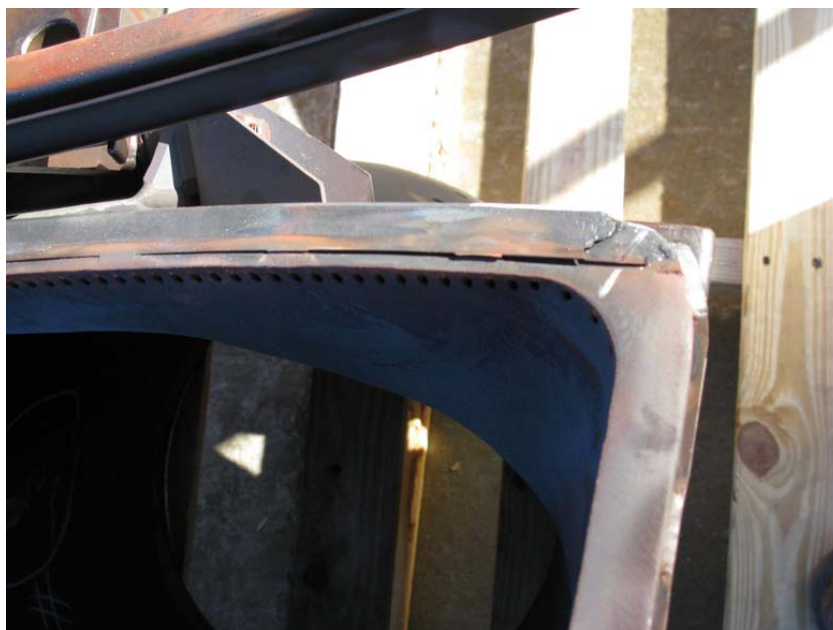
TP Picture Frame - As Found Condition
