**TECO's Responses OPC's Third Request
to Produce Documents, No. 11.**

**TAMPA ELECTRIC COMPANY
DOCKET NO. 20220001-EI
OPC'S THIRD REQUEST FOR
PRODUCTION OF DOCUMENTS
DOCUMENT NO. 11
BATES PAGES: 1-1472
FILED: AUGUST 10, 2022**

PK1 – Forced Major Outage High Potential
Date: 11/29/2021

Polk Power Station

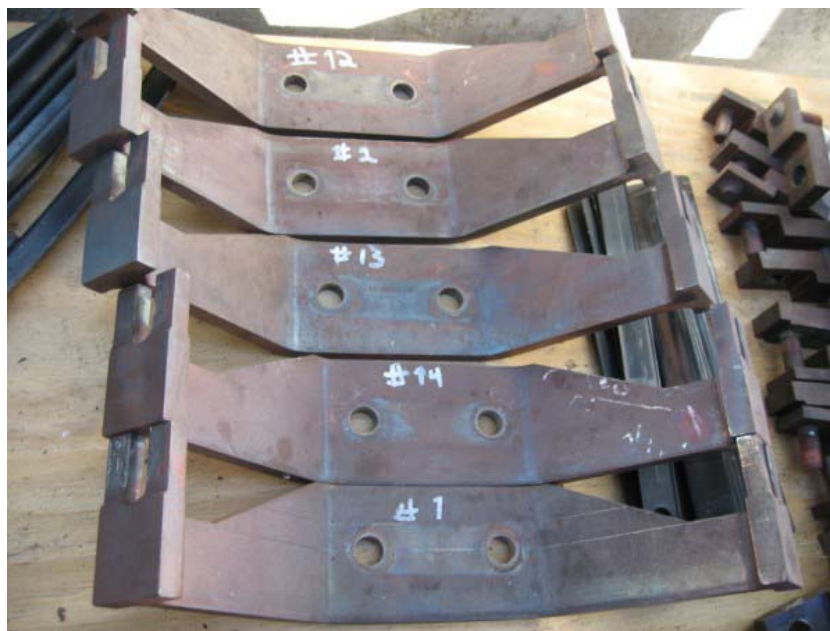
Bullhorns - General Condition

Comments:
Typical wear on all bullhorn blocks. All were replaced during the outage with a spare set.

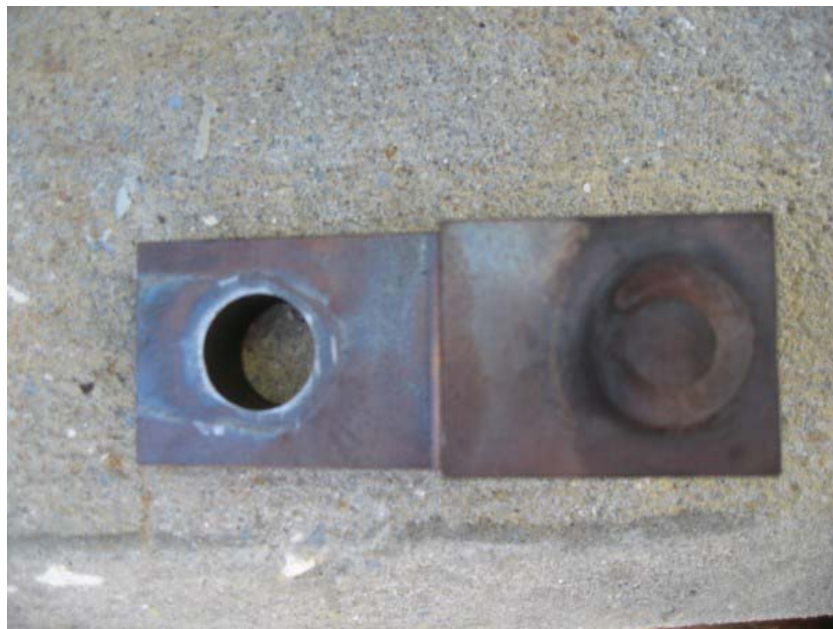
Side seal block condition

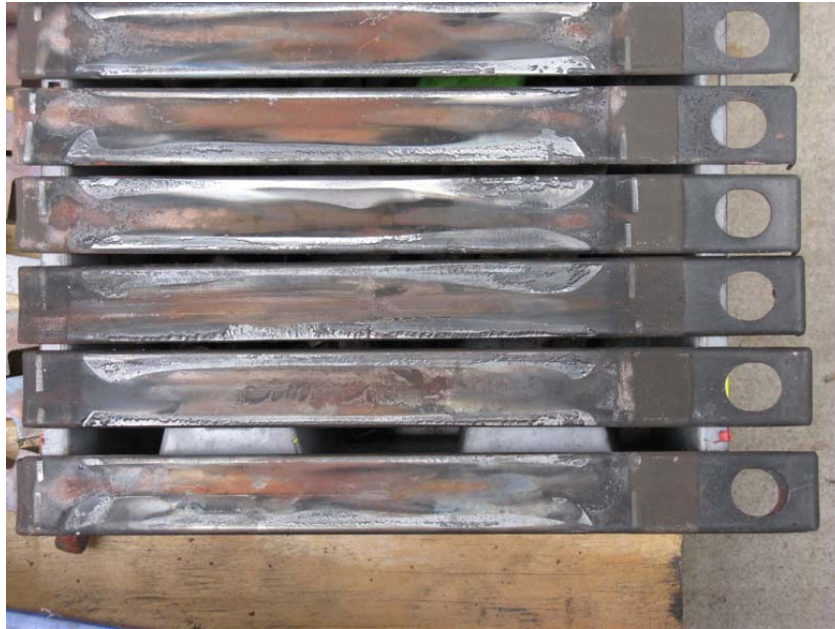
Side seal wear - As Found

Typical condition for side seals.
No major defects to note. All were replaced with new parts during the outage.

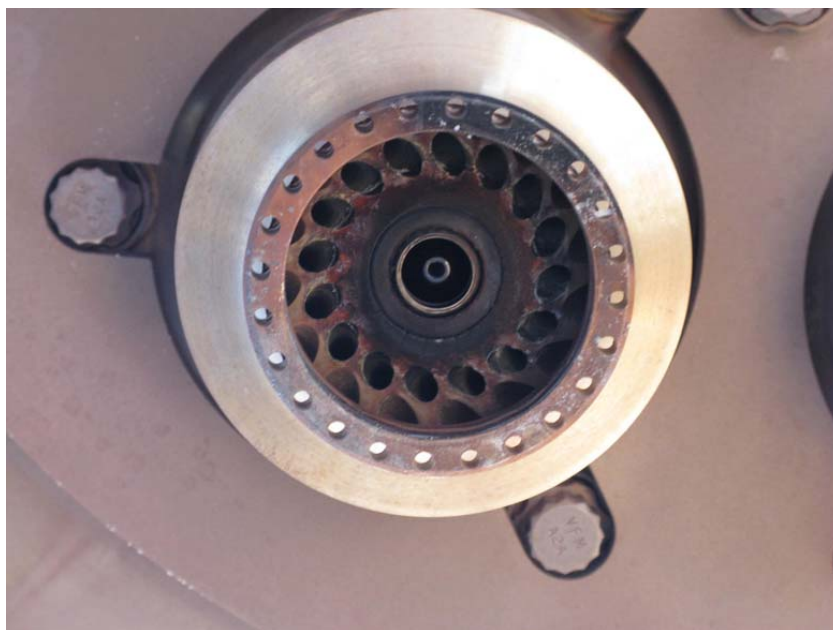
The fuel nozzles were removed from the combustion system and visually inspected. No damage was found on the swirl tips, no coking was present, and no holes were plugged. The part numbers and the serial numbers were recorded after the visual inspection was complete.

Fuel Nozzles As Found

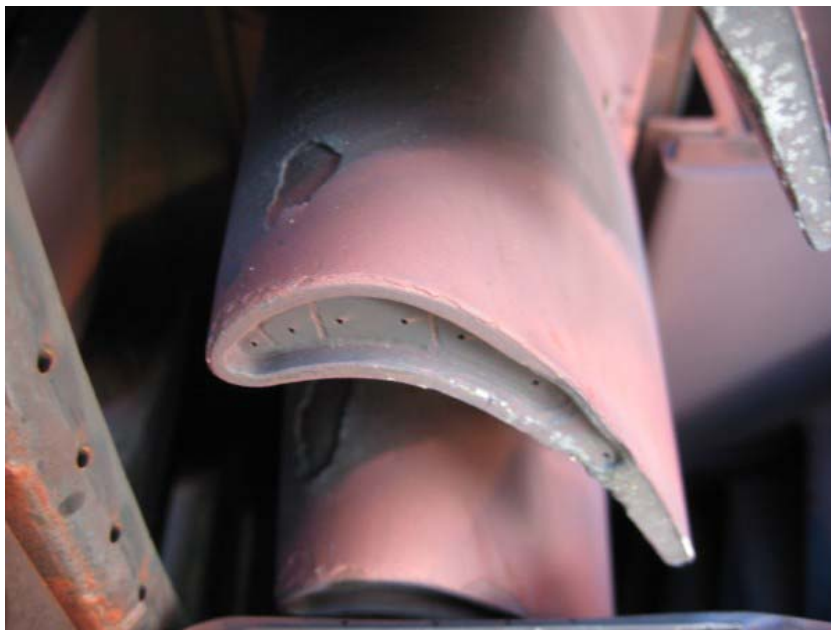
1st Stage Bucket - As Found

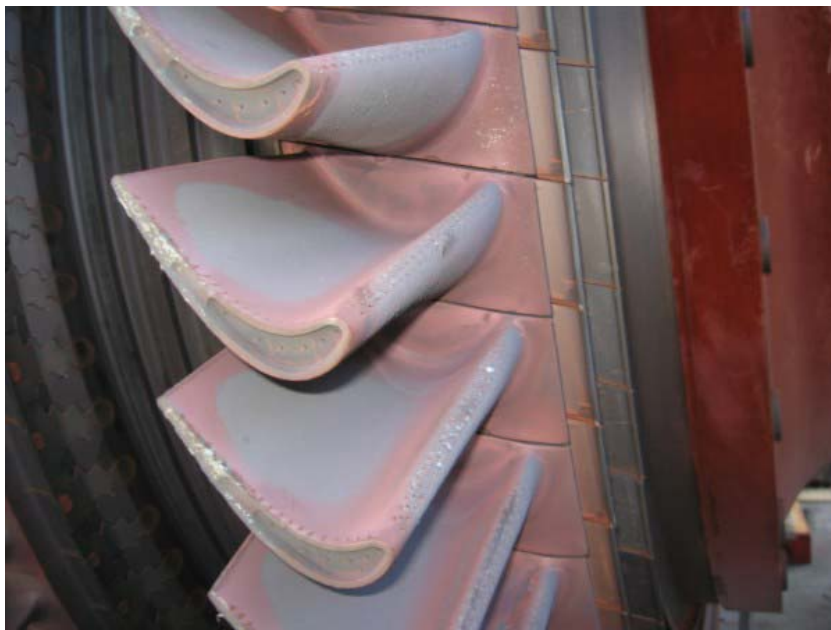
1st stage bucket - As Found Condition

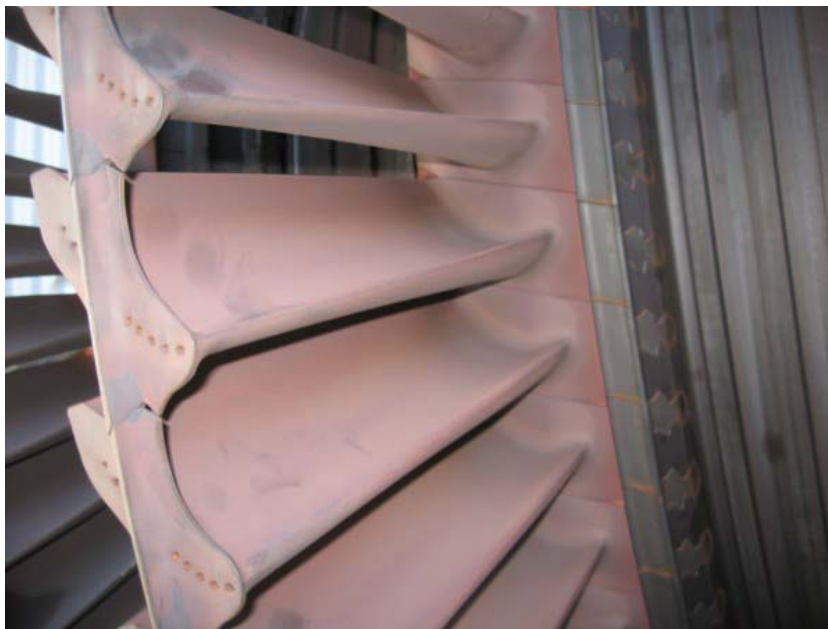
2nd stage bucket - As Found

The overall condition of the 2nd stage buckets were good with no major defects to note. All will be further inspected at the GE Service Center.

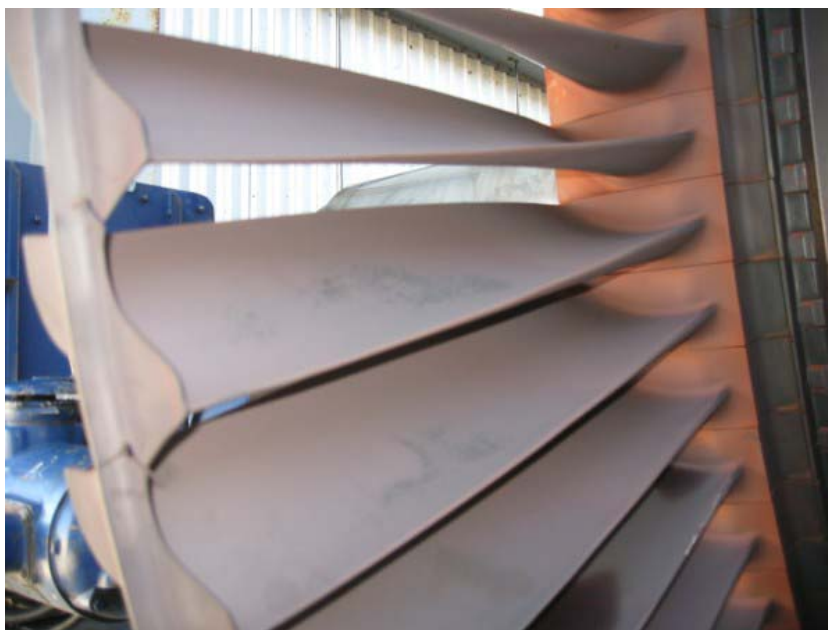
3rd Stage Bucket - As Found

No major issues to note.

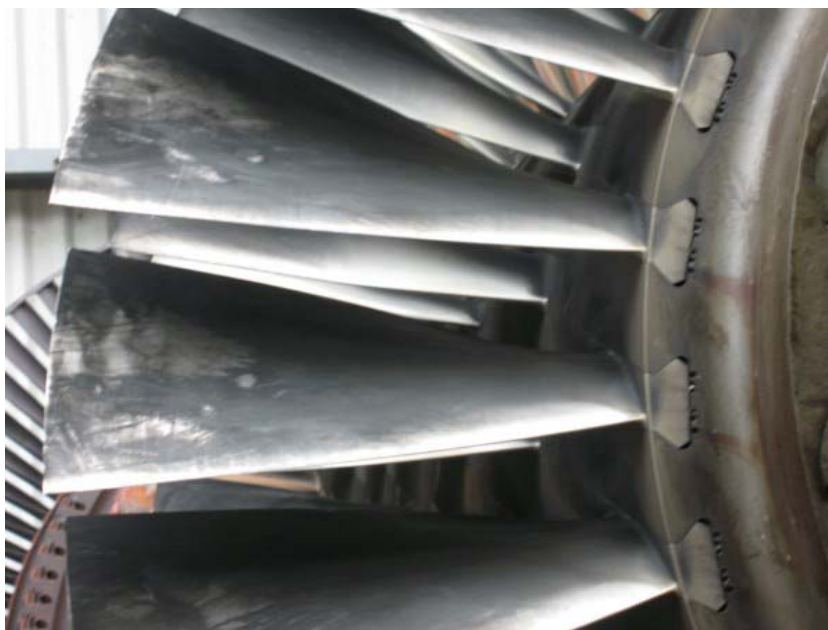
RO staking conditon - As Found

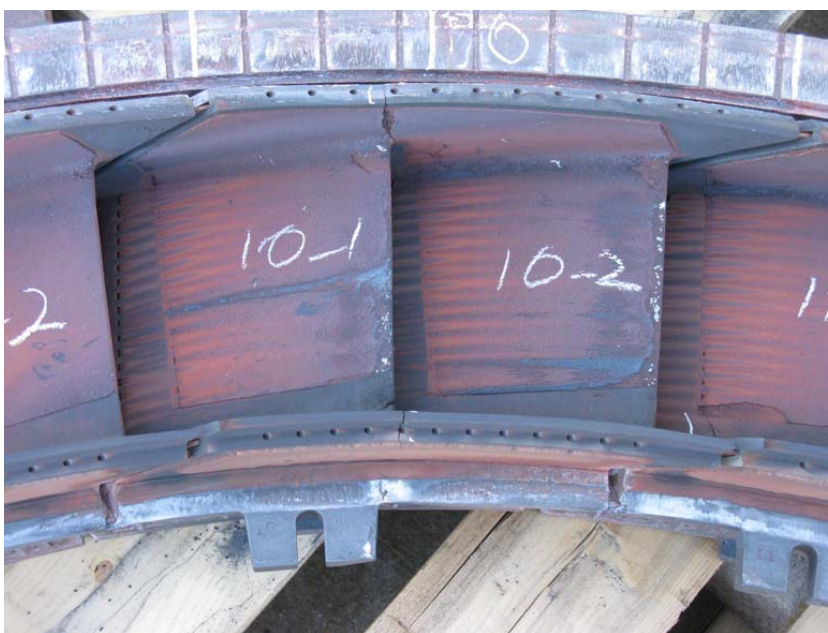
1st stage nozzle - As Found

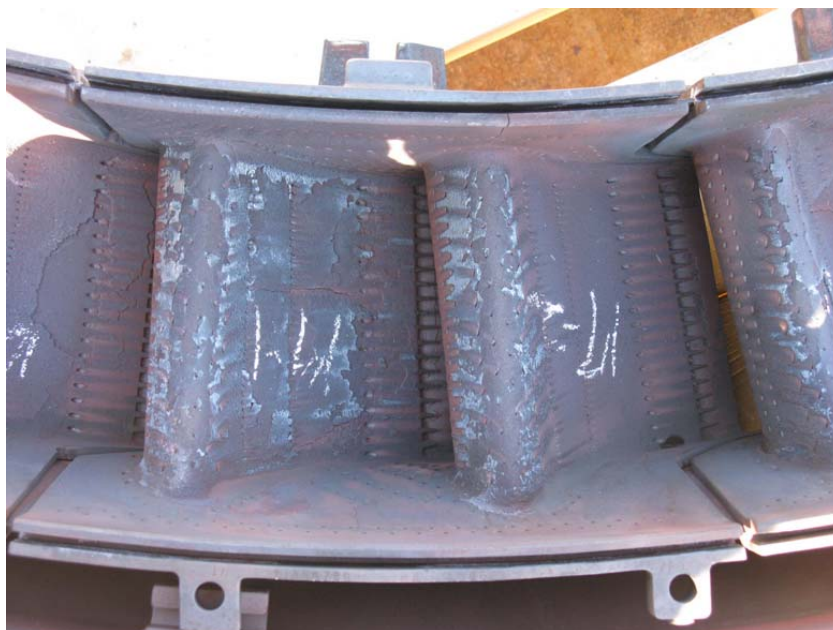
1st stage nozzle - As Found Condition

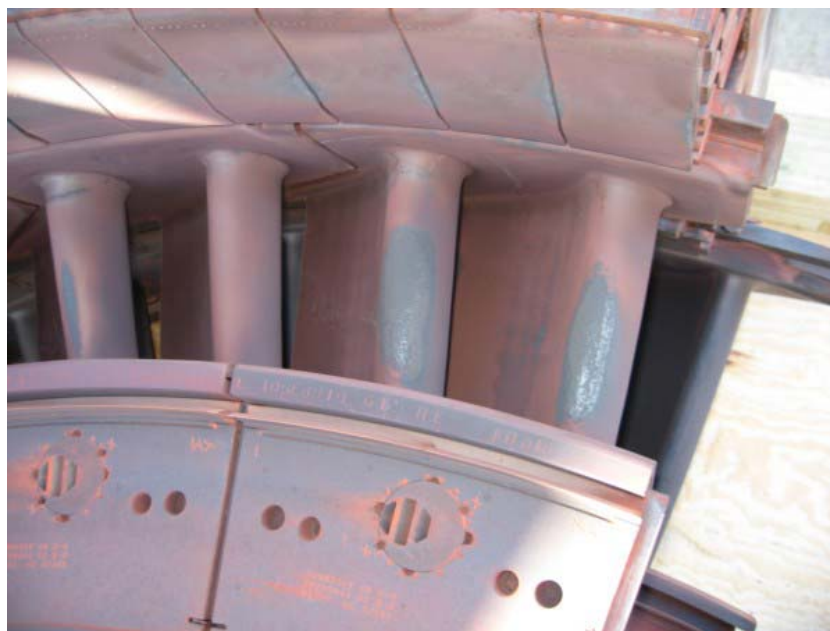
2nd Stage Nozzle - As Found

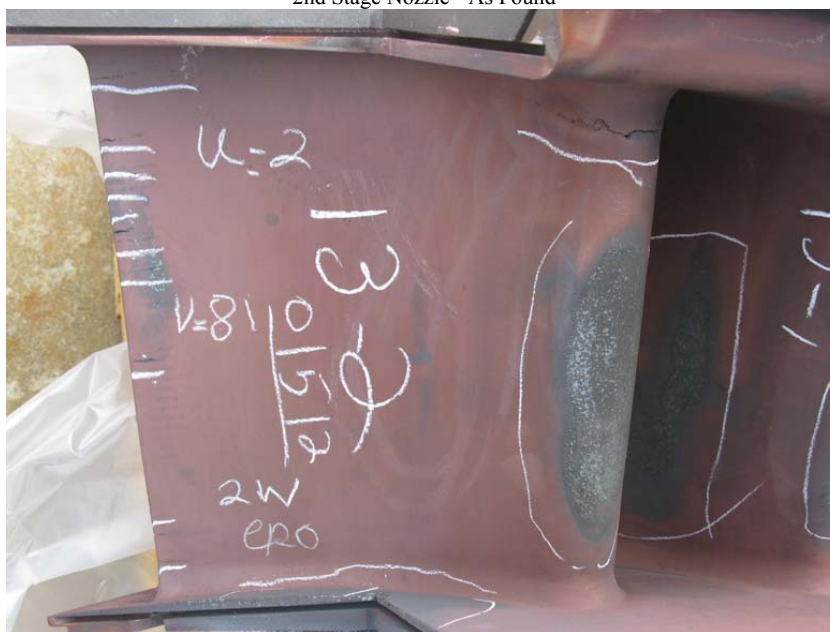
2nd Stage Nozzle - Typical Cracking

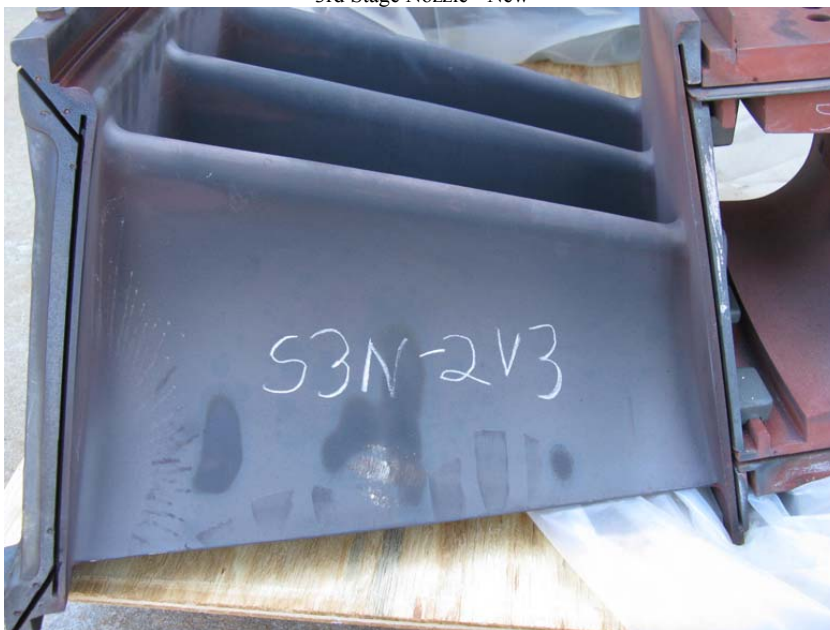
3rd Stage Nozzle - As Found

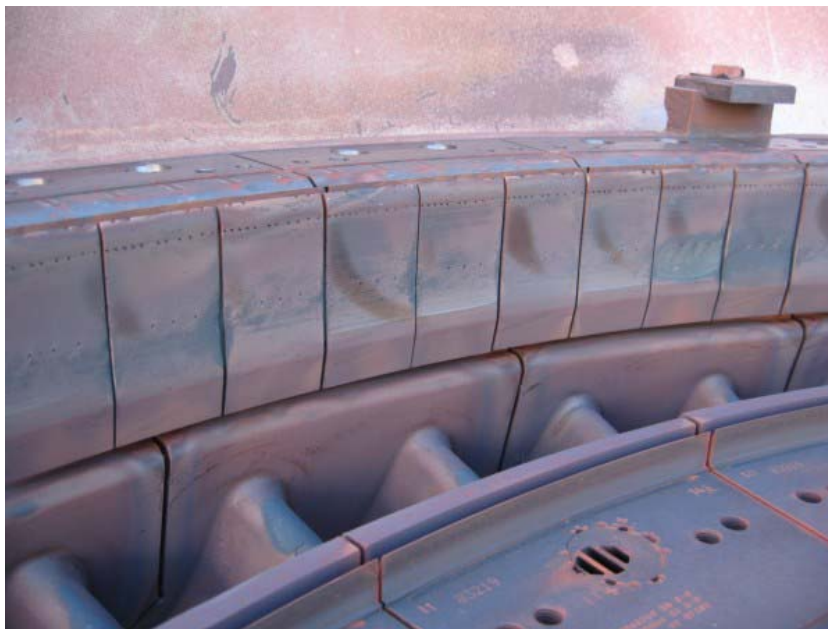
1st Stage Shroud - As Found

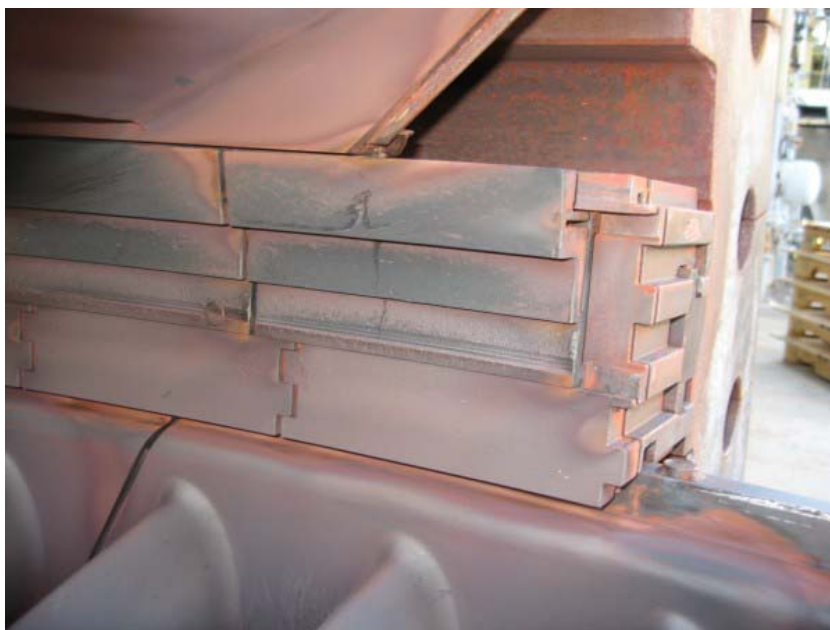
2nd Stage Shroud - As Found

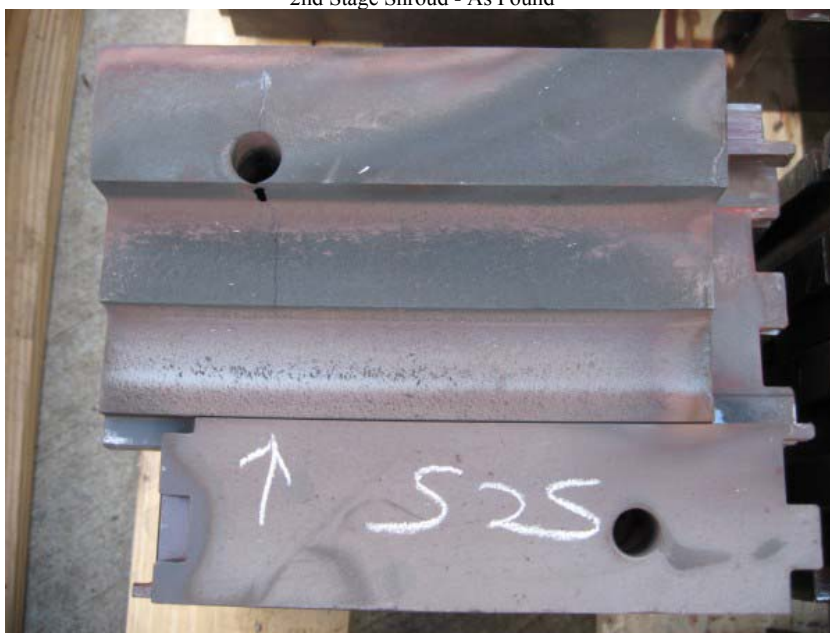
2nd Stage Shroud - Cracks

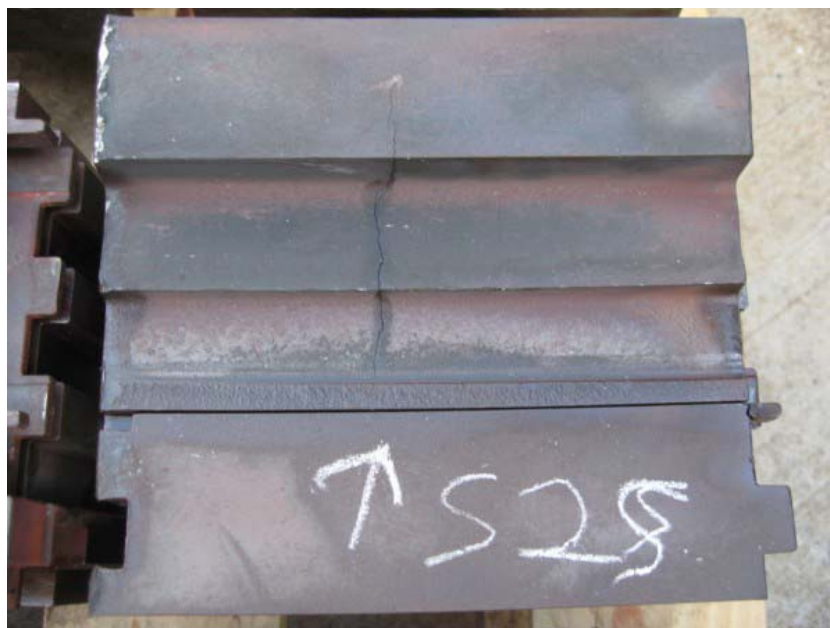
2nd Stage Shrouds - Cracking

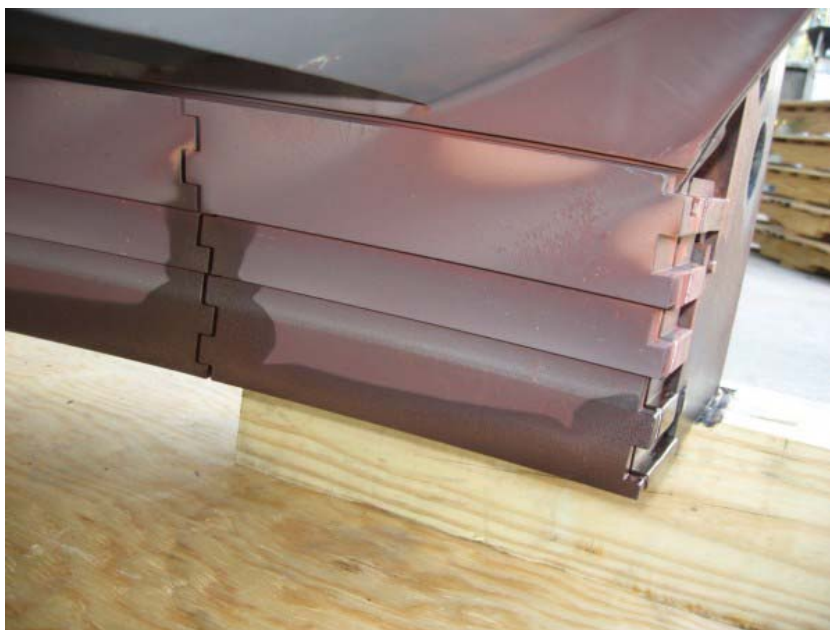
3rd Stage Shroud - As Found

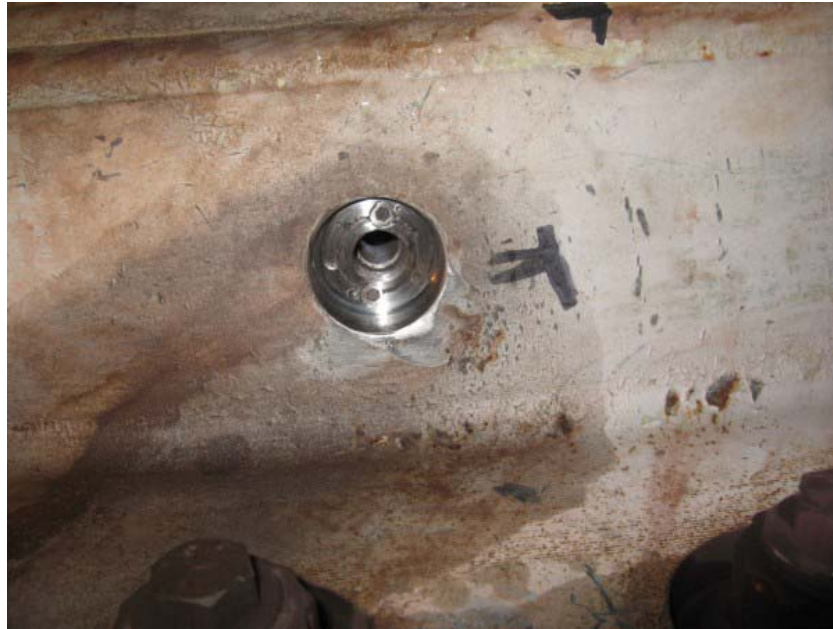
3rd Stage Shroud Pin Repair

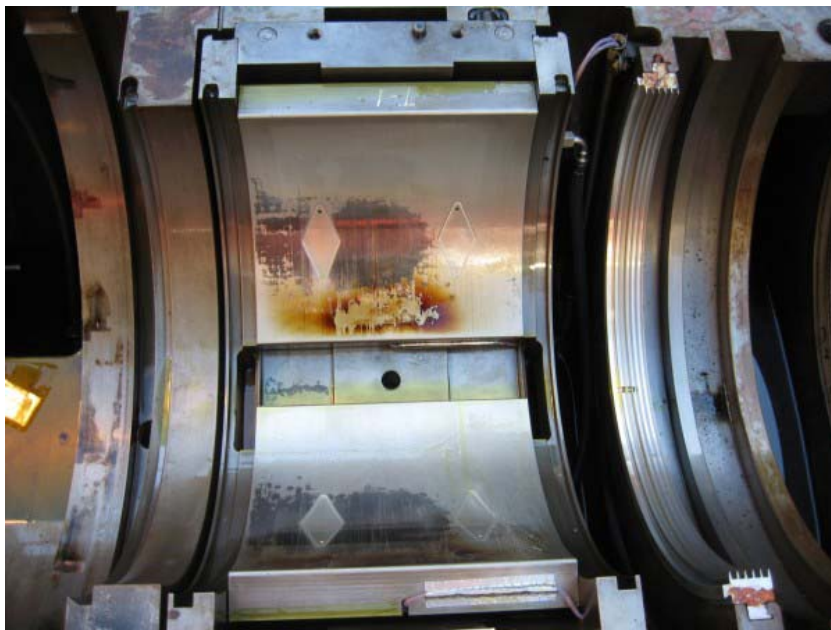
T1 Bearing As Found

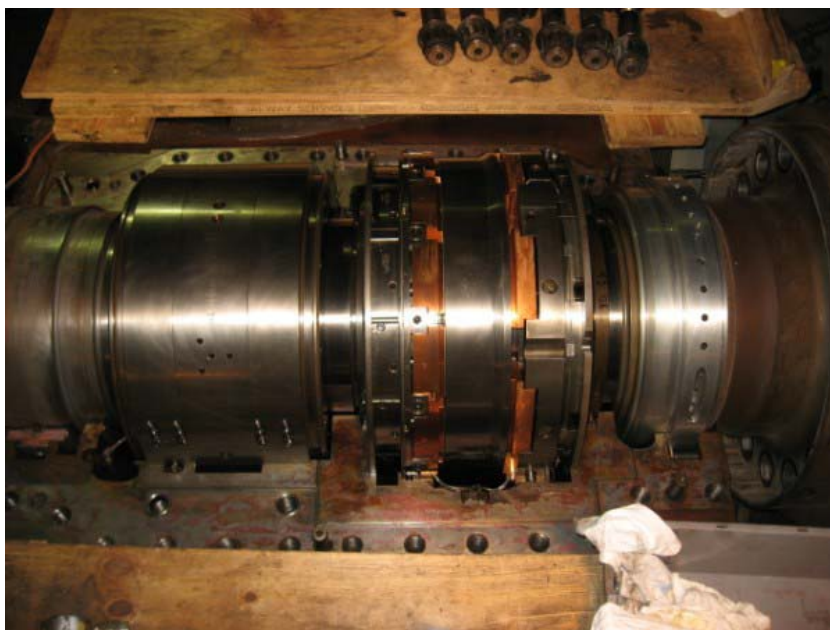
As Found Thrust Bearing

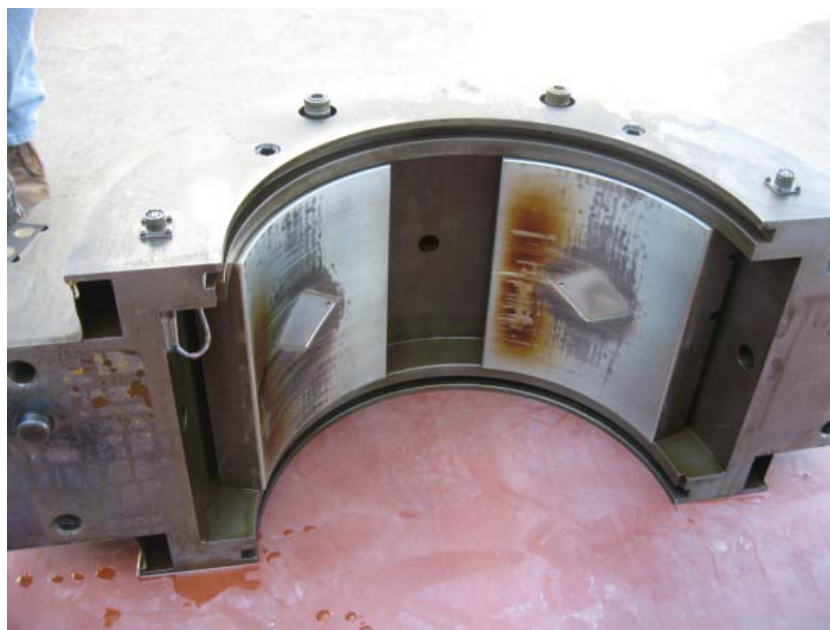
CE LH bearing - as found
