# Power Delivery Performance

## Hurricane Eta

Storm Date: November 9, 2020

Report Date: September 28, 2021

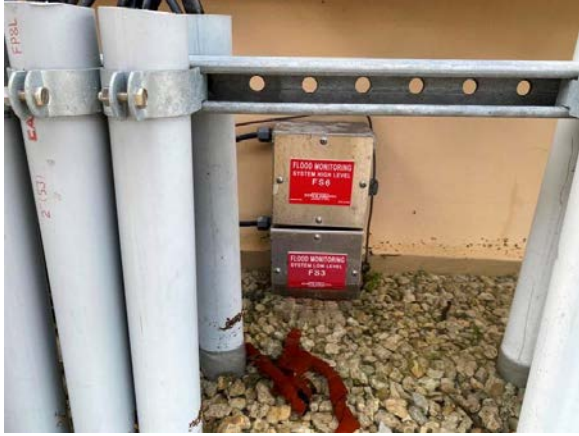
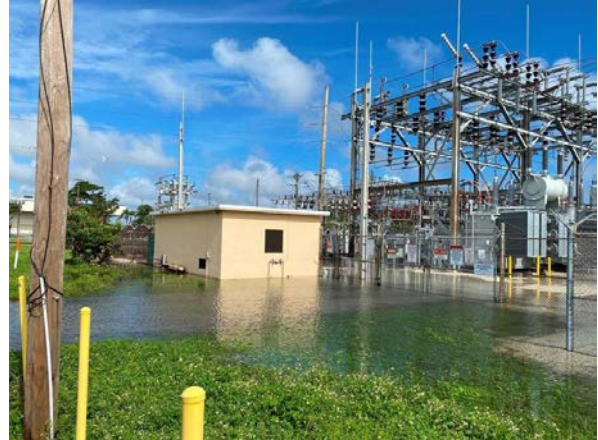
### Seaboard Substation (Dade County) - Flooded

- 0 Substations Impacted
- 2 Flooded Substations
  - Seaboard (Dade Area)
  - Verena (Broward Area)

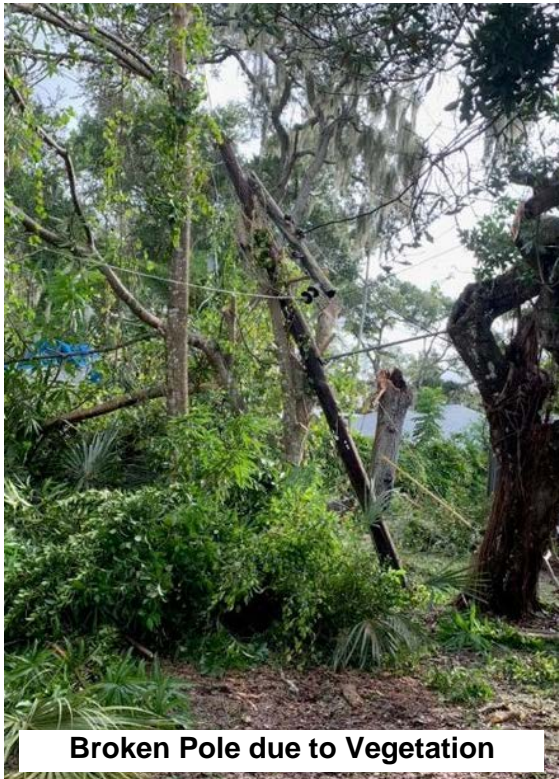
**Broken Pole due to Vegetation**

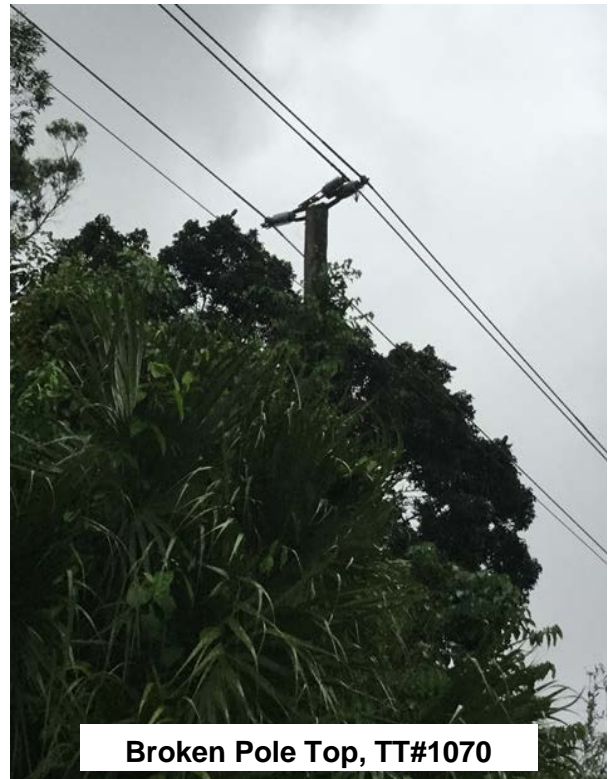
**Broken Pole Top, TT#1070**

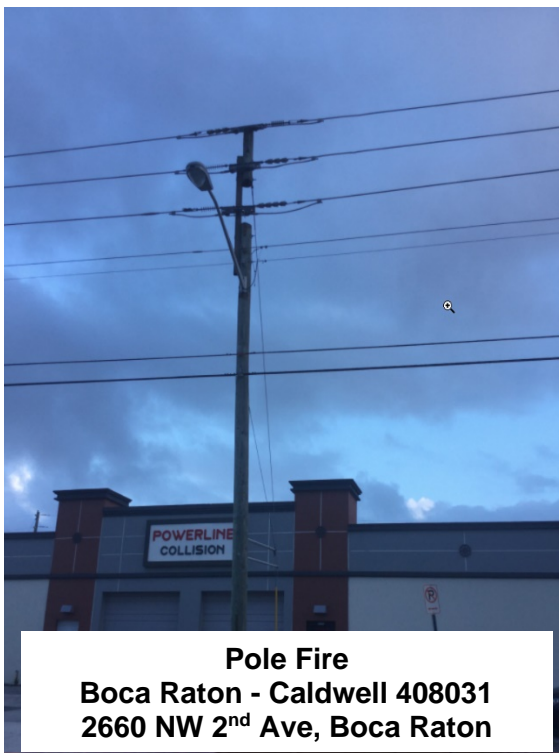
**Pole Fire  
Boca Raton - Caldwell 408031  
2660 NW 2<sup>nd</sup> Ave, Boca Raton**

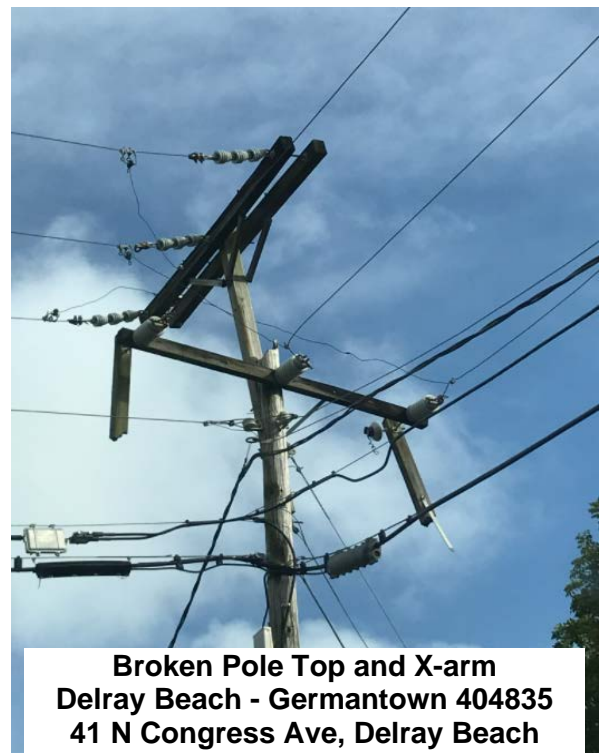
**Broken Pole Top and X-arm  
Delray Beach - Germantown 404835  
41 N Congress Ave, Delray Beach**

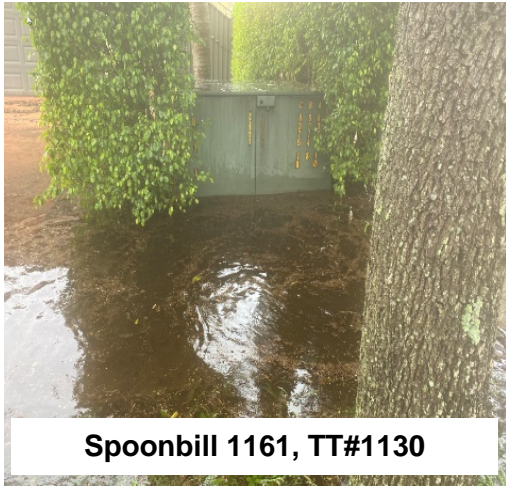
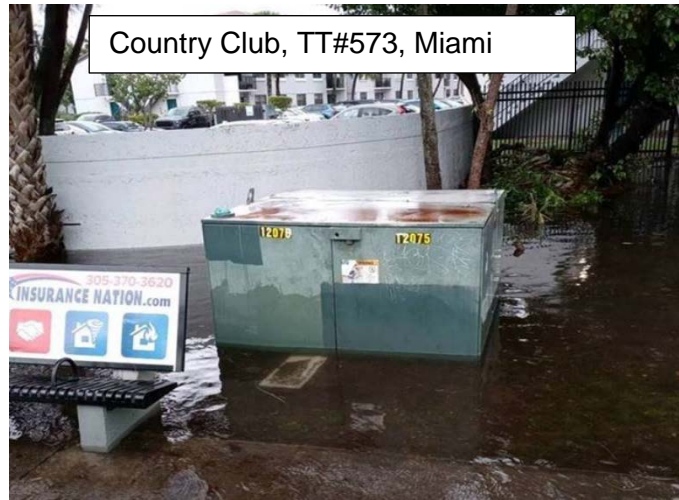
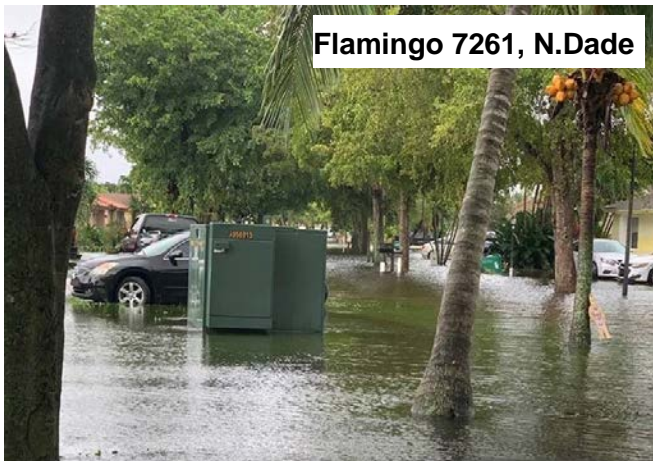
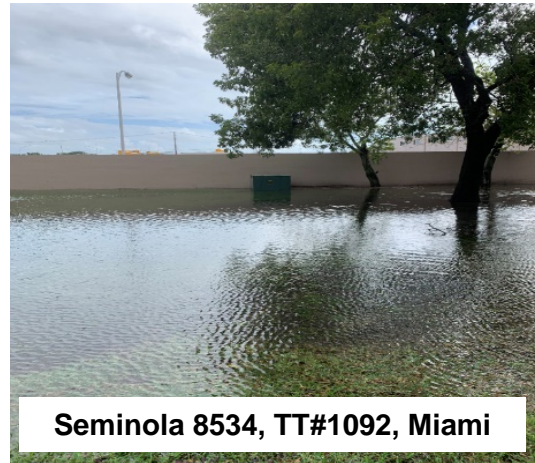
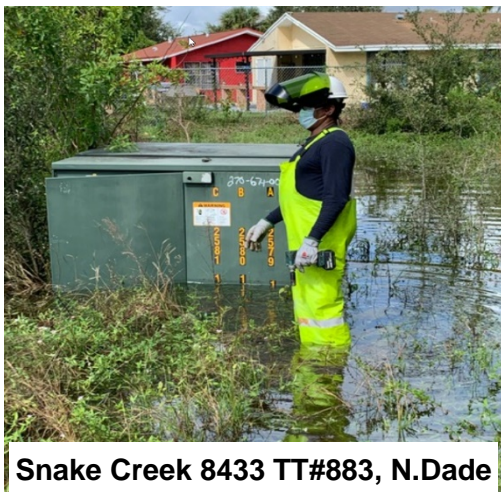
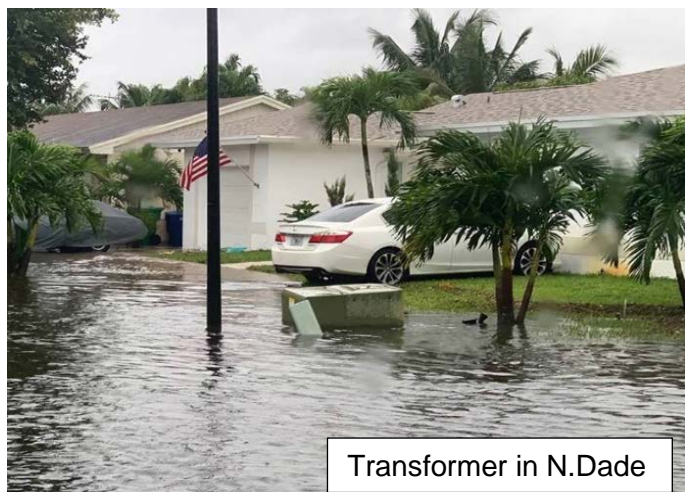
## Transformer and Padmounted Switch Pictures

- 7 failed switches were reported based on trouble tickets
  - Flooding and equipment failures were cited as a cause
