**RE:** Docket No. 160176-WS – Application for staff-assisted rate case in Polk County by Four Lakes Golf Club, Ltd. – Supplemental Information for Pro Forma Hydropneumatic Tank Replacement, Purchased Power Invoices, and G&A Expense Allocations.

# The Hydro Tank

Welded Steel Horizontal Hydropneumatic Cylindrical Tank

October 14, 2016

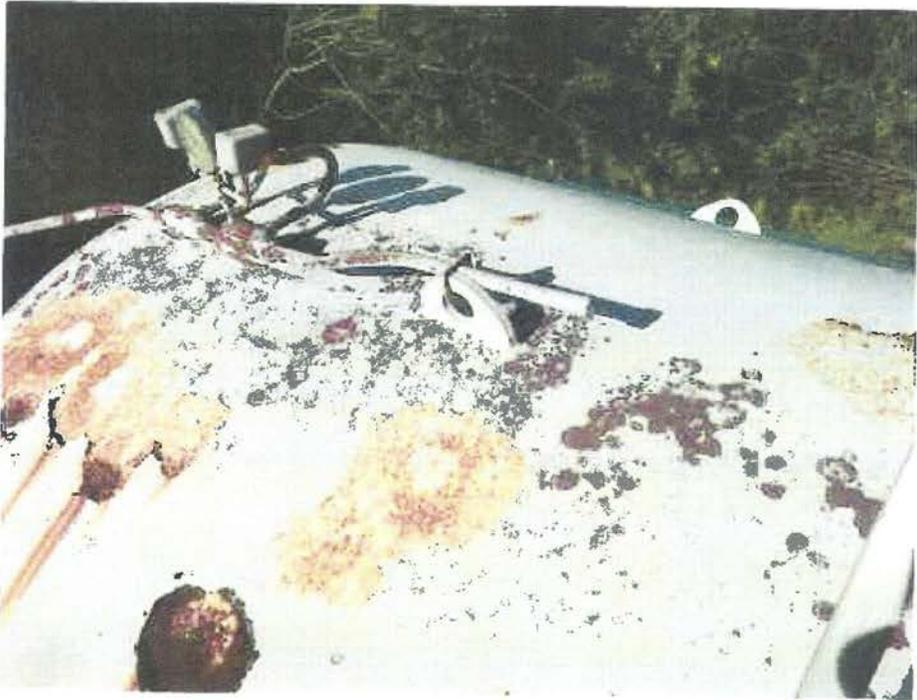
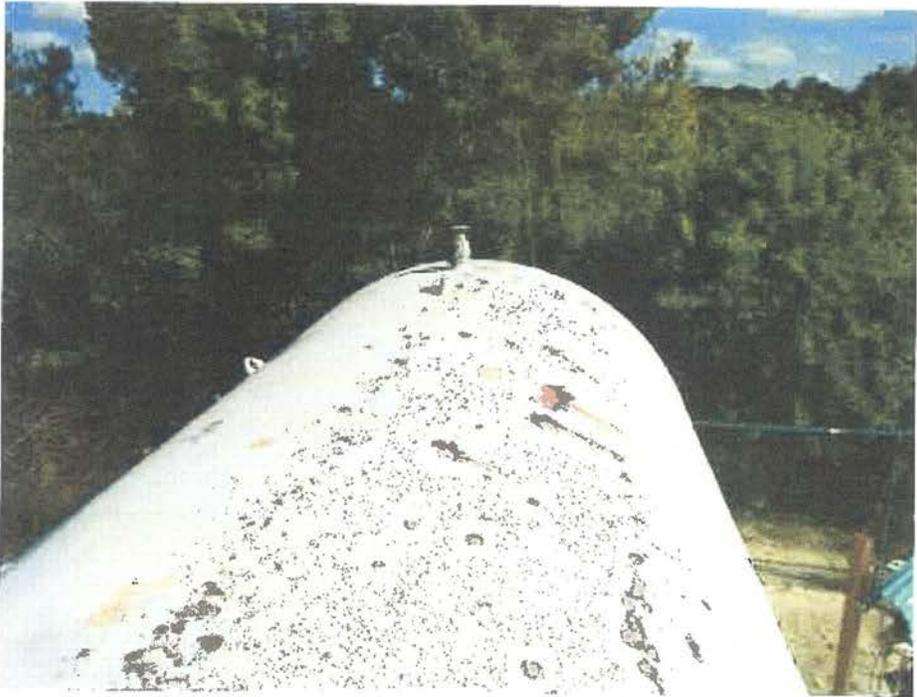
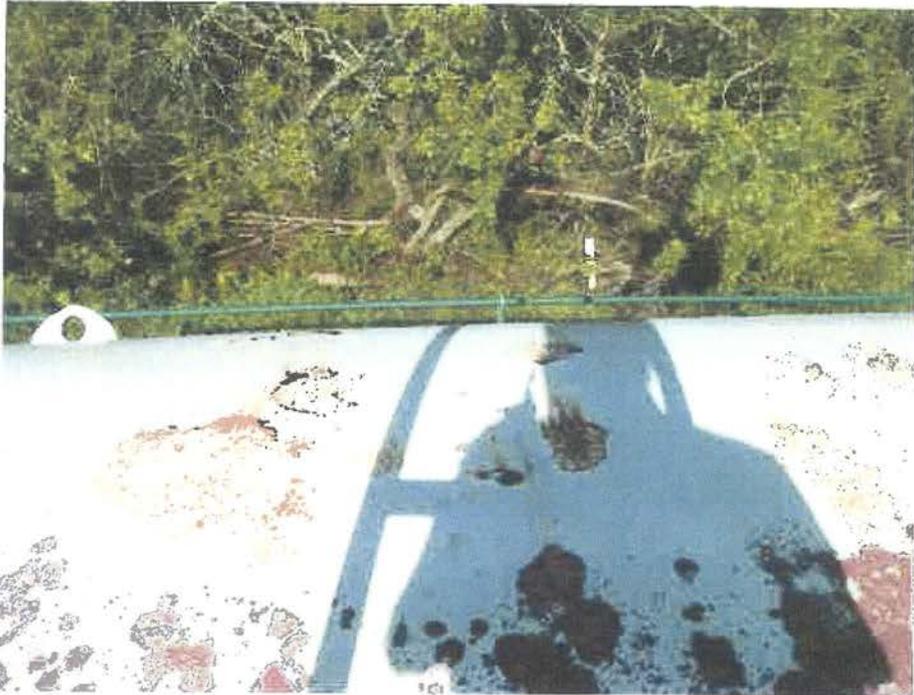
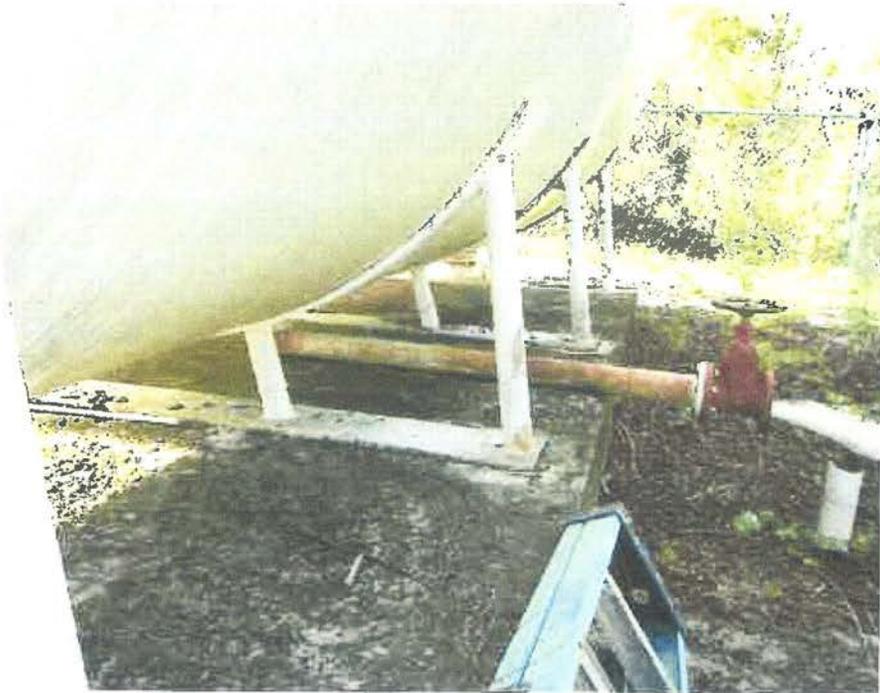
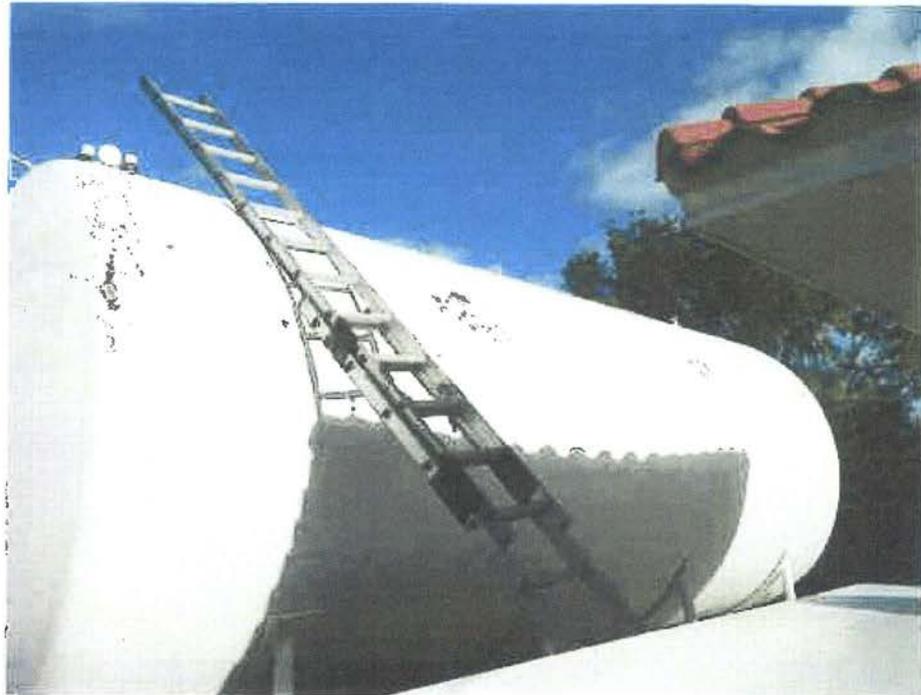
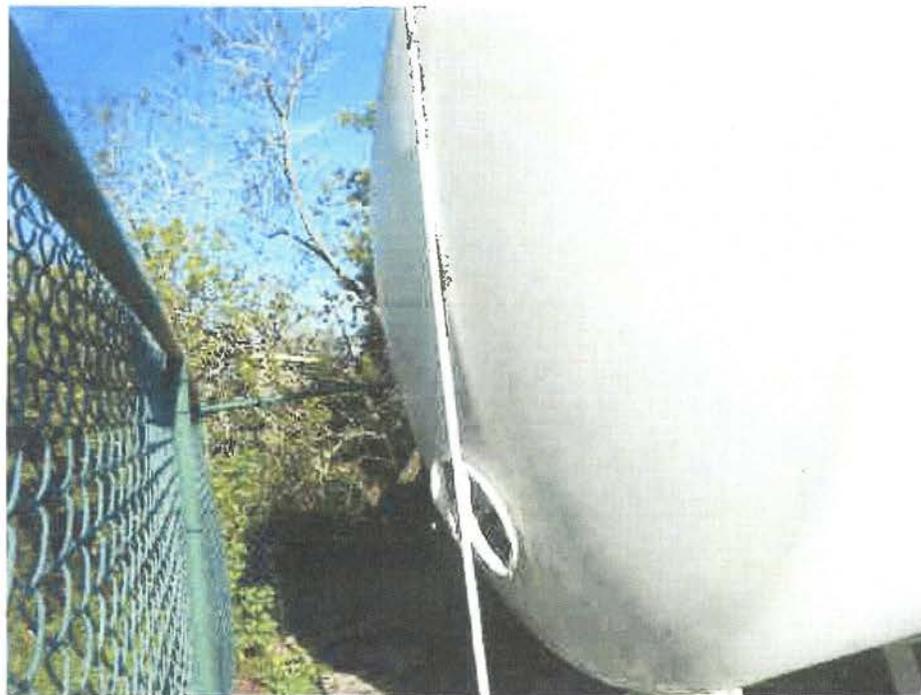
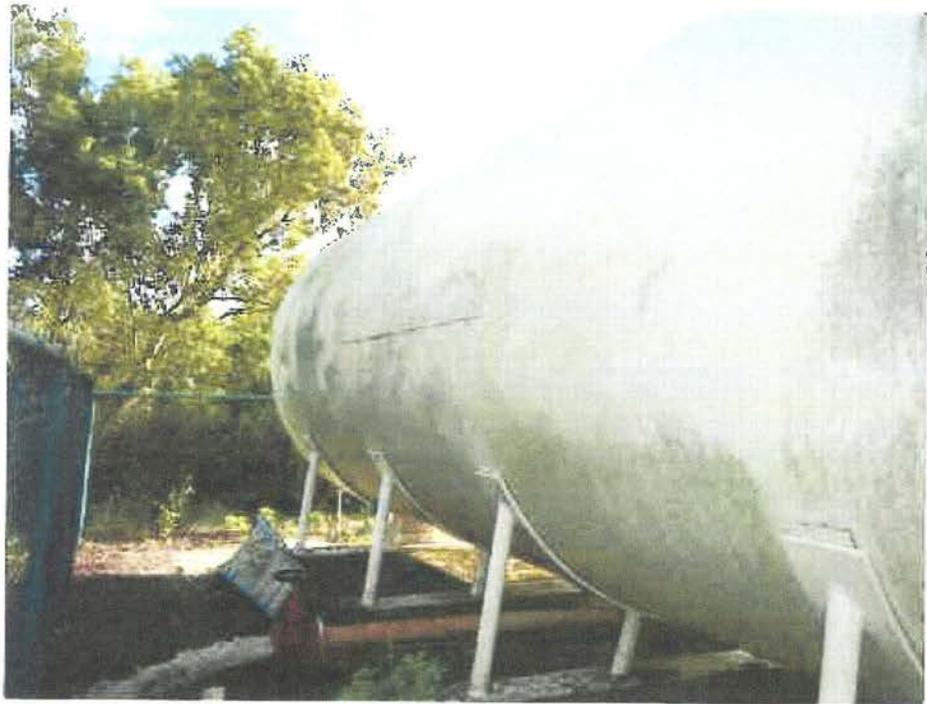
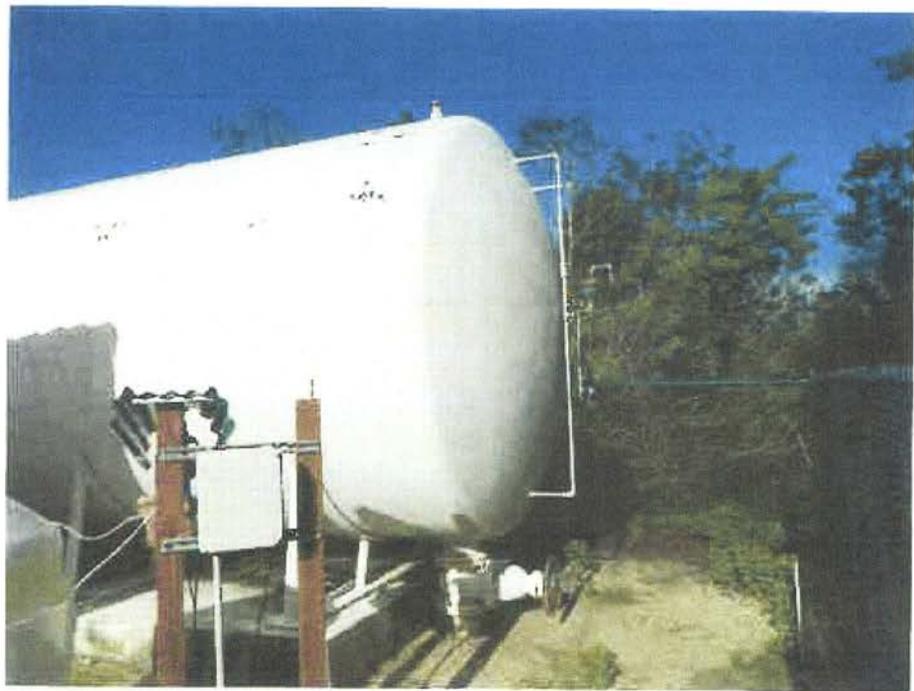
1. It appeared that the exterior has been overcoated since the initial installation.
2. The exterior appears to be coated with an industrial enamel or epoxy material which appeared to have about 5% or less failure and corrosion.
3. This tank has an overpressure relief valve installed.
4. The steel cradles appeared to still be in excellent condition and although some slight corrosion is occurring, they are not excessively corroded or deteriorated.
5. The concrete base which supports the steel cradles appeared to be in excellent condition and not excessively cracked, spalled or otherwise deteriorated.
6. There are pads installed between the steel cradles and the tank.

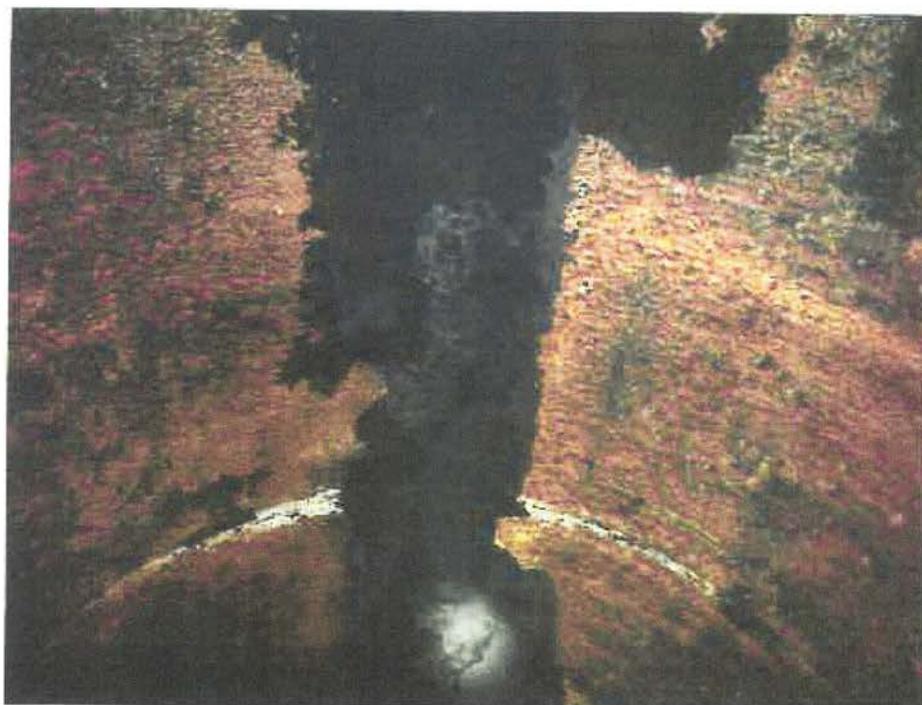
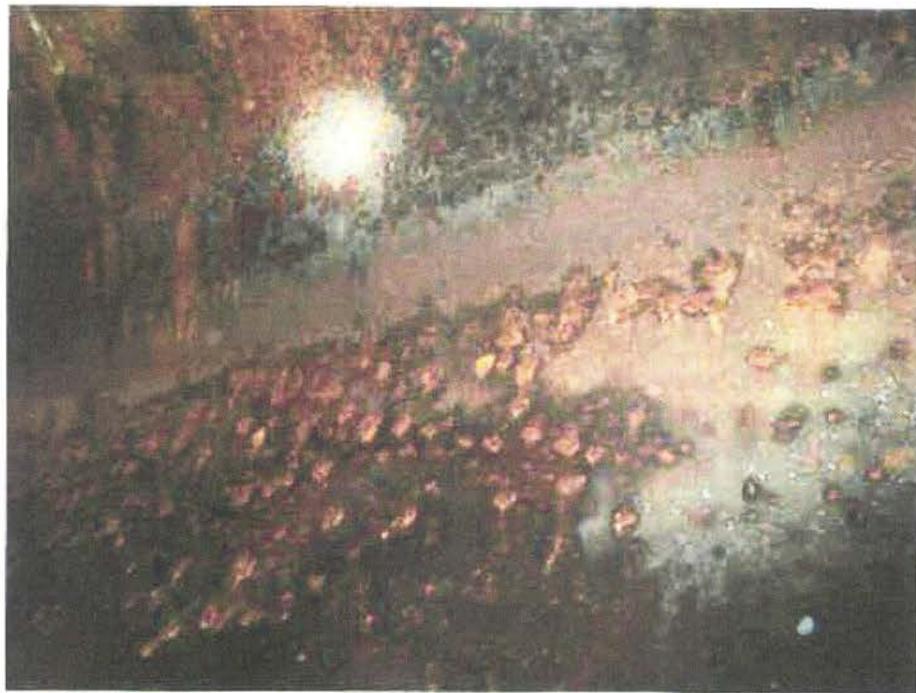
2. It appeared that the interior has not been recoated since the initial installation.
3. The interior appears to be coated with a white epoxy.
4. Incidences of interior protective coating failure and corrosion were observed on the plate surfaces and welds above the normal working water level that appeared to affect 30% or more of the surface area, and on the plate surfaces and welds below the normal working water level which appeared to affect 20% or more of the surface area.

1. It should be noted that the life expectancy of these tanks are about 30 years.
2. No interior or exterior corrective actions are recommended at this time.
3. This tank should be rehabilitated or replaced within about 8 months of this inspection depending upon the cost difference.
4. This tank should be reinspected again in 5 years to comply with the Florida Department Of Environmental Regulation – Florida Administrative Code Chapter 62-555 Permitting, Construction, Operation, And Maintenance Of Public Water Systems Section 350 – Operation And Maintenance Of Public Water Systems – Paragraph 2 that requires your “Finished Water Storage Tanks, Including Conventional Hydropneumatic Tanks With An Access Manhole, Be Inspected For Structural And Coating Integrity At Least Once Every 5 Years By Personnel Under The Responsible Charge Of A Professional Engineer Licensed In Florida.”
