BEFORE THE FLORIDA PUBLIC SERVICE COMMISSION

In re: Application for limited proceeding for recovery of incremental storm restoration costs related to Hurricanes Irma and Nate by Duke Energy Florida, LLC

Docket No. 20170272-EI

DUKE FL POLE FORENSICS SUPPORT REPORT

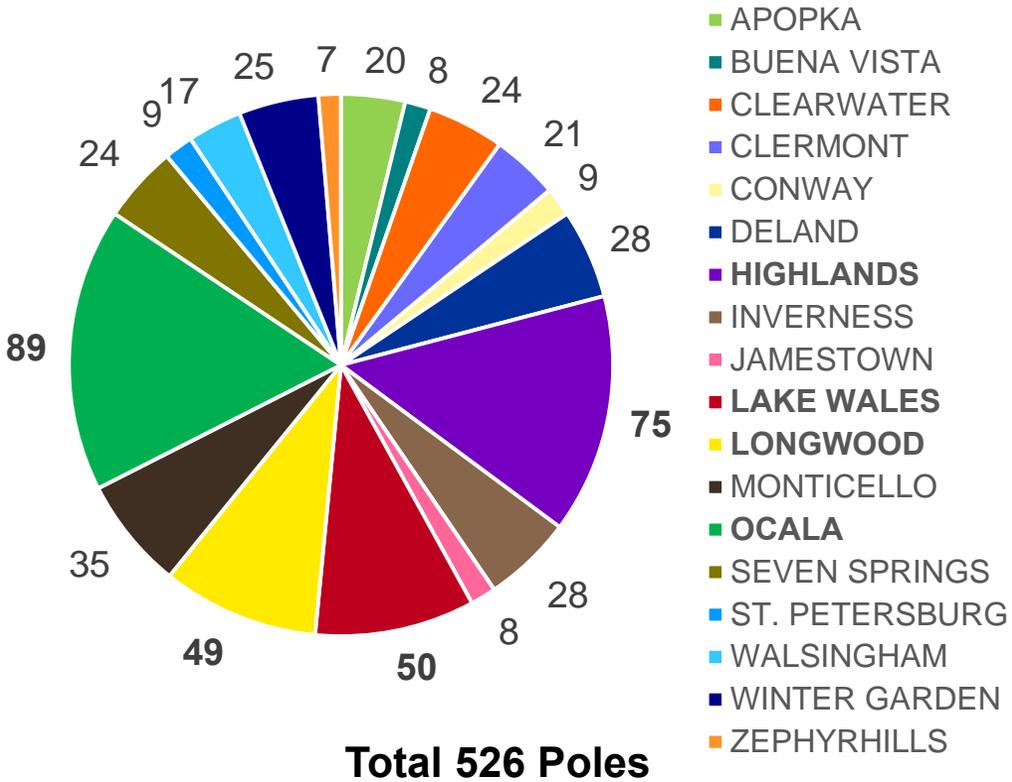
Broken Poles By OP Center

50% of broken pole data came from **Ocala**, **Highlands**, **Lake Wales** and **Longwood** OP Centers

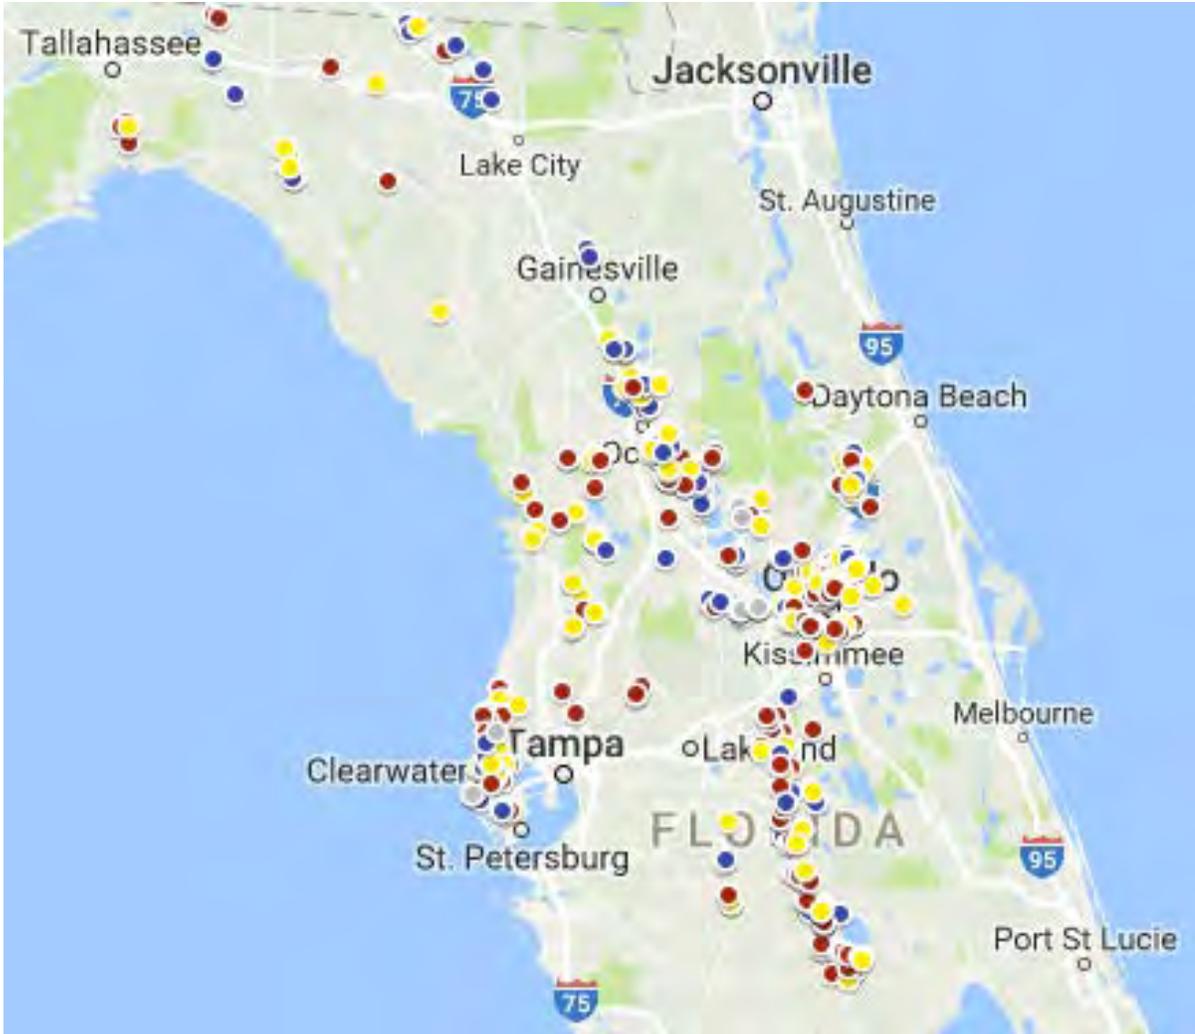
- 37.2% of poles broke in the middle

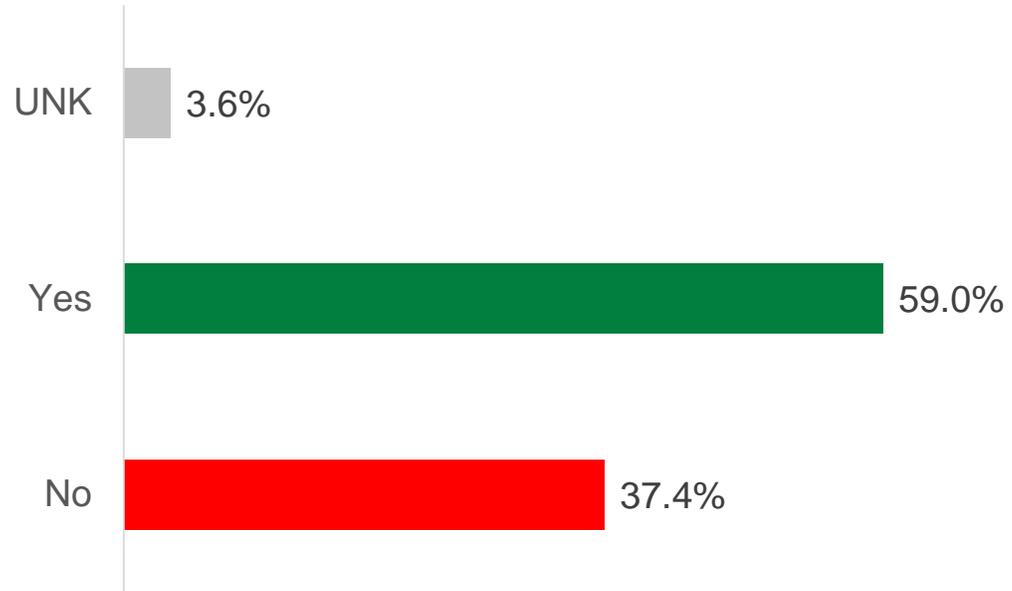
Attachment

59% of broken poles had an attachment

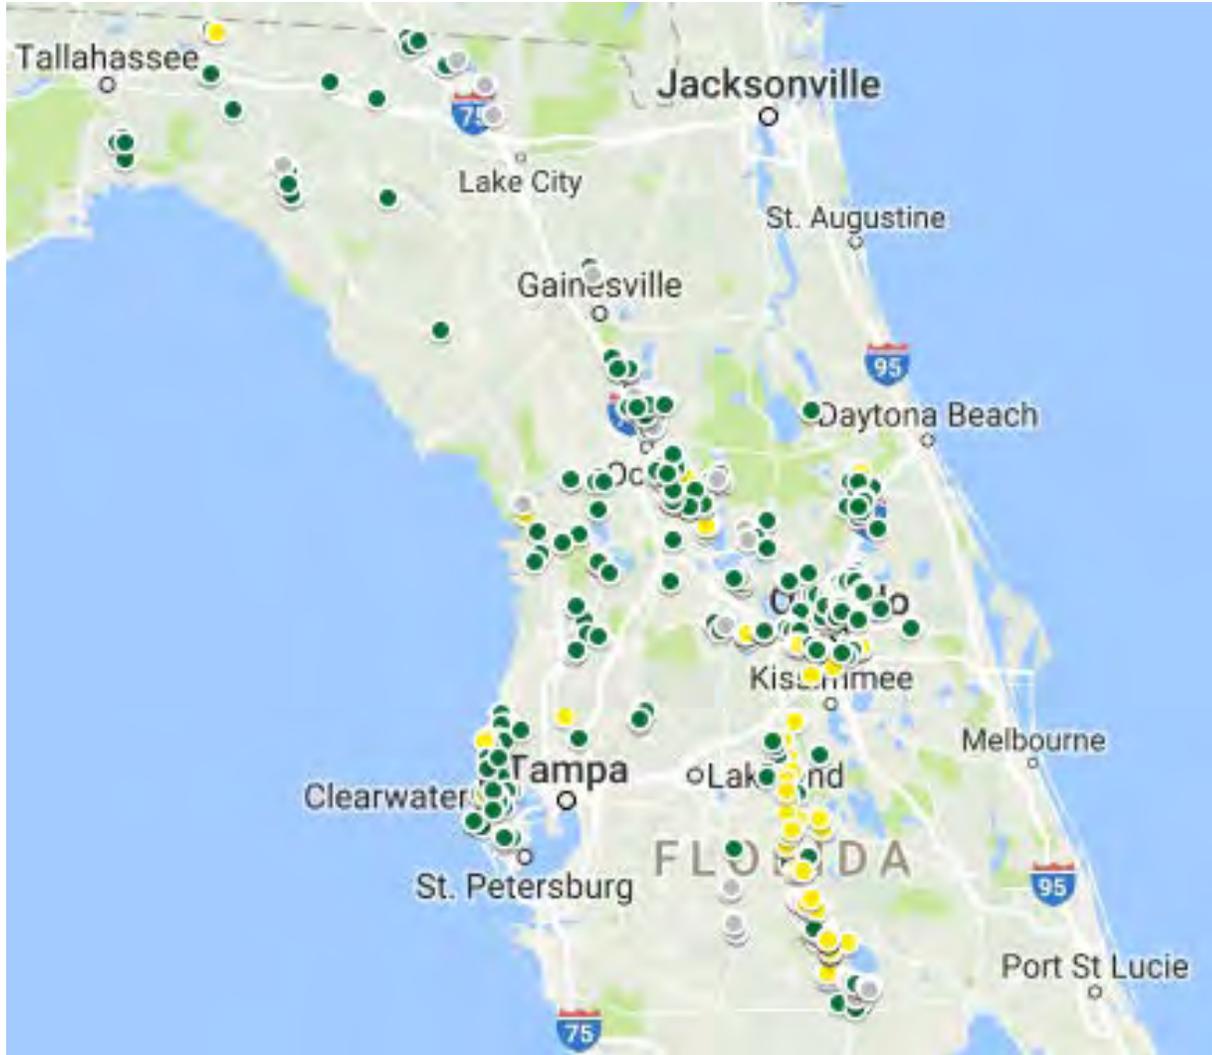
TREE INVOLVED

71.8% of broken poles had a tree involved

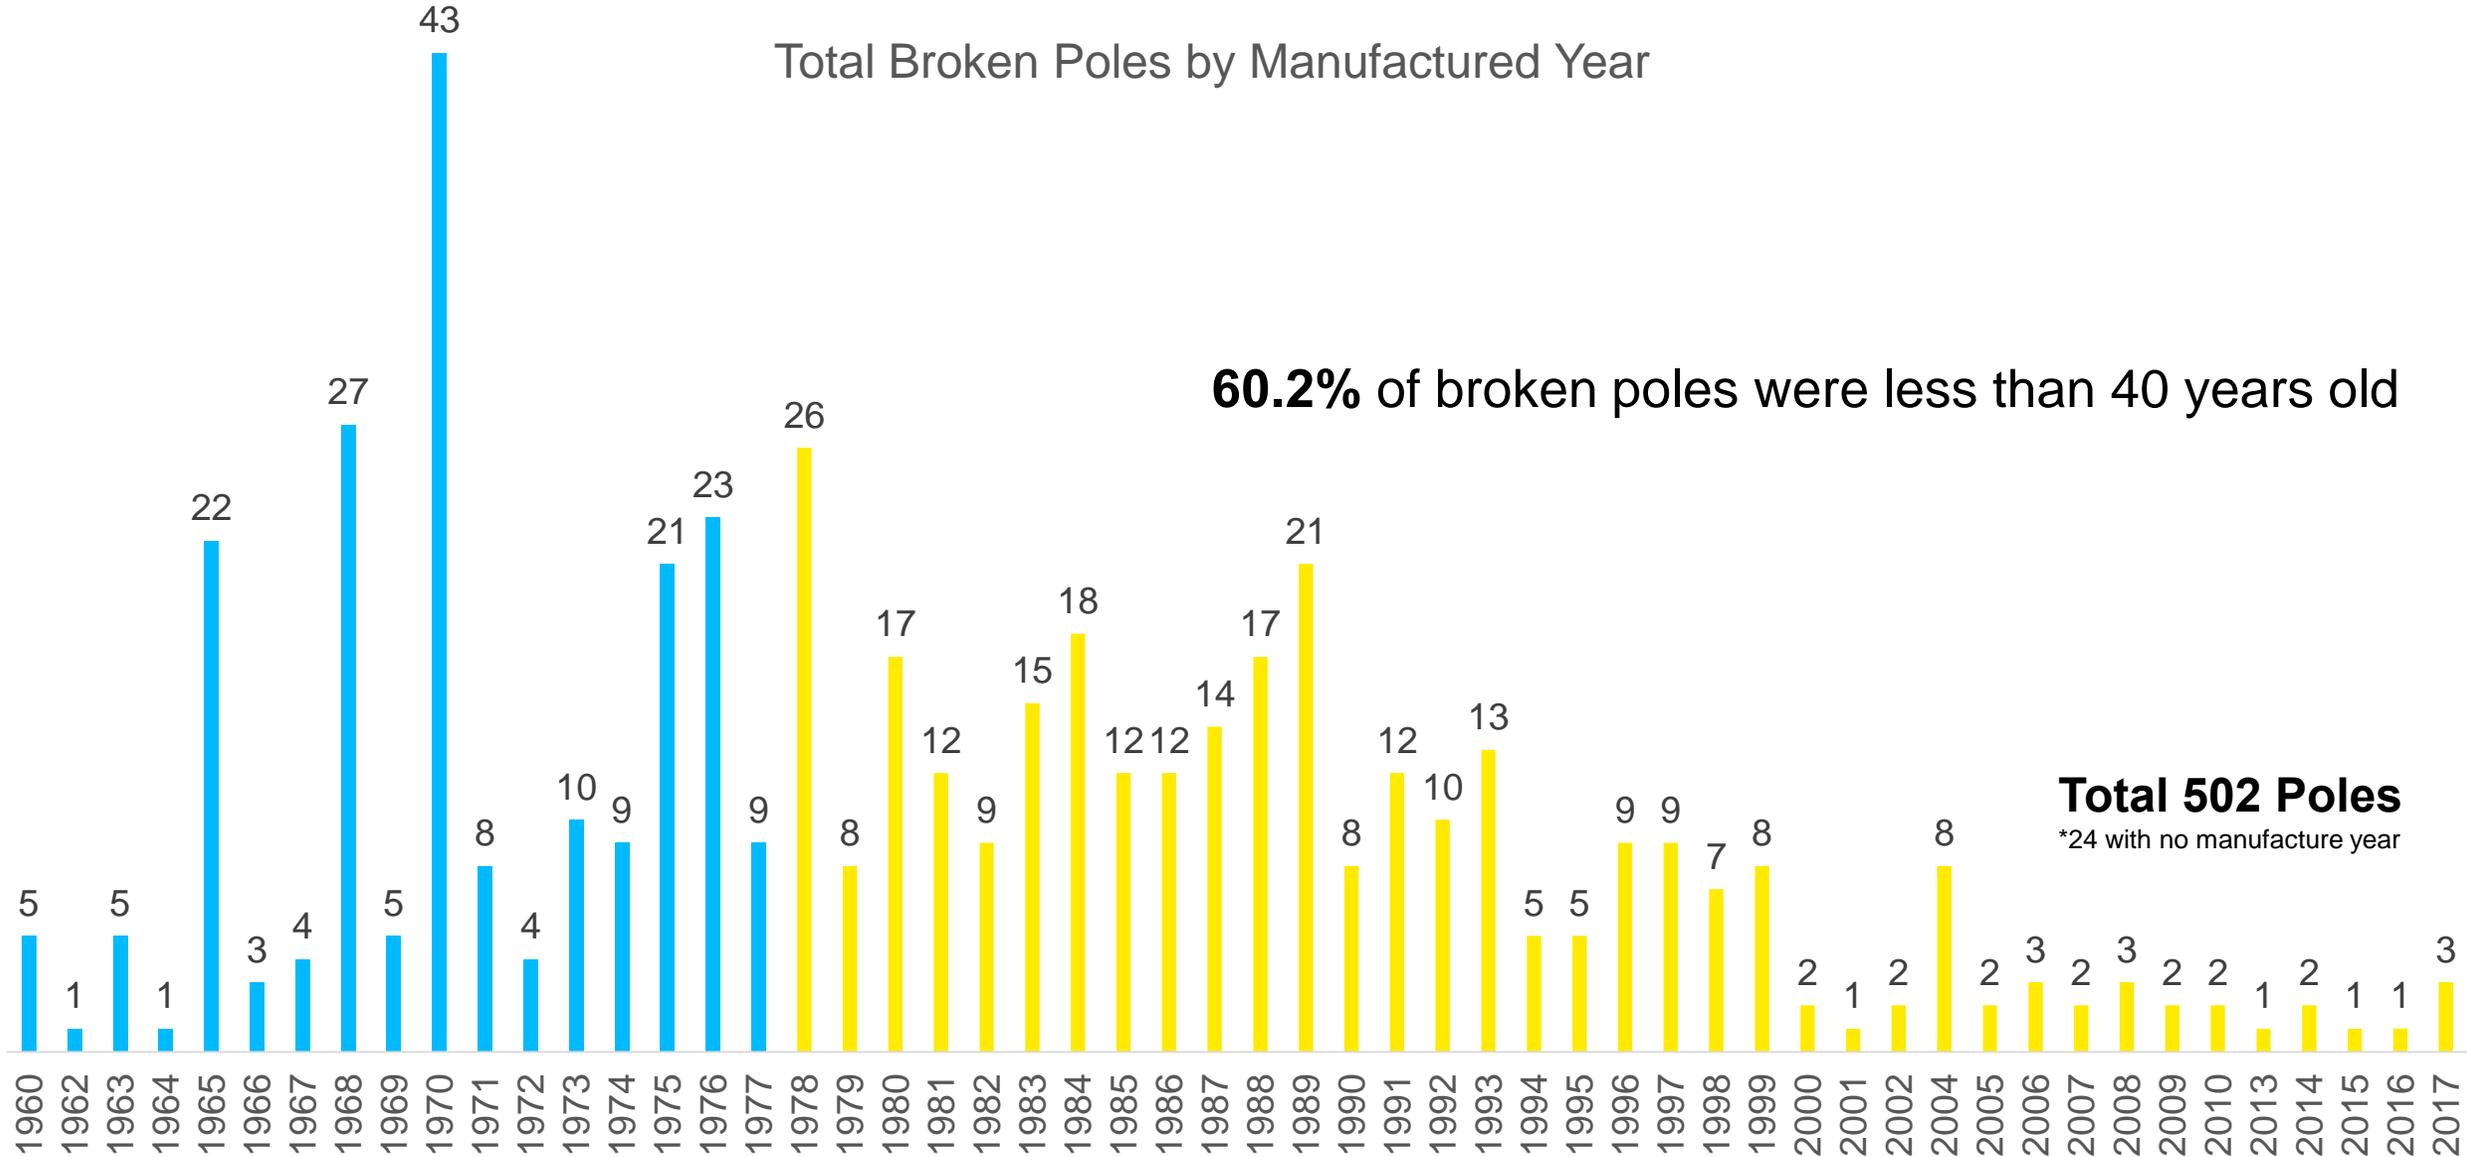
Total Broken Poles by Manufactured Year

60.2% of broken poles were less than 40 years old

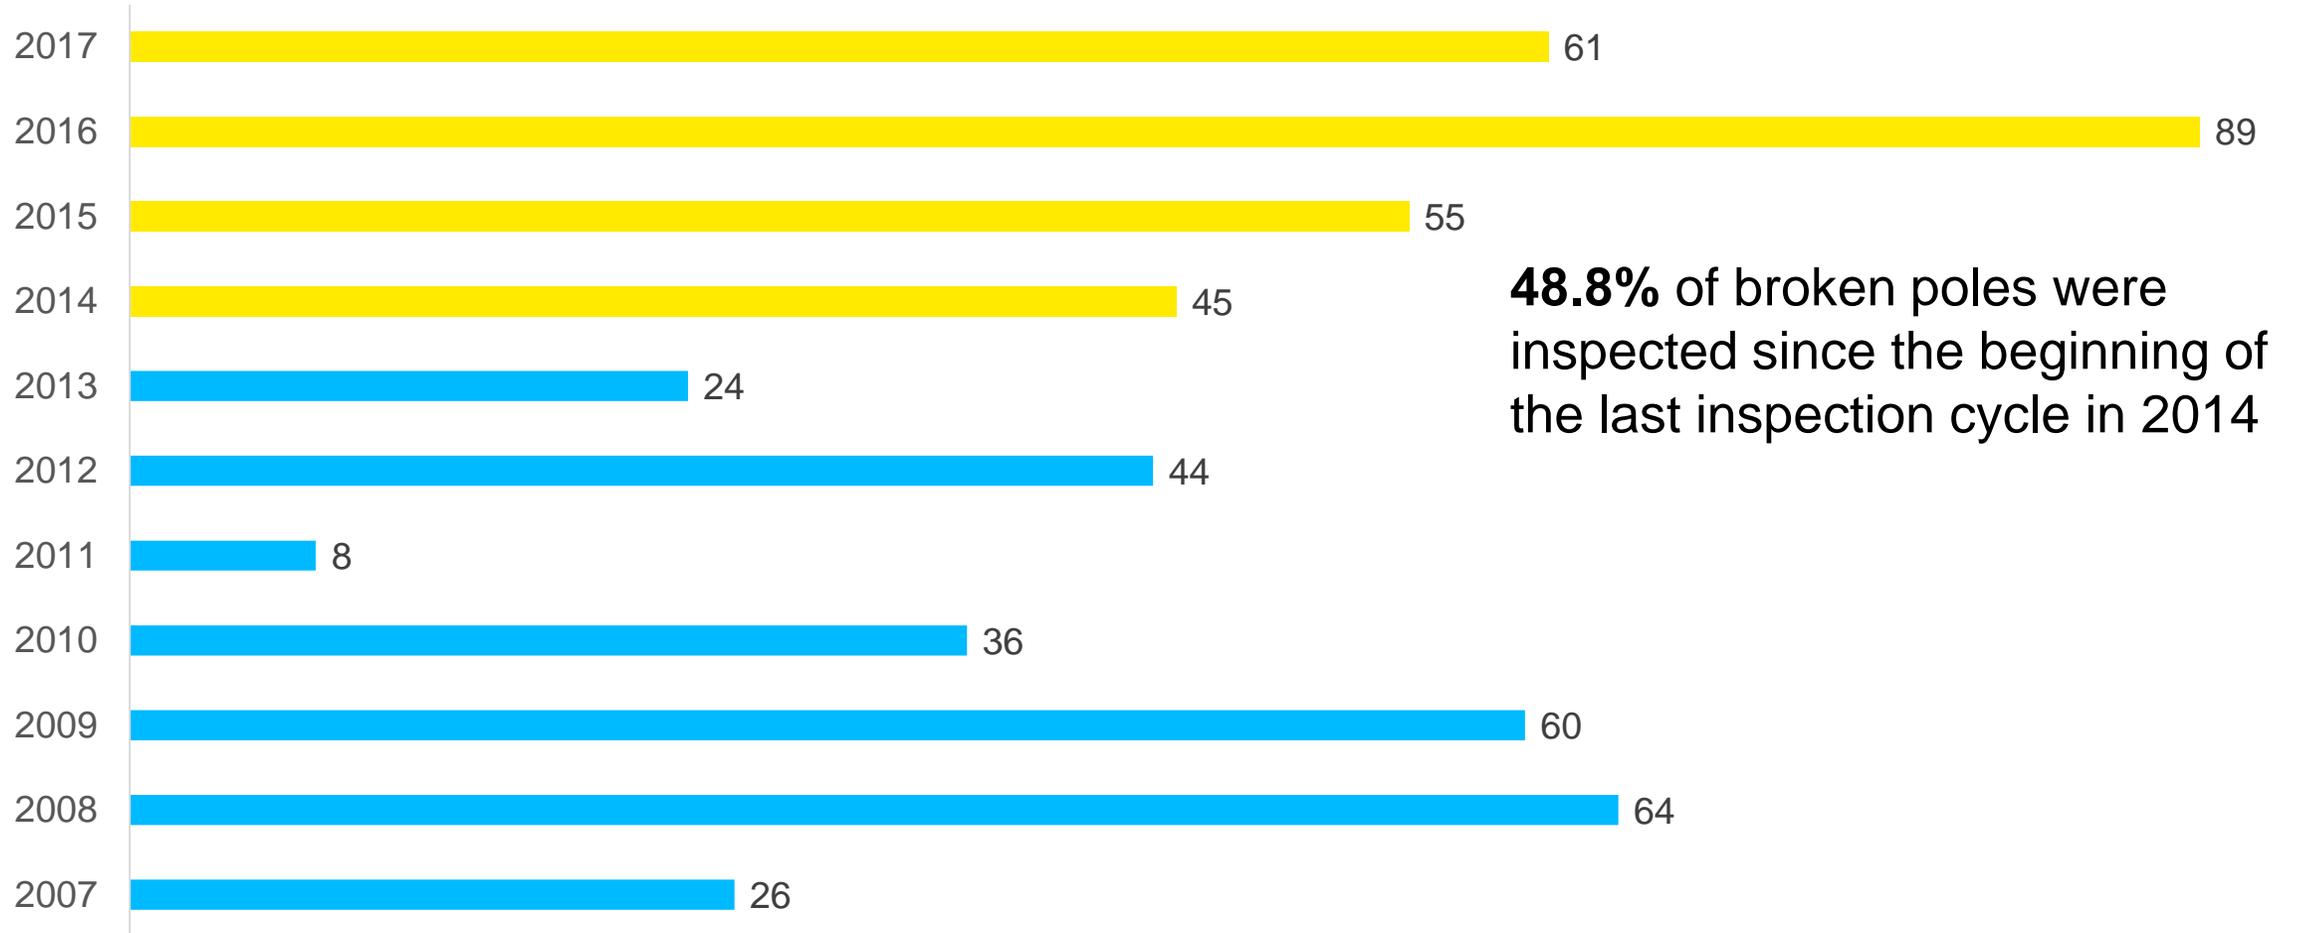
Total Broken Poles By Last Inspection Year

48.8% of broken poles were inspected since the beginning of the last inspection cycle in 2014

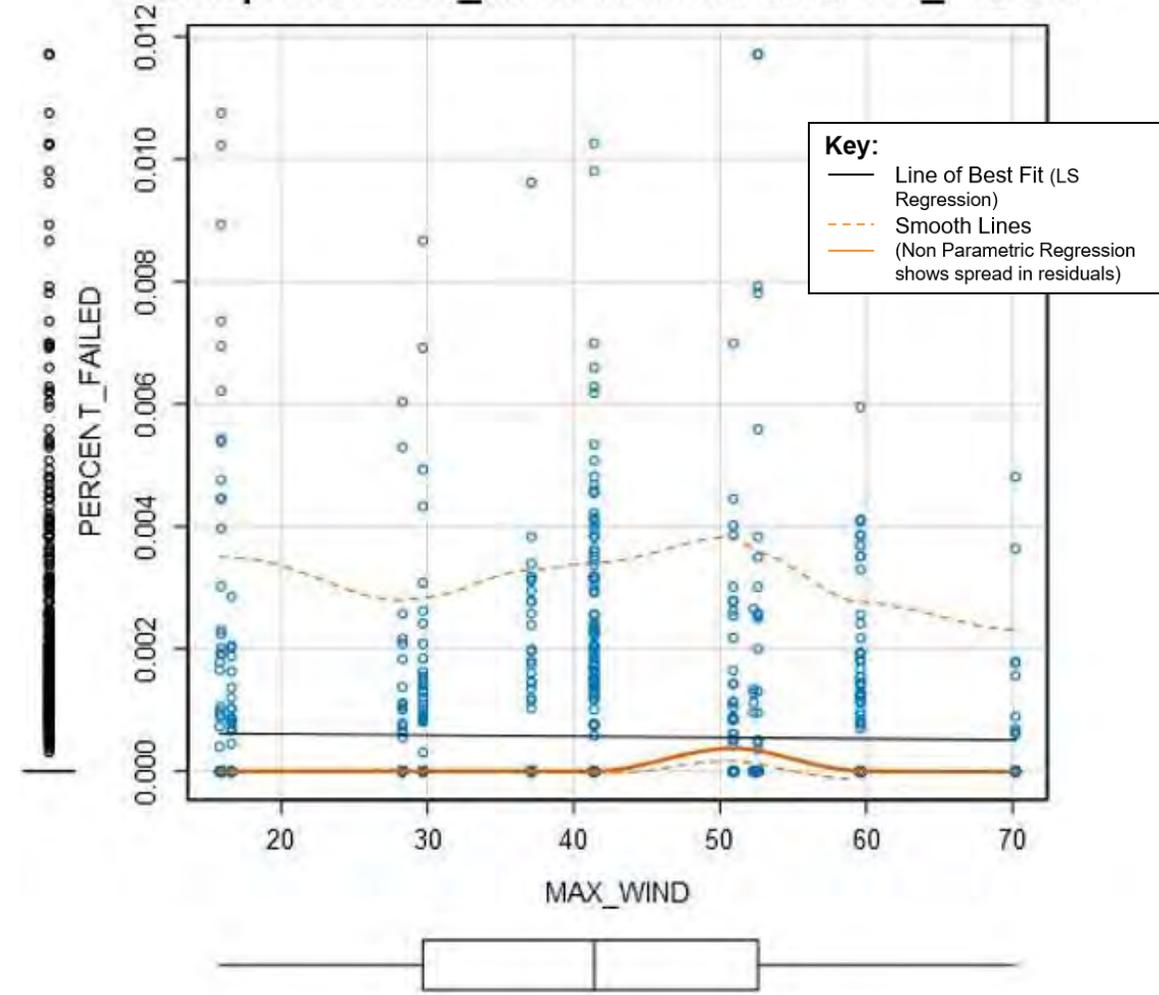
Scatterplot of MAX_WIND versus PERCENT_FAILED

- No statistically significant relationship between max wind experienced by a circuit and pole failure rate ($P = 0.44725 > 0.05$)
- Data suggests other factors contributed to distribution pole failure

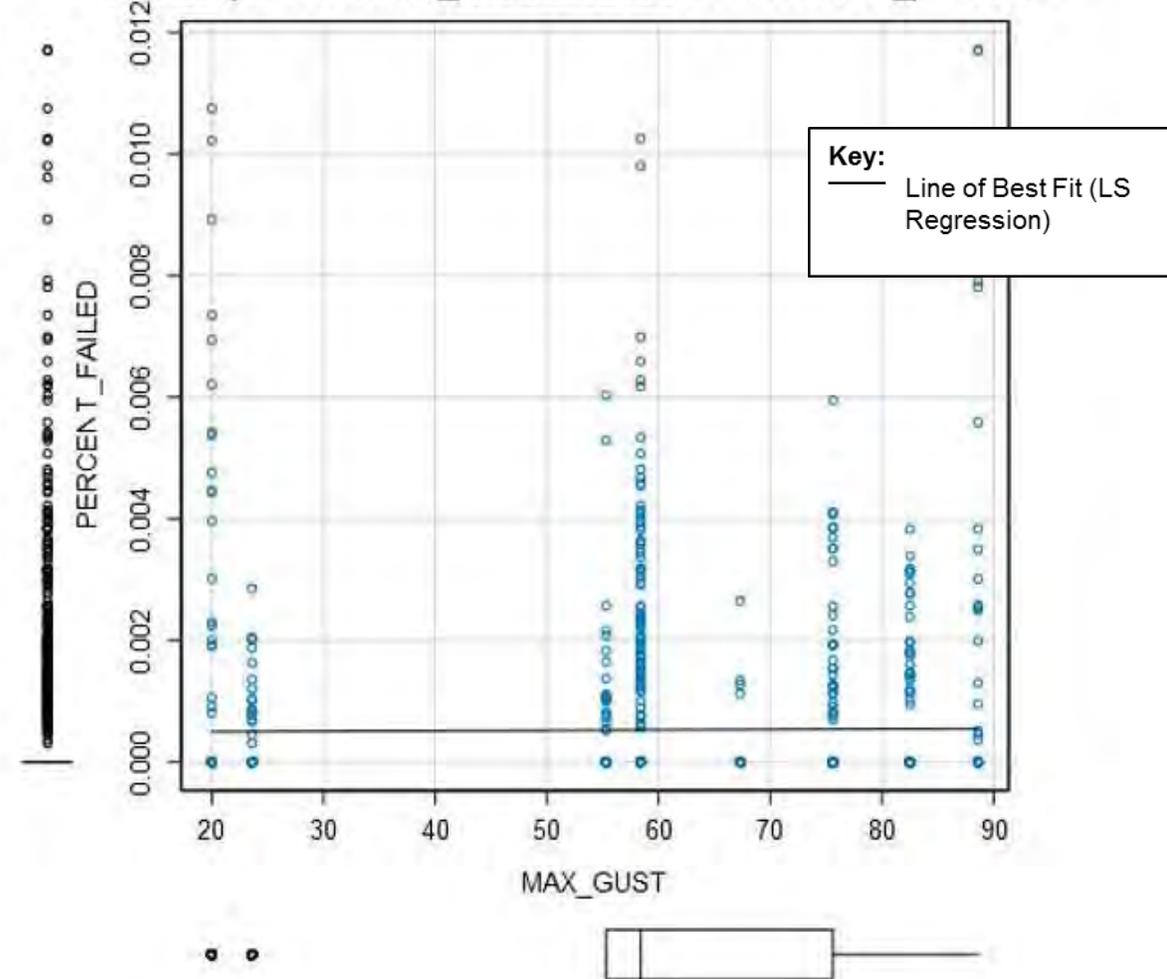
Scatterplot of MAX_GUST versus PERCENT_FAILED

- No statistically significant relationship between max gust experienced by a circuit and percent pole failure ($P = 0.71111 > 0.05$)
- Data suggests other factors contributed to distribution pole failure

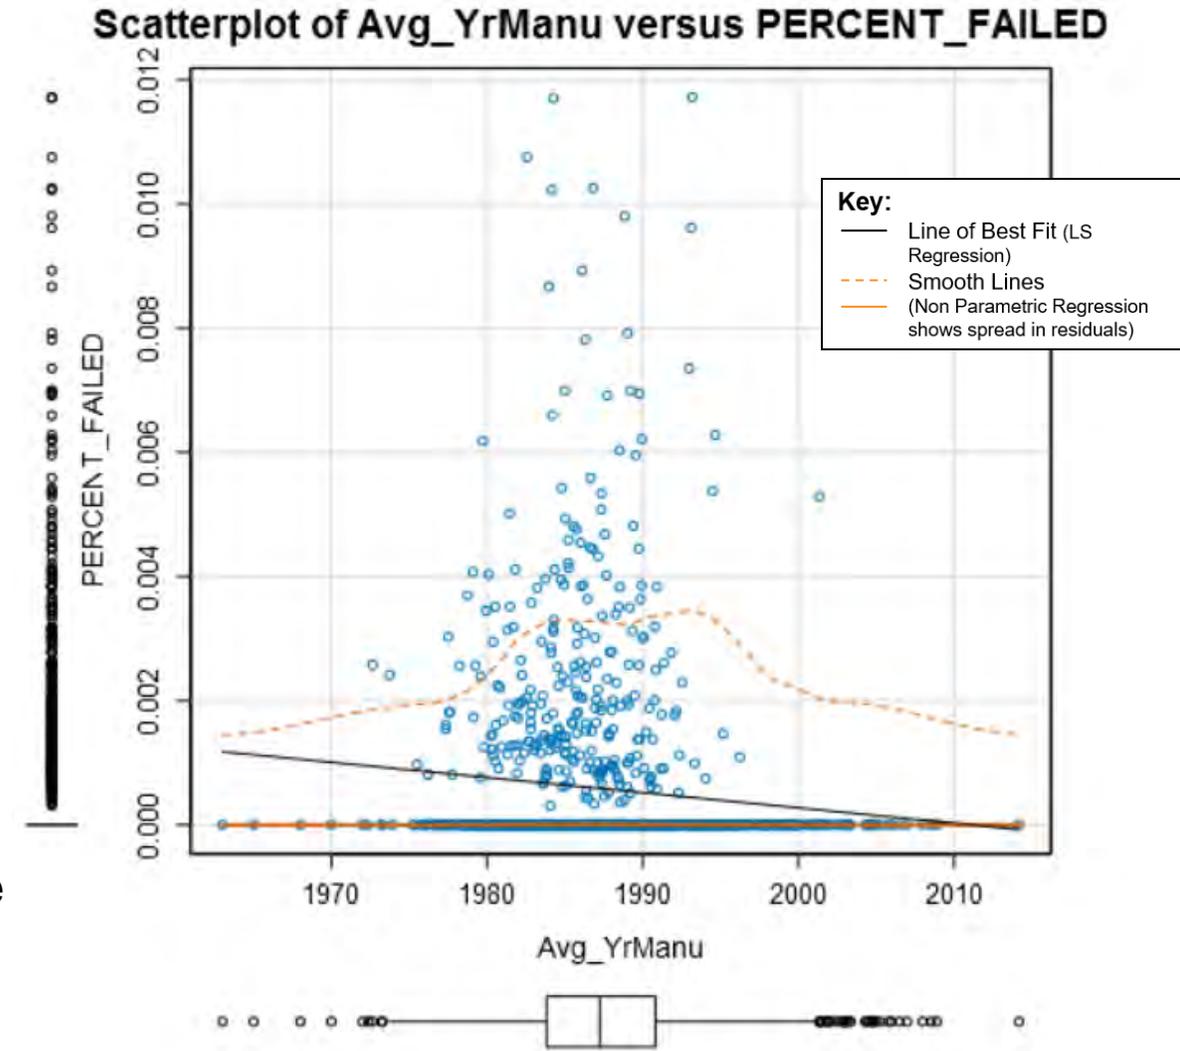
- There is a statistically significant relationship between average manufactured year of a circuit and percent pole failure. ($P = 0.0005 < 0.05$)
- Data suggests circuits with newer poles on average are associated with lower pole failure rates*.

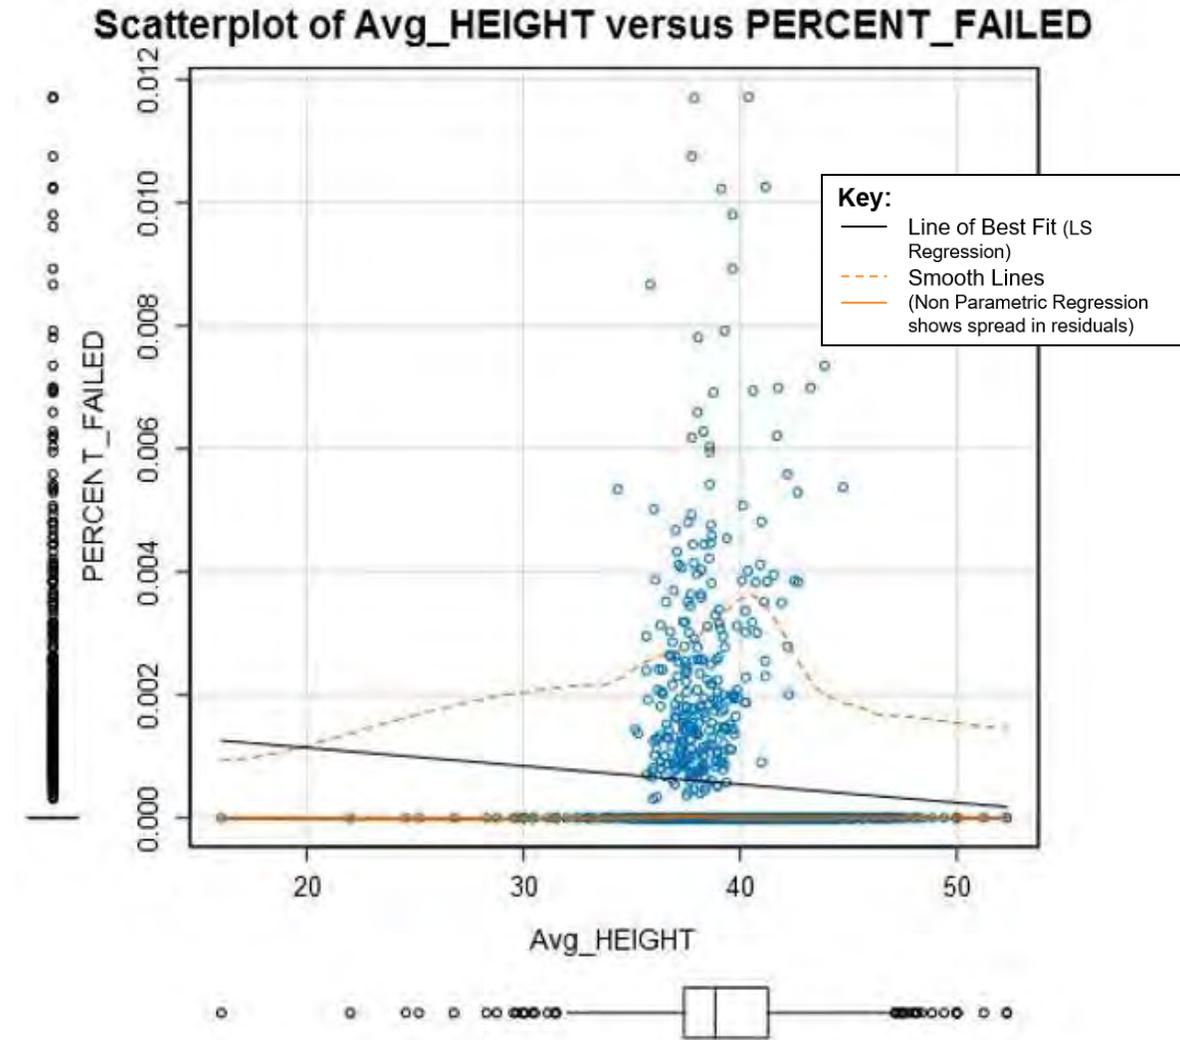
- There is a statistically significant relationship between average pole height of a circuit and percent pole failure. (P = 0.01267 < 0.05)
- Data suggests circuits with taller average pole heights are associated with lower pole failure rates.

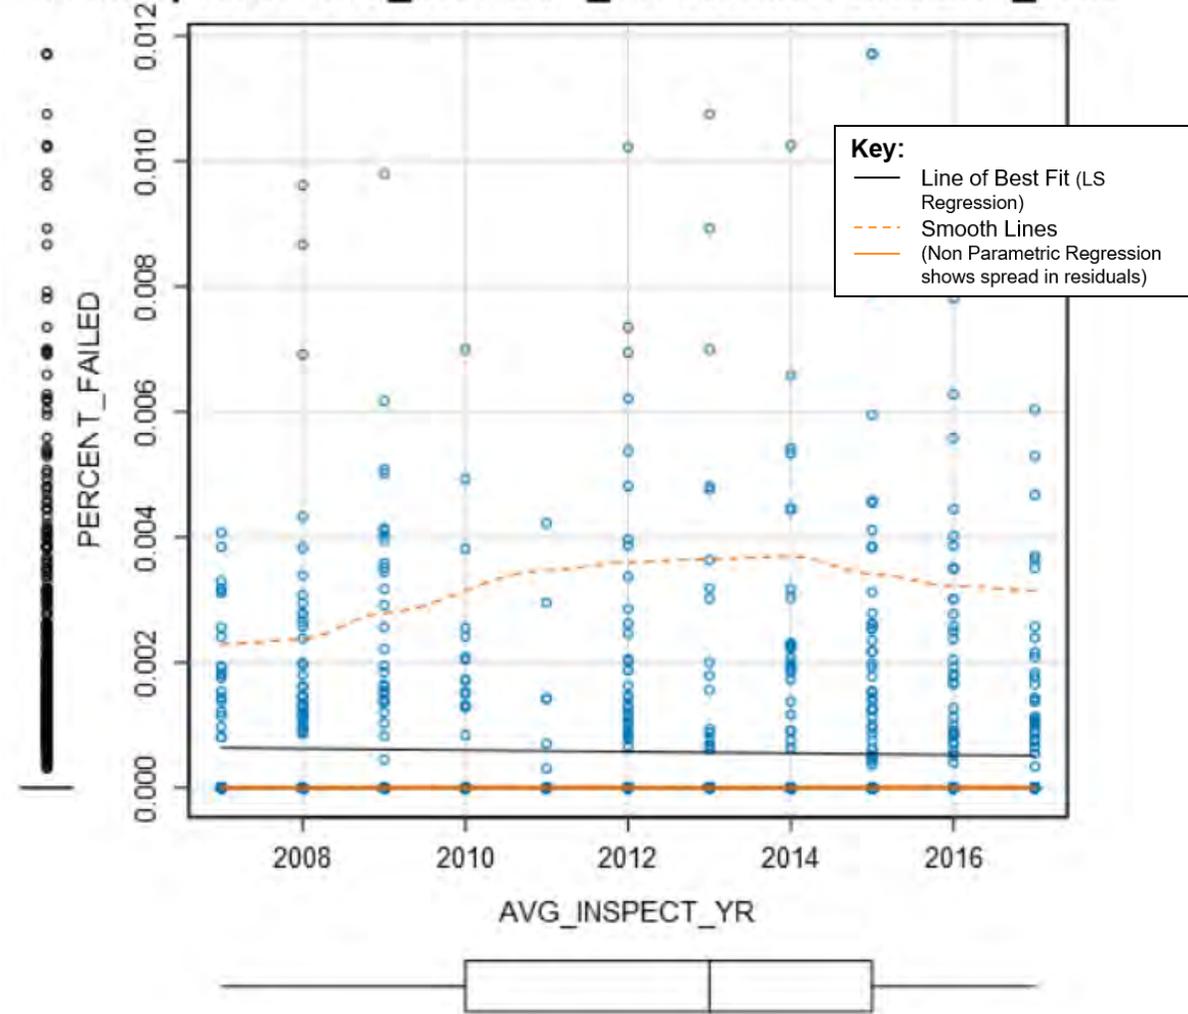
Scatterplot of AVG_INSPECT_YR versus PERCENT_FAIL

- No statistically significant relationship between average last inspection year of a circuit and percent pole failure ($P = 0.34264 > 0.05$)
- Data suggests other factors contributed to distribution pole failure

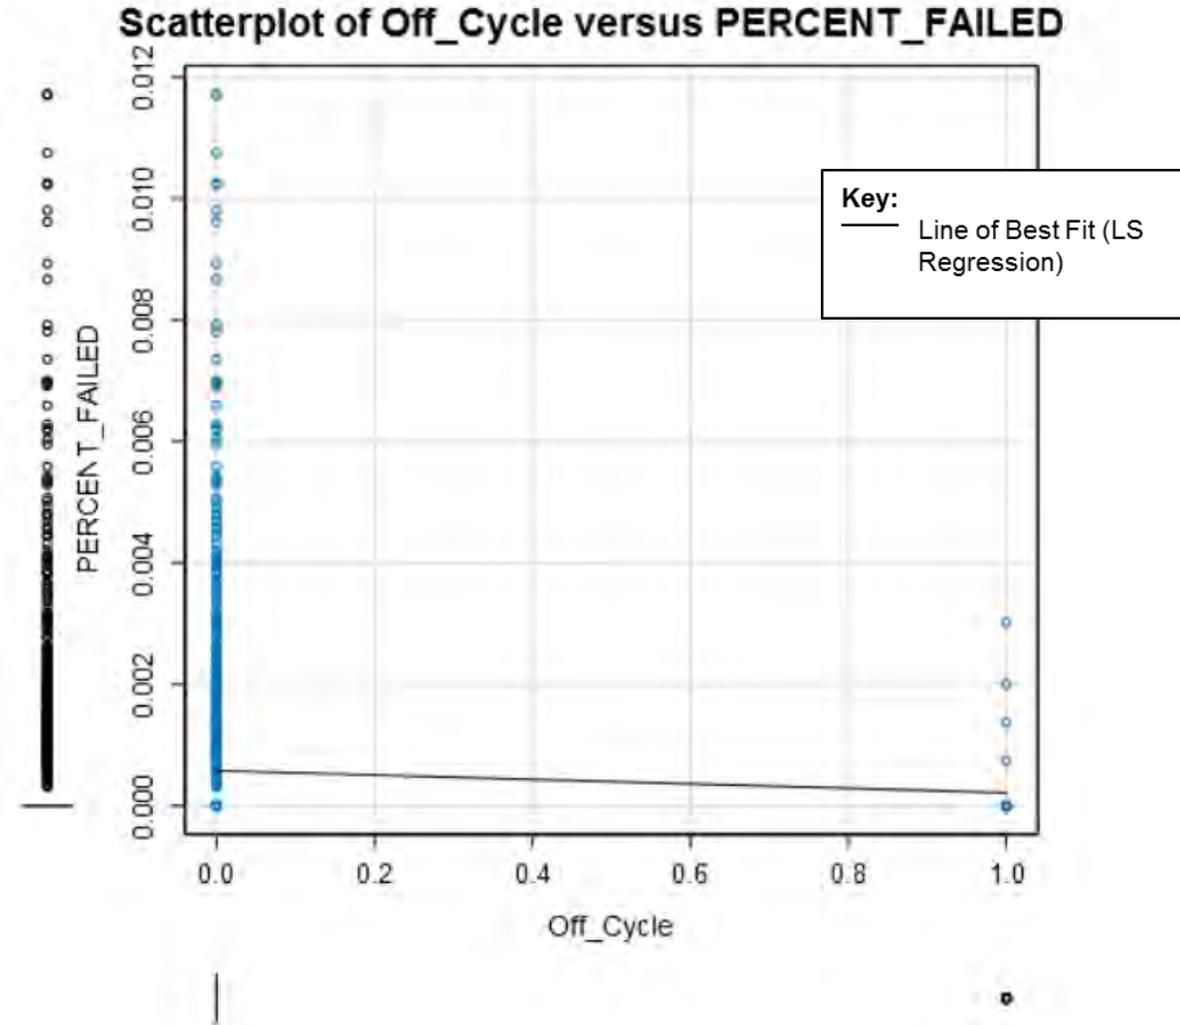
- No statistically significant relationship between whether or not the vegetation maintenance of a circuit is on cycle or off cycle and the percent pole failure. ($P = 0.157 > 0.05$)
- Data suggests other factors contributed to distribution pole failure.

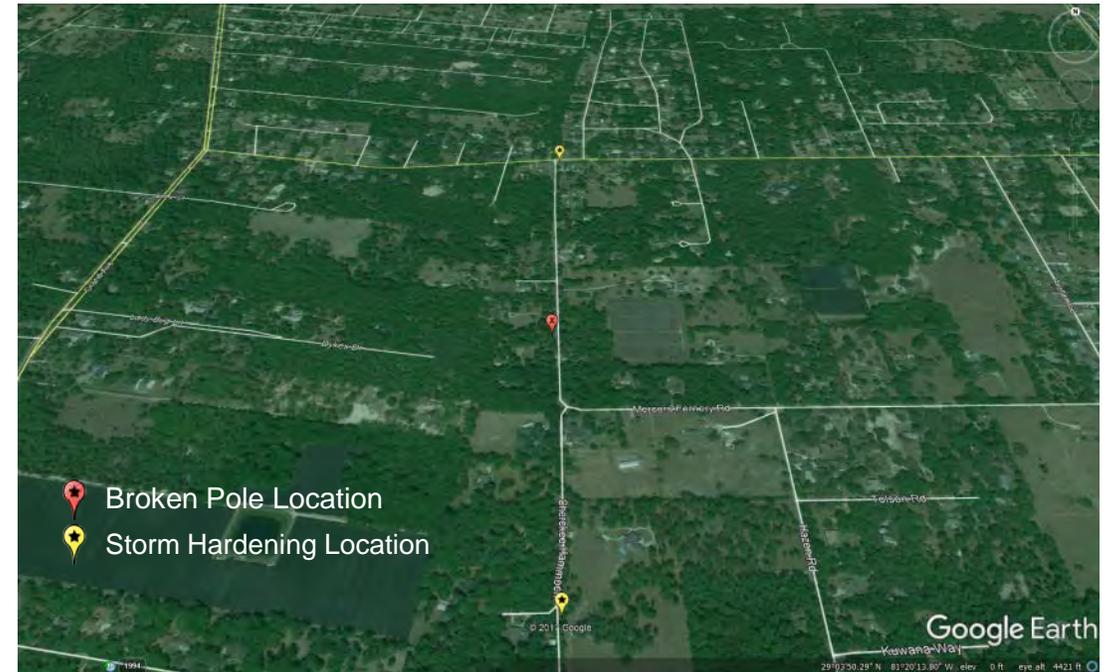
North Central - Mercers Fernery Rd

- A forensic assessment of five hundred twenty-six (526) randomly selected poles was made across DEF's total broken pole population. None of these poles were a part of the 29 Storm Hardening projects.
- A separate assessment of twenty-nine (29) randomly selected Storm Hardening projects was made. No broken poles were identified.
- Initial findings led the team to believe there was one pole that failed in the North Central Zone, Mercers Fernery Rd storm hardening project, but further analysis showed it was not a part of the project
