St. Lucie 1 Generator Ground Fault Analysis

July 11th 2019

St. Lucie Unit 1 Generator Ground Fault

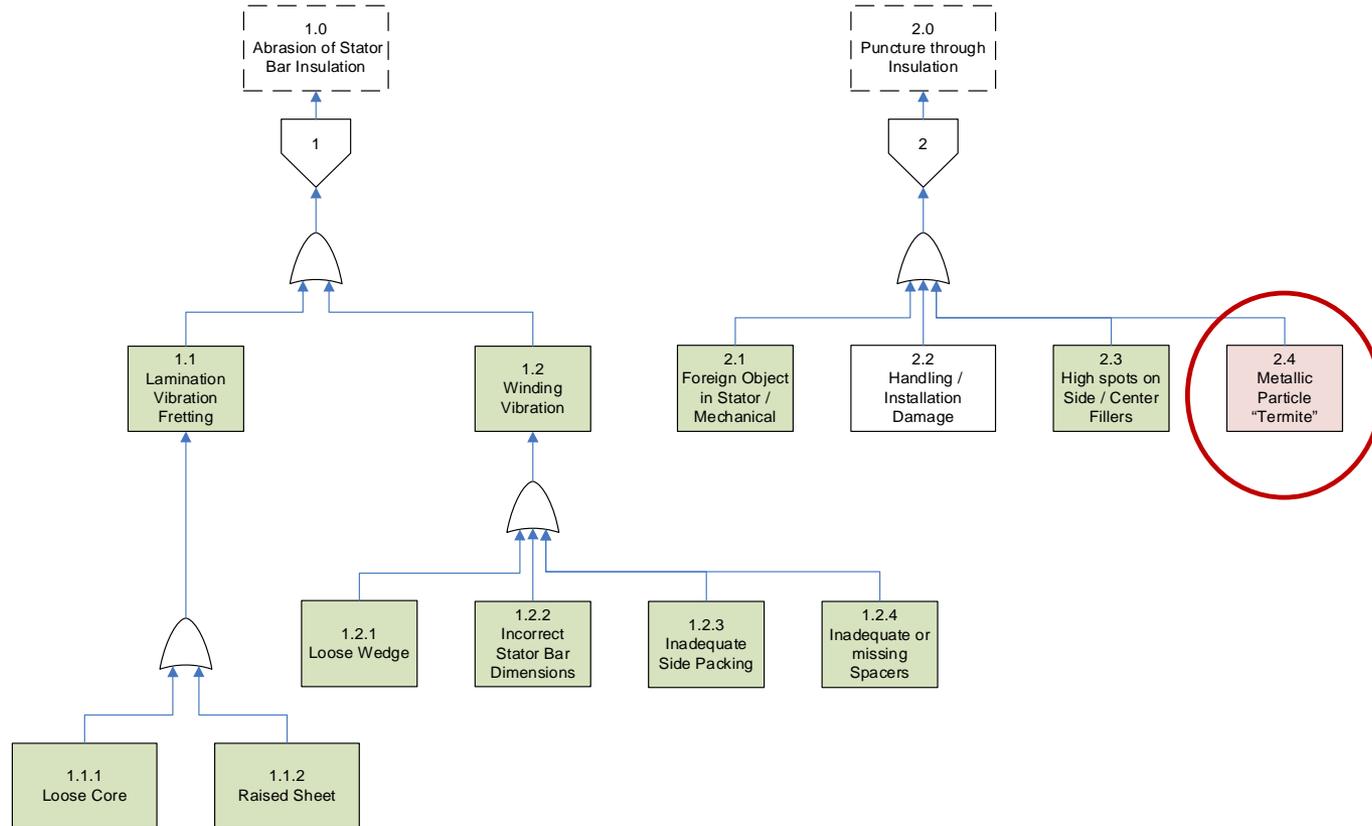
By Elimination of possible failure modes the most probable and verified by 3rd party consultant is a “Magnetic Termite”

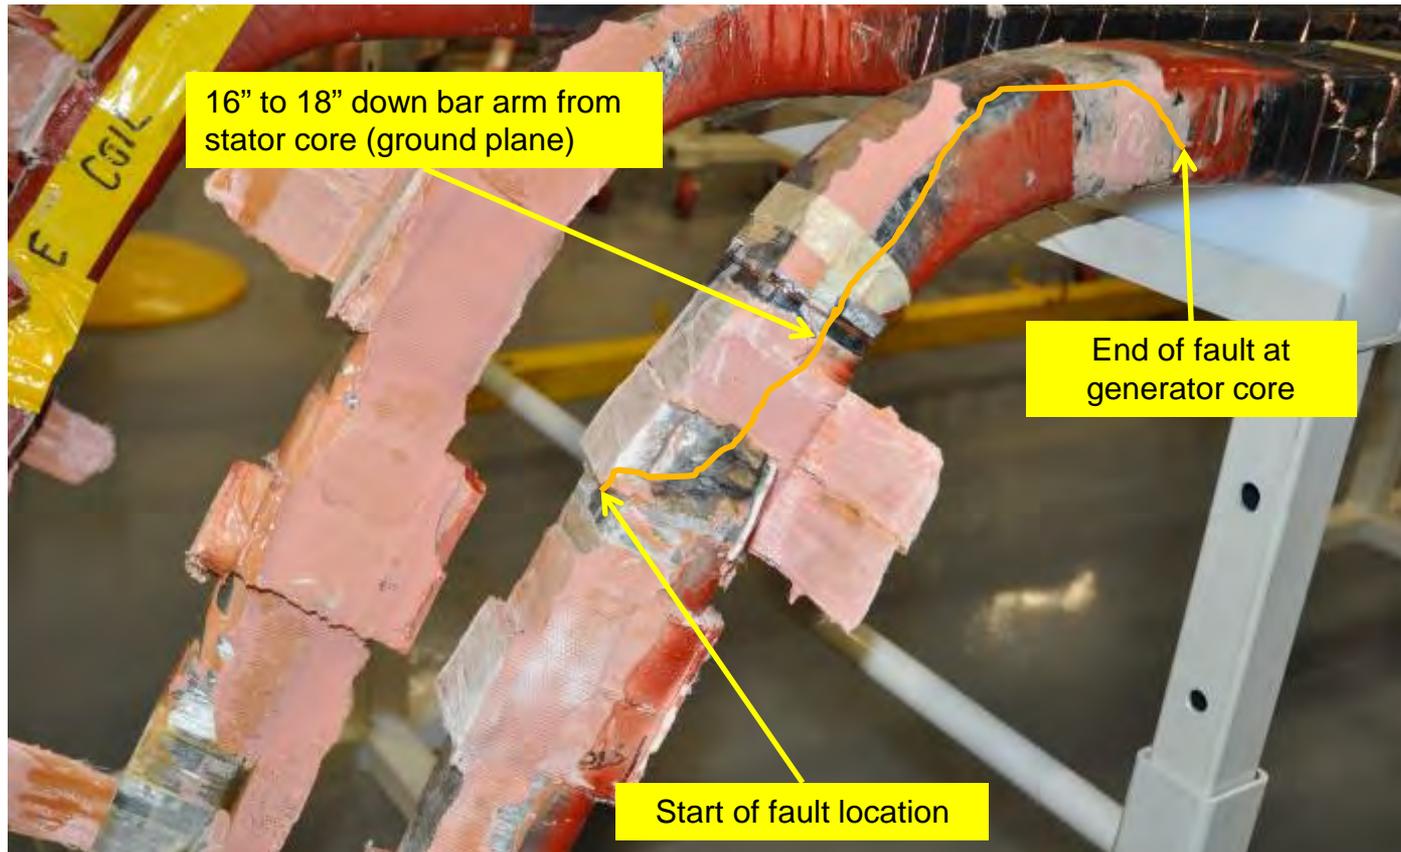
Fault Initiation at Endwinding Leading to Core Finger Plate

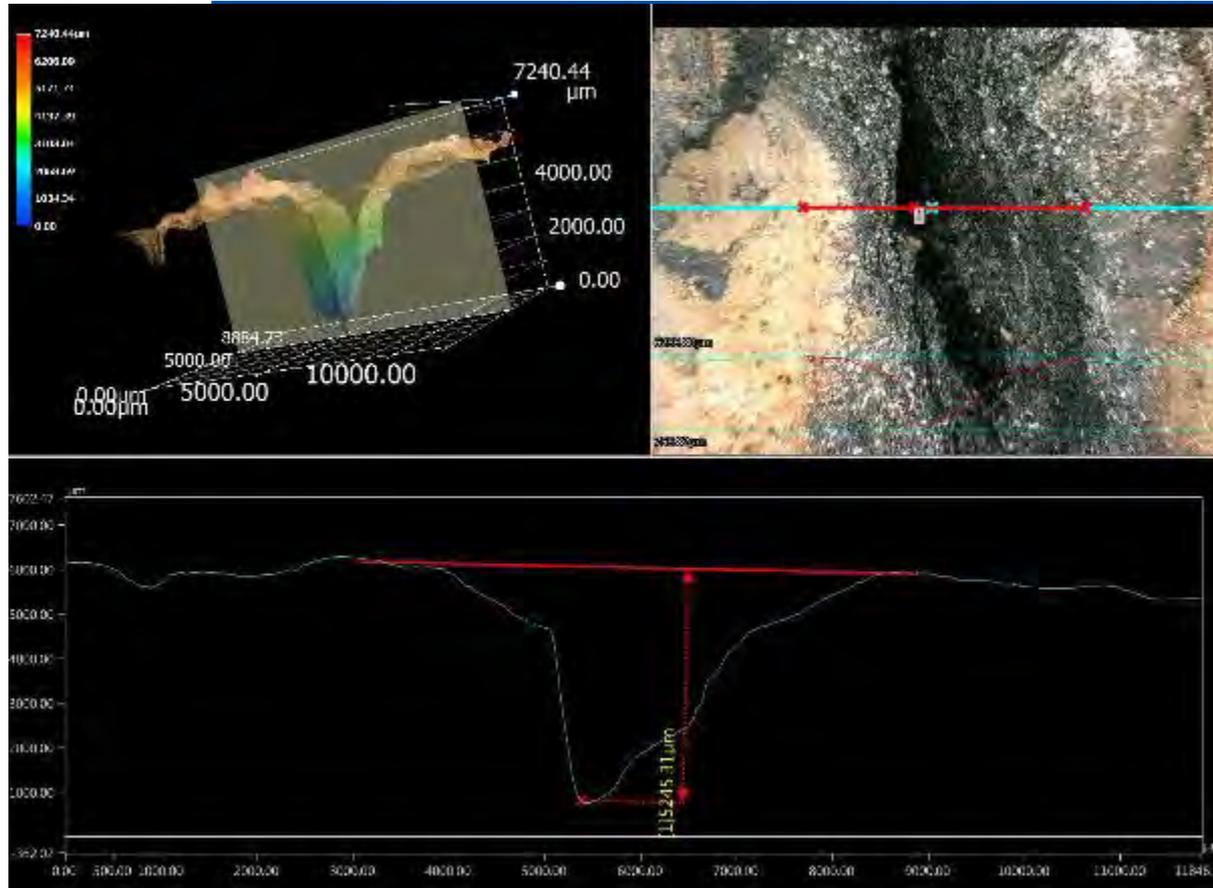
Failure straight down through insulation system

Failure mode characteristics of a Magnetic termite – 2.4 on refute matrix

**Failure mode characteristics of a “Magnetic Termite” – 2.4 on fault tree
Magnetic Termite relatively long term failure mode**

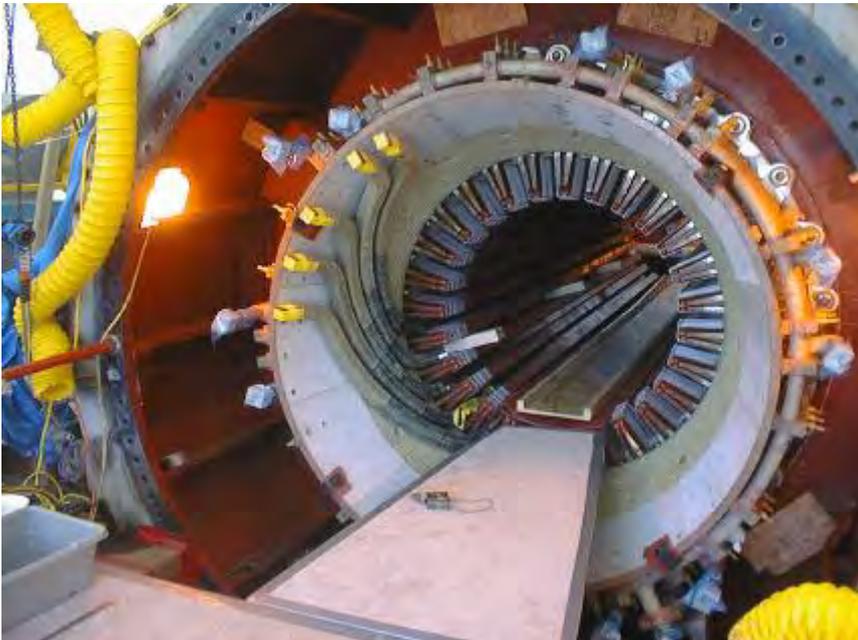
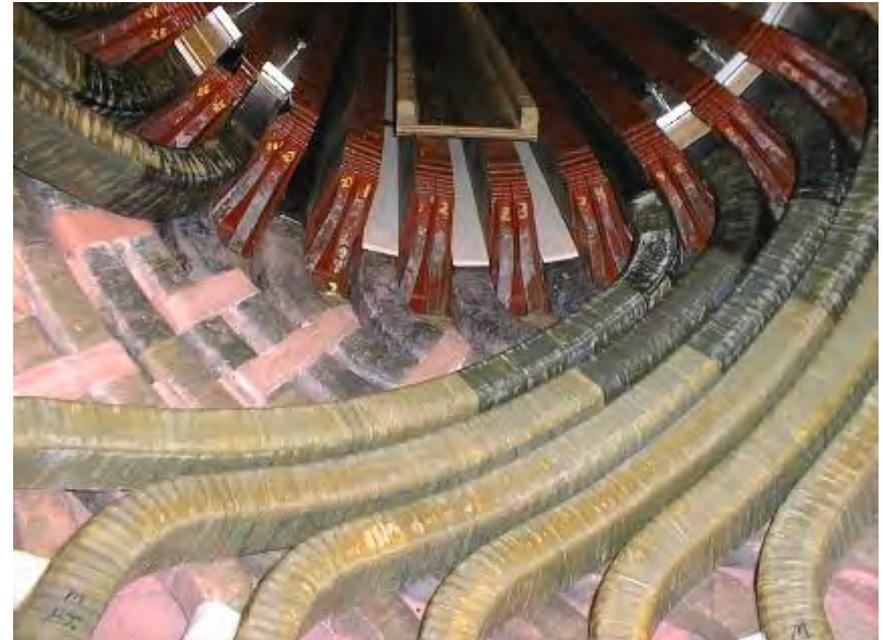
Inspection of bottom bars is extremely difficult

This is a Sanford STG which has the same endwinding support design as PSL-1

There is no practical method to inspect many areas of the winding for 'termite' activity, most of which may be under the top layer of the bar and thus invisible even if it was possible to inspect the whole winding

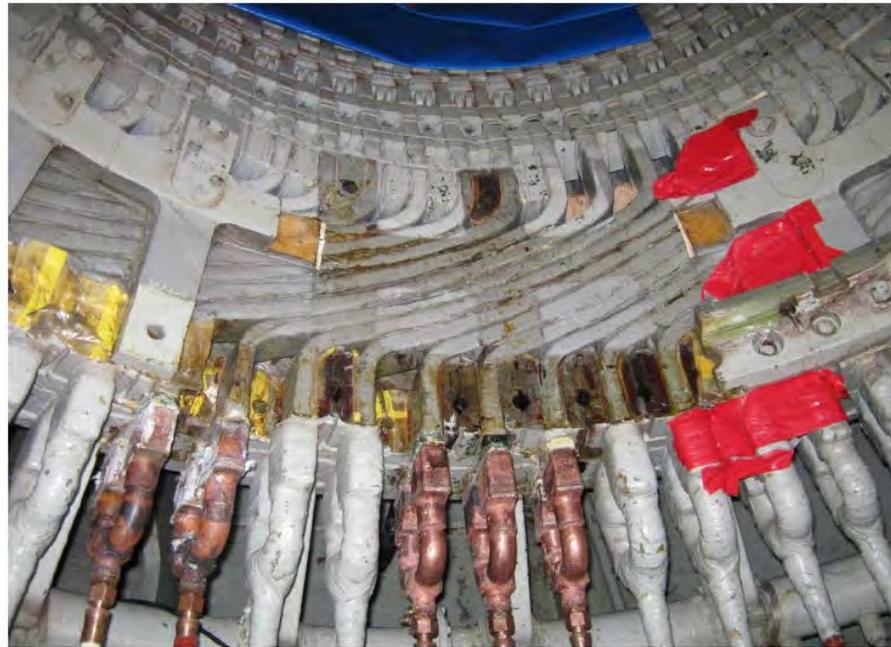
Fan baffle and cruciform removed

Failure under end winding supports similar to St. Lucie Unit 1

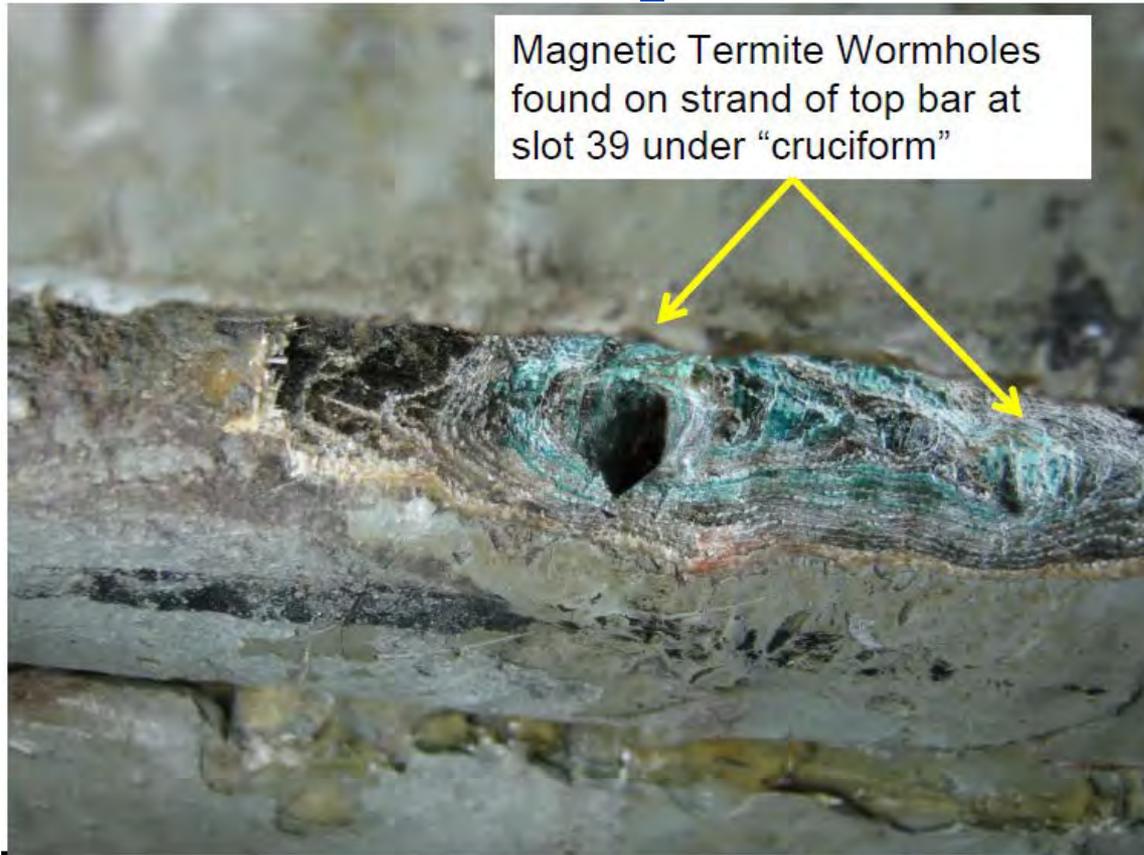
Failure opening in insulation similar to St. Lucie Unit 1

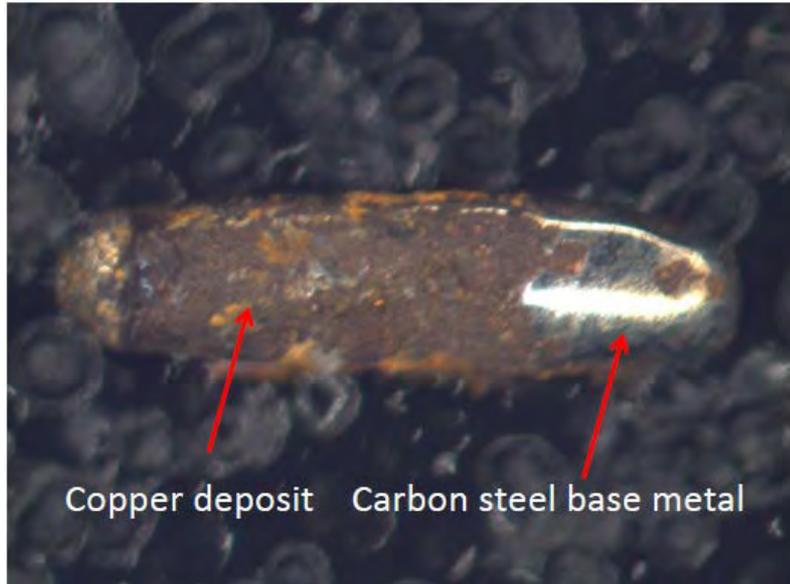
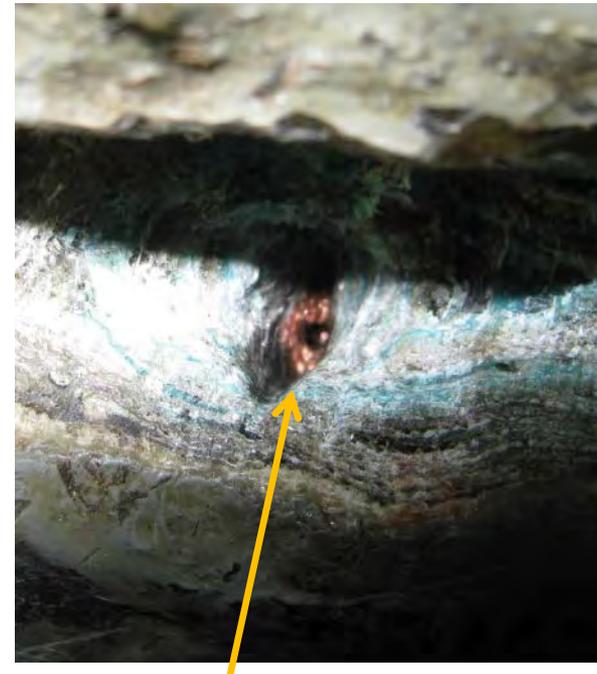
Particle is approx. 2.39 X 0.613 mm

Magnetic Termite – worm hole

Failure opening in insulation similar to St. Lucie Unit 1 but, since there was no electrical fault, the particle was recovered

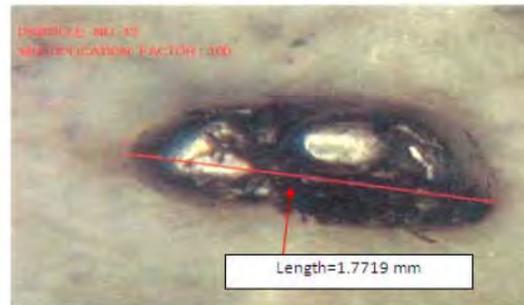
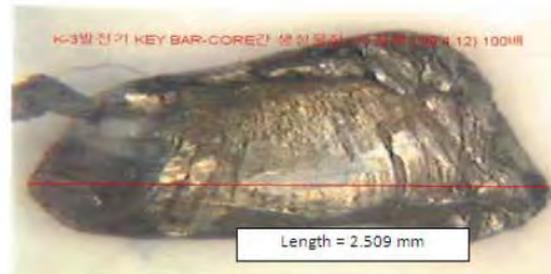
Termites found at Kori

Particles from KoRi generator [lo carbon steel]

Magnetic termites failure mode documentation

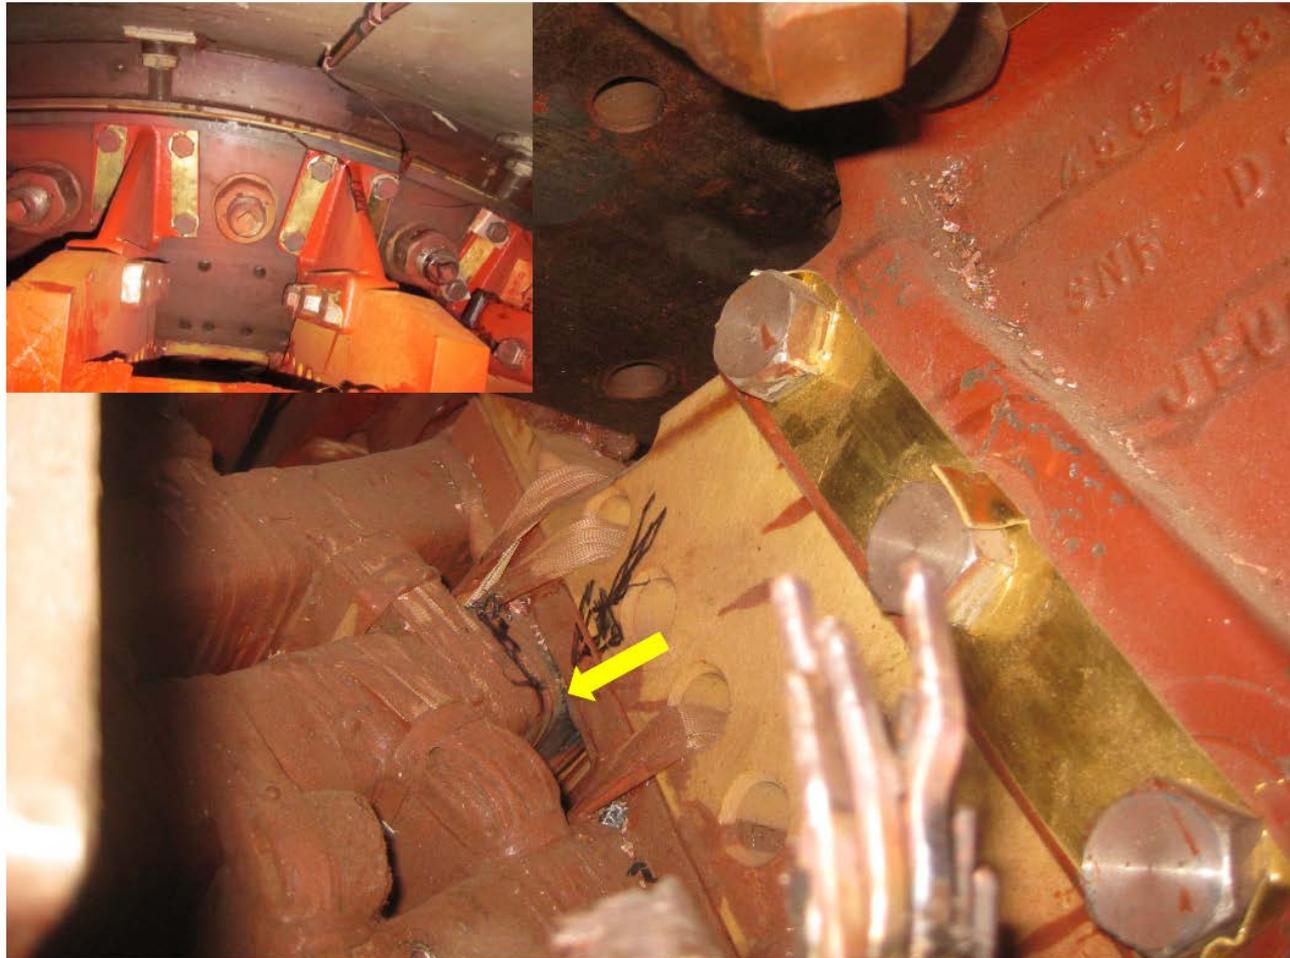
Bottom bar failure

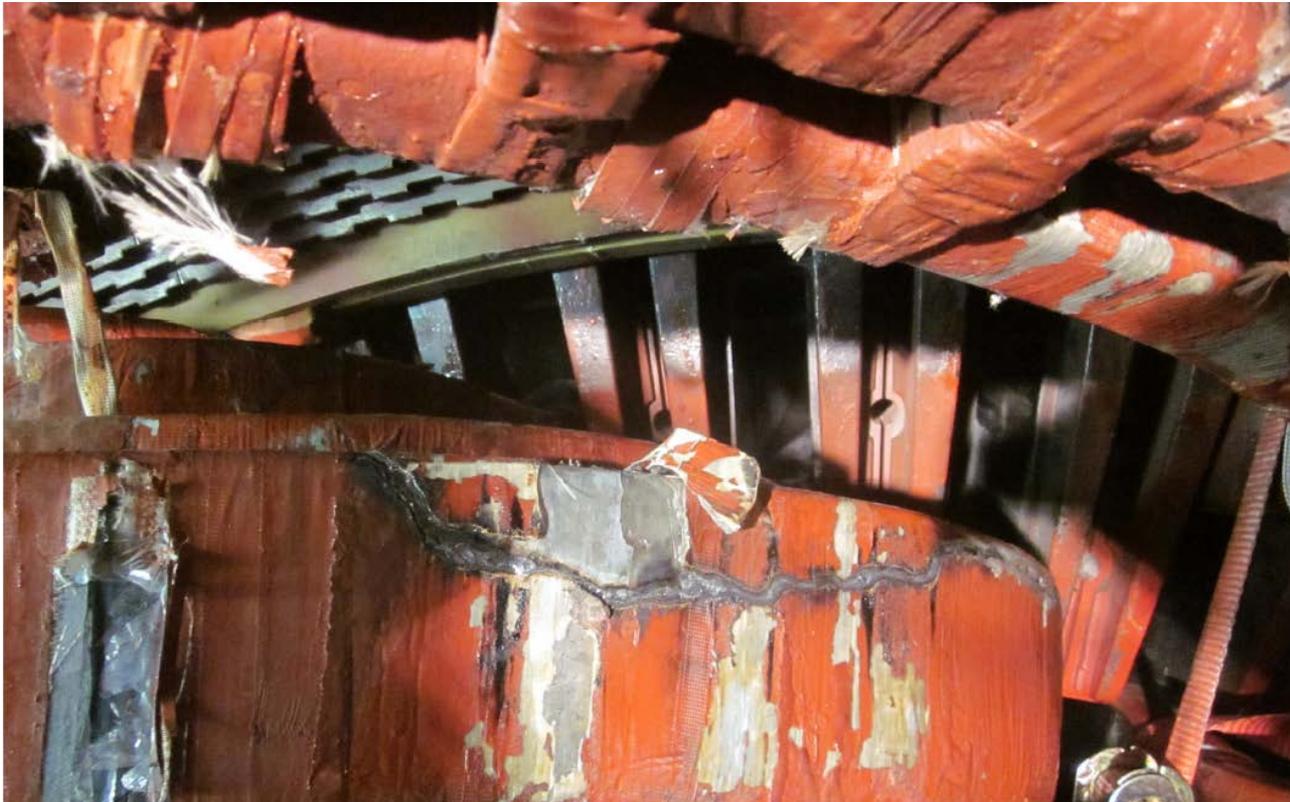
Failure mode identical to St. Lucie Unit 1 – tracking from insulation opening to ground over stator bar insulation

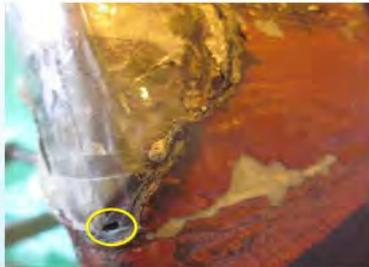
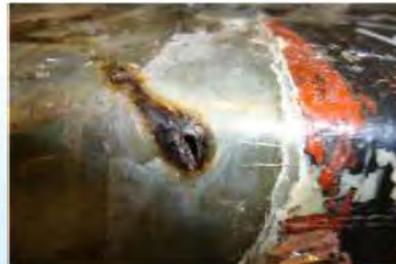
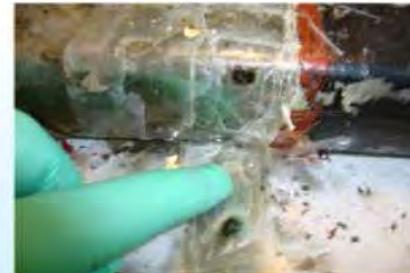
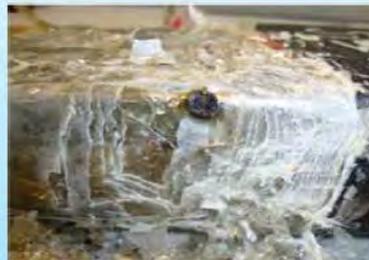
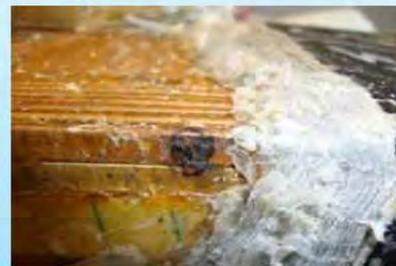
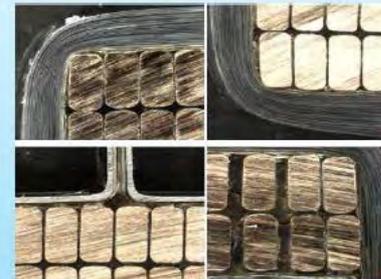
- General condition of insulation good given the age of the machine (37Y)
- Correct alignment and impregnation of insulation layers
- Breakdown channel goes straight through insulation layers
- No traces of partial discharge activity between insulation layers
- No foreign materials found

Exact failure mode as St. Lucie Unit 1

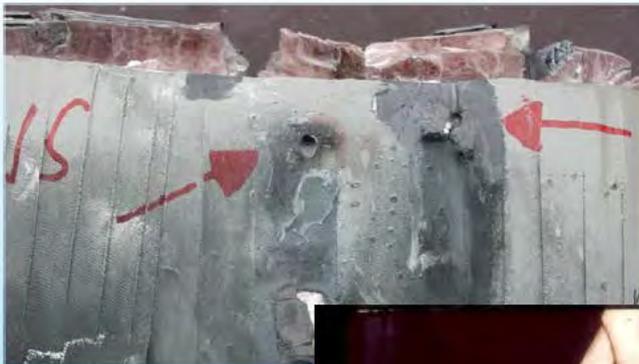
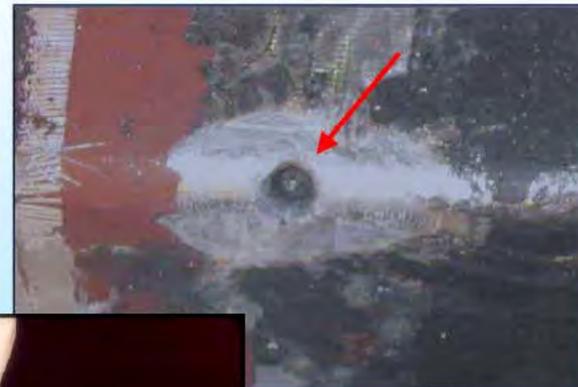
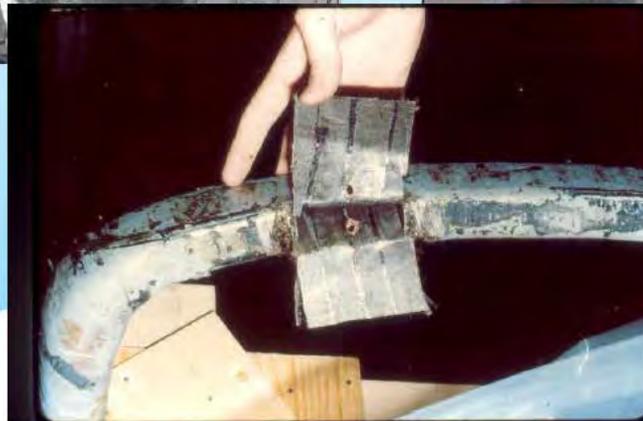
- Other examples of insulation failure caused by magnetic termites

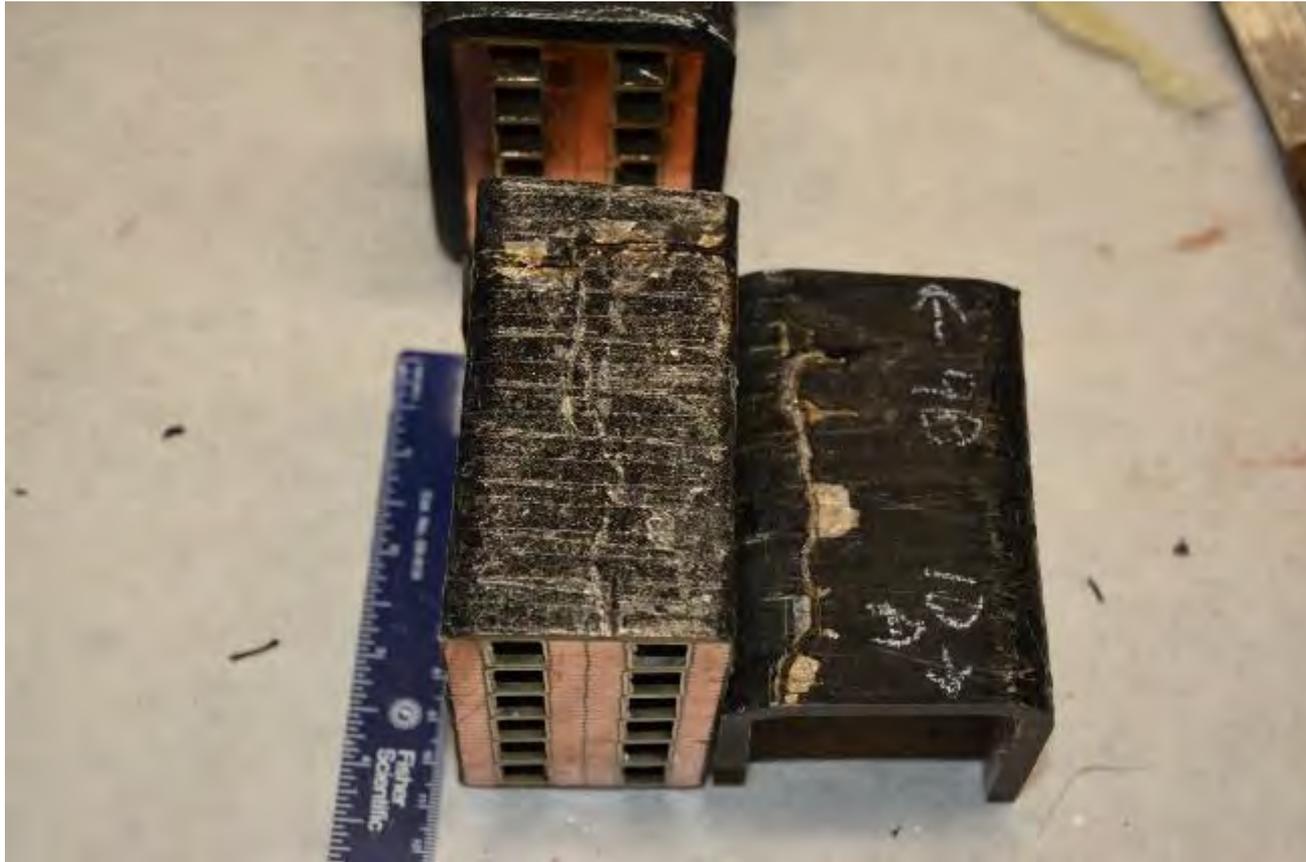
Separated insulation from ICP layer – Forensic process evaluating specimen for failure mode – none NOTED AT THIS TIME

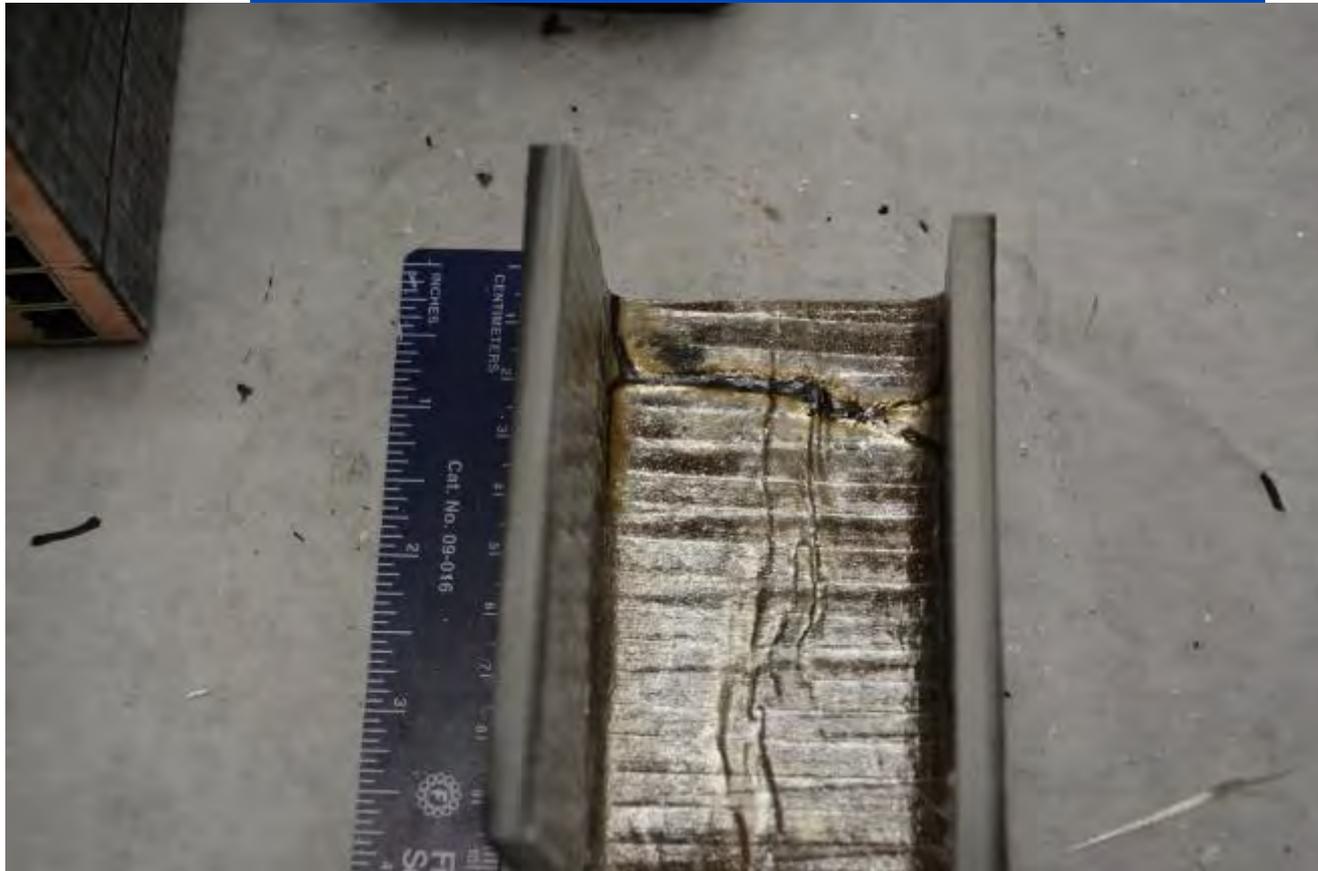
FAULT OPENING STRAIGHT DOWN DID NOT FOLLOW TAPE EDGS AS A NORMAL FAILURE MODE WOULD

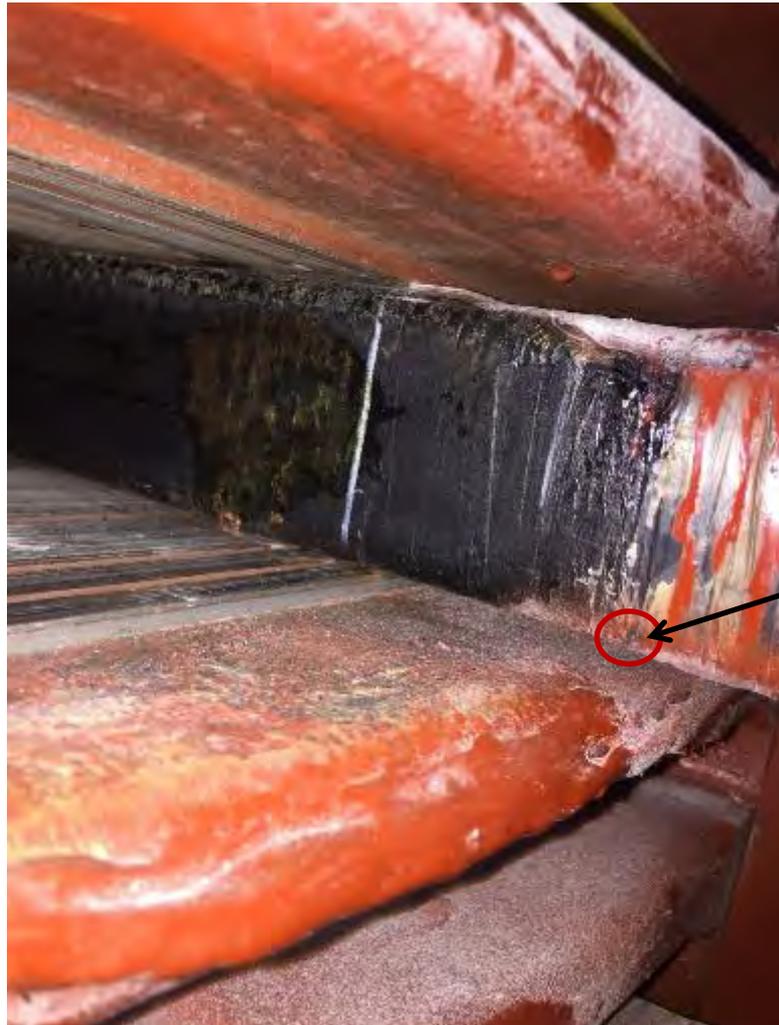
Discharge
site to ground
– Stator Core
Finger Plate

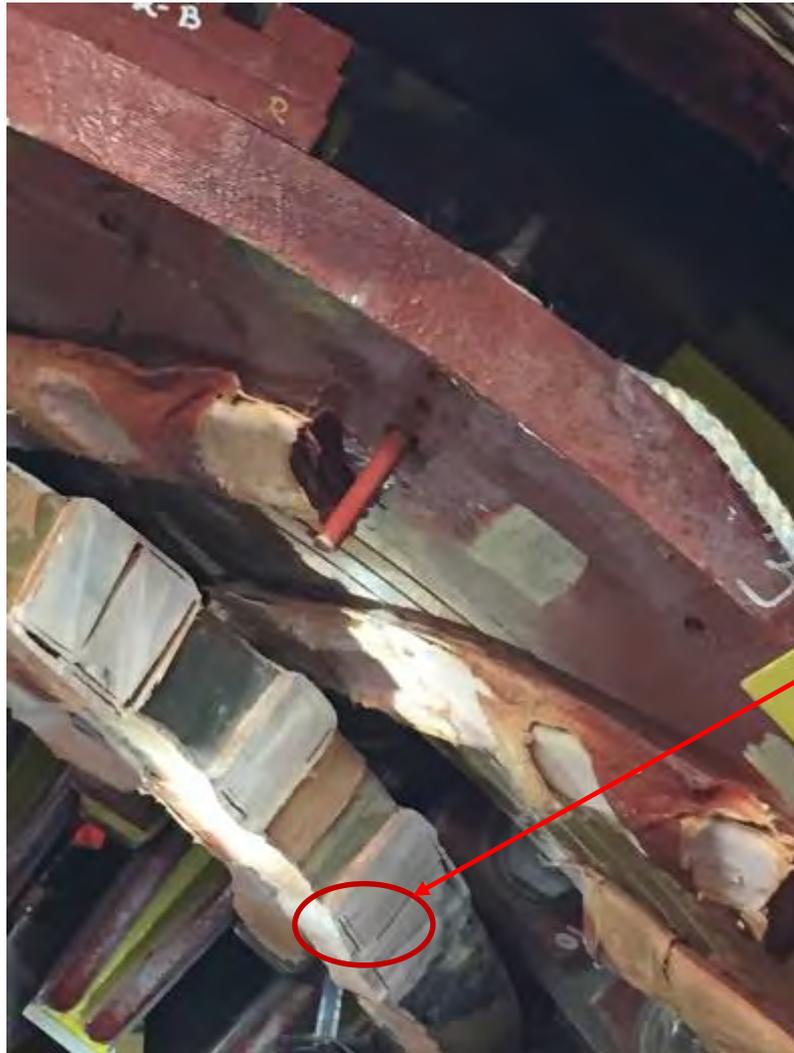
Extraction of Bottom
Bar 17 - Fault location
under blocking
Hidden from view by
blocking
