Power Delivery Performance

Hurricane Dorian

Storm Date: September 3, 2019

Report Date: May 8, 2020

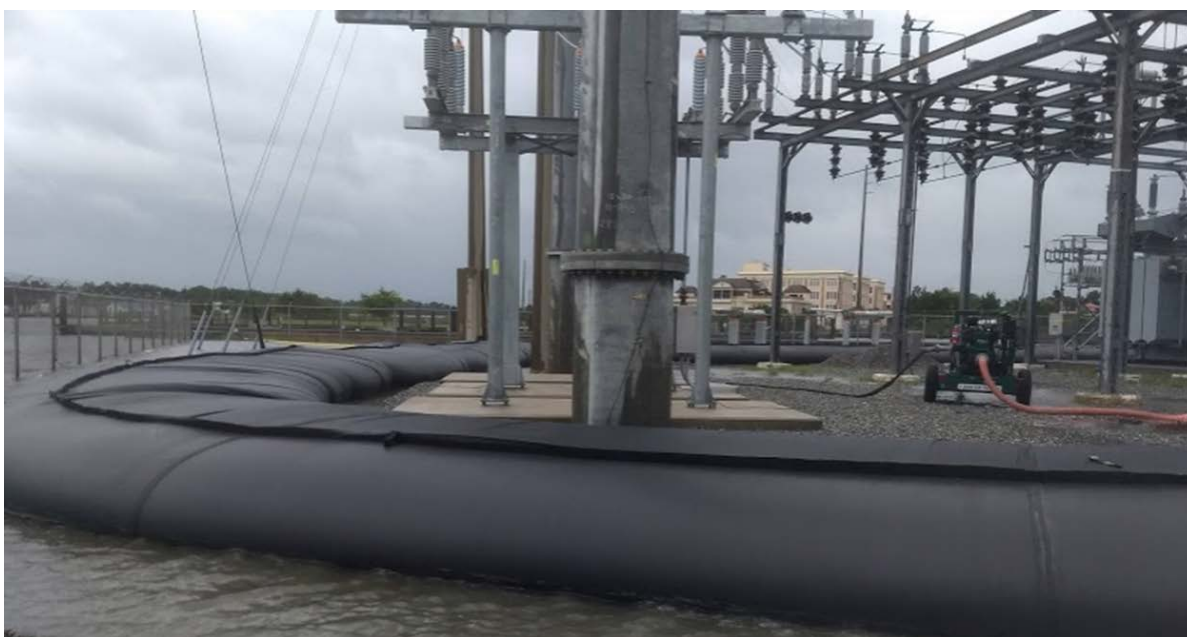
The AquaDam installed for Dorian prevented storm surge from entering yard.

AquaDam held back storm surge and an interior pump kept rain from accumulating

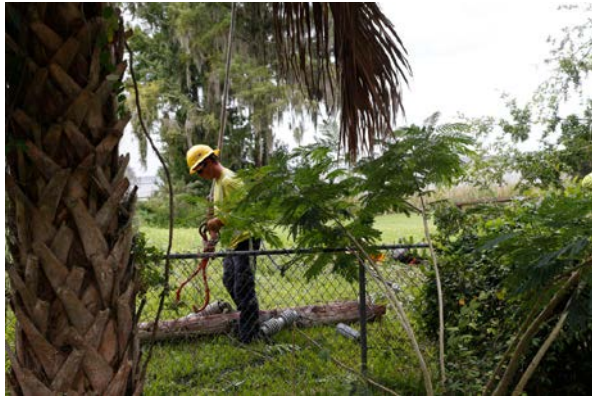
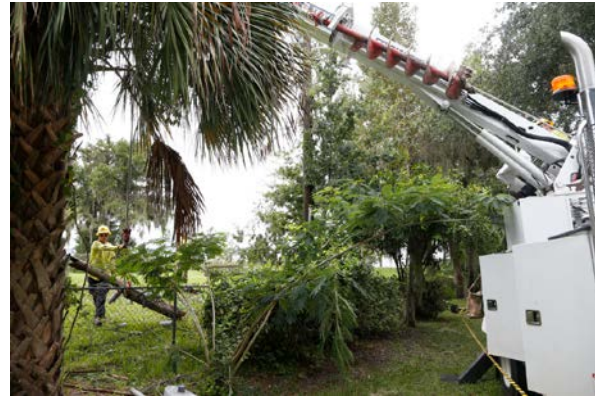
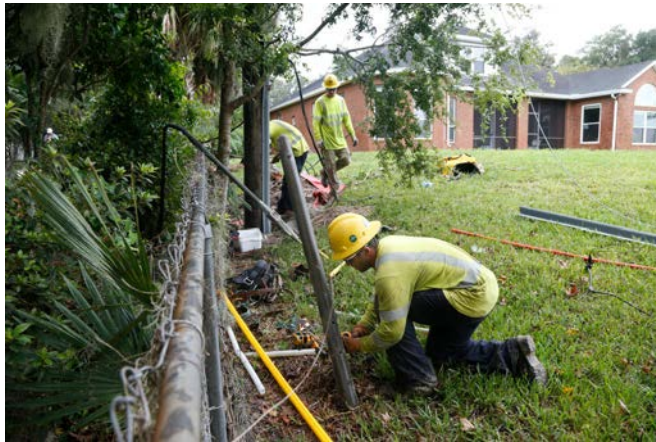
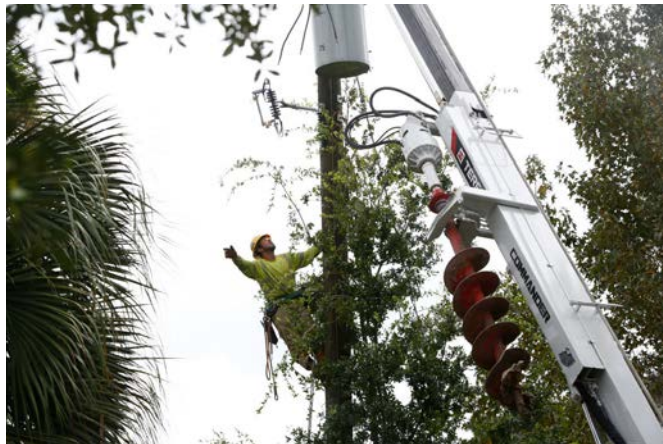
- FPL
- No cause identified (Other)
- No Ticket information (Pictures from Crew)
- St. Augustine on 9/4/19

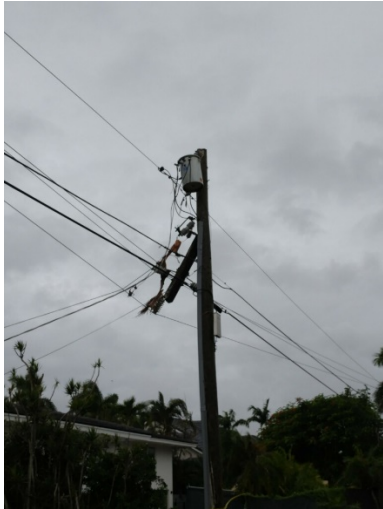
- FPL
- Vegetation (Palm Frond) wrapped around stinger and caused a pole fire
- TT# 247
- NB / Fashion / 704463 (Pompano / Ft.Lauderdale)

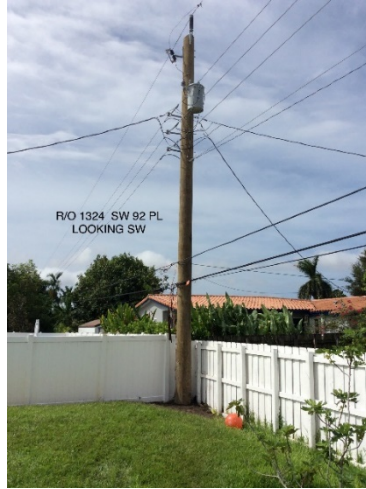
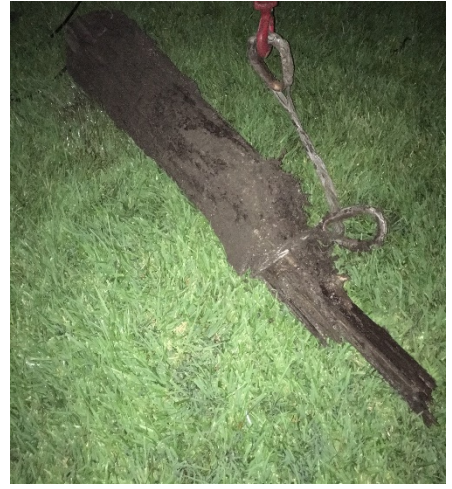
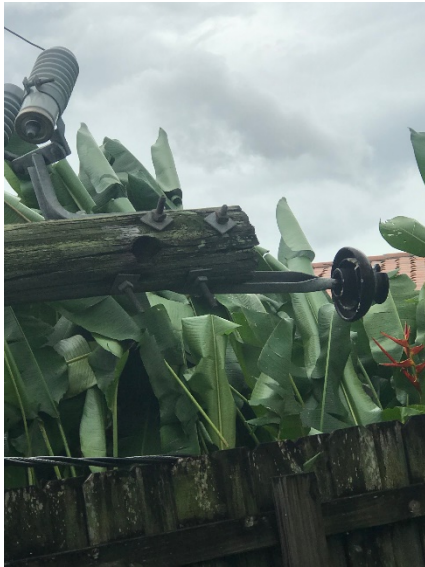
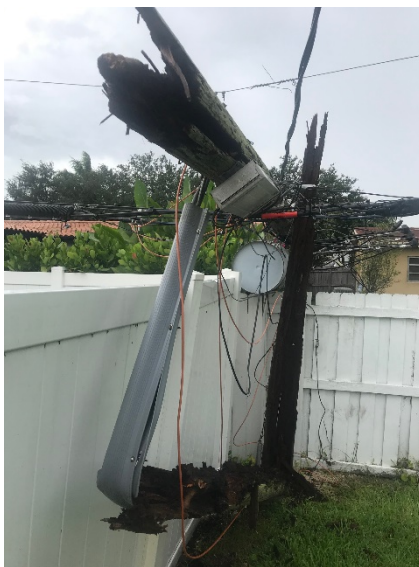
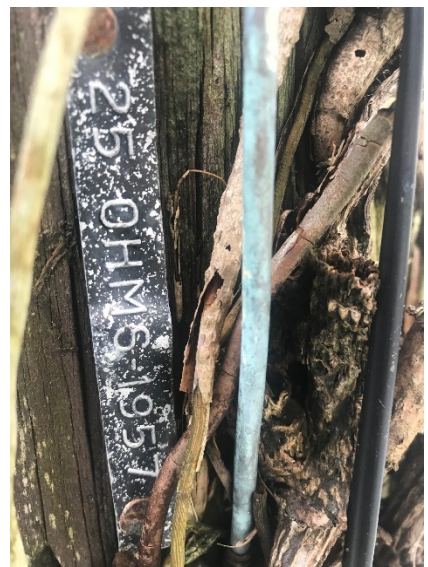
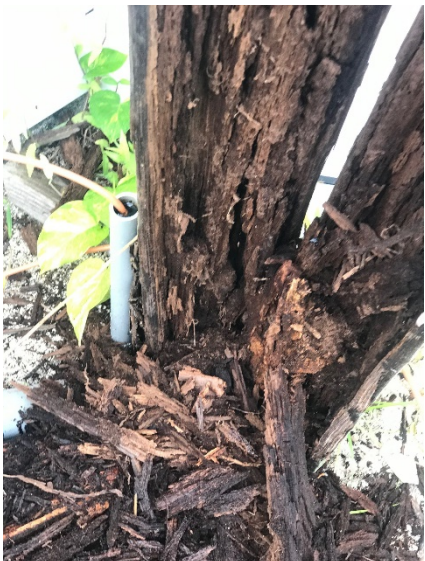
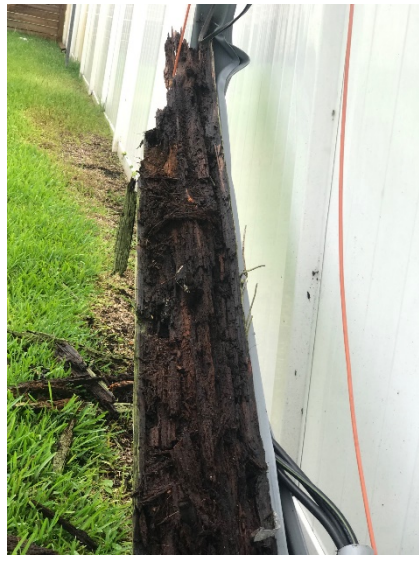
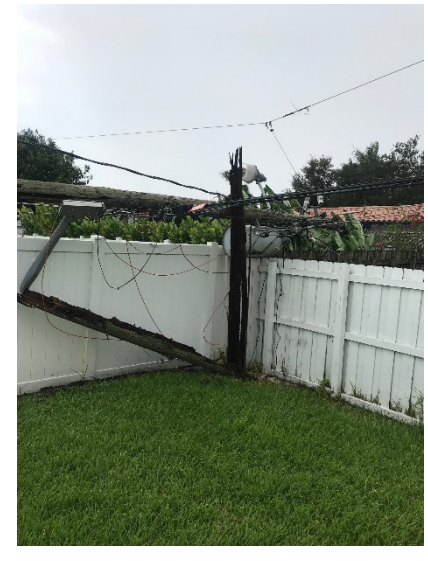
| FDR# | Sub | MA | FPL or ATT | TT# | Date | LLN#/FPL ID | Detail Comments of outage |
|---|---|---|---|---|---|---|--|
| 803038 | TROPICAL | WD | ATT | 666 | 9/2/2019 | 8-6253-9852 | Deteriorated AT&T pole - West Dade - need replace badly broken tx pole..40/3 pole.. 1 phs lat..tx 50 kv 7620/13 strt 120/240 tx..oil spill crew.. 1/p/s broken ptp.. rs open pull off lat. r/o 1431 sw 93 ct.. pole & tx r/o 1320 sw 92 pl.. no truck access.. RS Interruption Category Code - OCA |

- ATT
- Deteriorated
- TT# 666
- WD / Tropical / 803038
(Miami)

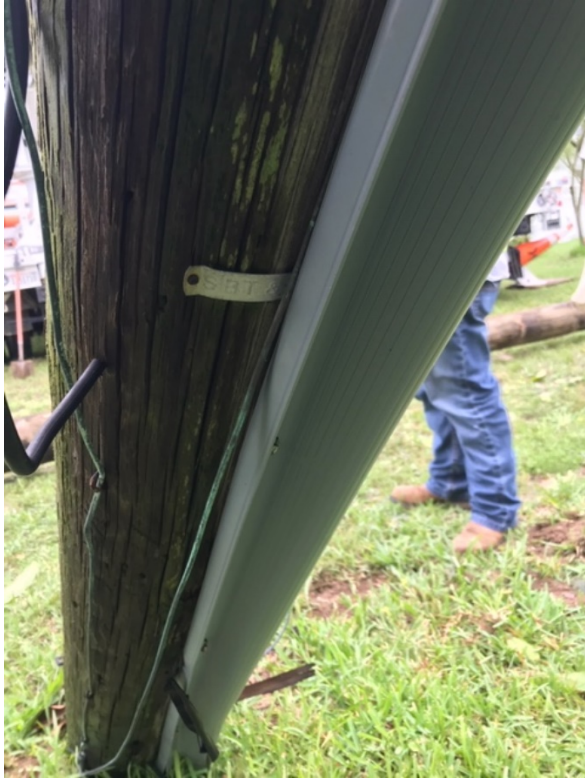
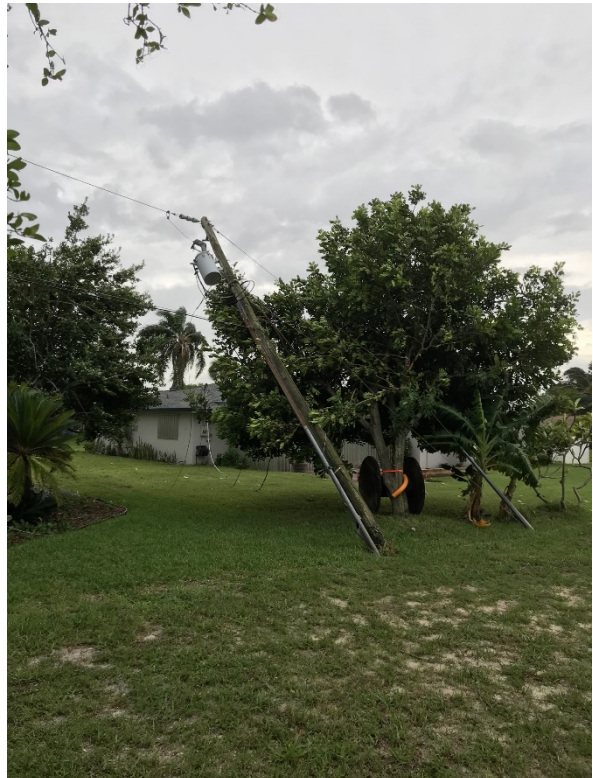
- ATT
- Tree fell into lateral and broke pole
- TT# 1674
- BV / Satellite / 404132 (Melbourne / Cape Canaveral)
