RE: SECO Energy Report to the Florida Public Service Commission Pursuant to Rule 25-6.0343, F.A.C. Calendar Year 2015

SECO Energy Report to the Florida Public Service Commission Pursuant to Rule 25-6.0343, F.A.C. Calendar Year 2015

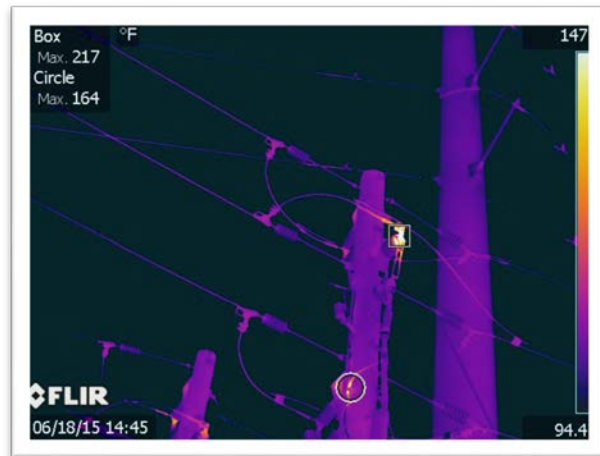
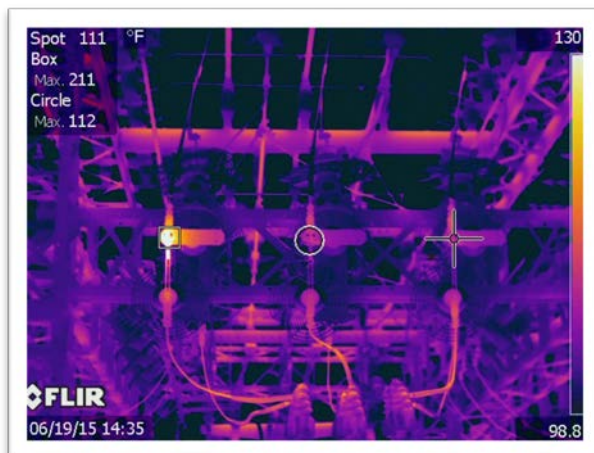
As illustrated by the infrared photos of a distribution pole (right) and a substation (below), this proactive approach allows SECO to detect hotspots and identify devices before they fail in order to minimize service interruptions to its members.
