RE: SECO Energy Report to the Florida Public Service Commission Pursuant to Rule 25-6.0343,
F.A.C. Calendar Year 2024

SECO Energy Report to the Florida Public Service Commission Pursuant to Rule 25-6.0343, F.A.C. Calendar Year 2024

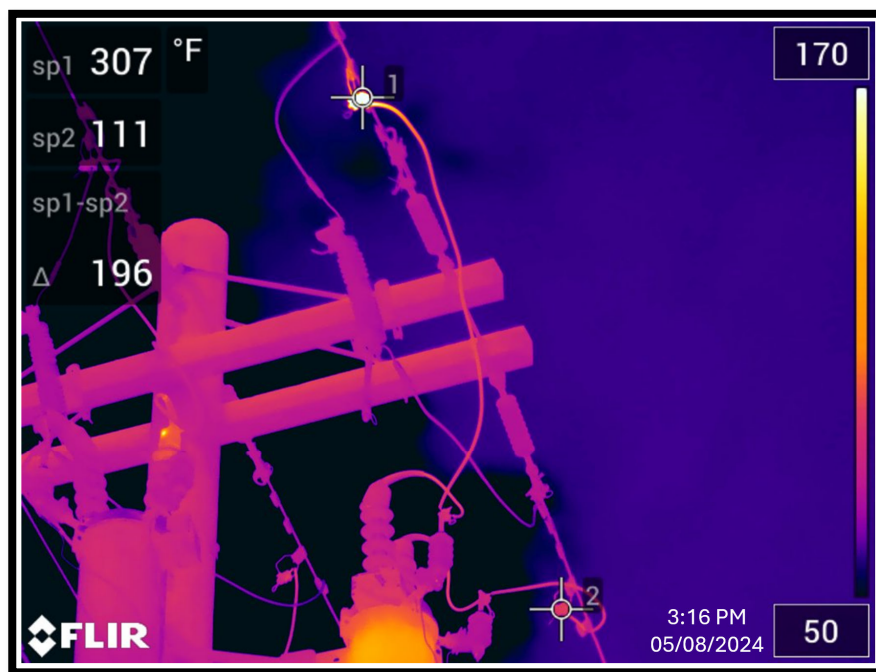
In addition, SECO performs annual visual and infrared inspections for SECO and Seminole Electric Cooperative (SECI) owned transmission lines. As illustrated by the following infrared photo of an oil circuit recloser ("OCR") hot line clamp connection, this proactive approach allows SECO to detect even the slightest of hotspots and identify devices before they fail to minimize service interruptions to its members. Spot 1 in the following infrared photo distinguishes a heat-related concern, whereas Spot 2 shows the expected temperature of a similar piece of equipment for comparison.
