RE: Docket No. 950520-EI

Enclosed are an original and fifteen copies of the of Gulf Power Company's Natural Gas Research and Demonstration Project Report which was requested in Order No. PSC-95-1146-FOF-EG in the above docket.

Field Testing of Gas Engine-Driven Heat Pumps

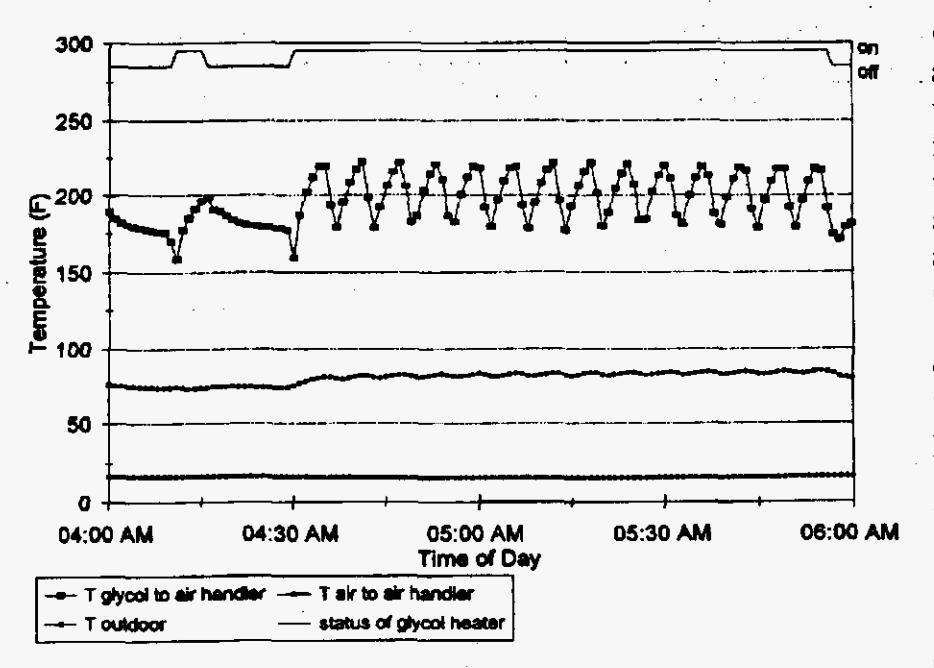
Figure 7.1 – February 13, 1996 Operation at Site 2

On several occasions, the auxiliary glycol heater was observed to cycle on its high-temperature safety cut-out. Figure 7.1 shows one period starting at 4:30 AM and ending at 6:00 AM on February 13, 1996 when heater cycled on and off 14 times. During this period, the EDHP continuously called for heat from the glycol heater as shown by the "high" status channel for the auxiliary heat. Both the engine speed and the glycol flow rate remained constant, the former at 3000 rpm and the latter at 5 gpm.

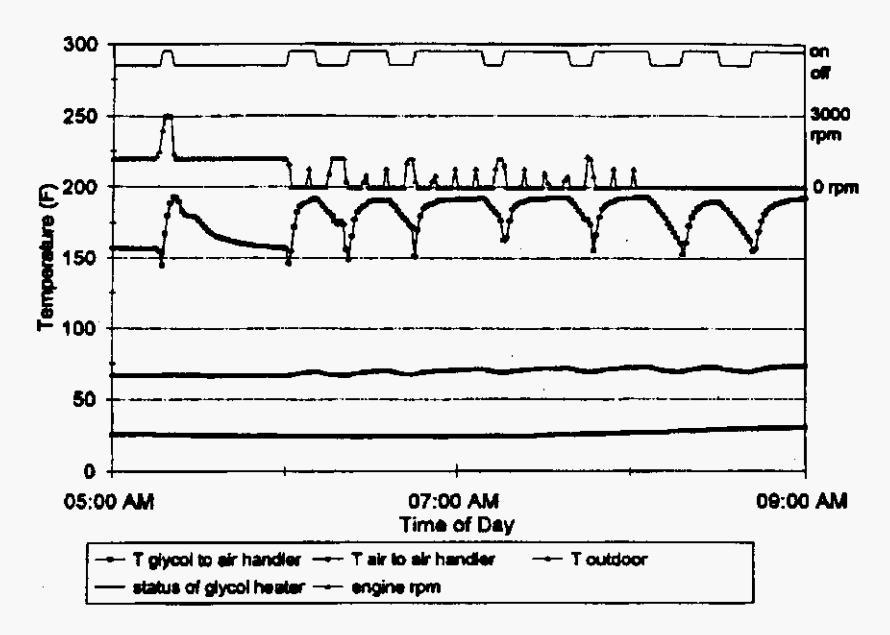
Figure 7.2 – November 3, 1996 Operation at Site 2

Site 2 - Control Problem

Starting at 6:00 AM on November 3, 1996, the EDHP at Site 2 cycled for two hours between low-speed engine operation and the glycol heater. This behavior is shown in Figure 7.2. At no time did the engine speed increase above its minimum level of 1200 rpm before the glycol heater turned on. (One would expect the engine to be operating at full speed--3000 rpm-before the glycol heater turns on.) Almost three weeks later, a service technician traced the problem to a shorted thermostat wire within the air handler. However, before this diagnosis was made the thermostat at the site was replaced twice and the EDHP's controller was replaced once.

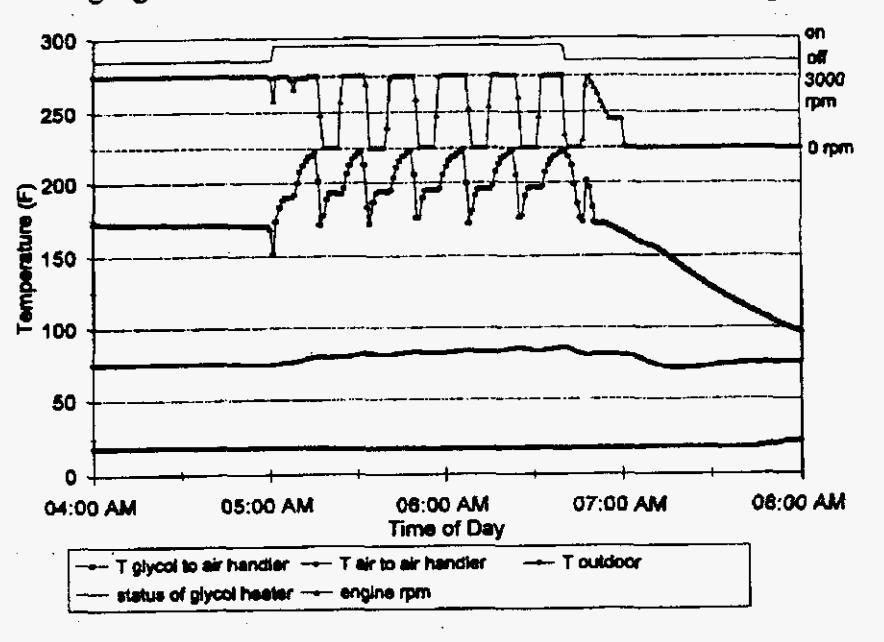
Site 4 - Glycol Loop Problems

During both heating seasons for the field test, the EDHP at Site 4 had chronic problems that showed up as short cycling of the heat pump and glycol heater. For most of the winter, the system would keep the house comfortable, and a homeowner who was not part of this field test might not have been aware of the anomalous operation. However, there were periods when the warning light on the EDHP would frequently come on, requiring either the homeowner or, in a number of instances, a service contractor to reset the system. During the two winters, the warning light came on 34 times and the thermostat was replaced twice.

Figure 7.4 illustrates the anomalous operation that was observed at Site 4. At 5:00 AM on February 6. 1996, the engine was running at high speed when the system started a defrost cycle. The defrost cycle ended normally after about seven minutes and the glycol heater continued to operate to supply additional heat to the house. As the heater ran, the glycol supply temperature to the indoor air handler steadily increased.
