# **Vegetation Reliability Analysis**

**April 11, 2012**

**Vegetation Management**

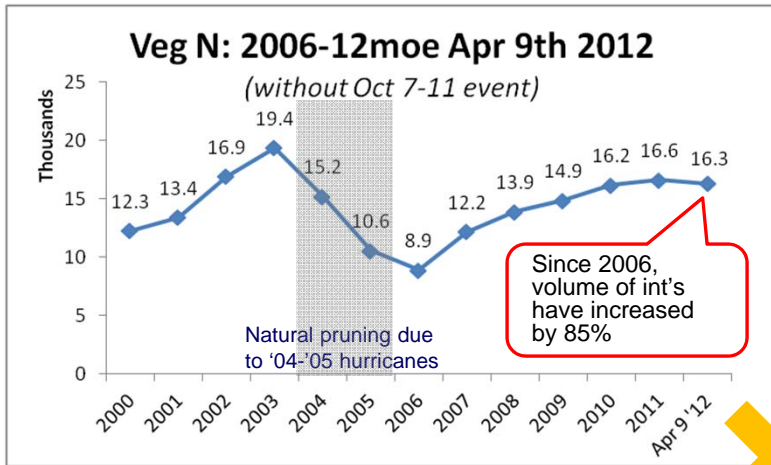
## Prevention (N)

- Data excludes Oct 7-11, 2011 event
- $CI = N \times CI/N$   
(Impact) (Prevention) (Prioritization)

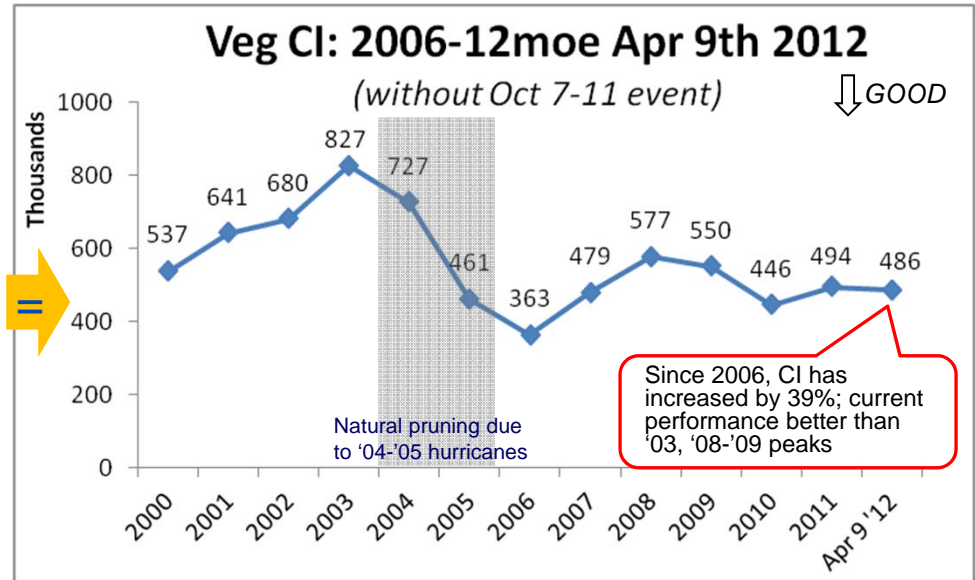
## Impact (CI)

Since 2006, CI has increased by 39% driven by an increase in the volume of outages after “hurricane pruning” but partially offset by improved CI prioritization. Recent CI performance is better than 2003, 2008 & 2009 peaks.

- Since 2006, CI has increased by 39% driven by an increase in the volume of outages after “hurricane pruning” but partially offset by improved CI prioritization.

- Recent CI performance is better than 2003, 2008 & 2009 peaks. Statically significant step-change in prioritization (CI/N) occurred in 2010.
- Backbone (feeder & ocr) outages “outside of trim scope” & circuit body (lateral & below) outages “within trim scope” are the main drivers.

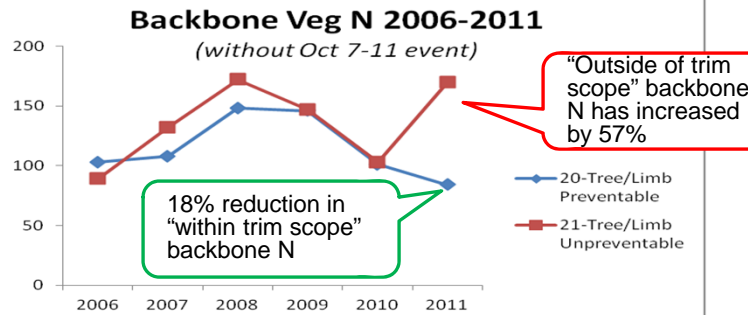
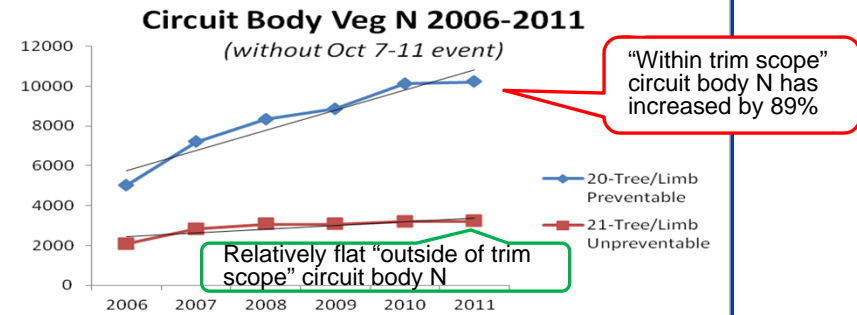
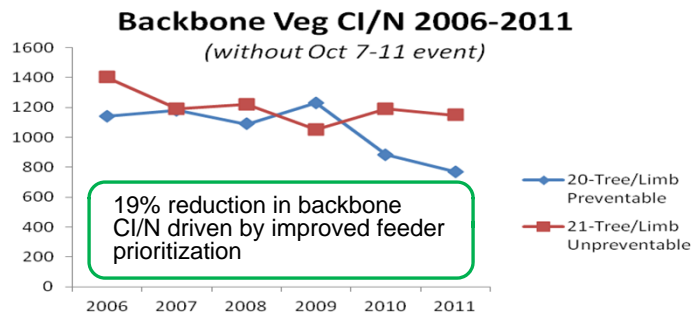
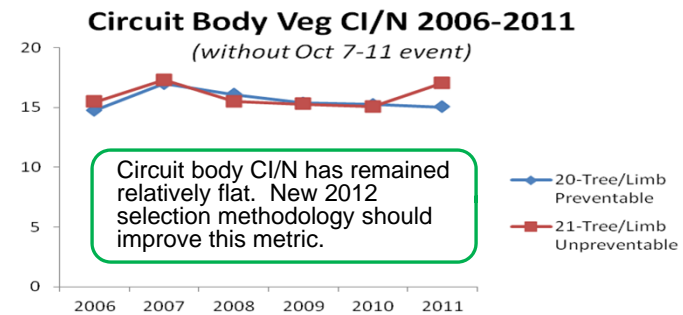
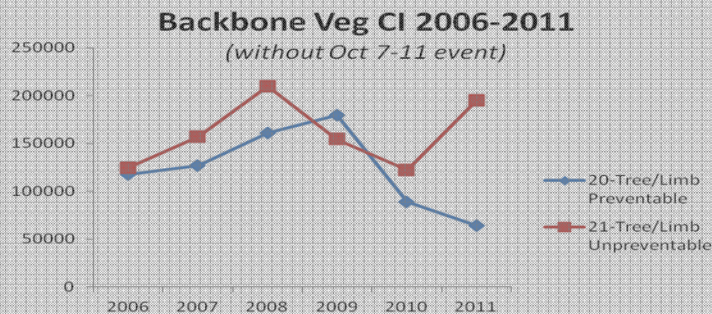
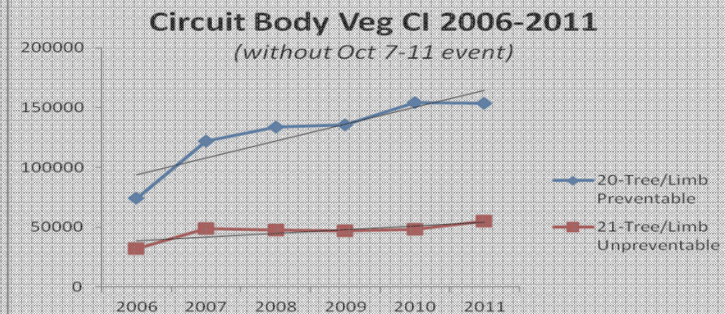
- Tree/Limb outages account for 95% of the CI (remaining 5% vines/grass).

Backbone outages "outside of trim scope" & circuit body outages "within trim scope" are the main drivers

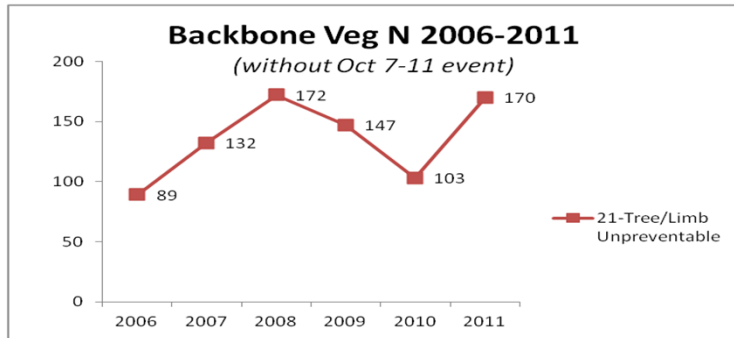
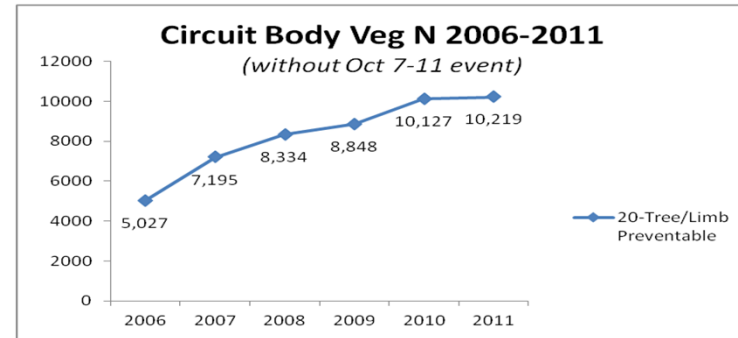
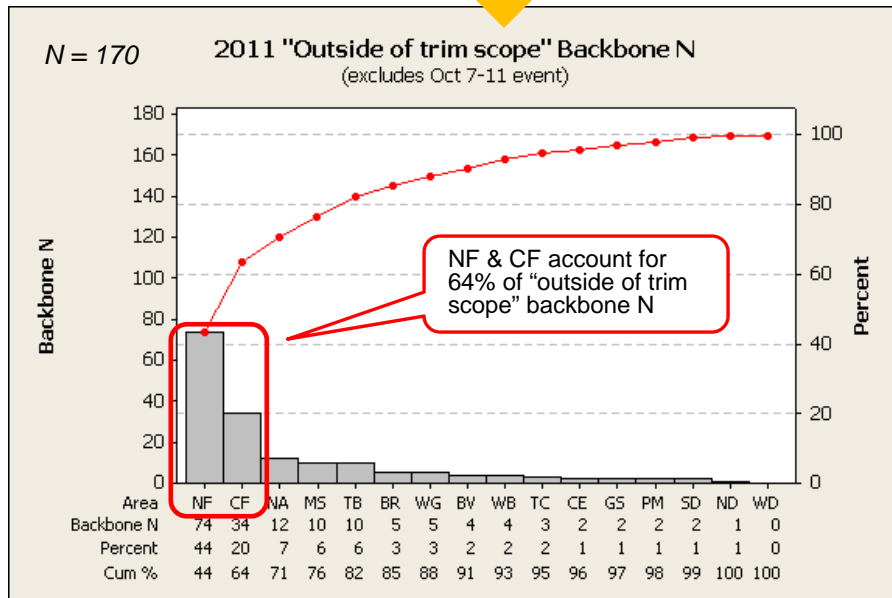
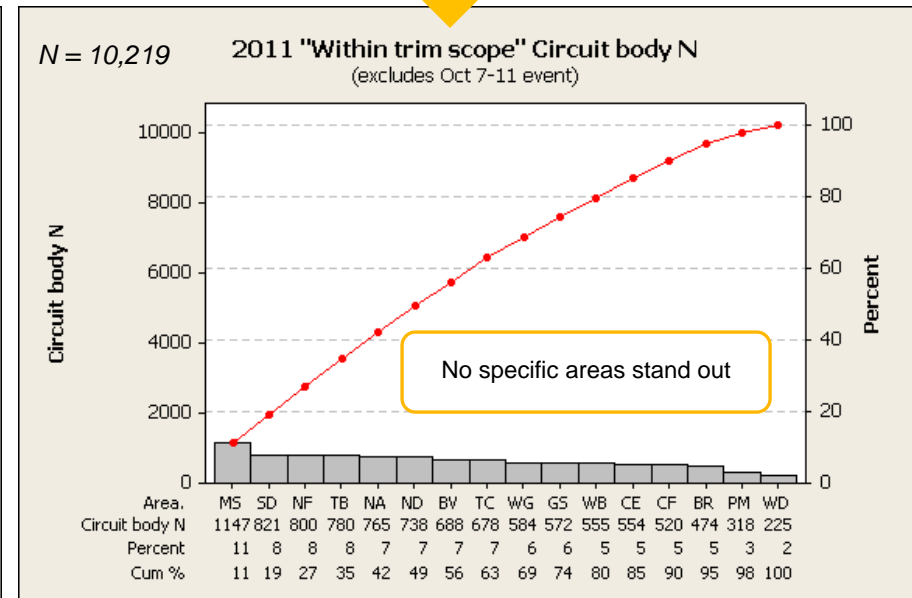
**Backbone outages “outside of trim scope” are concentrated in NF/CF while circuit body outages “within trim scope” are scattered**

- Using 2011 St. Augustine wind data, both types of outages tend to pickup during gusts of approx. 35mph or higher.
- Backbone outages “outside of trim scope” are concentrated in North Florida and Central Florida areas while circuit body outages “within trim scope” are scattered.

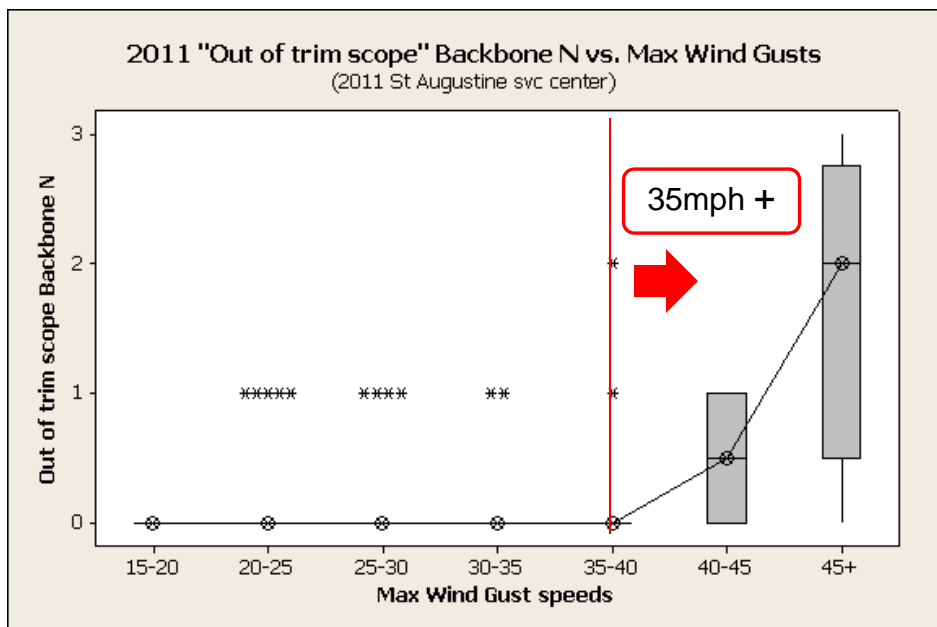
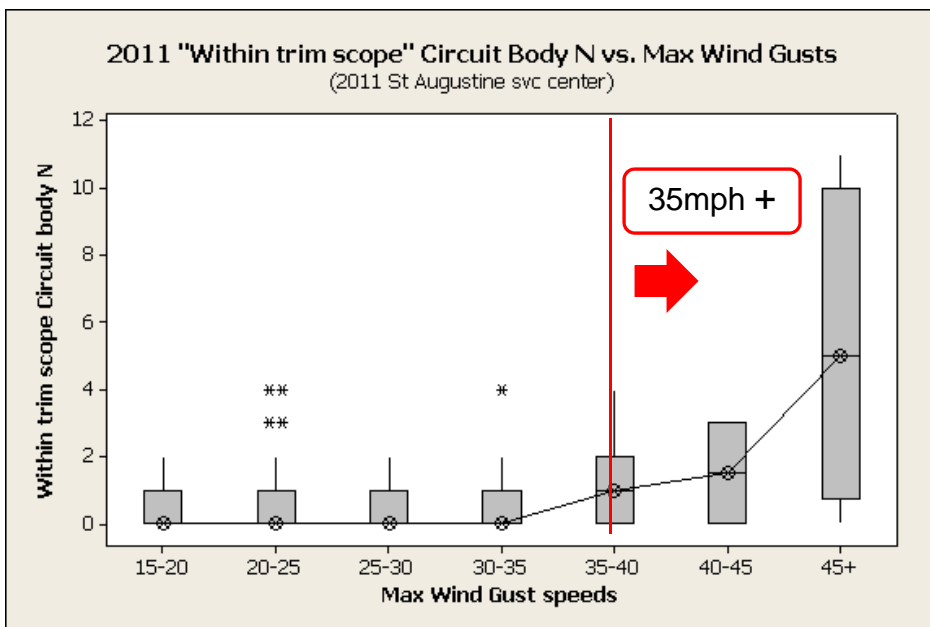
## How prone are these outages to wind? (using St. Augustine wind sample data)

**Using 2011 St. Augustine wind data, both types of outages tend to pickup during gusts of approx. 35mph or greater**

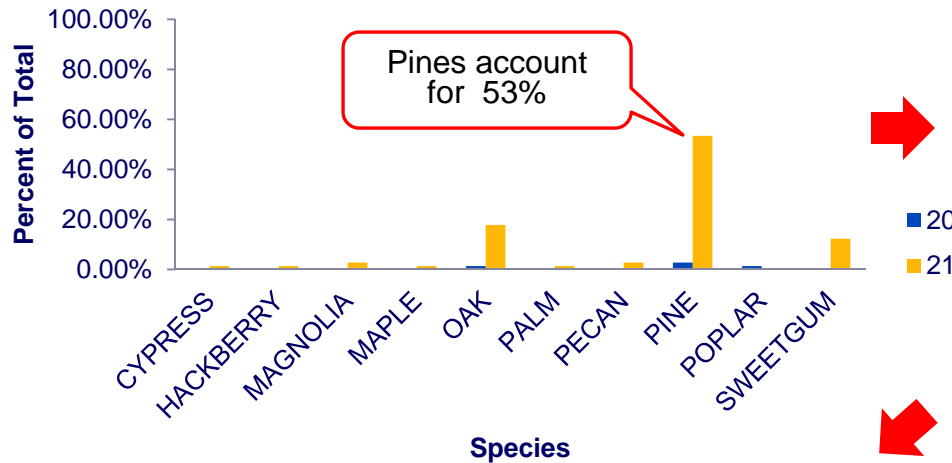
## 2011 North Region Fdr N - Species

“Out of trim scope” outages in the North Region typically involve healthy pine trees that fail several feet from the power lines and are challenging to identify before an outage occurs.

- “Out of trim scope” outages in the North Region typically involve healthy pine trees that fail several feet from the power lines and are challenging to identify before an outage occurs.

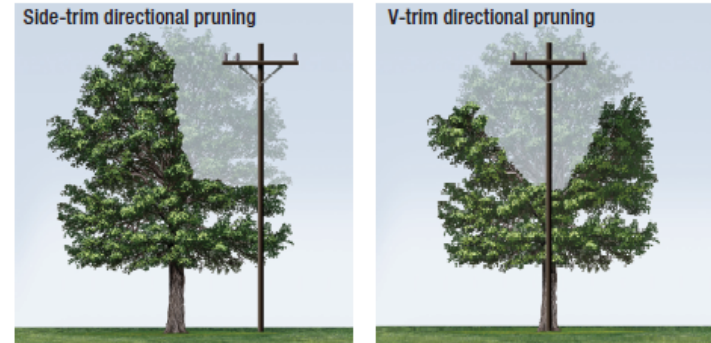
**Clearance for Primary: 8 to 12 feet**

**Clearance for Secondary & Neutral: 4 to 6 feet**

- Based on this, the clearance for Primary is 8 to 12 feet and the clearance for Secondary & Neutral is 4 to 6 feet. The range depends on the species and its re-growth rate.

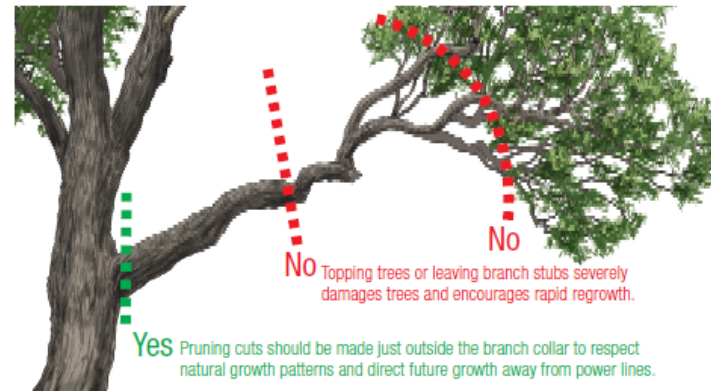
Proper pruning for tree health

**Per ANSI A-300 standard, line clearance should not remove more than 25% of the tree canopy**

- Pruning Standards, which dictate, through form, growth rate, and location of tree, where and how pruning cuts will be made.
- Rule 5.5.3: **No more than 25%** of the foliage should be removed within an annual growing season.
