BEFORE THE  
FLORIDA PUBLIC SERVICE COMMISSION

In re: DOCKET NO. 20250052-WS

Application for increase in water and  
wastewater rates in Brevard, Citrus, Duval,  
Highlands, Marion, and Volusia Counties by  
CSWR-Florida Utility Operating Company.

PROCEEDINGS: HEARING

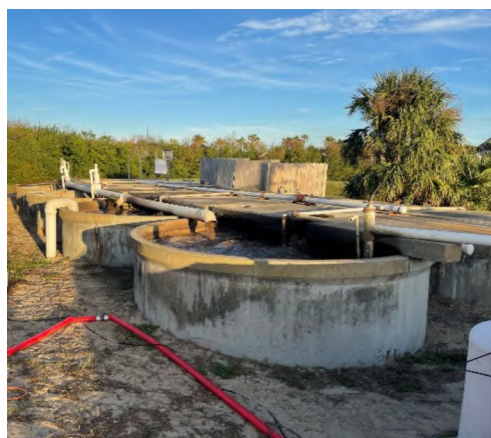
3        *The two steel (“Plant 1” top left and “Plant 3” right) and concrete (“Plant 2” bottom)*  
 4        *package plants making up the treatment facility at acquisition. Note poor condition of all*  
 5        *steel equipment, tanks, and structures.*

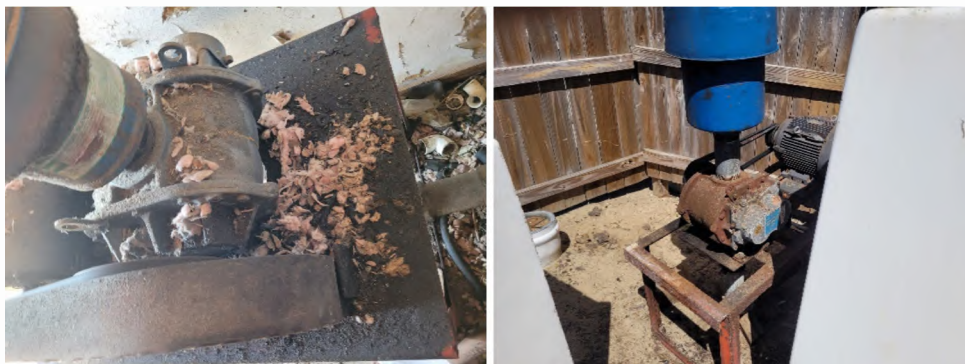
8 *Poor condition of blowers at acquisition with signs of rodent nesting.*

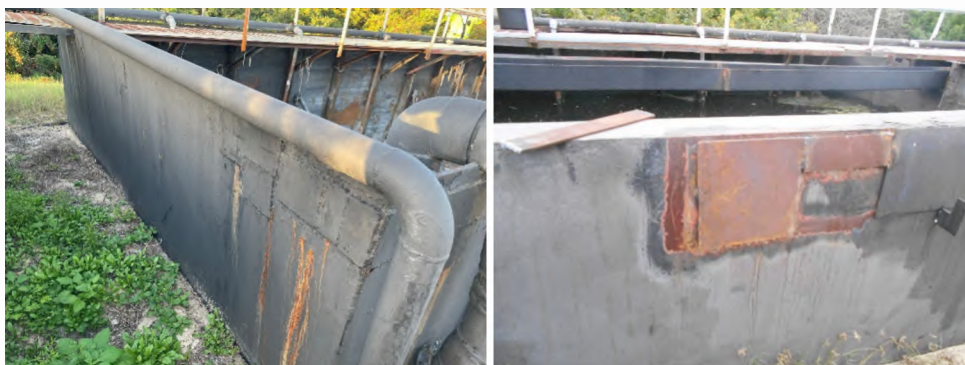
11 *Examples of steel tanks and equipment deterioration at close and examples of the numerous*  
12 *poorly installed welded patches on the tanks.*

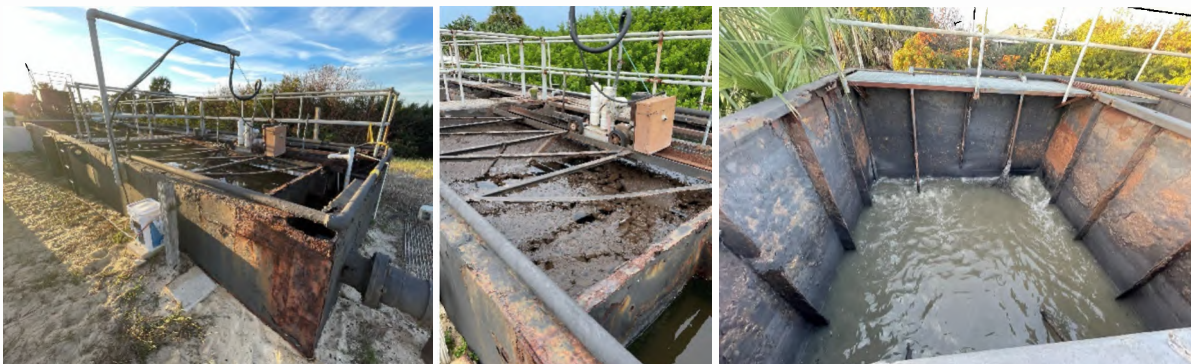
*Examples of cracking and exposed rebar in concrete tanks.*

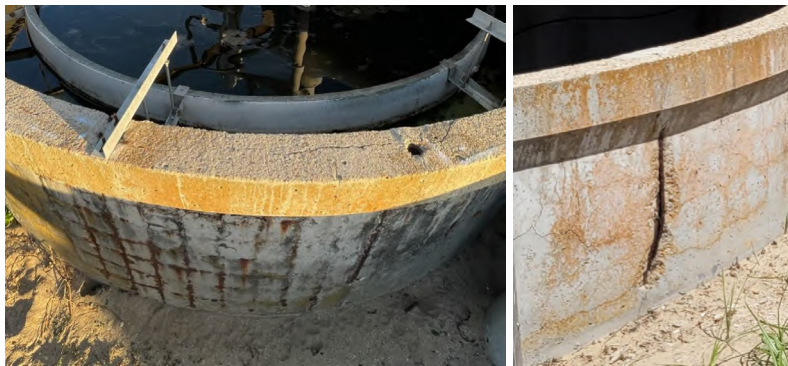
12 concrete package plant being used for flow equalization was found to be in similarly  
13 poor condition, with cracked concrete and exposed rebar in many places. Indeed, that  
14 plant has experienced a catastrophic wall failure since its acquisition. These issues  
15 demonstrated that repairs to the existing facility were not a workable long-term  
16 solution.

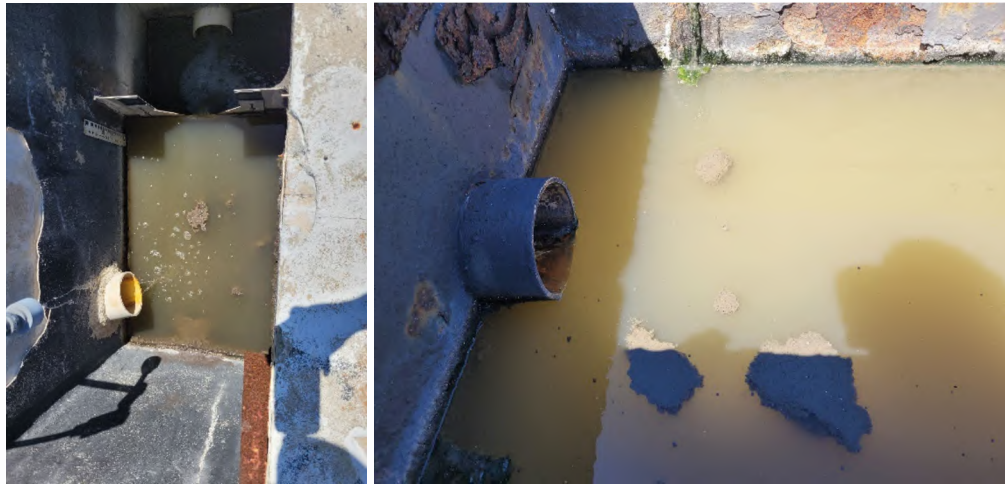
*Discolored effluent and floating sludge at discharge at acquisition, indicating poor treatment.*

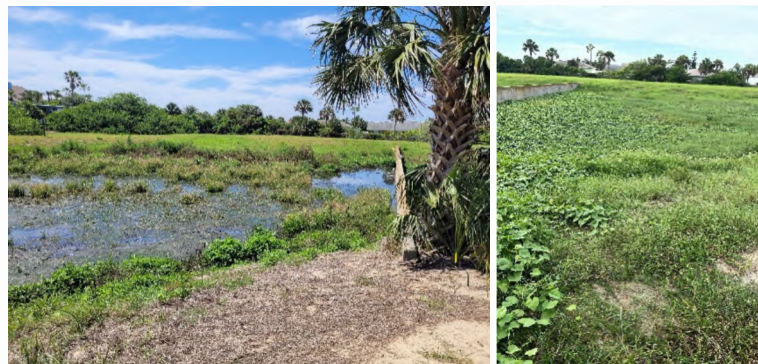
*Examples of overgrowth of rapid infiltration basins.*

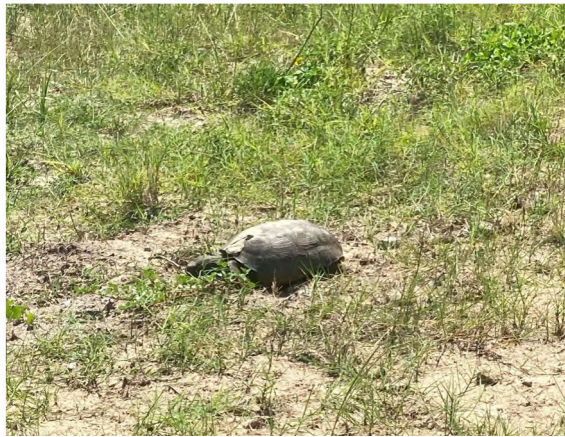
15 Regardless of which of the first two options were selected, CSWR Florida  
16 determined an additional issue that would need to be addressed is the impact on a  
17 threatened species of wildlife (gopher tortoises) living in the rapid infiltration basins at  
18 the treatment facility. This would require either approved relocation of the tortoises  
19 during required construction activity or permitting and protection of the area occupied  
20 by the tortoises during construction activities. The costs associated with these measures  
21 further reduce the viability of either of the first two options.

2 *Protected Gopher Tortoise creating obstacles to regular operations, maintenance activities*  
 3 *and construction projects (pictured in rapid infiltration basin)*

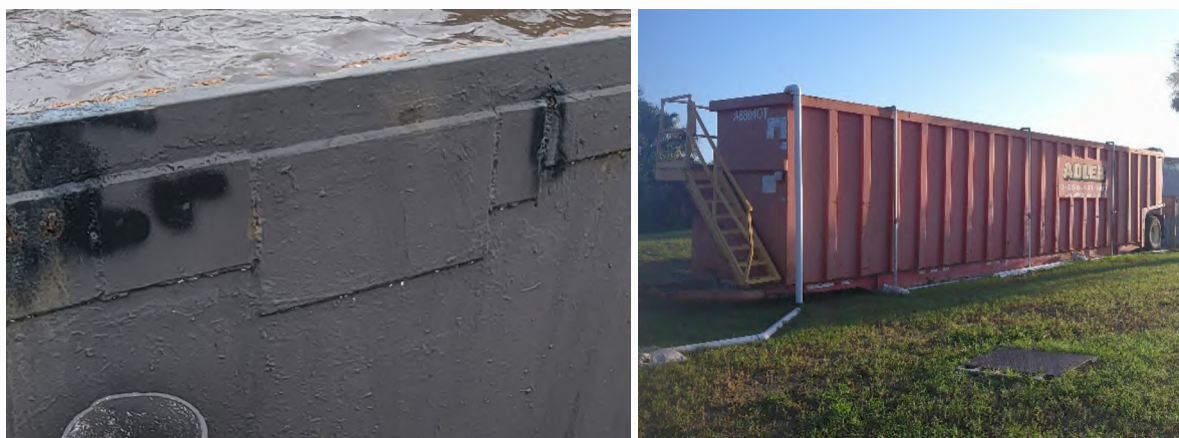
*Example of patching leaks in steel tanks at North Peninsula (left) Temporary tank in place since concrete tank failure (right).*

Repairs to tanks have been made to patch leaks and a temporary tank has been installed following the failure of the concrete package plant used for flow equalization. This is the bare minimum required to prevent ongoing releases of untreated or partially treated wastewater on the site.

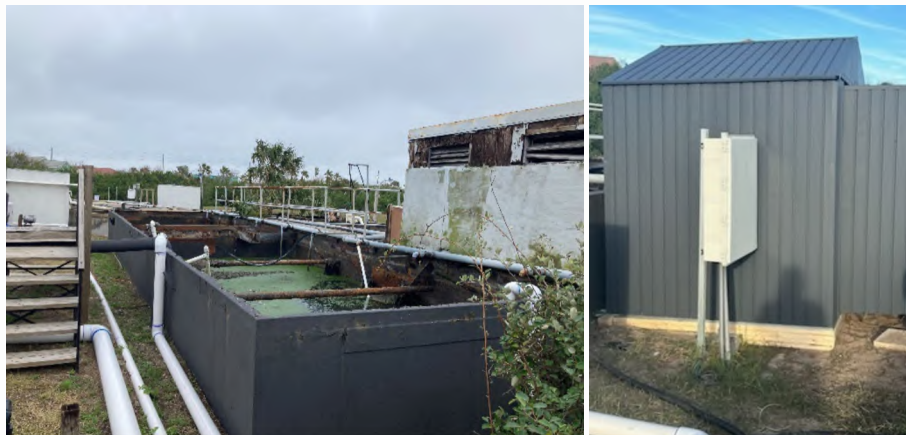
4  
5 *New temporary PVC aeration and sludge return lines throughout facility (left). Sound*  
6 *dampening shed installed around blowers (right).*

Aeration system improvements have consisted of repairs and replacement of damaged air lines, diffusers, blowers, sludge returns, and installation of a sound dampening barrier around blowers following continued complaints regarding excessive

1 noise from the facility which began under previous ownership. The installation of the  
2 sound barrier was a requirement of the compliance agreements entered into by the  
3 previous ownership.

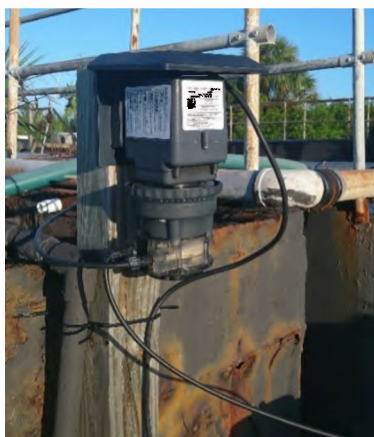
9  
10 *Repaired chemical feed pump.*

7 Disinfection system improvements consisted of repairing the chemical feed  
8 pump to ensure proper dosage and patching a leak in the chlorine contact chamber.

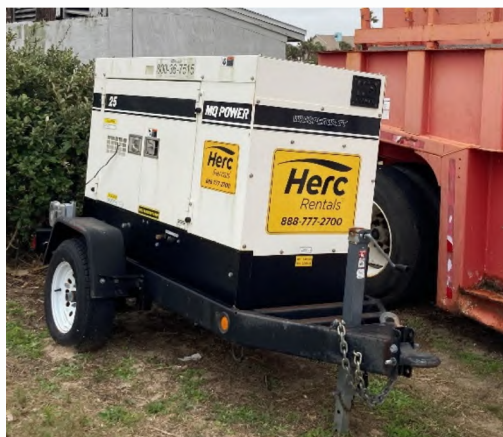
*Mobile generator placed temporarily at North Peninsula site.*

11 Repairs to the electrical system included repairs and replacements of failed  
12 panels, blower timers, pumps, breakers, and placement of a temporary generator on the  
13 site.

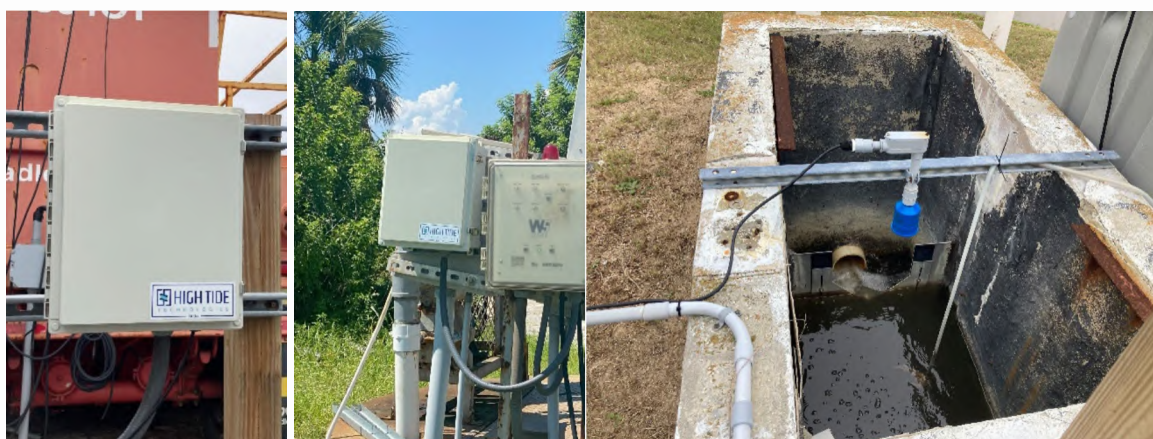
*New remote monitoring units installed at the treatment plant (left) and lift stations (center).*

Improvements to monitoring systems included installation of remote monitoring equipment on collection system lift stations, replacement of various meters that had failed but are necessary for sampling requirements, repairs to a groundwater sampling well, and connection of equipment to the remote monitoring system. The remote monitoring unit installed at the treatment plant will be able to be moved to the new lift station that will convey wastewater to the City of Ormond Beach's system in the future.

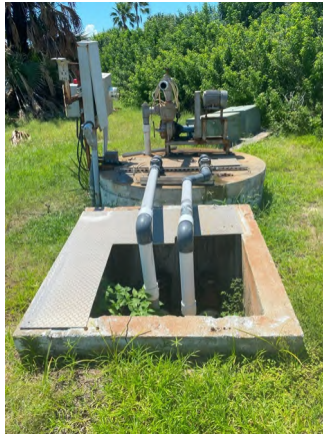
10 *New discharge piping installed on lift station.*

1 basins included mowing and tilling the basins and replacing the discharge valve  
2 controlling flow from the plant to the rapid infiltration basins. Collection system  
3 repairs included completing a CCTV inspection to identify damaged lines, repairs to  
4 those lines, and repairs to damaged manhole rings to reduce inflow and infiltration of  
5 stormwater into the system. Improvements to lift stations have included replacement  
6 of damaged or poorly performing pumps, repairs to discharge lines, repairs to pump  
7 rails and chains, replacement of level transducers, and repairs to electrical and control  
8 systems. Discharge piping has been replaced on the main lift station as well.

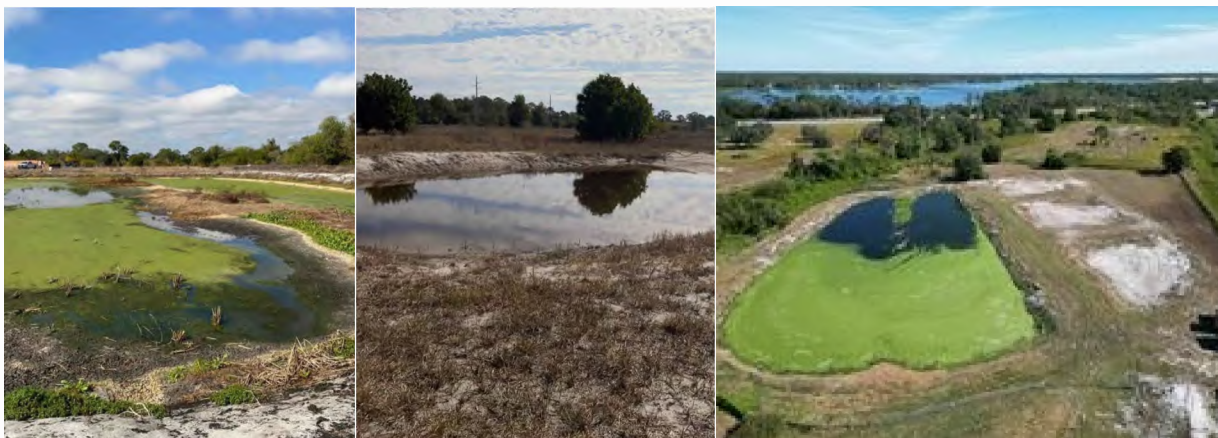
17 *Rapid infiltration basin (left) and percolation ponds (center) before sludge and vegetation*  
 18 *removal. Note percolation pond is holding water rather than draining both due to*  
 19

6 A. Various improvements have been made to date to the Sebring Ridge wastewater  
 7 system. Both the percolation ponds and the rapid infiltration basin had issues that  
 8 needed to be addressed to ensure adequate disposal of treated wastewater. Both these  
 9 sets of assets had significant sludge accumulation resulting in vegetation growth.  
 10 Furthermore, the elevation of the bottom of the percolation ponds meant that during  
 11 rain events groundwater would rise to the point of accumulating in the percolation  
 12 ponds, thereby preventing wastewater from percolating into the ground. To address  
 13 these issues, sludge and nuisance vegetation has been removed and a maintenance  
 14 schedule implemented to regularly service the ponds. In addition, a layer of sand was  
 15 added to raise the elevation of the bottom of the percolation ponds to prevent the  
 16 previously described groundwater issues.

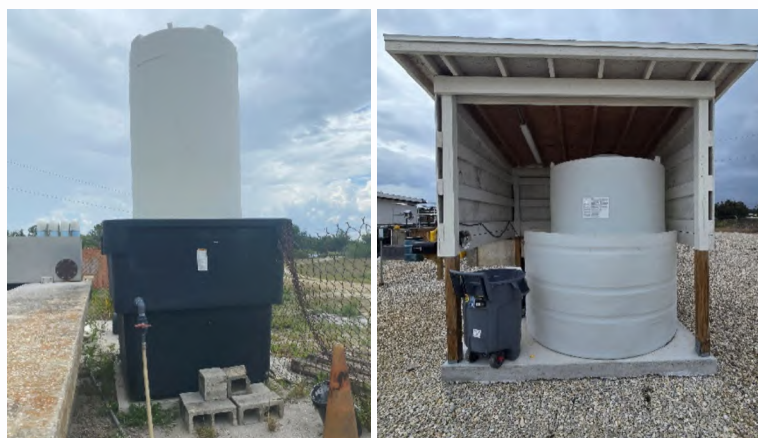
14  
15 *Disinfection chemical storage before (left) and after (right) improvement.*

4 At acquisition, the disinfection chemical storage was an elevated spill tote with  
5 chemical storage above. Although this provided spill containment and allowed  
6 chemicals to be distributed to the contact chamber without a chemical pump, delivered  
7 chemicals still would have to be pumped up into the tank upon arrival. In addition, the  
8 disinfection chemicals and tank were exposed to sunlight, which accelerates the  
9 breakdown of the chemicals and thereby reduces the efficacy of the disinfection  
10 process. A new spill tote and chemical storage tank with a chemical feed pump have  
11 been installed at ground level and the chemical storage tank has been covered by a  
12 shade structure to eliminate the issue with UV exposure. This will also allow for more  
13 precise dosing for disinfection and tracking of chemical inventory.

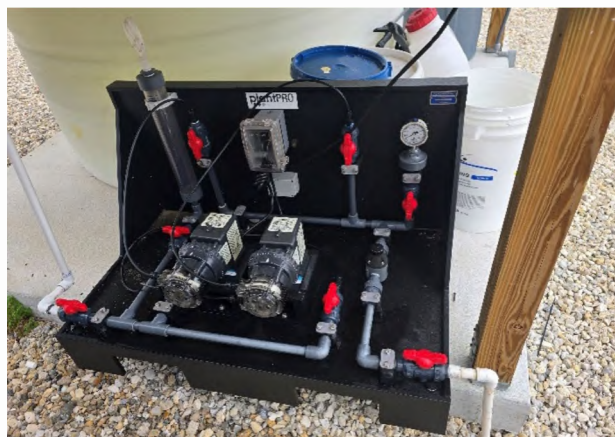
*New chemical feed pump system for precise dosing of sodium hypochlorite.*

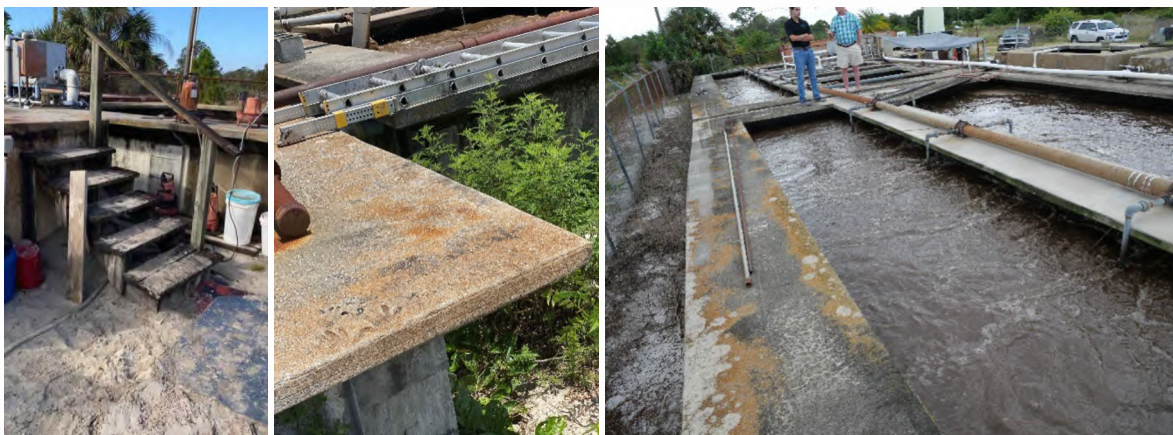
At acquisition the existing handrails, catwalks, and stairs were in poor condition and some areas lacked access with any operator safety features. CSWR Florida has begun to replace damaged safety features and install new ones and will continue to do so as improvement projects proceed.

*Examples of inadequate safety features for operations access. Rotting wooden stairs with missing handrail on one side (left), aluminum ladder resting across tanks for access to air header (center), no leading edge protection or grating over open basins throughout plant (right).*

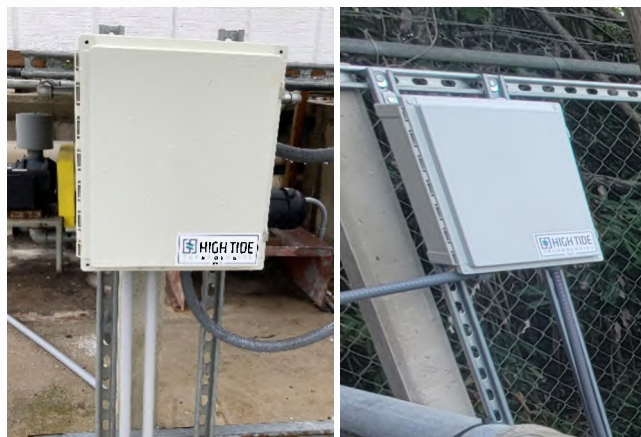
*Remote monitoring equipment installed at the wastewater treatment plant (left) and lift stations (right).*

At acquisition, no remote monitoring equipment was present at the wastewater treatment facility or lift stations, and the other monitoring equipment at the plant was either in poor condition or missing entirely. New remote monitoring equipment has been installed at the treatment plant and at each lift station. A new flow meter has also been installed to allow for active measurement of flow through the remote monitoring system.

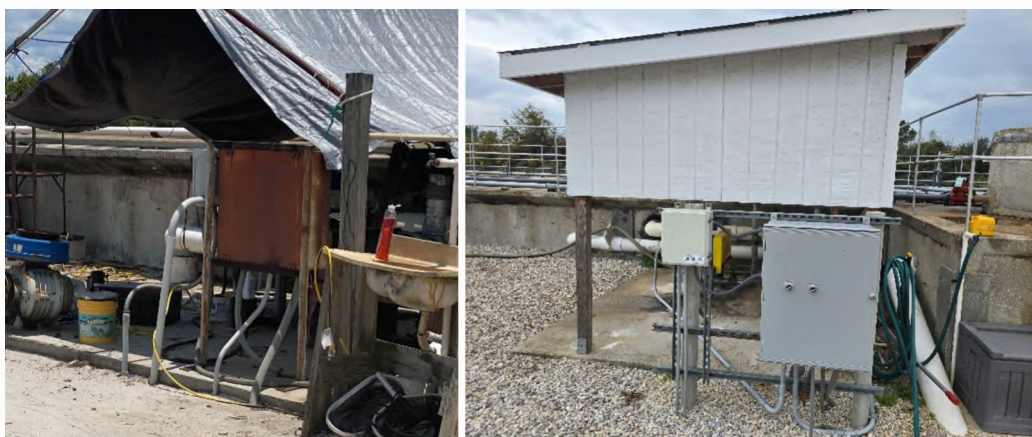
*Blower control panel and shade structure before (left) and after (right) improvements, note general cleanup of area from trash and debris as well.*

Although more improvements are required, some improvements also have been made to the power and control systems at the treatment plant to replace damaged equipment found throughout the facility. This included replacing the heavily deteriorated power and control panel for the blower system. Also, a proper shade structure has been installed over the blowers. Previously the blowers were protected from sunlight and rain with a tarp secured to scrap piping with rope and bungee cords. A proper structure has now been installed and the area cleaned up from trash and debris.

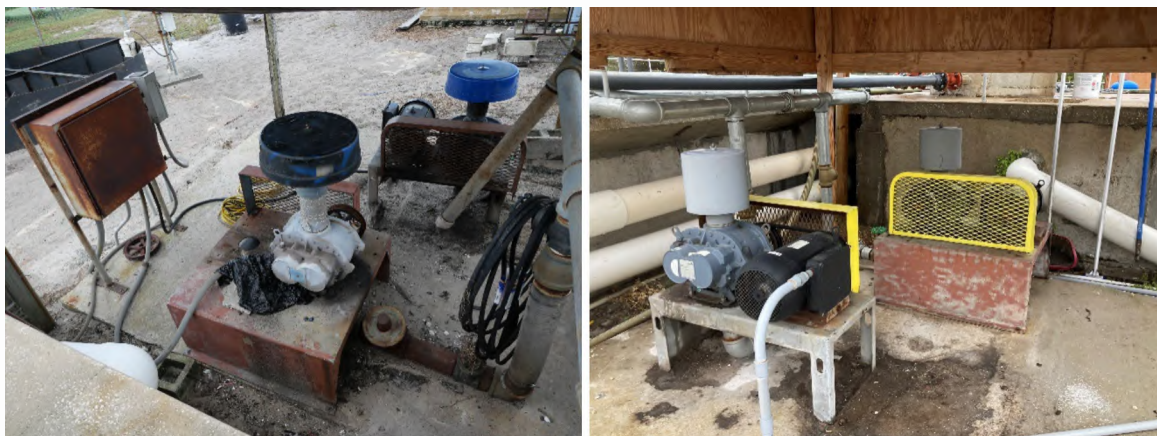
1 on the second blower. In addition, the blower housings were in poor condition, the  
2 functioning blower motor was in poor condition, belts were missing for the out of  
3 service blower, and both blower housings were deteriorating. Both blower motors and  
4 blowers have been replaced, including rewiring both units to the new blower controller.  
5 A belt housing has been installed along with new blower mufflers. Air leaks have been  
6 identified, and some aeration piping repairs have also been implemented.

7  
8 *Blowers before (left) and after (right) improvements.*

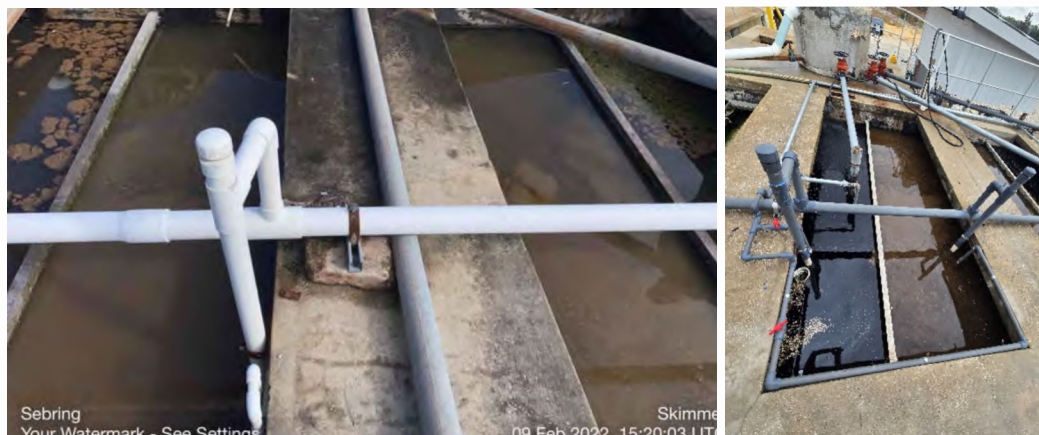
9 At acquisition, the clarifier sludge returns and skimmers were not properly  
10 functioning, and significant suspended solids in the clarifiers were noted in FDEP's  
11 previous enforcement action. To improve the function of the clarifiers, new sludge  
12 returns, sludge air lifts, and skimmers have been installed.

13  
14 *Old skimmer and air l.f.ts (left) and newly installed air l.f.ts and sludge returns (right), note*

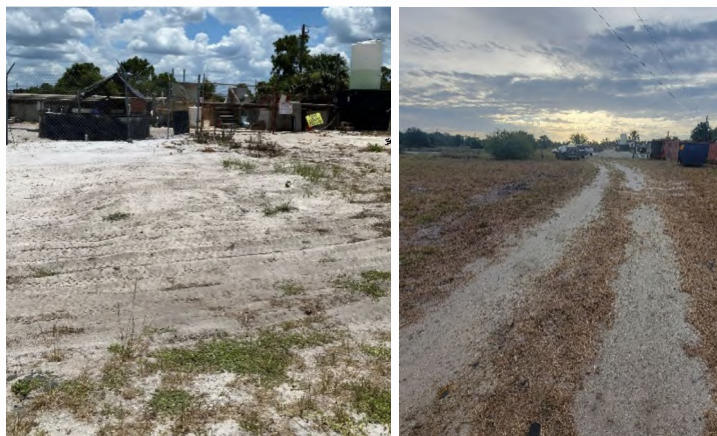
At the time CSWR Florida acquired the system, the access road and gravel throughout the site were eroded, crushed, and poorly maintained, with bare spots and nuisance vegetation growing throughout. To maintain facility access and operational access throughout the site, new gravel has been applied and nuisance vegetation removed.

*Typical degraded condition of roads and surfaces at acquisition.*

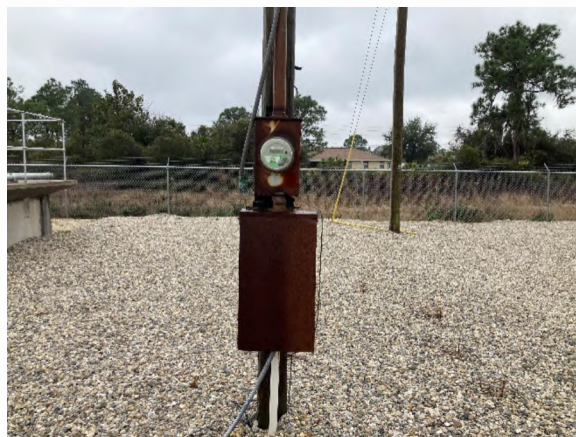
*Extremely corroded existing 200 amp power supply.*

To facilitate improvements and upgrades to the treatment processes at the Sebring Ridge facility, electrical upgrades will be required at the facility. This will include upgrading from a 200 amp service to a 400 amp service and replacing the current power supply and control panels, as appropriate, to meet the needs of upgraded equipment and to replace damaged or corroded electrical equipment. The new power supply will also include the means to connect an emergency generator to the system and prevent service interruption in the event of a power outage.

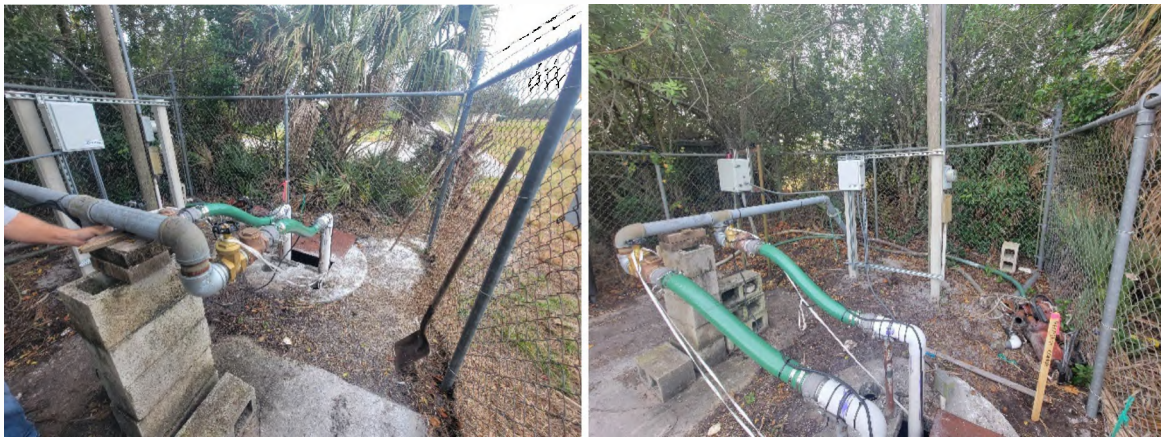
aging and in need of replacement, including control panels, manhole covers, pumps, and piping. Much of the discharge piping has been repeatedly repaired and is no longer properly supported (e.g., raised on piles of cinder blocks with wood shims) and often consists of improper piping materials including flex hoses and PVC pipes. The lift stations also do not include rail systems to aid in pump maintenance. None of the systems currently include emergency bypass piping, which allows a mobile pump to be connected to the lift station for operation during pump malfunctions or during power outages. All three stations will be overhauled with new pumps, control systems, rails, and piping to ensure proper function. Emergency bypass piping will also be installed during the piping overhaul. In addition, none of the lift stations currently include the means necessary to connect an emergency generator. This would typically be an emergency quick connect and manual transfer switch allowing a mobile generator to be connected to provide power to the lift station during a power outage. This equipment will be installed to improve the system's resiliency.

*Example of lift station piping and condition currently.*

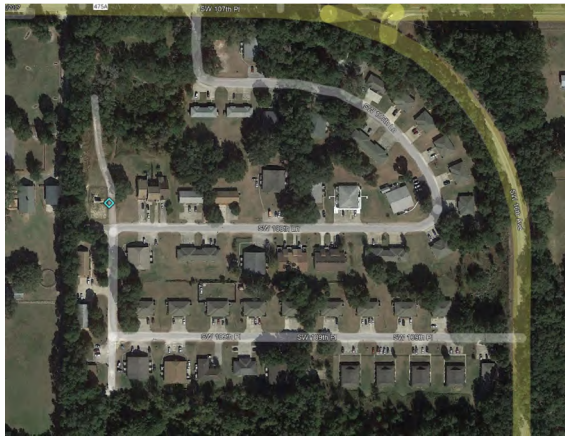
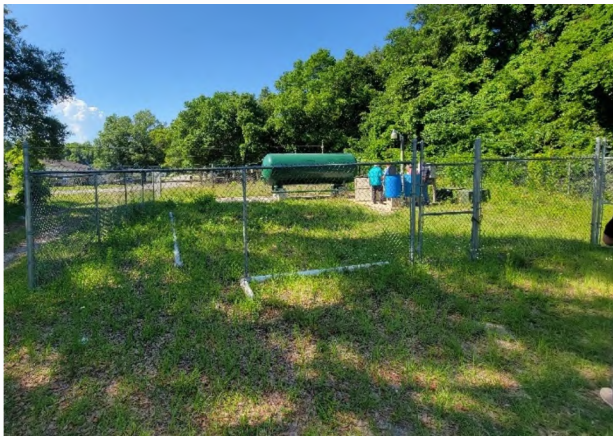
*Ground level views cf Ponderosa Pines well site 1 (left) and well site 2 (right) at acquisition.*

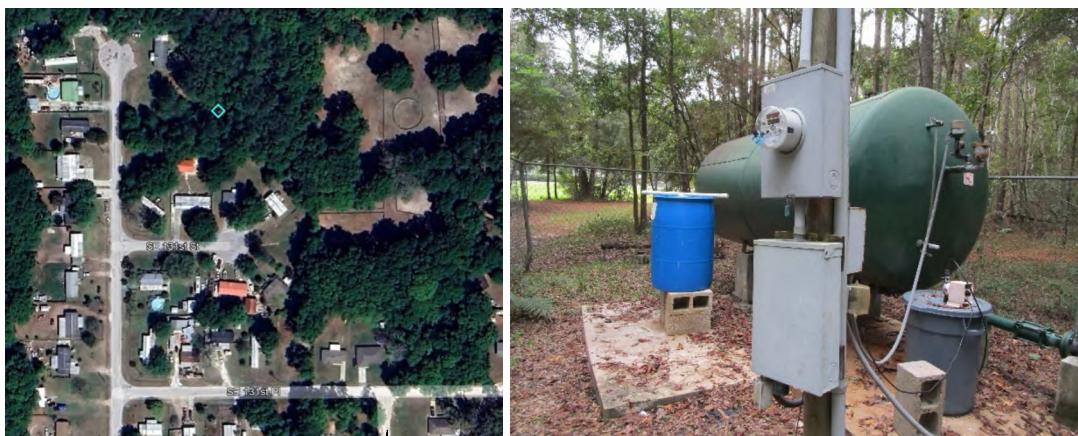
2 *Sun Ray Estates (FL3421314) well and hydro-pneumatic storage tank (left). Generator and*  
 3 *disinfestation shed (right).*

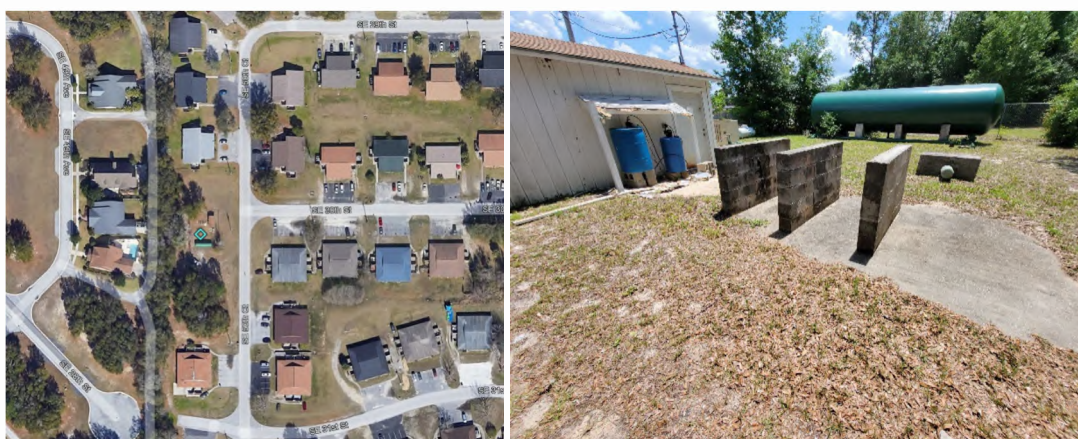
5 *Aerial (left) and ground level view (right) of the Sunlight Acres drinking water facility*  
 6 *(FL3421520) at acquisition.*

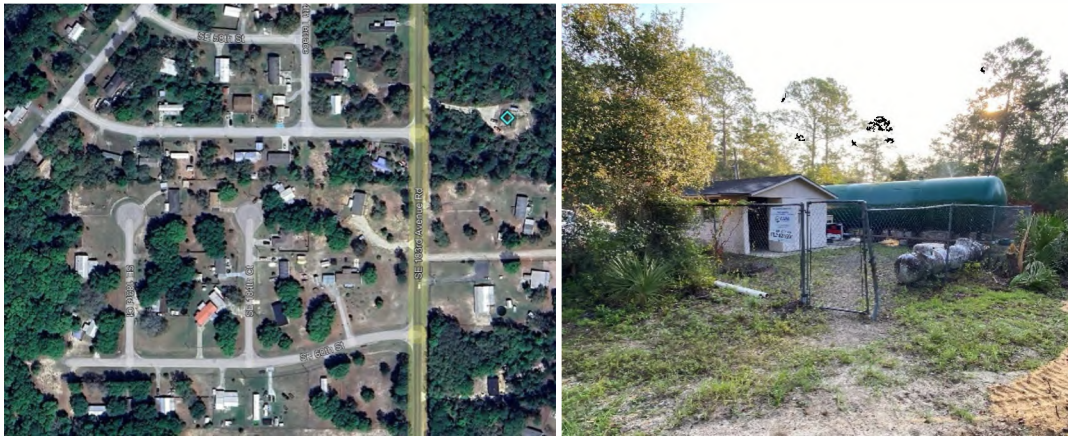
8 *Aerial (left) and ground level view (right) of the Whispering Sands drinking water facility*  
 9 *(FL3424009) at acquisition.*

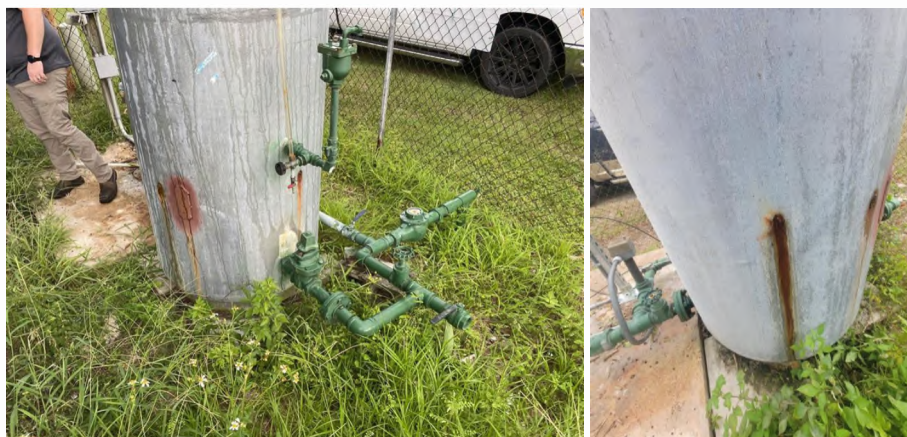
1 completed at each system. The severely deteriorated hydropneumatic tanks CSWR-  
2 Florida acquired from Sunshine included one that experienced a catastrophic tank  
3 failure (i.e., an explosion) shortly after closing, which shows the system's previous  
4 ownership failed to maintain system components in accordance with FDEP  
5 requirements. Indeed, CSWR-Florida identified hydropneumatic tanks at twenty-two  
6 of the twenty-three Sunshine system sites that did not meet minimum FDEP standards.

8  
9 *Hydro-pneumatic tank at Oakcrest Villas showing pinhole leaks and rust prior to catastrophic*  
10 *failure.*

3 Prior to acquiring the Sunshine water systems, CSWR-Florida determined that  
4 many of the hydropneumatic tanks were in poor condition and in need of evaluation  
5 followed by repair or replacement. Poor maintenance of these tanks by previous  
6 ownership was made obvious when the hydropneumatic tank at the Oakcrest Villas site  
7 failed catastrophically and exploded, damaging the site and interrupting service. These  
8 sorts of failures are extremely serious because they not only interrupt service but can  
9 cause severe damage to property on and around the utility site, thus posing a threat to  
10 customers, their property, and people on or near the site. CSWR-Florida responded  
11 immediately to the Oakcrest Villas tank failure and quickly installed three temporary  
12 bladder tanks to restore service until a new hydropneumatic tank could be acquired,  
13 permitted, and installed.

14 To prevent similar occurrences, CSWR-Florida has worked to evaluate and  
15 repair or replace hydropneumatic tanks at each of the Sunshine sites. This resulted in  
16 the replacement of four hydropneumatic tanks to date and replacements or installations  
17 of additional tanks planned for 21 of the 23 Sunshine sites. Other existing tanks also  
18 will be repaired and recoated at 19 of the 23 sites.

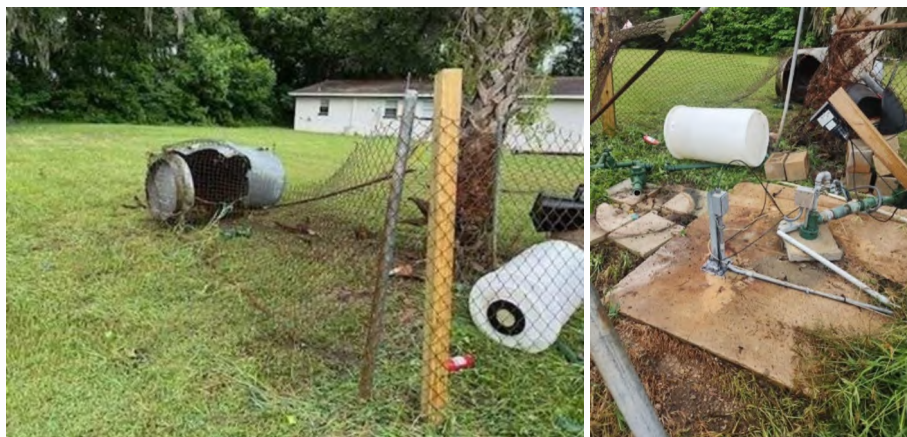
11  
12 *Oakcrest Villas hydro-pneumatic tank explosion. Failed tank with damaged fencing (left) and*  
13 *damage to other water assets (right).*

5 *New hydropneumatic tank was installed at Oakcrest Villas to replace failed tank. Damage to*  
 6 *site caused by tank explosion also repaired including new fence installation.*

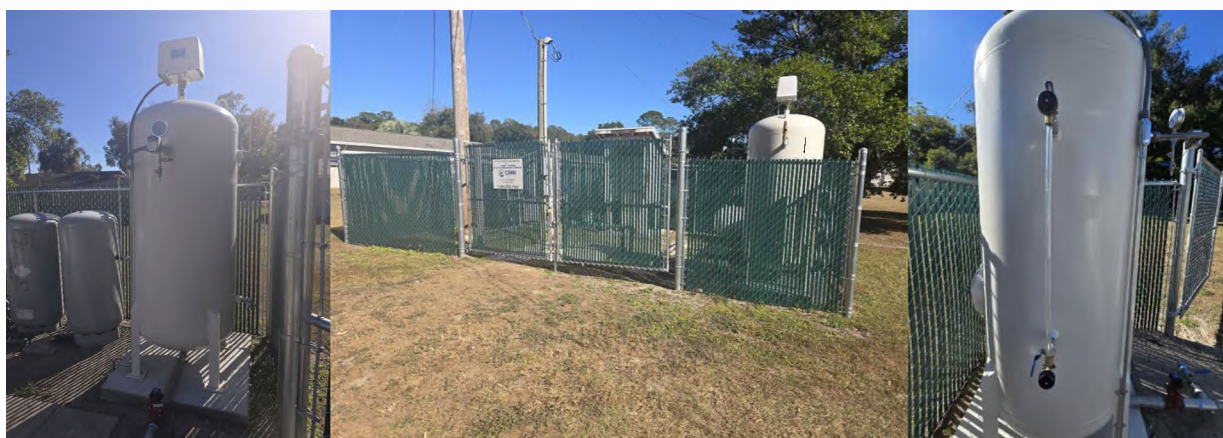
2 *Before (Left) & After (Right): Hydro-pneumatic tank replacement (current tank leaking and at*  
 3 *risk of failure) - Ashley Heights system.*

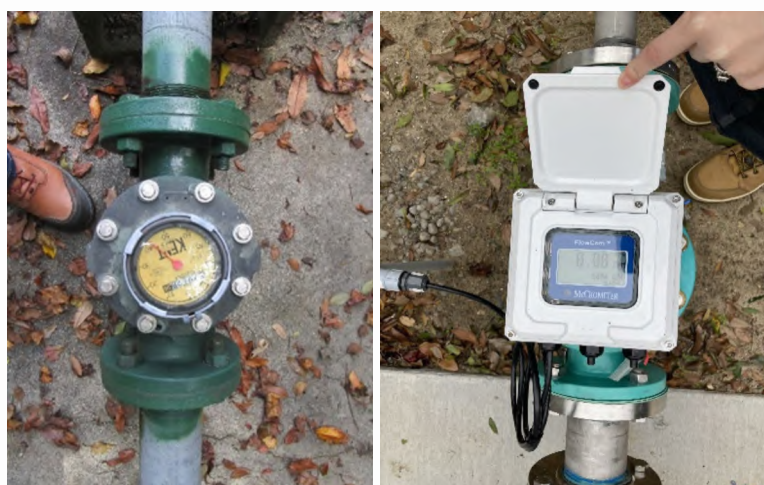
8 *Before (Left) & After (Right): Flow Meter Replacement - Ashley Heights system*

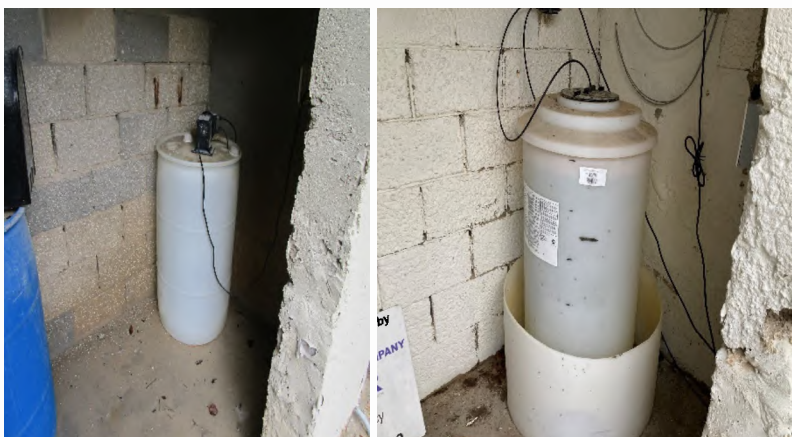
2 *Before (Left) & After (Right): Chemical containment upgrades - Ashley Heights system.*

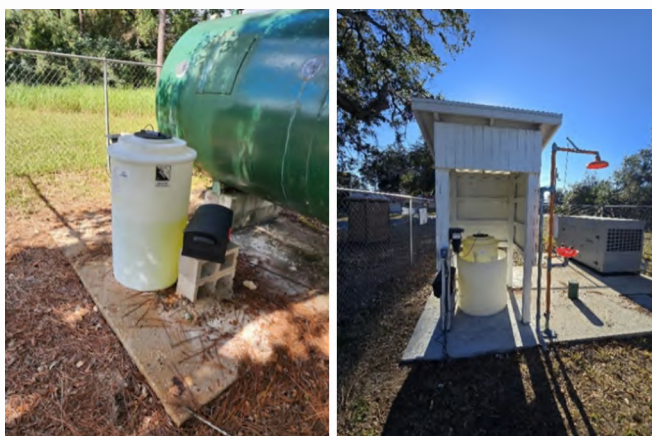
4 *Before (Left) & After (Right): Disinfection system improvements (shade structure and*  
 5 *containment) - Bellevue Oaks Estates system.*

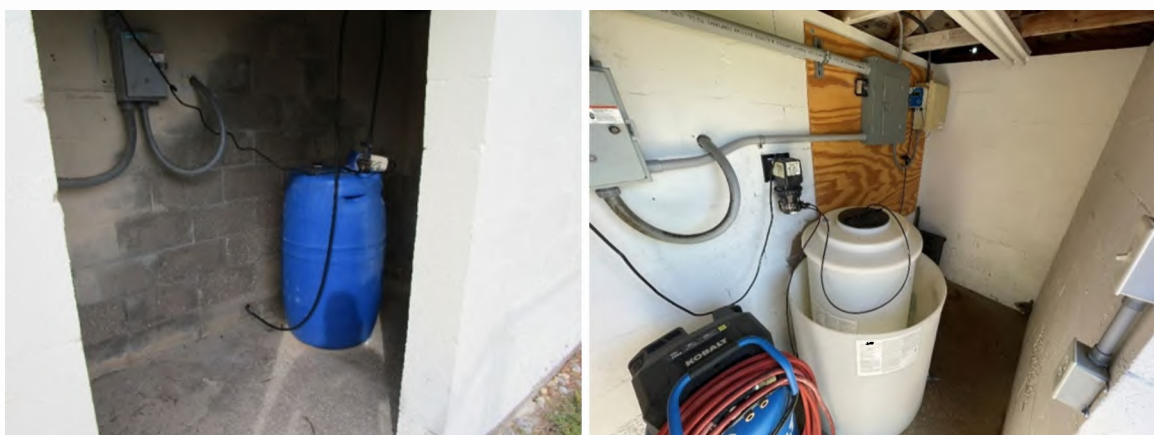
7 *Before (Left) & After (Right): Disinfection improvements, containment, and lighting -*  
 8 *Country Walk system.*

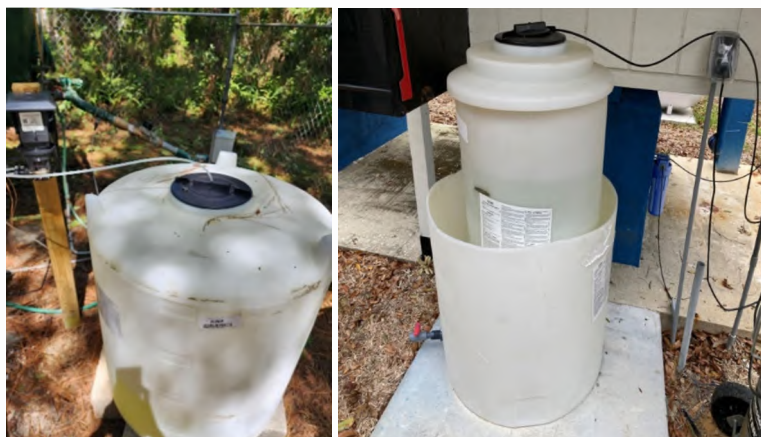
2 *Before (Left) & After (Right): Chemical containment and shade structure - Emil-Mar system.*

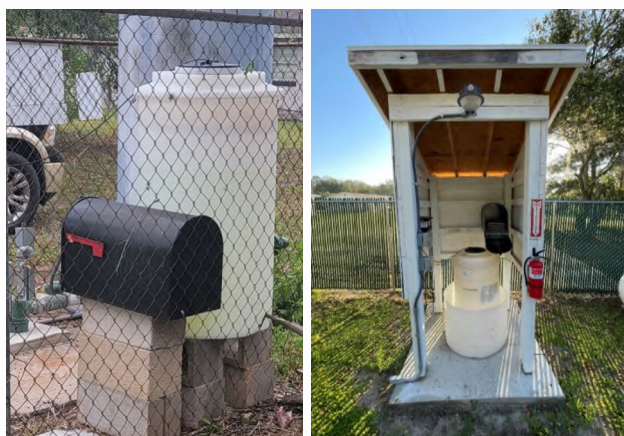
4 *Before (Left) & After (Right): New Chemical containment and shade structure - Oakcrest*5 *Villas system.*

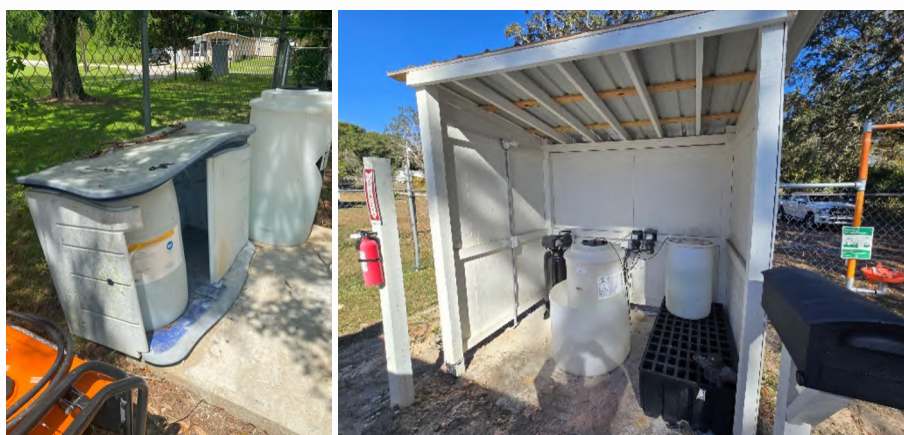
7 *Before (Left) & After (Right): New Chemical containment and shade structure - Ponderosa*8 *Pines system.*

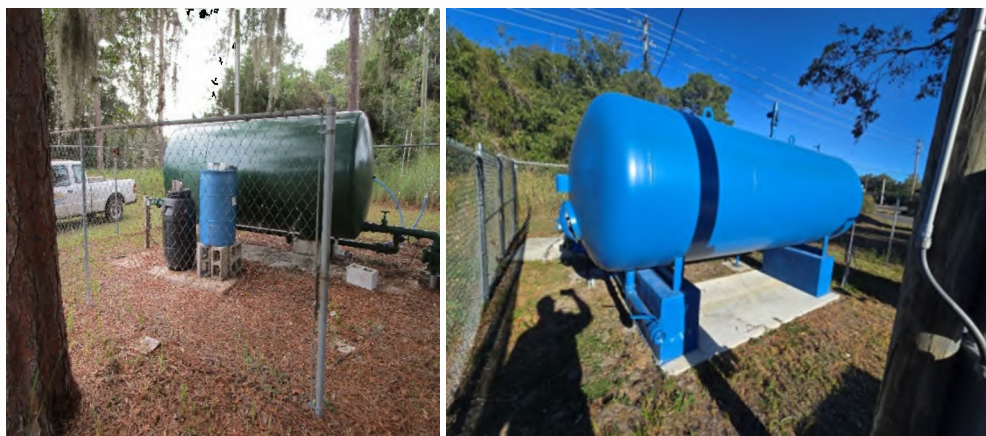
5 *Before (Left) & After (Right): Hydro-pneumatic tank replacement - Belleview Oaks Estates*  
 6 *system.*

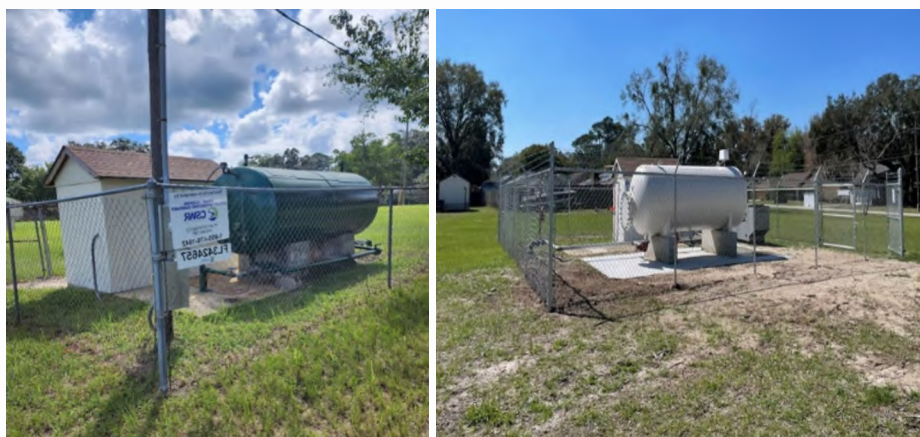
8 *Before (Left) & After (Right): Hydro-pneumatic tank replacement - Country Walk system.*

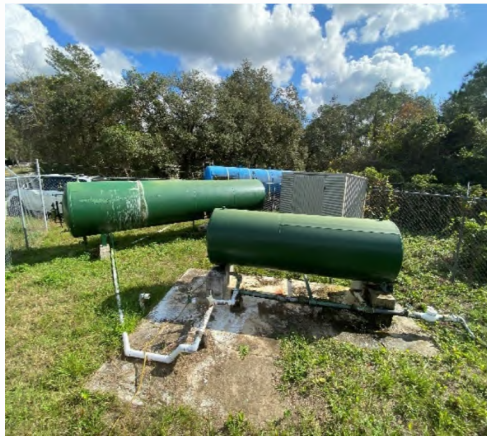
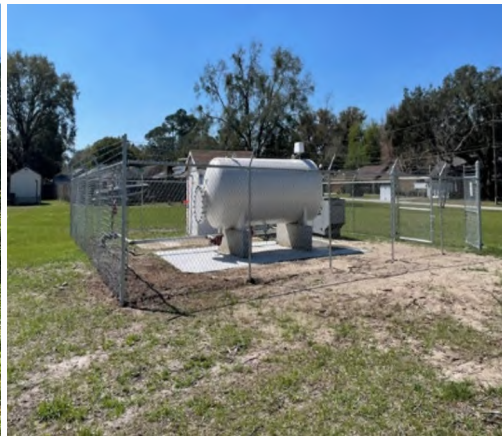
2 *Before (Left) & After (Right): Hydro-pneumatic tank replacement - Ponderosa Pines system.*

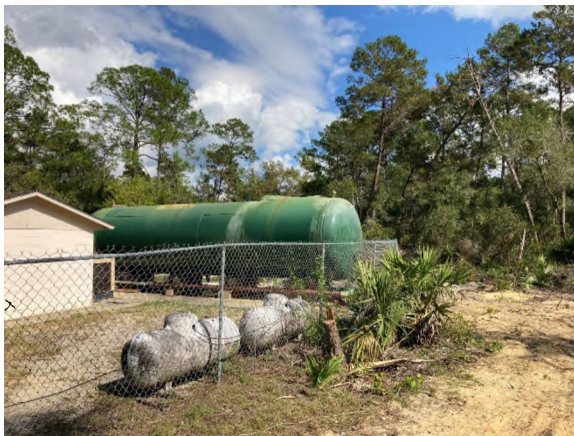
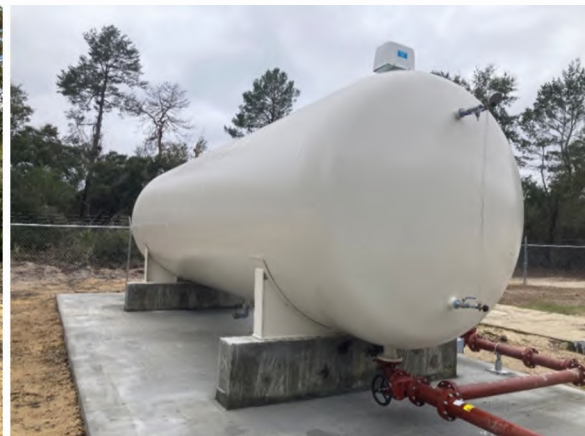
4 *Before (Left) & After (Right): Hydro-pneumatic tank replacement - Winding Waters system.*

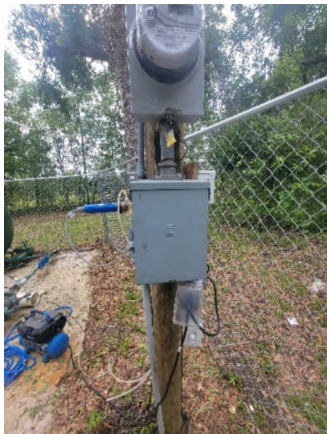
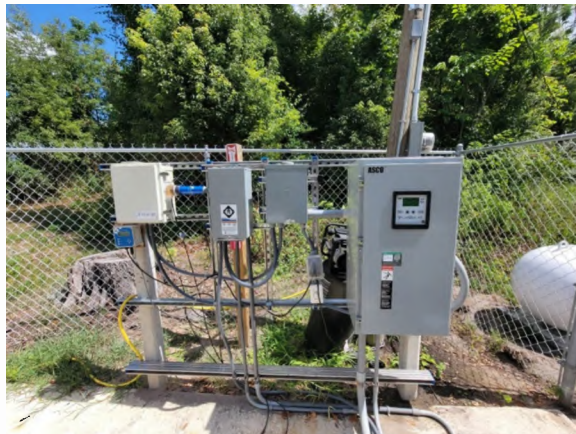
6 *Before (Left) & After (Right): Electrical Panel Improvements - Eleven Oaks system.*

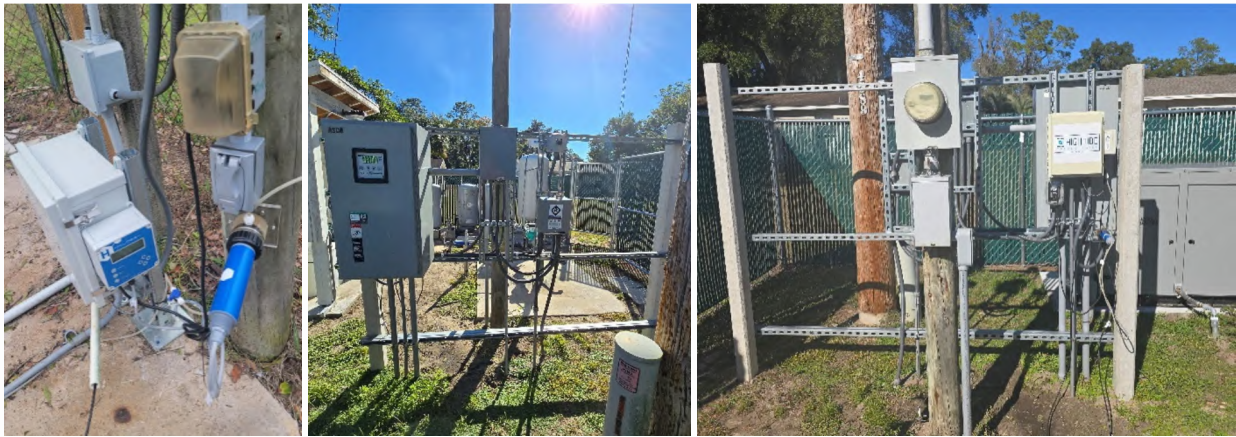
2      *Before (Left) & After (Center & Right): New Electric Panels - Oakcrest Villas system.*

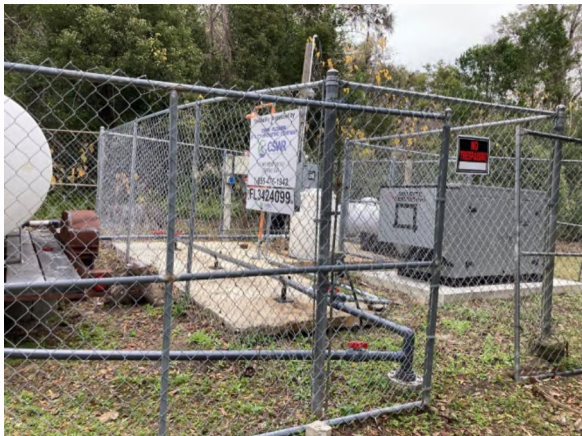
6      *Emergency generator installation - Eleven Oaks system*

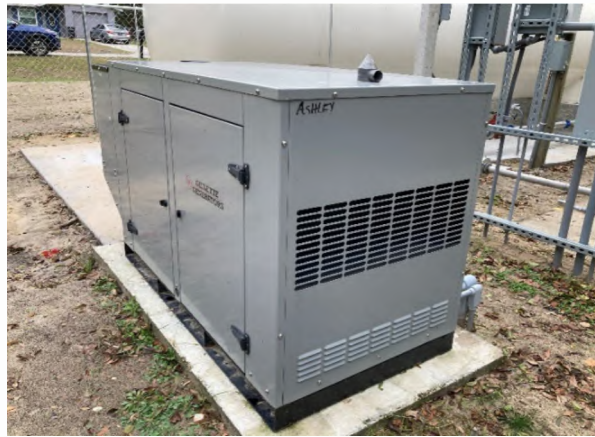
*Emergency generator installation - Ashley Heights system.*

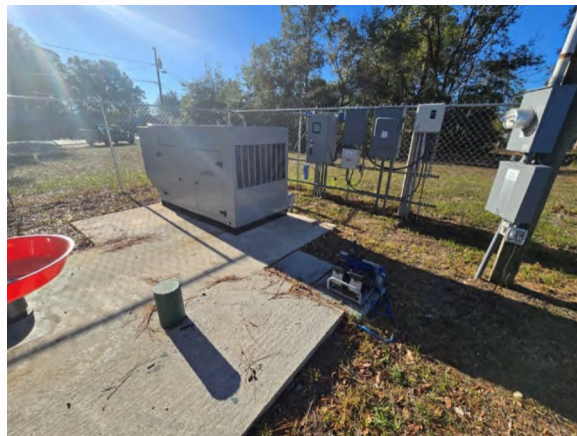
*New generator - Belleview Oaks Estates system.*
