BEFORE THE  
FLORIDA PUBLIC SERVICE COMMISSION

In re: DOCKET NO. 20250052-WS

Application for increase in water and  
wastewater rates in Brevard, Citrus, Duval,  
Highlands, Marion, and Volusia Counties by  
CSWR-Florida Utility Operating Company.

PROCEEDINGS: HEARING

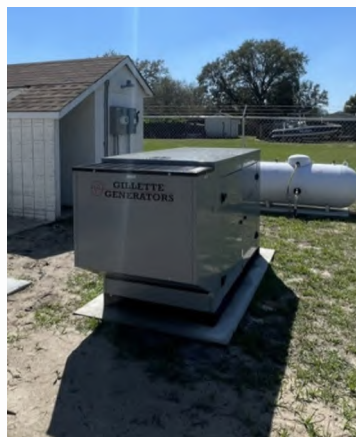
*New generator - Country Walk system.*

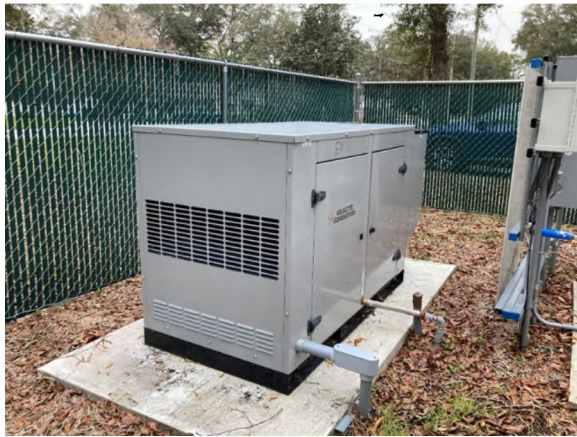
*New generator - Emil-Mar system.*

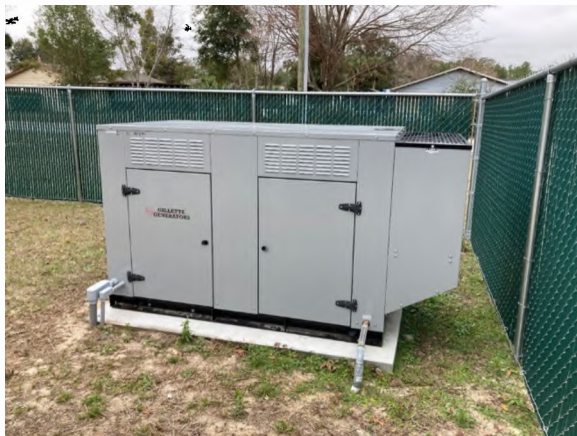
*New generator - Florida Heights system.*

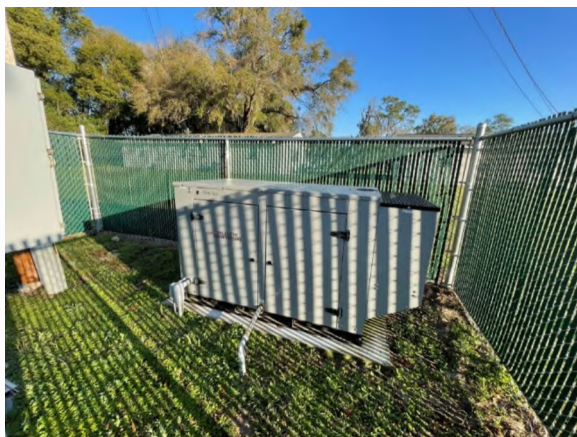
*New generator and fence - Oakcrest Villas system.*

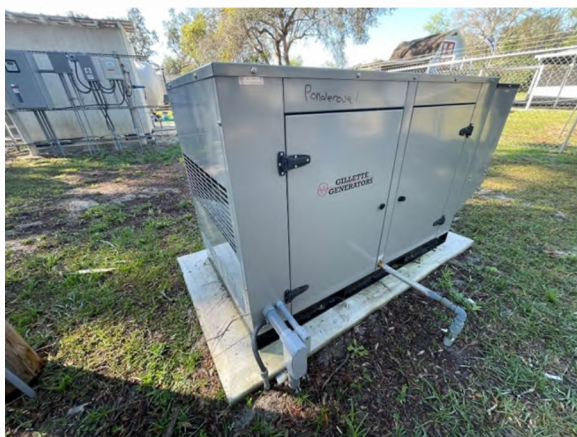
*New generator - Ponderosa Pines system.*

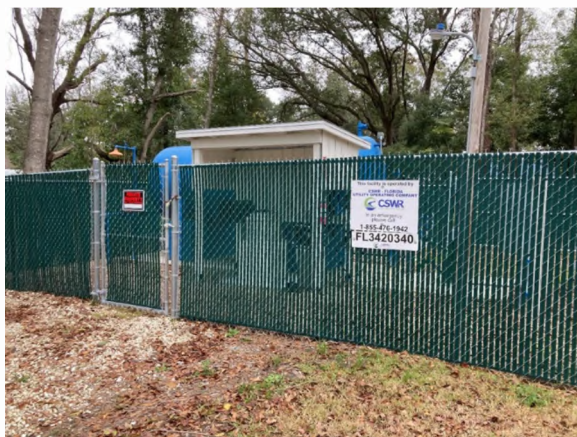
2 *New fencing - Emil-Mar system. (Note: similar fencing improvements have been made at all*  
 3 *Sunshine water sites)*

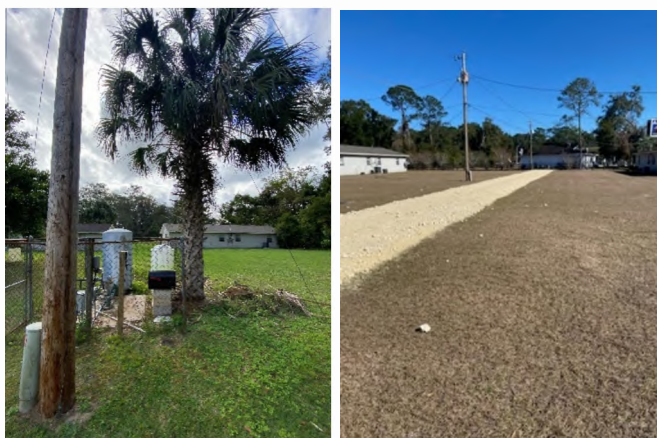
5 *Before (left) and after (right) access road installation - Oakcrest Villas system. (Note:*  
 6 *similar access road improvements have been made at all Sunshine sites where appropriate)*

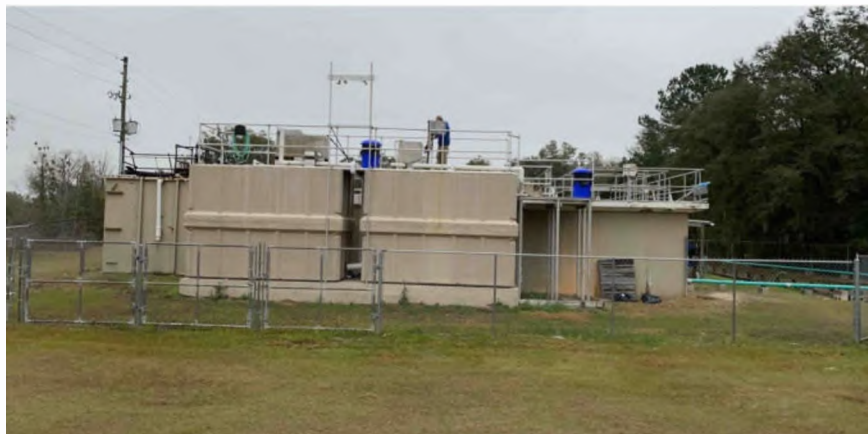
*Ground level overview photo of Landfair WWTF at acquisition.*

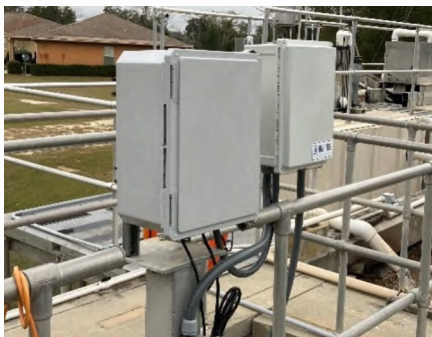
A. Improvements made to date to the Landfair wastewater system include installation of remote monitoring equipment at the wastewater treatment facility including all six lift stations. The remote monitoring unit installed at the treatment plant will be able to be moved to the new treatment facility in the future.

*Newly installed remote monitoring equipment at the Landfair facility and lift stations  
(example at treatment plant)*

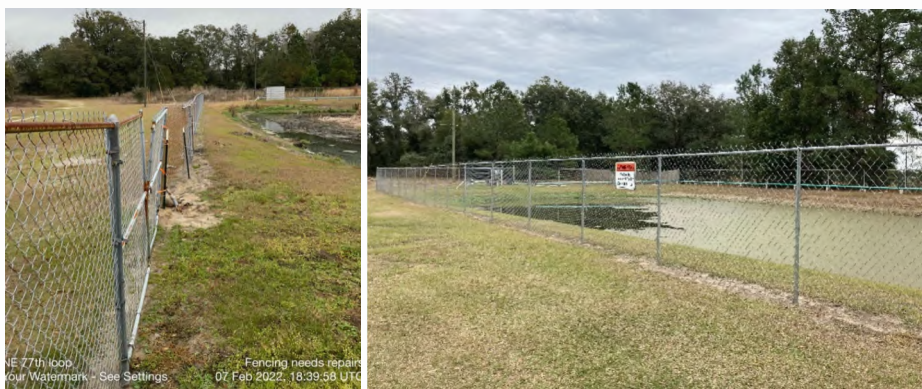
Damaged fencing was identified at the treatment facility, rapid infiltration basins, and lift stations 1 and 2. Adequate fencing is important to prevent members of the public from entering utility sites, both to protect the equipment and ensure its safe and reliable operation and to protect the public from potential injury or illness due to exposure to wastewater and wastewater equipment. To ensure site security and public safety all fencing has been repaired.

*Example of damaged (left) and repaired (right) fencing at the Landfair treatment facility.*

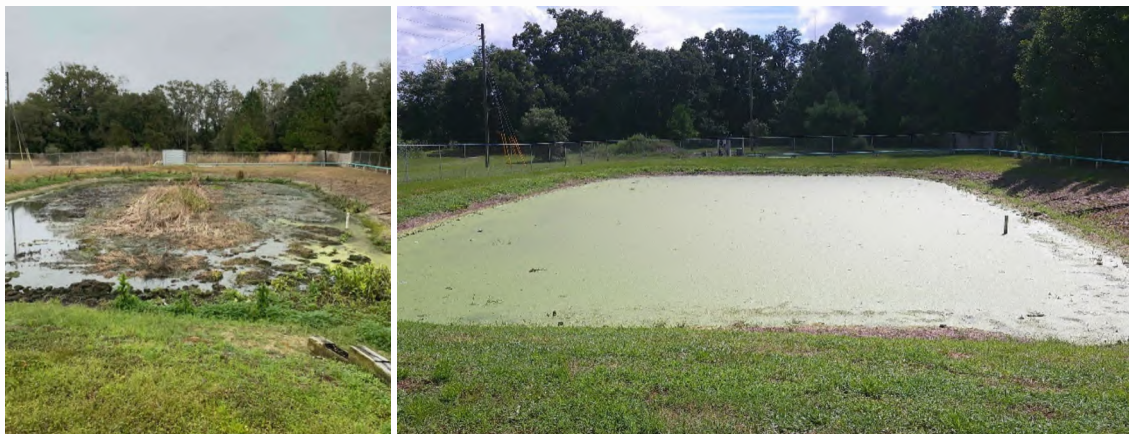
1 properly maintain the holding pond for treated wastewater, allowing significant sludge  
2 accumulation and vegetation growth in the holding pond. As required by the current  
3 Consent Order, CSWR Florida immediately cleaned the holding pond and has  
4 maintained it since taking acquisition.

5  
6 *Condition of holding pond before (left) and after (right) improvements by CSWR Florida.*

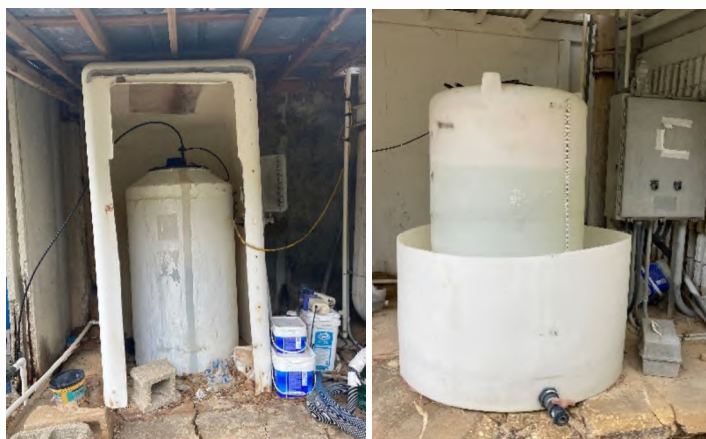
7 At acquisition, no spill containment was present for the sodium hypochlorite  
8 disinfection chemicals. This means if a spill occurred the chemicals could flow freely  
9 on and into the ground, potentially damaging the environment or exposing operators to  
10 disinfection chemicals. A spill containment drum was installed to contain potential  
11 spills of the chemicals.

12  
13 *Sodium hypochlorite storage before (left) and after (right) addition of spill catching drum.*

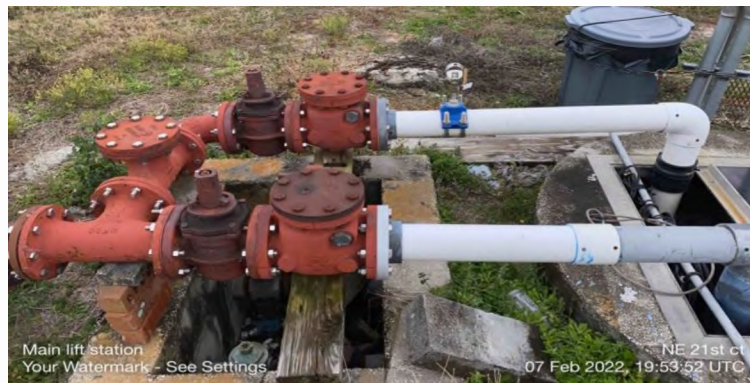
1 stations. Portions of the aeration apparatus in the aeration basin were not functioning  
2 properly, indicating damage to some of the drop pipes and diffusers. These needed to  
3 be repaired to maintain proper function of the treatment facility until the plant  
4 replacement can be completed. The discharge and bypass piping of the main lift station  
5 were in very poor condition at the time of acquisition, with rusting piping and damaged  
6 valves supported by stacks of loose brick and rotting wood. The piping has been  
7 replaced to ensure proper function and to prevent a support failure resulting in service  
8 interruption.

9  
10 *Main lift station piping at acquisition with brick and rotting wood supports.*

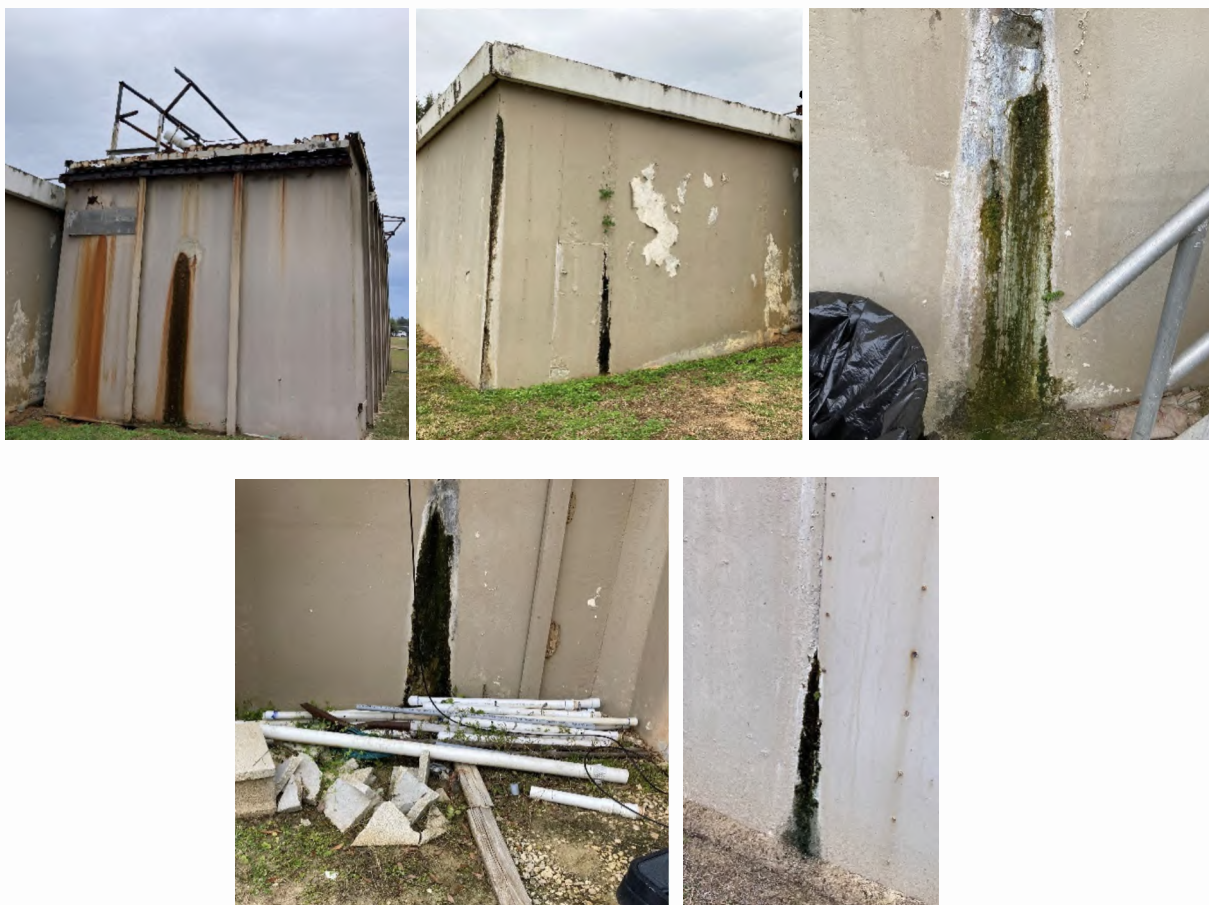
1 third-party engineering partners evaluated the facility and determined that the tanks  
2 could not be cost-effectively repaired or refurbished and had reached the end of their  
3 useful lives. These issues related to poor tank condition were present on both the  
4 system's steel and concrete treatment tanks. Numerous active leaks were present on  
5 the tanks, which had persisted for some time and had been addressed only through  
6 ineffective attempts at patching leaks. In addition, there is significant algal and  
7 bacterial growth on tanks exteriors where leaks have occurred. Examples of the leaks  
8 and damage to the facility's treatment tanks can be seen below.

10  
11 *Examples of leaks on the steel (top left) and concrete (all other photos) tanks with ongoing*  
12 *leaks evident by ineffective patching and significant growth of algae and rust accumulation*  
13 *below leaks.*

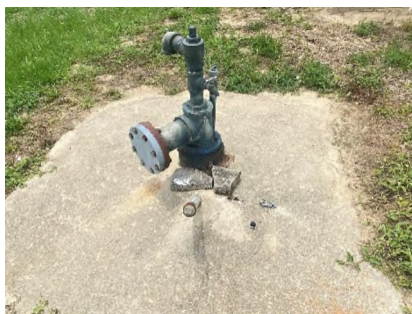
14 A. To date, CSWR Florida has completed several improvements to the Landfair drinking  
15 water system. First, the out of service well was properly decommissioned. Proper  
16 decommissioning of wells is important to prevent potential contamination of  
17 groundwater and to eliminate tripping hazards from the utility site.

19 *Out of service well now properly decommissioned and removed.*

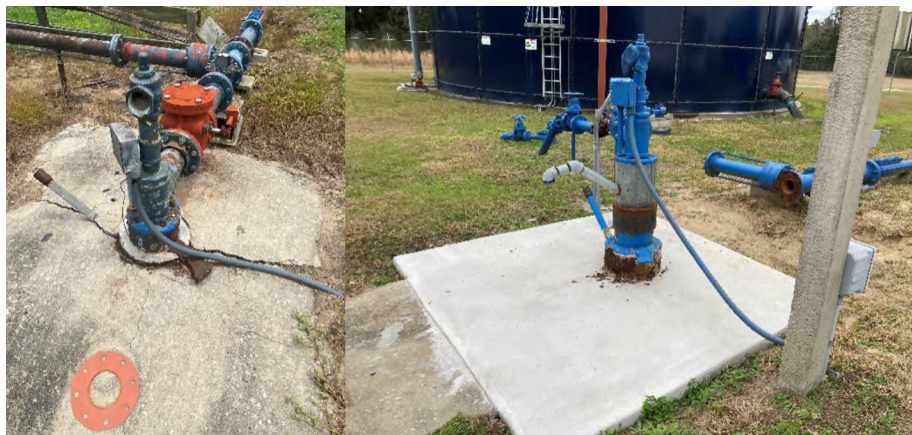
20 The well pad for well 2 has been replaced, and flow meters have been installed  
21 on both active wells. Active flow metering allows for greater operational awareness

3  
4 *Well pad for well 2 before (left) and after (right) replacement. Well piping has also been*  
5 *replaced and well casing will be rehabilitated with future well reworking.*

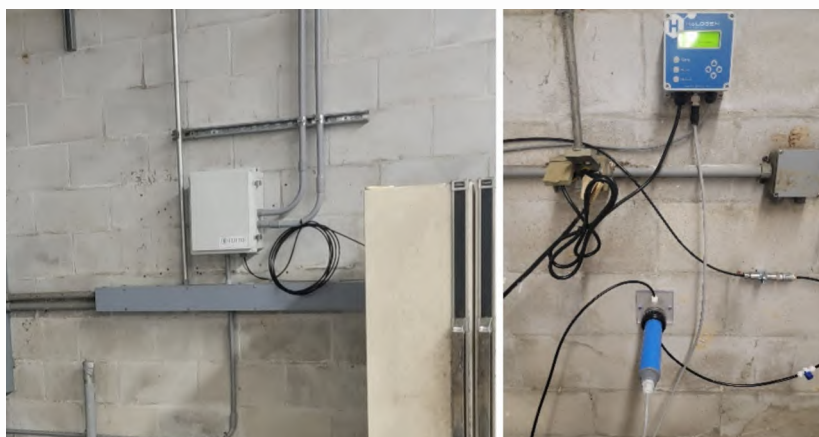
8 Remote monitoring equipment has been installed at the water site. With the  
9 installation of the remote monitoring equipment, a continuous chlorine analyzer was  
10 also installed. These analyzers actively monitor to ensure that adequate chlorine  
11 residual is maintained in drinking water, which prevents bacteriological contamination  
12 issues in the drinking water and reduces manual testing requirements.

*New Remote monitoring unit (left) and continuous chlorine analyzer (right).*

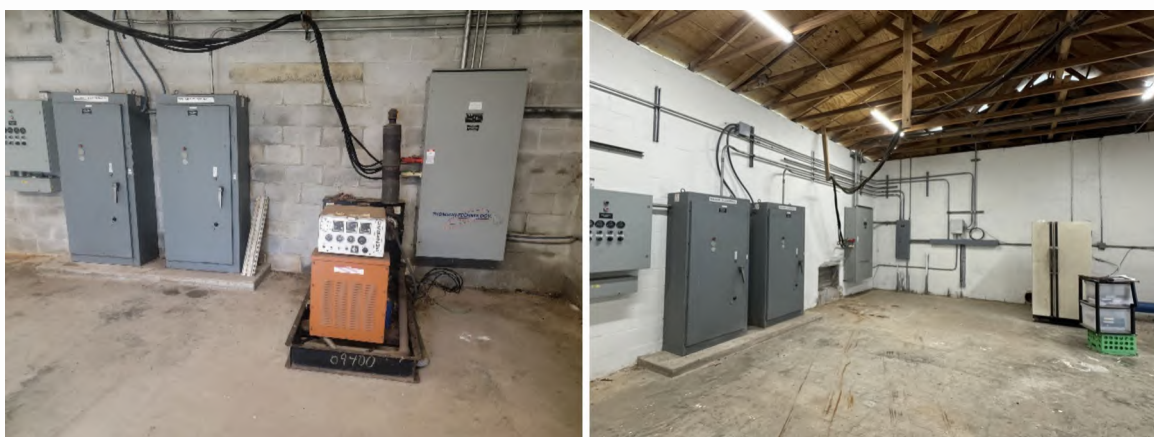
*Before (left) and after (right) removal of stationary generator. Also note painting of building interior.*

The out of service stationary generator has been removed so that, in the future, a new stationary generator can be installed. Once a new stationary generator is installed, the mobile generator that currently is permanently connected to the system can be disconnected so that it can be mobilized to provide emergency power to the nearby Landfair wastewater treatment facility and any of the lift stations in its collection system during power outages.

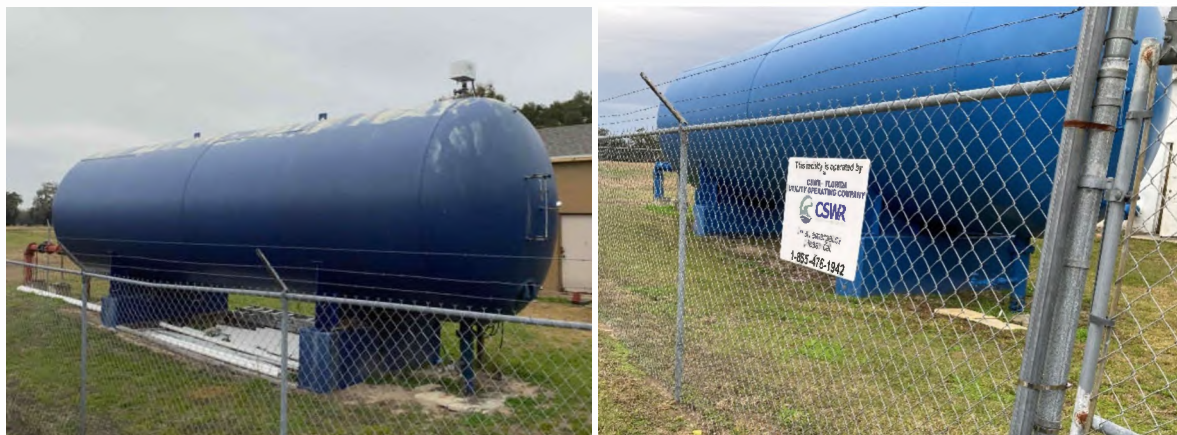
- 3  
4 *Hydro-pneumatic tank before (left) and after (right) recoating.*

- 1 extend the useful life of the equipment. CSWR has worked to recoat the tanks, piping,  
2 and structures on the site, where needed.

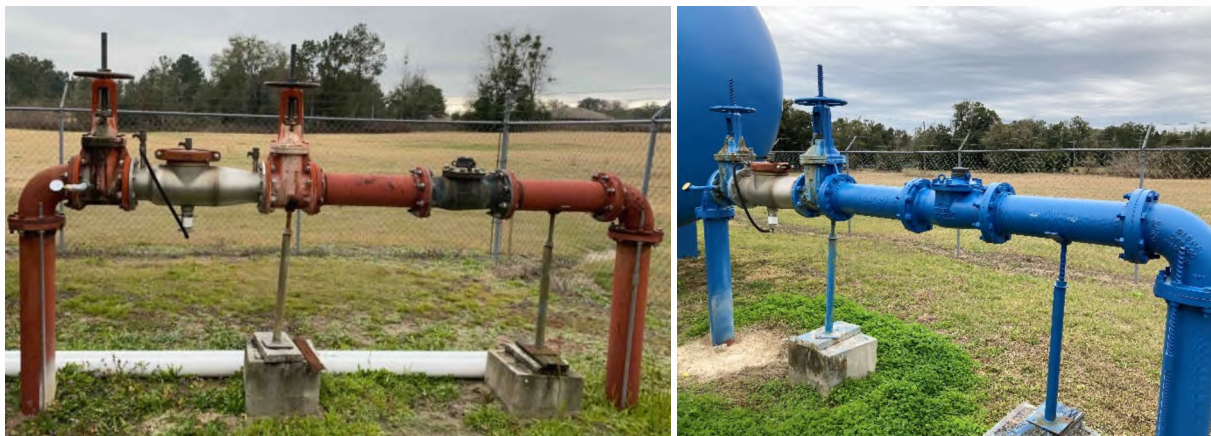
Much of the equipment, piping, and structures on the site had either deteriorating protective coatings or lacked such coatings entirely. Maintaining paint and coatings on equipment is important to prevent deterioration due to exposure and to

- 5  
6 *Examples of piping and valves before (left) and after (right) recoating.*

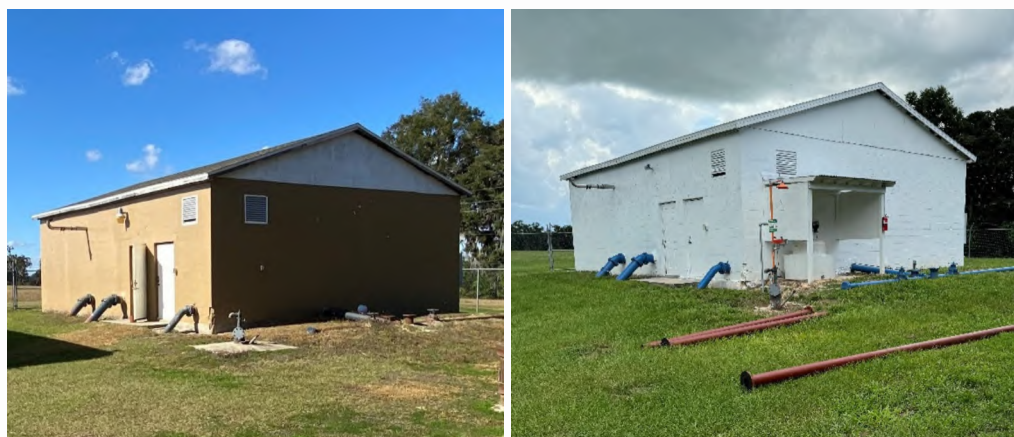
- 7  
8 *Treatment, pumping, and control building before (left) and after (right) recoating.*

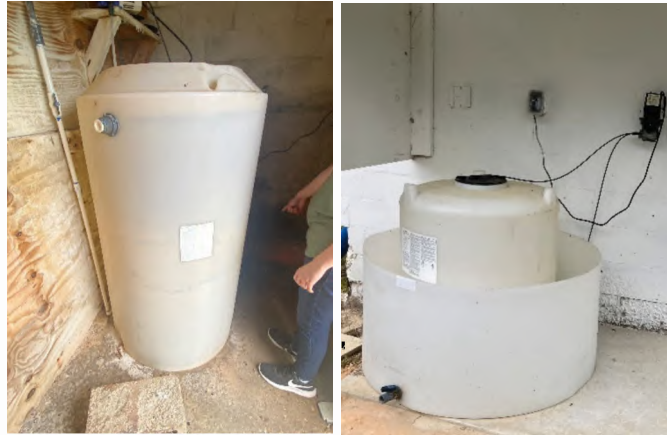
form of chemical containment. Without proper containment, spilled chemicals can cause damage to the environment, present a hazard to operators, or damage equipment. CSWR Florida has installed chemical containment at the water system site.

*Chlorine storage before (left) and after (right) installation of spill containment.*

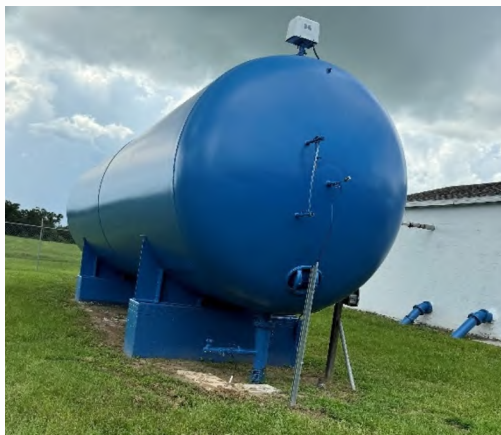
- The surge tank and control panels for booster pumps were in poor condition.
- The system's hydropneumatic tank was not properly certified and cannot be recertified due to age. Additionally, the hydropneumatic tank is massively oversized for the system, meaning ongoing maintenance costs would be much higher than for an appropriately sized tank.

3 *Oversized uncertified hydropneumatic tank to be replaced with appropriately sized and*  
 4 *certified tank.*

**A.** Despite what has been done thus far, further improvements are needed at the Landfair drinking water system to ensure the facilities are in a safe and operable condition, that the facility can satisfy regulatory requirements, and to ensure the facilities can be properly and efficiently maintained moving forward. As I previously mentioned, the existing hydropneumatic tank has several issues that need to be addressed. The tank was never properly certified for drinking water use and cannot be properly certified now due to the tank's age. Additionally, the tank is oversized for the system. A water system that has both ground storage and a booster pump system does not require large amounts of pressurized storage. Consequently, the cost to maintain the larger tank will be excessive over time compared to an appropriately sized tank. For these reasons CSWR Florida plans to replace the existing hydropneumatic tank with a 5,000-gallon

1 tank that has proper certification for use in drinking water.

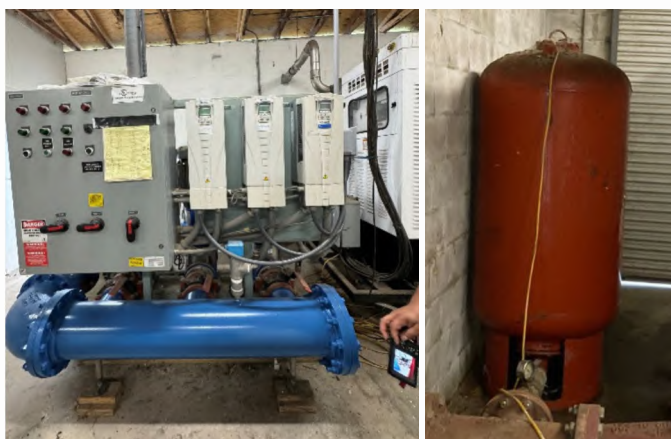
5 The control systems and surge tank connected to the booster pump system are  
 6 in poor condition due to age and poor maintenance practices. The surge tank is rusted,  
 7 has deteriorating coatings and is unnecessary due to the variable frequency drives  
 8 (“VFDs”). To ensure the system can function properly, CSWR Florida will replace the  
 9 controls and the surge tank.

11 *Booster pump control system (left) and surge tank (right)*

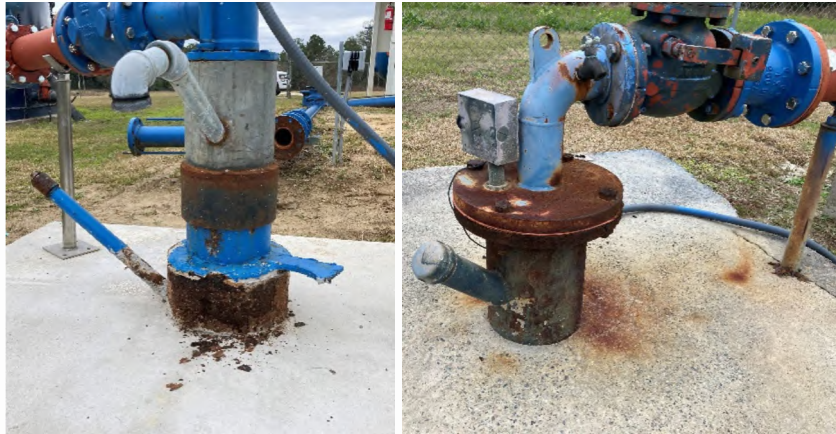
1 appropriate. In addition, immediately notable issues include rust to the exposed well  
 2 casings, damaged above ground piping and equipment coatings, and potentially  
 3 underperforming well pumps. CSWR Florida will perform the required evaluations  
 4 and will make whatever repairs, upgrades, or refurbishments are required.

5  
 6 *Well 2 (left) and well 3 (right) showing rusting on well columns, damaged coatings on*  
 7 *attached equipment, exposed wiring, etc.*

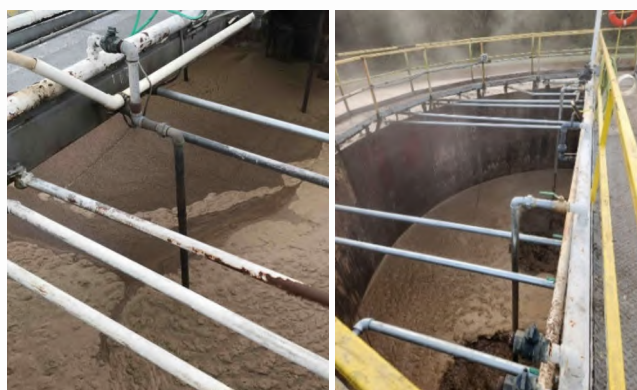
21 A. Improvements have been made to the facility's aeration equipment. A damaged air  
22 header for the digester was replaced. Leaking air headers reduce the air supply (in this  
23 case to the digester), which impedes the breakdown of sludge, resulting in higher  
24 sludge hauling costs. Deteriorated drop legs and diffusers have been replaced, and  
25 areas where drop legs and diffusers had been removed previously and not replaced had

new drop legs and diffusers installed. Deteriorated or removed drop legs and diffusers reduce the efficacy of aeration treatment by creating poor diffusion patterns, reducing air flow in leaks, and creating uneven aeration in basins. Restoring the aeration system will result in greater oxygen transfer to water, which improves biological treatment processes, improves mixing and mechanical breakdown of wastewater solids, and eliminates dead spots where mixing does not occur and solids can accumulate in the aeration basin, which results in reduced treatment capacity. A failed blower motor was also replaced to restore treatment effectiveness and facility resiliency by allowing for greater air supply and blower redundancy in the event of blower failures and during maintenance activities.

*Examples of Aeration headers and drop pipes before and after replacement.*

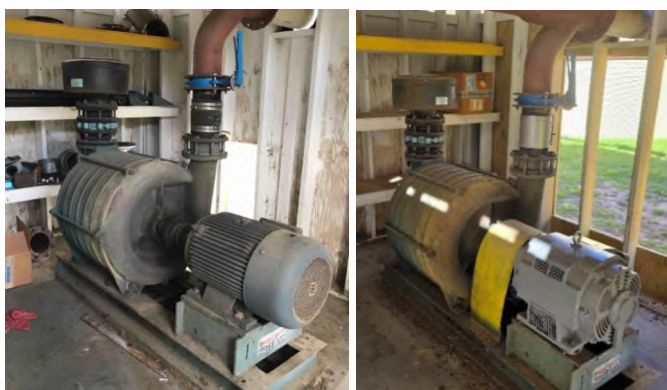
*Blower motor before (left) and after (right) replacement, also repair work to blower building underway at time of photo.*

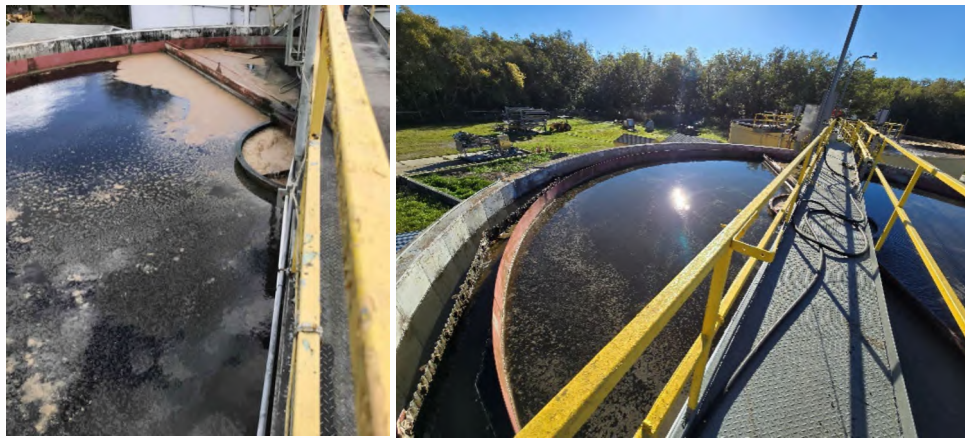
8  
9 *Clarifier with excessive floating solids before repair (left) and clear following repair (right).*

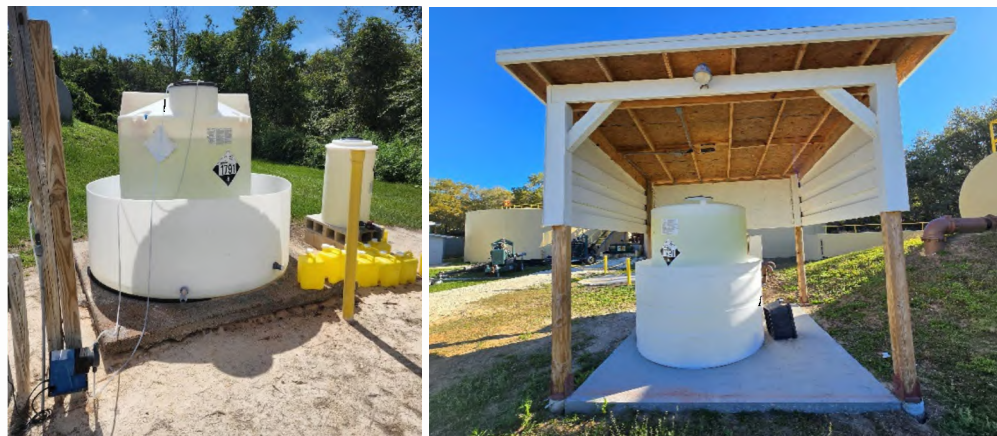
*Chemical storage before (left) and after (right) improvement.*

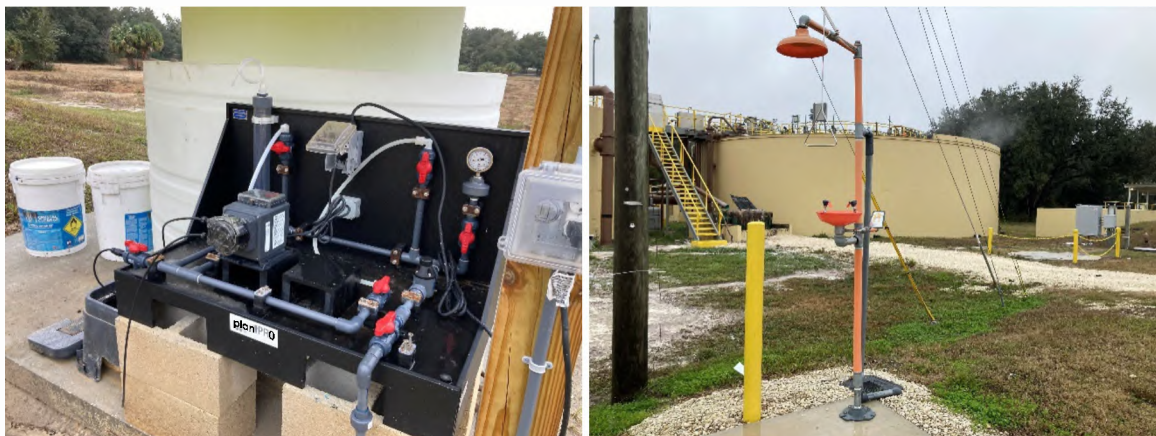
12 A. As I previously noted, at acquisition the disinfection system lacked any sort of shade  
13 structure over the disinfection chemicals (sodium hypochlorite), and the feed system  
14 used a continuous rate dosing pump. With no shade structure the chemical drum is  
15 exposed to ultraviolet light in sunlight, which leads to a breakdown in the potency of  
16 disinfection chemicals, which requires higher dosing rates and higher chemical costs.  
17 A continuous dosing rate system also leads to higher chemical costs because it does not  
18 adjust chemical dosing based on factors such as time of day or active flow rate through  
19 the disinfection system. CSWR Florida has installed a new shade structure and a new

*New variable chemical dosing pump (left) and emergency chemical shower and eyewash station (right)*

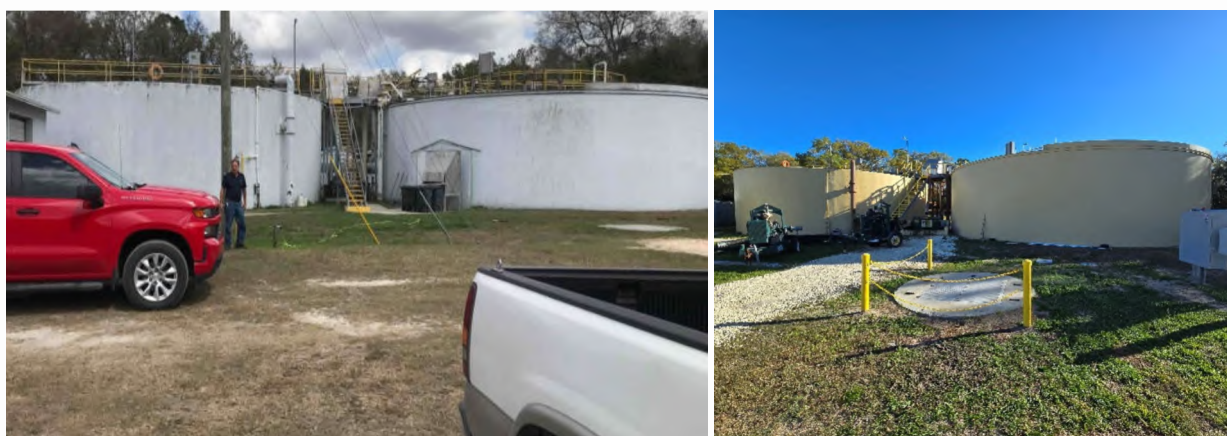
*Facility tanks before (left) and after (right) recoating.*

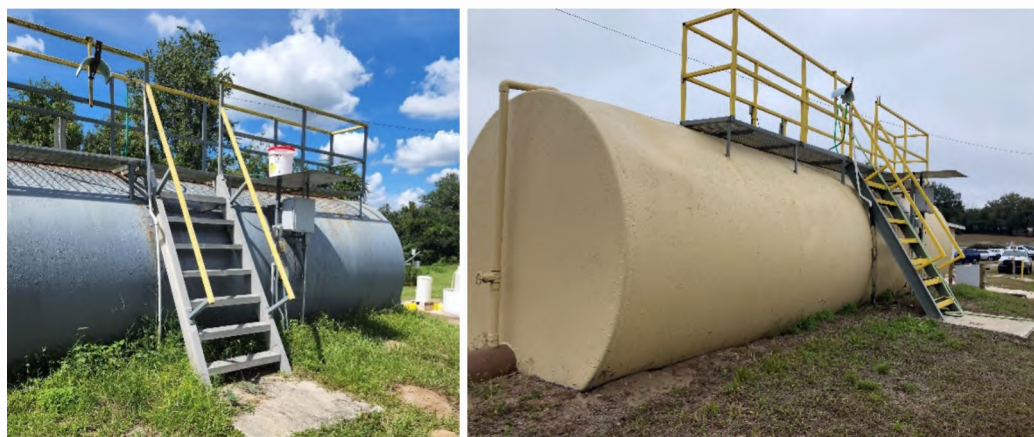
condition on the blower building, damaged or missing handrails and catwalks around the treatment facility, and deteriorating coatings on the facility's tanks, pipes, and other equipment. Repairs and regular maintenance of basic facility structures like these are important to protect equipment and materials stored within. Handrails and catwalks are essential to operator safety. Structure and equipment coatings are essential to protect equipment and halt corrosion processes that can lead to failures and reduce useful life. CSWR Florida has made the appropriate structure repairs, recoated all tanks, structures, and appropriate equipment, and made repairs and improvements to the catwalk and handrail systems, including repainting all handrails and stairs in high visibility coatings to enhance operator safety.

*Disinfection mixing tank before (left) and after (right) recoating and repainting handrails*

1 *and stair treads.*

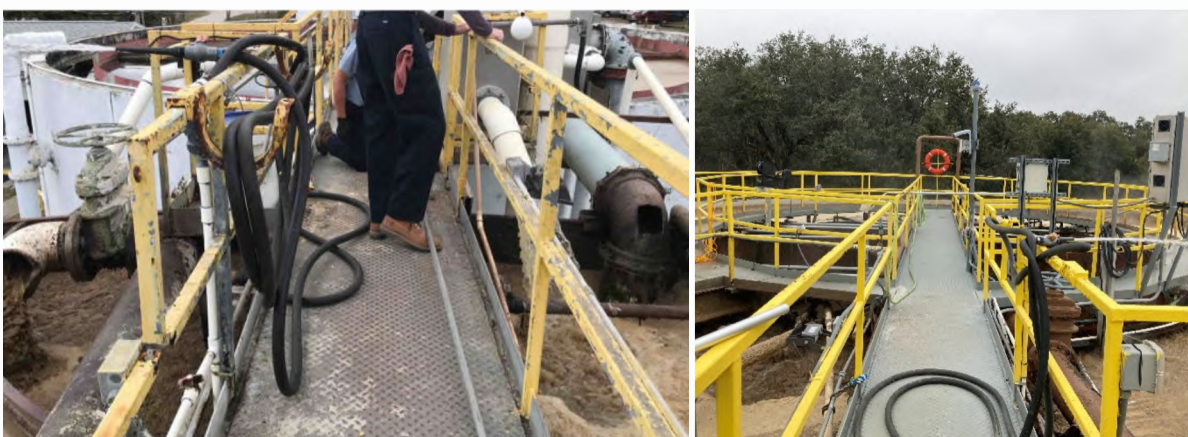
7 *Typical condition of catwalks and rails before (left) and after (right) improvements.*

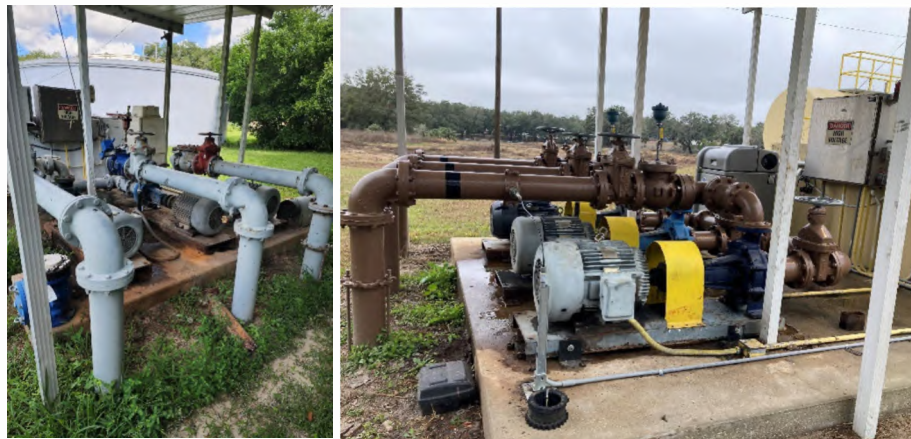
*Examples of before (left) and after (right) recoated piping and equipment (effluent pumps and piping)*

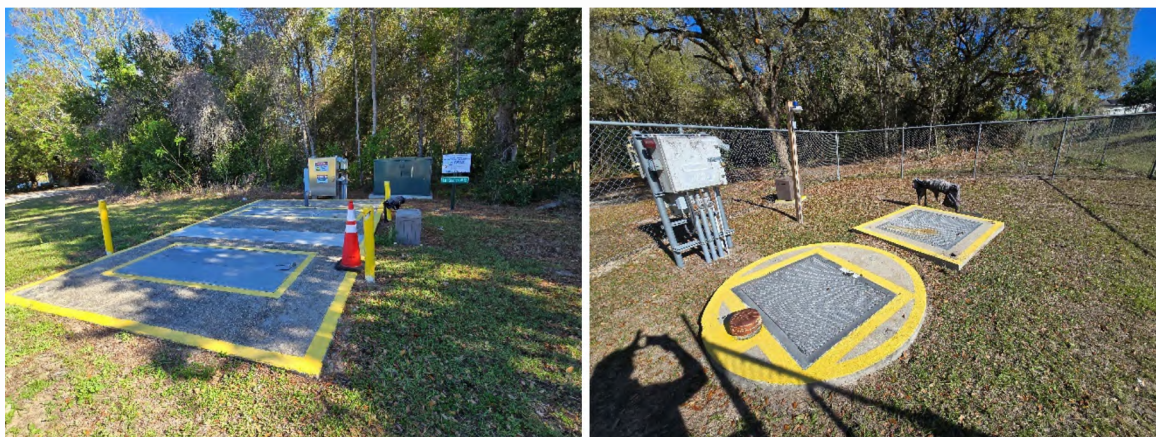
*Examples of high visibility paint application to tripping hazards.*

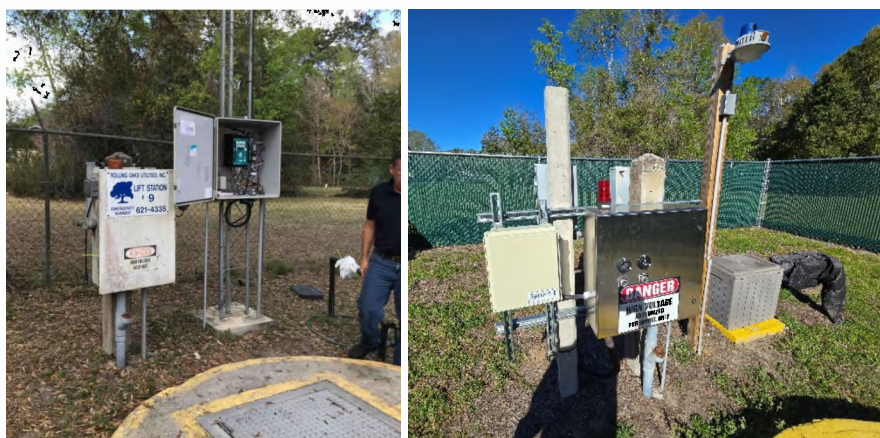
*Example of before (left) and after (right) control panel replacement at Lift Station #9. Note remote monitoring unit to the left of the new panel installed as well to be discussed below.*

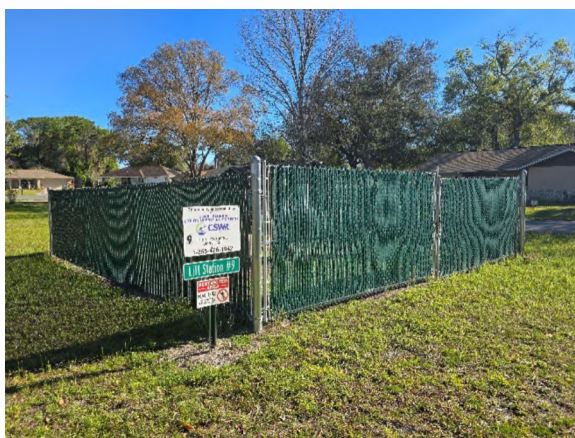
*Example of new fencing installed at lift stations.*

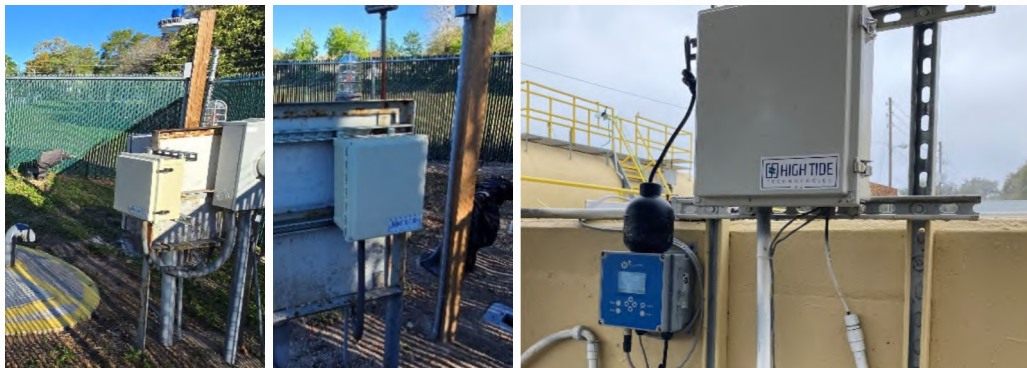
wastewater treatment facility and all lift stations. Remote monitoring equipment allows live collection of data, providing continuous information on system performance and equipment status over time allowing for more precise and efficient operations, and provides operators with real-time information concerning system performance and equipment status. This allows for immediate notifications regarding abnormal operating conditions and emergencies, which often enable operations staff to respond to and address problems before they can result in service interruptions.

*Examples of new remote monitoring equipment installed at the lift stations (left and center) and the treatment plant (right).*

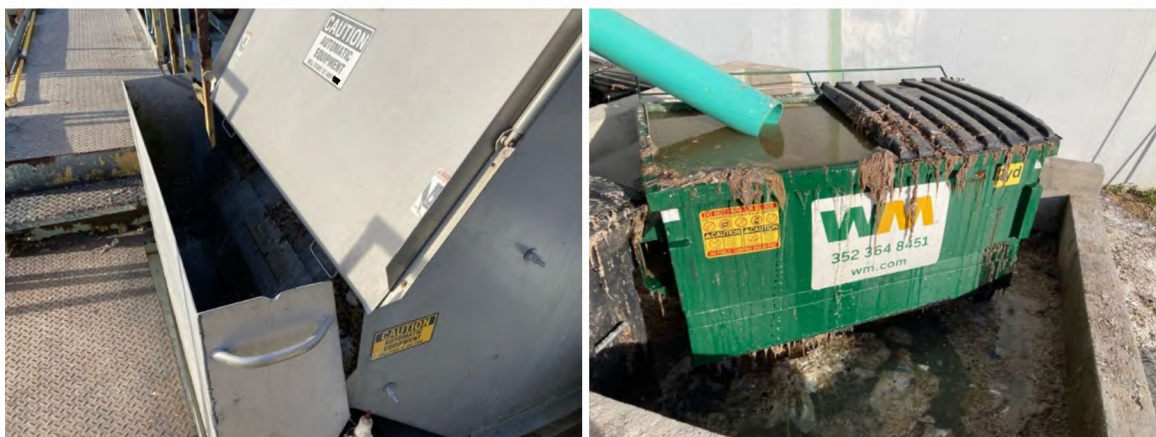
3  
 4 *Overwhelmed hydrosieve (right) resulting in overflows of wastewater at the nuisance solids*  
 5 *collection dumpster (left).*

23 treatment plant. To resolve this problem, the out of service lime stabilization basin will  
24 be converted into an influent surge basin, the existing hydrosieve will be relocated to  
25 this tank, and one or two additional hydrosieves will be installed to split the flow and

1 thereby prevent the system from being overwhelmed. This will also require pumping  
 2 modifications to then convey the screened wastewater to the existing headworks.

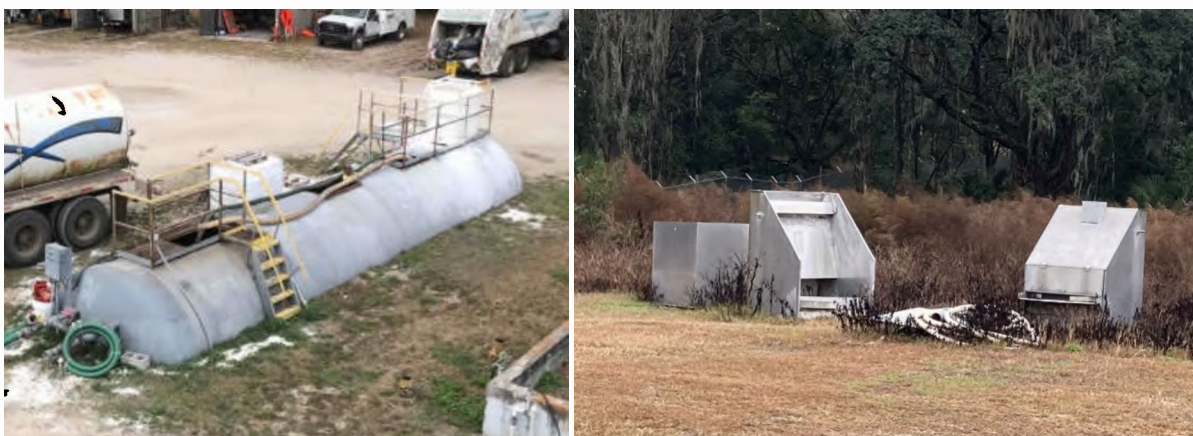
6  
 7 *Out of service lime stabilization tank to be converted to influent surge basin (left) and*  
 8 *additional hydrosieves on site to be repaired for use (right)*

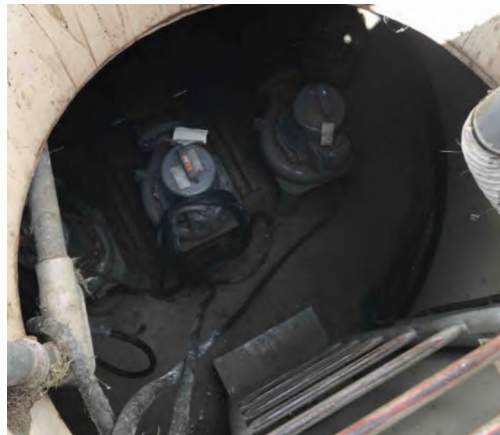
9 Additional improvements will be made to the lift stations, including the  
 10 installation of new guiderails at lift stations 5, 7, and 9 to aid in future pump  
 11 maintenance. The control panels at lift stations 3, 4, 5, 6, and 12 are in poor condition  
 12 and will be replaced to ensure reliable function. Finally, because lift station 2 is in poor  
 13 condition and is an older-style dry well lift station, it will be replaced to ensure proper  
 14 function.

*Lift station 2 dry well basin*

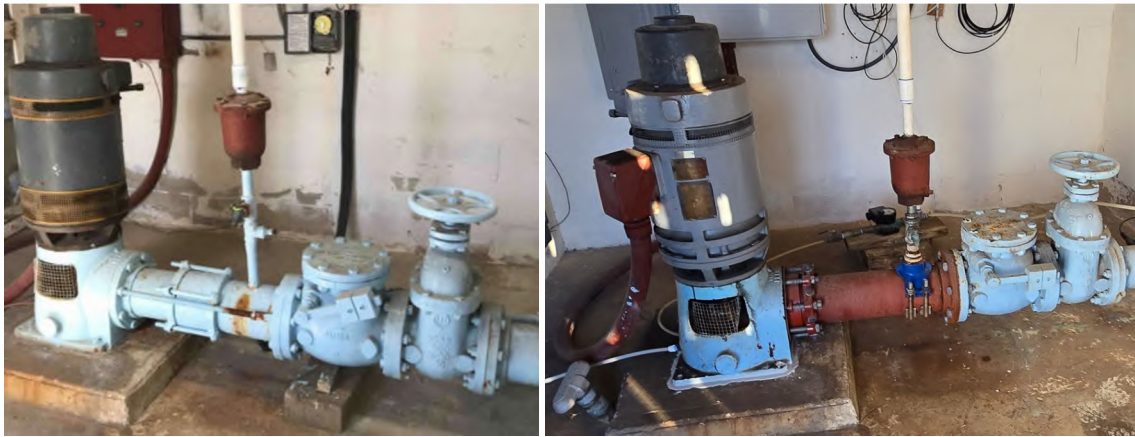
2 *Well 6 before (left) and after (right) rehab work. Motor and pump serviced, leaking section*  
3 *cf pipe replaced.*

15 A. Since it acquired the Rolling Oaks system CSWR Florida has made several  
16 improvements to the drinking water system. Due to the age of the system, all wells  
17 were due for evaluation and potentially repairs or reworking. This process began with  
18 the rehabilitation of well 6, which also included replacing the electrical system at the  
19 well house. The existing electrical controls and service were installed when the system  
20 was originally built and had reached the end of their useful life.

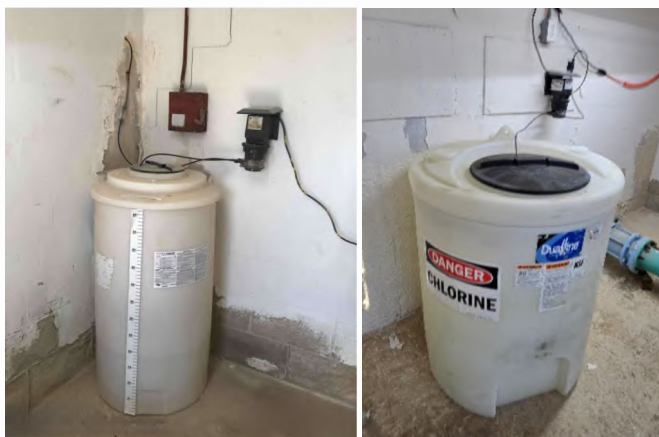
*Example of sodium hypochlorite drums before (left) and after (right) replacement in this cast at Well 6.*

6 All sodium hypochlorite drums at the well sites were single wall drums with no  
7 spill containment. Due to the limited space for containment in the well houses, single  
8 walled drums were replaced with double walled drums at all nine well sites to help  
9 reduce the risks of spills and to contain spills that occur.

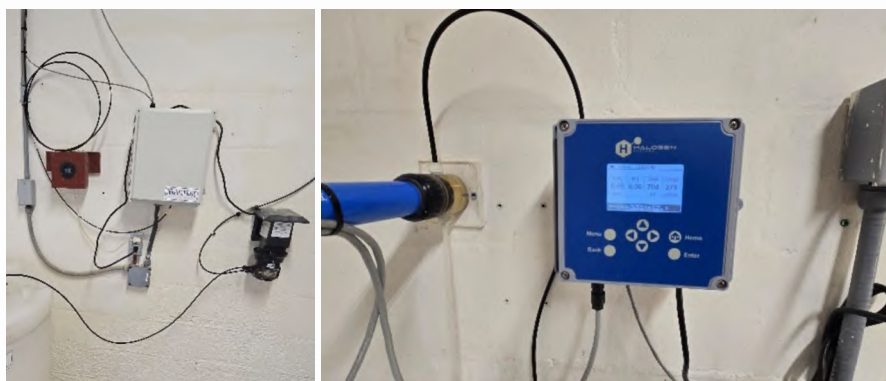
*Examples of remote monitoring unit installed at each well site (left) and new chlorine residual monitoring equipment installed at each well site (right) (examples from Well 8 site).*

At acquisition, the well sites lacked remote monitoring and chlorine residual monitoring equipment. Remote monitoring equipment and a continuous chlorine analyzer have been installed. These analyzers actively monitor to ensure adequate chlorine residuals are maintained to prevent bacteriological contamination issues in the drinking water and to also reduce manual testing requirements.

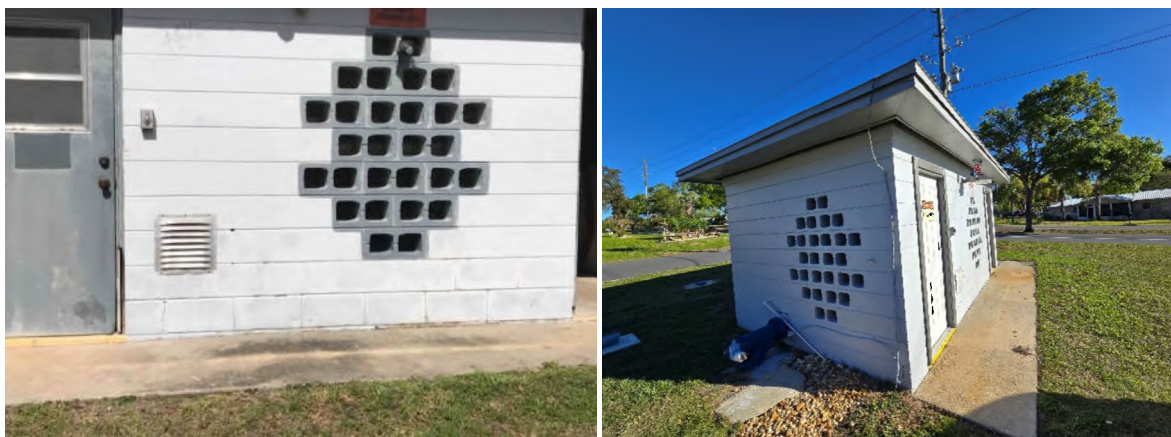
2 *Example of before (left) and after (repainting) (example is the Well 5 well house)*

Various issues with well house structures were identified that required repairs or improvements. All cinder block buildings were painted and repaired, as necessary, to ensure their longevity. The roofs of the well houses at wells 8 and 9 were in poor condition and were replaced to protect the equipment inside.

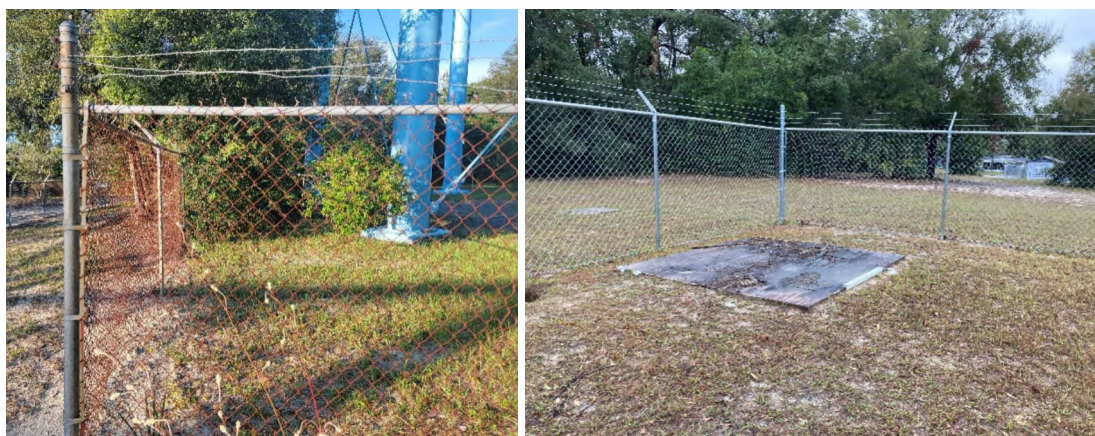
4 *Example of deteriorating (left) and replaced (right) fencing at Elevated Storage Tank 1.*
