BEFORE THE  
FLORIDA PUBLIC SERVICE COMMISSION

In re: DOCKET NO. 20250052-WS

Application for increase in water and  
wastewater rates in Brevard, Citrus, Duval,  
Highlands, Marion, and Volusia Counties by  
CSWR-Florida Utility Operating Company.

PROCEEDINGS: HEARING

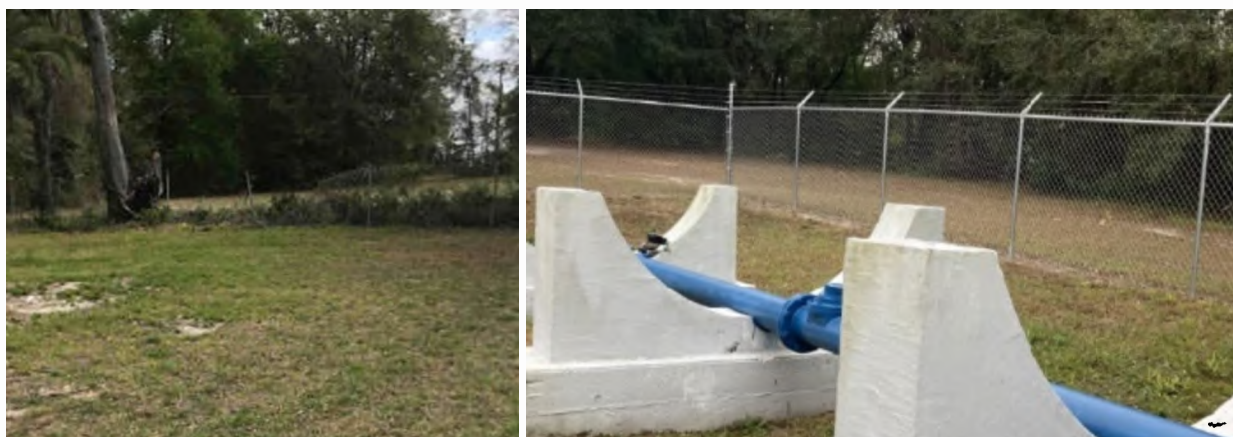
6 *Example of damaged (left) and new (right) fencing at Well 2 site.*

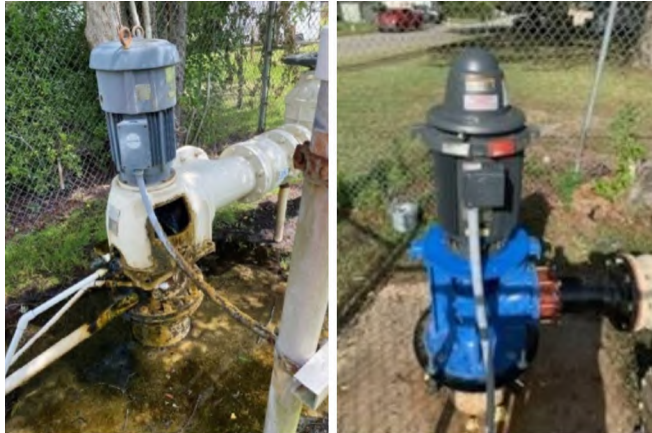
4  
5 *Well 2 pump before (left) and after replacement (right) well casing and wiring also replaced.*

23 A. CSWR Florida has already completed several upgrades and improvements to the  
24 Neighborhood Utilities drinking water system. First, because well pump on Well 2 was  
25 in poor condition and failed shortly after acquisition, CSWR Florida replaced the pump

1 to restore service to the system. Additional maintenance work was performed on the  
2 well itself, including clearing nuisance vegetation, replacing damaged piping, and  
3 installing a new flow meter.

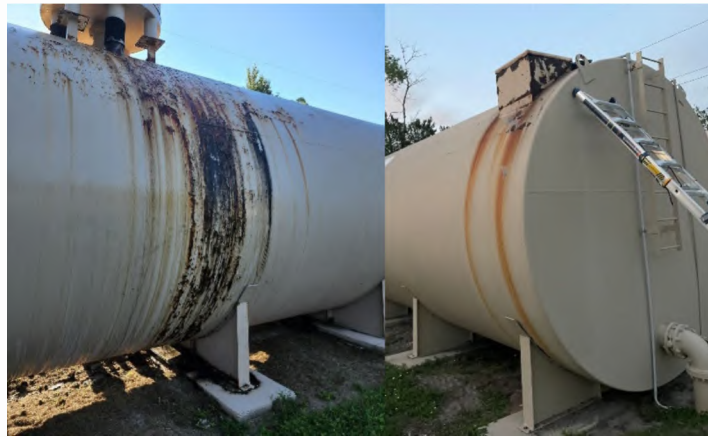
*Examples of rust on the ground storage tanks and general poor condition.*

6 Tank inspections have been completed on all tanks at the Neighborhood  
7 Utilities site. As a result, it was determined that both ground storage tanks were in poor  
8 condition and would need to be replaced. The hydropneumatic tank was found to be  
9 in fair condition, so the interior and exterior of the tank was recoated to extend its useful  
10 life. A new compressor was also installed to maintain pressure and air gap in the  
11 hydropneumatic tank. The replacement of the ground storage tanks will take time for  
12 design, permitting, equipment lead time, and construction. To address the longer-term  
13 issues related to corrosion on Tank 2 until the it can be replaced, the exterior of Tank  
14 2 was recoated.

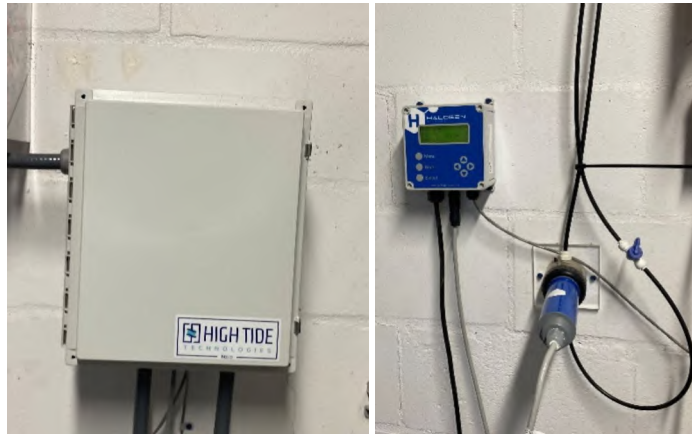
7 *Remote monitoring unit (left) and continuous chlorine monitor installed at Neighborhood*

1 monitoring equipment at both locations and installed a continuous chlorine analyzer.  
2 These analyzers ensure that adequate chlorine residuals are maintained in drinking  
3 water to prevent bacteriological contamination issues in the drinking water and reduce  
4 manual testing requirements, and the remote monitoring equipment allows operators to  
5 monitor the analyzers to ensure they are performing as required.

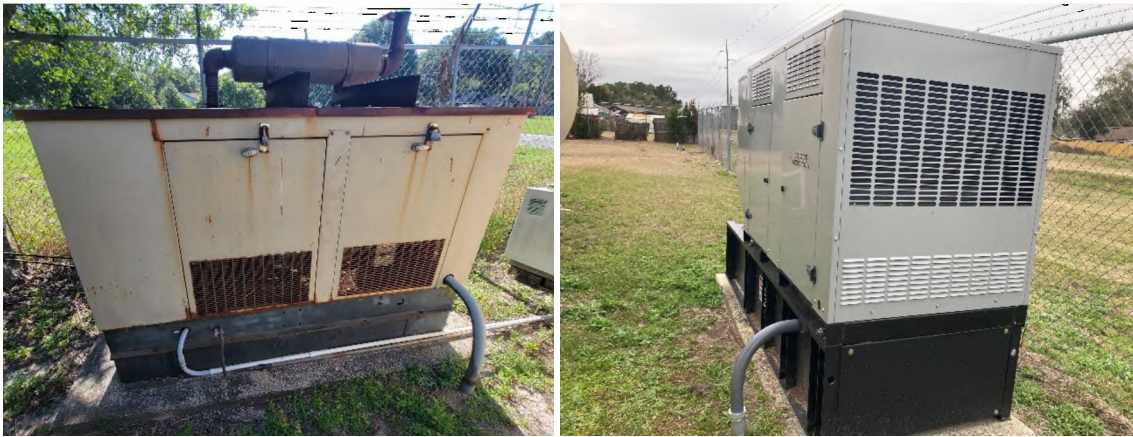
2 *Emergency generator at Neighborhood Utilities before (left) and after (right) replacement.*

9 As I discussed in the compliance section of my testimony, the emergency  
10 generator has been nonfunctional since 2017 and has resulted in numerous warning  
11 letters and a Consent Order. CSWR Florida replaced the generator to ensure the facility  
12 can deliver uninterrupted service in the event of a power outage. Flood lighting has  
13 also been installed to ensure operators can safely complete maintenance activities after  
14 dark and during emergency maintenance responses.

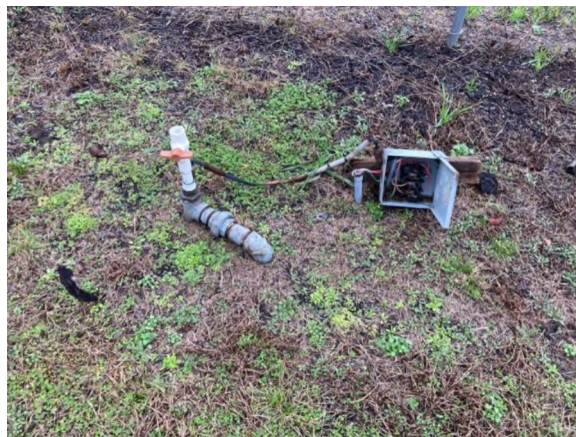
11  
12 *Well 1 needs to be properly decommissioned and removed.*

4 A. Further improvements are needed at the Neighborhood Utilities drinking water system  
5 to ensure the facilities are in safe and operable condition, that the facility can meet  
6 regulatory requirements, and that the facilities can be properly and adequately  
7 maintained. As previously testified, well 1 has been out of service for some time but  
8 was not properly abandoned by the prior owner. CSWR Florida will properly  
9 decommission and abandon the well to protect groundwater quality and eliminate a  
10 tripping hazard from the water treatment site.

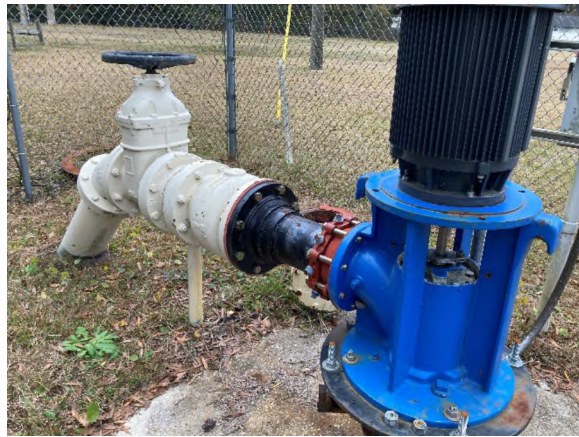
*Well 2, new piping needs to be painted, flow meter needed, etc.*

13 While the well pump and some of the piping was replaced, well 2 still requires  
14 additional rehabilitation work. The well is being evaluated to also determine if  
15 chemical treatment or subsurface casing repair is needed. A flow meter will be installed  
16 on the well and piping that has not already been coated with a protective coating yet  
17 will be properly painted. The well will also have a soft start controller installed to  
18 reduce risk of cavitation, reduce wear and tear on the motor, and reduce water hammer  
19 in the line connecting the pump to the treatment site.

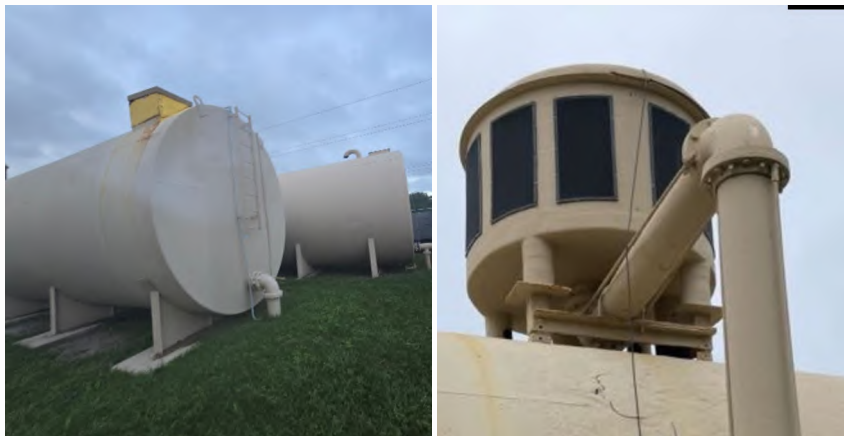
Tank 1 and tank 2 as the aeration treatment unit mounted on tank 2 are in poor condition. The two tanks will be replaced with a single, larger ground storage tank (a standpipe) and a new aeration treatment unit will be installed.

*Tanks 1 & 2 (left) to be replaced with a single larger ground storage tank and aeration treatment unit (right) to be replaced.*

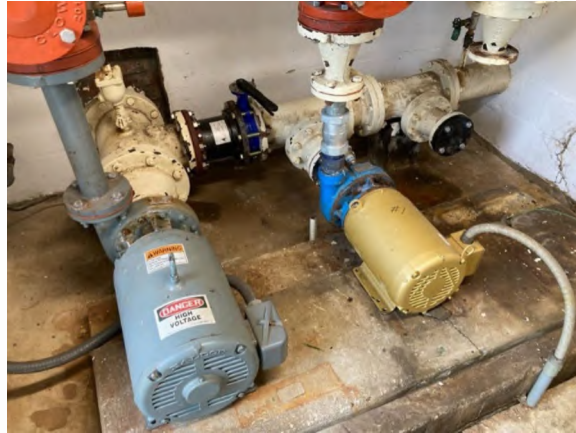
The high service pumps are in poor condition and are nearing the end of their useful lives. In addition, since closing on acquisition of the system, one of the three pumps has failed. To ensure the pumping system can continue to ensure adequate system pressure, the booster pumps will be replaced. The existing high service/booster pump system also does not include VFDs in the control system, which allows pumps to run at less than full power and allows pumps to be ramped up rather than starting at

4  
5 *Booster pumps in need of replacement, note empty pump flange from pump which failed since*  
6 *acquisition by CSWR Florida, emphasizing the poor condition of the pumps.*

1 full power. This helps to reduce power consumption, reduce wear and tear to pumps,  
2 and reduce pressure hammer when pumps turn on. CSWR Florida will install VFDs  
3 on the booster pump control system.

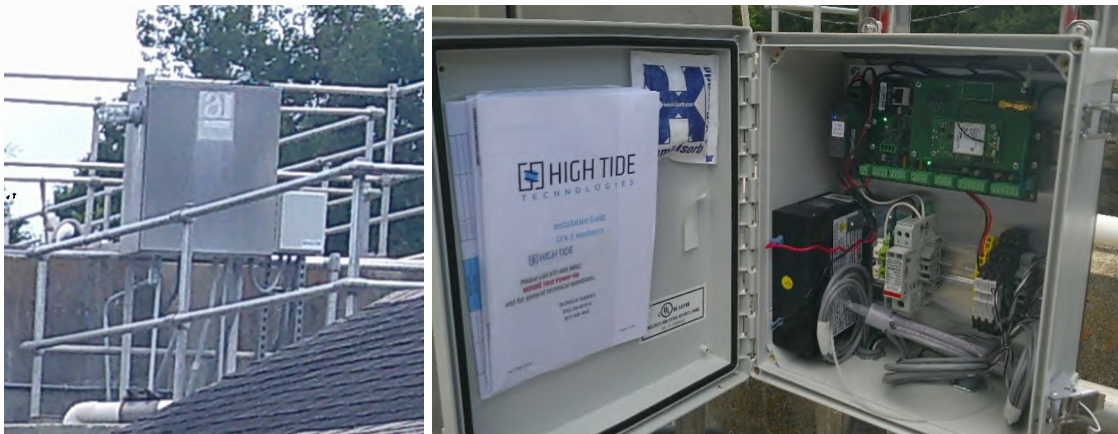
15  
 16 *Newly installed remote monitoring equipment at the Tymber Creek facility and lift stations*  
 17 *(example at treatment plant)*

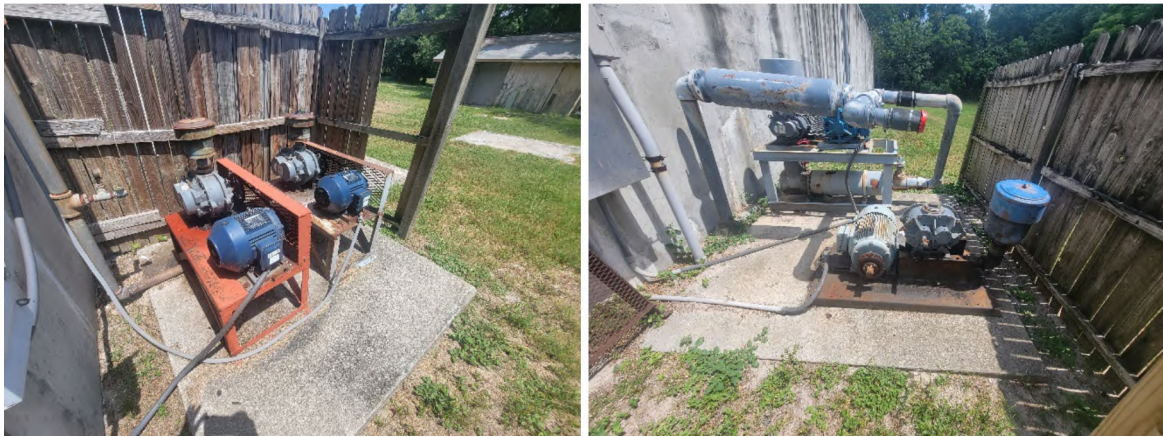
*Surge basin / digester blowers (left) and aeration basin blowers (right)*

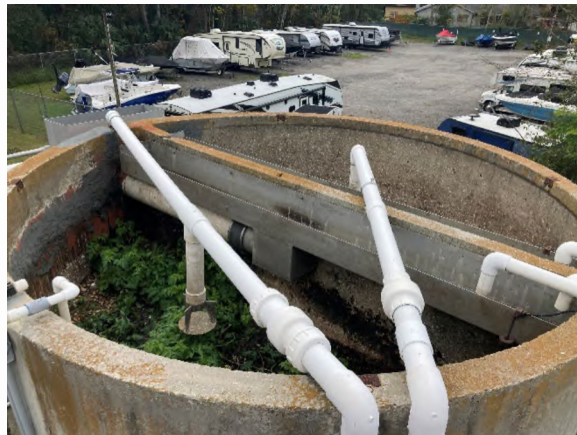
The facility's sand filters have some areas with impacted sludge preventing proper flow through the filter and allowing vegetation to grow in the filters. The sand filters provide additional removal of solids prior to discharge. The impaired function of the filters contributes to the ongoing daily maximum TSS limit exceedances. The sand filter media will be replaced to enhance solids removal.

*Sand filter with impacted sludge allowing vegetation growth.*

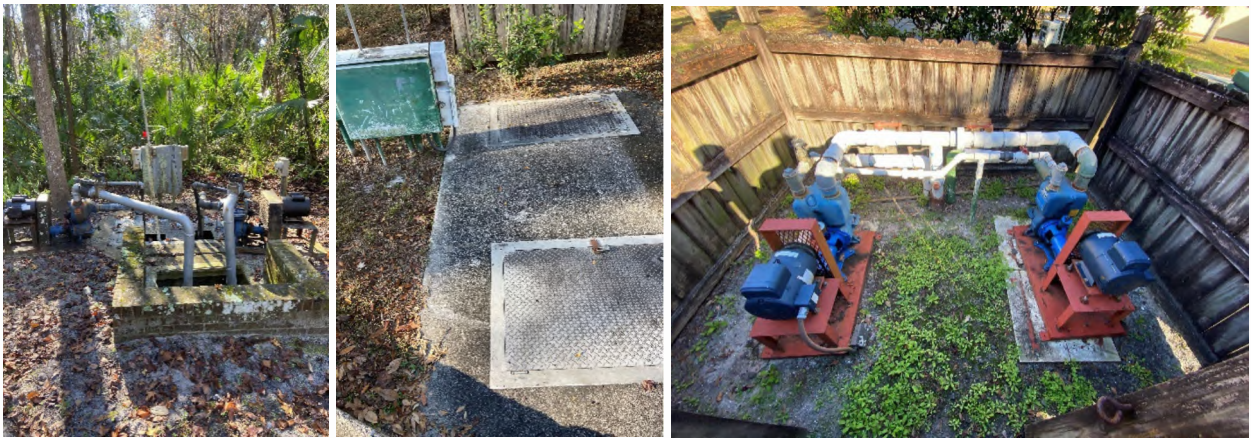
9  
10 *Lift Stations 1 (left), 2 (center), and 3 (right).*

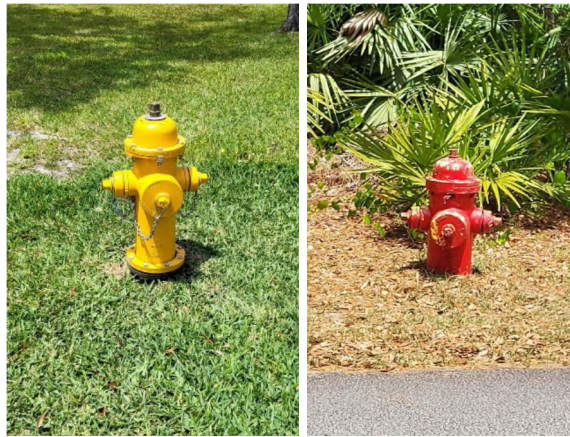
2     *Example of Tymber Creek fire hydrants (left is one replaced by CSWR Florida since taking*  
3                                     *ownership of the system right is an original hydrant).*

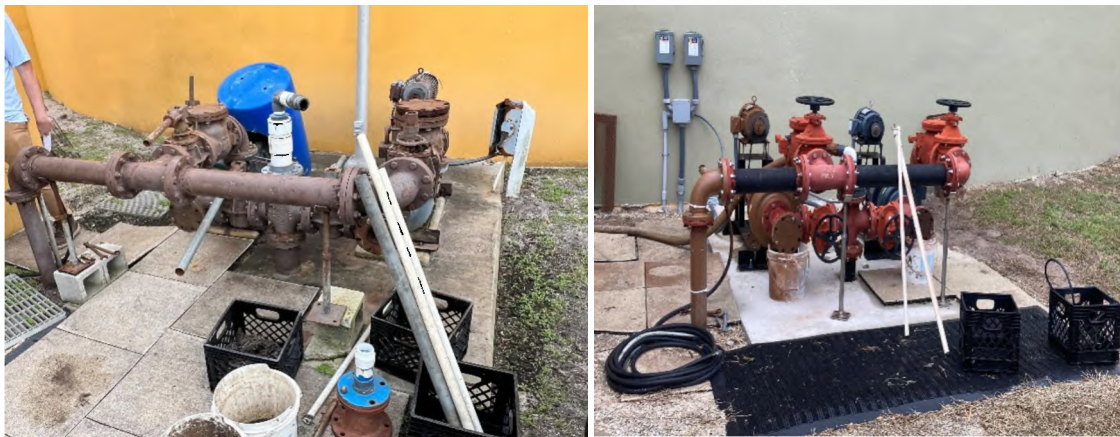
15  
16 *RAS/WAS pumping system before (left) and after(right) improvements, note both pumps in*  
17 *service, piping improvements, valve replacements, and new power supply.*

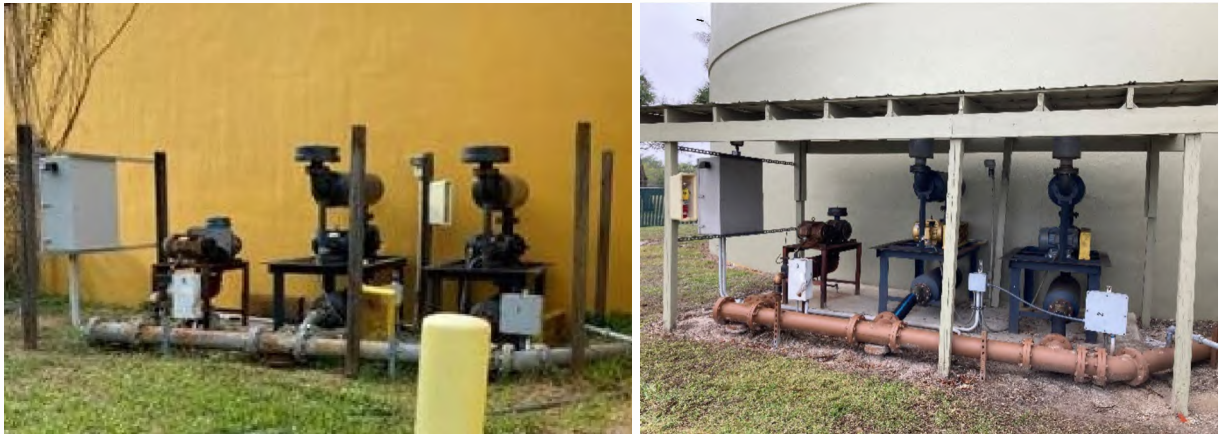
7  
8 *New Shade structure over Aquarina blowers before (left) and after(right) improvement.*

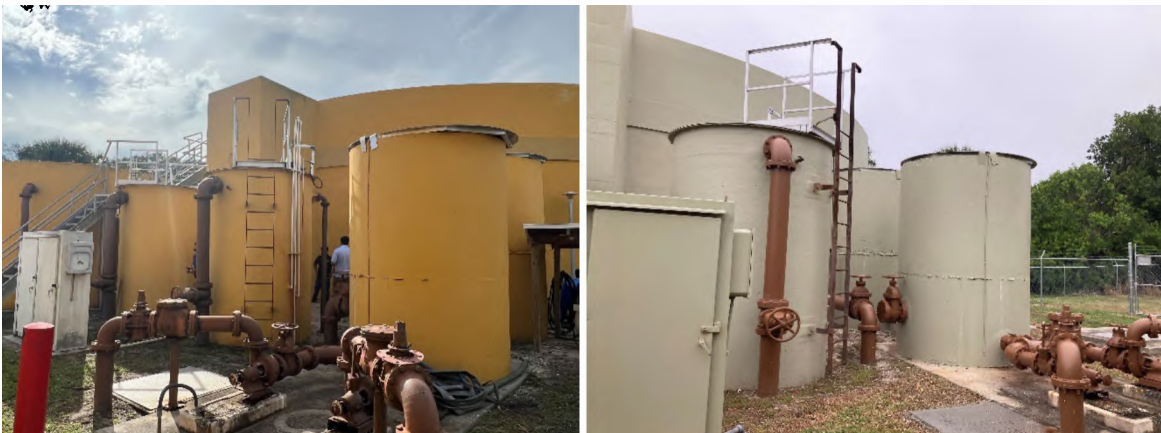
13  
14 *Treatment tanks, piping, and equipment before (left) and after (right) recoating.*

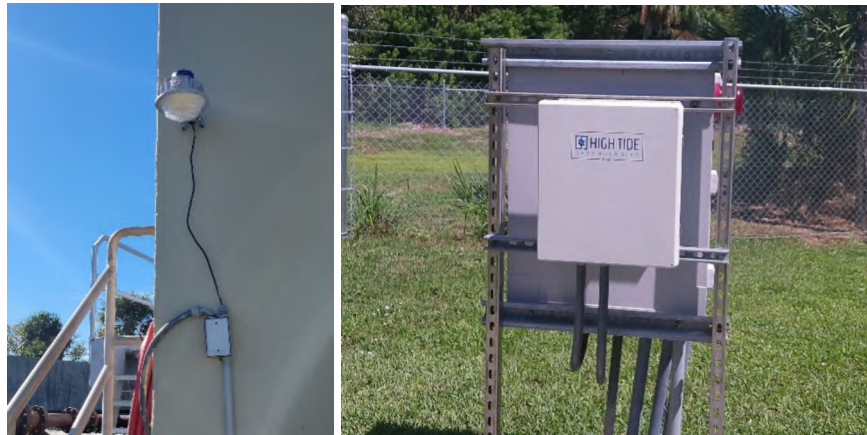
*Example of new flood lights installed for safety in after-hours operations activities (left).*

*Example of remote monitoring units installed at Aquarina treatment plant and lift stations (right).*

In addition, flood lighting has been installed at various locations at the treatment plant and lift stations. Lighting improvements ensure that operations staff can safely and effectively respond to emergency maintenance issues after dark to quickly repair items or restore service. Remote monitoring equipment has also been installed at the treatment plant and collection system lift stations. Remote monitoring equipment allows collection of data and provides continuous information on system performance over time allowing for more precise and efficient operations. Remote monitoring also provides operations staff with live information concerning system performance and equipment status. This allows for immediate identification and notification of abnormal operating conditions and emergencies, which often enables operations staff to respond and address problems before they can result in service interruptions.

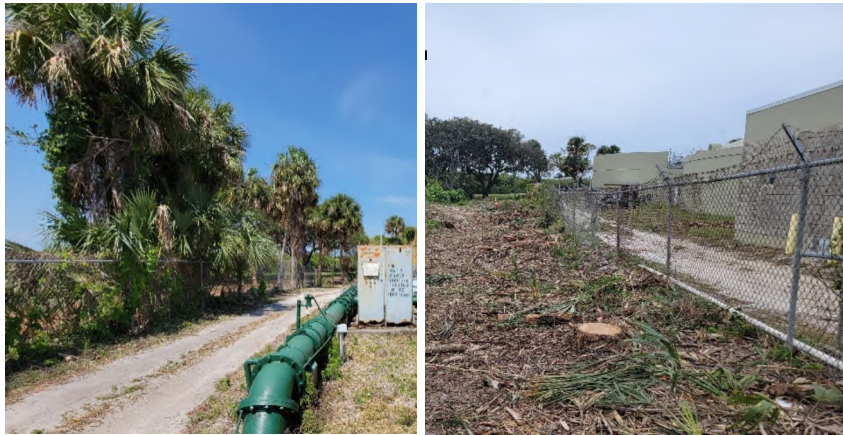
Several of the fence lines around the water and wastewater site were extremely overgrown with vegetation causing damage to the fencing. CSWR Florida has removed the nuisance vegetation and repaired the damaged fencing. Similarly, the effluent drain fields were found to be overgrown and the fencing surrounding the drain fields was

3  
4 *Fence lines damaged by vegetation overgrowth (left) and cleared fence line (right)*

1 completely overgrown. Vegetation has been removed from the drain field fence and  
2 controlled in the drain field.

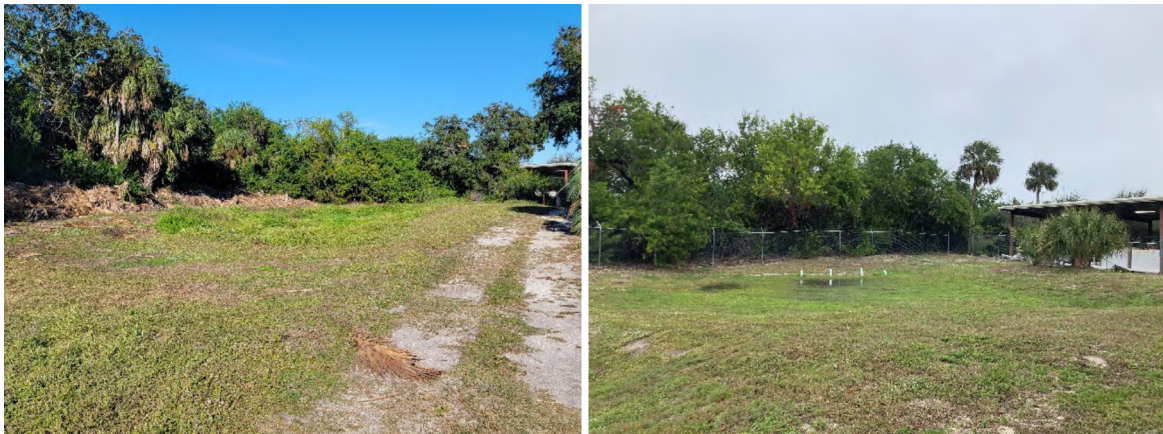
5  
6 *Fencing around drain field completely covered in overgrowth and vegetation overgrowing in*  
7 *drain basin (left). Fence line cleared and vegetation controlled in drain basin (right).*

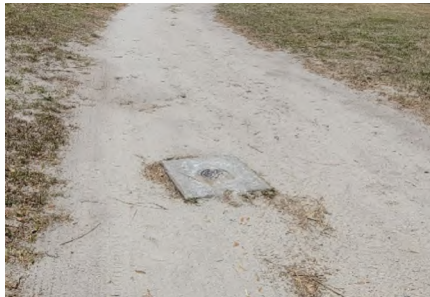
*Example of monitoring well at Aquarina wastewater system requiring replacement adjacent to drain field.*

A. Further improvements are needed at the Aquarina wastewater system to ensure consistent compliance with regulatory requirements, to ensure the facility is in a safe and operable condition, and to ensure the facility can be properly maintained. To comply with FDEP monitoring requirements, a new monitoring well must be installed in the drain field area. Monitoring wells are wells with direct access to the upper water tables that under effect of the water that infiltrates into the ground through the drain field. Testing is periodically conducted to ensure groundwater limits are not exceeded as a result of the treated wastewater discharge. In addition, because one of the wells has been consistently dry for several years, the FDEP notified the previous ownership a new monitoring well would need to be installed. The non-functioning well caused previous ownership to consistently submit groundwater sampling results that stated “No Sample Result.” Because FDEP will not accept “No Sample Result” reporting, CSWR Florida is working to install a new monitoring well as part of planned plant improvements, which will allow proper groundwater sampling to resume.

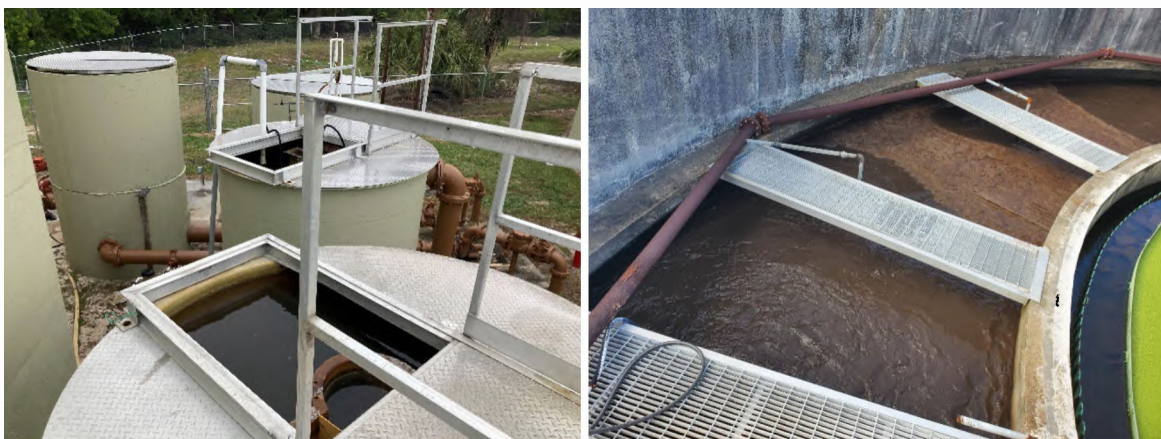
12  
 13 *Leading edges without edge protection handrails/chains or grating over open basins (left).*

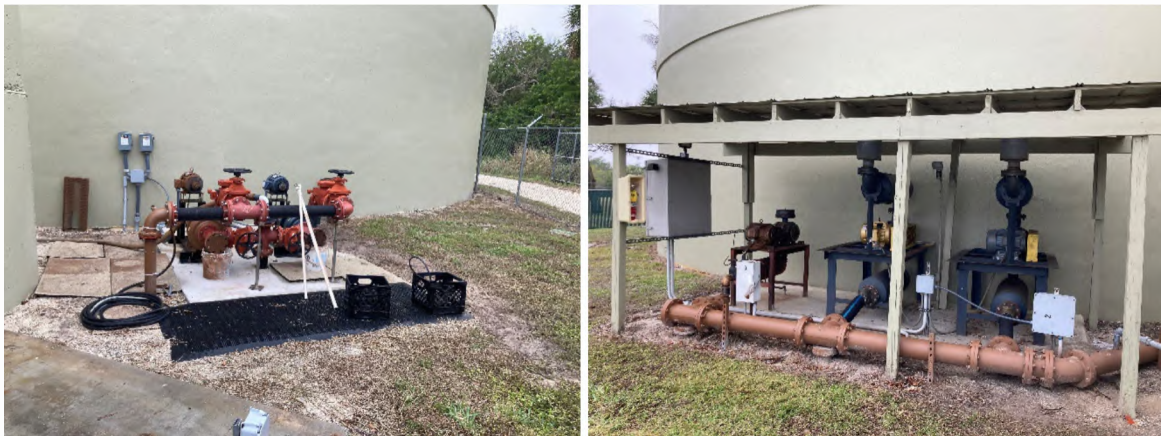
7  
8           *No shade structure currently installed over RAS/WAS pumping equipment (left), and new*  
9           *shade structure installed over facility blowers as example (right)*

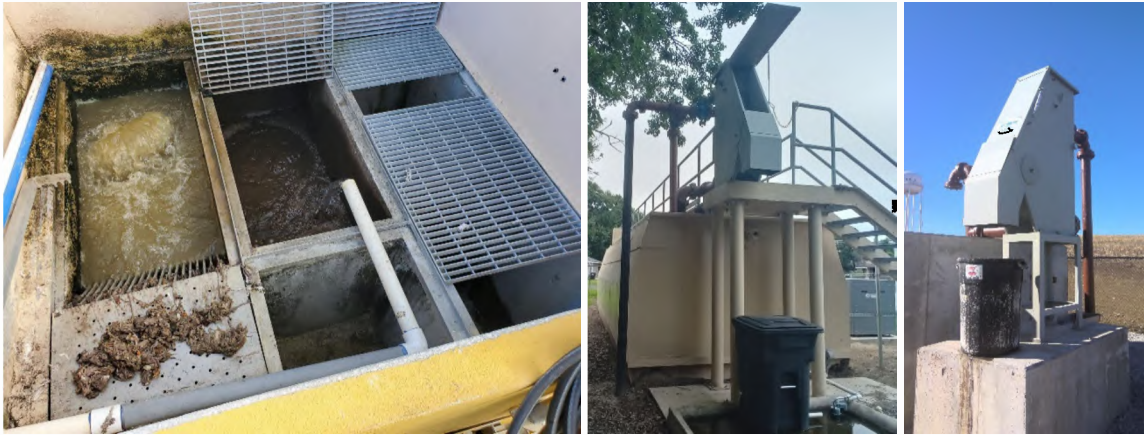
3  
 4 *Existing bar screen backing up due to impacted solids in photo (left), examples of Hydrosieve*  
 5 *with automatic trash collection beneath at two CSWR affiliated facilities (center and right).*

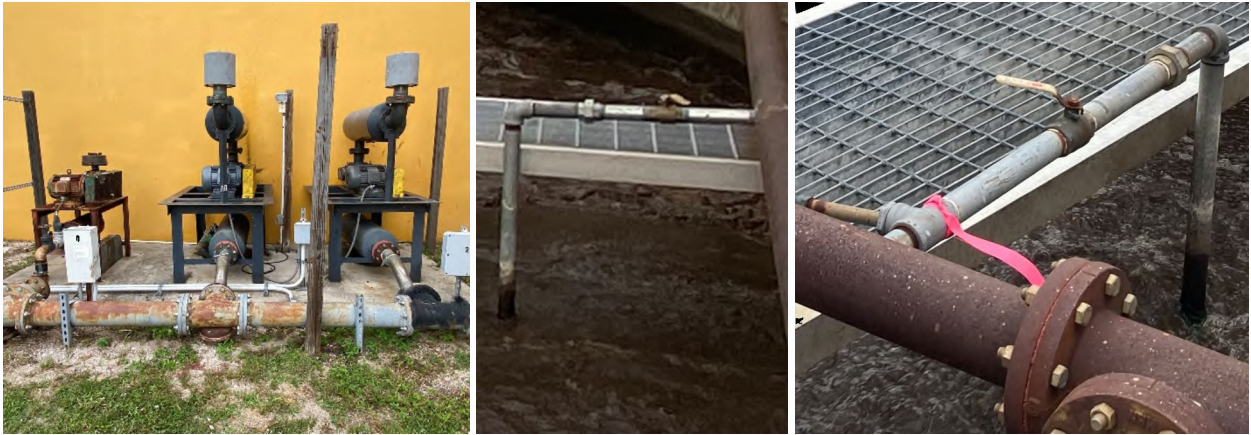
3 *Aging blowers in need of replacement (left) examples of aeration piping with rust on aeration*

4 *headers, at water level, fittings and valves resulting in air leaks (center and right)*

17 state of poor repair. Leaking pipes and poor aeration diffusion negatively affects  
 18 treatment efficacy by reducing air delivered to the aeration basins. Aeration piping and  
 19 diffusers will be repaired or replaced, as appropriate, to ensure proper treatment can

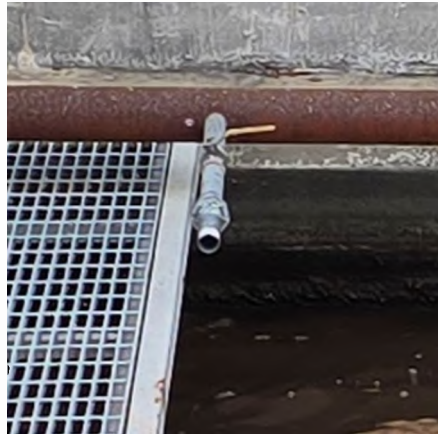
6 *Aeration piping with missing drop pipe indicating section of aeration basin not being*

7 *aerated.*

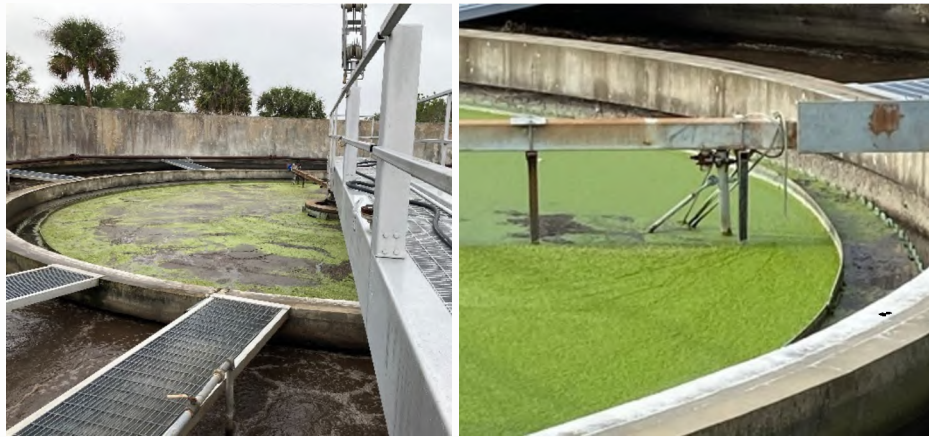
8 The facility's clarifier regularly has issues with duckweed growth inside the  
 9 interior ring of the clarifier trough. The presence of duckweed can lead to increased  
 10 levels of solids, ammonia, and biochemical oxygen demand ("BOD") in discharged  
 11 wastewater. Duckweed can also sometimes pass over the trough and be discharged  
 12 with treated wastewater to the drain field. To prevent ongoing duckweed growth, a  
 13 laundry cover will be installed over the clarifier to reduce sunlight to levels so  
 14 duckweed no longer will thrive.

*Examples of accumulation of duckweed growth in clarifier (left and right) including duckweed passing over the trough (right).*

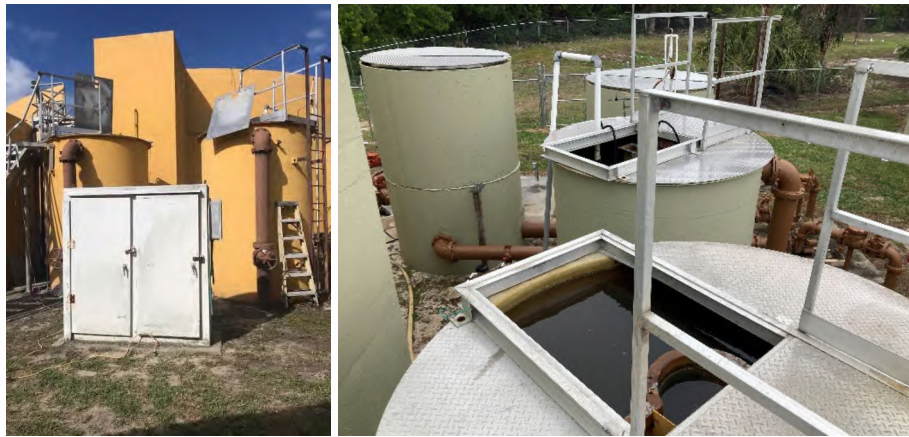
*Sand filter tanks which have been out of service for an extended period and need to be properly decommissioned or repurposed.*

There are two tertiary sand filters on the site that were removed from service many years ago. The out of service filters have never been fully decommissioned and should have the impacted media removed and either have the tanks removed or repurposed for other treatment processes on the site. As described previously, the disinfection system currently present at the treatment facility was not constructed to match the permitted plan submitted in the 2018 permit renewal and lacks precise chlorine dosing. To ensure proper disinfection occurs and that the facility is in line with the permitted plans the Company will either install a new chlorine contact chamber or convert the decommissioned sand filters into chlorine contact chambers and install a new chlorine dosing system utilizing sodium hypochlorite solution.

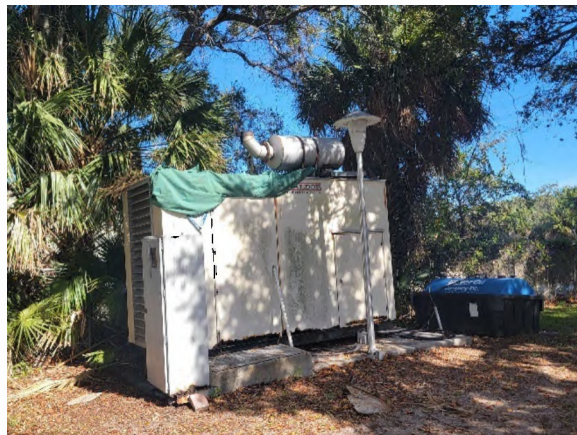
*Old generator shared by water and wastewater site which has reached the end of useful life.*

The irrigation pumping system is also aging and its pumps should be replaced to ensure proper function moving forward. General site improvements will also continue at the wastewater treatment site, including ongoing wastewater and aeration piping replacements as leaks or damage is identified, some remaining fencing repairs, access improvements, and housekeeping improvements. Miscellaneous repairs and improvements are also being completed in the collection system as leaking or damaged collection mains are identified and replaced. Finally, the generator supplying emergency power for the water and wastewater sites has reached the end of its useful life and will require replacement.

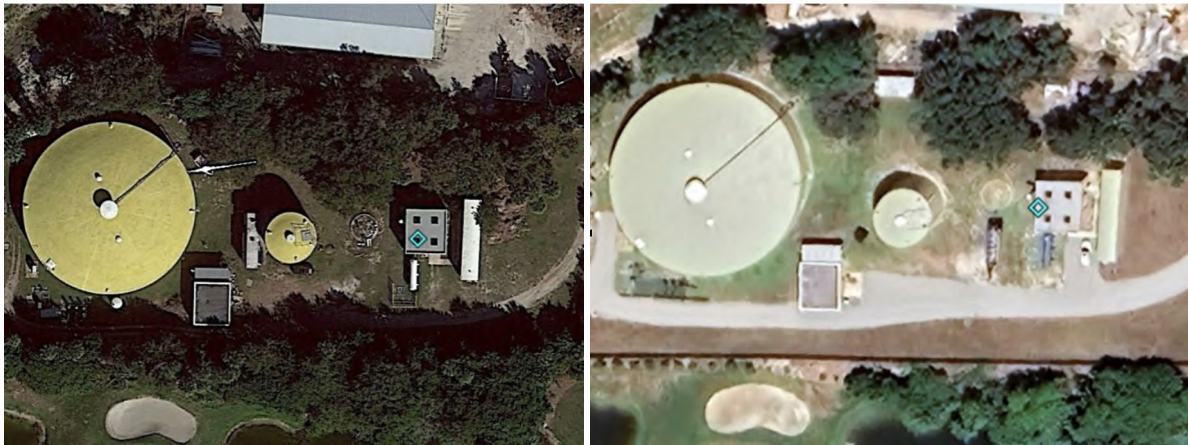
*Aerial view of the Aquarina water system at acquisition (left) and currently (right). Note recoated tanks, cleared vegetation and debris, new access roads, and temporary hydro-pneumatic tank on site.*

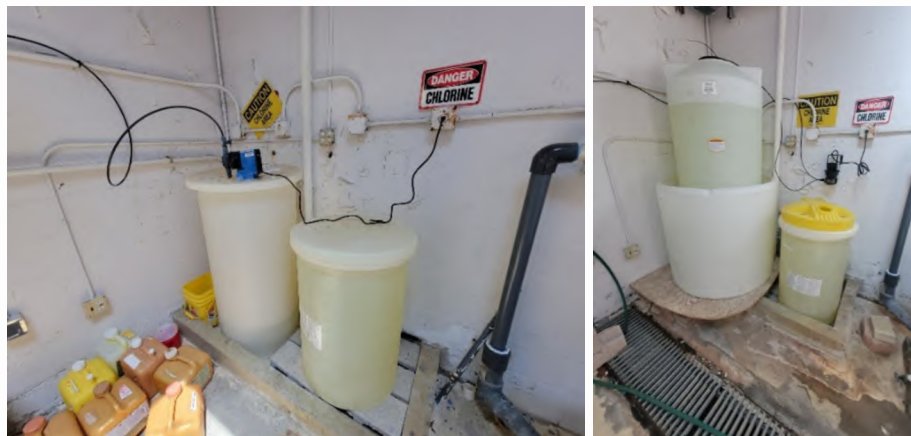
12  
 13 *Chemical containment before (left) and after improvement (right). Note bleaching and dried*  
 14 *chemicals all over ground previously due to inadequately sized spill berm and lack of*  
 15 *cleanup.*

7 A. Improvements have been made to the disinfection system, including improving  
 8 chemical containment in the treatment building to address ongoing spills from the  
 9 inadequate spill berm and installation of a continuous chlorine analyzer to ensure that  
 10 adequate chlorine residuals are maintained to prevent bacteriological contamination  
 11 issues in the drinking water.

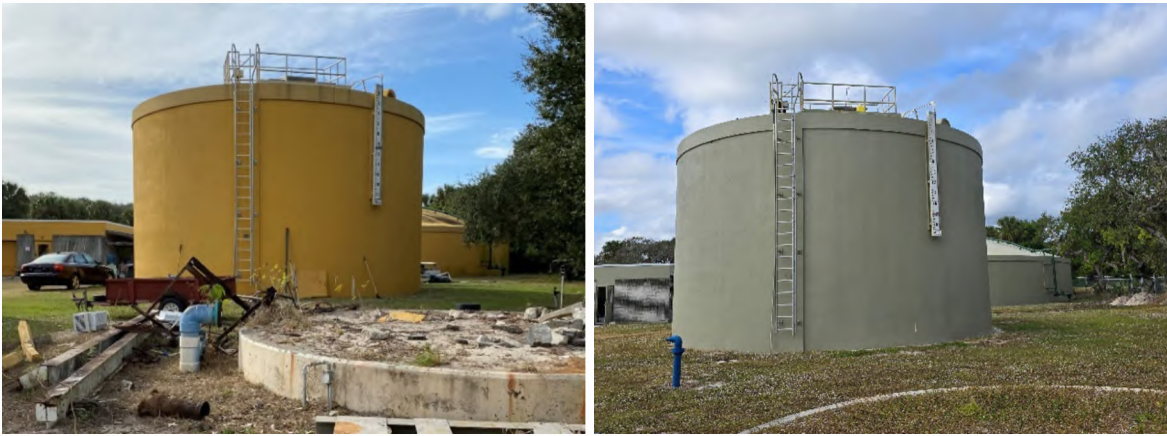
8  
9 *Ground Storage tank before (left) and after (right) before and after inspection and recoating,*  
10 *note trash and debris removed from tank area as well.*

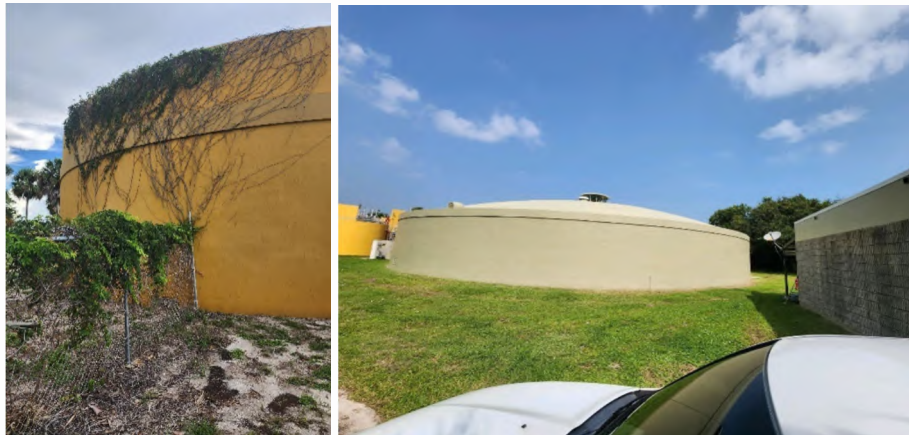
11  
12 *Irrigation and Fire Control Ground Storage tank before (left) and after (right) before and*  
13 *after inspection and recoating, note vegetation overgrowth removed from tank.*

16 The facility's tanks were inspected, sanded, and recoated where appropriate.  
 17 This process ensures that any needs for tank repairs are identified, and that recoating  
 18 occurs to protect the tank structures from exposure, wear, and corrosion, which helps  
 19 extend their useful lives. Both ground storage tanks (one for irrigation and fire control

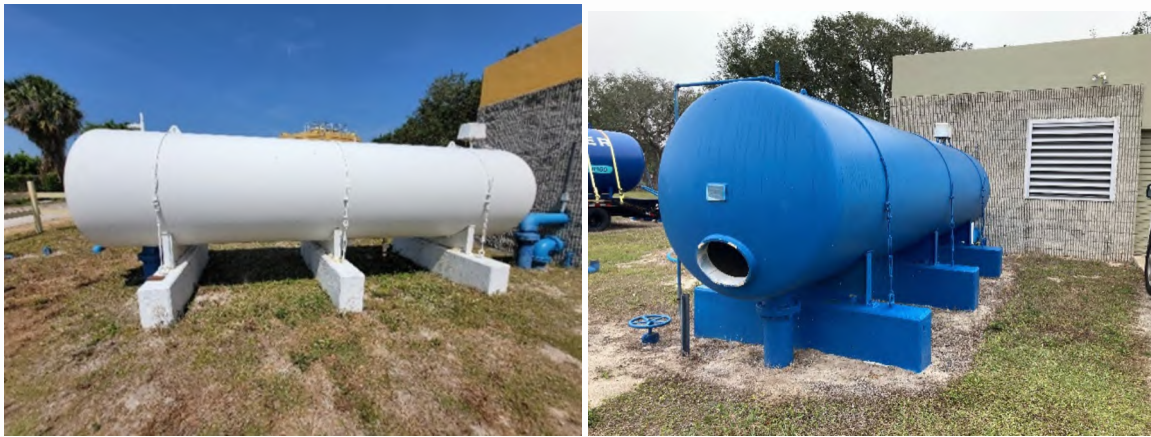
1  
2 *Hydropneumatic tank before (left) and after (right) exterior recoating, inspection for interior*  
3 *recoating halted improvements on tank when numerous pinhole leaks were identified, and*  
4 *tank was removed from service.*

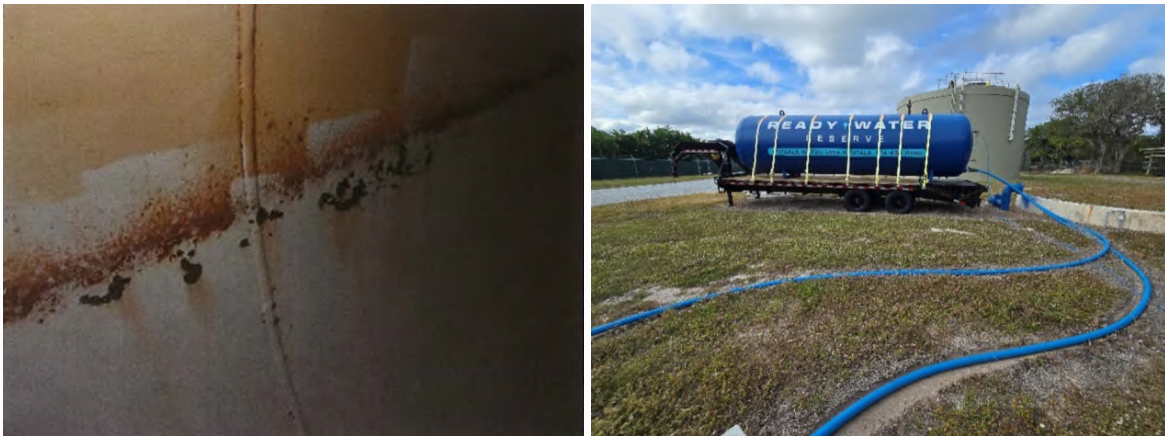
5  
6 *Example of pinhole leaks along waterline on interior (left) and temporary tank brought in to*  
7 *maintain service till tank replacement can be completed (right).*

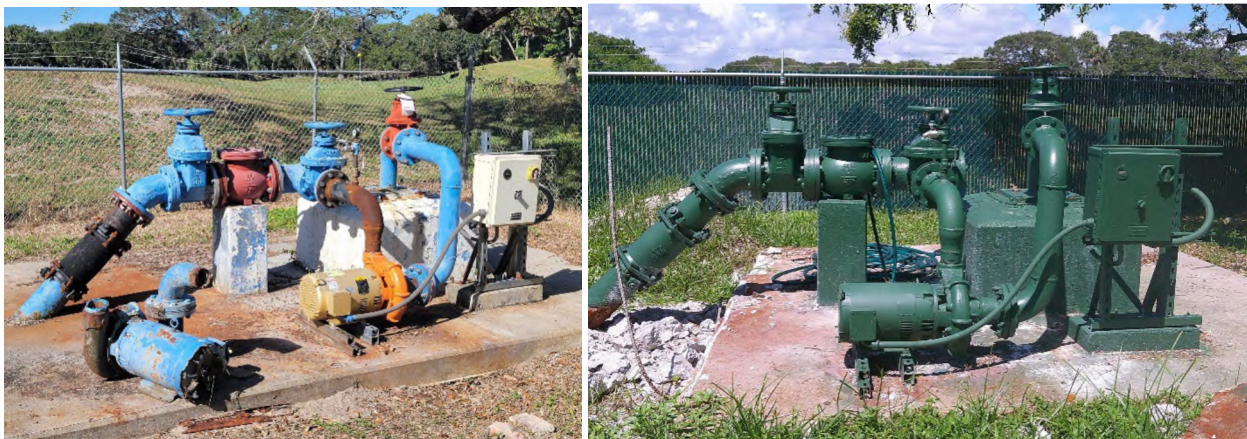
*Example of before (left) and after (right) recoating of above ground piping and equipment.*

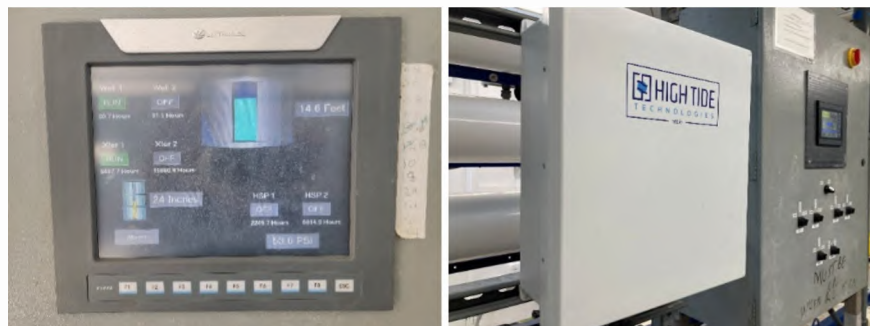
*Telemetry with tank levels (left) and new remote monitoring equipment (right).*

Various improvements have also been made to the electrical and monitoring systems at the Aquarina water system. This includes installing new flow meters for the wells and the distribution system, improving telemetry between tank monitoring equipment and control systems, and installation of remote monitoring equipment.

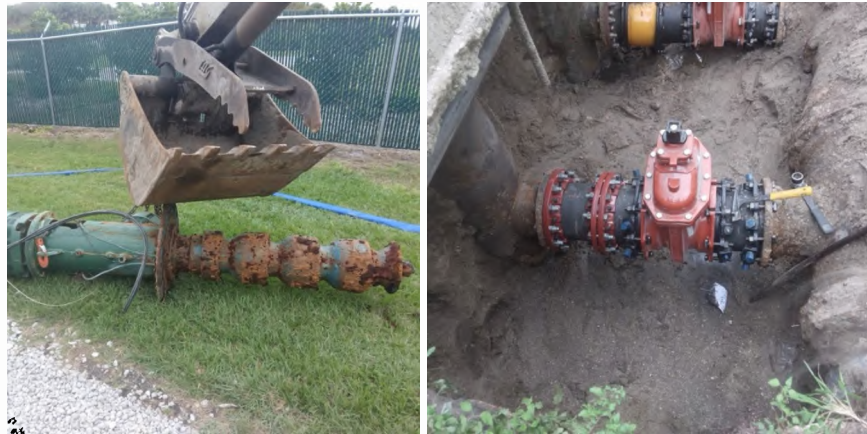
5  
6 *Rusted high pressure fire protection valves (left) removed and new valves installed (right)*

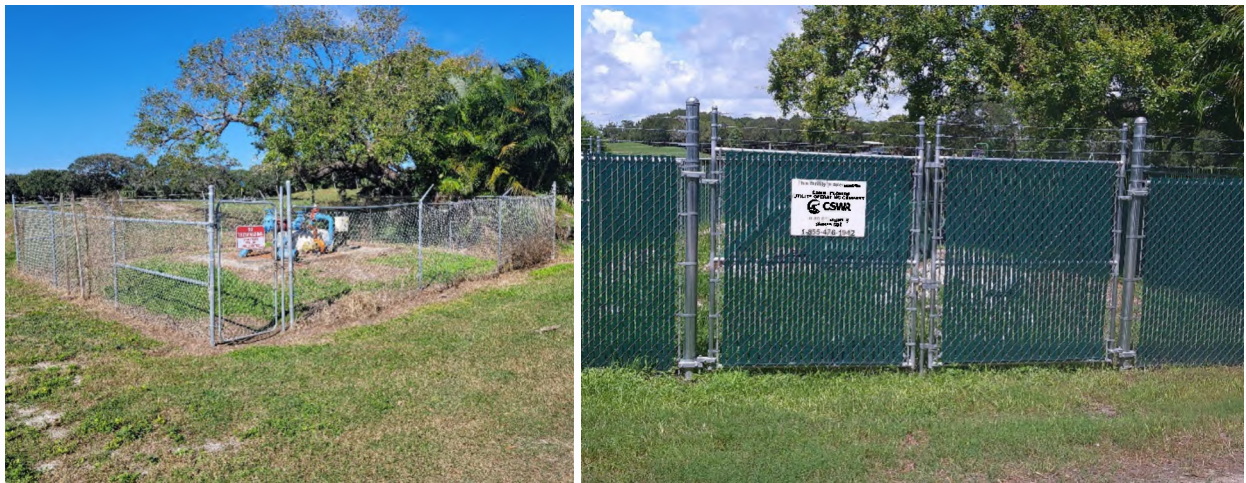
7  
8 *Damaged fencing (left) replaced with new fencing (right)*

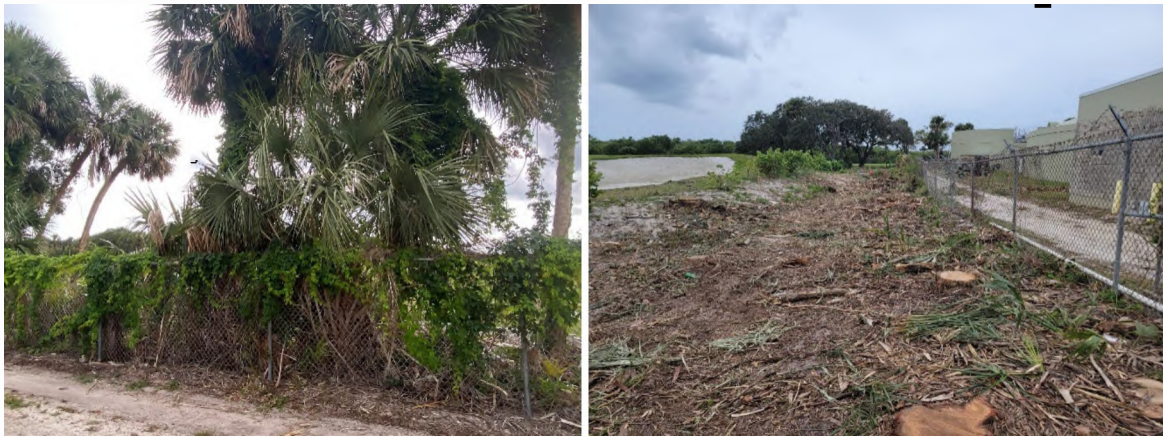
*Clearing of vegetation from facility fence line*

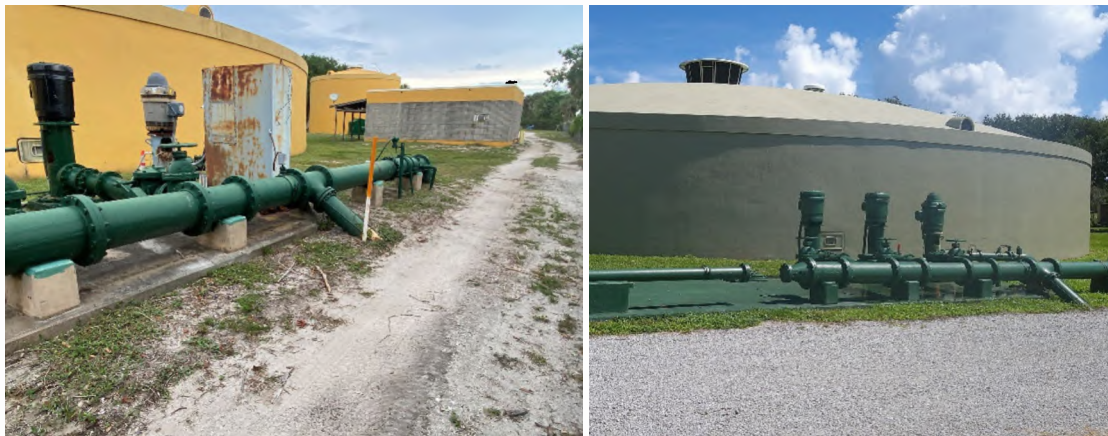
*Before (left) and after (right) access road improvements and piping and equipment recoating.*

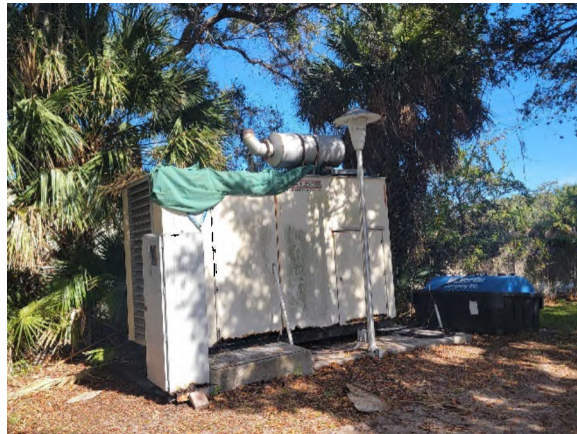
6  
7 *Old generator shared by water and wastewater site which has reached the end of useful life.*

1 contamination, service interruptions, or damage that would be caused if the tank failed  
2 catastrophically a (hydropneumatic tanks can explode). A temporary tank has been  
3 placed on site and a new permanent tank will be installed in the future. Finally, the  
4 generator supplying emergency power for the water and wastewater facility, which has  
5 reached the end of its useful life, will require replacement.

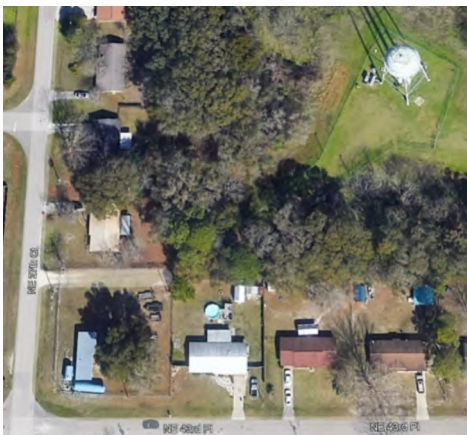
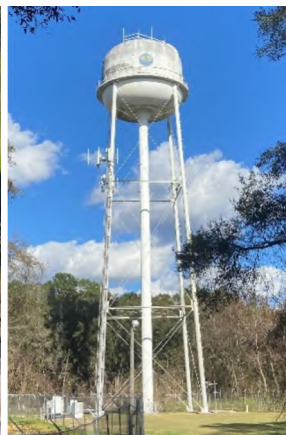
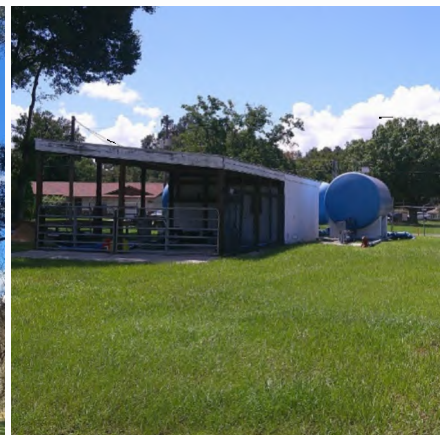
*Aerial view of Tradewinds elevated storage tank, disinfection, and hydropneumatic storage sites (left) and ground level views of the elevated storage tank (center) and the hydropneumatic storage tank and disinfection site (right).*
