BEFORE THE  
FLORIDA PUBLIC SERVICE COMMISSION

In re: DOCKET NO. 20250052-WS

Application for increase in water and  
wastewater rates in Brevard, Citrus, Duval,  
Highlands, Marion, and Volusia Counties by  
CSWR-Florida Utility Operating Company.

PROCEEDINGS: HEARING

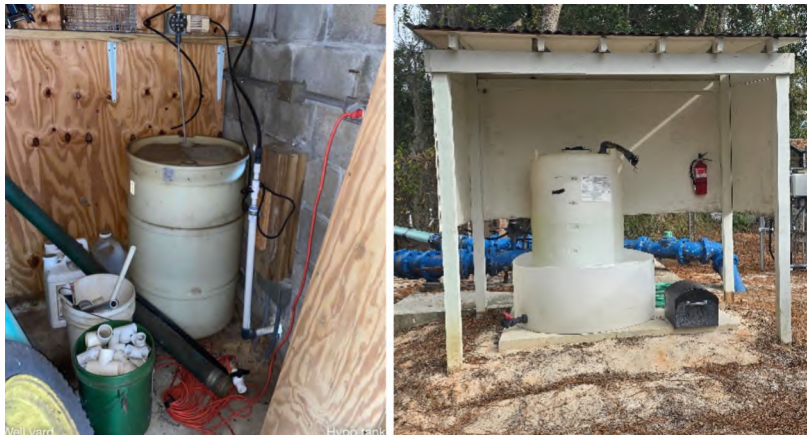
12 *Disinfection system before (left) and after (right) improvement.*

4 A. Various improvements have been completed to date at the Tradewinds drinking water  
5 system. First, improvements were made to the disinfection system. At acquisition, the  
6 system consisted of a single 55-gallon drum with a feed pump located in the corner of  
7 a room full of trash and spare materials. Access to the drum was difficult and no spill  
8 protection was present. Additionally, there was no venting in the room to remove  
9 chlorine gas. A new pad and shade structure were installed outside the structure and a  
10 new drum with spill protection were installed to provide better access, better  
11 ventilation, and spill containment for the disinfection system.

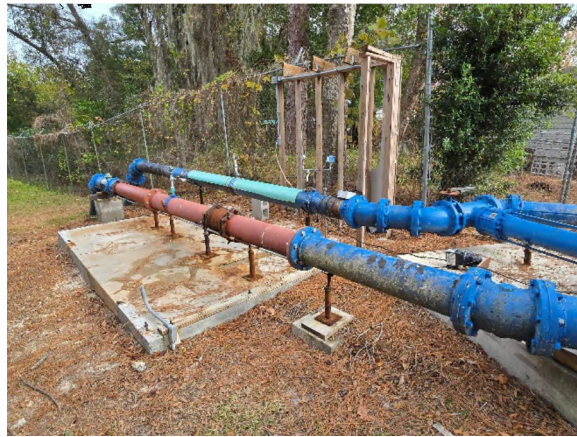
*Replaced segment of above ground piping*

13  
14 At acquisition, the elevated storage tank needed evaluation to determine  
15 necessary long-term repairs to the tank. To evaluate the tank, it was power-washed and  
16 an engineering inspection was completed. A damaged section of above ground piping  
17 running from the primary well to the elevated storage tank has also been replaced.

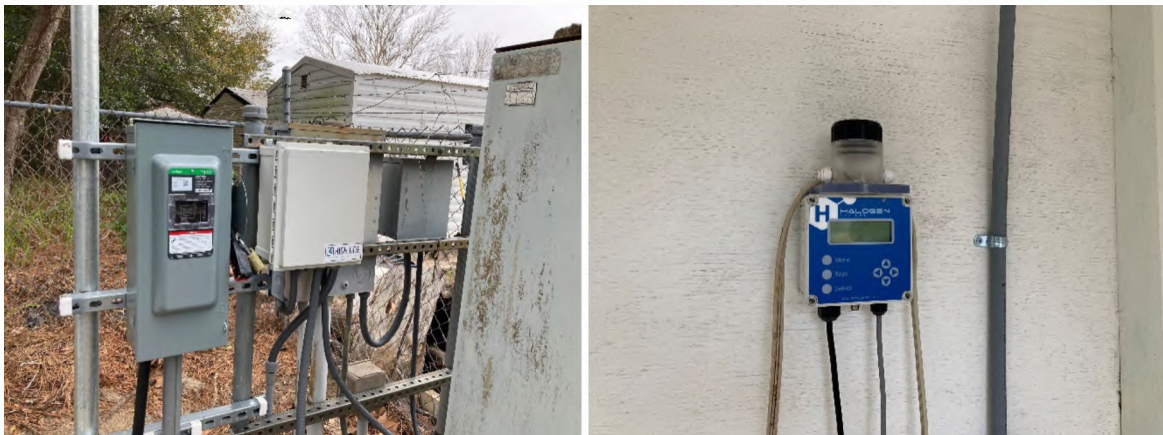
*New remote monitoring equipment (left) and new chlorine residual monitoring (right)*

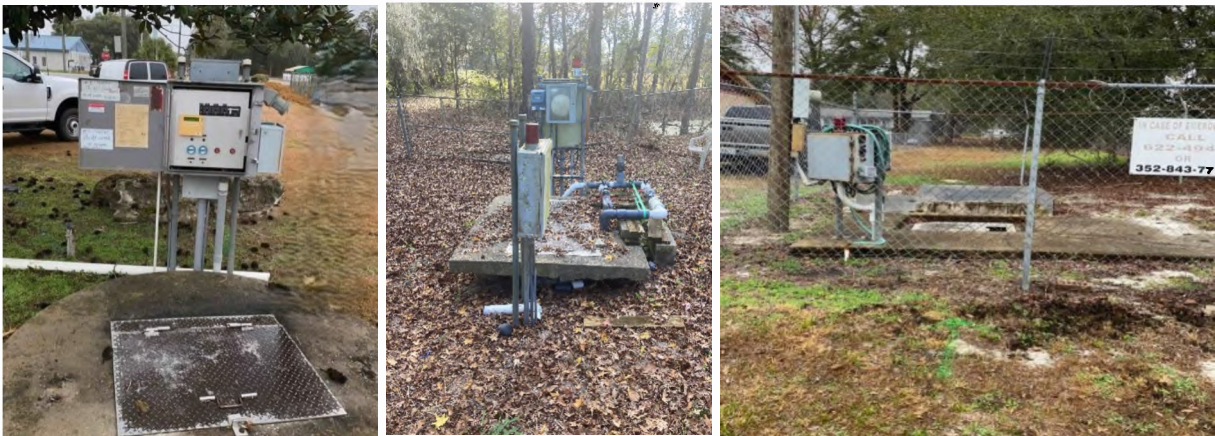
*Examples of older Tradewinds collection system lift stations. Some lift stations lacked fencing, remote monitoring, and had rusting or degraded assets.*

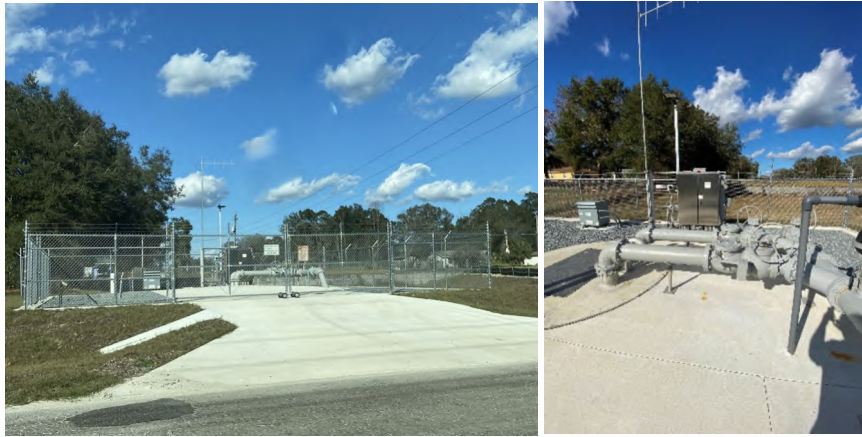
*New lift station connecting to the Marion County Utilities wastewater system.*

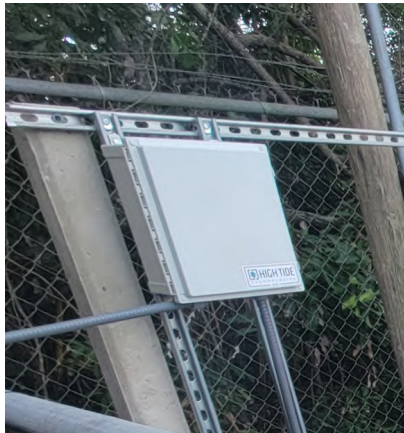
12  
13 *Example of remote monitoring units installed at all lift stations.*

3 A. The primary improvement completed to date at the Tradewinds wastewater system has  
4 been the installation of remote monitoring equipment at each lift station. As I noted  
5 earlier in my testimony, remote monitoring equipment allows live collection of data,  
6 providing continuous information on system performance and equipment status over  
7 time allowing for more precise and efficient operations, and providing operations staff  
8 with real-time information concerning system performance and equipment status. This  
9 allows for immediate identification of abnormal operating conditions and emergencies,  
10 often enabling operations staff to respond to and address problems before they can  
11 result in service interruptions.

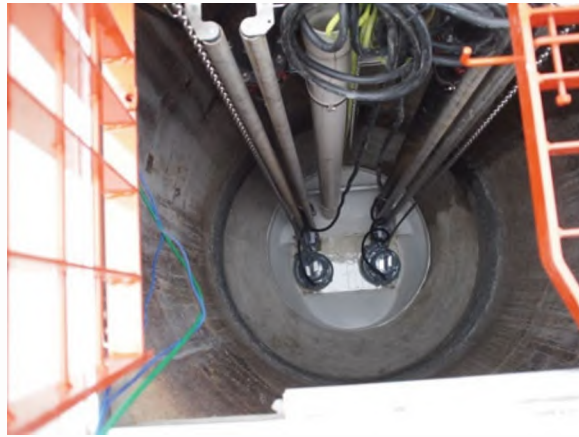
16 A. CSWR Florida has identified various additional improvements that are needed at the  
17 Tradewinds lift stations and wastewater collection system. First, four of the existing  
18 lift stations lack guiderail systems for pump maintenance. Guide rail systems allow  
19 pumps to be easily raised and lowered from the lift station wet well for maintenance or

1 replacement and significantly reduce the complexity of pump maintenance. Guiderail  
2 systems will be installed in the lift stations that do not currently have them.

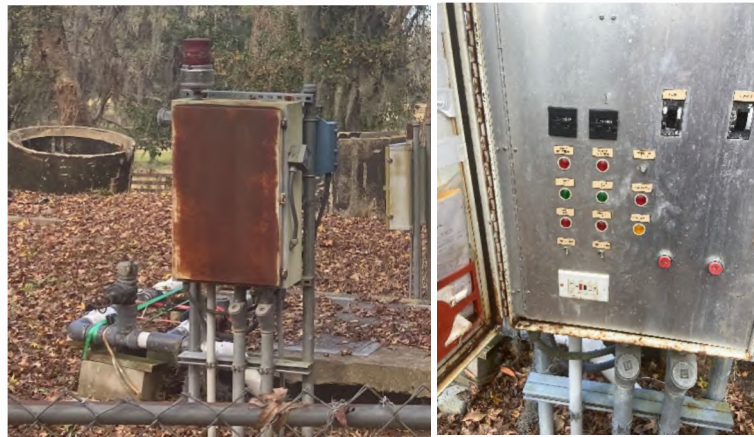
One of the lift stations has a control panel in poor condition with rust on the weatherproof box. This control panel and box will be replaced.

*Damaged lift station control box.*

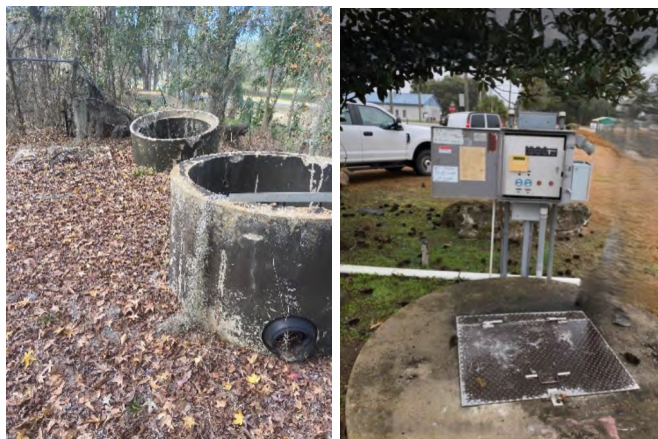
*Damaged unused manhole rings, trash, and vegetation overgrowth at Tradewinds lift station site, including vegetation causing fence damage (left). Tradewinds lift station lacking fencing (right).*

mobile pump to be connected to the lift station for operation when pumps malfunction and during power outages. The discharge piping at this lift station is also in poor condition and will be replaced and bypass piping will be installed. In addition, many of the lift station sites have significant accumulation of trash, debris, discarded equipment and materials, and nuisance vegetation around the sites and site perimeters. These materials can cause damage to fencing and equipment and pose operational obstacles and hazards to operations staff. These materials are being removed from the sites. Finally, all the older lift stations have issues with fencing, either lacking fencing entirely or having areas with damaged fencing, which create issues with site security. CSWR Florida will install, repair, or replace fencing where necessary.

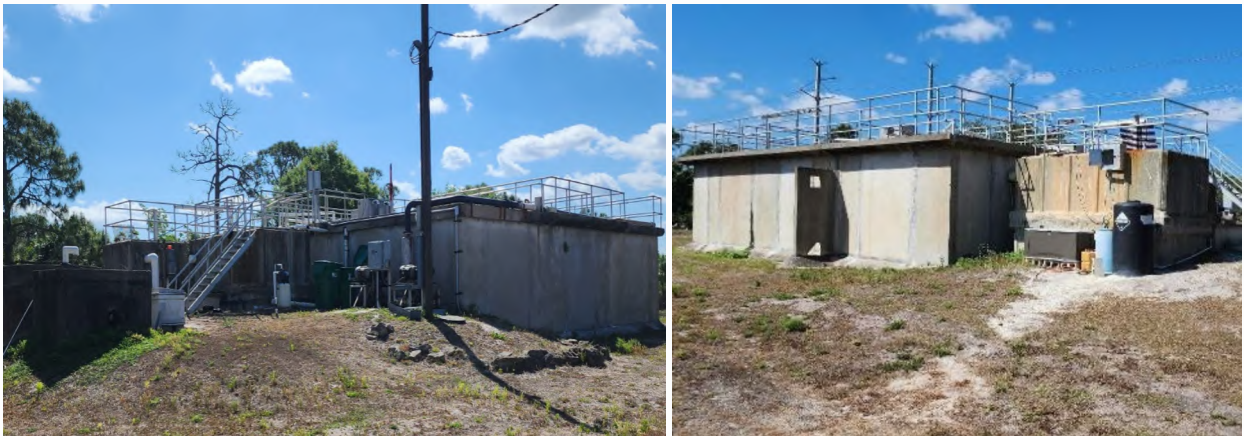
*Ground level views of the Sun Lake Estates wastewater treatment facility at acquisition.*

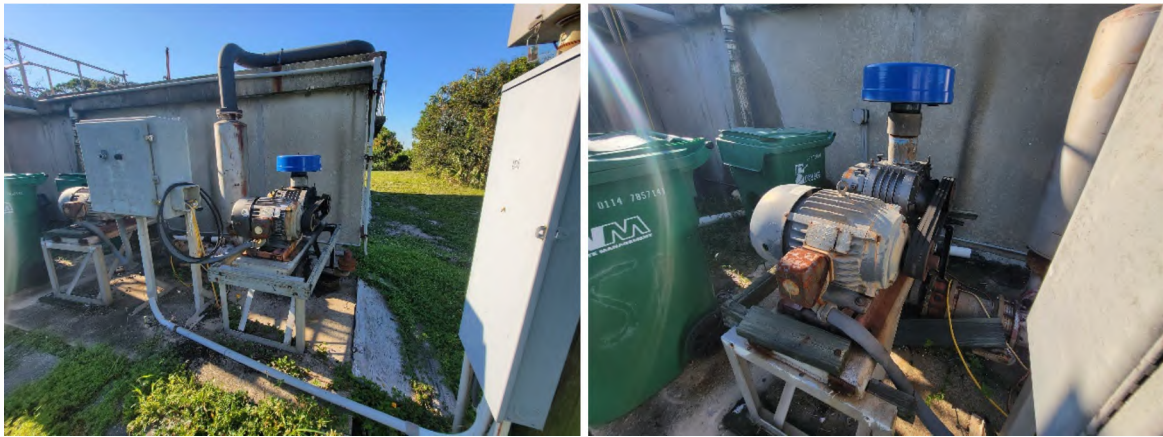
*Blowers at acquisition with poor condition motors, no belt shrouds or covers.*

10 A. At acquisition, the blower motors and blower control panel were reaching the end of  
11 their useful lives, and the blowers lacked belt shrouds and covers. Well-functioning  
12 blower motors ensure full power is delivered to the aeration system. Belt shrouds  
13 prevent debris from snagging in belts, which can prevent damage, and ensure operator  
14 safety. Shade covers protect the blowers from overheating and the elements and reduce  
15 ambient sound from the blower operation. These benefits extend the useful lives of the  
16 blowers and reduce the likelihood of noise complaints. A shade structure has been  
17 installed over the blowers to reduce overheating and protect the blowers from the  
18 elements, blower motors and control panel have been replaced, and belt shrouds and  
19 blower covers are in the process of being installed.

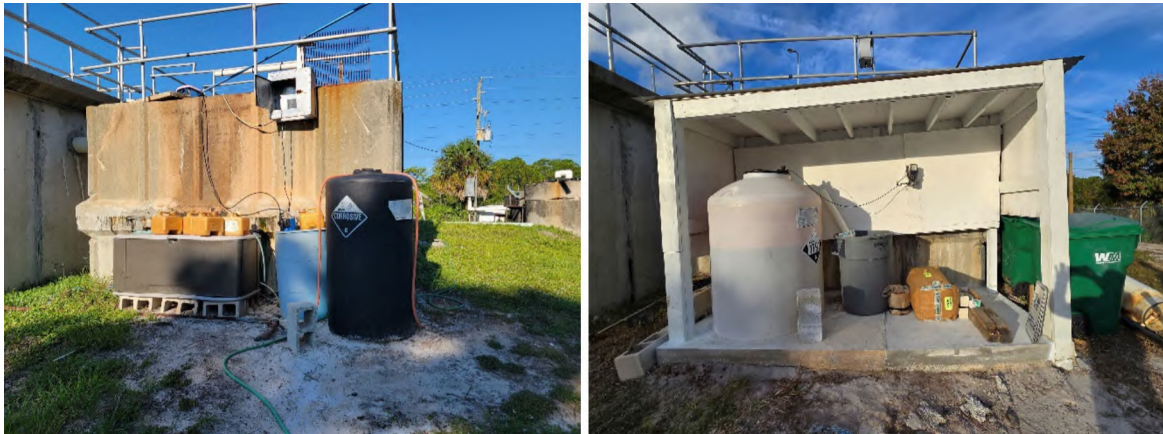
7  
8 *Chemical storage before (left) and after (right) improvement. Note dead grass and chemical*  
9 *storage around old tank indicating chemical spills and disorganized arrangement.*

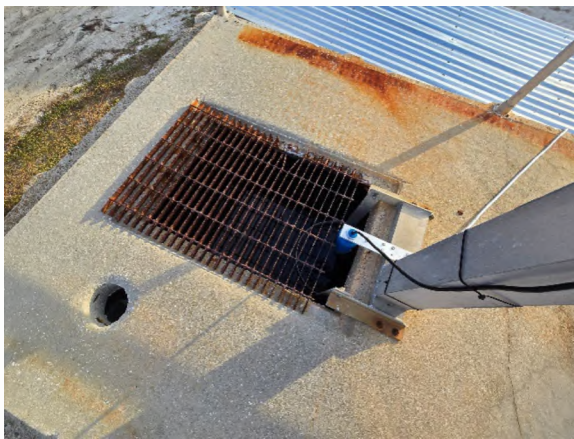
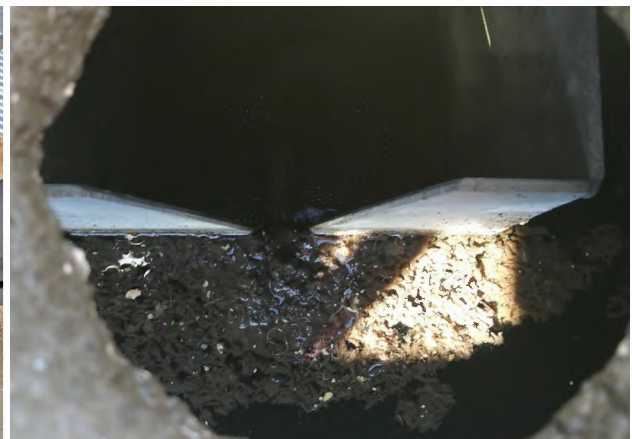
*New remote monitoring units are installed at treatment facility and lift station.*

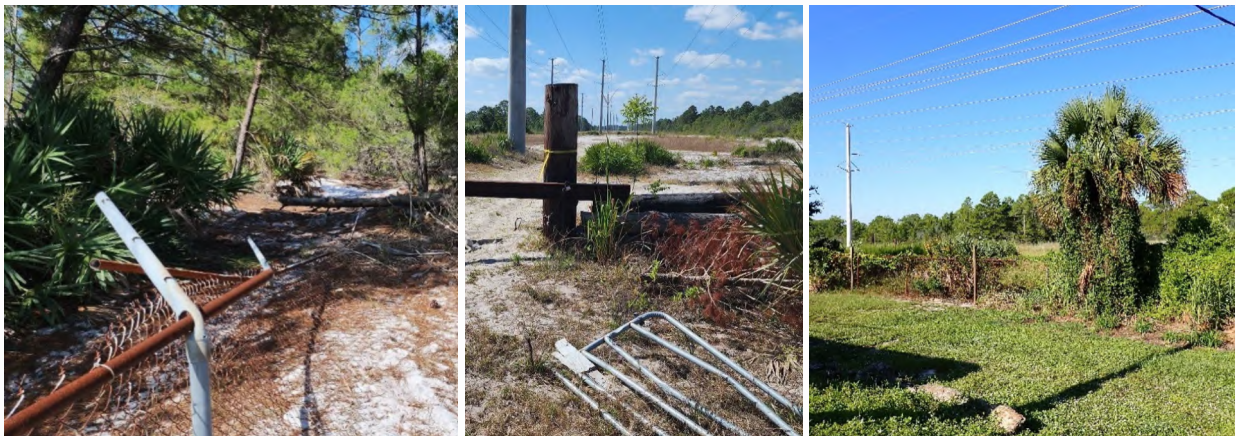
7  
8 *Examples of damaged fencing and gates at the Sun Lake Estates Facility at acquisition.*

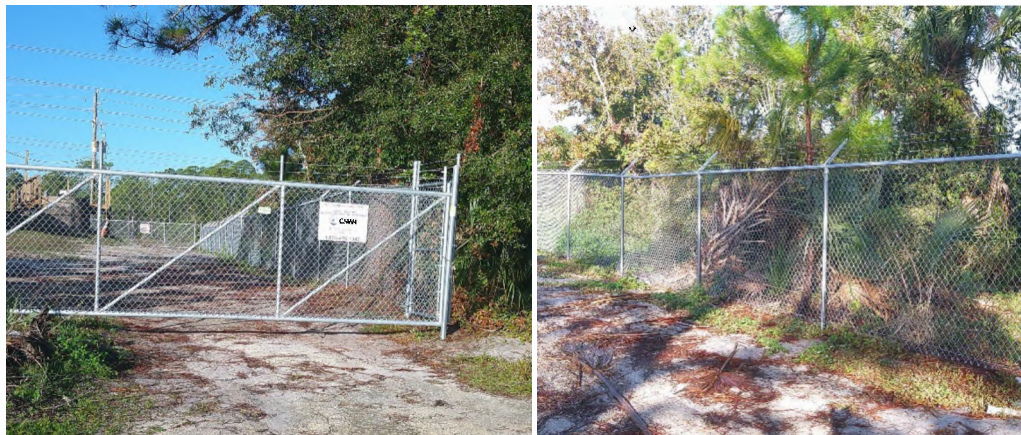
9  
10 *New gates and fencing installed by CSWR Florida.*

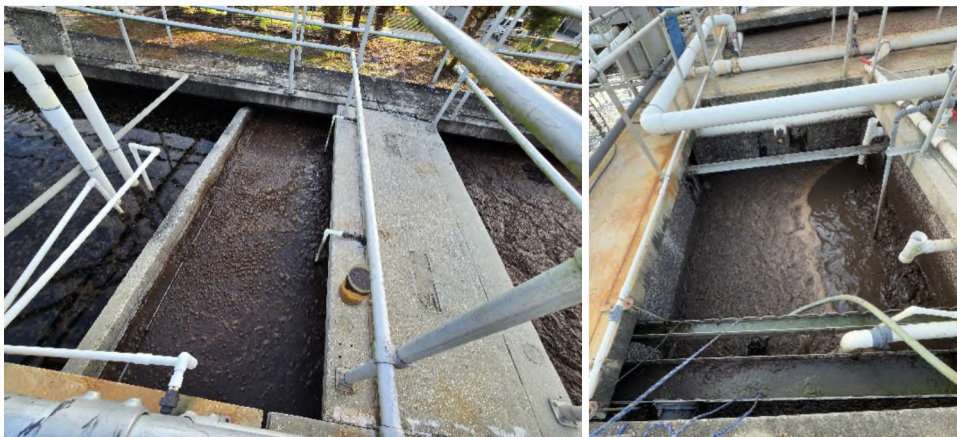
13  
14 *PVC aeration piping throughout facility to be replaced with proper materials.*

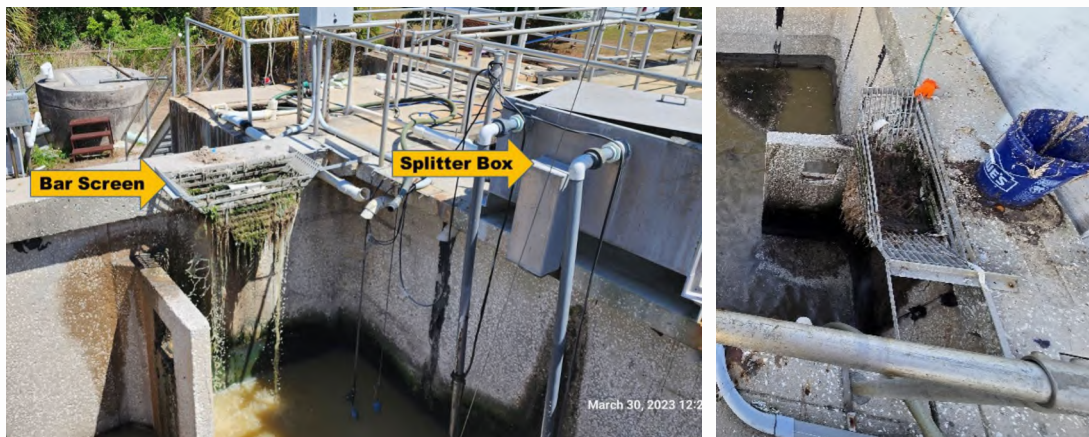
10  
11 *Current configuration of splitter box and bar screen (left) and photo of bar screen filling*  
12 *with solids, note bar screen is not easily accessible by the protected walkways and hangs*  
13 *over the influent basin and frequently overfills with solids.*

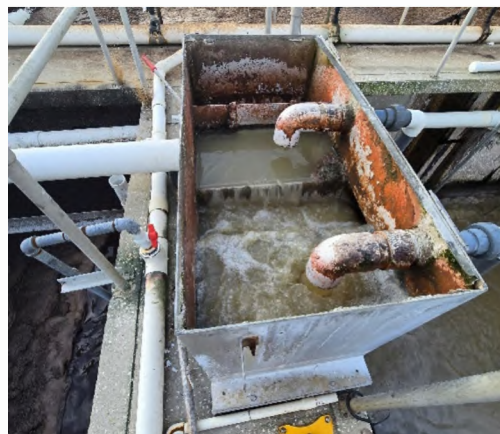
1 from entering the facility. As a result, the bar screen regularly fills with solids. The  
2 splitter box serves direct wastewater and returned active sludge from the clarifier to  
3 different portions of the aeration basins. The box's interior is in poor condition and  
4 will require replacement. CSWR Florida plans to replace existing facilities and  
5 equipment so influent flows directly into the splitter box through a new bar screen.  
6 This will allow easier cleaning of the bar screen with the splitter directing flow into the  
7 treatment basins. With these changes only excessive flows will be stored in the influent  
8 basin instead of the current design that directs all flow to the influent basin. This will  
9 improve the operational configuration of the facility.

*Condition of splitter box. Note interior rust and corrosion.*

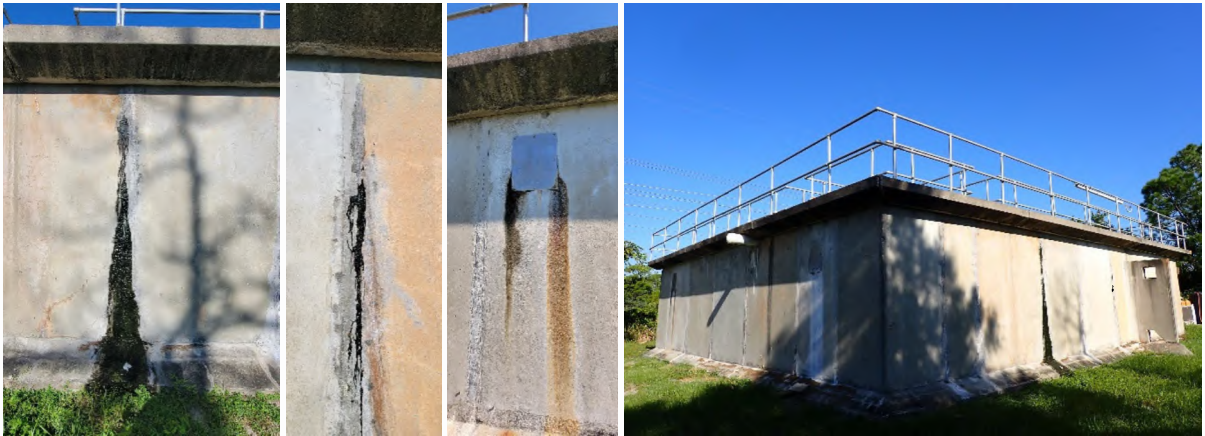
*Examples of leaks throughout tanks, and context for leaks along the outside of most tanks.*

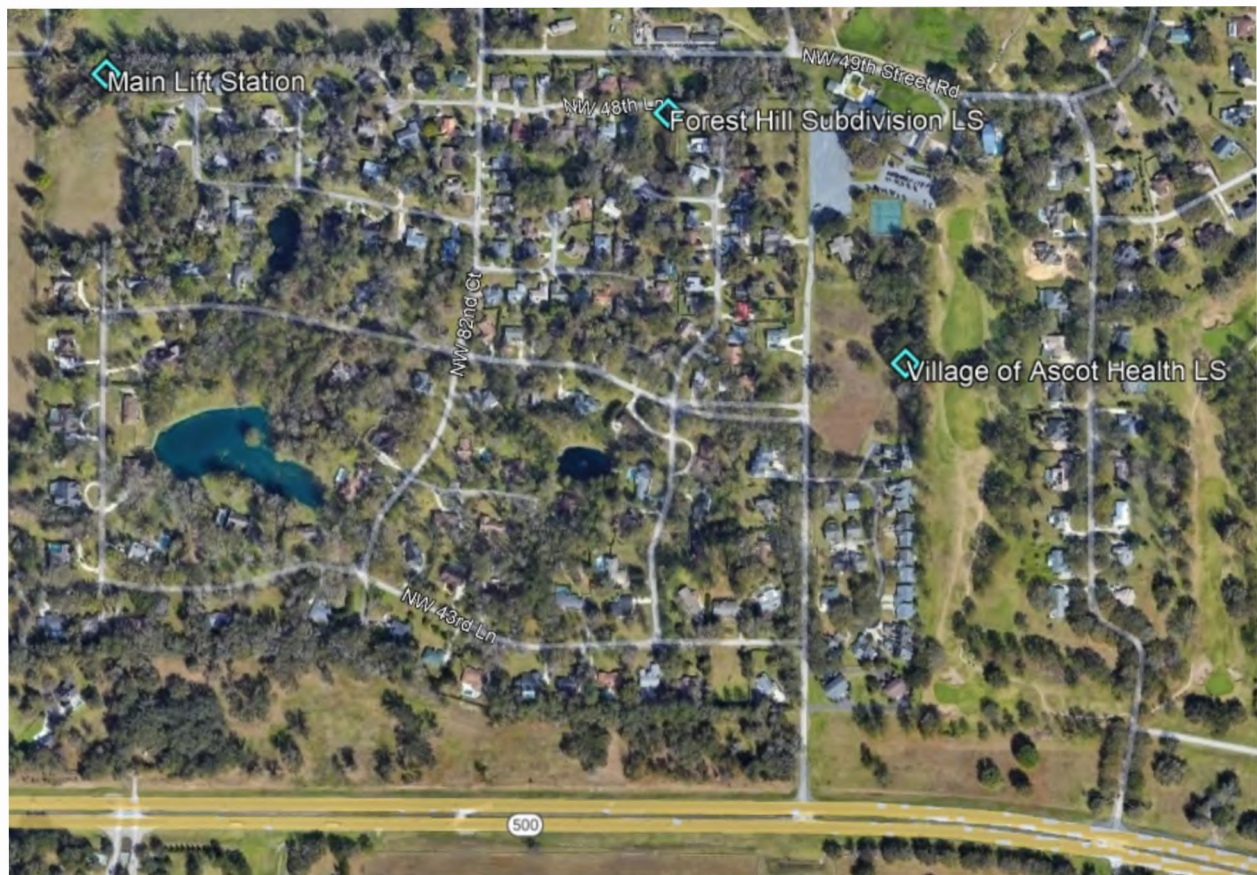
*Aerial view of the Sandlin Woods Community.*

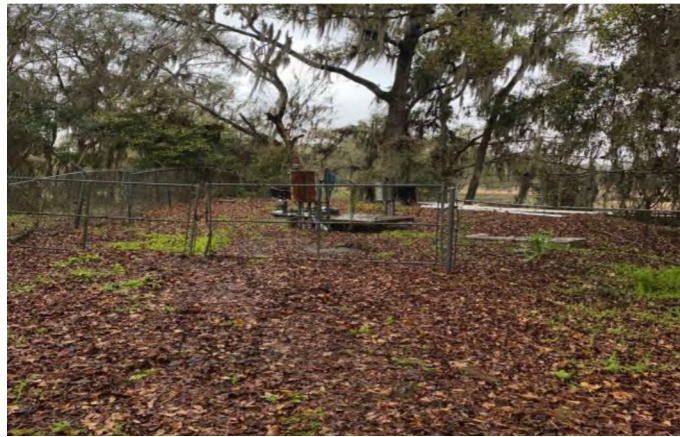
*Sandlin Woods Main Lift Station at the time of acquisition*

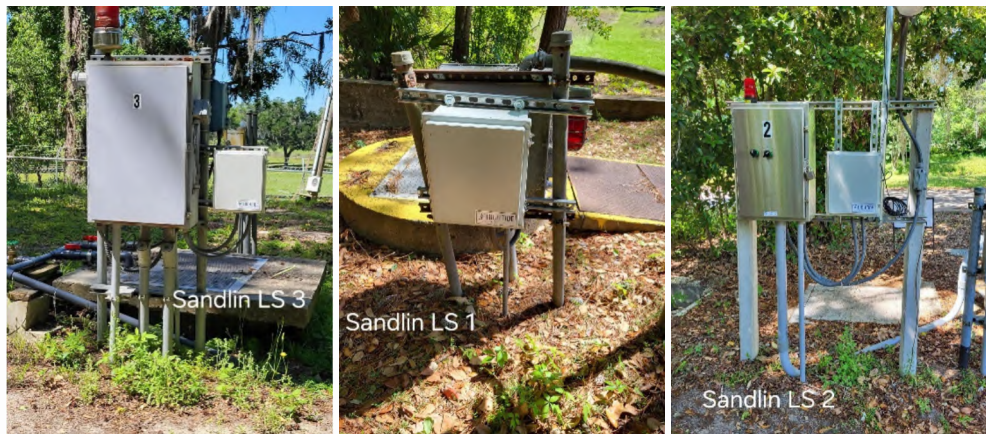
12  
13 *Remote monitoring installed at lift stations (left Main Lift Station, center Ascot Health Lift*  
14 *station, right Forest Hill lift station)*

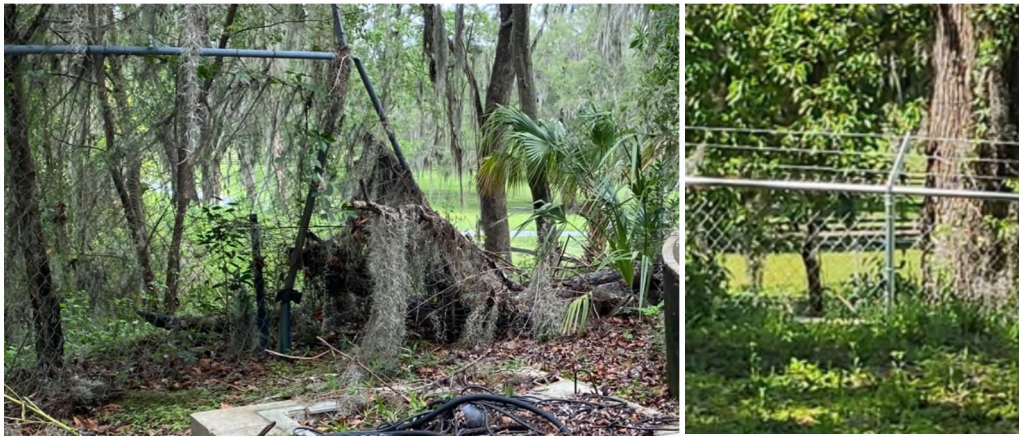
*Example of fencing damage at the main lift station site (left) and new fencing (right)*

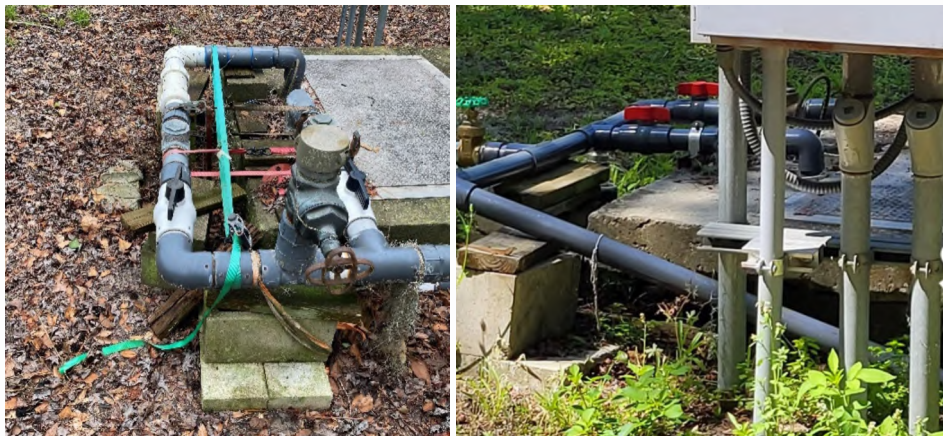
*Improper repairs to discharge piping at main lift station with PVC and ratchet straps (left) and new discharge piping (right)*

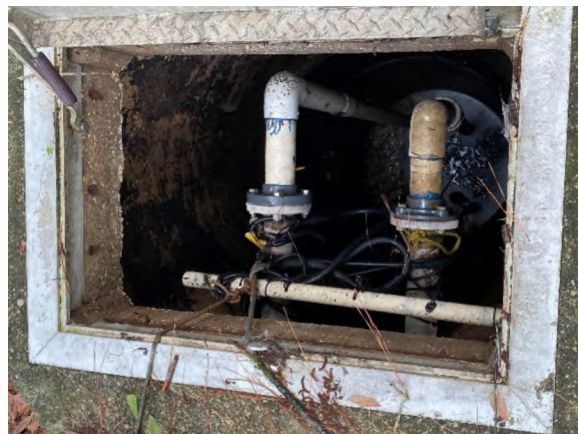
*Note example of lack of guide rail lifting system for pump maintenance in the Sandlin Woods lift stations.*

the facilities are in a safe and operable condition, and to ensure the facilities can be maintained moving forward. All three lift stations require some common improvements. First, none of the lift stations included the means to connect an emergency generator. Being able to connect a generator allows lift stations to be operated during power failures with enough frequency to prevent service interruptions, backups, or overflows. None of the lift stations included guide rails for servicing lift station pumps. Rails make it safer and easier to lift pumps for service and help to extend the useful life of the pumps. Finally, the pumps in the lift stations were approaching the end of useful lives and no service records were available to enable CSWR Florida to determine if proper pump maintenance had been completed under previous ownership. To ensure the pumps are in good operable condition for the future, all pumps have been slated for replacement.

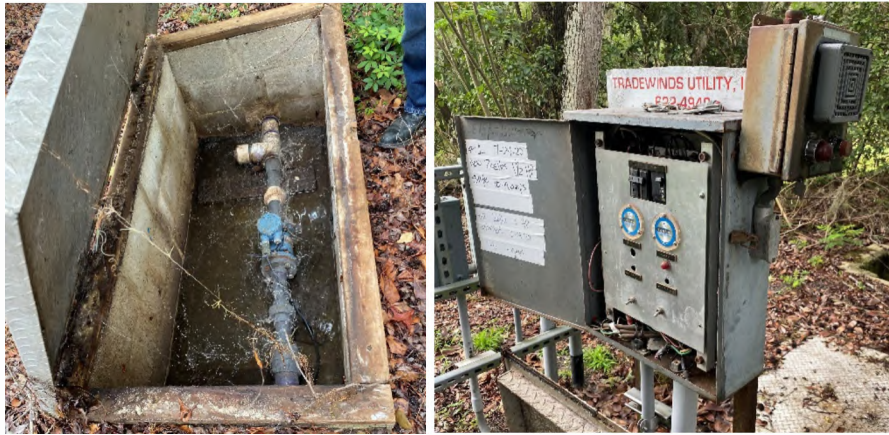
The main lift station has several other planned improvements. The valve box cover is damaged and in need of replacement to extend the useful life of the valves. The power and control panels were also in poor condition and did not include the means to connect a mobile backup generator.

*Valve box cover allowing water infiltration (left) and poor condition power and control panels (right) at main lift station.*

CSWR Florida has made, or has plans to make in the future, all the repairs, replacements, and upgrades to the Sandlin Woods facility I just mentioned.

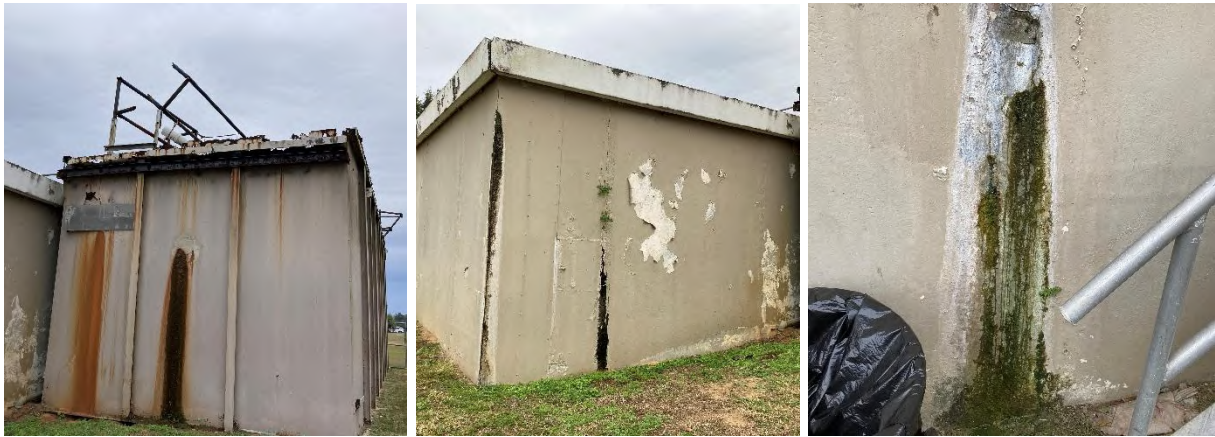
Examples of leaks on the steel (top left) and concrete (all other photos) tanks with ongoing leaks evident by ineffective patching and significant growth of algae and rust accumulation below leaks.

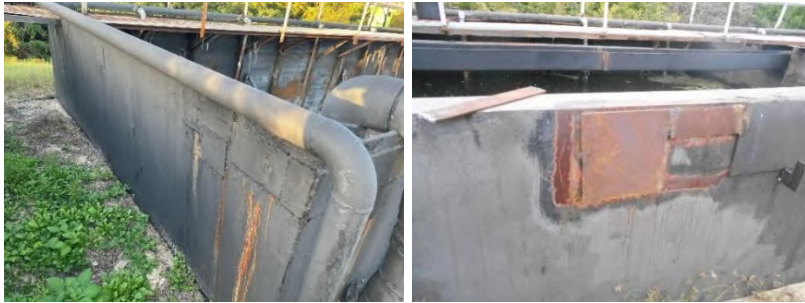
7           Examples of steel tanks and equipment deterioration at closing and examples of the numerous poorly installed  
8           welded patches on the tanks.  
9  
10

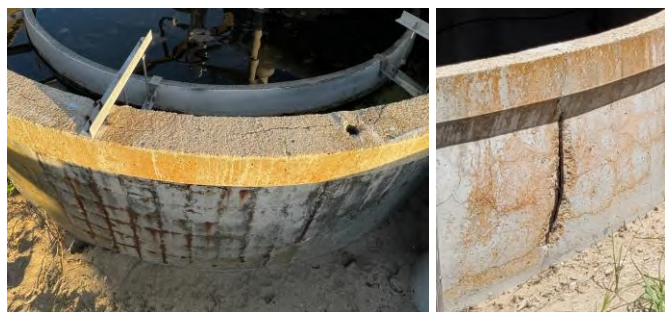
11           Examples of cracking and exposed rebar in concrete tanks.  
12
