Re: Docket No. 160001-EI

Subject: **Failure Analysis of Titanium Tubing from 2A1 Condenser
Purchase Order No.: 02341346
Ref AR: 2025590**

Unit 2 Shutdown for 2A1 Condenser Tube Leak

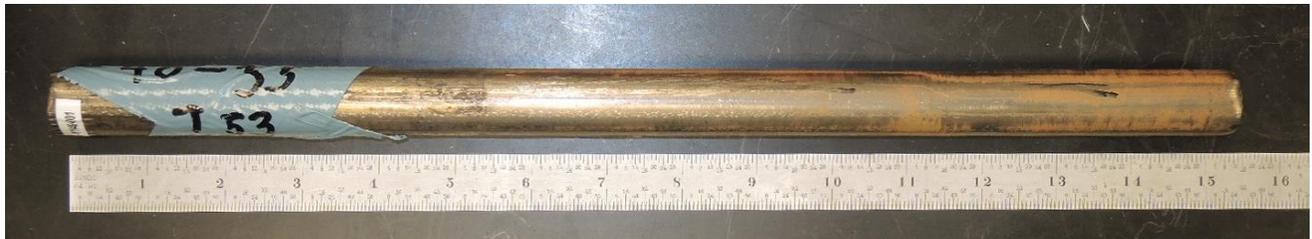
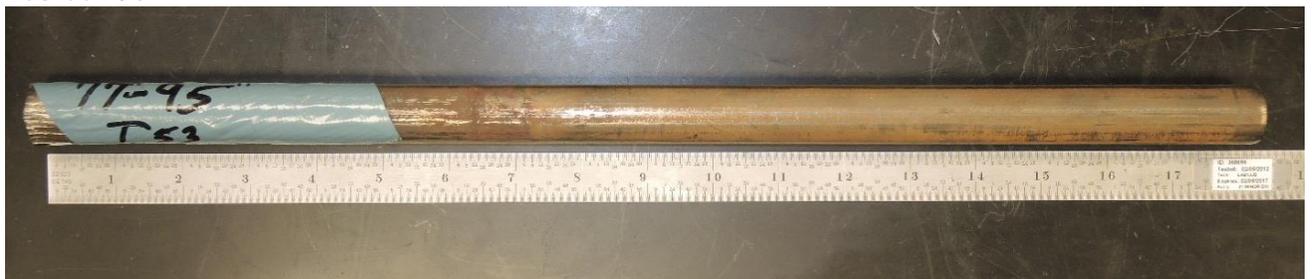
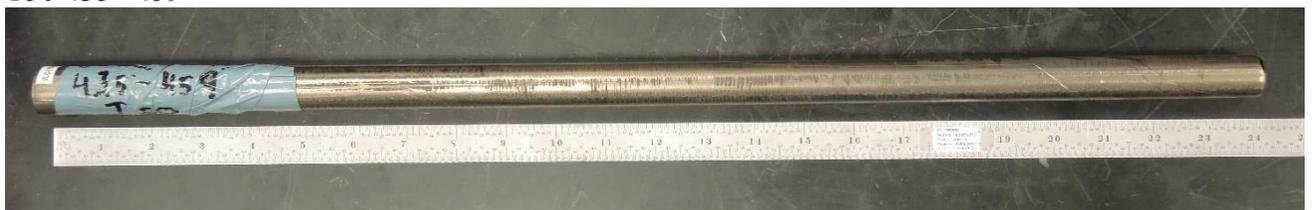
Figure 2: Longitudinal Crack on Segment T53 55"-77"

Visible dye penetrant testing was performed on the OD of T53 55"-77" and T50 435"-459". No additional cracking was detected on segment T53 55"-77", and no indications were observed on segment T50 435"-459". The OD of each segment exhibited brown deposits (analysis in Figure 14).

The longitudinal crack on tube T53 was examined visually and using the stereomicroscope. The crack was relatively straight and continuous and was located along a shallow groove. Adherent deposits or scale partially covered the groove, indicating it was introduced during installation in the condenser.

The crack was located approximately 180° from the seam weld.

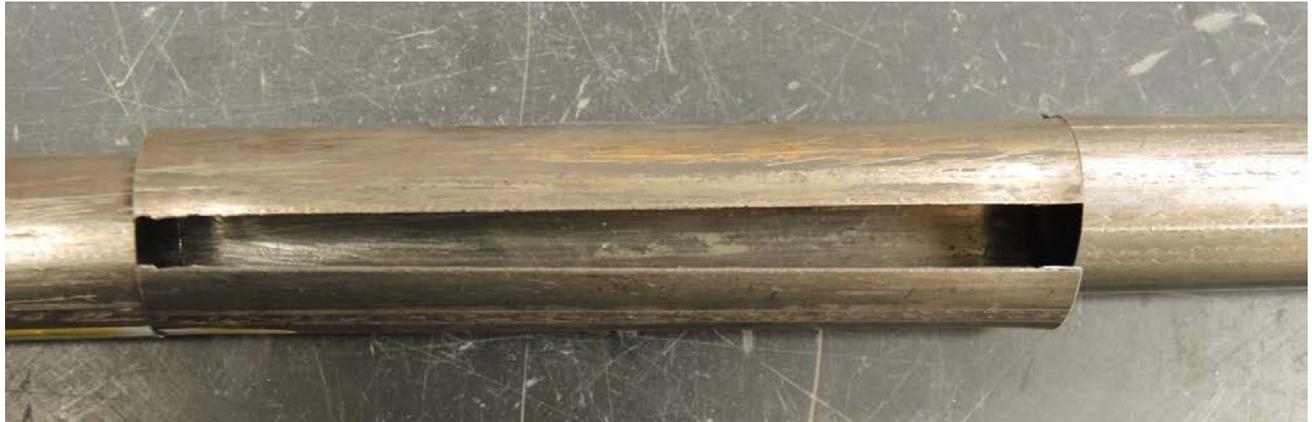
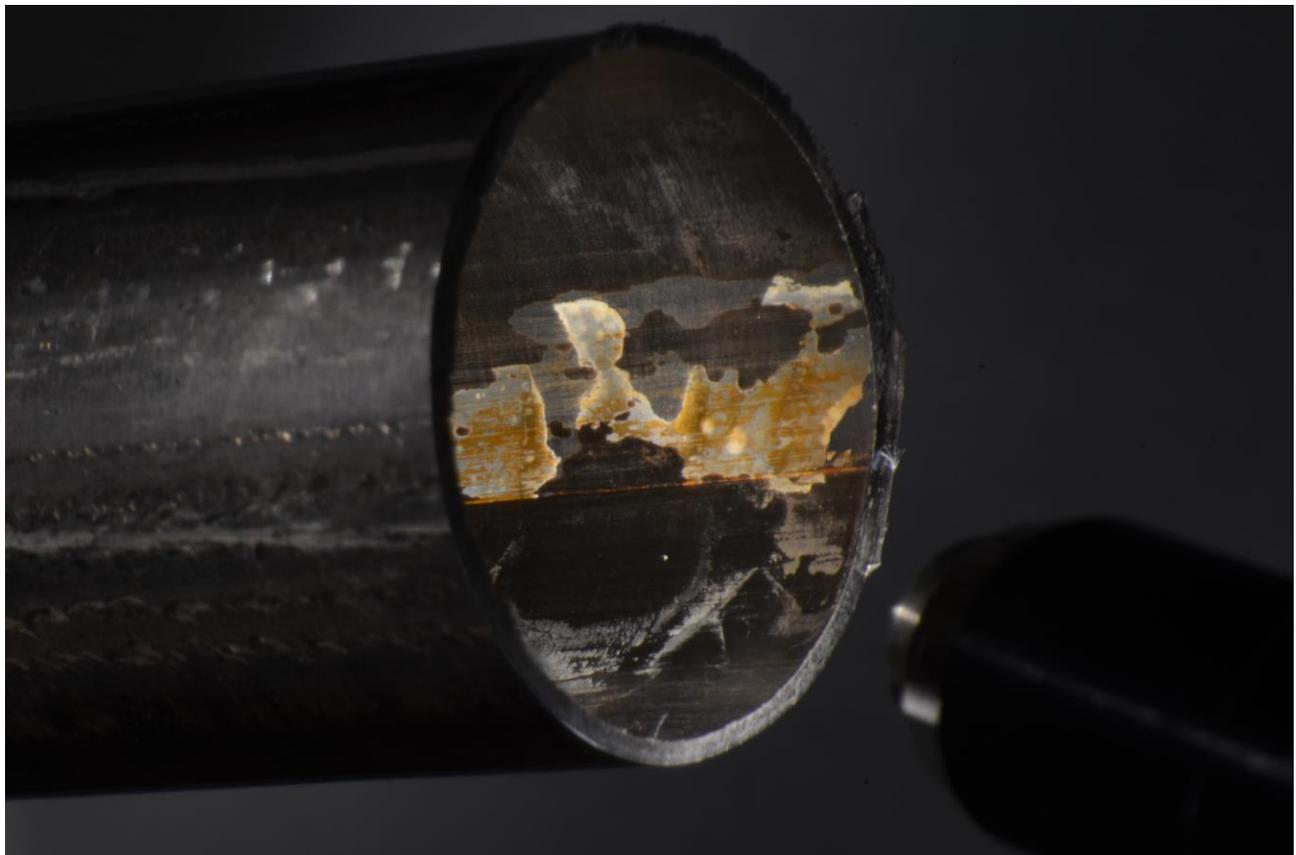
The portion containing the crack was sectioned beyond the crack tips and the crack was split open. Examination of the ID surface was performed. The ID surface exhibited some adherent white and orange deposits, such as shown below. No ID damage mechanisms (pitting, corrosion, erosion) were observed.

Samples of the deposits were analyzed and were consistent with waterborne deposits (Figure 14).
