RE: Docket No. 950520-EI

Enclosed are an original and fifteen copies of the of Gulf Power Company's Natural Gas Research and Demonstration Project Report which was requested in Order No. PSC-95-1146-FOF-EG in the above docket.

Field Testing of Gas Engine-Driven Heat Pumps

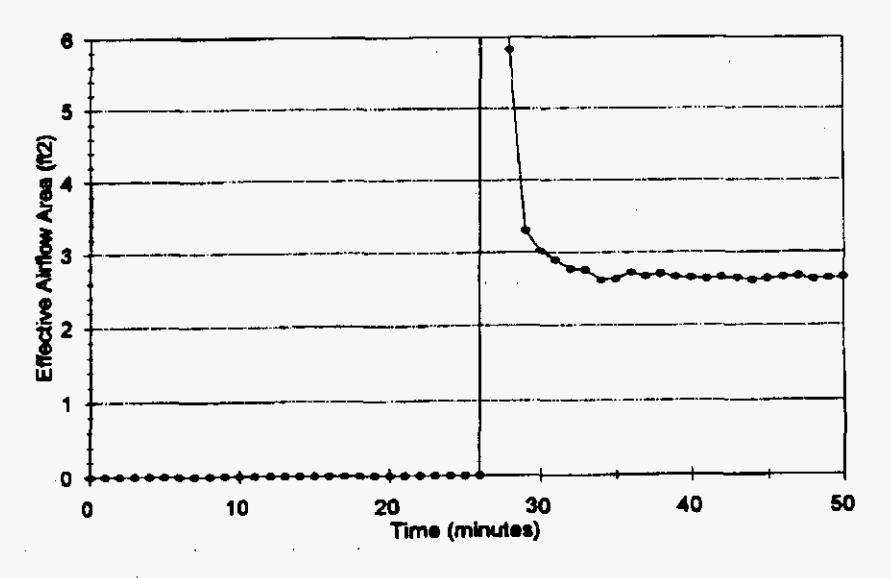
Figure 7.5 – Air Flow Calibration Test

The results of a typical calibration test are shown in Figure 7.5. For each minute of the test, an effective cross-sectional area for air flow at the anemometer was calculated using the preceding energy balance. As shown in this figure, the calculated area reached a steady value after about 10 to 15 minutes of operation.

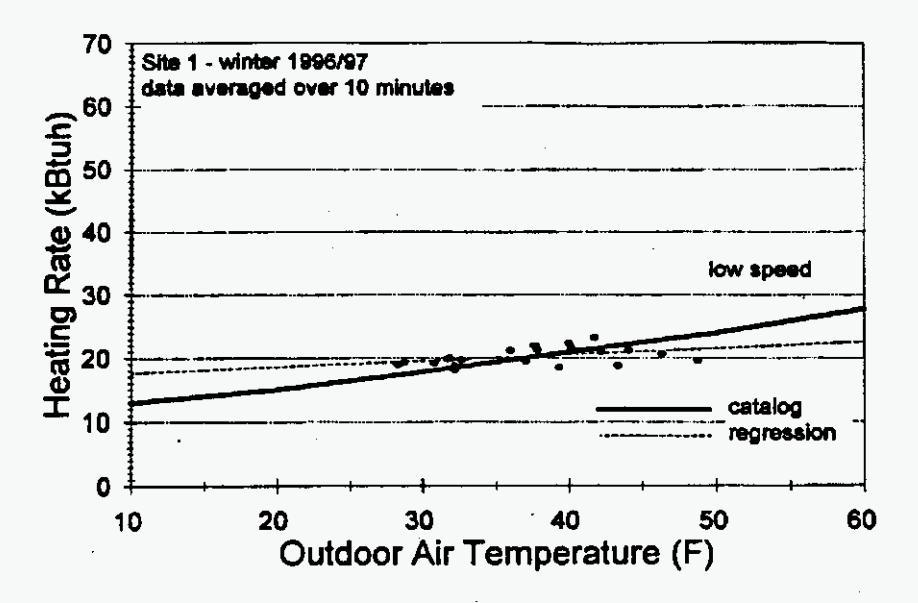
Figure 7.8 – Winter Heating Rate at Site 1

Because of the relatively mild winters at Site 1, it was not possible to compare the field test performance with catalog data during high-speed heating operation of the EDHP. Low-speed performance could be compared, and it is shown in Figures 7.8 and 7.9 for the winter of 1996/1997. The average inlet air temperature and flow for the low-speed heating operation was 70°F and 734 cfm.

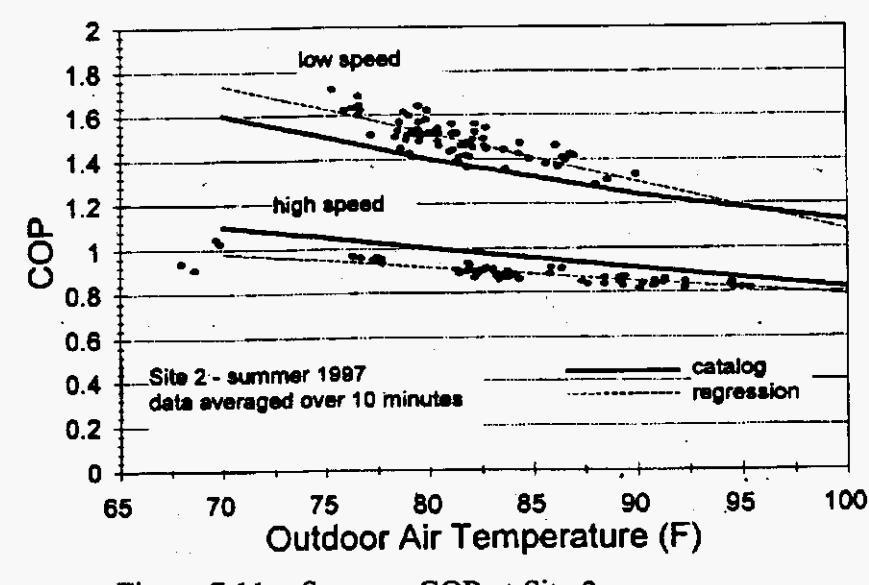
Figure 7.11 – Summer COP at Site 2

The performance of the EDHP at Site 2 during the summer of 1997 is compared with catalog performance in Figures 7.10 and 7.11. For high speed operation, the linear regression curve-fits through the field test data again fall very close to the catalog performance curves: the measured

low-speed operation of the EDHP during cooling. As shown in Figures 7.10 and 7.11, the regression curve-fit through the low-speed data for cooling rate is about 14% higher than the catalog curve, and for the COP, it is 9% higher. The average wet-bulb temperature for this data was 61°F and the average air flow was 950 cfm.

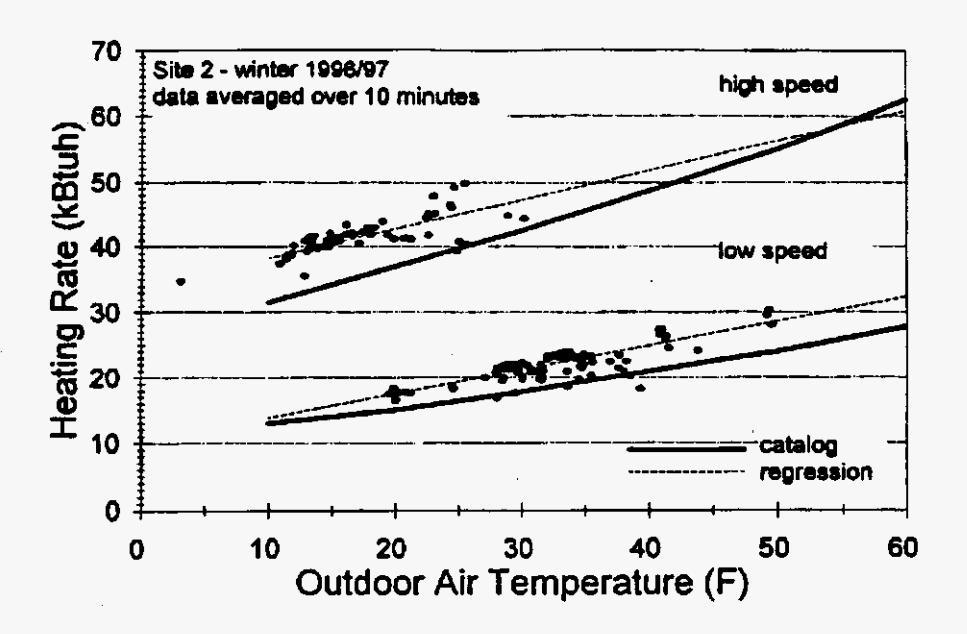
Figure 7.12 – Winter Heating Rate at Site 2

During heating, the measured performance of the EDHP during high-speed operation did not agree as well with catalog data as did the data for cooling. As shown in Figures 7.12 and

7.13 the regression curve-fits through the high-speed heating data were about 16% higher for the heating rate and 11% higher for the COP. Approximately 2% of these deviations could be explained by a combination of a higher inlet air temperature (74°F for the field test data versus 70°F for the catalog) and higher air flow (1514 cfm versus 1200).

The measured performance during low-speed heating also tended to be higher than the catalog curves. As shown in Figures 7.12 and 7.14, the linear regression curve-fit for the heating rate was about 17% higher than the catalog curve, and for the COP it was 23% higher. The average inlet air temperature and air flow for these data were 70°F and 862 cfm.

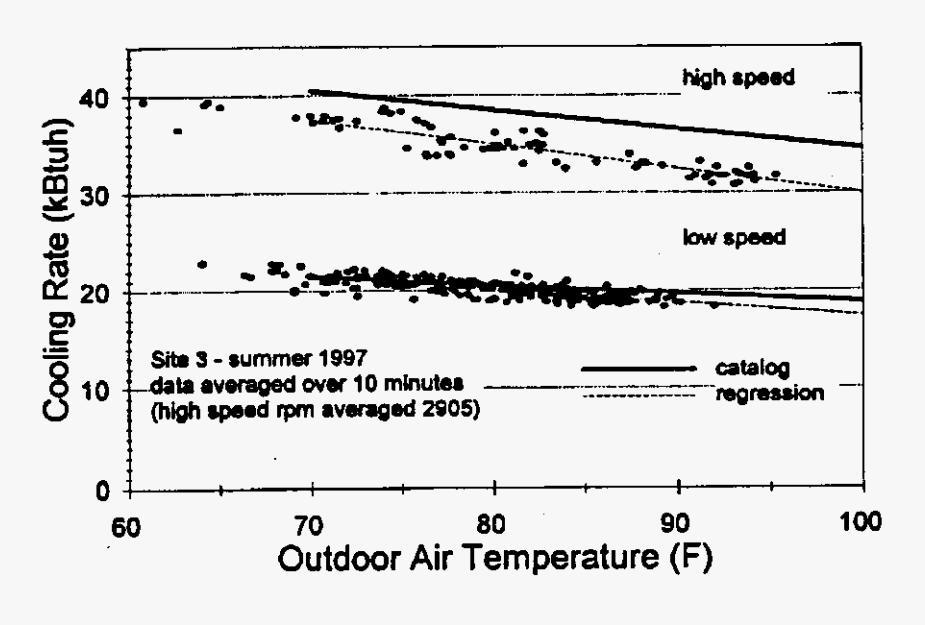
Figure 7.15 – Summer Cooling Rate at Site 3

The process for correcting the field test data for air inlet conditions that deviate from the catalog test conditions was complicated by the fact that the dew-point hygrometer at the inlet to the air handler malfunctioned during the summer of 1997 at Site 3. Assuming that the inlet air has relative humidity of 60% (a value frequently seen prior to the failure of the dew-point hygrometer), the inlet wet-bulb temperature averaged 61°F during high-speed operation. The air flow averaged 1473 cfm. Using the correction factors listed above, these inlet air condi-

The performance of the EDHP at Site 3 during the summer of 1997 is compared with catalog performance in Figures 7.15 and 7.16. For high speed operation, the linear regression curvefits through the field test data fall moderately below the catalog performance curves: the measured cooling rate is about 9% lower than the catalog curve and the COP is about 4% lower.

tions would produce a cooling rate that was 8.5% below the catalog curve and a COP that was 7% below. These values compare reasonably well with the regression curvefits through the measured data.

At Site 3 there was good agreement between the measured cooling performance at low speed and coalog data. As shown in Figures 7.15 and 7.16, the regression curve-fits for both the

cooling rate and the COP at low speed were within 2% of the catalog curves. Assuming an inlet air relative humidity of 60%, the inlet air wet-bulb temperature averaged 61°F for the low speed data. The air flow was 781 cfm.

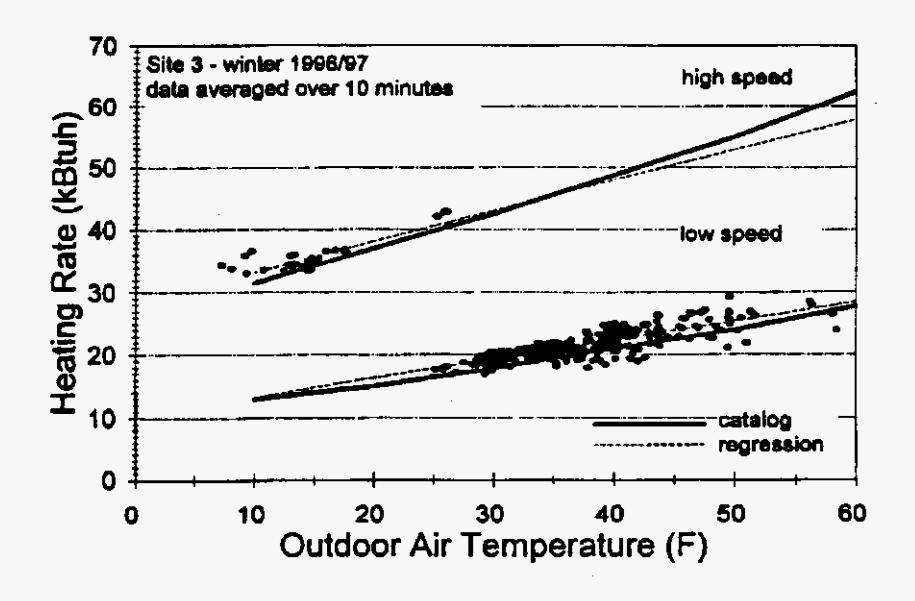
Figure 7.17 – Winter Heating Rate at Site 3

The performance of the EDHP at Site 3 agreed well with catalog data for both low-speed and high-speed heating. As shown in Figures 7.17 and 7.18, the linear regression curve-fits through the data for heating rate and COP at high speed are high by 4% and 7% respectively. The average inlet air temperature for the measured data was 70°F and the air flow was 1389 cfm. The higher air flow would account for a heating rate that was high by 1.3% and a COP that was high by 2.5%.

curves. As shown in Figures 7.17 and 7.19, the linear regression curve-fit for the heating rate was about 7% higher than the catalog curve, and for the COP it was 12% higher. The average inlet air temperature and air flow for these data were 70°F and 740 cfm.
