St. Lucie Station

Unit 1 Main Generator Ground Fault Root Cause Evaluation Report

Event Date: 04/25/2019

CR Number: 02312208

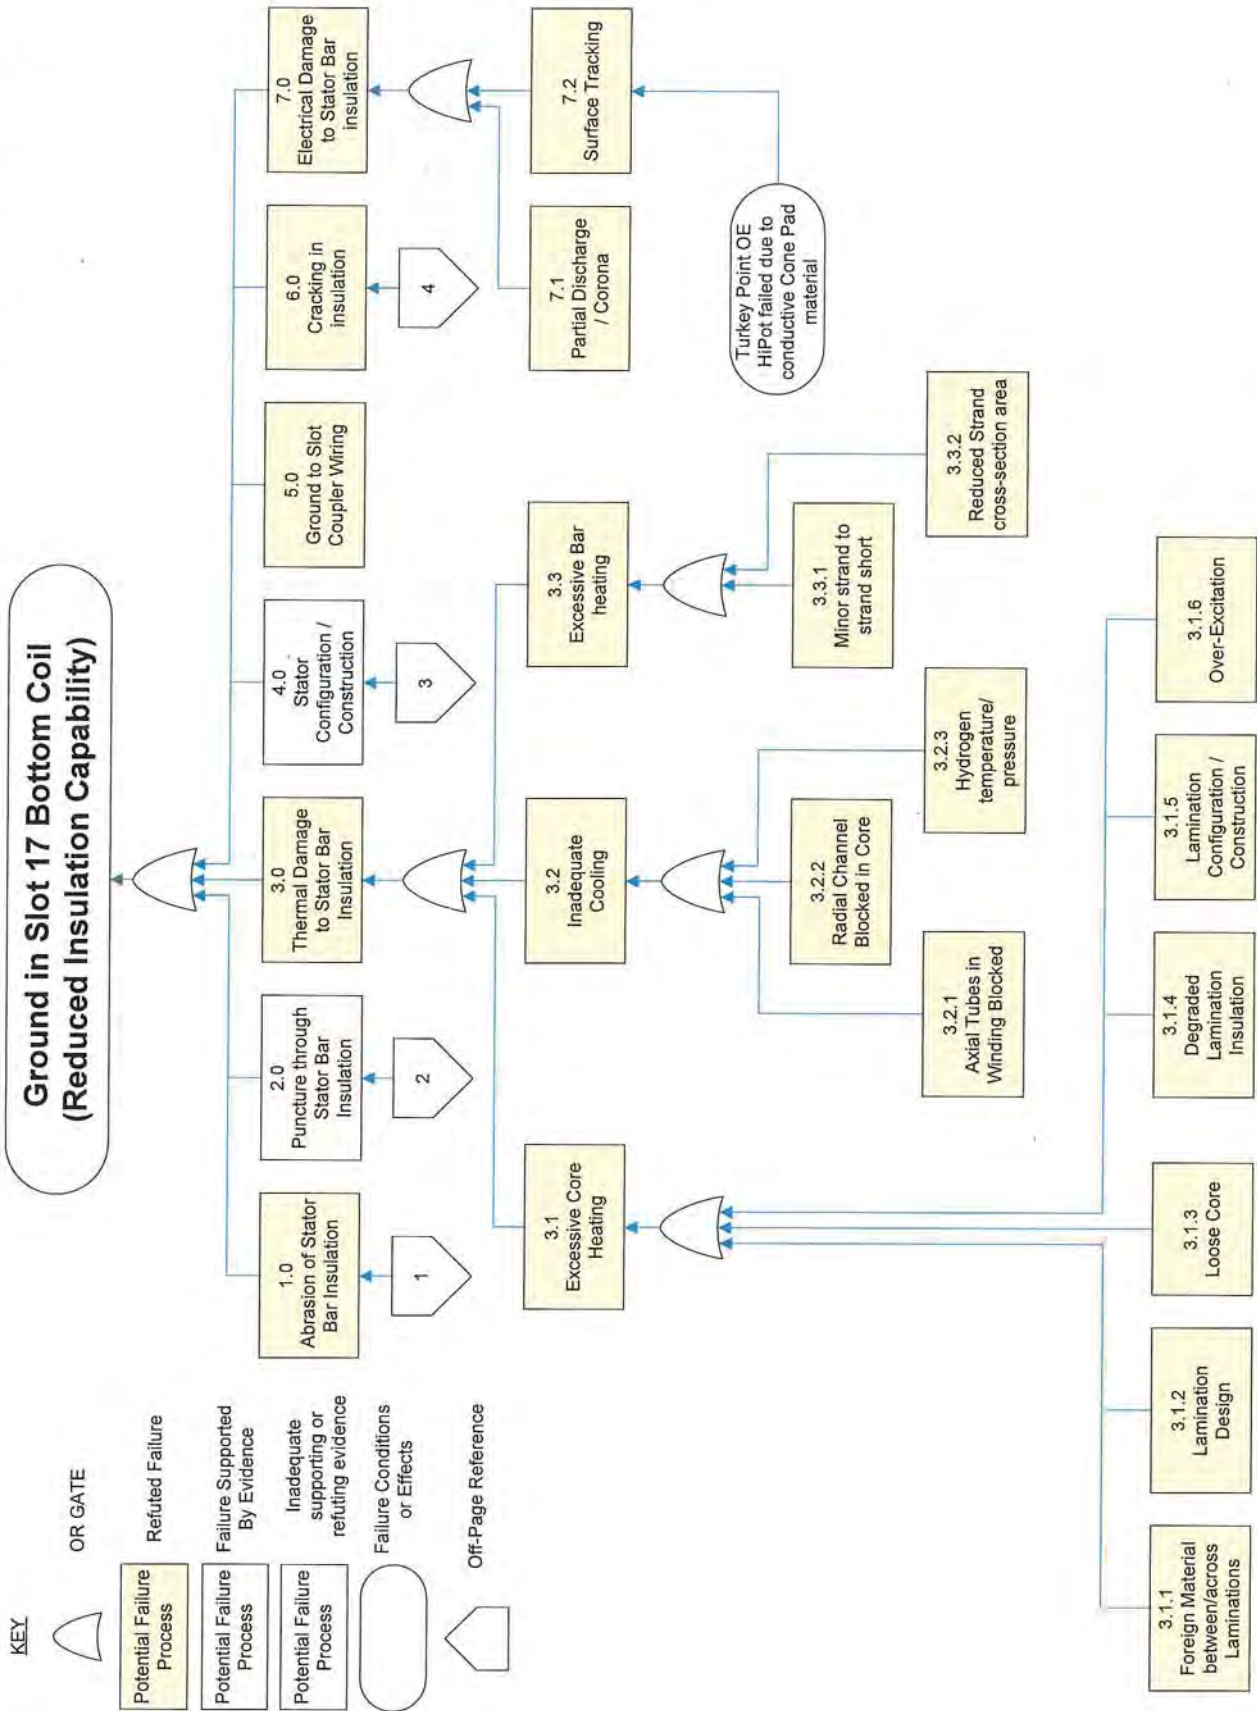
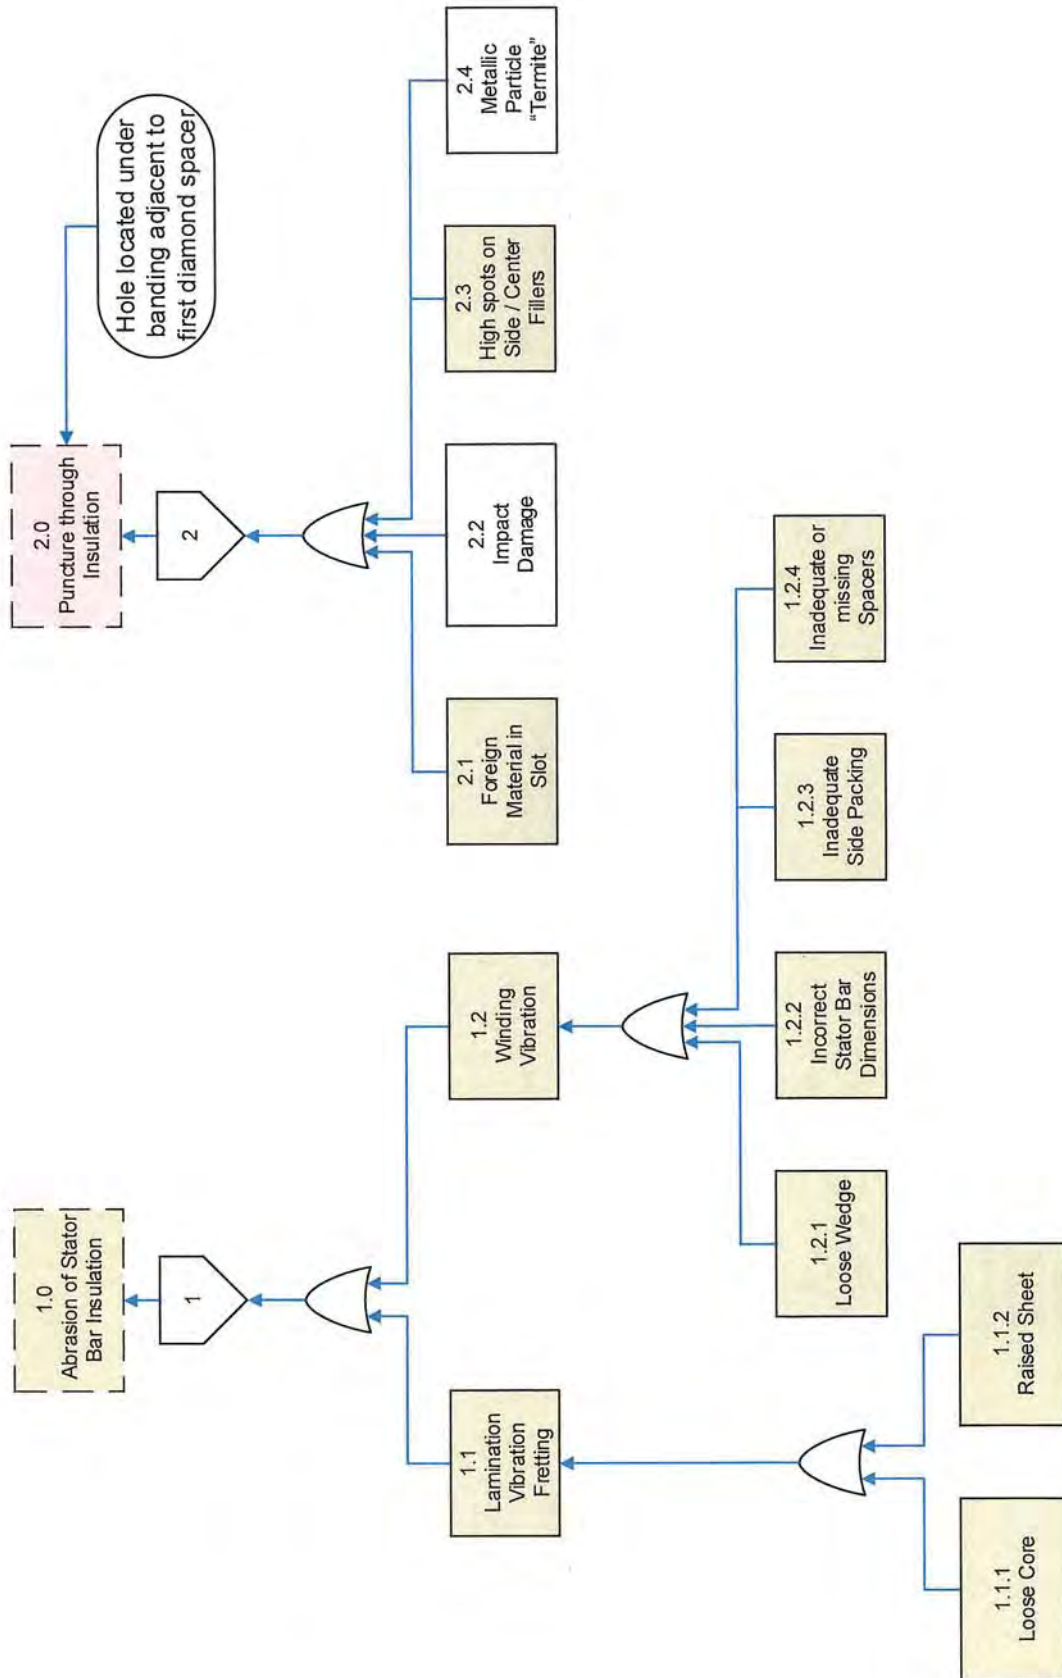
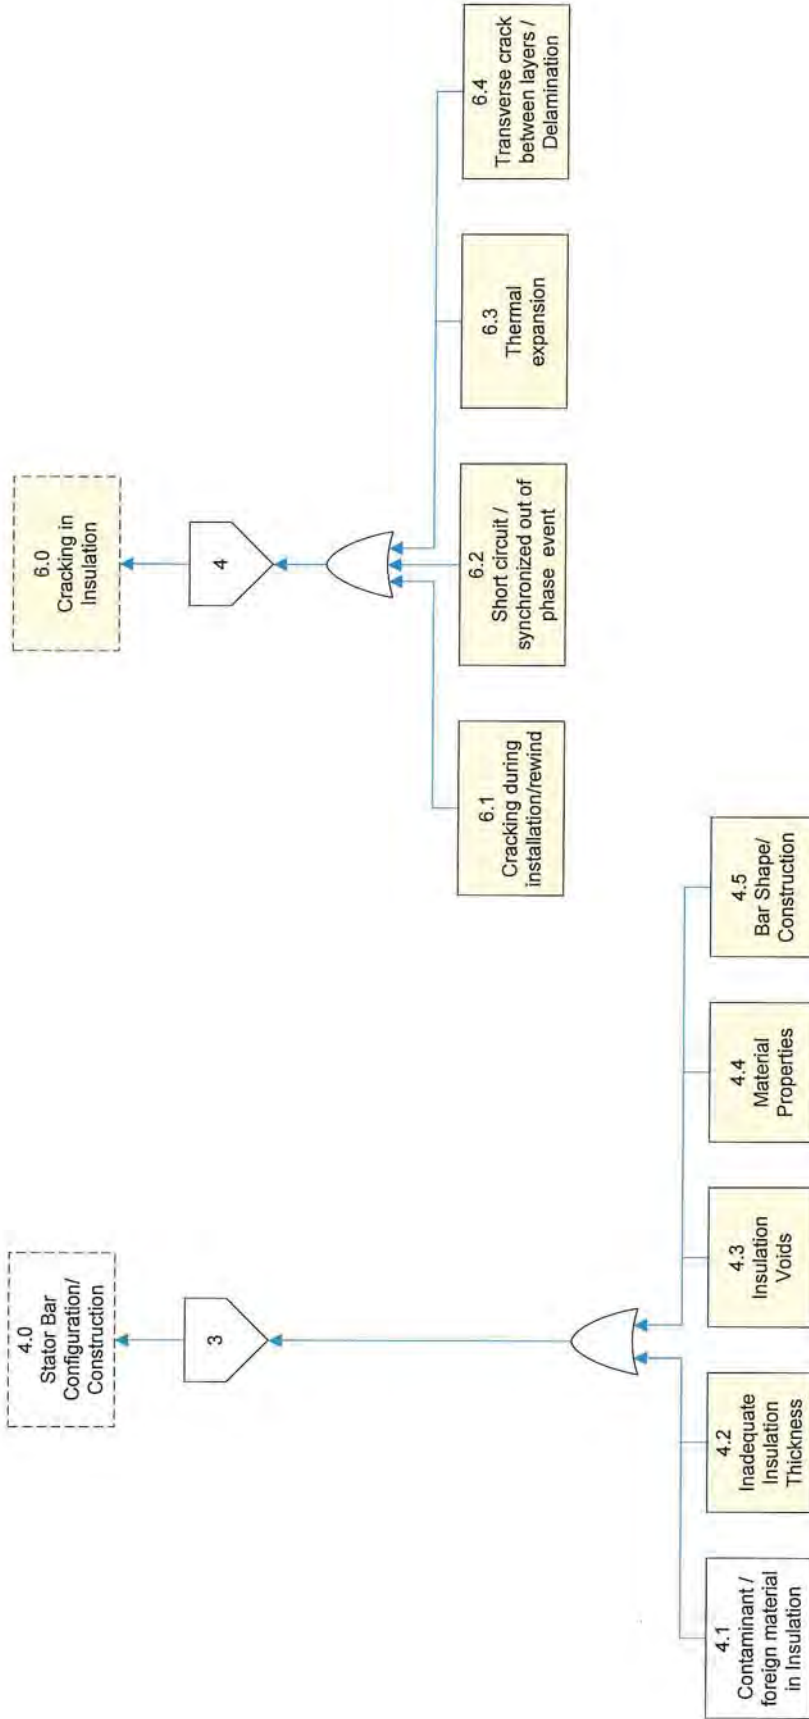
RCE AR 02312208
Attachment B – Fault Tree

The Fault Tree presented in Attachment B was developed to investigate a range of possible causes for insulation failure. The fault tree reflects input from relevant EPRI and IEEE publications on rotating electrical machines and their insulation systems [D16,D17,D20]. Evidence supporting or refuting each failure was captured in the Support Refute Matrix presented in Attachment C.

Examination of the fault current track and the insulation breach demonstrates that the fault was caused by a small puncture through the insulation. This small puncture is located on the turbine end outside of the stator slot and underneath a layer of structural banding material at the first diamond spacer. Available data is insufficient to determine a singular cause for the presence of this puncture; three possible causes hypothesized under the fault tree were neither refuted nor adequately supported:

- Ferromagnetic particle introduced during installation of the stator bar
- Impact damage during handling, or installation of the stator bar
- A contaminant or small object introduced in the stator bar insulation during its manufacture or construction
