# St. Lucie Station

## *Unit 1 Main Generator Ground Fault Interim Root Cause Evaluation Report*

**Event Date: 04/25/2019**

**CR Number: 02312208**

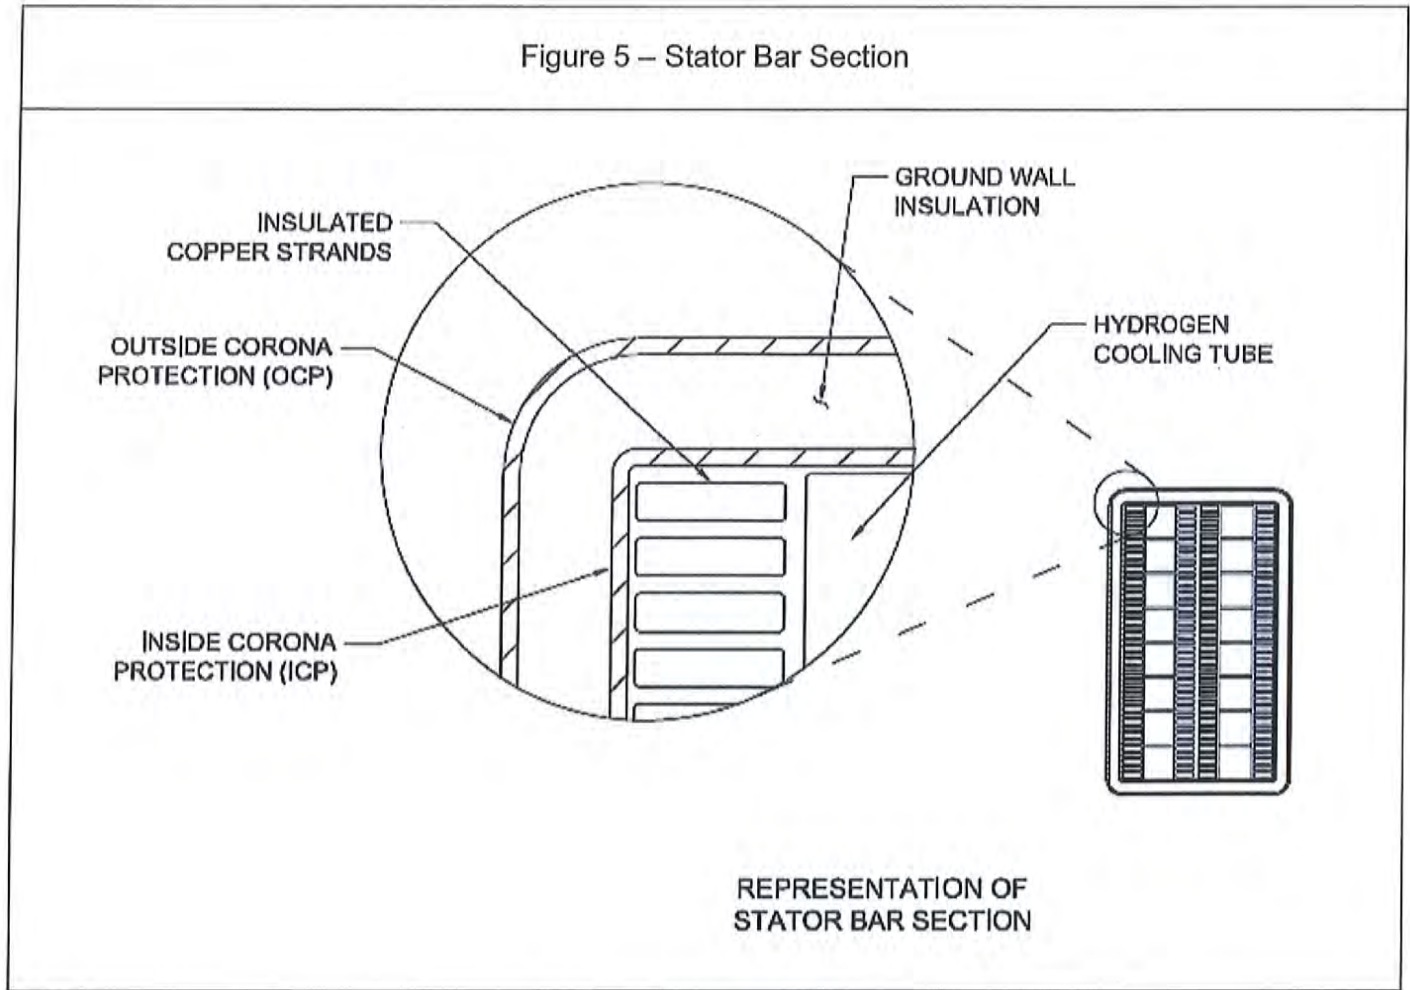
Figure 5 – Stator Bar Section

Each stator bar contains conductor, hydrogen cooling tubes, and several layers of materials forming the insulation system (Figure 5 and 6). The conductor consists of copper strands that are individually insulated from each other to reduce losses and arranged close to the cooling tubes for heat removal. The ground wall insulation is 'Thermalastic'; a trademarked insulation system originally developed by Westinghouse consisting of layers of inorganic mica tape impregnated with an organic epoxy resin.

Special semi-conductive layers are applied to protect the ground wall insulation from partial discharges (sometimes termed corona) which are damaging to the organic components of the insulation. The Inside Corona Protection (ICP) is applied around the conductor strands under the ground wall. The ICP layer incorporates a conductive copper strip connected to a strand at one end of the stator bar to provide a drain for excess electrical charge. The Outside Corona Protection (OCP) layer is applied over the ground wall insulation. The OCP is maintained in contact with the grounded core laminations to provide a drain path for excess electrical charge outside the ground wall.

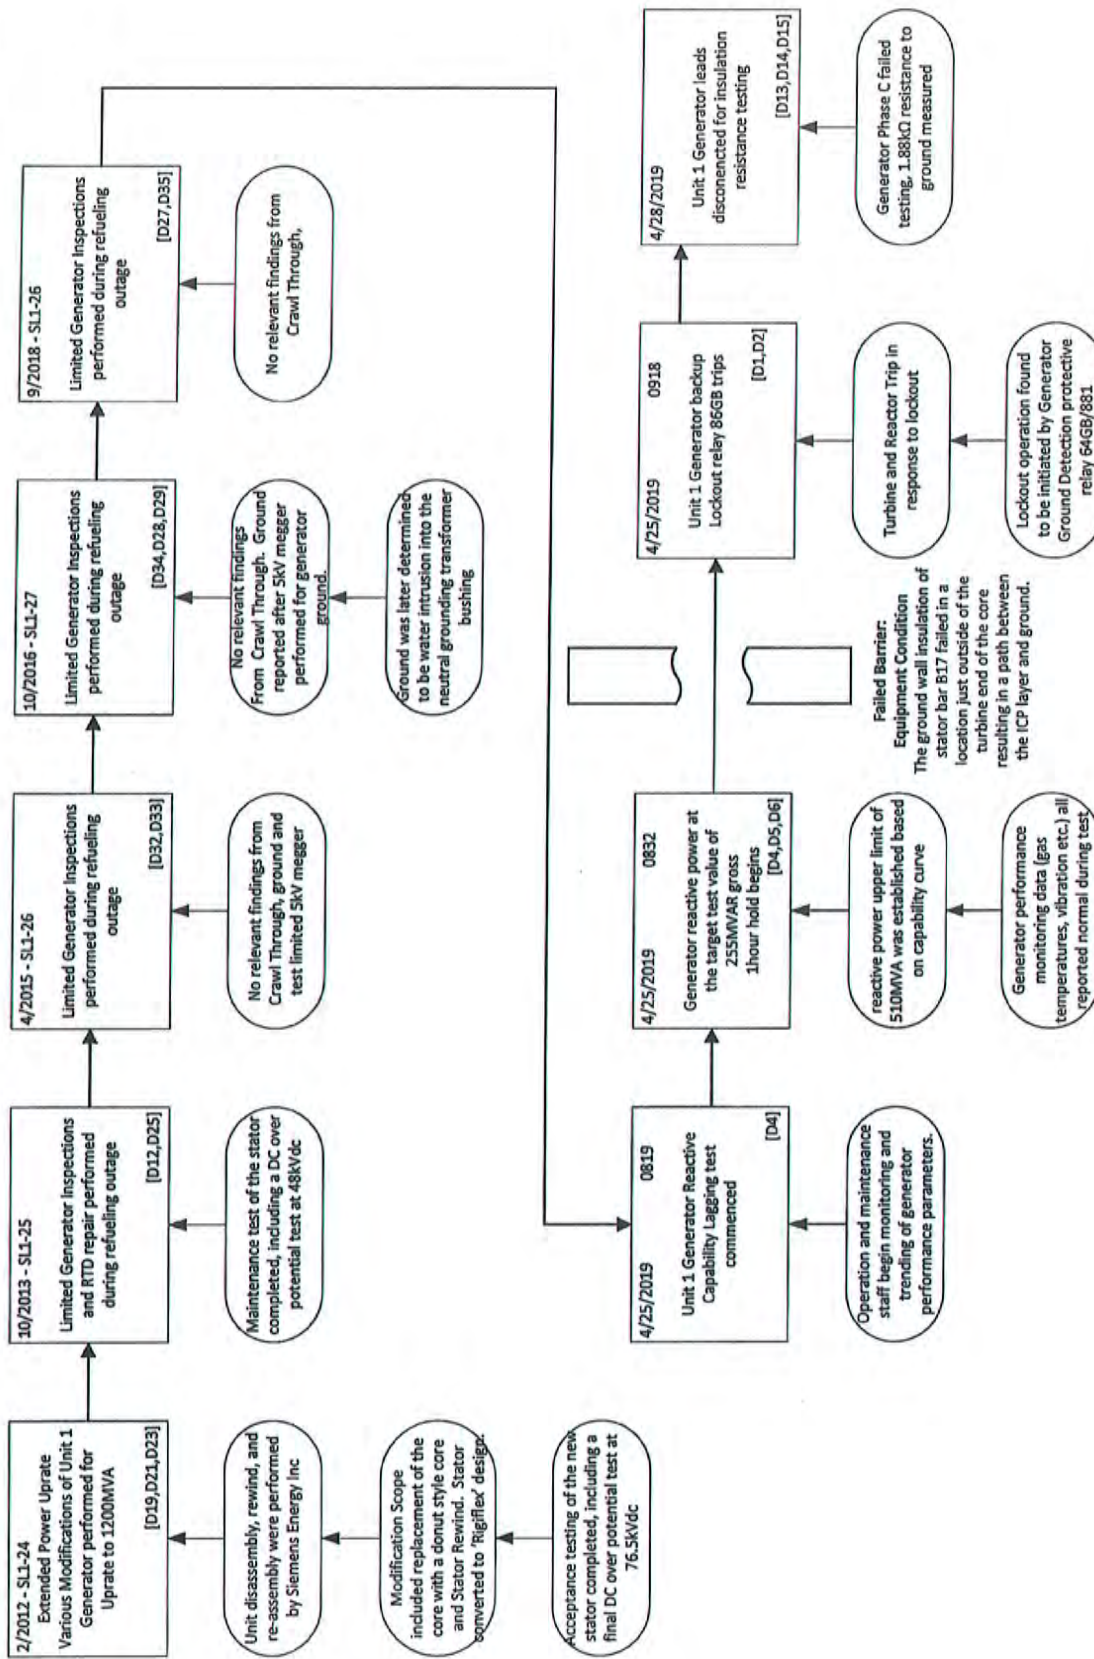
RCE AR 02312208  
Attachment D – Event and Causal Factors Chart

The field testing performed on the Phase C Generator Stator coils demonstrated that the ground fault was located in the bottom stator bar in slot 17 of the stator. The insulation failure resulted in a circuit path to ground from the inner corona protection (ICP) layer of the bar sufficient to operate the generator ground protective relaying. Care was used for removal of this stator bar during disassembly of the stator. Initial visual inspections and field resistance tests confirmed the fault occurred due to an insulation breach located just outside the stator slot on the turbine end. The breach has the appearance of crack in the underlying insulation. The surrounding OCP layer material was degraded and carbon tracking is noted along the adjacent surface areas.

A determination of why the ground wall insulation failed on B17 and at this location requires further evaluation. The failure is significantly premature given the in service time, and appears limited to a localized insulation breach in this specific bar. The failed B17 bar and several control bars were quarantined pending additional forensic testing necessary to establish the failure process and complete the root cause analysis. The summary of proposed forensic testing D31 has been developed and referenced to various open items in the Support Refute Matrix provided in Attachment C.
