# Power Delivery Performance

## Hurricane Eta

Storm Date: November 9, 2020

Report Date: September 28, 2021

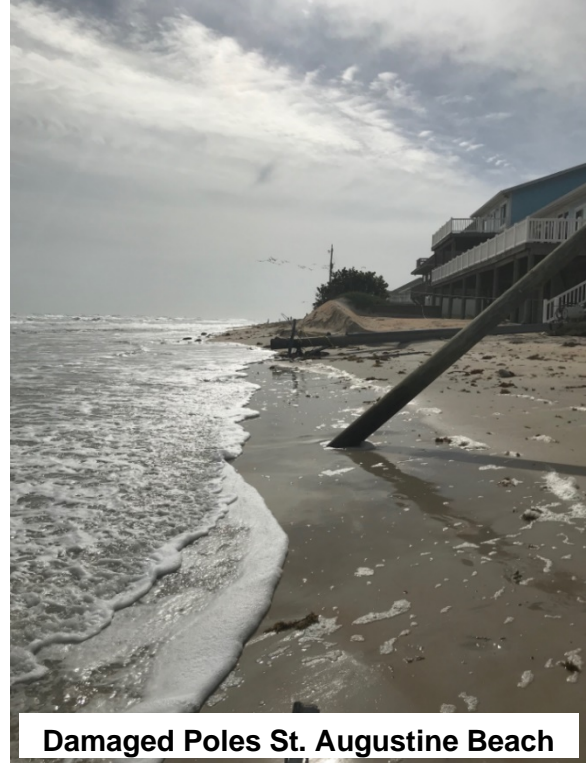
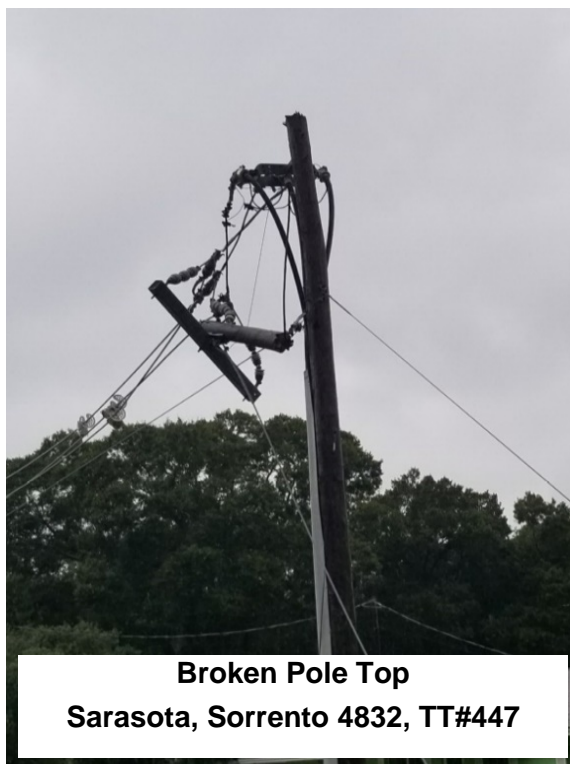
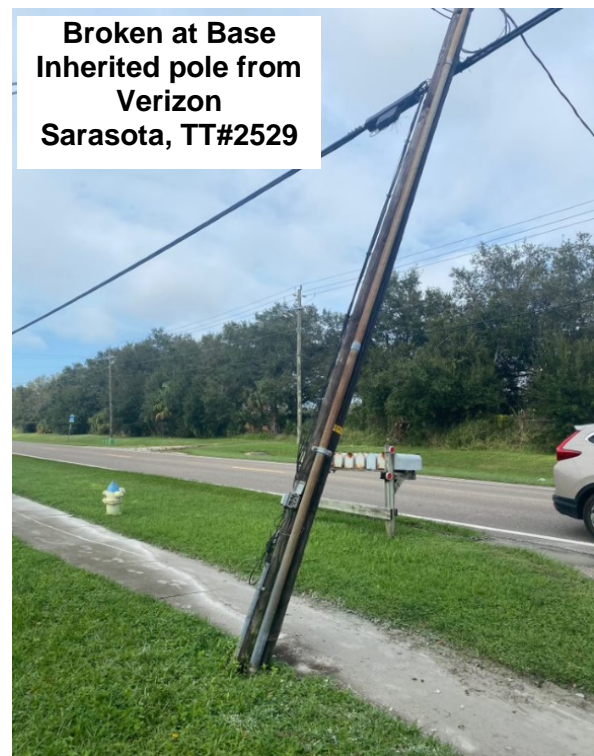
- Details provided by crews and patrols, when available
- Due to the nature of a small storm, most repairs were completed quickly
- Hardened Feeder, 0 Poles
- Non-Hardened Feeder, 7 Poles
  - FPL, 3 Broken pole top
  - FPL, 1 Pole Fire
  - FPL, 3 No cause given
- Lateral, 8 Poles
  - FPL, 3 No cause given
  - ATT, 3 Deteriorated
  - ATT, 2 Vegetation
- Service, 4 Poles
  - FPL, 2 No cause given
  - FPL, 1 Deteriorated
    - Inherited from Verizon
  - ATT, 1 Vegetation
