St. Lucie 1 Generator Ground Fault Analysis

July 11th 2019

St. Lucie Unit 1 Generator Ground Fault

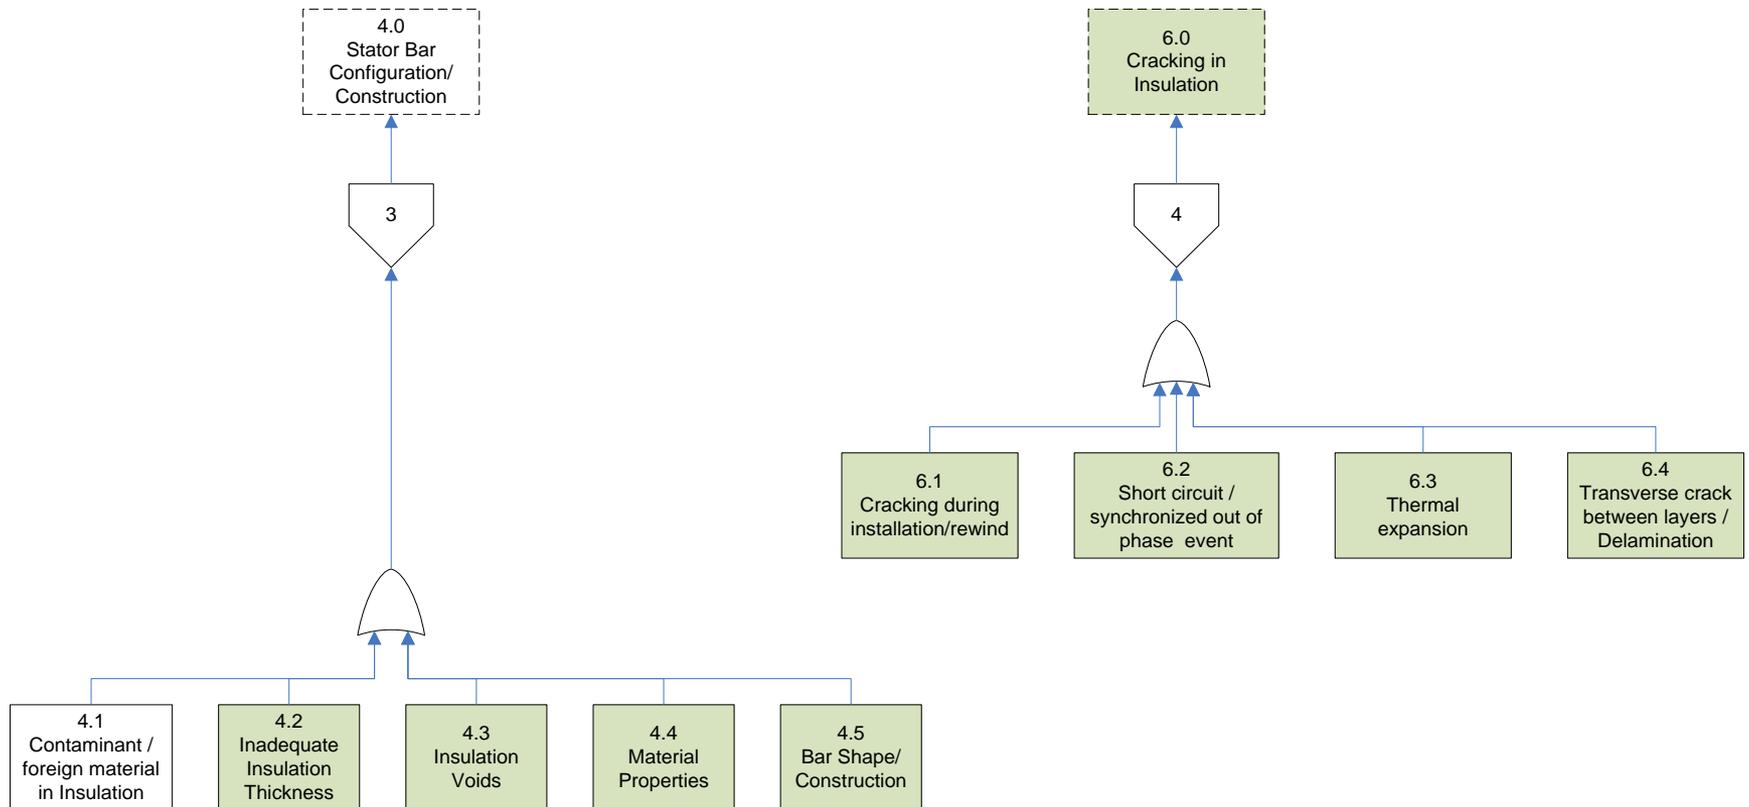
Fault Tree

By Elimination of possible failure modes the most probable and verified by 3rd party consultant is a “Magnetic Termite”
