Power Delivery Performance

Hurricane Dorian

Storm Date: September 3, 2019

Report Date: May 8, 2020

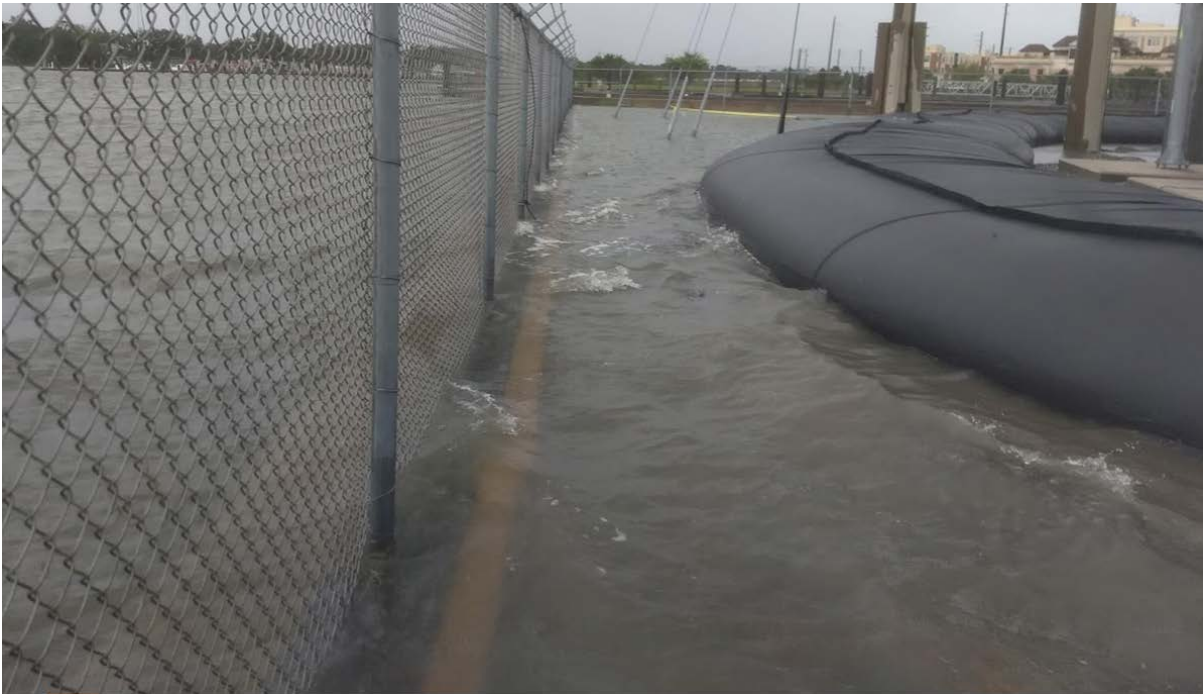
St. Augustine AquaDam during hurricane at high tide
