*Florida's*  
*Investor-Owned*  
*Electric Utilities*

*Service Reliability reports*

Florida Public Service Commission  
Division of Safety, Reliability & Consumer Assistance

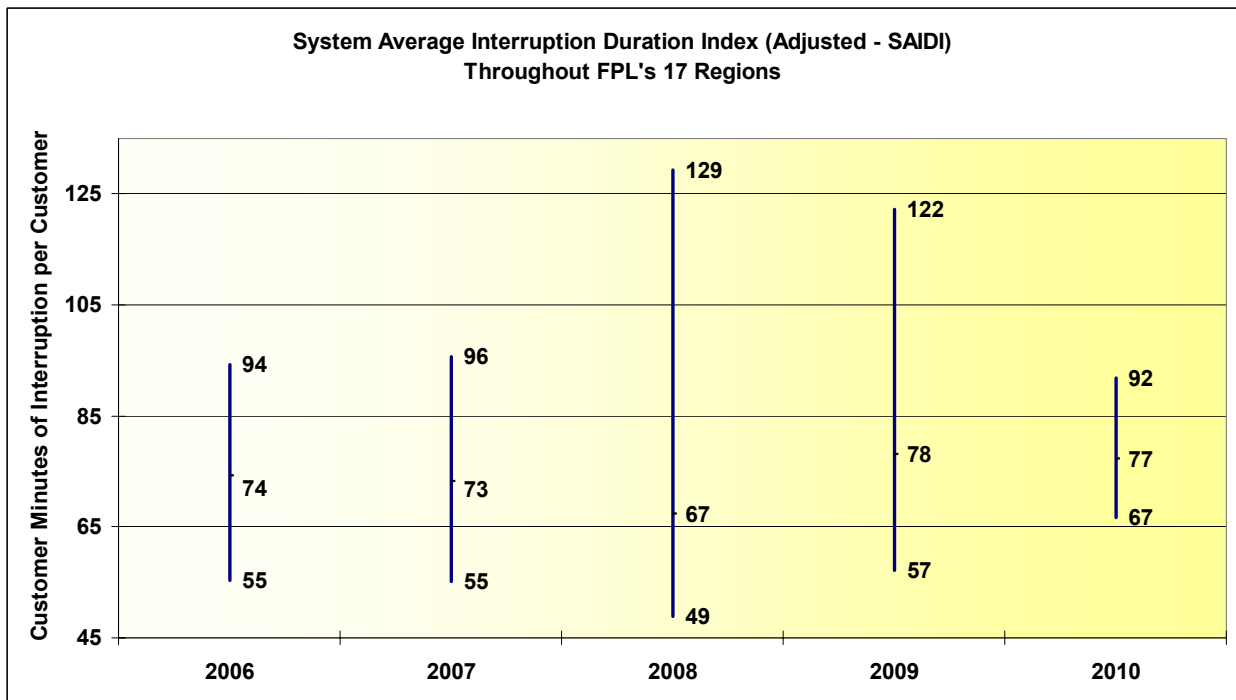
**Figure 3-1. SAIDI across FPL's 17 Regions (Adjusted)**

**Figure 3-1** shows the highest, average, and lowest adjusted SAIDI (System Average Interruption Duration Index) recorded across FPL's system that encompasses five management regions with seventeen service areas. The highest and lowest SAIDI values are the values reported for a particular service area. **Figure 3-1** shows an increase in the lowest SAIDI to 67 minutes for the West Palm service area in 2010, and there is a decrease in the highest SAIDI to 92 minutes for the Naples service area. FPL had an overall decrease of 1 minute (1 percent) to the average SAIDI results for 2010 compared to 2009. FPL attributes the SAIDI improvement primarily to the 2010 improvement in SAIFI (System Average Interruption Frequency Index) performance.

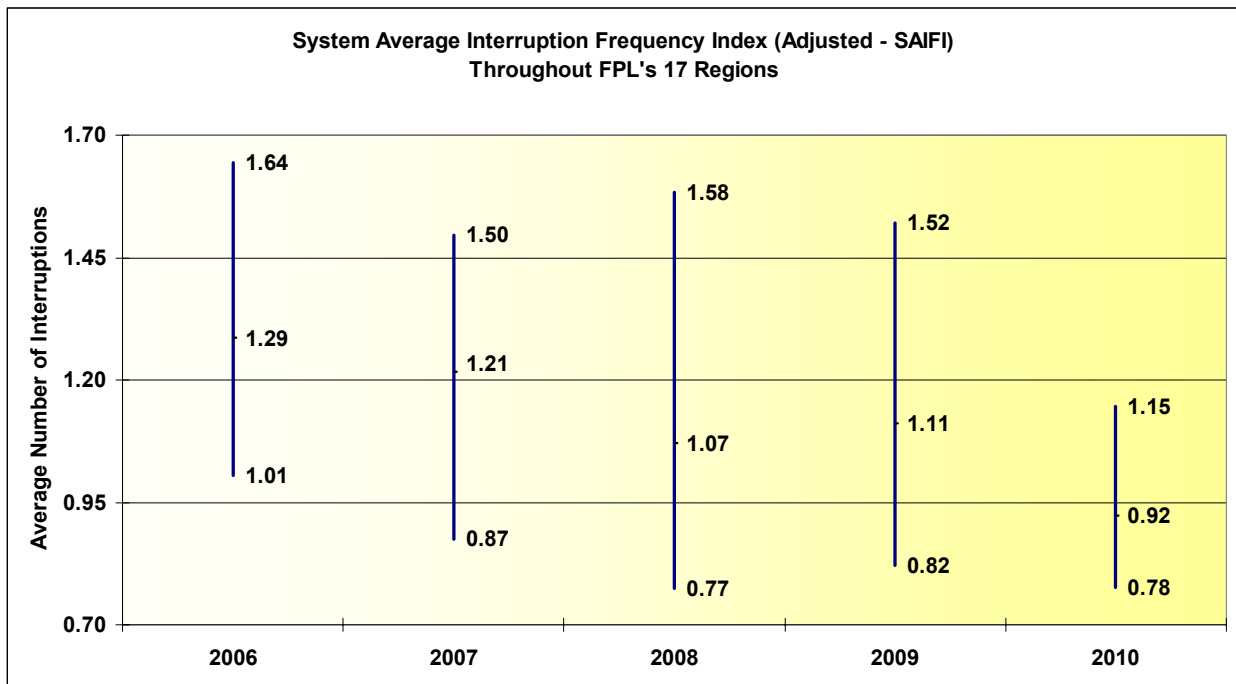
**Figure 3-2. SAIFI across FPL's 17 Regions (Adjusted)**

**Figure 3-2** is a chart of the highest, average, and lowest adjusted SAIFI (Frequency or Number of Interruptions Per Customer) across FPL's system. FPL had a decrease in the average results of 0.92 outages in 2010, compared to 1.11 outages in 2009. FPL reported a decrease to the highest SAIFI for West Dade of 1.15 interruptions compared to South Dade's 1.52 interruptions in 2009. The region reporting the lowest adjusted SAIFI for 2010 was Central Dade at 0.78 interruptions compared to Pompano's 0.82 interruptions in 2009. The highest, average and lowest SAIFI appear to be trending downward suggesting improvements.

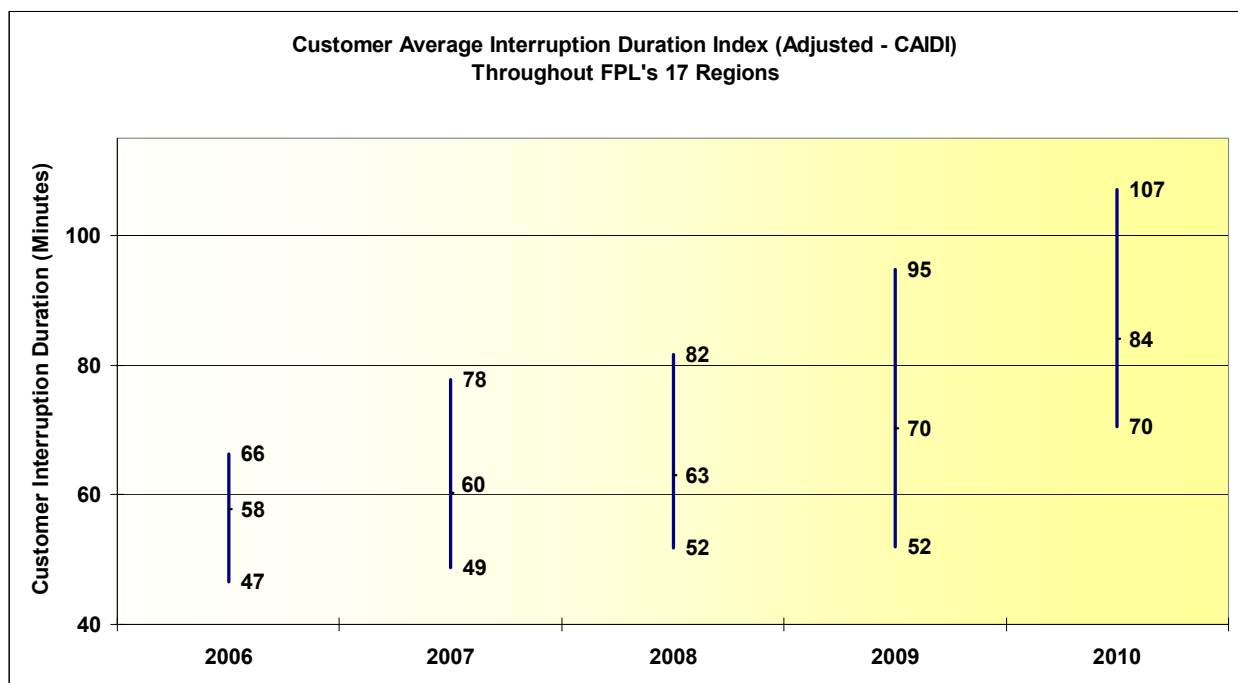
**Figure 3-3. CAIDI across FPL's 17 Regions (Adjusted)**

**Figure 3-3** is a chart of FPL’s highest, average, and lowest customer interruption duration indexes expressed in minutes. FPL’s adjusted average CAIDI (Customer Average Interruption Duration Index) has risen approximately 20 percent from 70 minutes in 2009, to 84 minutes in 2010. The average duration of CAIDI, or the average number of minutes a customer is without power when a service interruption occurs, is trending upwards. For 2010, the Brevard service area reported the lowest duration of CAIDI, which was 70 minutes; however, the lowest CAIDI for 2010, is 35 percent higher than the Boca Raton service area, reported as 52 minutes in 2009.

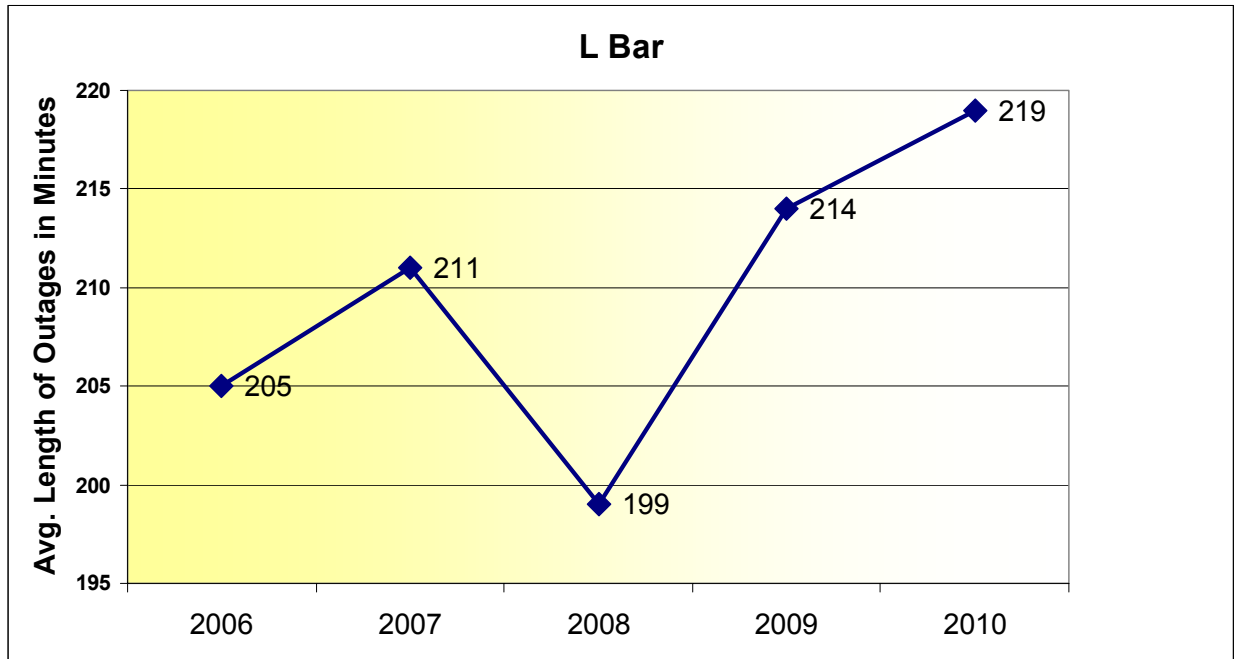
**Figure 3-4. FPL's Average Duration of Outages (Adjusted)**

**Figure 3-4** depicts the average length of time that FPL spends recovering from outage events, excluding hurricanes and other extreme outage events and is the index known as L-Bar (Average Service Restoration Time). FPL had a two percent increase in L-Bar (the time required to restore service) from 214 minutes in 2009, to 219 minutes in 2010, which represents the highest average duration of outages since 2006. The L-Bar measures the average length of time of a single service interruption. The IEEE standard for calculation of L-Bar is the summation of the minutes of interruption divided by the total number of outages.

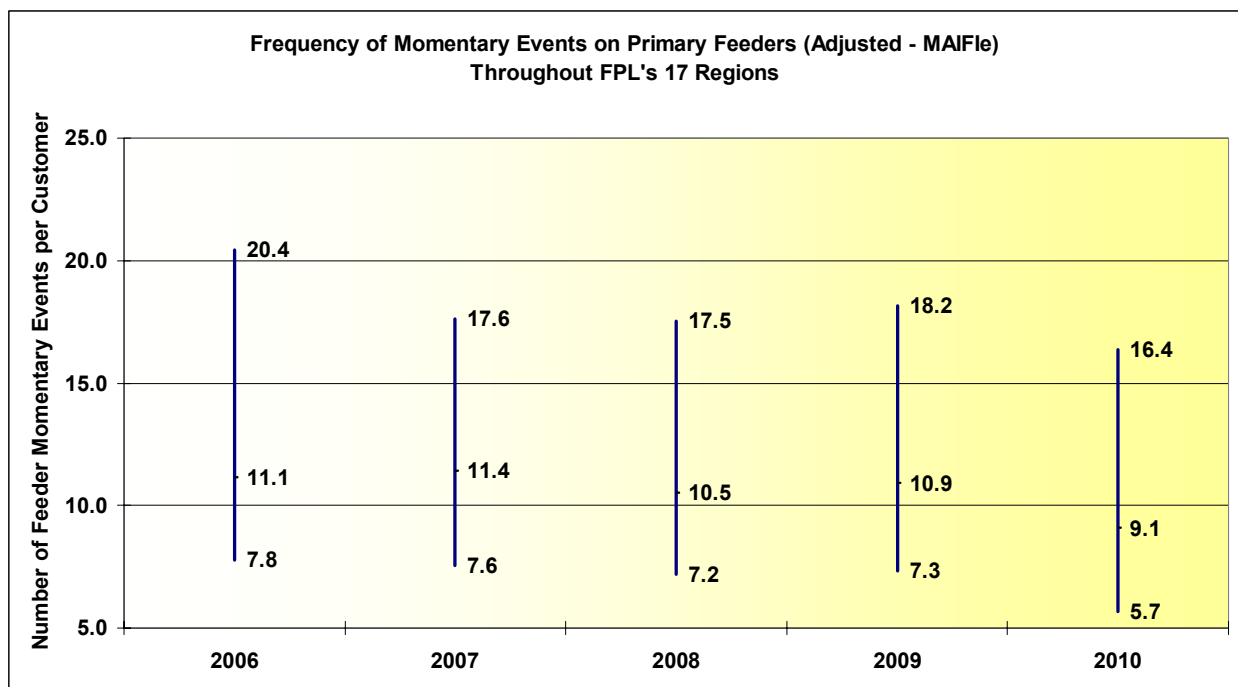
**Figure 3-5. MAIFle across FPL's 17 Regions (Adjusted)**

**Figure 3-5** is the highest, average, and lowest adjusted MAIFle (Frequency of Momentary Events on Primary Circuits per Customer) recorded across FPL's system. These momentary events often affect a small group of customers. FPL's Toledo Blade and Treasure Coast service areas have experienced, and continue to have, the least reliable MAIFle results over the 17 regions of FPL since 2006. The Pompano service area had the fewest momentary events and the results have been trending downwards over the last five years.

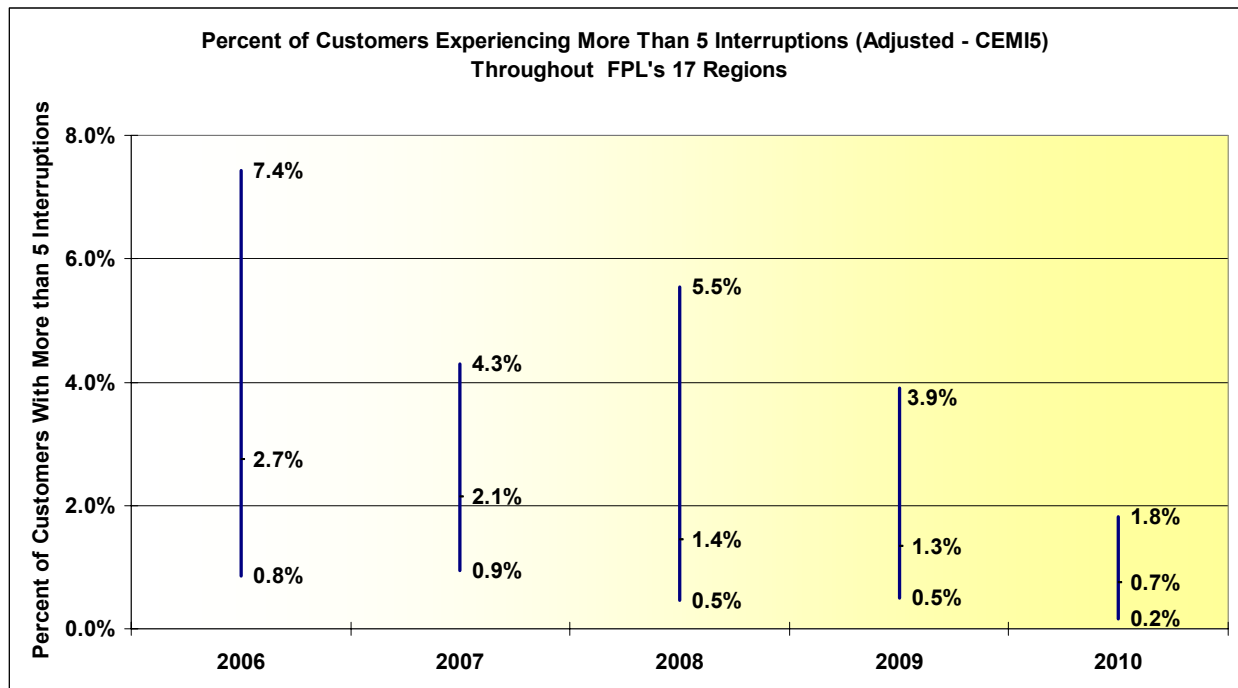
**Figure 3-6. CEMI5 across FPL's 17 Regions (Adjusted)**

**Figure 3-6** shows the highest, average, and lowest adjusted CEMI5 (Percent of Customers Experiencing More Than Five Interruptions). FPL reported a “best-ever performance” for CEMI5 for FPL’s combined 17 service areas. FPL’s customers with more than five interruptions per year appear to be decreasing and represent an overall improvement that appears to be trending downward. The service areas experiencing the highest CEMI5 appear to fluctuate among the areas; however, Brevard and Pompano are reported as having the lowest percentages in the last five years.

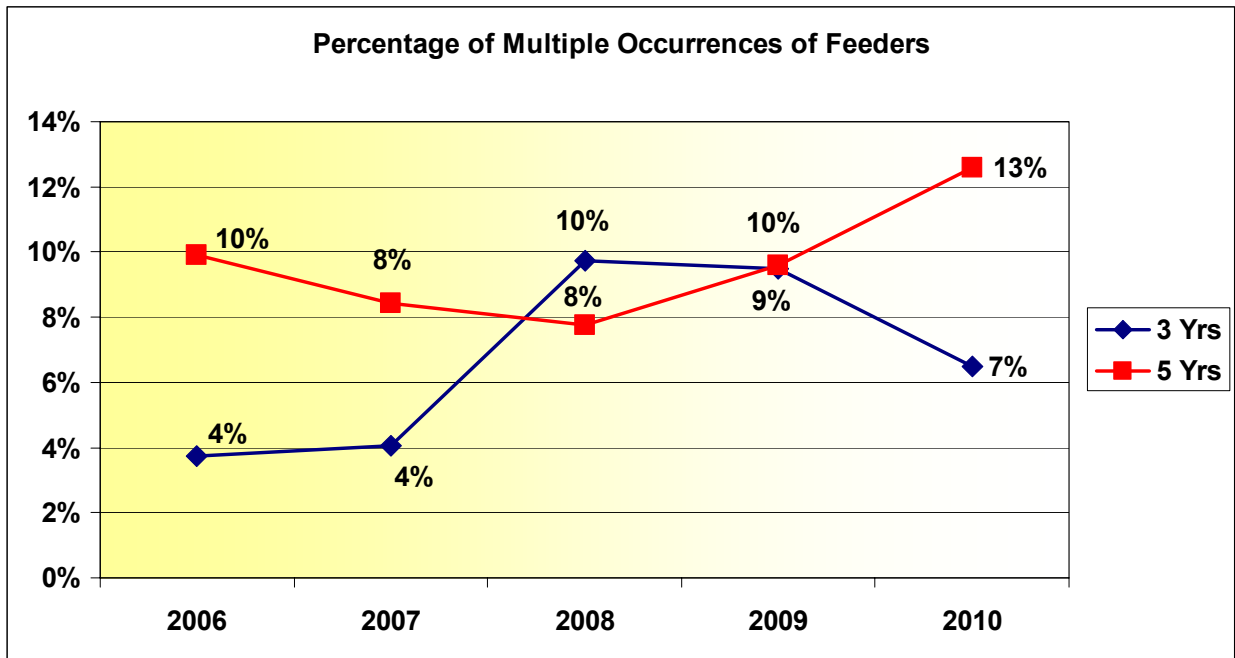
**Figure 3-7. FPL's Three Percent Feeder Report (Adjusted)**

**Figure 3-7** is a graphical representation of the percentage of multiple occurrences of FPL's feeders and is derived from The Three Percent Feeder Report which is a listing of the top three percent of feeders reported by the utility. The percentage of multiple occurrences is calculated from the absolute number of multiple occurrences divided by the ending total number of feeders reported on a three-year and five-year feeder analysis. The three-year and five-year percentages of multiple occurrences are trending upward since 2006. The three-year percentage improved from 9 percent in 2009 to 7 percent in 2010.

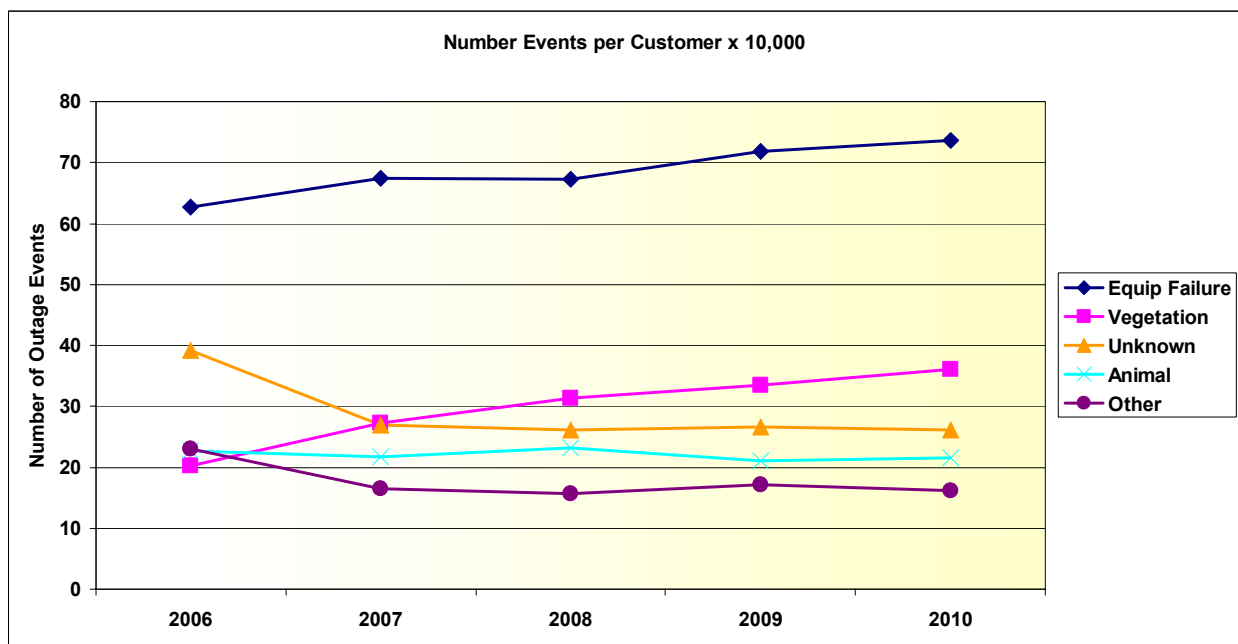
**Figure 3-8. FPL’s Top Five Outage Causes (Adjusted)**

**Figure 3-8** depicts the top five causes of outage events on FPL’s distribution system normalized to a 10,000-customer base. The graph is based on FPL’s adjusted data of the top ten causes of outage events. For the five-year period, the five top causes of outage events included equipment failures (35 percent), vegetation (17 percent), unknown (12 percent), animals (10 percent), and other causes (8 percent) on a cumulative basis. The data shows an increasing trend in outage events caused by equipment failure, which continues to dominate the highest percentage of outage causes throughout the FPL regions. In addition, outage events due to vegetation are also trending upward. The outage events due to unknown and other causes are trending downward, as the outage; events due to animals remain relatively flat over the five-year period.

Equipment failure and vegetation outages continue to be the leading cause of the number of outage events per customer for the past five years. Analysis of **Figure 3-8** shows an increasing trend in the number of outage events attributed to equipment failure and vegetation. FPL has budgeted reliability programs targeted at reducing its equipment and vegetation outage events that include \$15.8 million for reducing the number of direct buried lateral and feeder cables failures. \$59.8 million to minimize tree and vine related interruptions, and an additional \$10.1 million for switch replacement, pad-mounted transformers, submarine feeder cable, switch cabinets and vault inspections/repairs.

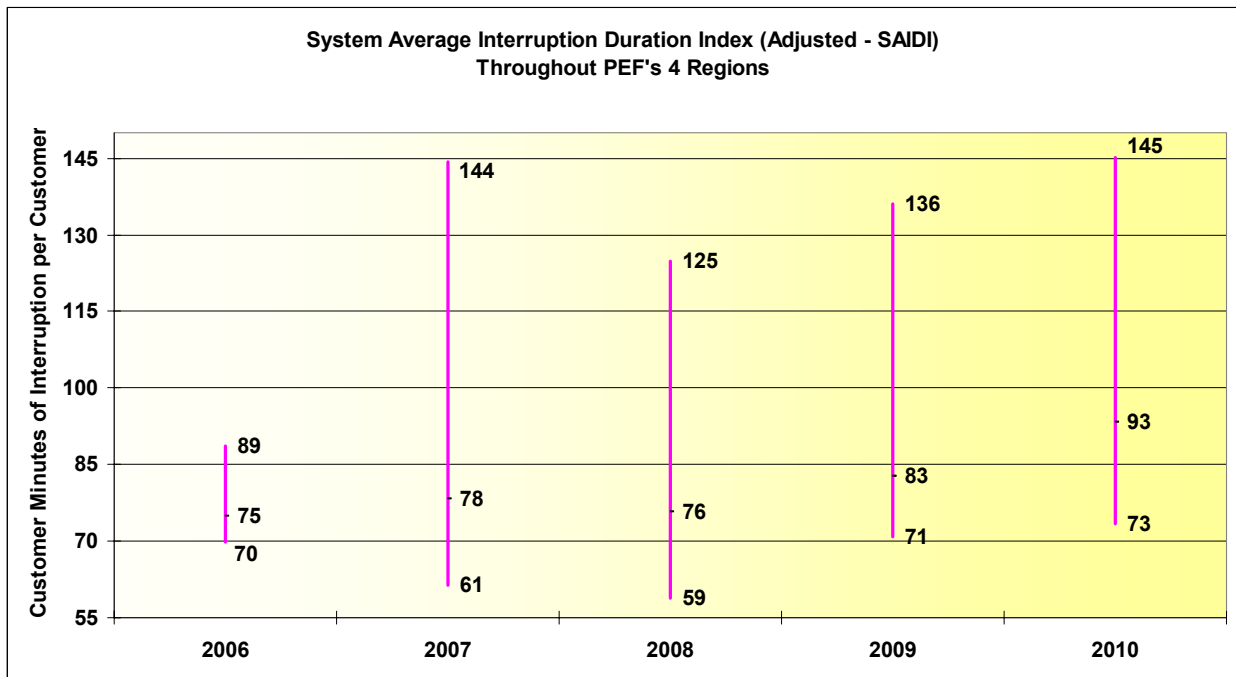
**Figure 3-9. SAIDI across PEF's Four Regions (Adjusted)**

**Figure 3-9** charts the adjusted SAIDI recorded across PEF’s system and depicts an increase in the highest, average, and lowest values for 2010. PEF notes that in 2010, two tornadoes and one named storm affected its service territory. Only 2.5 SAIDI minutes were excluded due to the weather events. The adjusted SAIDI for 2010 was reported as 93.3 minutes. PEF notes that it continues to focus on “reliability projects including, but not limited to, small wire upgrades, storm hardening, and pole replacements.”

**Figure 3-9** illustrates that the North Coastal region continue to report the poorest SAIDI over the last five years, fluctuating between 89 minutes and 145 minutes. While the South Coastal and South Central regions have the best or lowest SAIDI for the same period. PEF’s service territory is comprised of four regions: North Coastal, South Coastal, North Central, and South Central.

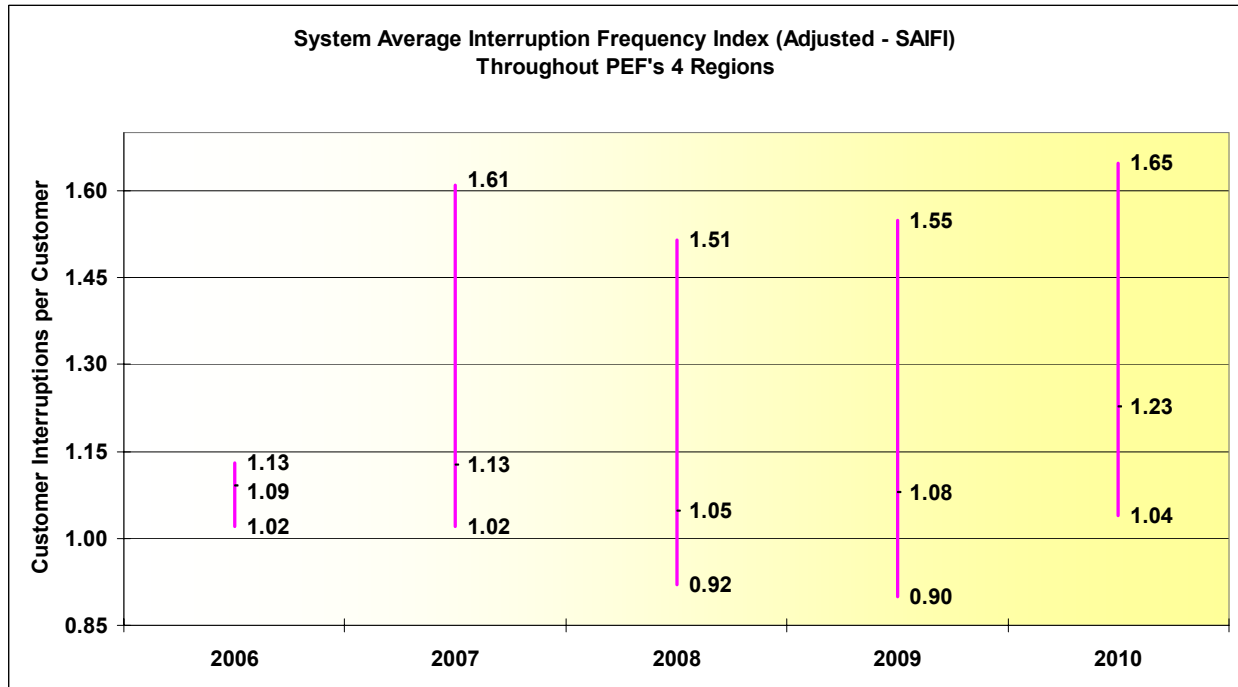
**Figure 3-10. SAIFI across PEF's Four Regions (Adjusted)**

**Figure 3-10** shows the adjusted SAIFI (System Average Interruption Frequency Index or the number of times a customer experiences a power interruption) across PEF's system. The maximum SAIFI index is trending upward as the minimum SAIFI index is trending downward. The South Central region continues to have the lowest number of interruptions, while the North Coastal region continues to have the highest number of interruptions.

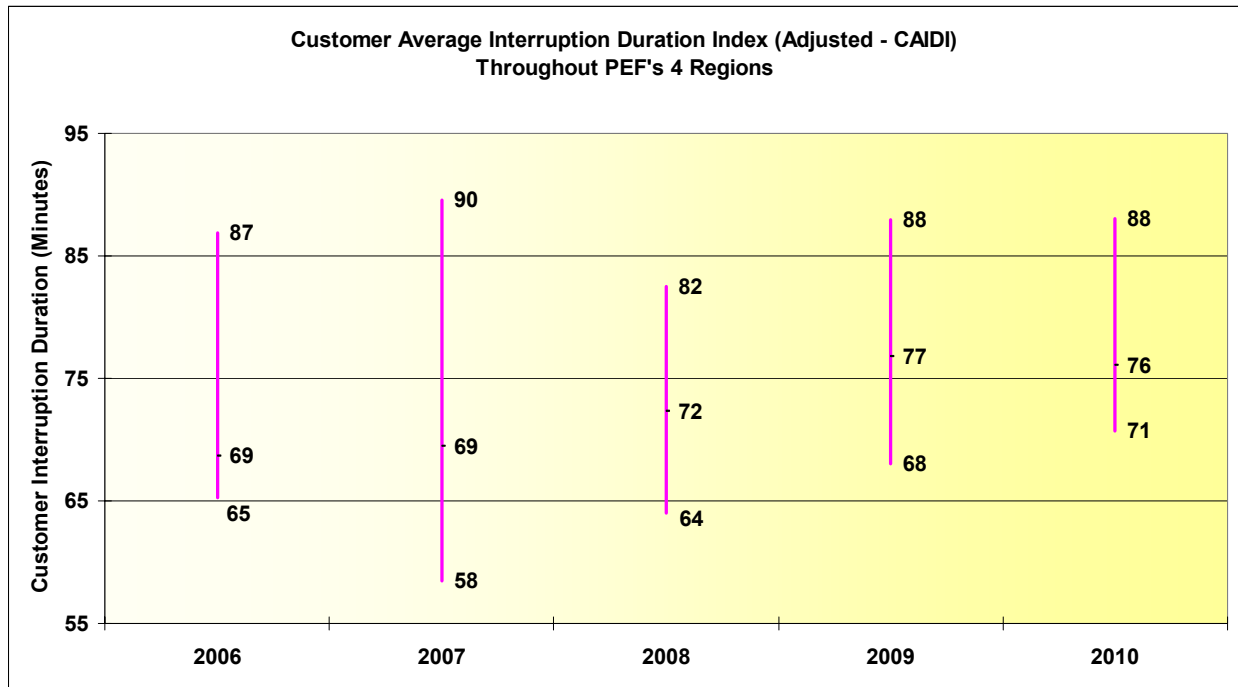
**Figure 3-11. CAIDI across PEF's Four Regions (Adjusted)**

**Figure 3-11** illustrates the Customer Average Interruption Duration Index or CAIDI for PEF's four regions. PEF's adjusted CAIDI is trending upward from 69 minutes in 2006 to 76 minutes in 2010. The North Coastal region has continued to have the highest CAIDI level for the past five years, as compared to the other PEF regions, while the South Coastal and South Central regions have maintained the lowest CAIDI level during the same period.

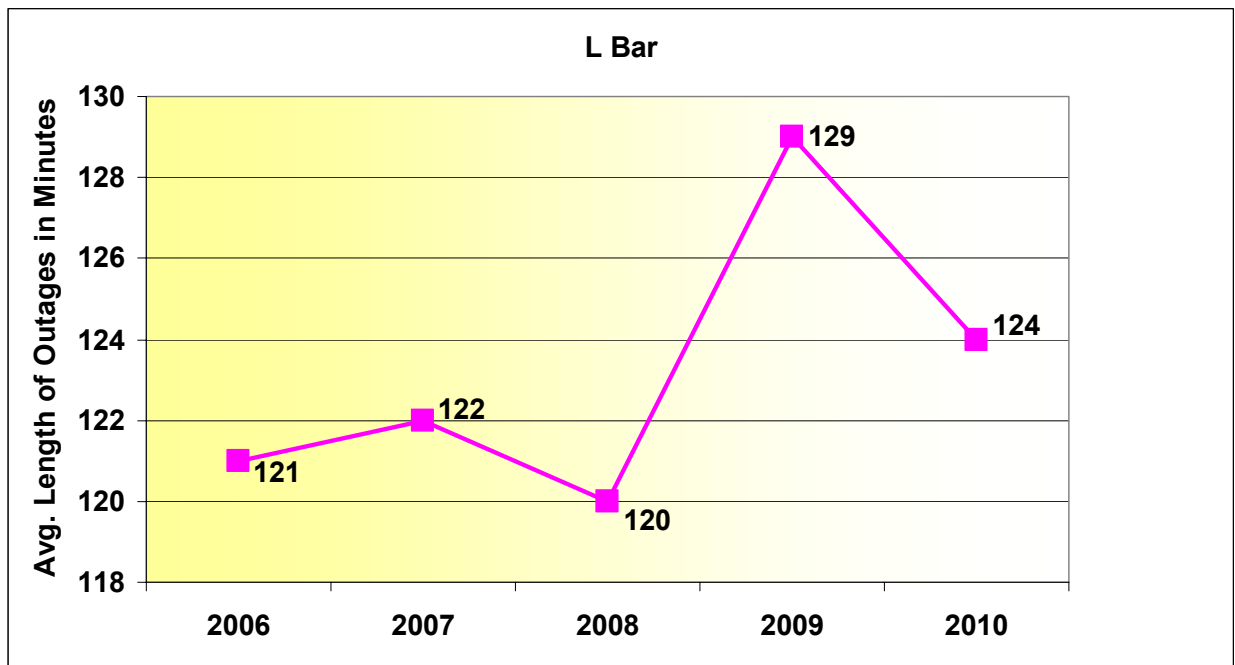
**Figure 3-12. PEF's Average Duration of Outages (Adjusted)**

**Figure 3-12** is the average length of time PEF spends restoring customers affected by outage events, excluding hurricanes and certain other outage events. This is displayed by the index L-Bar in the graph below. The data demonstrates an overall 2 percent increase of outage durations since 2006, and a 4 percent decrease from 2009 to 2010. Even with the drop in the L-Bar index from 2009 to 2010, PEF's overall L-Bar index is trending upward, indicating that PEF is still spending a longer time restoring service from outage events.

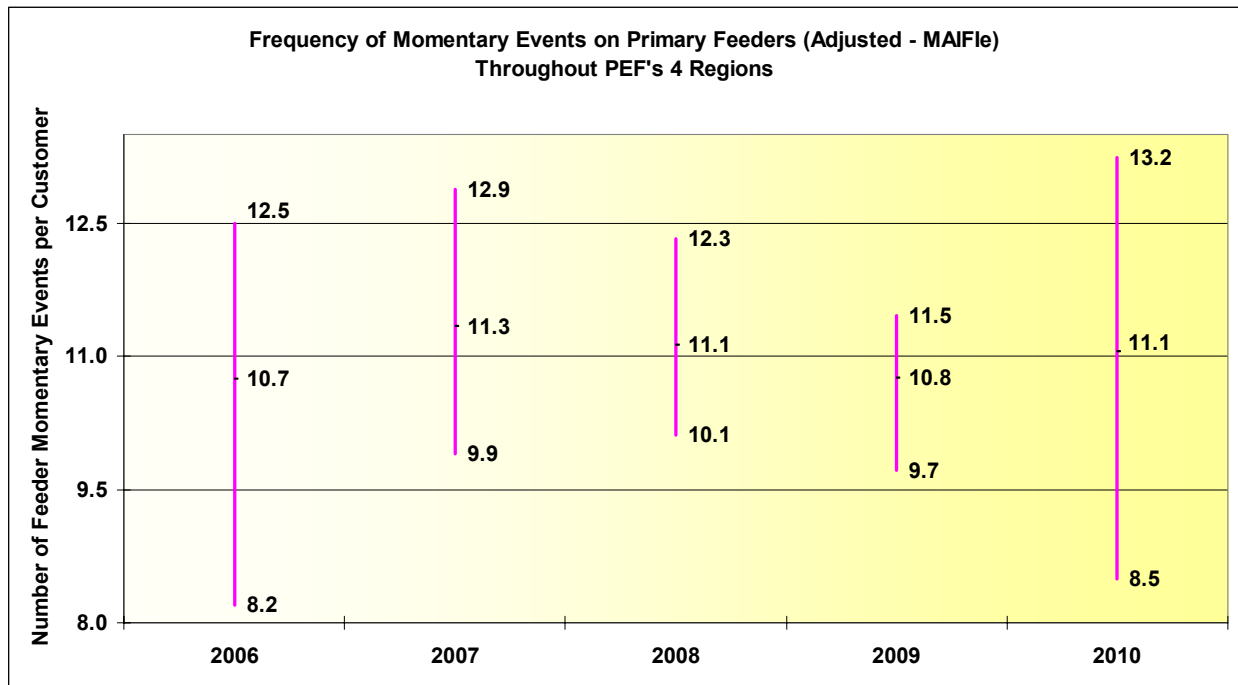
**Figure 3-13. MAIFle across PEF's Four Regions (Adjusted)**

**Figure 3-13** illustrates the frequency of momentary events on primary circuits for PEF's customers recorded across its system. A review of the supporting data suggests that the MAIFle results between 2006 and 2010 appear to be relatively flat. The best (lowest) results are distributed among three of the regions; however, the South Coastal region appears to have the worst (highest) results for the last five years.

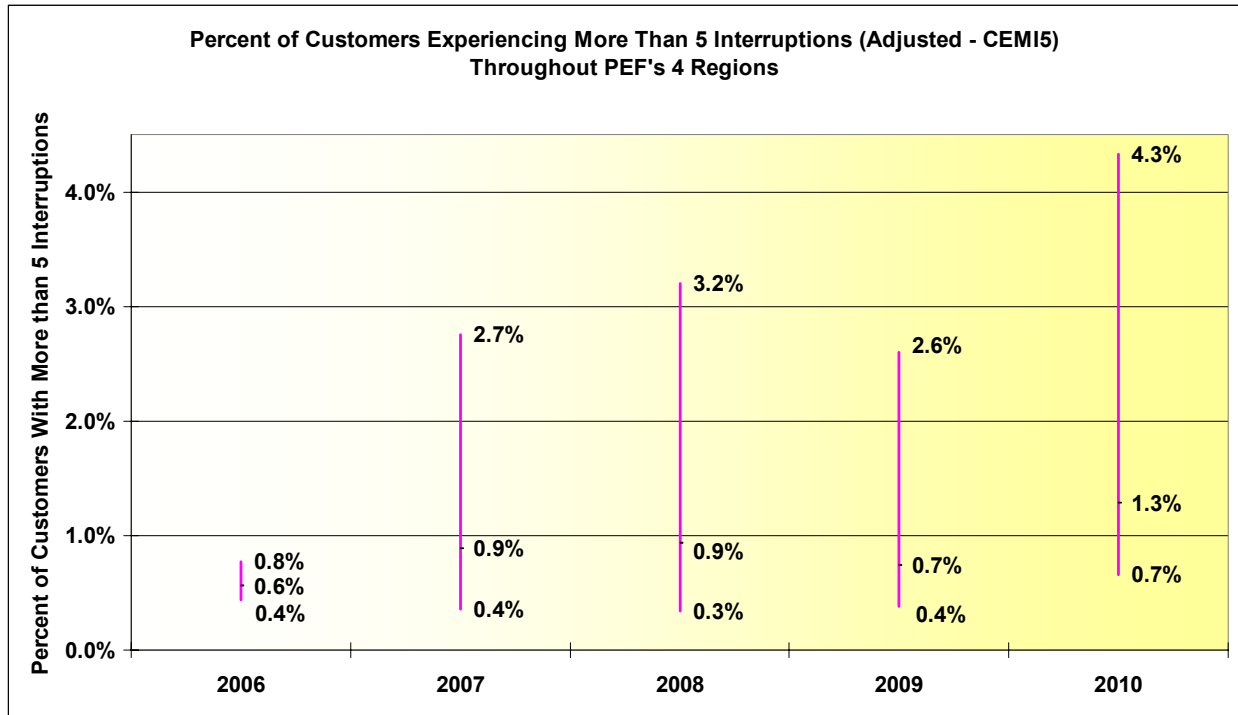
**Figure 3-14. CEMI5 across PEF's Four Regions (Adjusted)**

**Figure 3-14** charts the percent of PEF’s customers experiencing more than five interruptions over the last five years. PEF reported an 86 percent increase in the average CEMI5 performance from 2009 to 2010. The South Central region continues to have the lowest reported percentage for all of PEF’s regions and the North Coastal region continues to have the highest reported percentage.

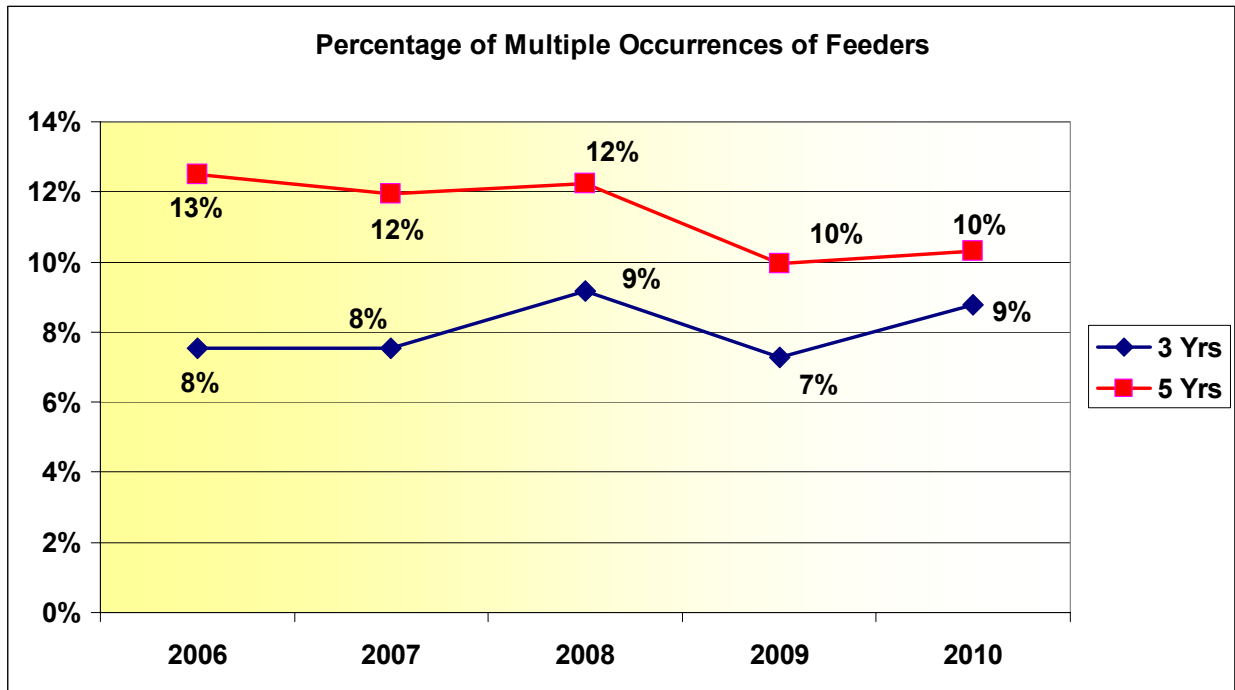
Figure 3-15. PEF's Three Percent Feeder Report t (Adjusted)

Figure 3-15 shows the fraction of multiple occurrences of feeders using a three-year and five-year basis. During the period of 2006 to 2010, the five-year fraction of multiple occurrences appears to be trending downward, while the three-year results are trending slightly upward. The Three Percent Feeder Report lists the top three percent of feeders with the most feeder outage events. The fraction of multiple occurrences is calculated from the number of recurrences divided by the number of feeders reported.

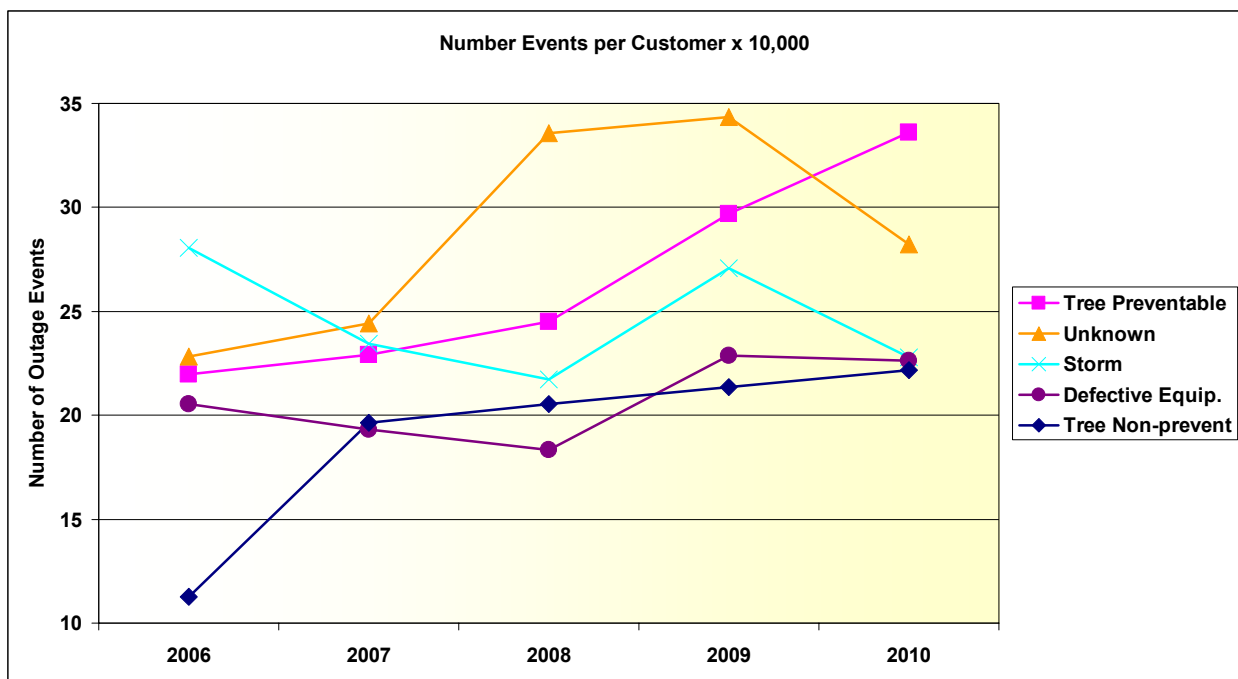
**Figure 3-16. PEF's Top Five Outage Causes (Adjusted)**

**Figure 3-16** shows the top five causes of outage events on PEF’s distribution system normalized to a 10,000-customer base. The figure is based on PEF’s adjusted data of the top ten causes of outage events and represents approximately 51 percent of the top ten causes of outage events that occurred during 2010. For the five-year period, the top five causes of outage events were tree preventable (13 percent), unknown (11 percent), storm (9 percent), defective equipment (9 percent) and tree non-preventable (9 percent) on a cumulative basis. The PSC/ECR form 103 allows the IOUs to list its top ten categories and it identifies the category “all other.” The “all other” category is not part of the top ten enumerated categories. PEF uses the “all other” category when no reasonable evidence is available as to what caused the outage. Staff notes PEF’s “all other” has increased 299 percent from 2008 to 2010 and in 2010 represents 30.5 percent of the total number of events per 10,000 customers.

In **Figure 3-16**, PEF's Top Five Outage Categories, the category "tree preventable" appears to be trending upward and has increased approximately 9 percent from 2009. The second top ten categories "unknown" decreased in 2010; however, for the five year period, all of the top five outage categories appear to be trending upward.

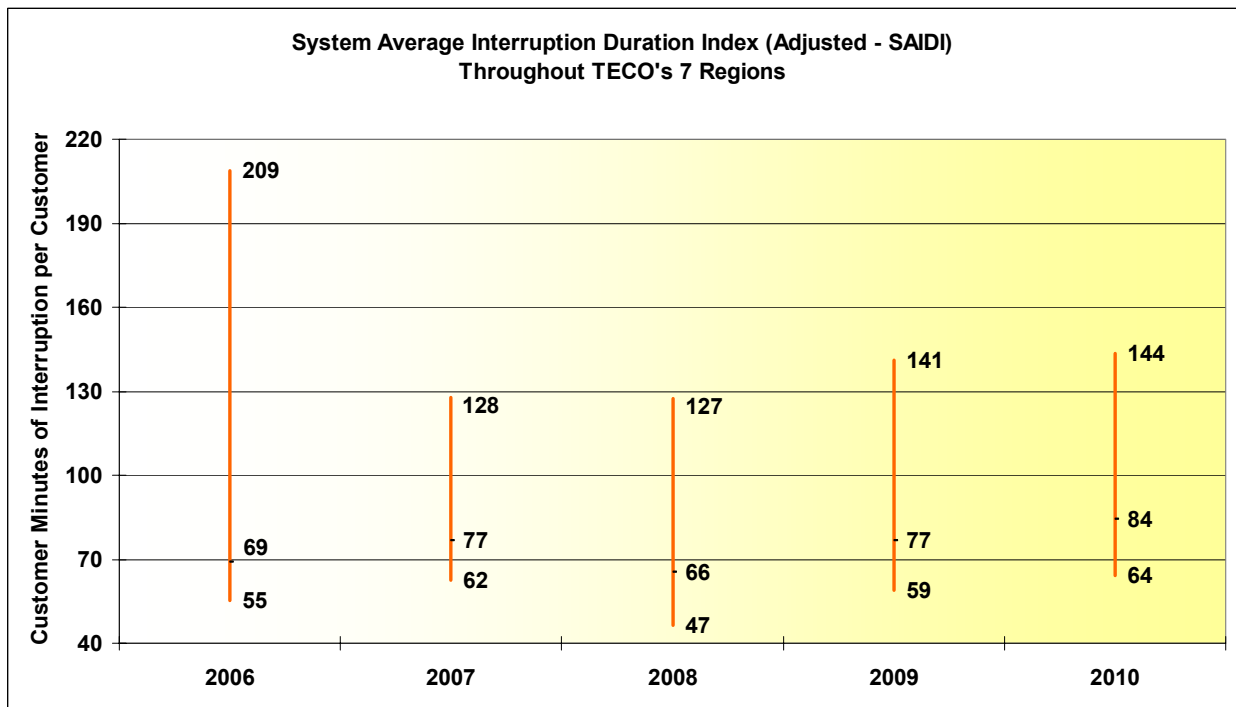
**Figure 3-17. SAIDI across TECO's Seven Regions (Adjusted)**

**Figure 3-17** shows the adjusted SAIDI values recorded by TECO's system. Six of the seven TECO regions had an increase in SAIDI performance during 2010, with Plant City and Dade City having the highest SAIDI performance results for the five-year period of 2006 to 2010.

**Figure 3-17** shows a slight increase in the average and lowest SAIDI recorded for all of TECO's regions. The highest SAIDI index for the seven regions appears to be trending downwards. Dade City, Plant City, and South Hillsborough regions have the fewest customers and represent the most rural, lowest customer density per line mile in comparison to the other four Tampa Electric divisions. The SAIDI indexes for all the regions except the Central, Eastern, and Winter Haven regions were above the 2010 average SAIDI index of 84 minutes. The Central and Winter Haven regions recorded the lowest SAIDI indexes for the five-year period.

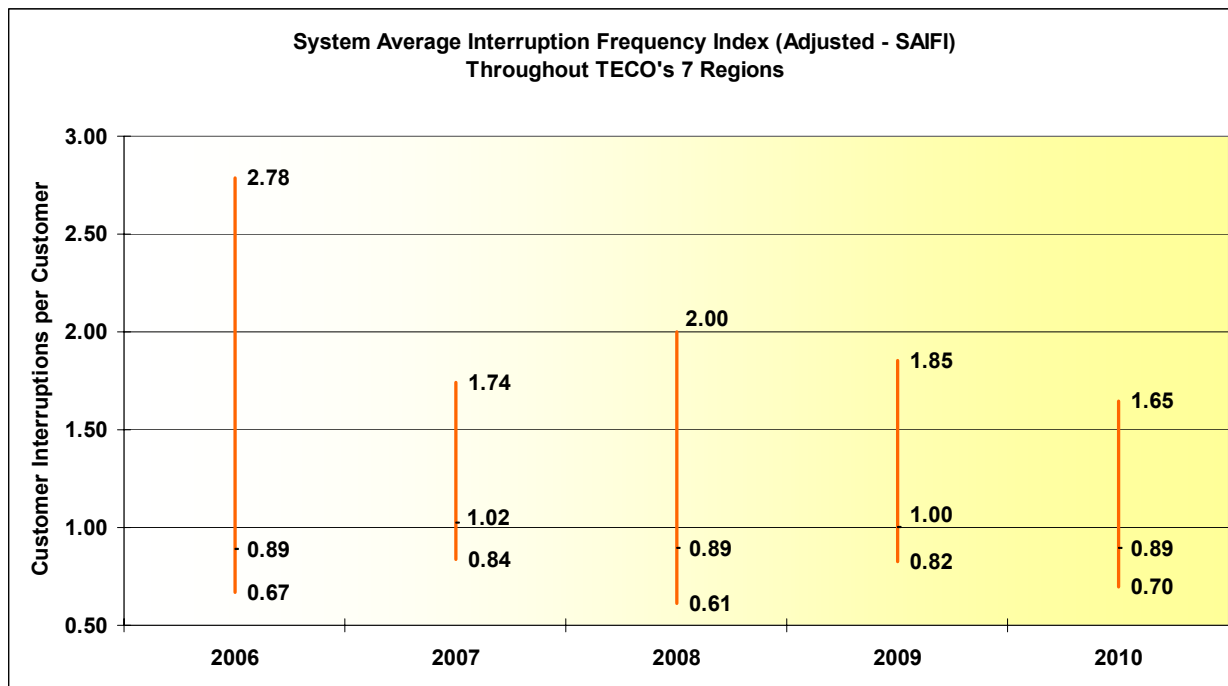
**Figure 3-18. SAIFI across TECO's Seven Regions (Adjusted)**

**Figures 3-18** illustrates TECO’s adjusted frequency of interruptions per customer reported by the system. TECO’s data represents an 11 percent decrease in the SAIFI average from 1.00 interruptions in 2009 to 0.89 interruptions in 2010. TECO’s Dade City region has the highest frequency of service interruptions when compared to TECO’s other regions. Staff has not identified any specific patterns among the SAIFI results throughout the seven TECO regions, as the maximum SAIFI index is trending downward and the minimum index is trending slightly upward. The average SAIFI index is remaining relatively flat.

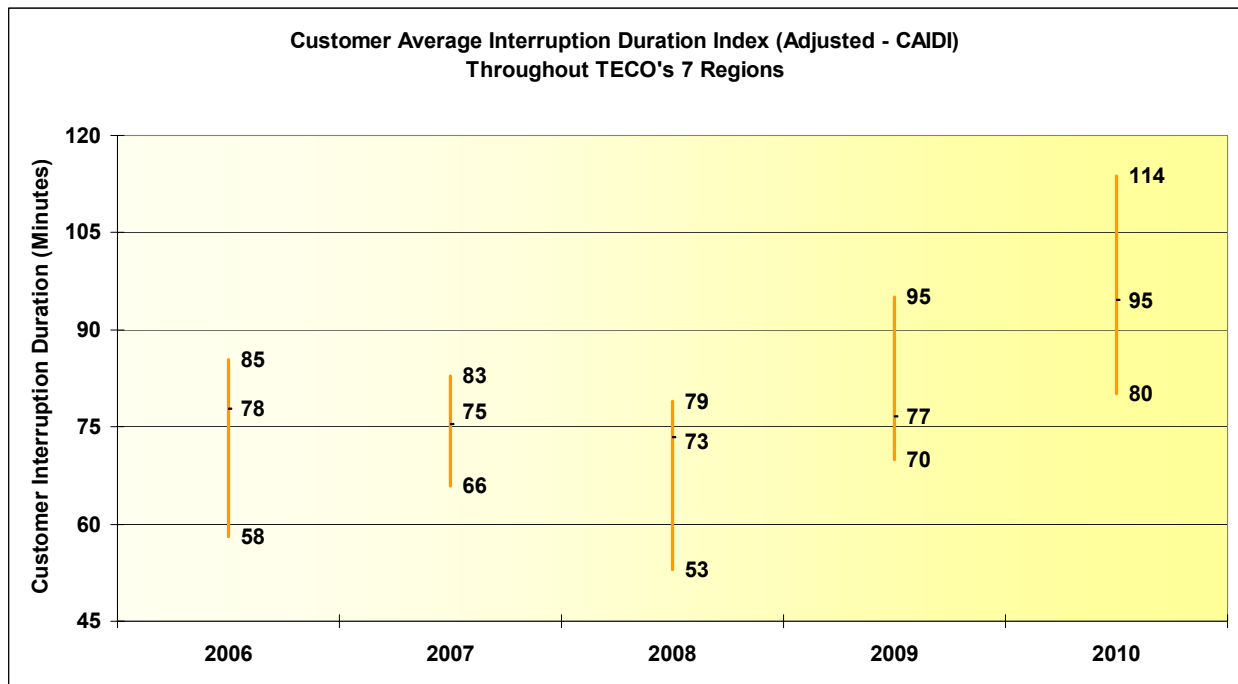
**Figure 3-19. CAIDI across TECO's Seven Regions (Adjusted)**

**Figure 3-19** charts the length of time that a typical TECO customer experiences an outage, which is known as CAIDI. The highest CAIDI minutes do not appear to be confined to any particular service area; however, Plant City and South Hillsborough both make appearances. Winter Haven has had the lowest (best) results for four out of the last five years. The average CAIDI seems to be trending upwards at this time suggesting TECO's customers are experiencing outages that are lasting longer.

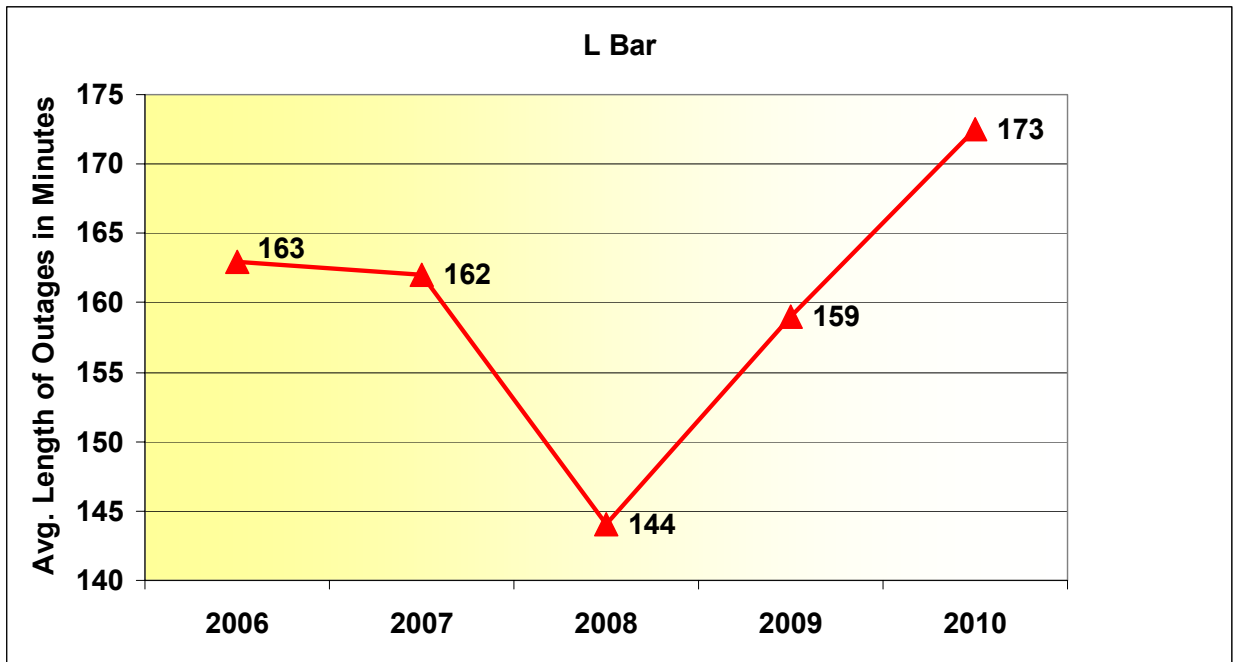
**Figure 3-20. TECO's Average Duration of Outages (Adjusted)**

**Figure 3-20** denotes a 9 percent increase in outage durations for the period from 2009 to 2010. TECO has made a 20 percent increase in the L-Bar index since 2008 and the L-Bar index appears to be trending upward suggesting an overall decline and longer restoral times. The average length of time TECO spends restoring service to its customers affected by outage events, excluding hurricanes and other allowable excluded outage events is shown in the index L-Bar.

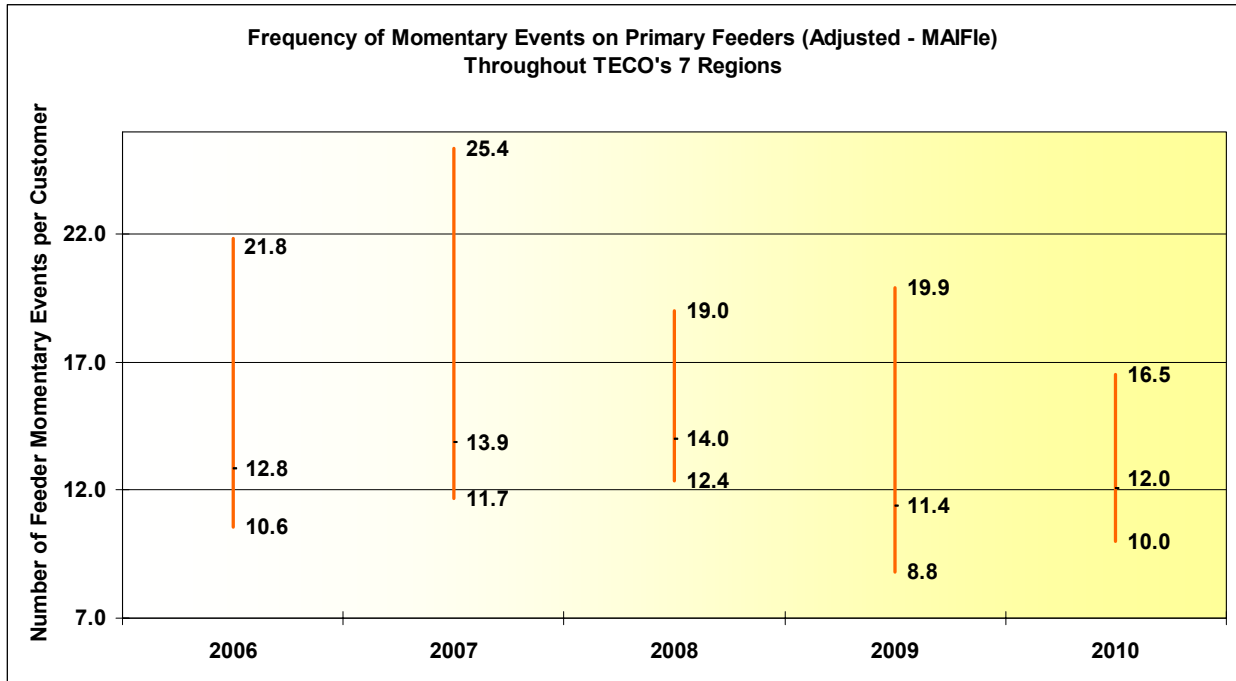
**Figure 3-21. MAIFle across TECO's Seven Regions (Adjusted)**

**Figure 3-21** illustrates TECO’s number of momentary events on primary circuits per customer recorded across its system. In 2010, TECO reported that the “MAIFle performance declined over 2009 in all divisions except Plant City.” **Figure 3-21** shows a downward trend for the average MAIFle index, which suggests improvement over the five-year period of 2006 to 2010.

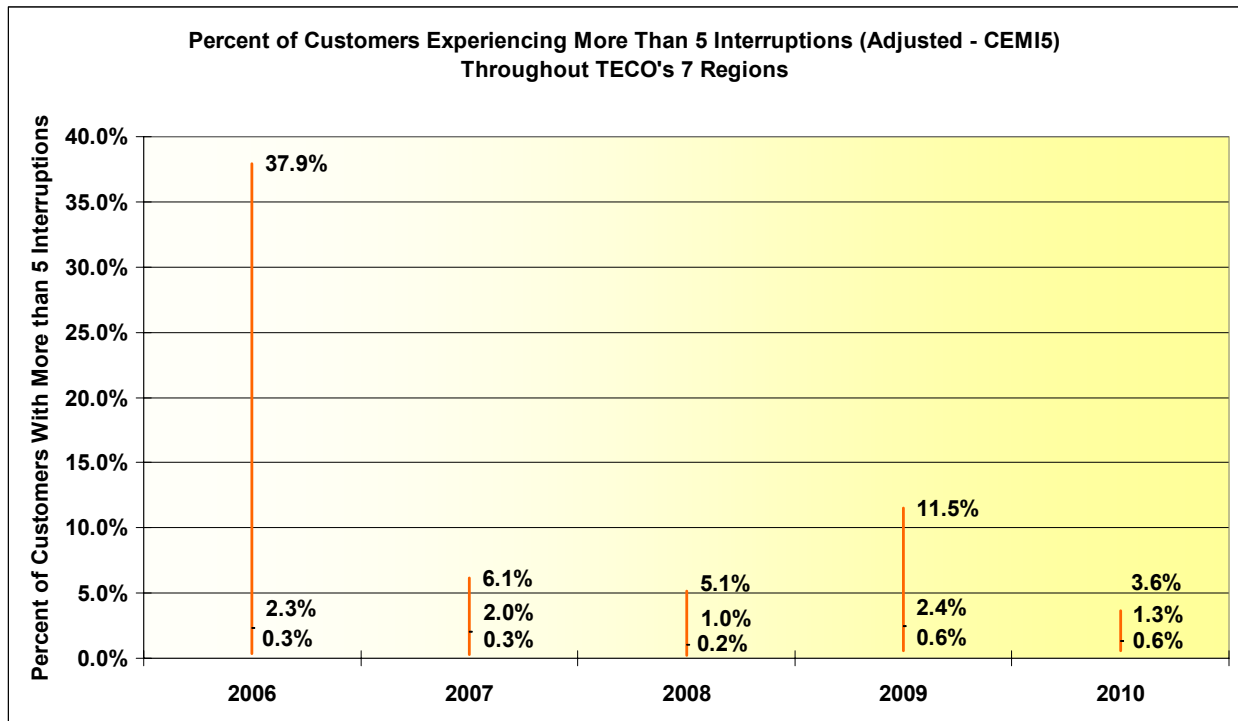
**Figure 3-22. CEMI5 across TECO's Seven Regions (Adjusted)**

**Figure 3-22** shows the percent of customers experiencing more than five interruptions. Five regions in TECO's territory experienced a decrease in the CEMI5 results for 2010. The Eastern and Winter Haven regions experienced an increase in the CEMI5 index with Winter Haven reporting the highest CEMI5 percentage for 2010. Even though TECO's results for this index have varied for the past five years, the average CEMI5 index appears to be trending downward suggesting improvement.
