*Florida's*  
*Investor-Owned*  
*Electric Utilities*

*Service Reliability reports*

Florida Public Service Commission  
Division of Safety, Reliability & Consumer Assistance

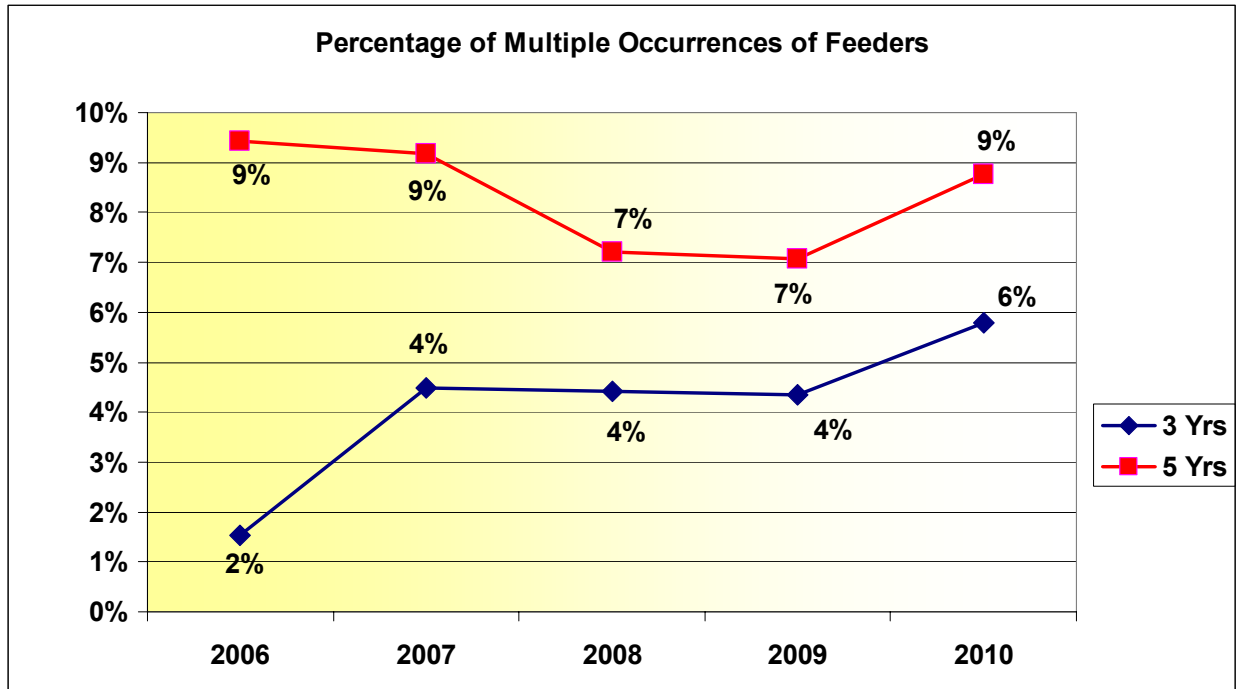
**Figure 3-23. TECO's Three Percent Feeder Report (Adjusted)**

**Figure 3-23** represents TECO's top three percent of feeders that have reoccurred (appeared on the Three Percent Feeder Report) on a five year and three year basis. The graph is developed using the number of recurrences divided by the number of feeders reported. The five-year average of outages per feeder increased from 2009 to 2010, as well as the three-year average. The three-year average of outages per feeder appears to be trending upward as the five-year average appears to be trending downward.

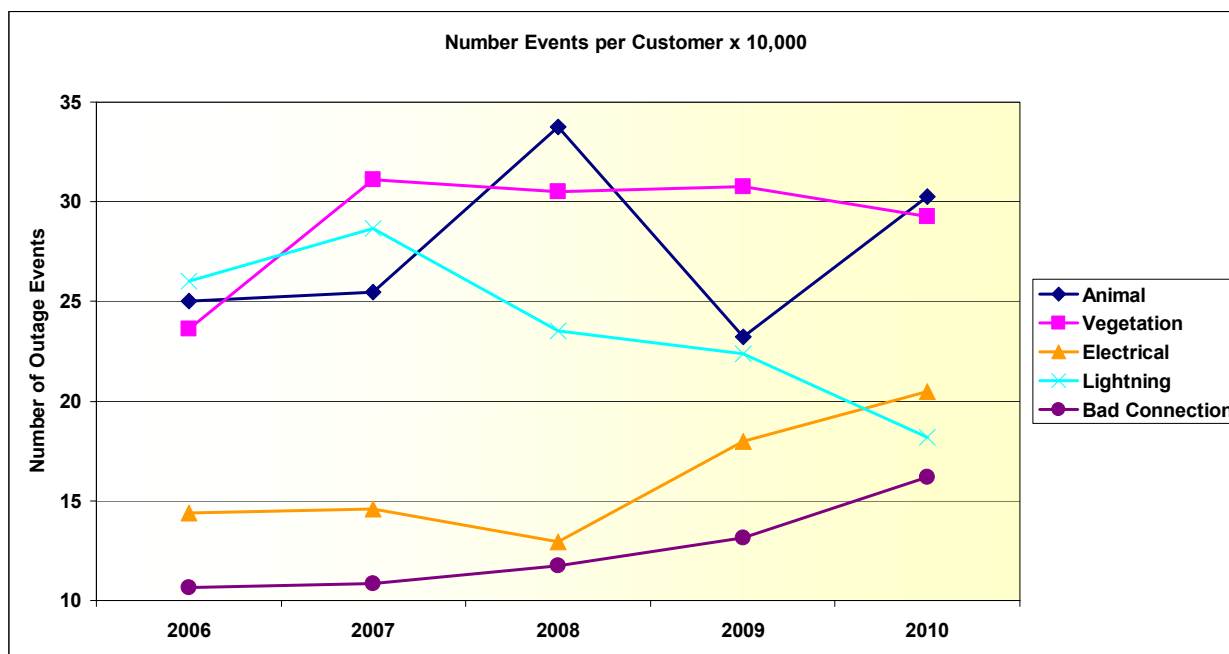
**Figure 3-24. TECO's Top Five Outage Causes (Adjusted)**

**Figure 3-24** shows the top five causes of outage events on TECO’s distribution system normalized to a 10,000-customer base. The figure is based on TECO’s adjusted data of the top ten causes of outage events and represents 76 percent of the total outage events that occurred during 2010. Vegetation and animal causes continue to be the top two problem areas for TECO; however, the cause due to vegetation was reduced by 4 percent from 2009 to 2010. TECO reports that “overall outages were up in 2010 in comparison to 2009” and “the total number of outages in comparison to the last five-year average is also up.” The numbers of outages due to animals, vegetation, electrical issues, and bad connections are trending upward while the number of outages due to lightning is trending downward.

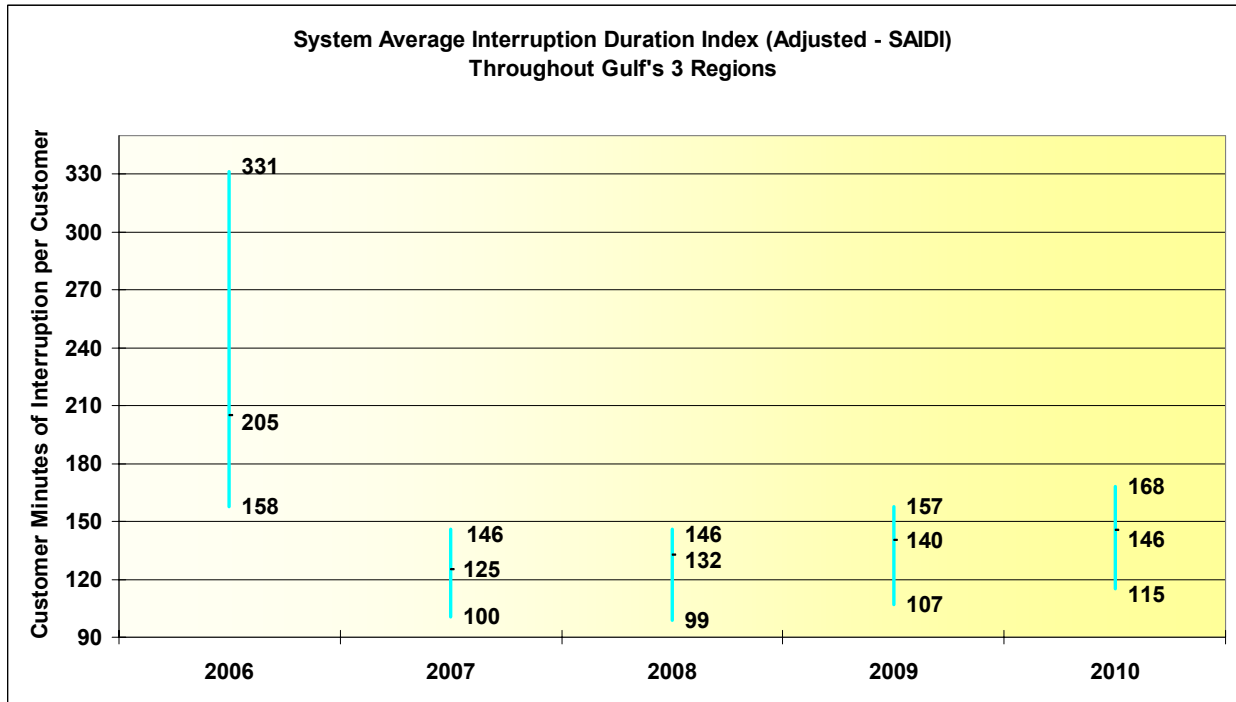
**Figure 3-25. SAIDI across Gulf’s Three Regions (Adjusted)**

**Figure 3-25** illustrates Gulf’s SAIDI minutes, or the interruption duration minutes on a system basis. The chart depicts an increase in the average SAIDI value by 6 minutes in Gulf’s combined regions over the 2009 results. Gulf’s 2010 average performance was 4 percent worse than the 2009 SAIDI results. Gulf reported there was an extreme January weather event that was not excludable because it was not a named storm or NWS recordable tornado. The total SAIDI impact for this significant event was 7.43 minutes, which would have resulted in a Gulf adjusted SAIDI of 138 minutes instead of the reported 146 minutes. Even though the average SAIDI value increased this year, it appears that the maximum, minimum, and average SAIDI indexes are trending downward, showing improvements.

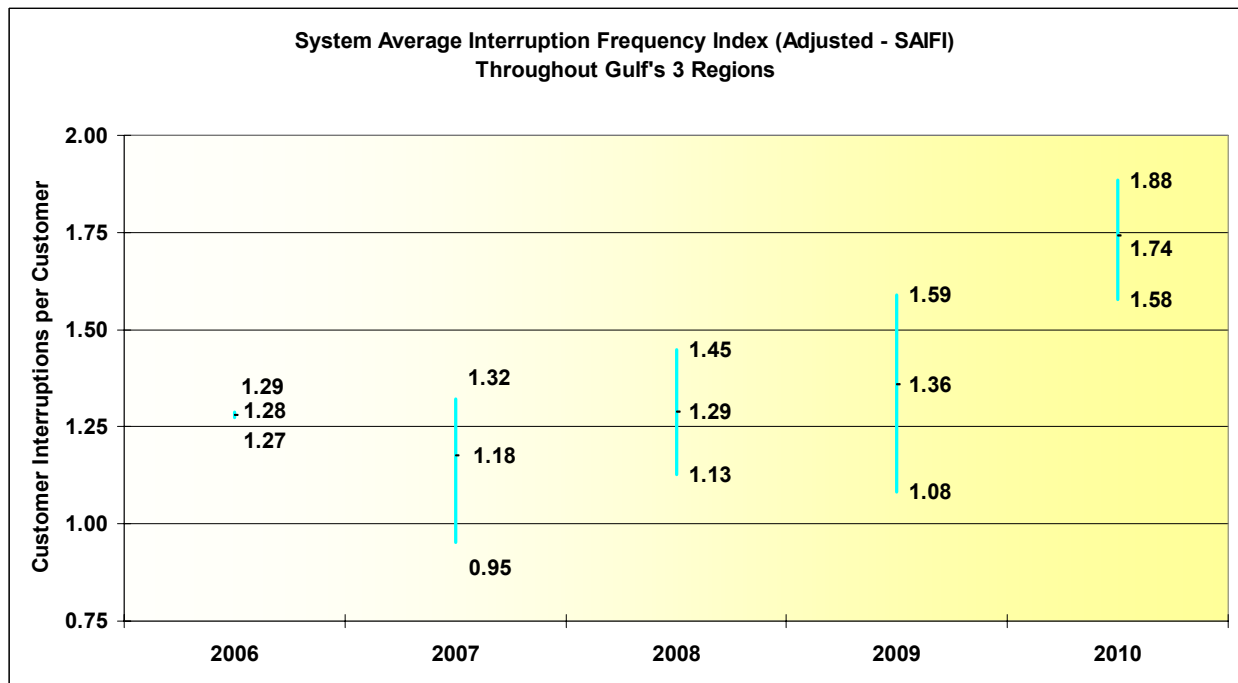
**Figure 3-26. SAIFI across Gulf’s Three Regions (Adjusted)**

**Figure 3-26** illustrates the System Average Interruption Frequency Index and Gulf’s index had a 28 percent increase in 2010 when compared to 2009. Gulf’s Western region had the highest SAIFI values in four of the last five years. The lowest values appear to be confined to the Central and the Eastern regions. Overall, the 2010 maximum, minimum, and average SAIFI values appear to be trending upward as the SAIDI values are trending downward.

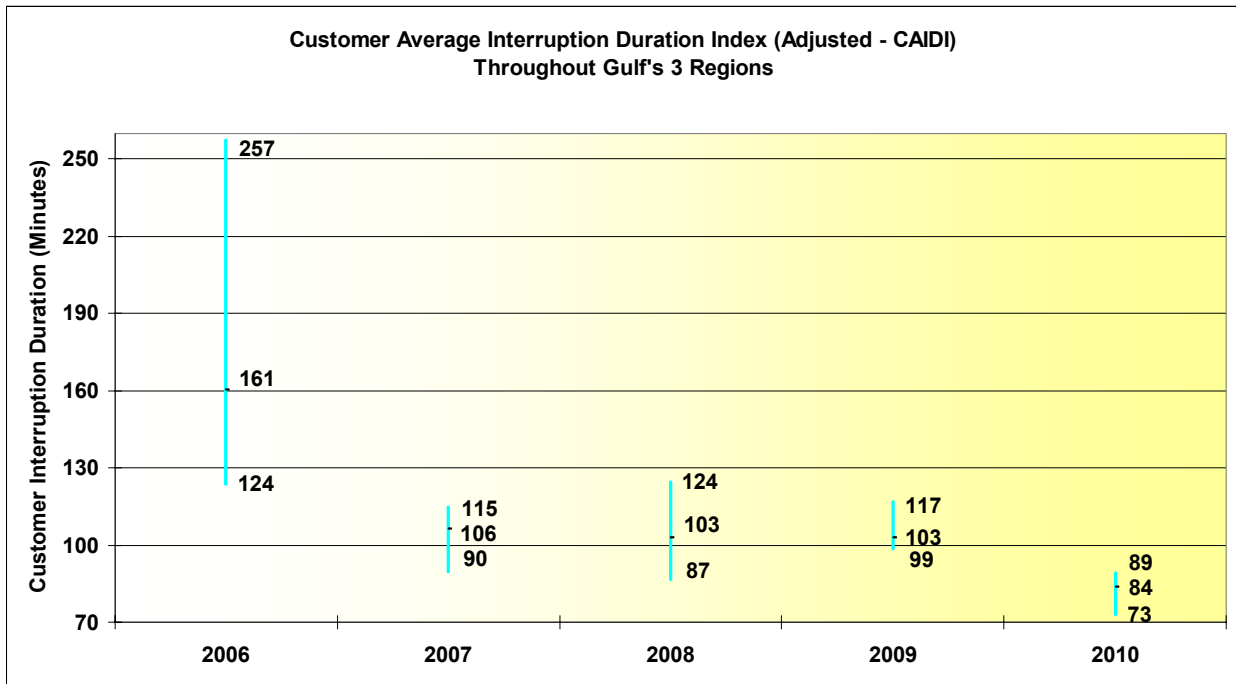
**Figure 3-27. CAIDI across Gulf's Three Regions (Adjusted)**

**Figure 3-27** is Gulf's adjusted CAIDI (Customer Average Interruption Duration Index). The average CAIDI in 2010 was 84 minutes and represents an 18 percent decrease from the 2009 value of 103 minutes. In 2010 the Western region had the highest CAIDI value, as the Central region had the lowest CAIDI. Staff notes that just like the SAIFI values in **Figure 3-25** the maximum, minimum, and average CAIDI values are also trending downward suggesting improvement.

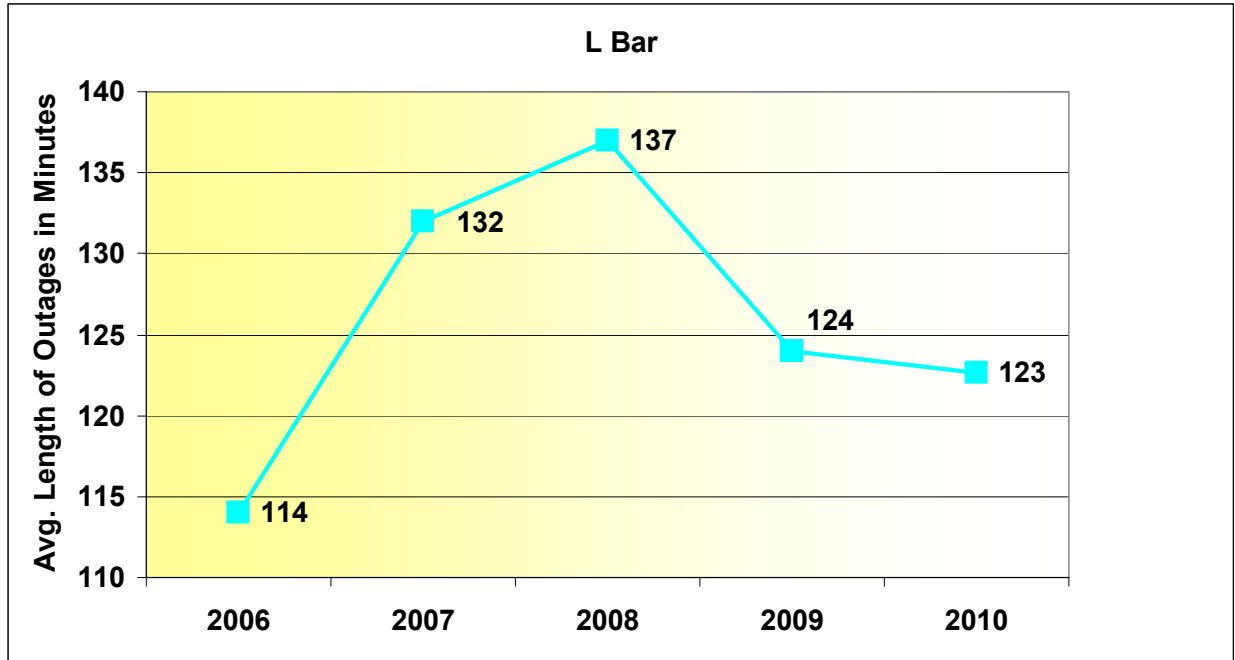
**Figure 3-28. Gulf's Average Duration of Outages (Adjusted)**

**Figure 3-28** illustrates Gulf's L-Bar or the average length of time Gulf spends recovering from outage events, excluding hurricanes and other allowable excluded outage events. Gulf's L-Bar showed a 1% improvement from 2009 to 2010. Even though for the past two years, Gulf's L-Bar values did improve, the data for the five-year period suggests that the L-Bar indexes are trending upward.

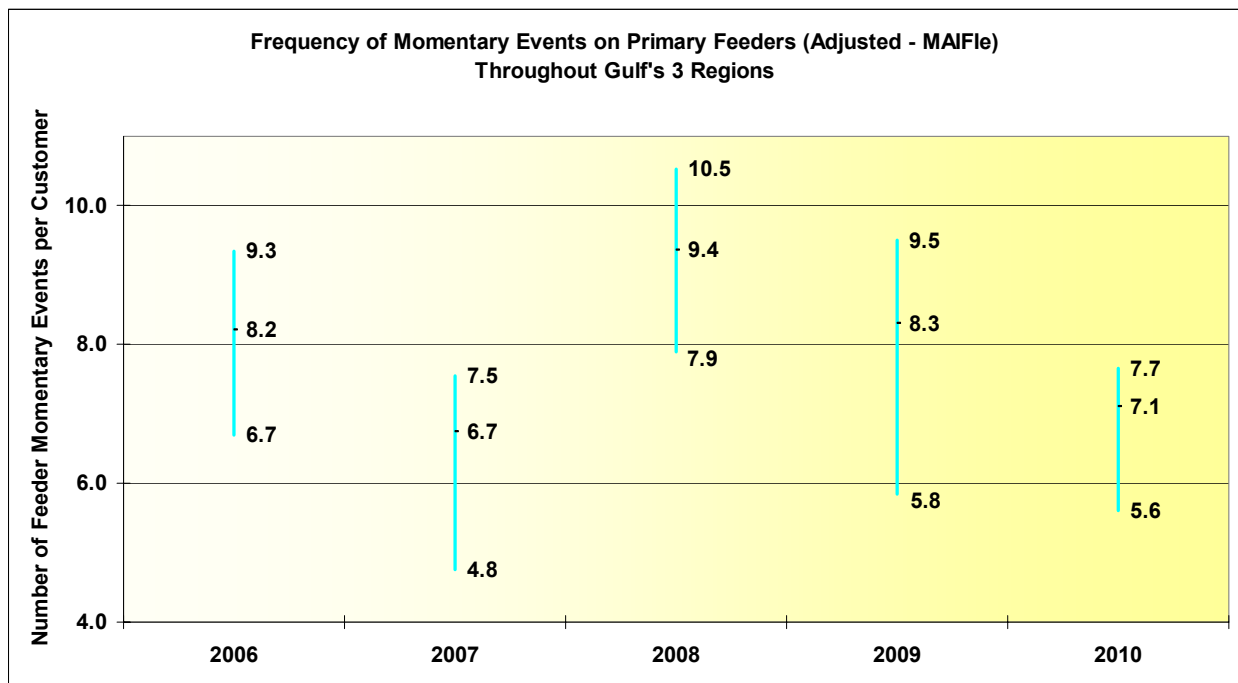
**Figure 3-29. MAIFle across Gulf’s Three Regions (Adjusted)**

**Figure 3-29** is the adjusted MAIFle recorded across Gulf’s system. The adjusted MAIFle results by region show that the Eastern region had the lowest frequency of momentary events on primary feeders. The Western region has the highest MAIFle index, with a 19 percent improvement from 2009 to 2010. The data suggests that the level of service reliability for the highest, average, and lowest MAIFle are all trending downward, which shows improvement.

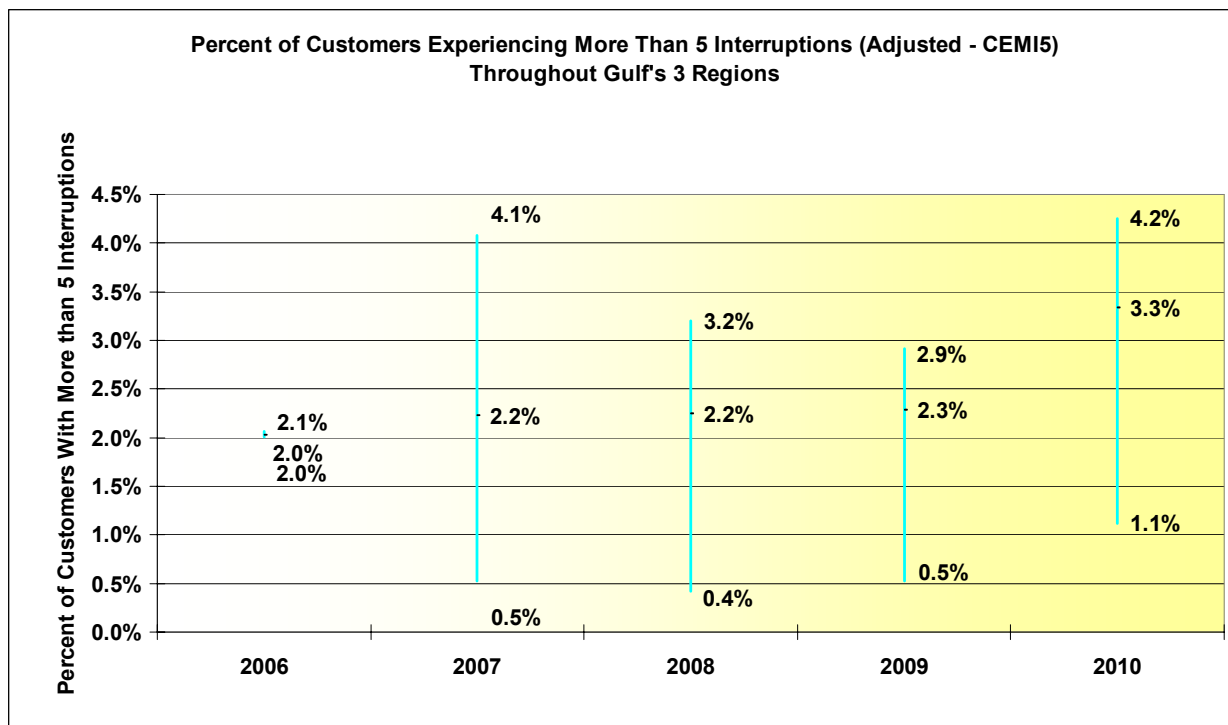
**Figure 3-30. CEMI5 across Gulf’s Three Regions (Adjusted)**

**Figure 3-30** shows the highest, average, and lowest adjusted CEMI5 (Customers Experiencing More Than Five Interruptions) across Gulf’s Western, Central and Eastern regions. Gulf’s 2010 results illustrate an increase when compared to 2009. The highest CEMI5 values have been trending upward as the lowest CEMI5 values have been trending downward over the five-year period of 2006 through 2010. The average CEMI5 appears to be trending upward suggesting that the percentage of Gulf’s customers experiencing more than five interruptions is still increasing.

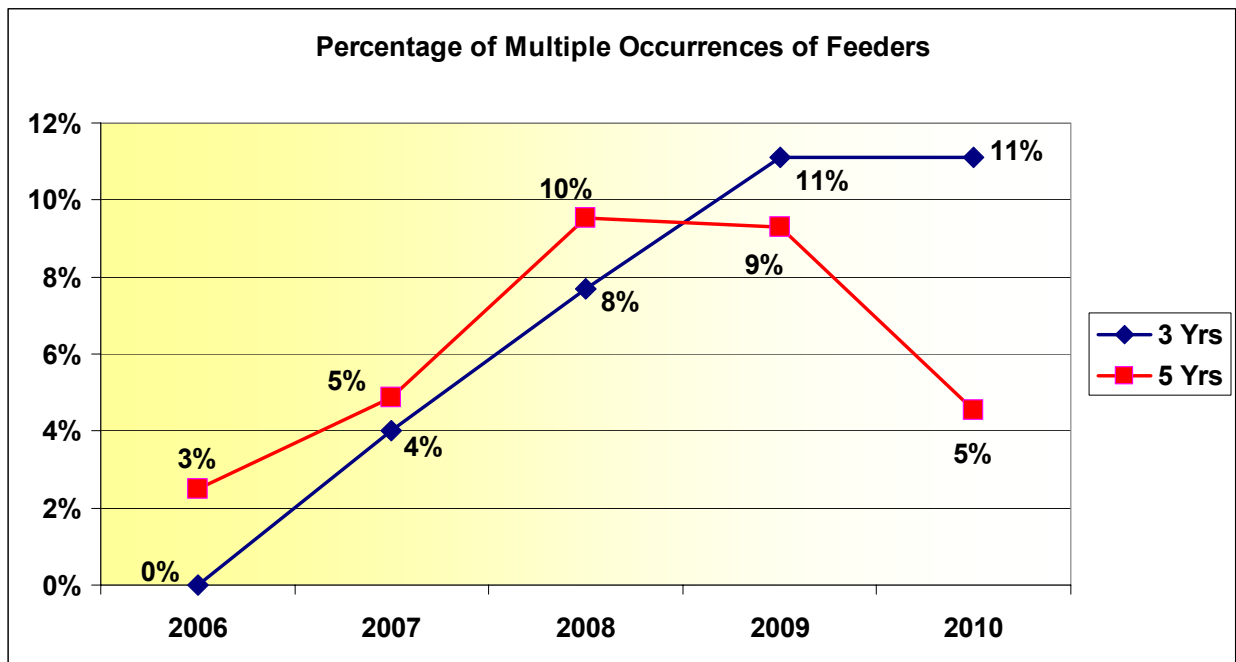
**Figure 3-31. Gul f’s Three Percent Feeder Report t (Adjusted)**

**Figure 3-31** shows the multiple occurrences of feeders using the utility’s Three Percent Feeder Report and is analyzed on a three-year and five-year basis. The five-year multiple occurrences analysis showed a decrease from the prior trend, which implies improving performance. The Three Percent Feeder Report is a listing of the top three percent of feeders that have the most feeder outage events. The supporting data illustrates that the five-year multiple occurrences have dropped from 9 percent to 5 percent from 2009 to 2010 as the three-year multiple occurrences remained steady at 11 percent. Even though the five-year multiple occurrences showed an improving performance for the two-year period from 2009 to 2010, the five-year period of 2006 to 2010 indicates overall that the five-year index is trending upward. The three-year multiple occurrences index appears to be trending upward as well.

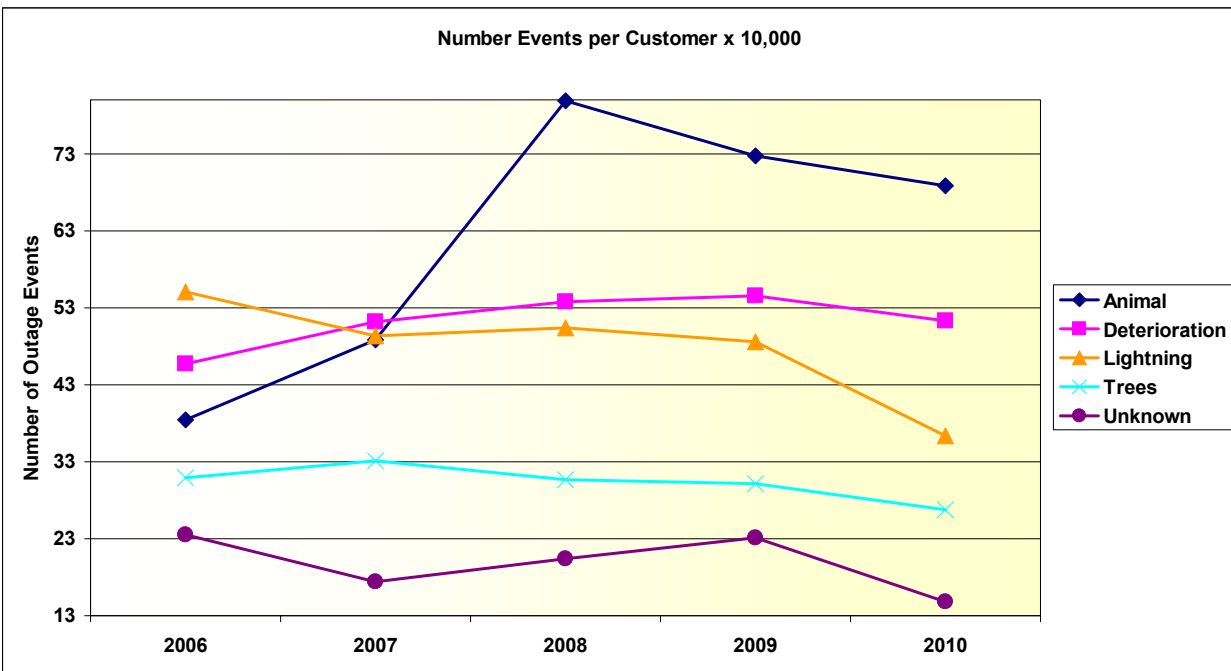
**Figure 3-32. Gulf’s Top Five Outage Causes (Adjusted)**

**Figure 3-32** is a graph of the top five causes of outage events on Gulf’s distribution system normalized to a 10,000-customer base. The figure is based on Gulf’s adjusted data of the top ten causes of outage events and represents 82.6 percent of the total adjusted outage events that occurred during 2010. The top five causes of outage events were animals (29 percent), deterioration (21 percent), lightning (15 percent), trees (11 percent), and unknown causes (6 percent). Even though the percentage of outages causes due to animals has decreased by 5 percent from 2009 to 2010, it remains the highest cause of outages. As the number of outage events due to animals and deterioration are trending upwards, the number of outage events due to lightning, unknown, and trees are trending downward.

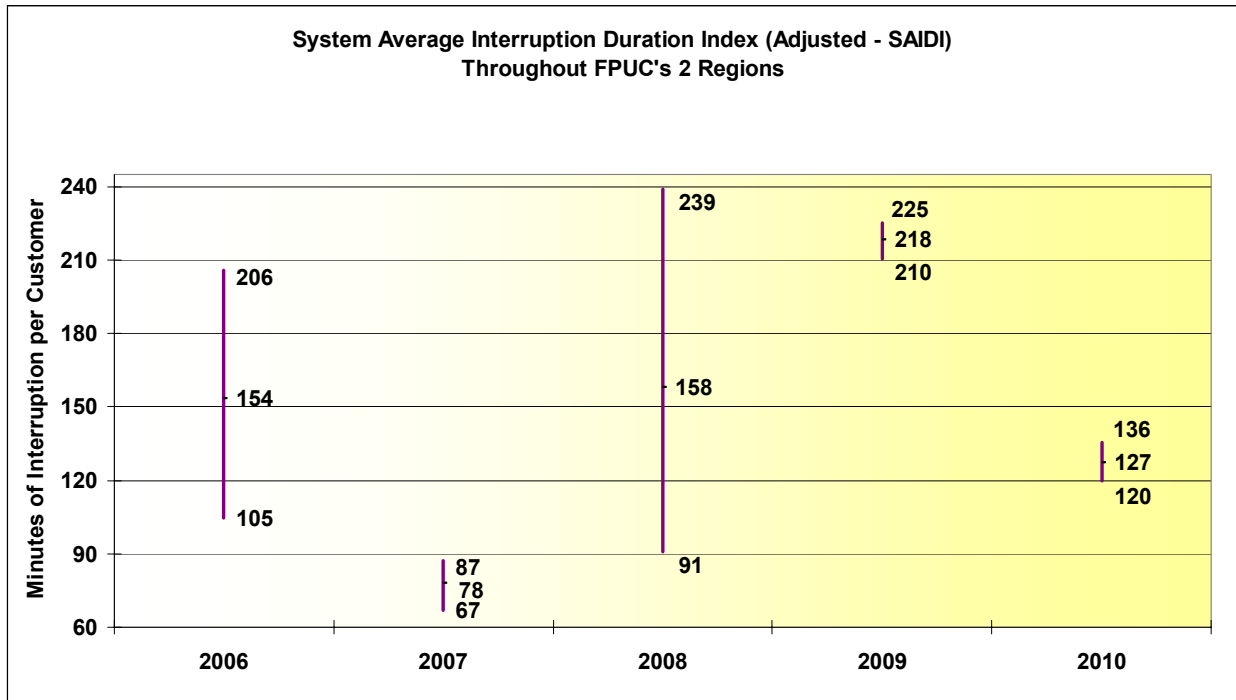
**Figure 3-33. SAIDI across FPUC's Two Regions (Adjusted)**

**Figure 3-33** shows the highest, average, and lowest adjusted SAIDI values recorded by FPUC’s system. The data shows the average SAIDI index is trending upward for the five-year period of 2006 to 2010. FPUC’s 2010 Reliability Report notes that 2010 was the second full year for the NE Division and the third year for the NW Division using an Outage Management System (OMS). FPUC stated, “two years did not provide enough data to produce credible trend results.” After the third full year for both divisions using the OMS, “FPUC will begin reporting trend information.”

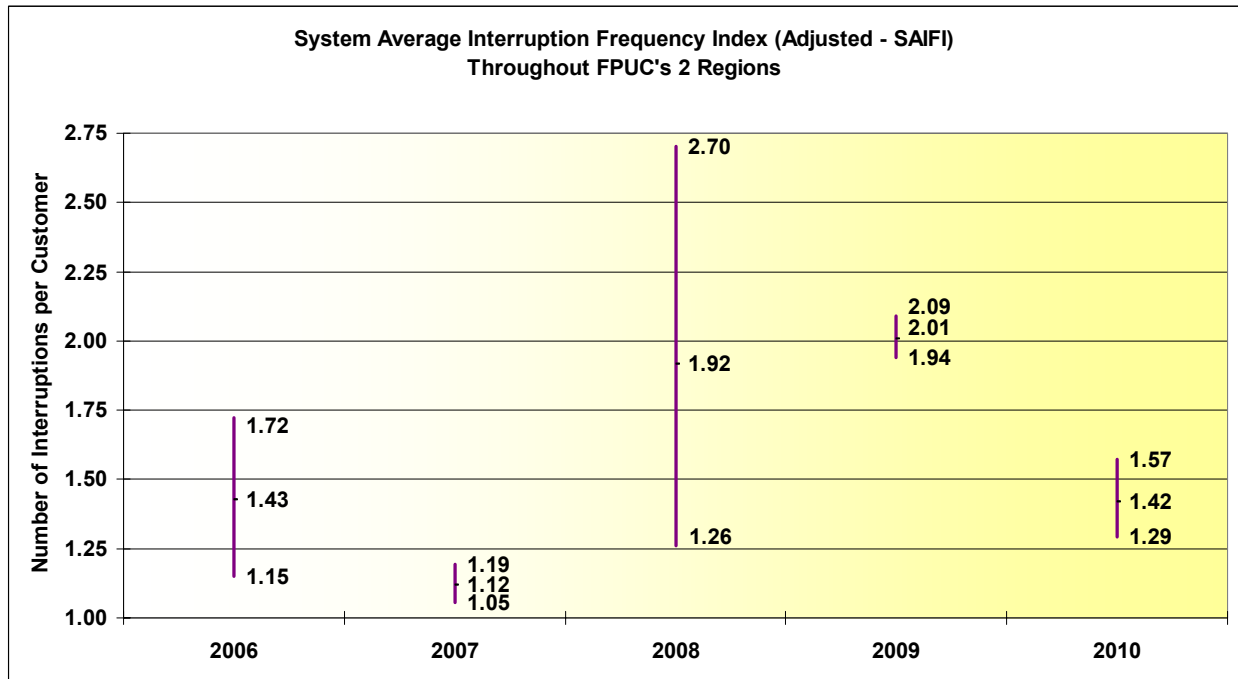
**Figure 3-34. SAIFI across FPUC's Two Regions (Adjusted)**

**Figure 3-34** shows the adjusted SAIFI (System Average Interruption Frequency Index or the average number of interruptions per customer) across FPUC's two divisions. The data depicts a 29 percent decrease in the 2010 average SAIFI reliability index from 2009. Staff notes that the maximum, minimum, and average SAIFI indexes are all trending upward even though there was a decrease (improvement) in the indexes in 2010 from 2009.

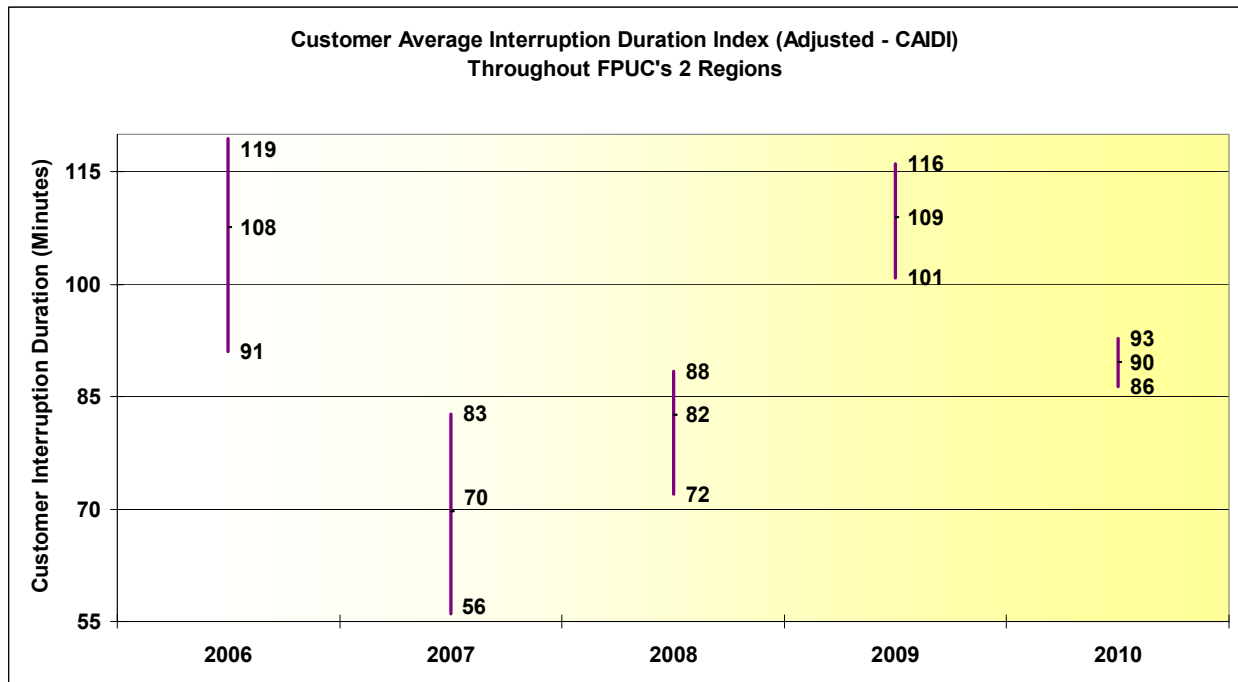
**Figure 3-35. CAIDI across FPUC's Two Regions (Adjusted)**

**Figure 3-35** shows the highest, average, and lowest adjusted CAIDI values across FPUC's system. FPUC's data shows a 17 percent decrease in the 2010 reliability indices relative to 2009 values. As stated earlier, 2010 is the second full year for the NE Division and the third year for the NW Division using FPUC's OMS system. FPUC stated that two years does not provide enough data to produce credible trend results. For the past five years, the maximum CAIDI index is trending downward, the minimum CAIDI index is trending upward, and the average CAIDI index is trending slightly upward.

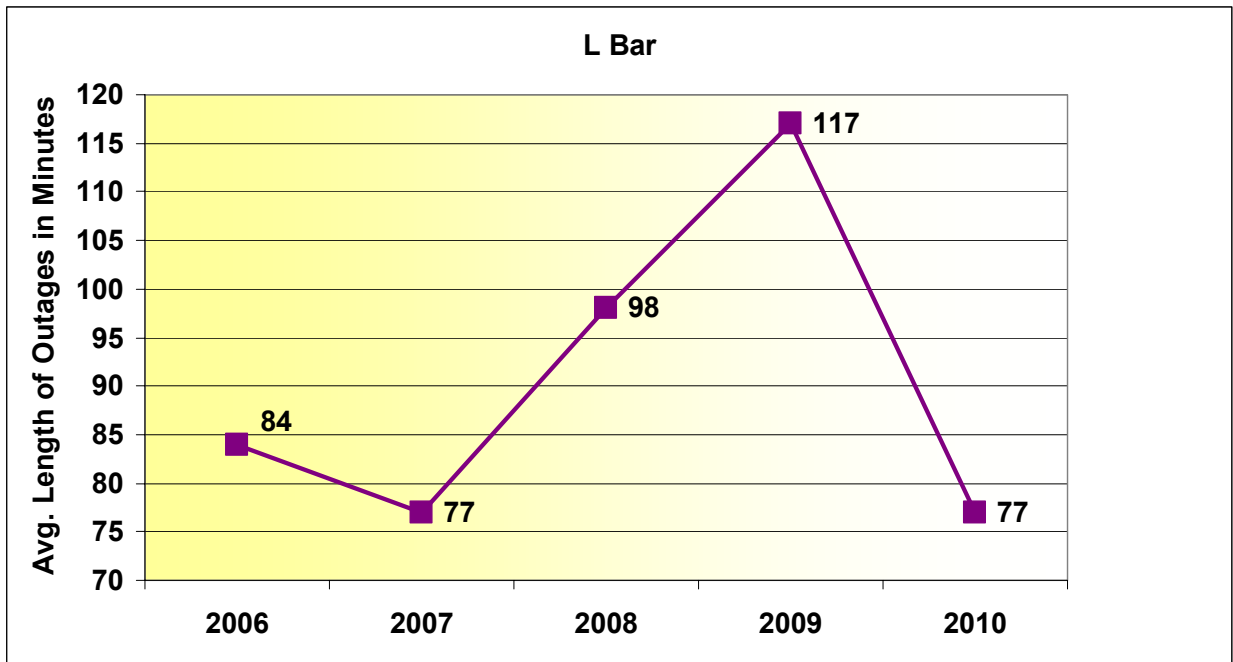
Figure 3-36. FPUC's Average Duration of Outages (Adjusted)

Figure 3-36 is the average length of time FPUC spends recovering from outage events (adjusted L-Bar). The data is trending upward even though there is a 34 percent decrease in the L-Bar value from 2009 to 2010. FPUC is taking steps to improve the overall reliability for both Divisions. It is having an independent coordination study performed on all transmission, substation, and distribution facilities to “verify existing designs and provide recommendations to achieve further enhancements.” FPUC is accelerating “the current substation capital improvement program for the NE Division.” The company has also “expedited the installation of additional underground and overhead fault detecting equipment throughout its distribution system.”

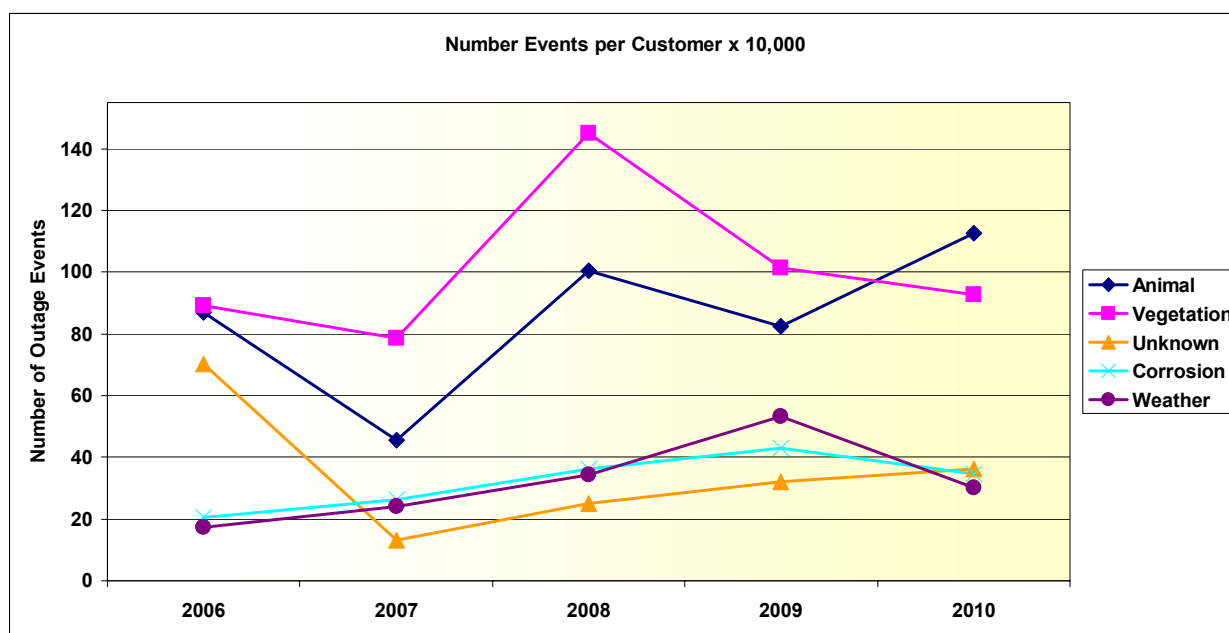
**Figure 3-37. FPUC's Top Five Outage Causes (Adjusted)**

**Figure 3-37** shows the top five causes of outage events on FPUC's distribution system normalized to a 10,000-customer base. The figure is based on FPUC's adjusted data of the top ten causes of outage. For the five-year period, the top five causes of outage events were animal (31 percent), vegetation (26 percent), unknown (10 percent), corrosion (10 percent), and weather (8 percent). These five factors represent 84.9 percent of the total adjusted outage causes in 2010. Four of the five-outage causes are trending upward. The four causes are animal, vegetation, corrosion, and weather. Vegetation, corrosion, and weather outages did decrease from 2009 to 2010, even though they are trending upward. Animal and unknown outages increased 36 percent and 12 percent, respectively, from 2009 to 2010. Even though the unknown caused outages increased from 2009 to 2010, it is still trending downward.

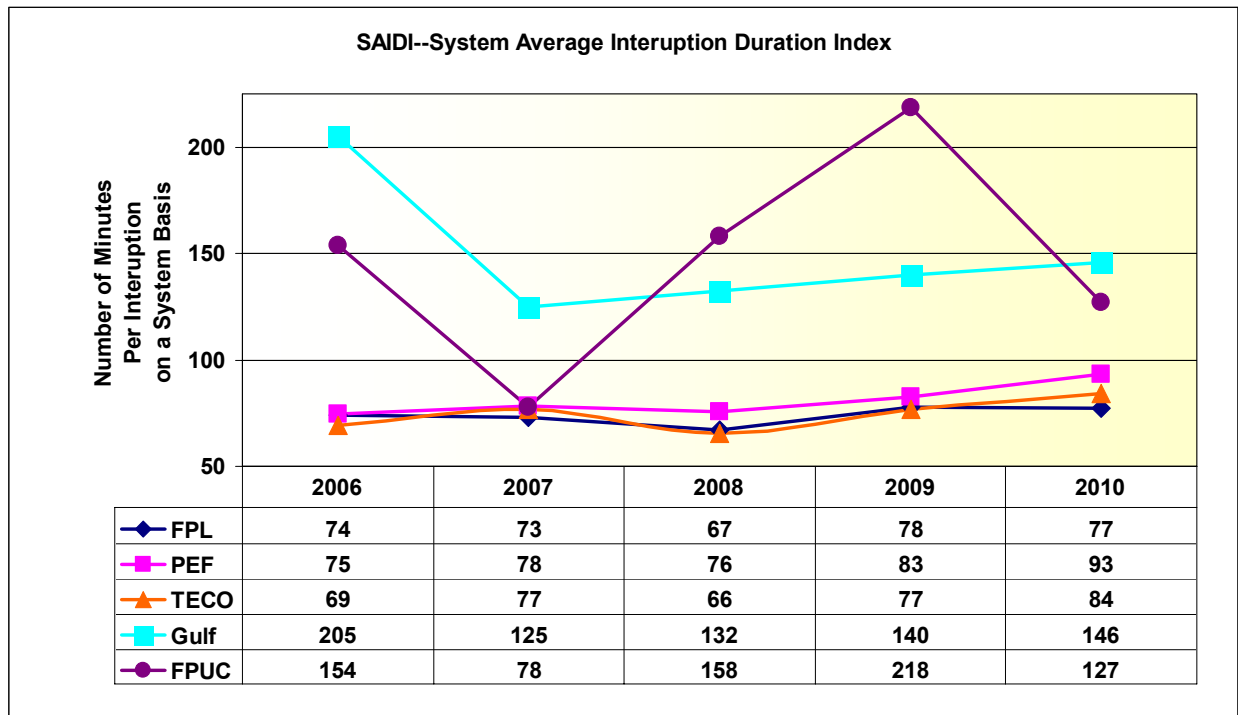
**Figure 4-1. System Average Interruption Duration (Adjusted SAIDI)**

**Figure 4-1** represents the System Average Interruption Duration Index (SAIDI) and it is the average minutes of service interruption. This is the duration per retail customer served within a specified area of service over a given period. It is determined by dividing the total Customer Minutes of Interruption (CMI) by total Number of Customers Served (C) for the respective area of service.

Figure 4-1 indicates that PEF, TECO, and GULF's SAIDI trends have gradually risen since 2007. FPL's trend has been primarily flat while FPUC appears to have cyclical rises and falls. 2010 was the second full year that FPUC has used its new Outage Management System (OMS) in both its NE and NW Divisions. FPUC believes the OMS is a significant improvement in data collection and retrieval capability for analyzing and reporting reliability indices. PEF and TECO's indices are much smaller; however, all three companies are trending upward.

The inter-utility trend comparison focuses on a graphical presentation that combines all of the IOUs' distribution reliability indices for the years 2006 through 2010. **Figures 4-1 through 4-3** apply to all five utilities while **Figures 4-4 and 4-5** does not apply to FPUC because it is not required to report MAIFle and CEMI5 due to the size of its customer base. The adjusted data is used in generating the indices in the report. It is based on the exclusion of certain events allowed by Rule 25-6.0455(4), F.A.C. Generalizations can be drawn from the side by side comparisons; however, any generalizations should be used with caution due to the differing sizes of the distribution systems, the degree of automation, and the number of customers. The indices are unique to each IOU.

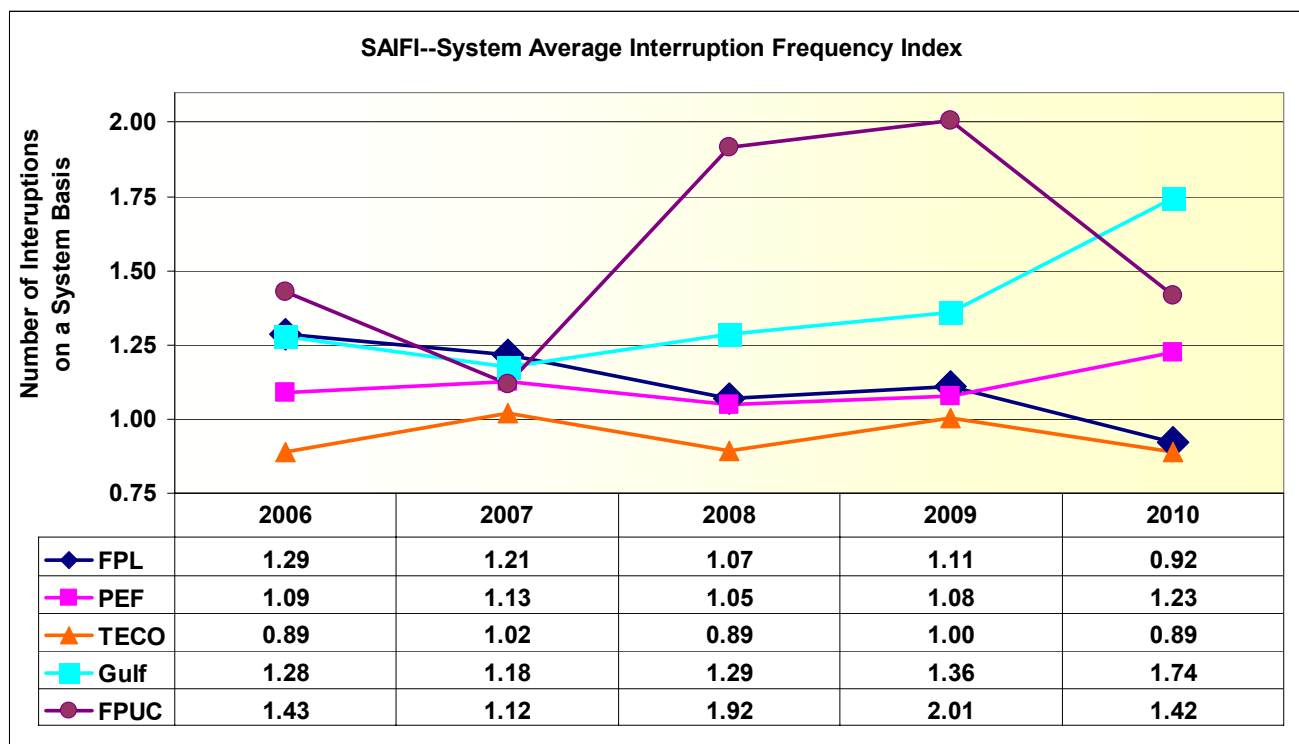
**Figure 4-2. Number of Service Interruptions (Adjusted SAIFI)**

Figure 4-2 is a five-year graph of the adjusted SAIFI (System Average Interruption Frequency Index) for each IOU. The 2010 data shows FPL and FPUC's SAIFI indices decreased (improved) from the 2009 results. TECO's indices fell as well, but appear cyclical per the yearly data. Gulf's and PEF's SAIFI metrics trended upward.

System Average Interruption Frequency Index (SAIFI) is the average number of service interruptions per retail customer within a specified area of service over a given period. It is determined by dividing the Sum of Service (aka Customer) Interruptions (CI) by the total Number of Customers Served (C) for the respective area of service.

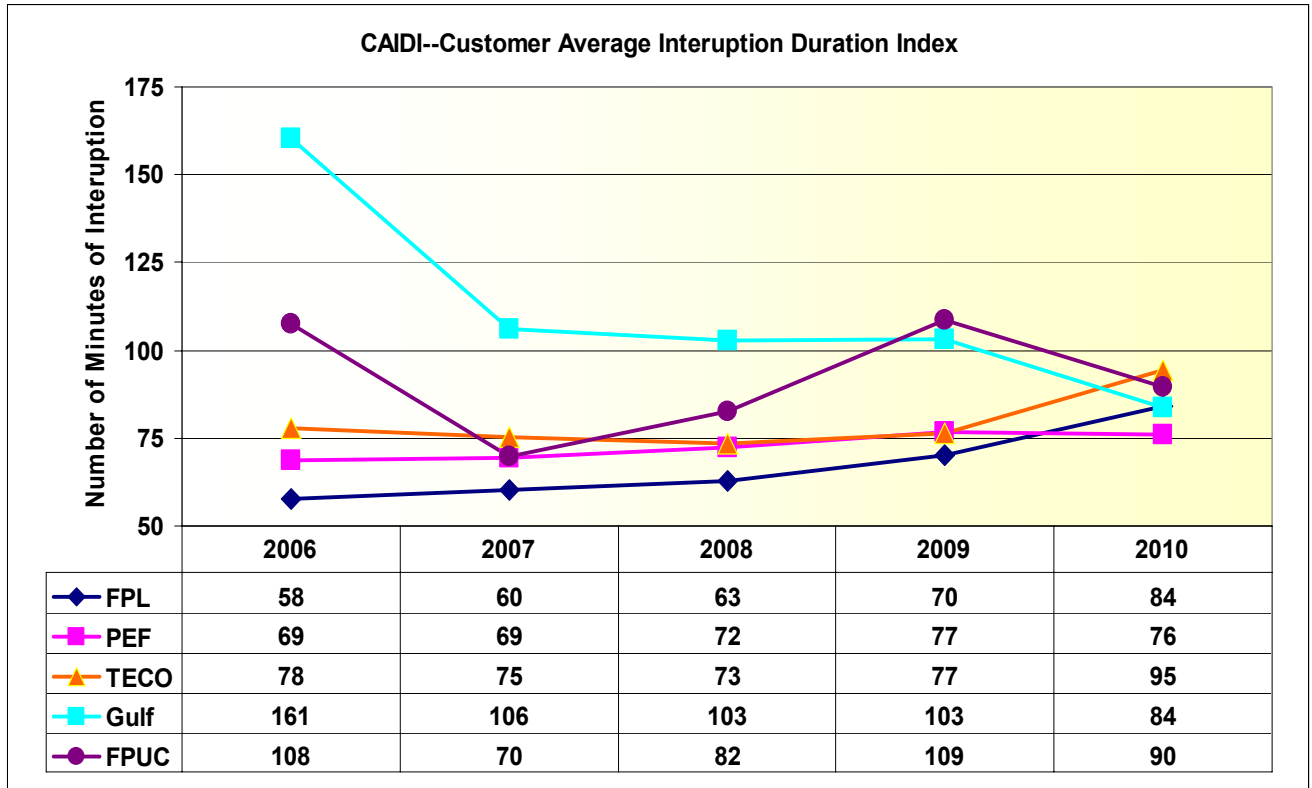
**Figure 4-3. Average Service Restoration Time (Adjusted CAIDI)**

**Figure 4-3** is a five-year graph of the adjusted CAIDI (Customer Average Interruption Duration Index) for each IOU. Despite the increase from 2009, FPL states its 2010 overall CAIDI performance ranks second in the nation when compared to the most recent available industry data. FPUC's CAIDI decreased in 2010, which reversed course from the previous two years. GULF continues to trend downward while PEF's performance is consistent from year to year. After being flat for several years, TECO saw an increase in its CAIDI by 23 percent.

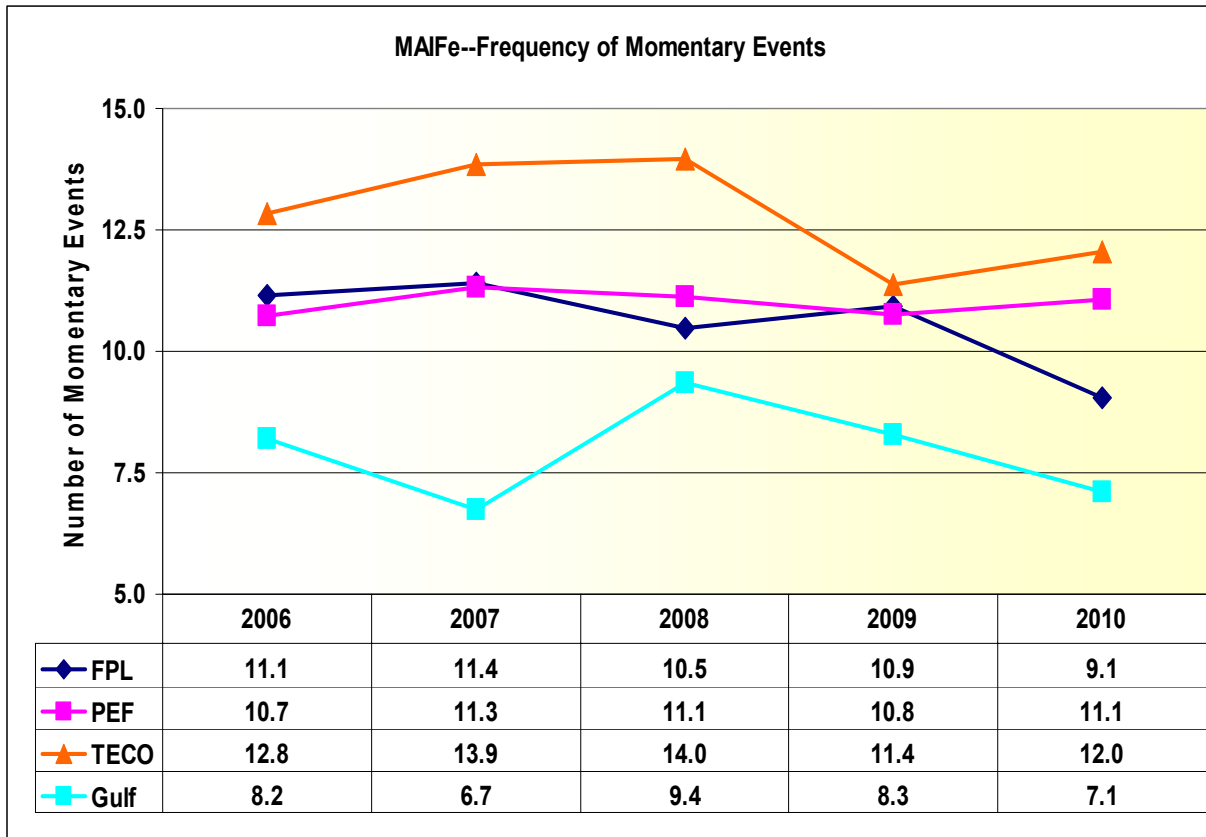
**Figure 4-4. Average Number of Feeder Momentary Events (Adjusted MAIFle)**

**Figure 4-4** shows a five-year graph of the adjusted MAIFle (Momentary Average Interruption Frequency Index) for FPL, PEF, TECO and GULF. All four companies' MAIFE indices are consistent with the previous four years. FPUC is exempt from reporting MAIFle and CEMI5 (Customers Experiencing More Interruptions than 5) because it has fewer than 50,000 customers.

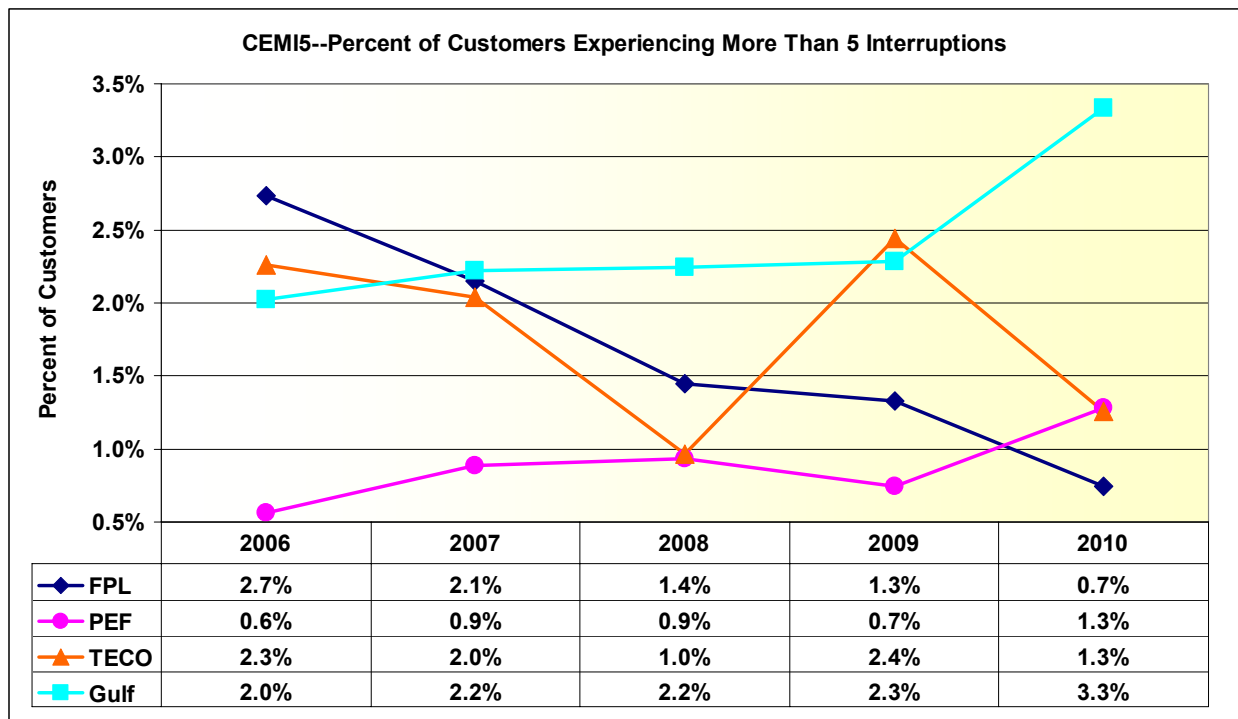
**Figure 4-5. Percent of Customers with More Than Five Interruptions (Adjusted CEMI5)**

**Figure 4-5** is a five-year graph of the adjusted CEMI5 (Customers Experiencing More Than Five Interruptions) for FPL, GULF, PEF and TECO. CEMI5 is a percentage. It represents the number of customers that experienced more than five service interruptions in the year divided by the total number of customers. The adjusted CEMI5 increased to 3.3 percent for Gulf in 2010 compared to 2.3 percent in 2009. FPL decreased to its lowest level in 5 years. PEF's trend continues upward and 2010 appears to have had the largest impact of the last five years. TECO's CEMI5 had a significant decrease in the percent of customers experiencing more than five interruptions in 2010 from its 2009 results.

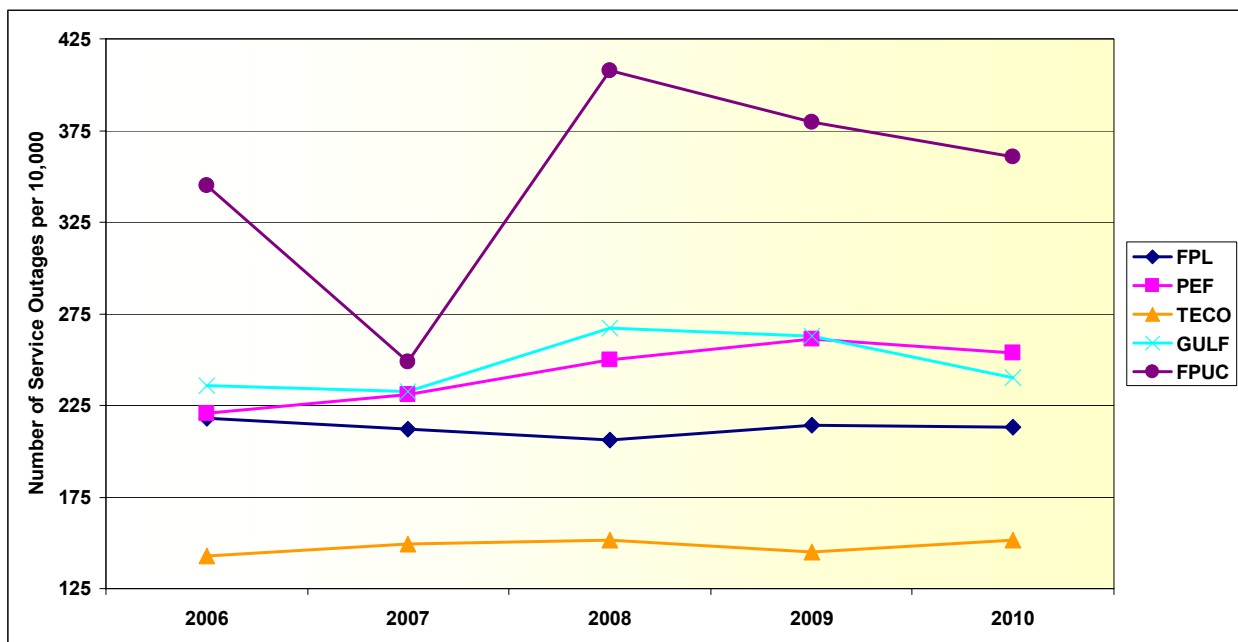
**Figure 4-6. Number of Outages per 10,000 Customers (Adjusted)**

**Figure 4-6** shows the number of outages per 10,000 customers on an adjusted basis for the five IOUs over the last five years. The graph explains each utility's adjusted data concerning the number of outage events and the total number of customers on an annual basis. The number of FPL outages increased marginally to 95,654 from 95,400 in 2009 and the number of outages per 10,000 customers remained flat for the five-year period. Similar results are seen for TECO. After seeing the number of outages rising earlier in the period for both PEF and Gulf, their outages appear to have stabilized and seem to be on the decline. FPUC's results increased sharply in 2008 and declined in 2009 and 2010. Due to the small customer base, the line graph for FPUC could be subject to greater volatility.
