*Florida's*  
*Investor-Owned*  
*Electric Utilities*

*Service Reliability reports*

Florida Public Service Commission  
Division of Safety, Reliability & Consumer Assistance

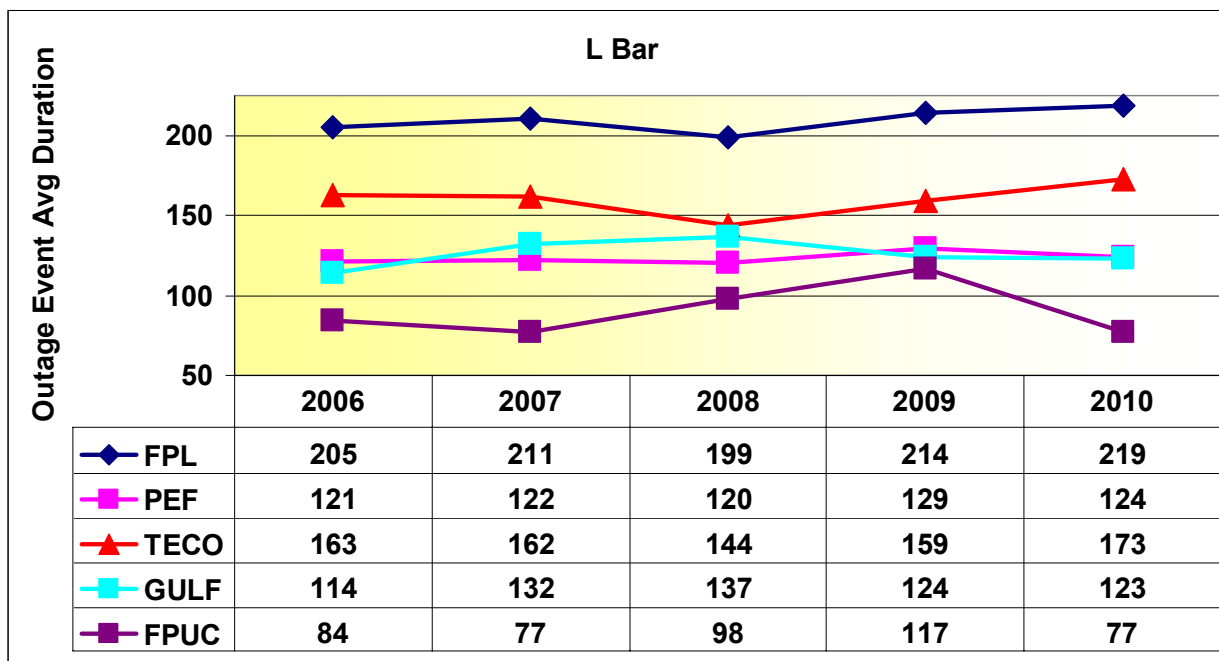
**Figure 4-7. Average Duration of Outage Events (Adjusted L-Bar)**

Figure 4-7 represents the average duration of outage events (Adjusted L-Bar) for each IOU. FPL's average outage duration remains higher than the other IOUs and appears to be increasing with the category "Equipment Failure" representing approximately 35 percent of FPL's outages. Correspondingly, TECO's outages appear to be increasing with 39.3% of TECO's outages attributed to animals (20.0%) and vegetation (19.3%). FPUC, Gulf and PEF L-Bar values decreased in 2010. FPUC's L Bar decreased to its lowest level in the past five years.

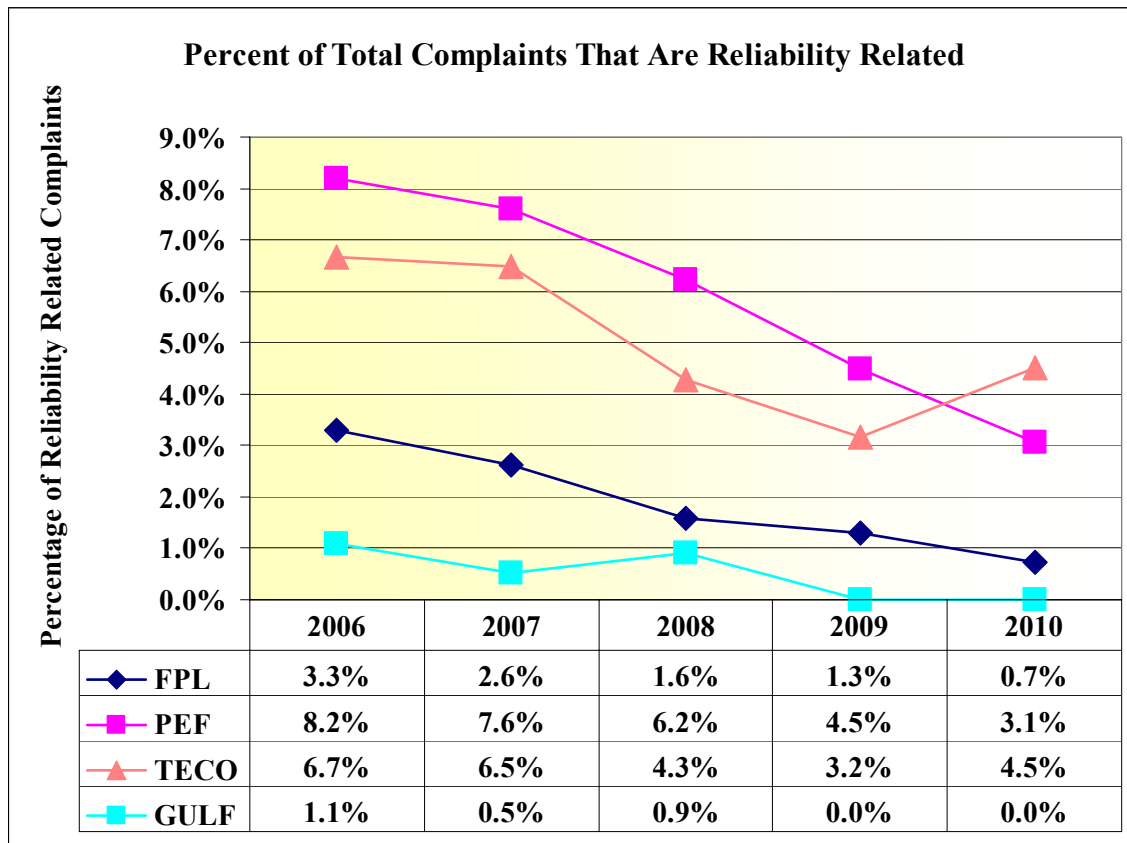
**Figure 4-8. Percent of Complaints That Are Reliability related**

Figure 4-8 shows the percentage of reliability related customer complaints in relation to the total number of complaints for each IOU and overall, it appears to be trending downward. FPUC was excluded from the comparison because FPUC has relatively few customer reliability complaints and a much smaller customer base in comparison to the other utilities.

For all of the FPL complaints received by the Commission, only 0.7 percent was categorized as reliability related. This represents an improvement over the 2009 results as shown in **Figure 4-8**. Overall, FPL's percentage of total complaints that are reliability related for the last five years appear to be trending downward.

Figures 4-8 and 4-9 represents consumer complaint data that was extracted from the Commission’s Consumer Activity Tracking System (CATS). Each customer complaint received by the Commission is assigned an alphanumeric category after the complaint is resolved. Reliability related complaints have 15 specific category types and typically pertain to trees, safety, repairs, frequent outages and momentary service interruptions. The “quality of service” category was established in July 2003, resulting in a shift of some complaints that previously would have been coded in another complaint category<sup>19</sup>.

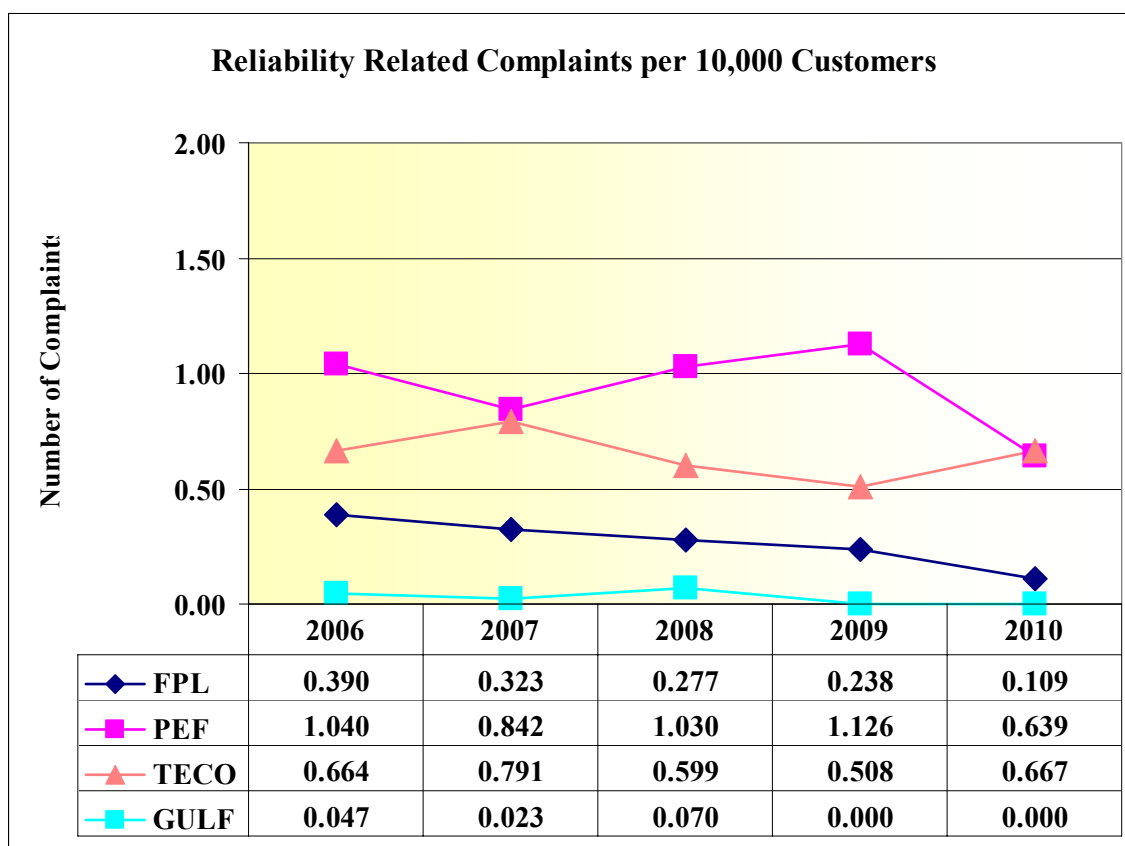
**Figure 4-9. Service Reliability Related Complaints per 10,000 Customers**

**Figure 4-9** charts the volume of reliability related complaints per ten thousand customers for the IOUs. FPL, PEF, TECO, and Gulf, for 2010, have less than one reliability complaint for ten thousand customers. For the five year period, FPL, PEF, and TECO appear to be trending downward. Gulf has the fewest reliability complaints in comparison to the other utilities and is staying relatively flat.

FPUC was also examined and for 2010, the utility had 53 total complaints of which five were reliability related. Normalizing to a 10,000-customer basis results in 1.790 reliability related complaints. The results for the previous years varied from 0.347 in 2006 to a high of 4.256 in 2008. The volatility of FPUC’s results can be attributed to its small customer base, which typically averages 28,000 or fewer customers.
