*Florida's*  
*Investor-Owned*  
*Electric Utilities*

*2 0 1 1*  
*Service Reliability reports*

Florida Public Service Commission  
Division of ENGINEERING

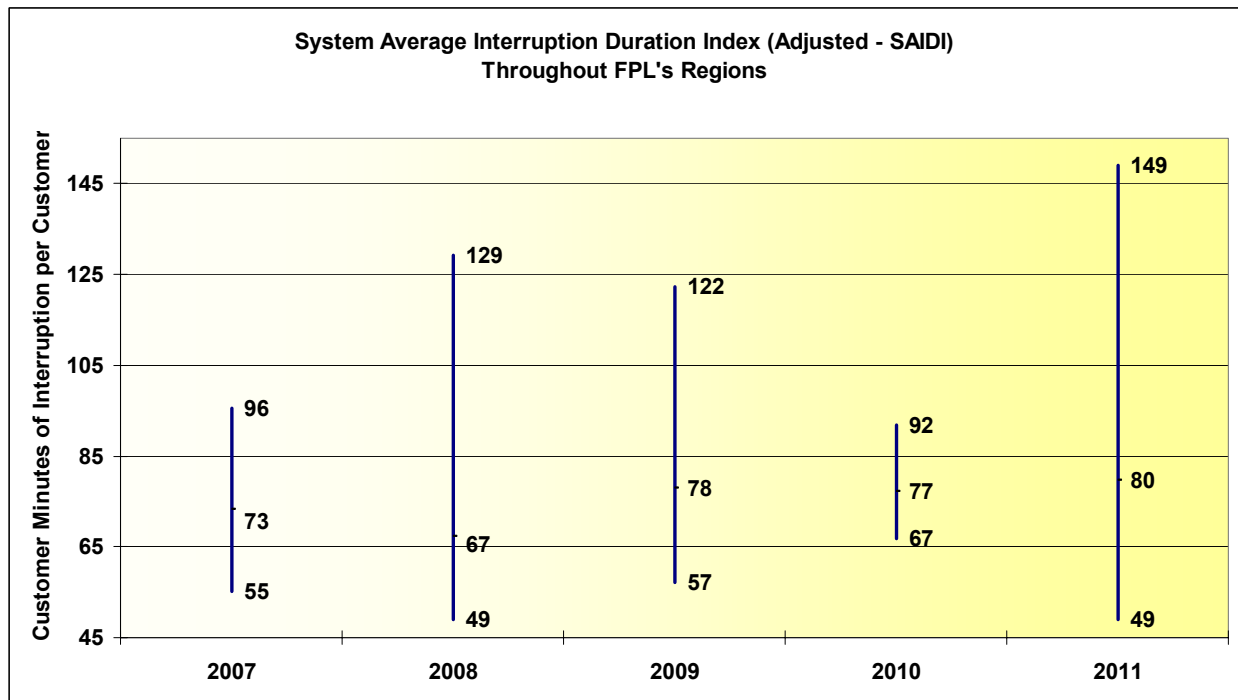
**Figure 3-1. SAIDI across FPL's Regions (Adjusted)**

**Figure 3-1** shows the highest, average, and lowest adjusted SAIDI recorded across FPL’s system that encompasses four management regions with sixteen service areas. The highest and lowest SAIDI values are the values reported for a particular service area. **Figure 3-1** shows a decrease in the lowest SAIDI to 49 minutes for the Central Dade service area in 2011 and an increase in the highest SAIDI to 149 minutes for the Central Florida service area. FPL had an overall increase of three minutes (four percent) to the average SAIDI results for 2011 compared to 2010. FPL attributes the decline in the SAIDI results to a single major weather event that lasted two days, October 9 and 10, 2011, and was not added as a named storm by the National Hurricane Center. FPL reported its service areas experienced 70 to 80 mph gusts of wind and 16 inches of rainfall. “Excluding this event, FPL’s 2011 SAIDI would have been approximately 76 minutes.”<sup>19</sup>

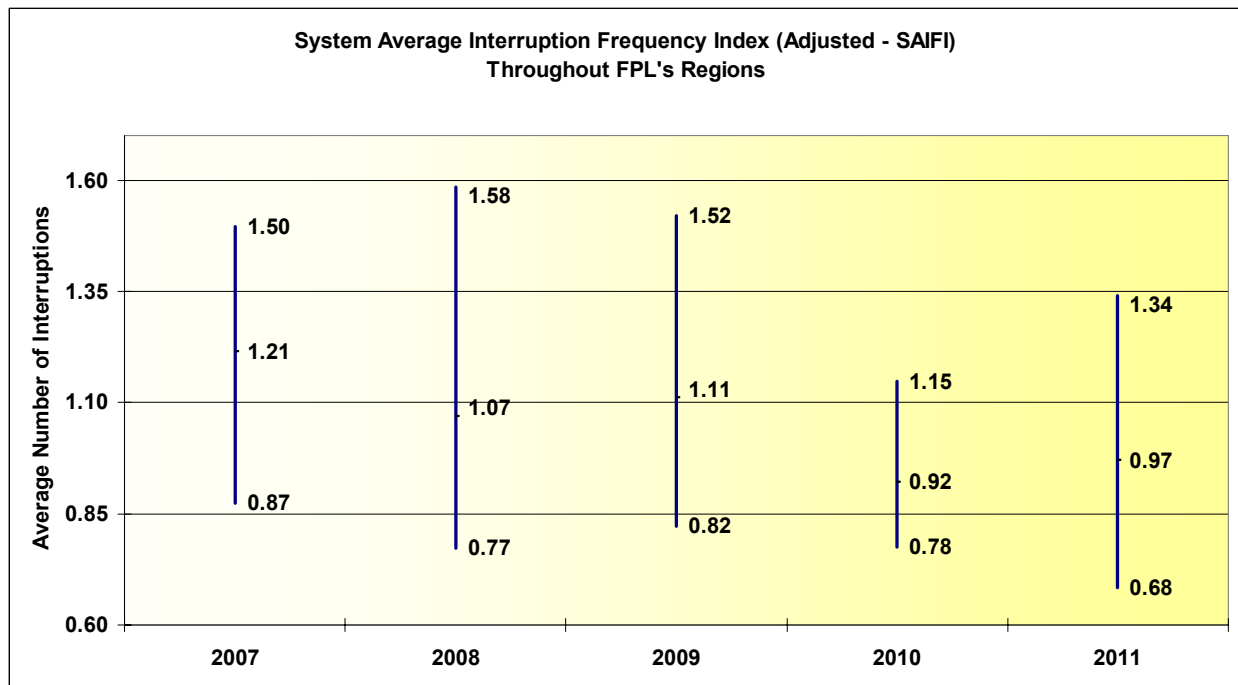
**Figure 3-2. SAIFI across FPL's Regions (Adjusted)**

**Figure 3-2** is a chart of the highest, average, and lowest adjusted SAIFI across FPL's system. FPL had an increase in the system average results to 0.97 outages in 2011, compared to 0.92 outages in 2010. FPL reported an increase to the highest SAIFI for North Florida of 1.34 interruptions in 2011 compared to West Dade's 1.15 interruptions in 2010. The region reporting the lowest adjusted SAIFI for 2011 was Central Dade at 0.68 interruptions compared to its 0.78 interruptions in 2010. The highest, average and lowest SAIFI appear to be trending downward suggesting improvements. Even though the SAIFI results appear to be improving, FPL reported the results were negatively impacted by the major weather event in October.

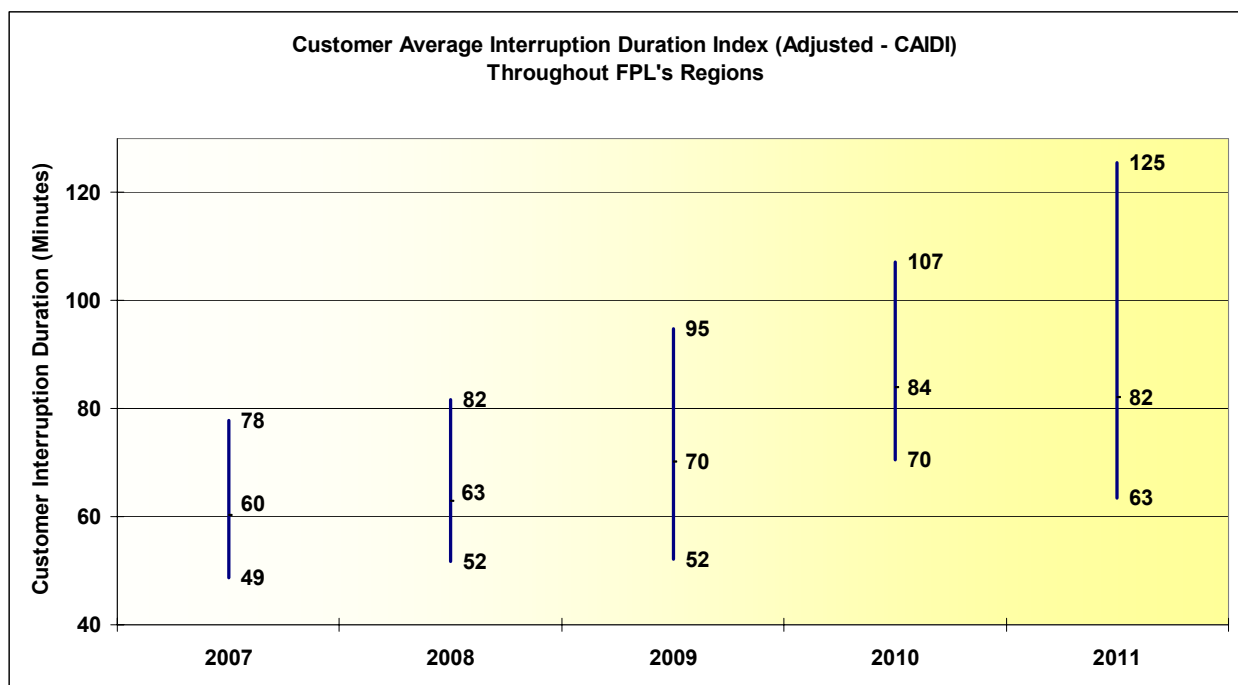
**Figure 3-3. CAIDI across FPL's Regions (Adjusted)**

**Figure 3-3** is a chart of FPL's highest, average, and lowest CAIDI expressed in minutes. FPL's adjusted average CAIDI has dropped approximately 2 percent from 84 minutes in 2010, to 82 minutes in 2011. The average duration of CAIDI, or the average number of minutes a customer is without power when a service interruption occurs, is trending upwards even though there was a decrease in CAIDI minutes. For 2011, the Boca Raton service area reported the lowest duration of CAIDI, which was 63 minutes. The lowest CAIDI for 2011 is 11 percent lower than the Brevard service area, which was reported as 70 minutes in 2010. The highest duration of CAIDI was 125 minutes for the Central Florida service area for 2011, which is 14 percent higher than the highest CAIDI minutes in 2010. The CAIDI results were negatively affected by the major weather event in October.

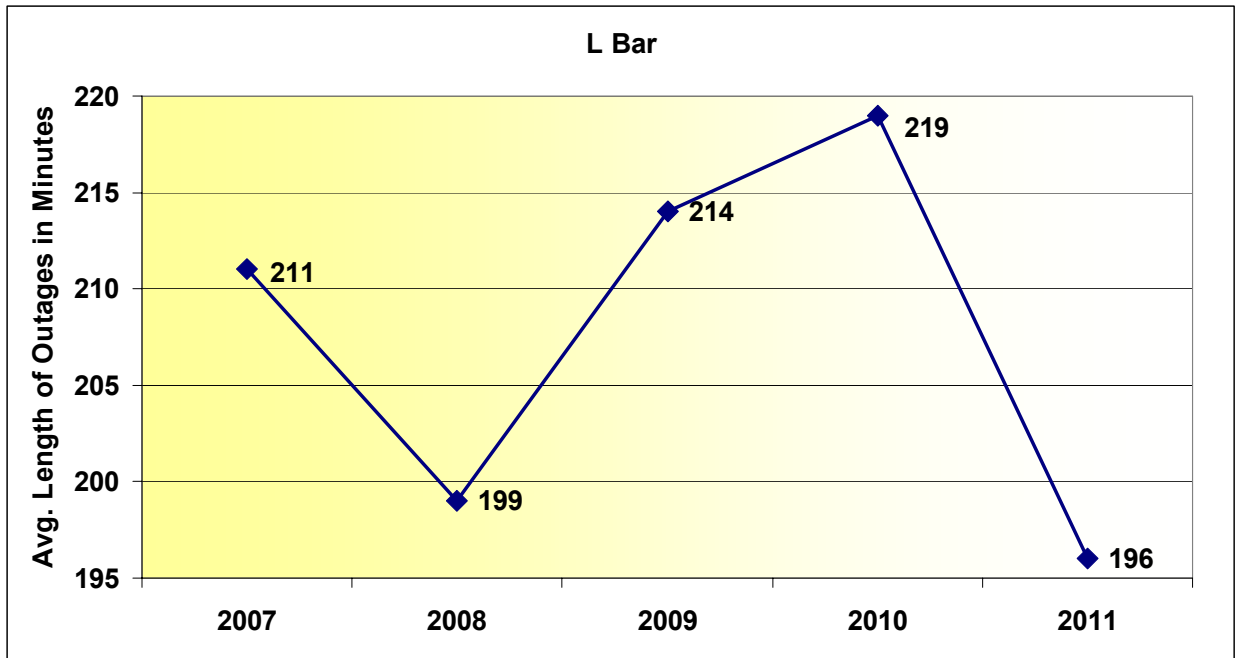
**Figure 3-4. FPL's Average Duration of Outages (Adjusted)**

**Figure 3-4** depicts the average length of time that FPL spends recovering from outage events, excluding hurricanes and other extreme outage events and is the index known as L-Bar (Average Service Restoration Time). FPL had a 12 percent decrease in L-Bar from 219 minutes in 2010, to 196 minutes in 2011, which represents the lowest average duration of outages since 2007. The L-Bar measures the average length of time of a single service interruption. The IEEE standard for calculation of L-Bar is the summation of the minutes of interruption divided by the total number of outages.

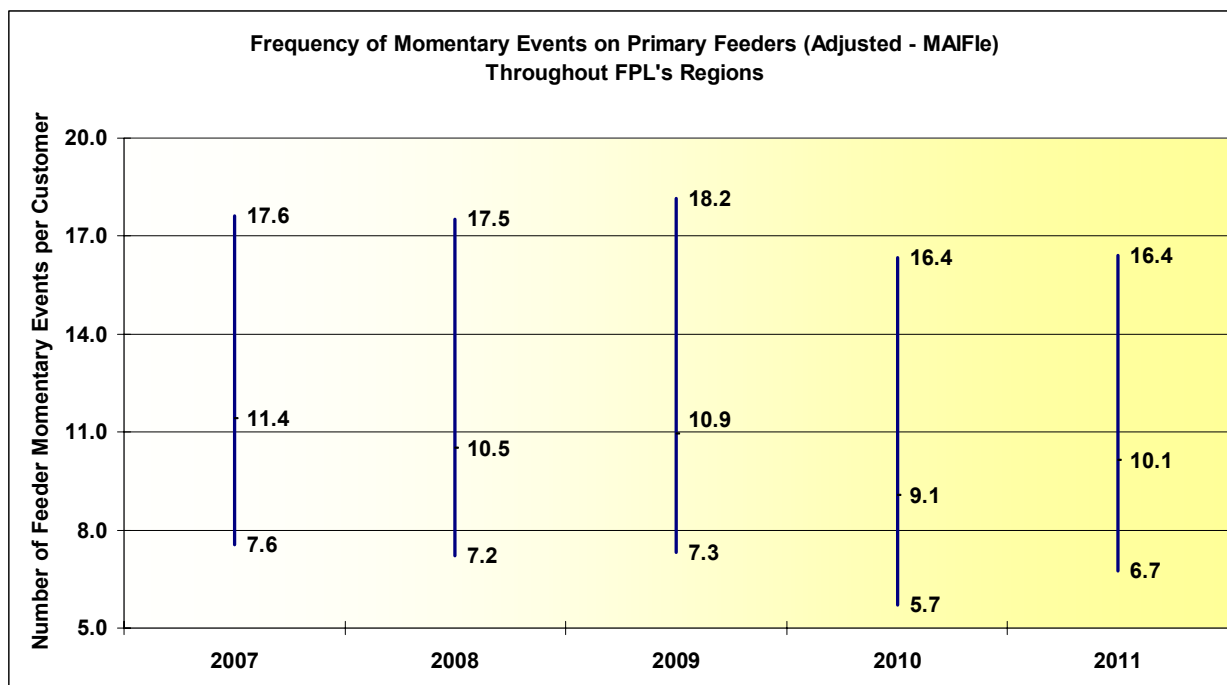
**Figure 3-5. MAIFle across FPL's Regions (Adjusted)**

**Figure 3-5** is the highest, average, and lowest adjusted MAIFle recorded across FPL's system. These momentary events often affect a small group of customers. FPL's Toledo Blade, Treasure Coast, and North Florida service areas have experienced the least reliable MAIFle results of the 16 service areas of FPL since 2007. The Pompano and Central Dade service areas had the fewest momentary events and the results have been trending downwards (improving) over the last five years.

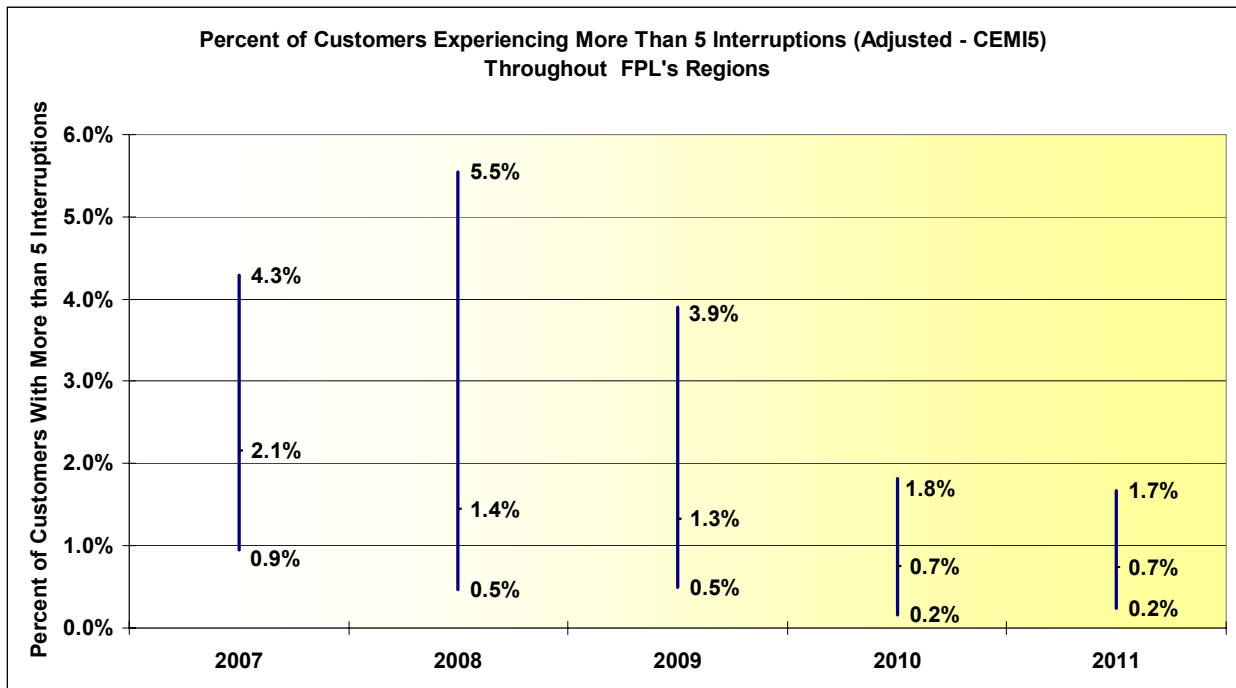
**Figure 3-6. CEMI5 across FPL's Regions (Adjusted)**

**Figure 3-6** shows the highest, average, and lowest adjusted CEMI5. FPL's customers with more than five interruptions per year appear to be decreasing and represent an overall improvement that appears to be trending downward. The service areas experiencing the highest CEMI5 appear to fluctuate among Naples, North Florida, and South Dade. Brevard, Gulf Stream, Pompano, and Central Dade are reported as having the lowest percentages in the last five years.

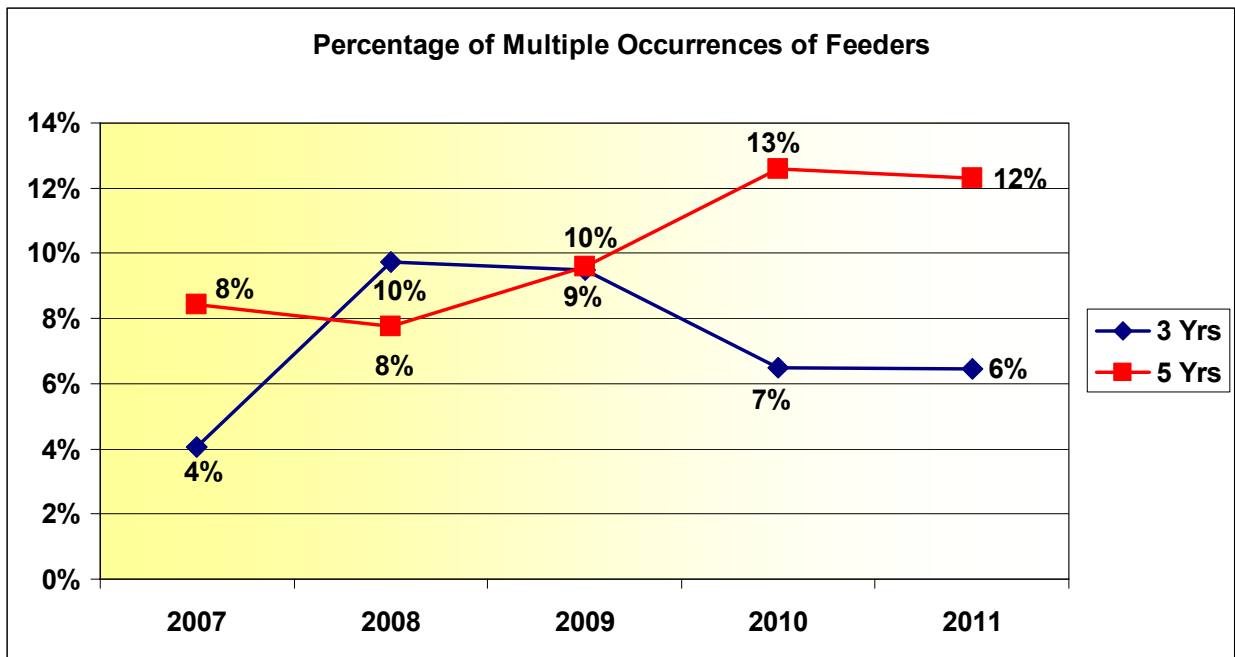
**Figure 3-7. FPL's Three Percent Feeder Report (Adjusted)**

**Figure 3-7** is a graphical representation of the percentage of multiple occurrences of FPL's feeders and is derived from The Three Percent Feeder Report, which is a listing of the top three percent of problem feeders reported by the utility. The percentage of multiple occurrences is calculated from the absolute number of multiple occurrences divided by the ending total number of feeders reported on a three-year and five-year feeder analysis. The three-year percentage improved from seven percent in 2010 to six percent in 2011. The five-year percentage also improved from 13 percent in 2010 to 12 percent in 2011. Even though both the three-year and five-year percentages did improve from 2010 to 2011, the five year percentage appears to be trending upwards as the three year percentage is slightly trending upwards for the five year period of 2007 to 2011.

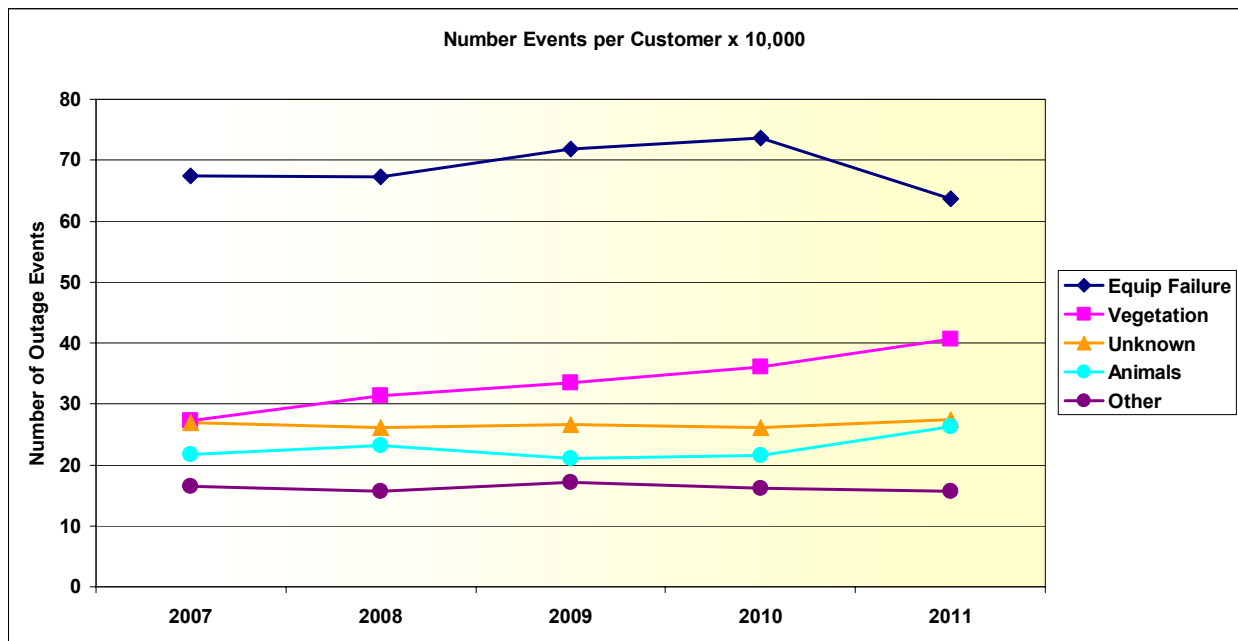
**Figure 3-8. FPL’s Top Five Outage Causes (Adjusted)**

**Figure 3-8** depicts the top five causes of outage events on FPL’s distribution system normalized to a 10,000-customer base. The graph is based on FPL’s adjusted data of the top ten causes of outage events. For the five-year period, the five top causes of outage events included equipment failures (29 percent), vegetation (19 percent), unknown (13 percent), animals (12 percent), and other causes (7 percent) on a cumulative basis. The data shows an increasing trend in outage events caused by equipment failure, which continues to dominate the highest percentage of outage causes throughout the FPL regions, even though the number of outages decreased from 2010 to 2011. In addition, outage events due to vegetation and animals are also trending upward. The outage events due to unknown and other causes are remaining relatively flat over the five-year period.

Equipment failure and vegetation outages continue to be the leading cause of the number of outage events per customer for the past five years. Analysis of **Figure 3-8** shows an increasing trend in the number of outage events attributed to equipment failure and vegetation. FPL has budgeted activities to minimize customer interruptions and FPL's reliability program targets all ten of the service outage causes totaling more than \$160 million.

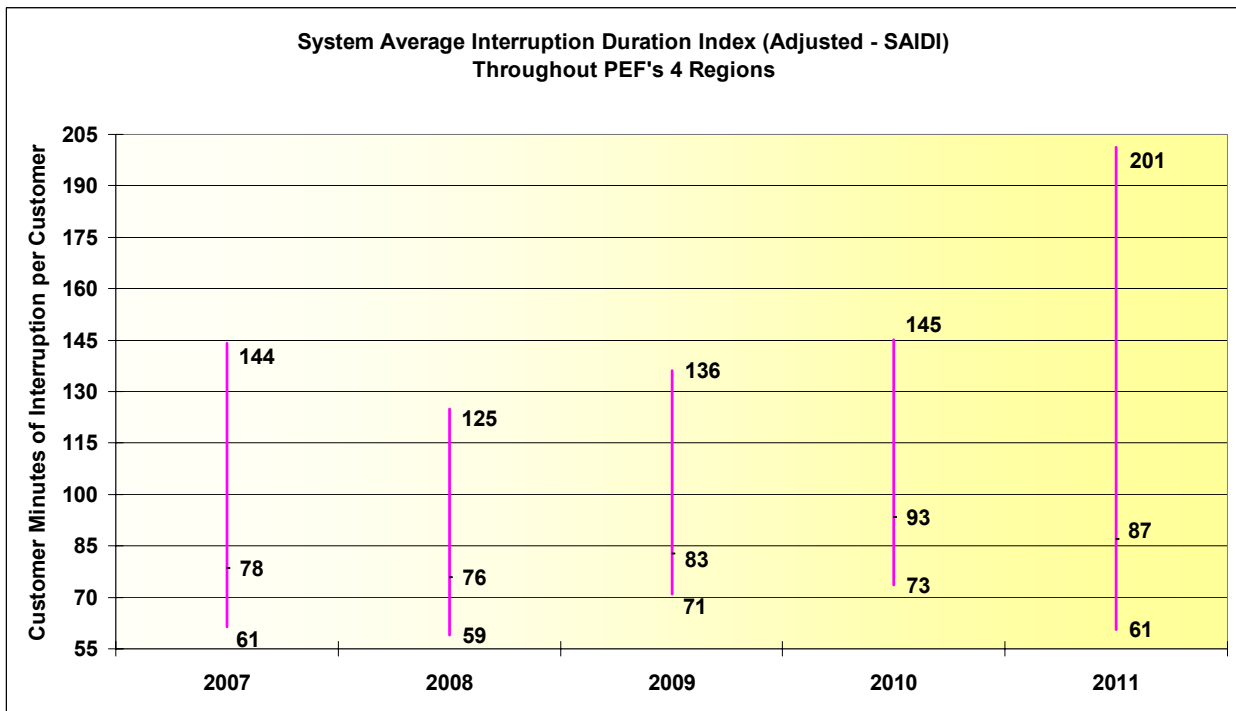
**Figure 3-9. SAIDI across PEF's Four Regions (Adjusted)**

**Figure 3-9** charts the adjusted SAIDI recorded across PEF’s system and depicts an increase in the highest values for 2011 and a decrease for the average and lowest values. PEF reported that in 2011, two tornados and one named storm affected its service territory. PEF notes that it continues to focus on “reliability projects including, but not limited to, small wire upgrades, storm hardening, and pole replacements.”<sup>22</sup>

PEF’s service territory is comprised of four regions: North Coastal, South Coastal, North Central, and South Central. **Figure 3-9** illustrates that the North Coastal region continues to report the poorest SAIDI over the last five years, fluctuating between 125 minutes and 201 minutes. While the South Coastal and South Central regions have the best or lowest SAIDI for the same period.

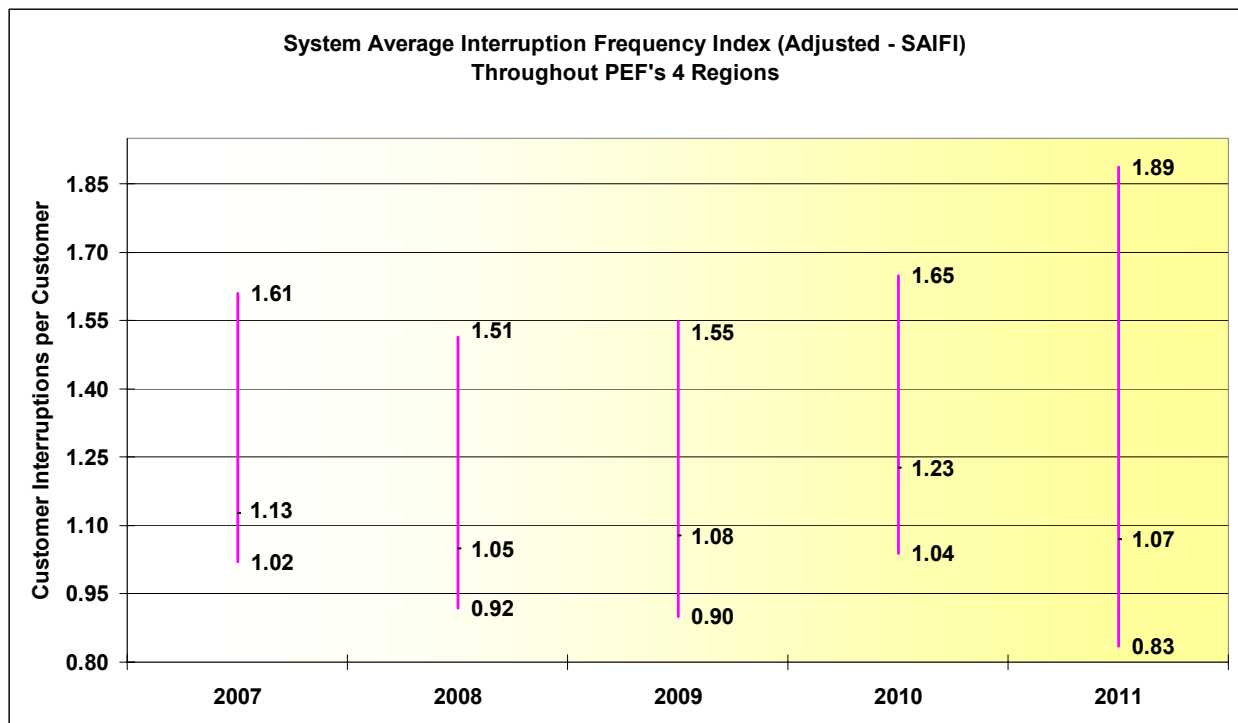
**Figure 3-10. SAIFI across PEF's Four Regions (Adjusted)**

Figure 3-10 shows the adjusted SAIFI across PEF's system. The maximum SAIFI index is trending upward as the minimum SAIFI index is trending downward. The average SAIFI index is trending slightly upward. The South Central region continues to have the lowest number of interruptions, while the North Coastal region continues to have the highest number of interruptions.

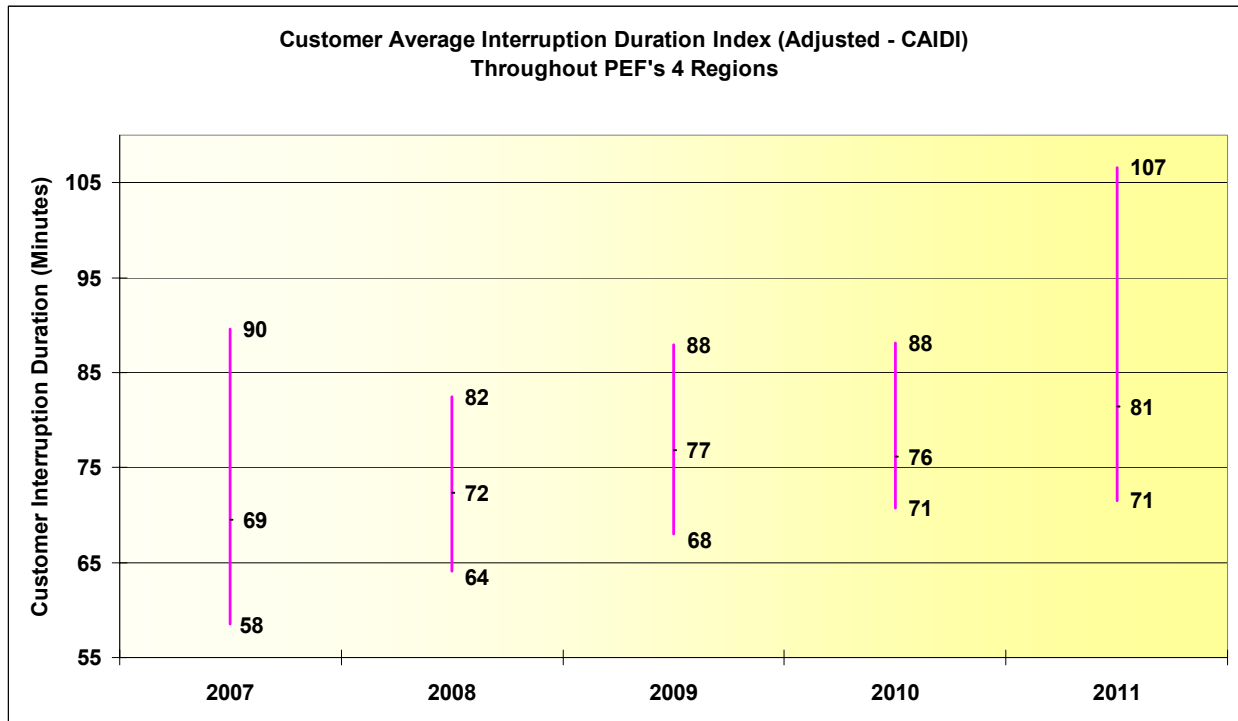
**Figure 3-11. CAIDI across PEF's Four Regions (Adjusted)**

**Figure 3-11** illustrates the CAIDI for PEF's four regions. PEF's adjusted CAIDI is trending upward from 69 minutes in 2007 to 81 minutes in 2011. The North Coastal region has continued to have the highest CAIDI level for the past five years, as compared to the other PEF regions, while the South Coastal and South Central regions have maintained the lowest CAIDI level during the same period.

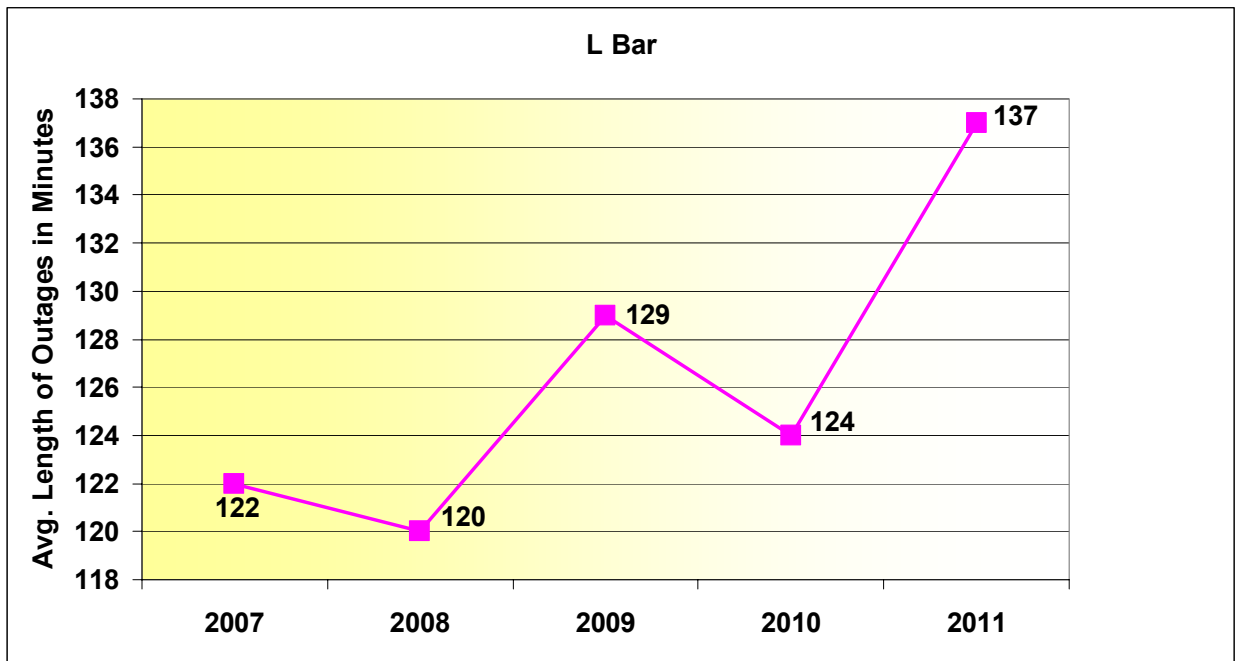
**Figure 3-12. PEF's Average Duration of Outages (Adjusted)**

**Figure 3-12** is the average length of time PEF spends restoring customers affected by outage events, excluding hurricanes and certain other outage events. This is displayed by the index L-Bar in the graph below. The data demonstrates an overall 11 percent increase of outage durations since 2007, and a 9 percent increase from 2010 to 2011. PEF's overall L-Bar index is trending upward, indicating that PEF is still spending a longer time restoring service from outage events.

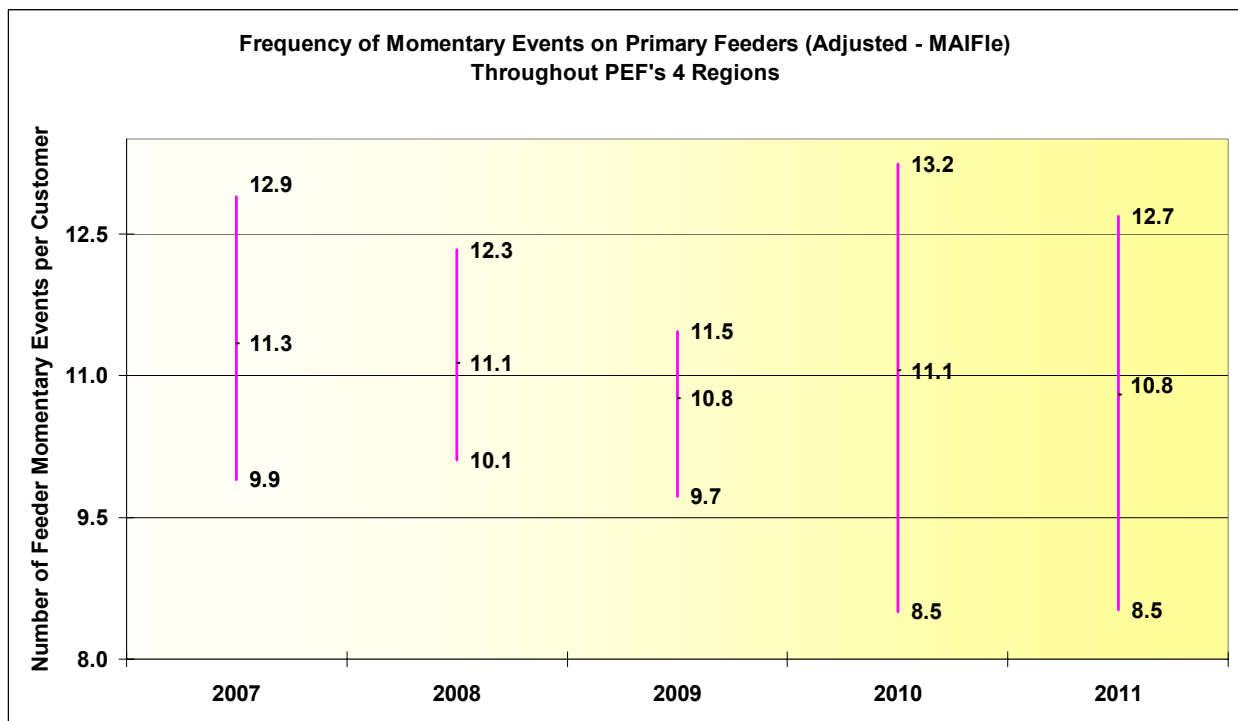
**Figure 3-13. MAIFle across PEF's Four Regions (Adjusted)**

**Figure 3-13** illustrates the frequency of momentary events on primary circuits for PEF's customers recorded across its system. A review of the supporting data suggests that the MAIFle results between 2007 and 2011 appear to be trending downwards showing improvement. The best (lowest) results are distributed among the North Central and South Central regions. The South Coastal region appears to have the worst (highest) results for the last five years.

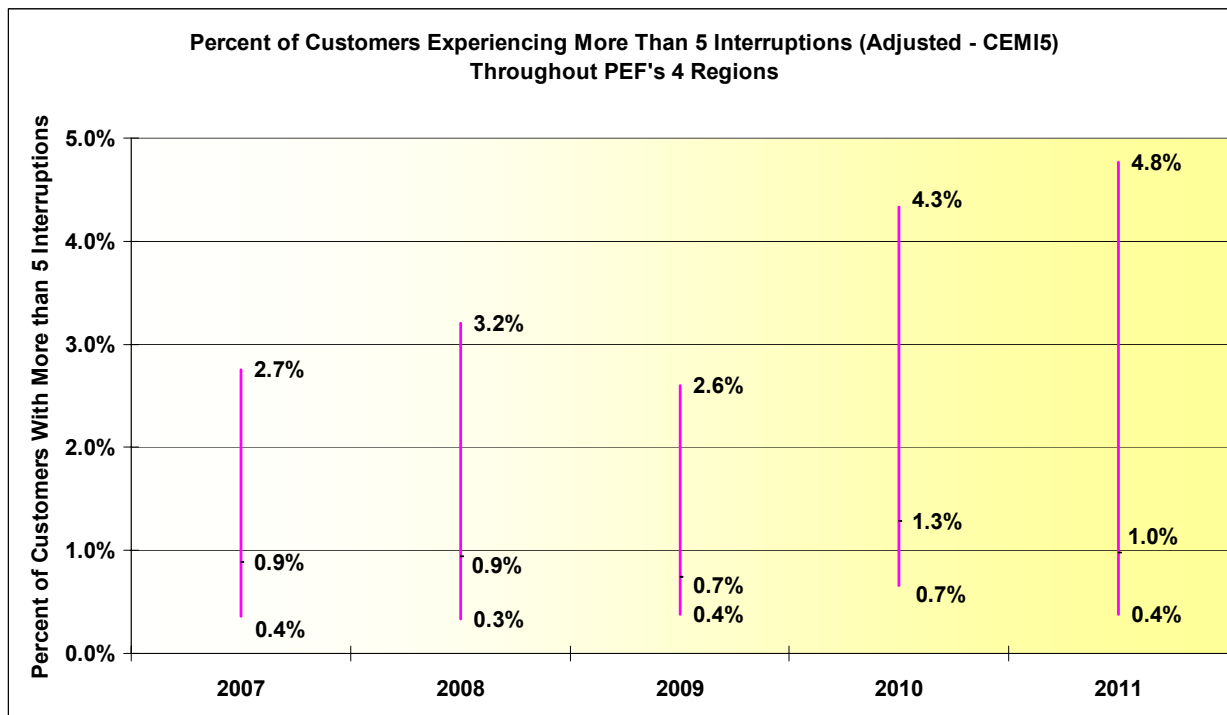
**Figure 3-14. CEMI5 across PEF's Four Regions (Adjusted)**

**Figure 3-14** charts the percent of PEF's customers experiencing more than five interruptions over the last five years. PEF reported a decrease (improvement) in the average CEMI5 performance from 1.3 percent in 2010 to 1.0 percent in 2011. Even though there was a decrease in the percentage from 2010 to 2011, the average CEMI5 performance is trending slightly upward over the past five years. The South Central and South Coastal regions continue to have the lowest reported percentage for all of PEF's regions and the North Coastal region continues to have the highest reported percentage.

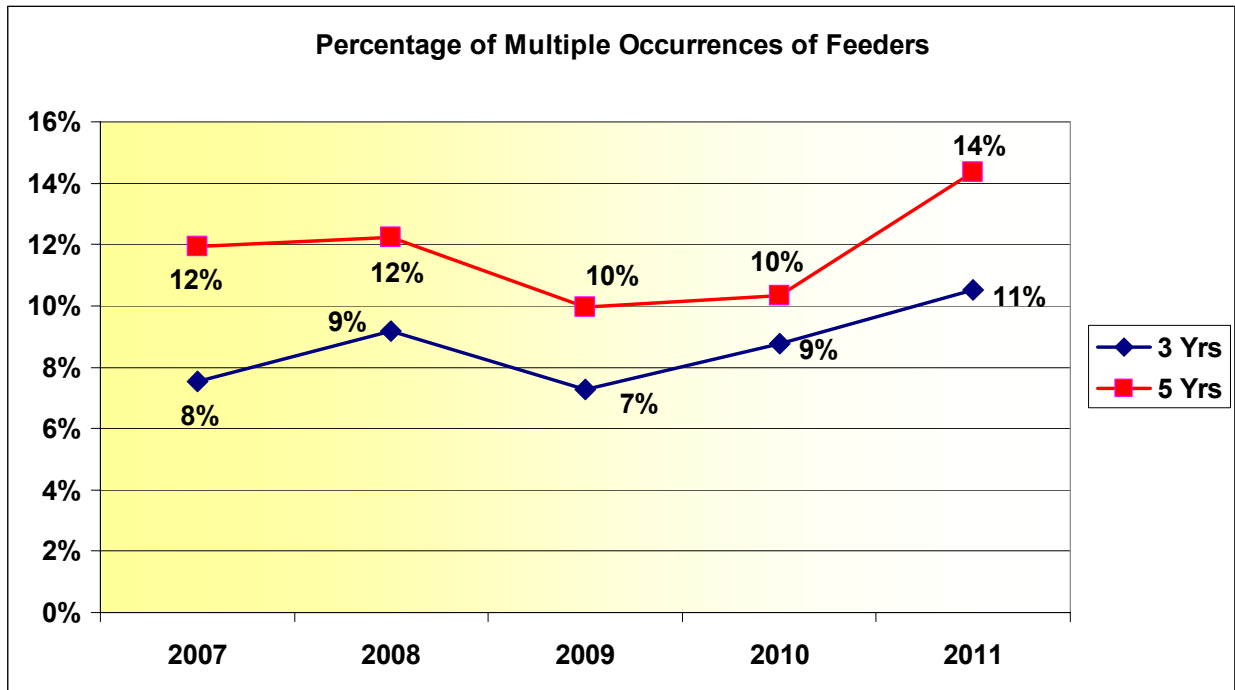
Figure 3-15. PEF's Three Percent Feeder Report (Adjusted)

Figure 3-15 shows the fraction of multiple occurrences of feeders using a three-year and five-year basis. During the period of 2007 to 2011, both the five-year and the three-year fraction of multiple occurrences results are trending slightly upward. The Three Percent Feeder Report lists the top three percent of feeders with the most feeder outage events. The fraction of multiple occurrences is calculated from the number of recurrences divided by the number of feeders reported.

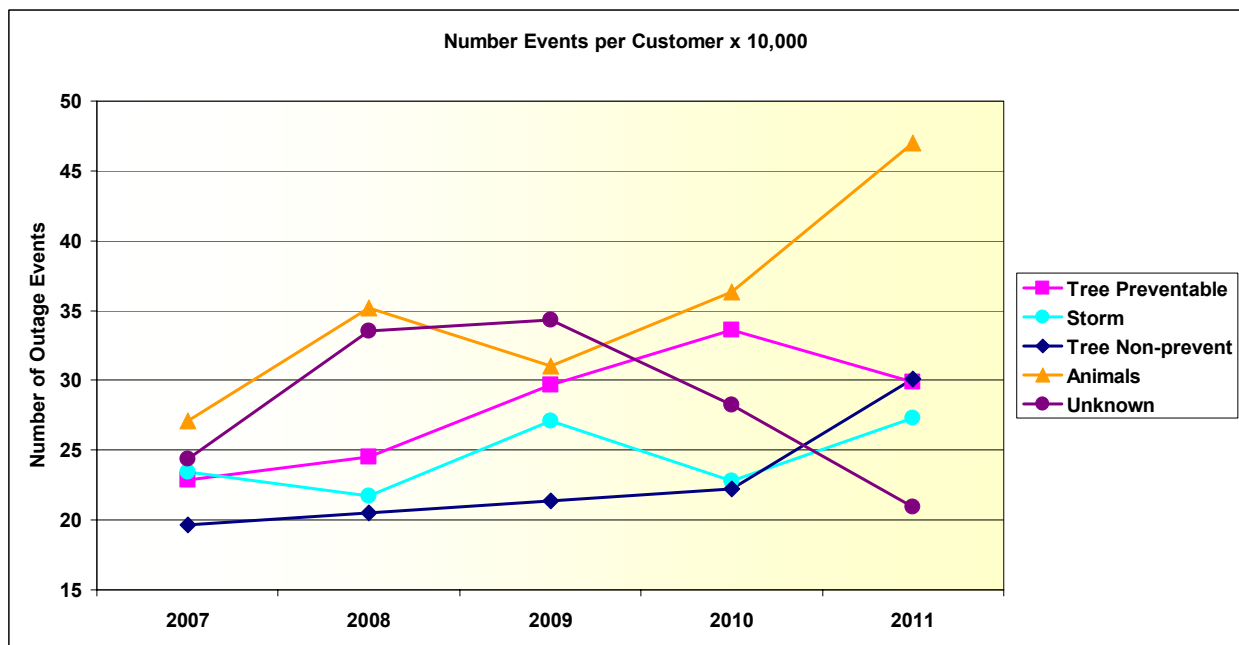
**Figure 3-16. PEF's Top Five Outage Causes (Adjusted)**

**Figure 3-16** shows the top five causes of outage events on PEF’s distribution system normalized to a 10,000-customer base. The figure is based on PEF’s adjusted data of the top ten causes of outage events and represents approximately 61 percent of the top ten causes of outage events that occurred during 2011. For the five-year period, the top five causes of outage events were animals (18 percent), tree non-preventable (12 percent), tree preventable (12 percent), storm (11 percent) and unknown (8 percent) on a cumulative basis. Staff notes that the number of outages caused by animals were included in the “all other” category for 2010 while this year, the number of outages caused by animals appeared in the top five causes of outage events.

In **Figure 3-16**, PEF's Top Five Outage Categories, the category "animals" climbed to the top spot, representing 18 percent of the ten outage categories. The next two top ten categories were "tree preventable (12 percent) and tree non-preventable (12 percent)." Tree non-preventable increased in 2011 over the 2010 results and tree preventable decreased in 2011. For the five year period, all of the top five outage categories appear to be mixed in that some are trending slightly upward while others are trending slightly downward.

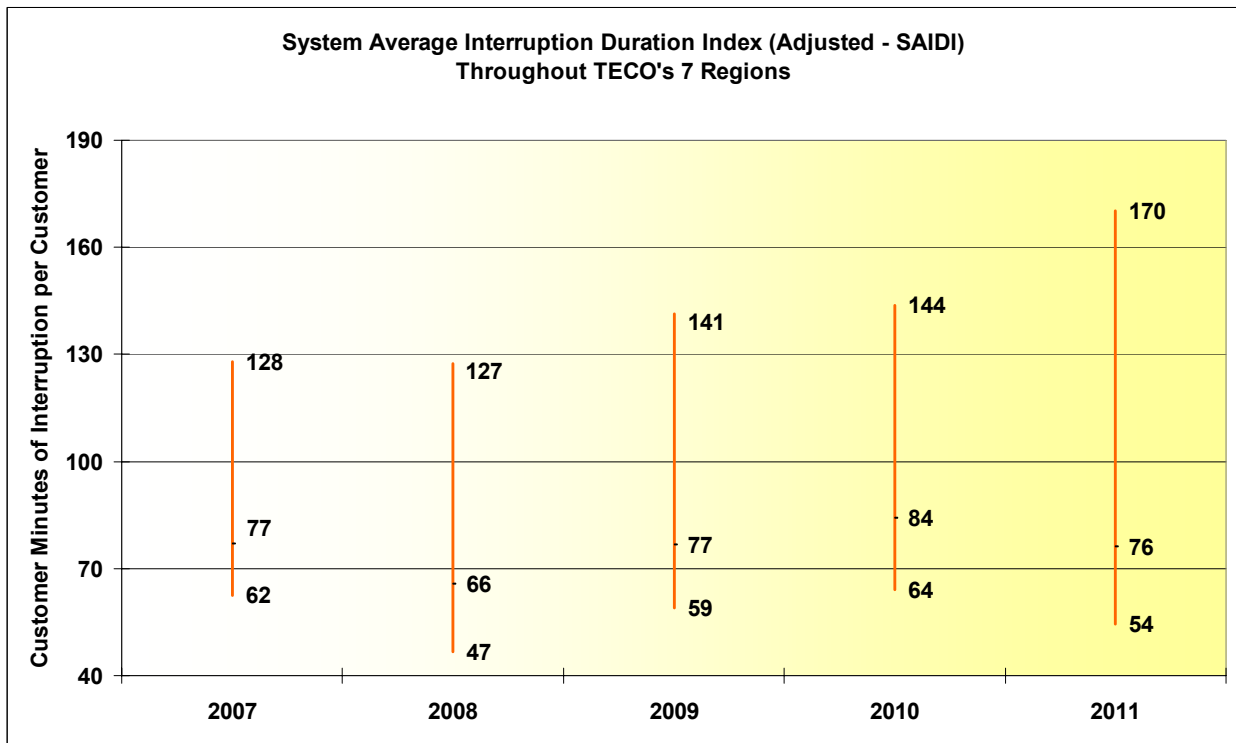
**Figure 3-17. SAIDI across TECO's Seven Regions (Adjusted)**

**Figure 3-17** shows the adjusted SAIDI values recorded by TECO's system. Three of the seven TECO regions had an increase in SAIDI performance during 2011, with Plant City and Dade City having the highest SAIDI performance results for the five-year period of 2007 to 2011. The lowest SAIDI index for the seven regions appears to be relatively flat. Dade City, Plant City, and South Hillsborough regions have the fewest customers and represent the most rural, lowest customer density per line mile in comparison to the other four TECO divisions. The SAIDI indices for all the regions except the Central, Eastern, and South Hillsborough regions were above the 2011 average SAIDI index of 76 minutes. The Central and Winter Haven regions recorded the lowest SAIDI indices for the five-year period.

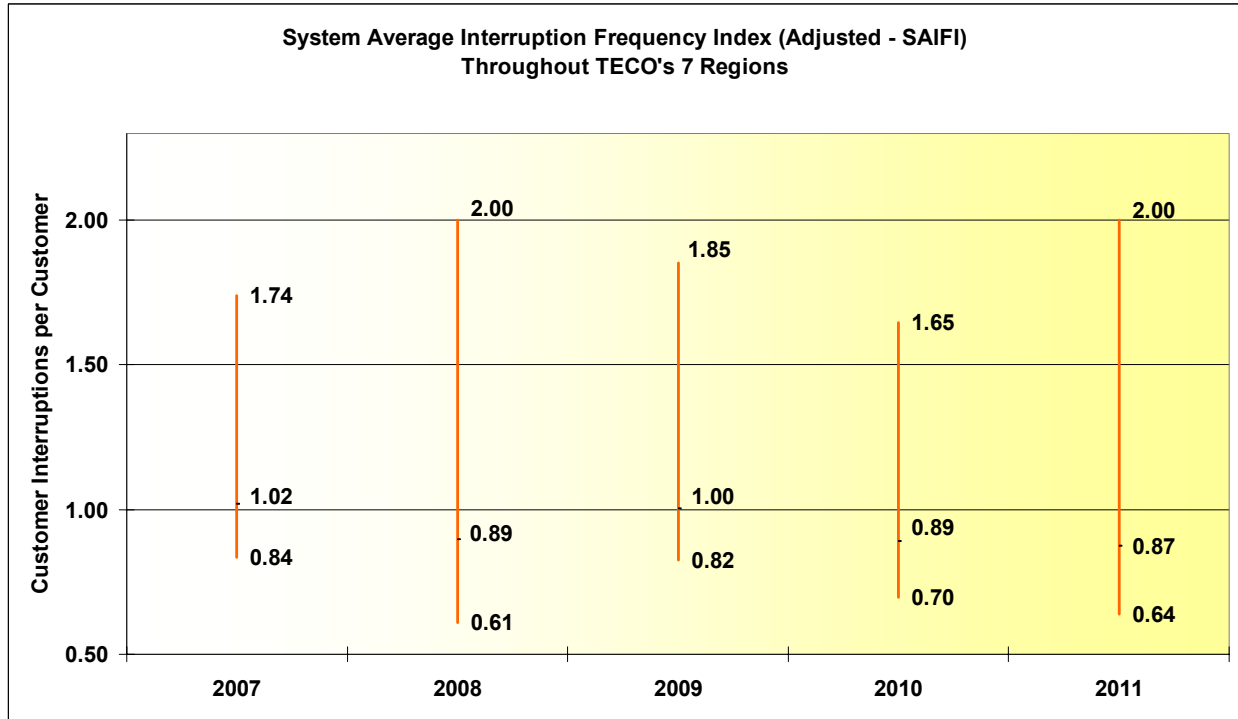
**Figure 3-18. SAIFI across TECO's Seven Regions (Adjusted)**

**Figures 3-18** illustrates TECO’s adjusted frequency of interruptions per customer reported by the system. TECO’s data represents a two percent decrease in the SAIFI average from 0.89 interruptions in 2010 to 0.87 interruptions in 2011. TECO’s Dade City region continues to have the highest frequency of service interruptions when compared to TECO’s other regions. The maximum SAIFI index is trending slightly upwards and the minimum and average indices are trending slightly downwards.

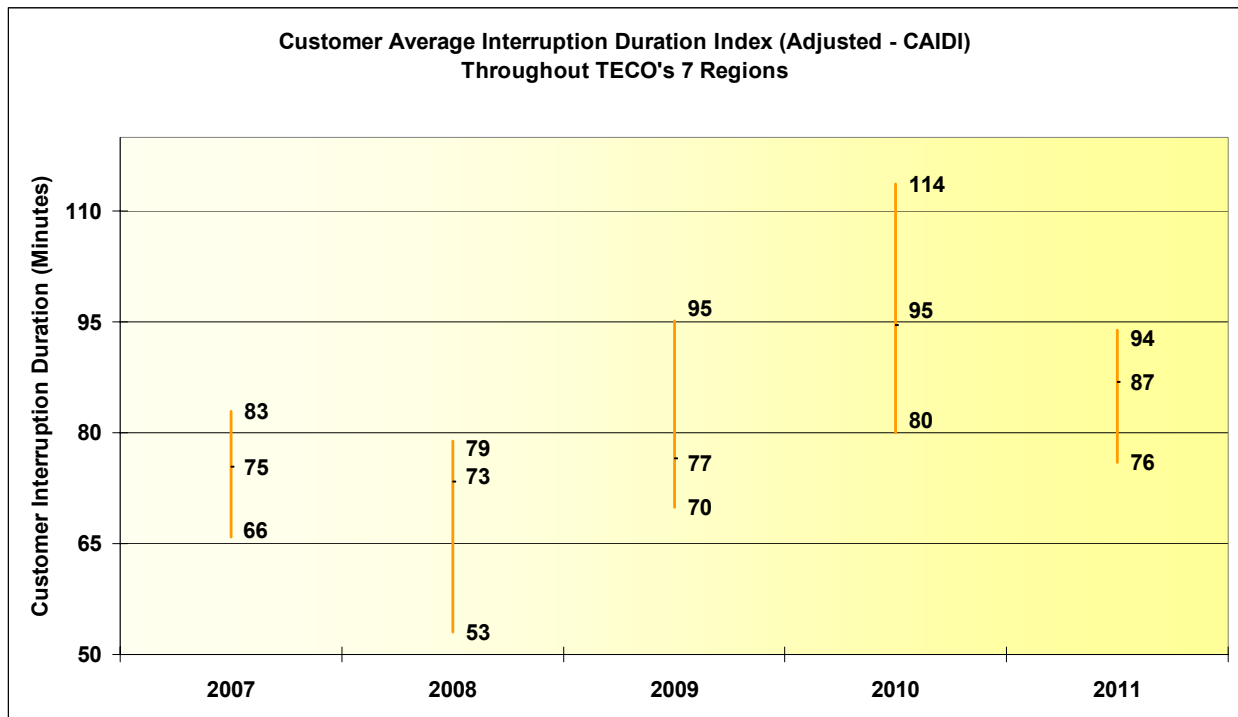
**Figure 3-19. CAIDI across TECO's Seven Regions (Adjusted)**

**Figure 3-19** charts the length of time that a typical TECO customer experiences an outage, which is known as CAIDI. The highest CAIDI minutes do not appear to be confined to any particular service area; however, Plant City and South Hillsborough both make appearances. Winter Haven has had the lowest (best) results for three out of the last five years. The average CAIDI continues to be trending upwards at this time suggesting TECO's customers are experiencing outages that are lasting longer.

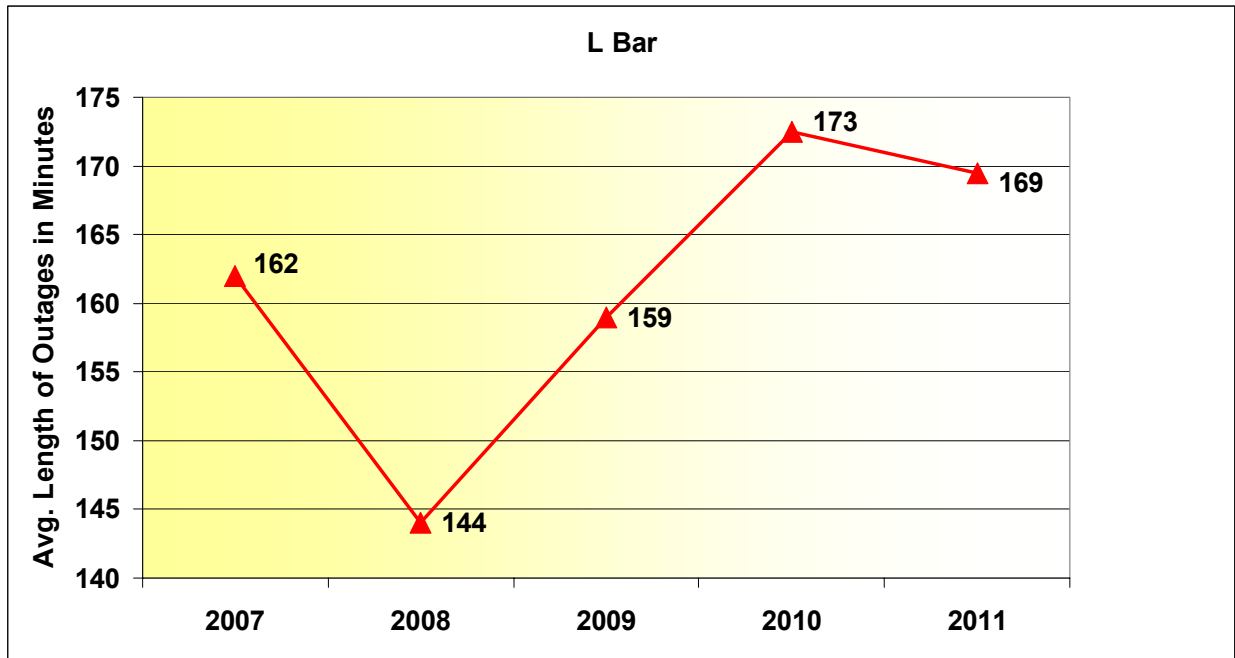
**Figure 3-20. TECO's Average Duration of Outages (Adjusted)**

**Figure 3-20** denotes a two percent decrease in outage durations for the period from 2010 to 2011. The L-Bar index appears to be trending upward suggesting an overall decline and longer restoral times. The average length of time TECO spends restoring service to its customers affected by outage events, excluding hurricanes and other allowable excluded outage events is shown in the index L-Bar.

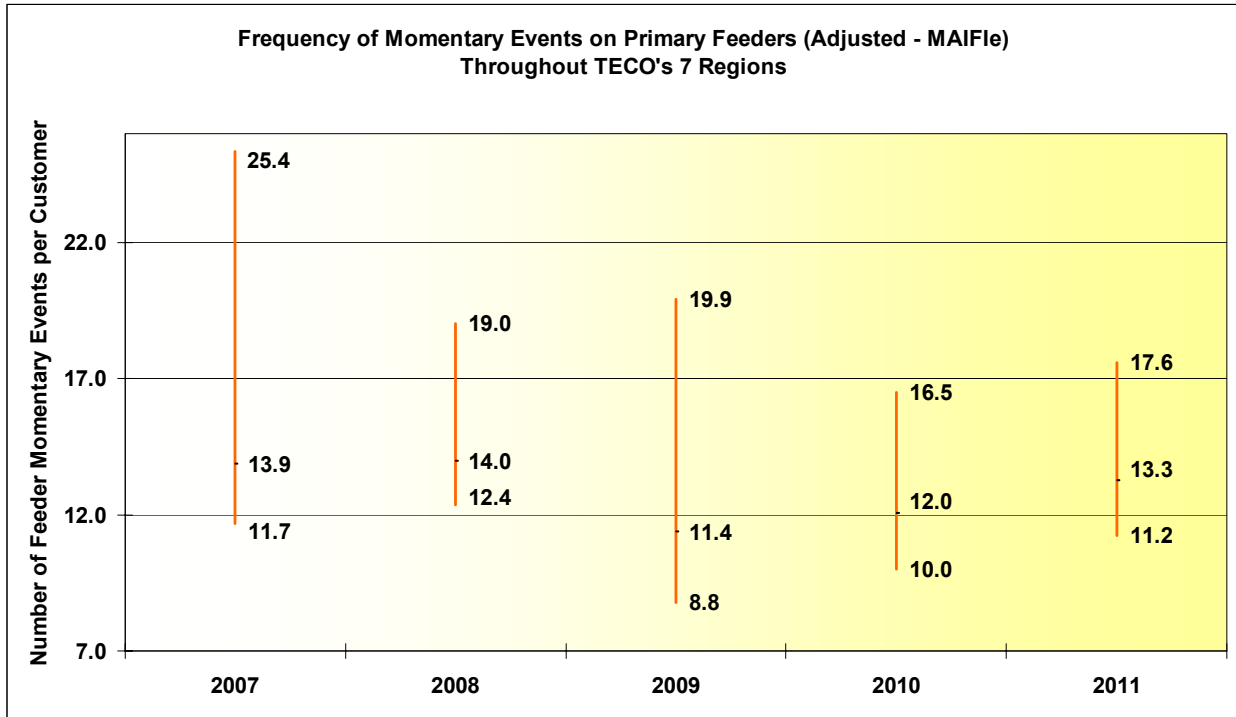
**Figure 3-21. MAIFle across TECO's Seven Regions (Adjusted)**

**Figure 3-21** illustrates TECO’s number of momentary events on primary circuits per customer recorded across its system. In 2011, the MAIFle performance declined over the 2010 results in all divisions except Dade City and South Hillsborough. **Figure 3-21** shows a downward trend for the average MAIFle, which suggests improvement over the five-year period of 2007 to 2011.
