*Florida's*  
*Investor-Owned*  
*Electric Utilities*

*2 0 1 1*  
*Service Reliability reports*

Florida Public Service Commission  
Division of ENGINEERING

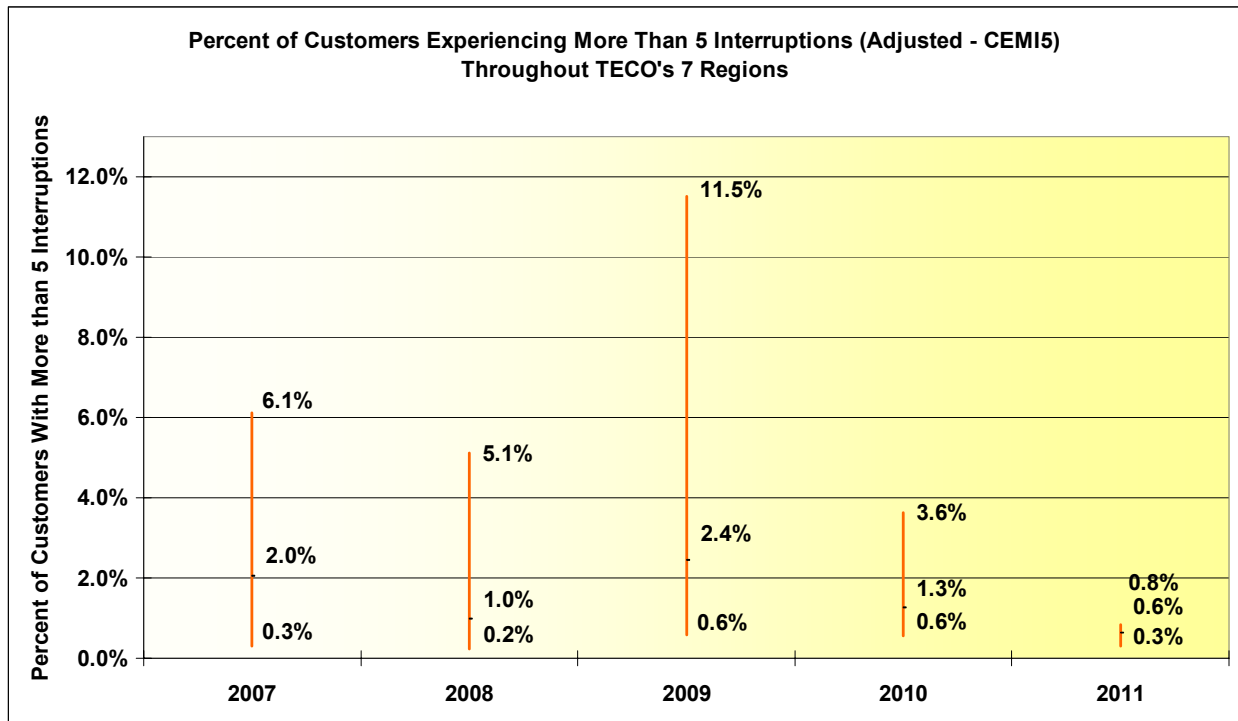
**Figure 3-22. CEMI5 across TECO's Seven Regions (Adjusted)**

**Figure 3-22** shows the percent of customers experiencing more than five interruptions. Five regions in TECO's territory experienced a decrease in the CEMI5 results for 2011. The Central and Dade City regions experienced an increase in the CEMI5 index. Plant City reported the highest CEMI5 percentage for 2011 even though there was a 58 percent decrease in its percentage from 2010. With TECO's results for this index varying for the past five years, the average CEMI5 index appears to be trending downward suggesting improvement.

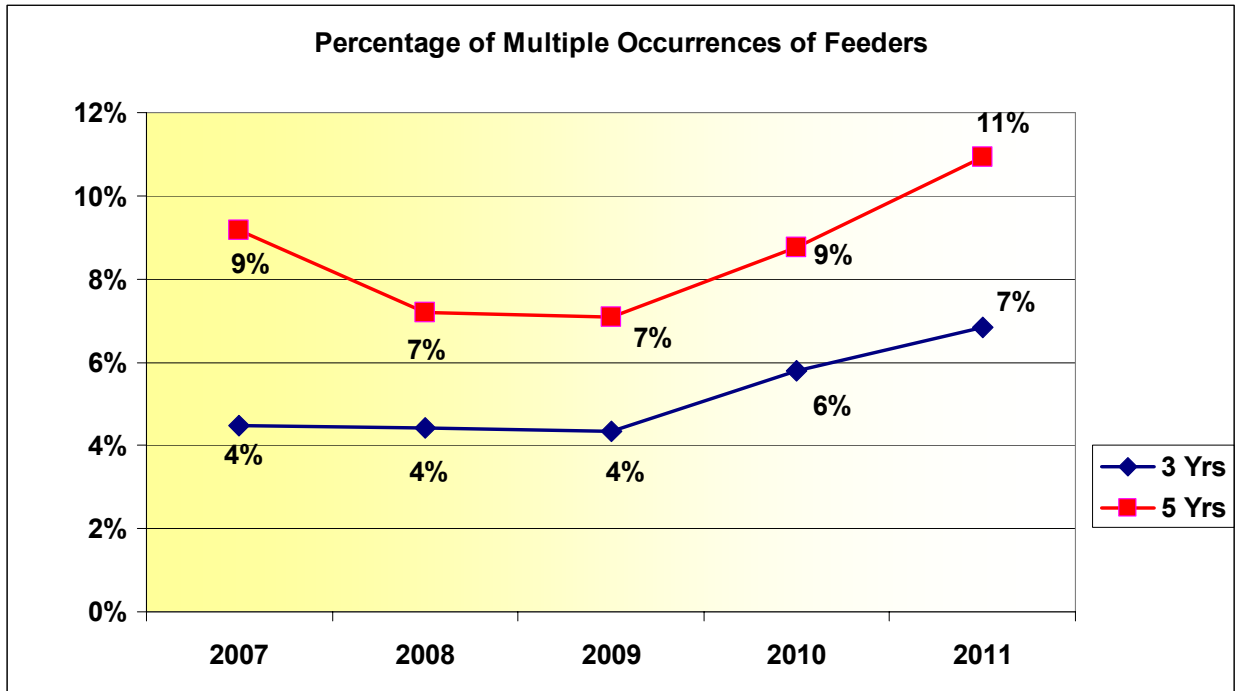
**Figure 3-23. TECO's Three Percent Feeder Report (Adjusted)**

**Figure 3-23** represents an analysis of TECO's top three percent of problem feeders that have reoccurred (appeared on the Three Percent Feeder Report) on a five-year and three-year basis. The graph is developed using the number of recurrences divided by the number of feeders reported. The five-year average of outages per feeder increased from 2010 to 2011, as well as the three-year average. Both the three-year and five-year averages of outages per feeder appear to be trending upward.

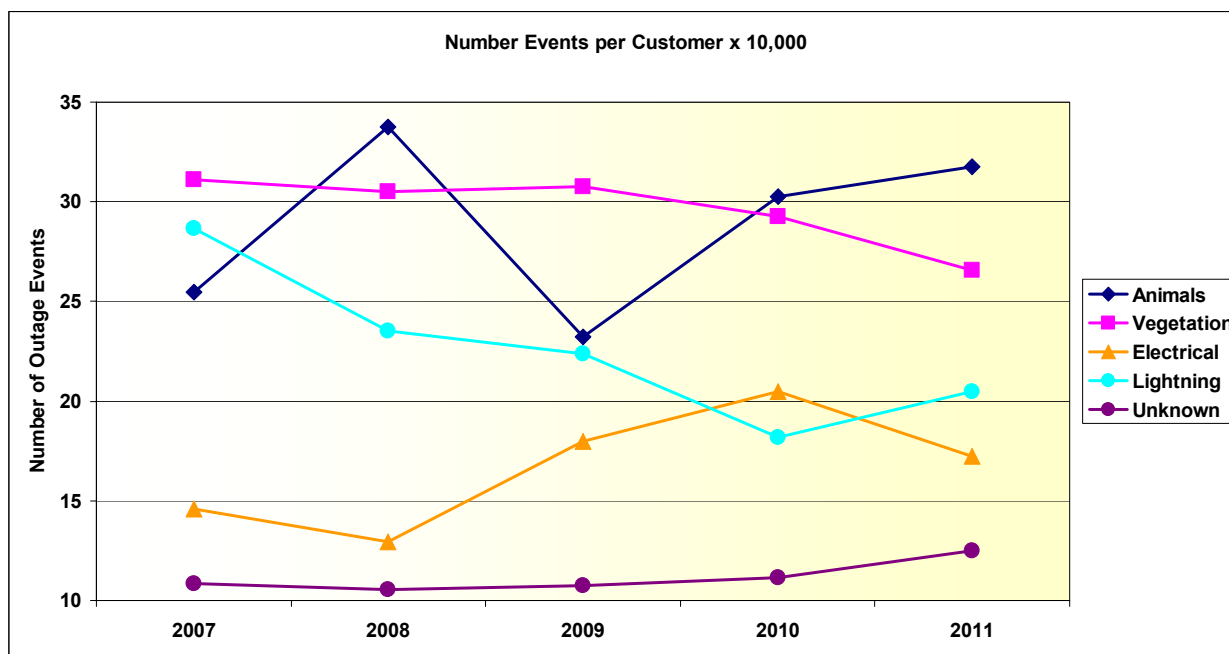
Figure 3-24. TECO's Top Five Outage Causes (Adjusted)

Figure 3-24 shows the top five causes of outage events on TECO's distribution system normalized to a 10,000-customer base. The figure is based on TECO's adjusted data of the top ten causes of outage events and represents 78 percent of the total outage events that occurred during 2010. Vegetation and animals causes continue to be the top two problem areas for TECO; however, the cause due to vegetation continues to decrease. TECO reports that "overall outages were down in 2011 in comparison to 2010"<sup>24</sup> and "the total number of outages in comparison to the last five-year average is also down by 4.51 percent."<sup>25</sup> The number of outages due to animals, electrical issues, and unknown causes are trending upward while the number of outages due to vegetation and lightning are trending downward.

Animals and vegetation continue to be the largest contributors to TECO's causes of outage events. **Figure 3-24** illustrates the top five outage causes and vegetation related causes continue to decrease over the last three years. However, animals related outages appear to be trending upward.

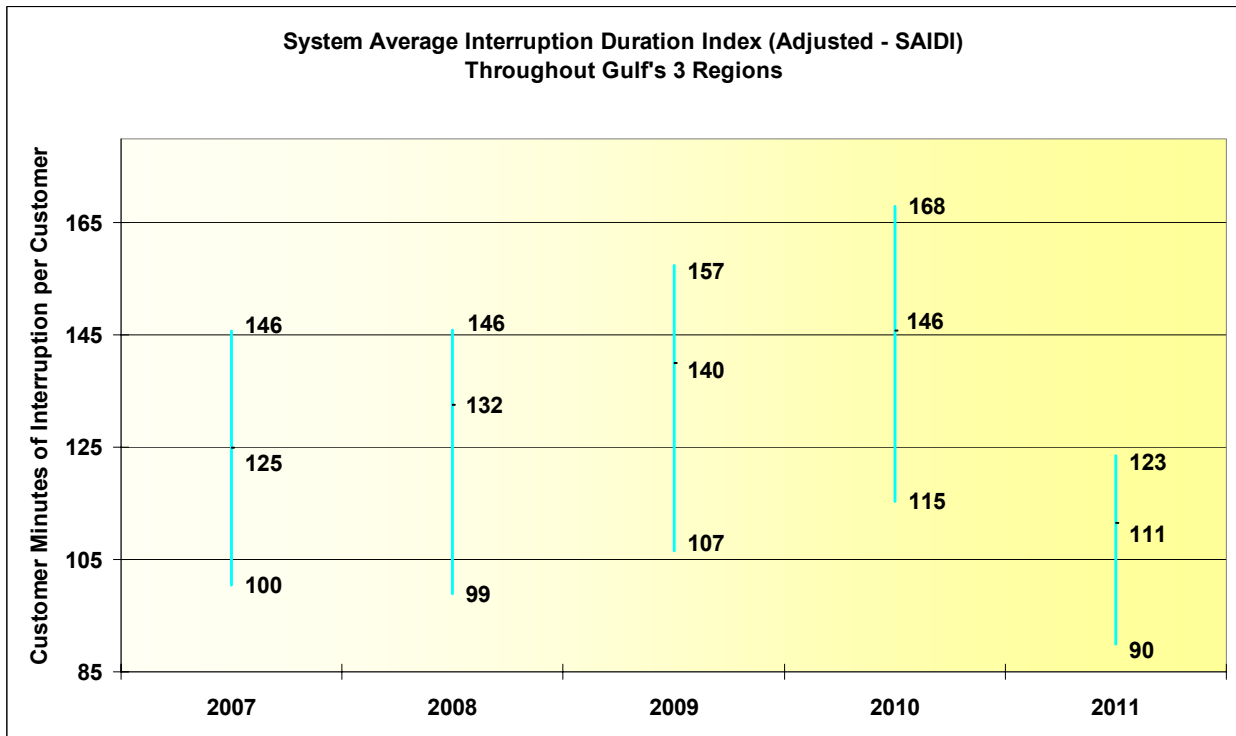
**Figure 3-25. SAIDI across Gulf's Three Regions (Adjusted)**

**Figure 3-25** illustrates Gulf's SAIDI minutes, or the interruption duration minutes on a system basis. The chart depicts a decrease in the average SAIDI value by 35 minutes in Gulf's combined regions over the 2010 results. Gulf's 2011 average performance was 32 percent better than the 2010 SAIDI results. The Western district has the highest SAIDI value for the past five years as the Central and Eastern districts have the best or lowest SAIDI values. The maximum, minimum, and average SAIDI indices are continuing to trend downward, showing improvements.

**Figure 3-27** is Gulf's adjusted CAIDI. For 2011, the average CAIDI is 89 minutes and represents a six percent increase from the 2010 value of 84 minutes. In 2011, the Western region had the highest CAIDI value, as the Central region had the lowest CAIDI. Staff notes that just like the SAIDI values in **Figure 3-25** the maximum, minimum, and average CAIDI values are also trending downward suggesting improvement.

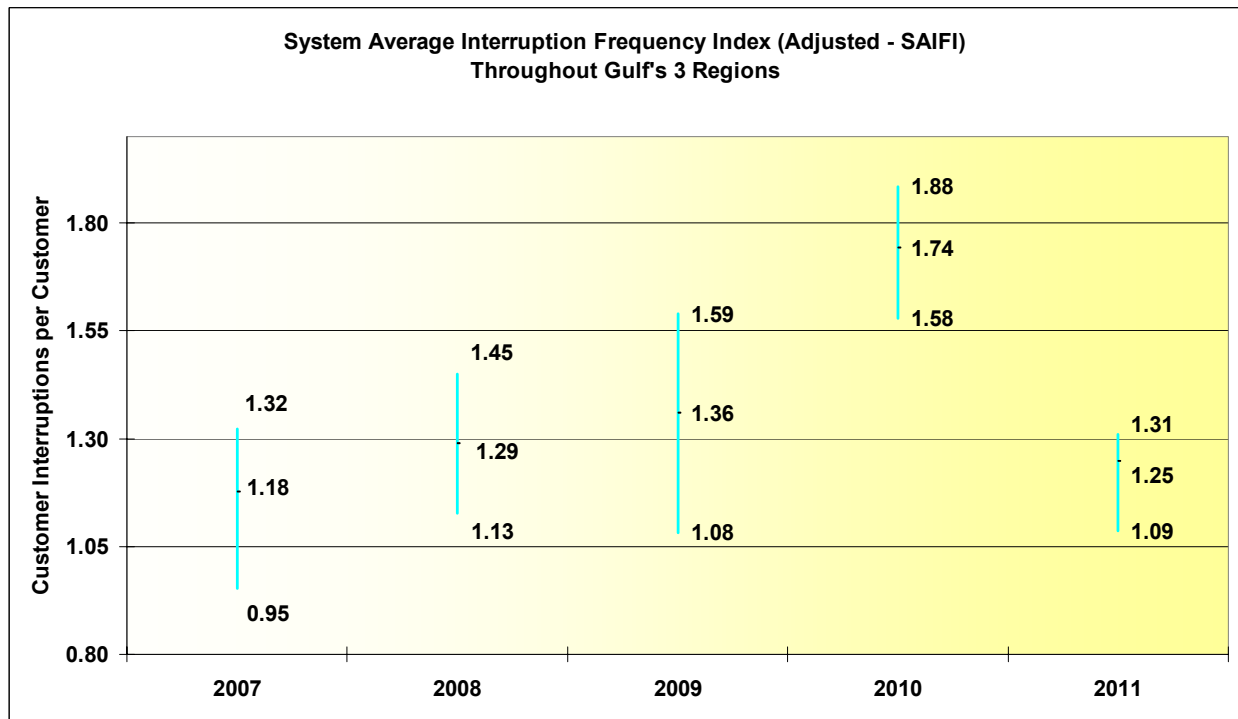
**Figure 3-26. SAIFI across Gulf's Three Regions (Adjusted)**

**Figure 3-26** illustrates that Gulf's SAIFI had a 39 percent decrease in 2011 when compared to 2010. Gulf's Western region had the highest SAIFI values in four of the last five years. The lowest values appear to be confined to the Central region. Even though there was a decrease in the 2011 SAIFI values, the maximum, minimum, and average SAIFI values appear to be trending upward.

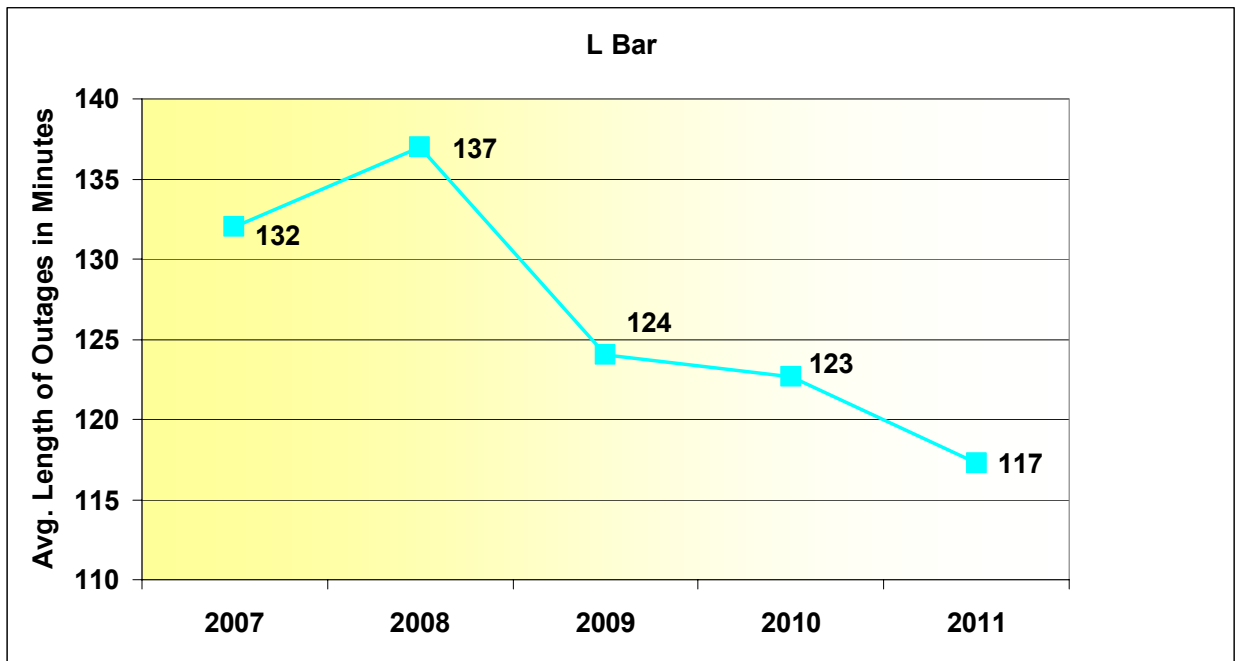
**Figure 3-28. Gulf's Average Duration of Outages (Adjusted)**

**Figure 3-28** illustrates Gulf's L-Bar or the average length of time Gulf spends recovering from outage events, excluding hurricanes and other allowable excluded outage events. Gulf's L-Bar showed a five percent improvement from 2010 to 2011. For the past three years, Gulf's L-Bar values did improve and the data for the five-year period suggests that the L-Bar index is trending downward.

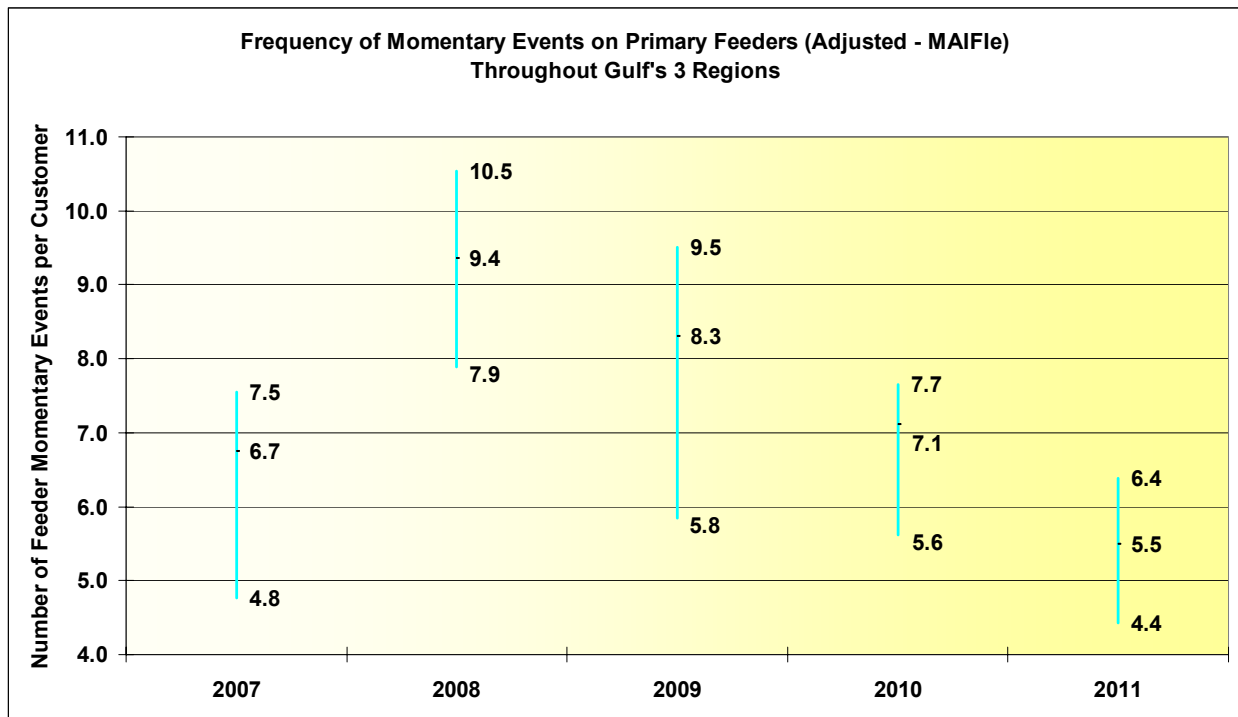
**Figure 3-29. MAIFle across Gulf’s Three Regions (Adjusted)**

**Figure 3-29** is the adjusted MAIFle recorded across Gulf’s system. The adjusted MAIFle results by region show that the Eastern region once again had the lowest frequency of momentary events on primary feeders. The Central region has the highest MAIFle index in 2011, with a 20 percent improvement from the Western region in 2010. The data suggests that the level of service reliability for the highest, average, and lowest MAIFle are all continuing to trend downwards, suggesting improvement.

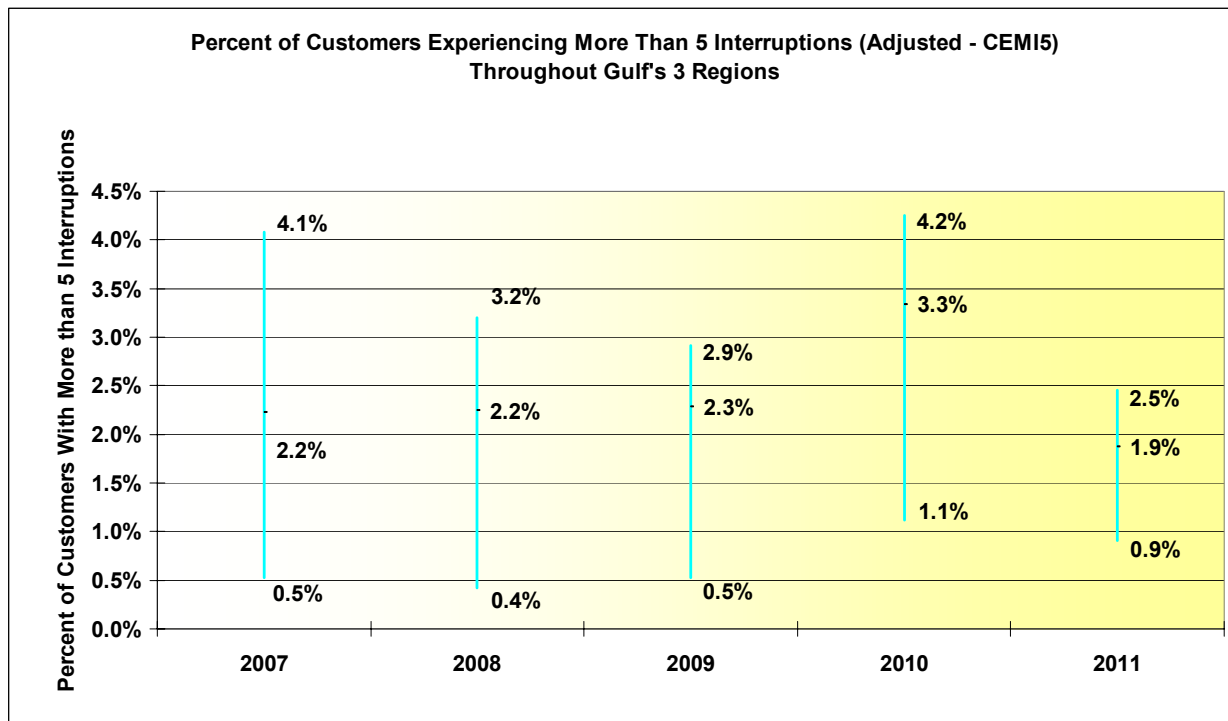
**Figure 3-30. CEMI5 across Gulf's Three Regions (Adjusted)**

**Figure 3-30** shows the highest, average, and lowest adjusted CEMI5 across Gulf's Western, Central and Eastern regions. Gulf's 2011 results illustrate a decrease when compared to 2010. The lowest CEMI5 values are trending upward as the highest CEMI5 values are trending downward over the five-year period of 2007 through 2011. The average CEMI5 appears to be trending upward suggesting that the percentage of Gulf's customers experiencing more than five interruptions is still increasing even though the 2011 results are the lowest results for the five-year period.

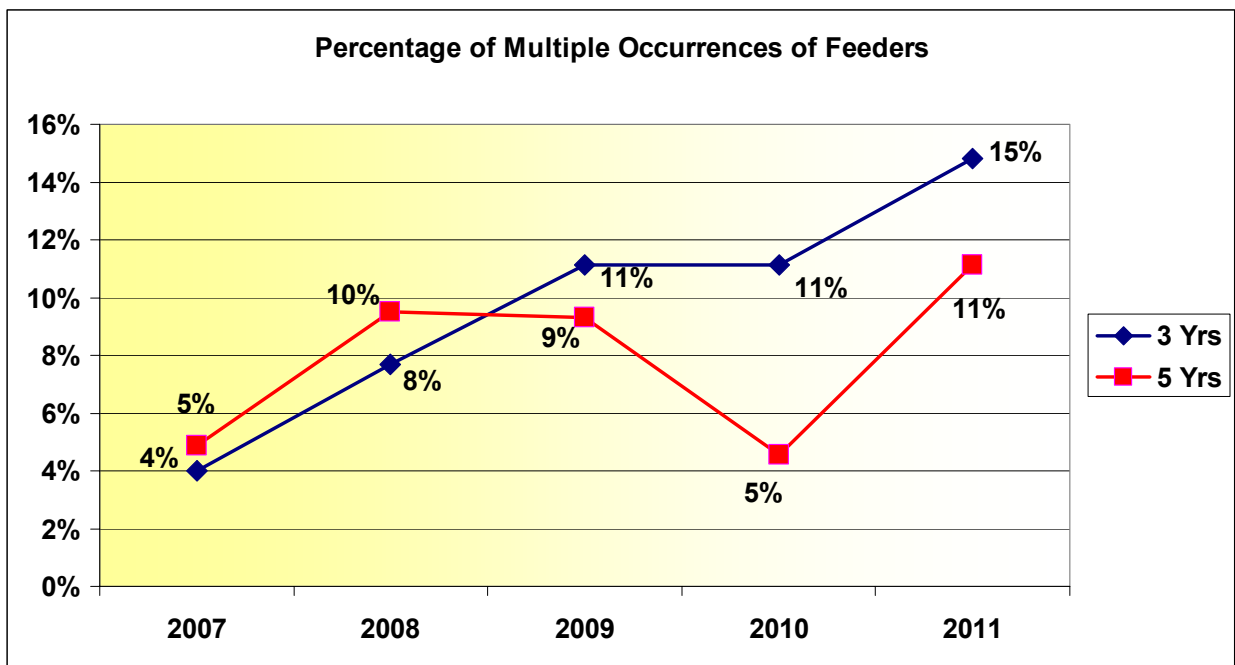
**Figure 3-31. Gulf’s Three Percent Feeder Report (Adjusted)**

**Figure 3-31** shows the multiple occurrences of feeders using the utility’s Three Percent Feeder Report and is analyzed on a three-year and five-year basis. Both the three-year and five-year multiple occurrences analysis showed an increase from the prior trend, which implies declining performance. The Three Percent Feeder Report is a listing of the top three percent of feeders that have the most feeder outage events. The supporting data illustrates that the five-year multiple occurrences have increased from five percent to 11 percent from 2010 to 2011 as the three-year multiple occurrences increased from 11 percent to 15 percent. The five-year period of 2007 to 2011 indicates overall that the five-year index is trending upward. The three-year multiple occurrences index appears to be trending upwards as well.

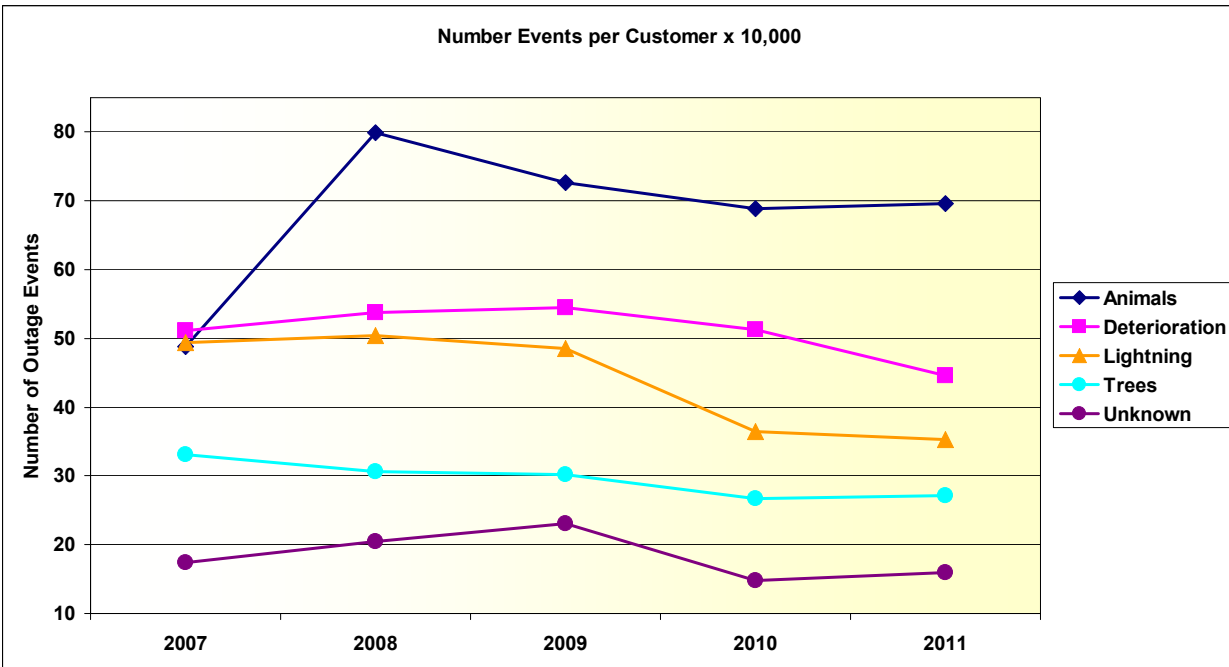
**Figure 3-32. Gulf's Top Five Outage Causes (Adjusted)**

**Figure 3-32** is a graph of the top five causes of outage events on Gulf's distribution system normalized to a 10,000-customer base. The figure is based on Gulf's adjusted data of the top ten causes of outage events and represents 86.9 percent of the total adjusted outage events that occurred during 2011. The top five causes of outage events were animals (31 percent), deterioration (20 percent), lightning (16 percent), trees (12 percent), and unknown causes (7 percent). The percentage of outages caused due to animals remains the highest cause of outages. As the number of outage events due to animals is trending upwards, the number of outage events due to deterioration, lightning, unknown, and trees are trending downward.

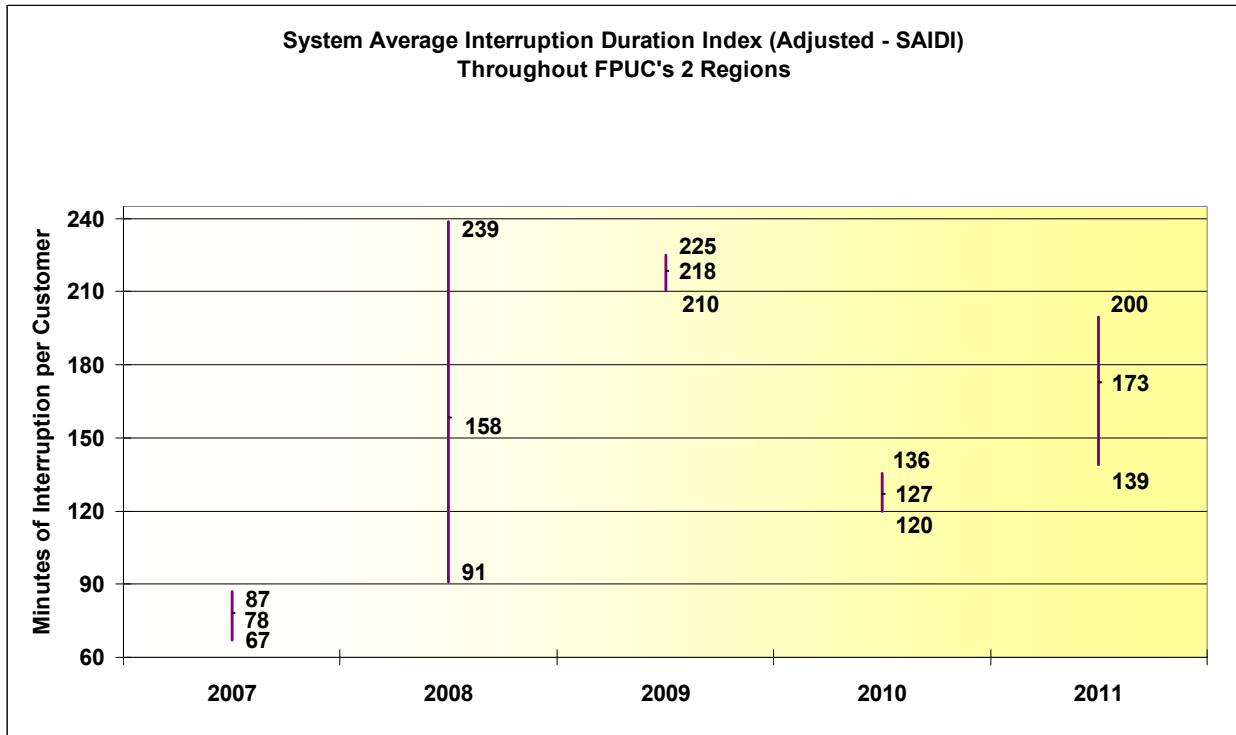
**Figure 3-33. SAIDI across FPUC's Two Regions (Adjusted)**

**Figure 3-33** shows the highest, average, and lowest adjusted SAIDI values recorded by FPUC’s system. The data shows the average SAIDI index is trending upward for the five-year period of 2007 to 2011. FPUC’s 2011 Reliability Report notes that the NW Division experienced “several outages as a result of the remnants of Tropical Storm Lee”<sup>31</sup> and a tornado on April 28, 2011. The NE Division experienced a significant weather event on September 6, 2011. This weather event was not a named storm, so it was not excluded.

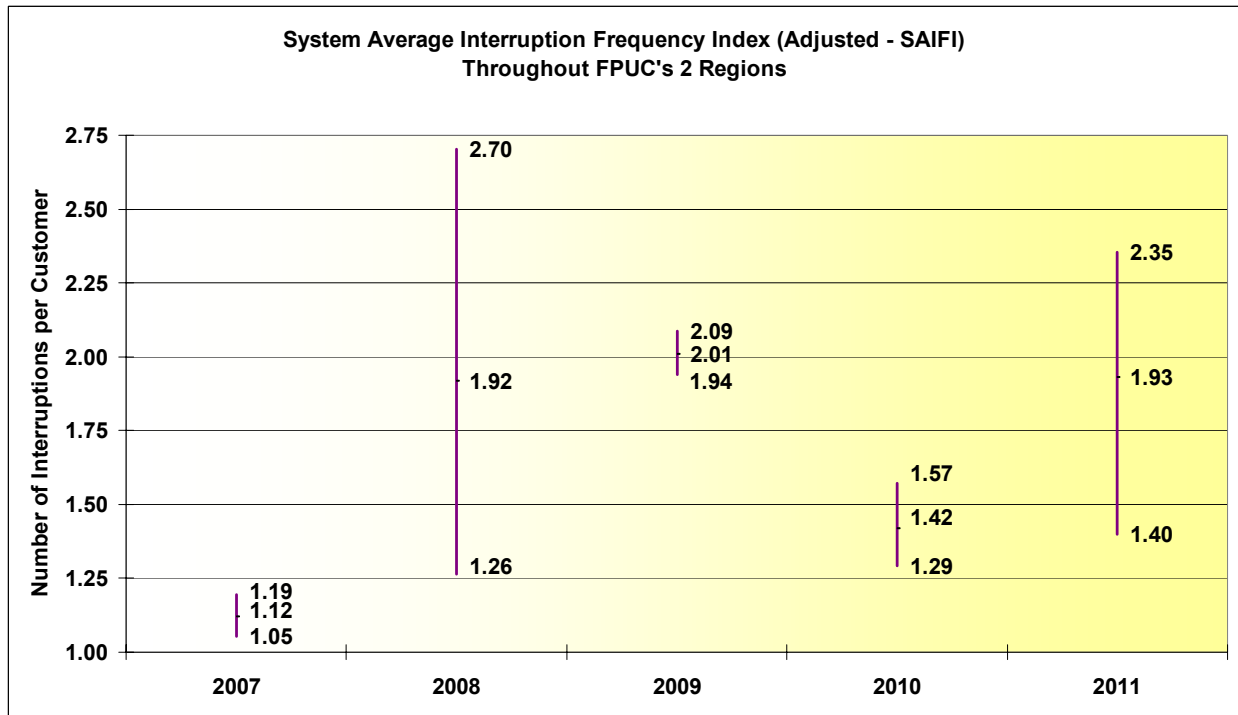
**Figure 3-34. SAIFI across FPUC's Two Regions (Adjusted)**

**Figure 3-34** shows the adjusted SAIFI across FPUC's two divisions. The data depicts a 26 percent increase in the 2011 average SAIFI reliability index from 2010. The data for the maximum, minimum, and average SAIFI indices are all trending upward showing a decline in the index over the five-year period of 2007 to 2011.

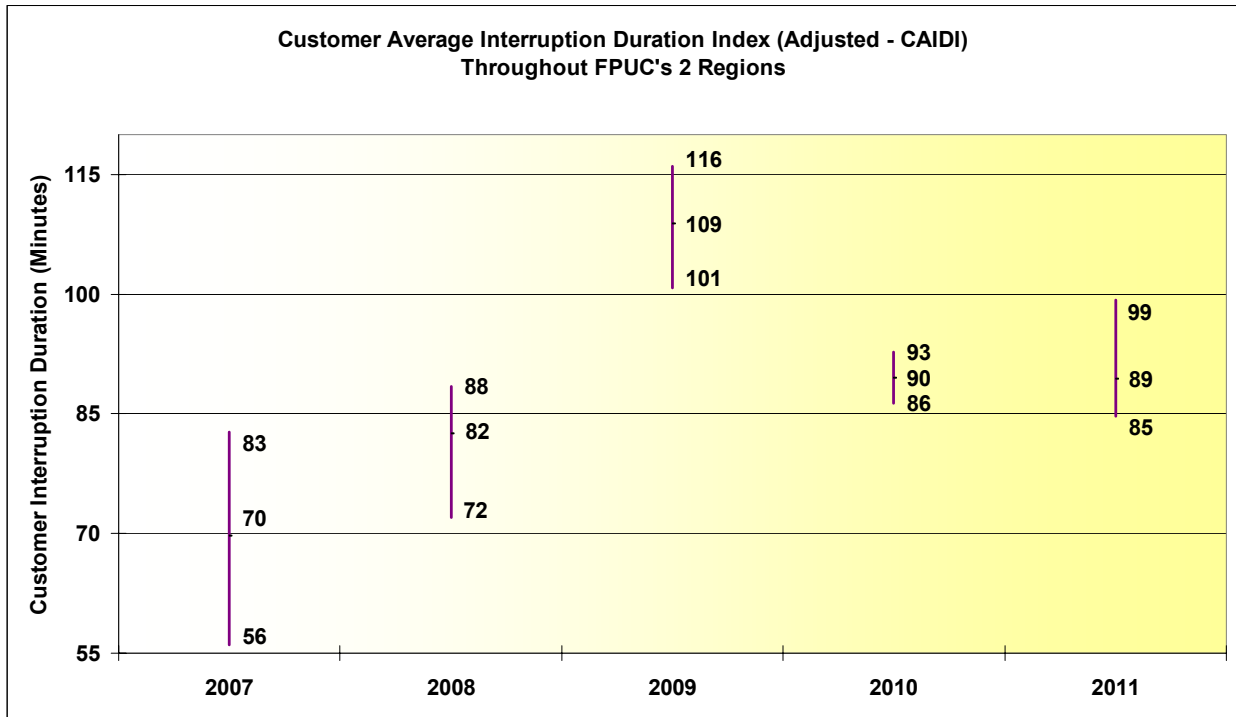
**Figure 3-35. CAIDI across FPUC's Two Regions (Adjusted)**

**Figure 3-35** shows the highest, average, and lowest adjusted CAIDI values across FPUC's system. FPUC's data shows a one percent decrease in the 2011 reliability indices relative to 2010 values. For the past five years, the maximum CAIDI index, the minimum CAIDI index, and the average CAIDI index are all trending upward.

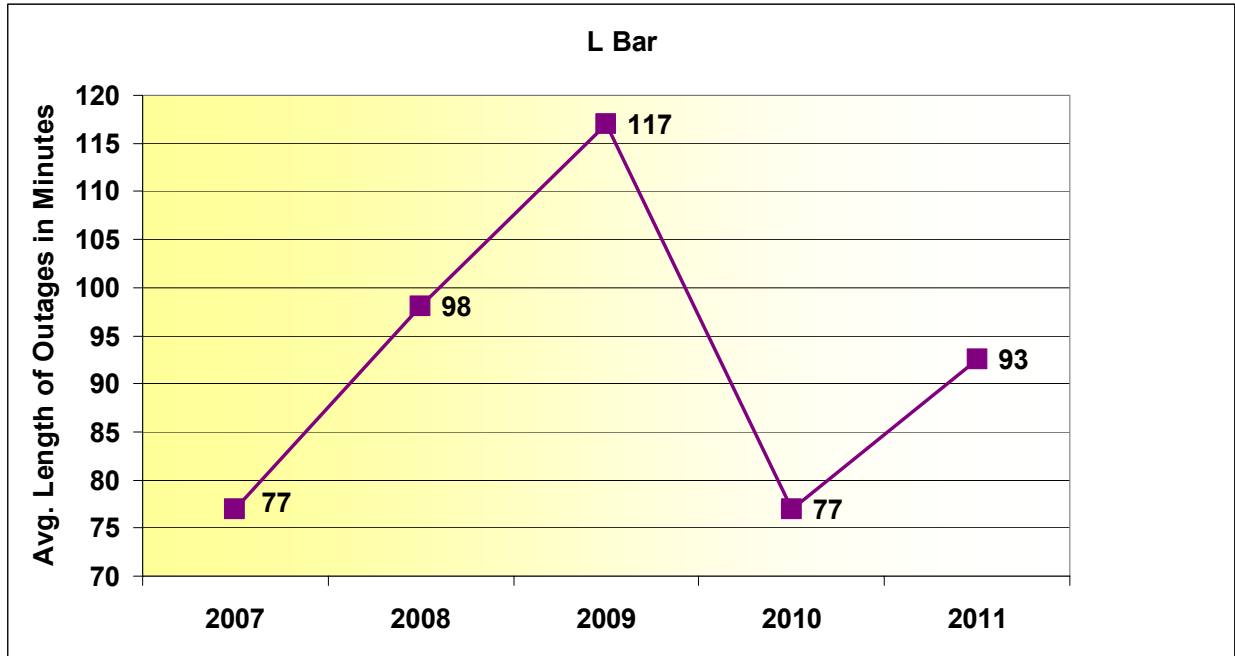
Figure 3-36. FPUC's Average Duration of Outages (Adjusted)

Figure 3-36 is the average length of time FPUC spends recovering from outage events (adjusted L-Bar). There was a 17 percent increase in the L-Bar value from 2010 to 2011. The data for the five-year period of 2007 to 2011 suggests that the L-Bar indices are trending upwards.

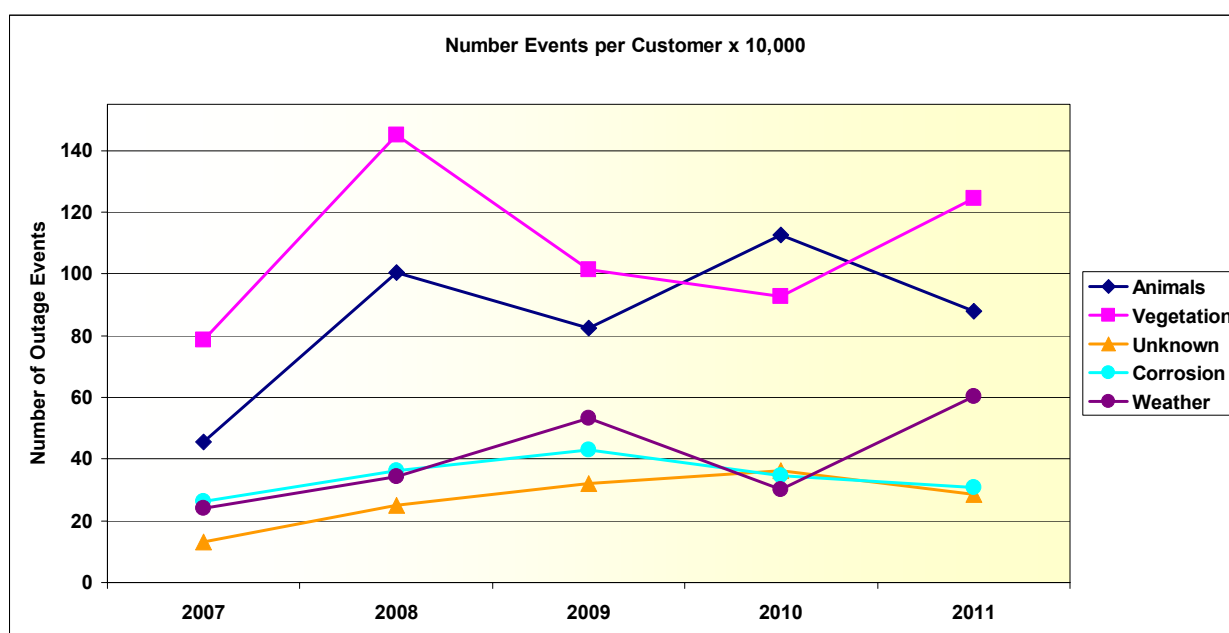
**Figure 3-37. FPUC's Top Five Outage Causes (Adjusted)**

**Figure 3-37** shows the top five causes of outage events on FPUC's distribution system normalized to a 10,000-customer base. The figure is based on FPUC's adjusted data of the top ten causes of outages. For 2011, the top five causes of outage events were vegetation (33 percent), animals (23 percent), weather (16 percent), unknown (8 percent), and corrosion (8 percent). These five factors represent 86.9 percent of the total adjusted outage causes in 2011. Four of the five outage causes are trending upward. The four causes are animals, vegetation, unknown, and weather. Animals and unknown outages did decrease from 2010 to 2011, even though they are trending upward. Vegetation and weather outages increased 25 percent and 50 percent, respectively, from 2010 to 2011. Even though the corrosion caused outages decreased from 2010 to 2011, corrosion outages remain relatively flat over the five-year period of 2007 to 2011.

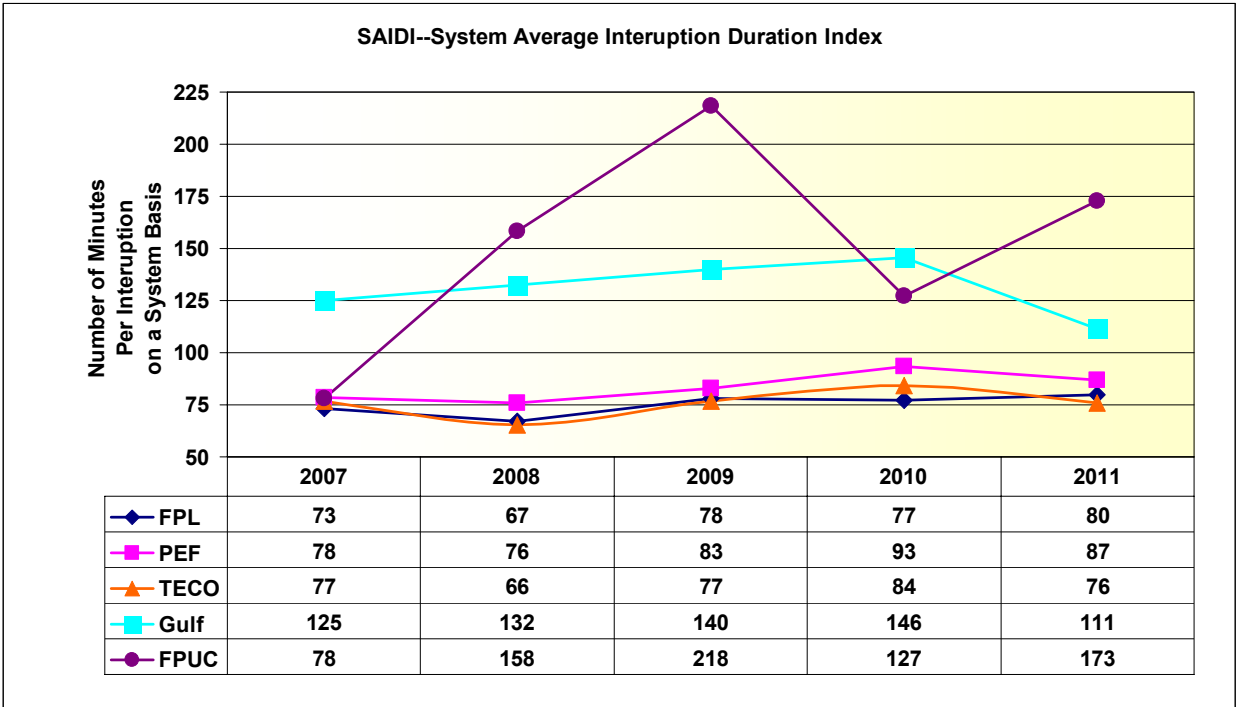
**Figure 4-1. System Average Interruption Duration (Adjusted SAIDI)**

**Figure 4-1** represents the SAIDI and it represents the average minutes of service interruption on a distribution system. This is the duration of an interruption per retail customer served within a specified area of service over a given period. It is determined by dividing the total Customer Minutes of Interruption (CMI) by total Number of Customers Served (C) for the respective area of service.

**Figure 4-1** indicates that PEF and TECO's SAIDI trends have gradually risen since 2007. FPL and Gulf's trend has been primarily flat while FPUC appears to be trending upwards. Comparing 2010 SAIDI indices to 2011 SAIDI indices, PEF, TECO, and Gulf's indices have fallen 6 percent, 10 percent, and 24 percent respectively. FPL and FPUC's SAIDI indices have risen 4 percent and 27 percent, respectively, from 2010 to 2011.

The inter-utility trend comparison focuses on a graphical presentation that combines all of the IOUs' distribution reliability indices for the years 2007 through 2011. **Figures 4-1 through 4-3** apply to all five utilities while **Figures 4-4 and 4-5** do not apply to FPUC because it is not required to report MAIFIE and CEMI5 due to the size of its customer base. The adjusted data is used in generating the indices in this report. It is based on the exclusion of certain events allowed by Rule 25-6.0455(4), F.A.C. Generalizations can be drawn from the side-by-side comparisons; however, any generalizations should be used with caution due to the differing sizes of the distribution systems, the degree of automation, and the number of customers. The indices are unique to each IOU.

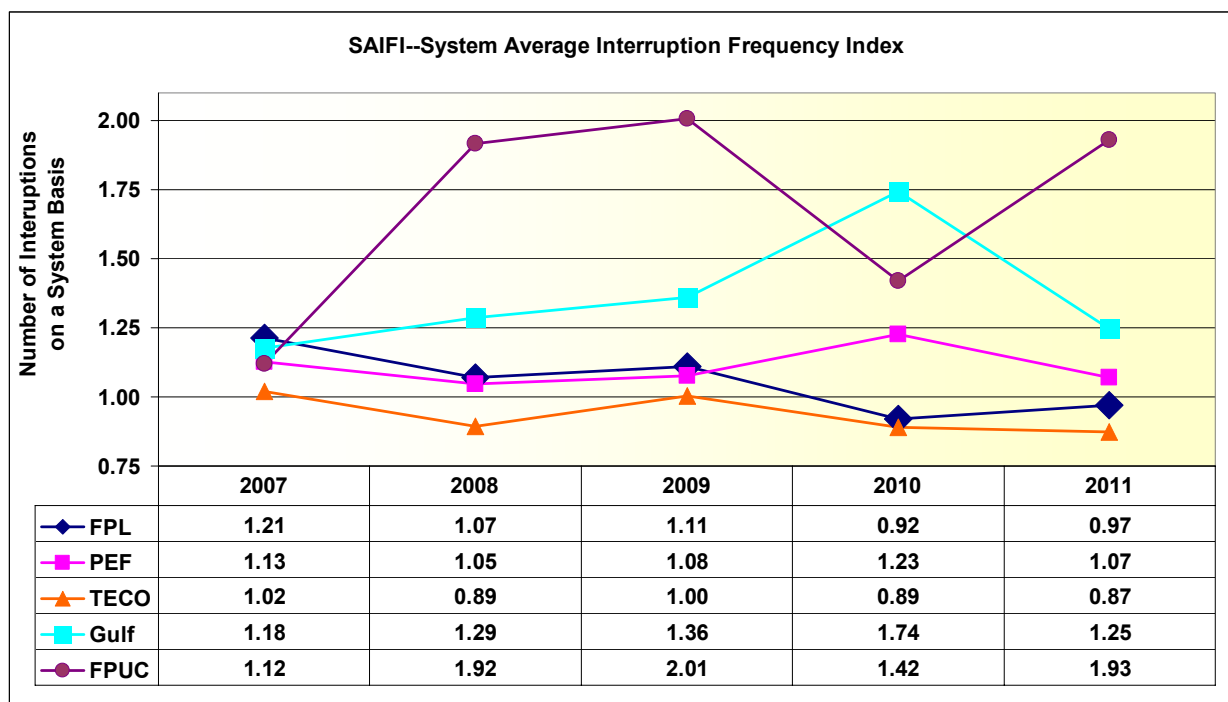
**Figure 4-2. Number of Service Interruptions (Adjusted SAIFI)**

**Figure 4-2** is a five-year graph of the adjusted SAIFI for each IOU. The 2011 data shows PEF, TECO, and Gulf's SAIFI indices decreased (improved) from the 2010 results as FPL and FPUC's SAIFI indices increased. Even though FPL's SAIFI increased from 2010 to 2011, over the five-year period of 2007 to 2011, FPL's SAIFI is trending downwards, along with TECO's SAIFI. Gulf and FPUC's SAIFI indices are trending upwards for the period of 2007 to 2011. Staff notes that PEF's SAIFI is trending marginally upwards for the same period.

SAIFI is the average number of service interruptions per retail customer within a specified area of service over a given period. It is determined by dividing the Sum of Service (aka Customer) Interruptions (CI) by the total Number of Customers Served (C) for the respective area of service.

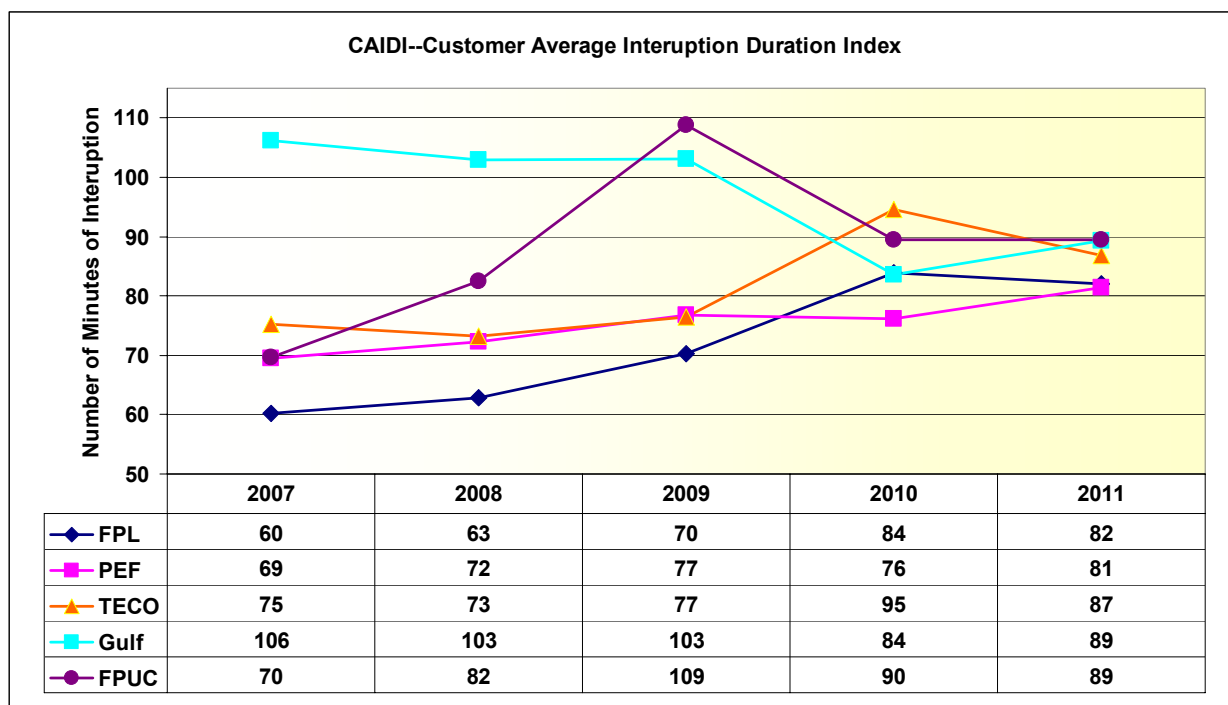
**Figure 4-3. Average Service Restoration Time (Adjusted CAIDI)**

**Figure 4-3** is a five-year graph of the adjusted CAIDI for each IOU. FPL, TECO, and FPUC had a decrease in the CAIDI from 2010 to 2011 while PEF and Gulf had an increase in the CAIDI. Even though FPL, TECO, and FPUC had a decrease in the CAIDI, these companies along with PEF have CAIDI indices that are trending upwards for the five-year period of 2007 to 2011. Gulf is trending downwards even though it had an increase in the CAIDI for 2011.

CAIDI is the average interruption duration or the time to restore service to interrupted customers. CAIDI is calculated by dividing the total system customer minutes of interruption (CMI) by the number of customer interruptions (CI) which is also SAIDI divided by SAIFI.

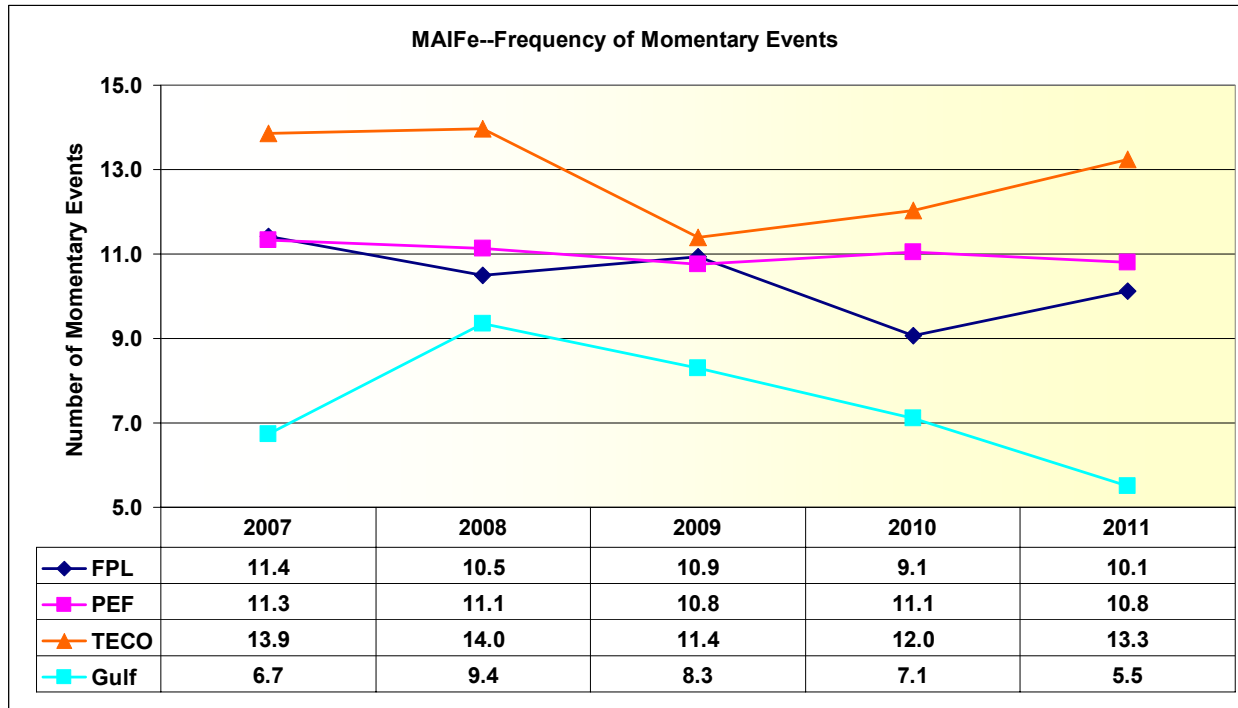
**Figure 4-4. Average Number of Feeder Momentary Events (Adjusted MAIFle)**

**Figure 4-4** shows a five-year graph of the adjusted MAIFle for FPL, PEF, TECO and Gulf. All four companies' MAIFle indices are trending downwards for the five-year period of 2007 to 2011. Comparing the MAIFle for 2010 and 2011, FPL and TECO increased 10 percent while PEF and Gulf decreased 3 percent and 23 percent, respectively. FPUC is exempt from reporting MAIFle and CEMI5 because it has fewer than 50,000 customers.

MAIFle is the average frequency of momentary interruptions or the number of times there is a loss of service of less than one minute. MAIFle is calculated by dividing the number of momentary interruptions events recorded on primary circuits (CME) by the number of customers served (C).

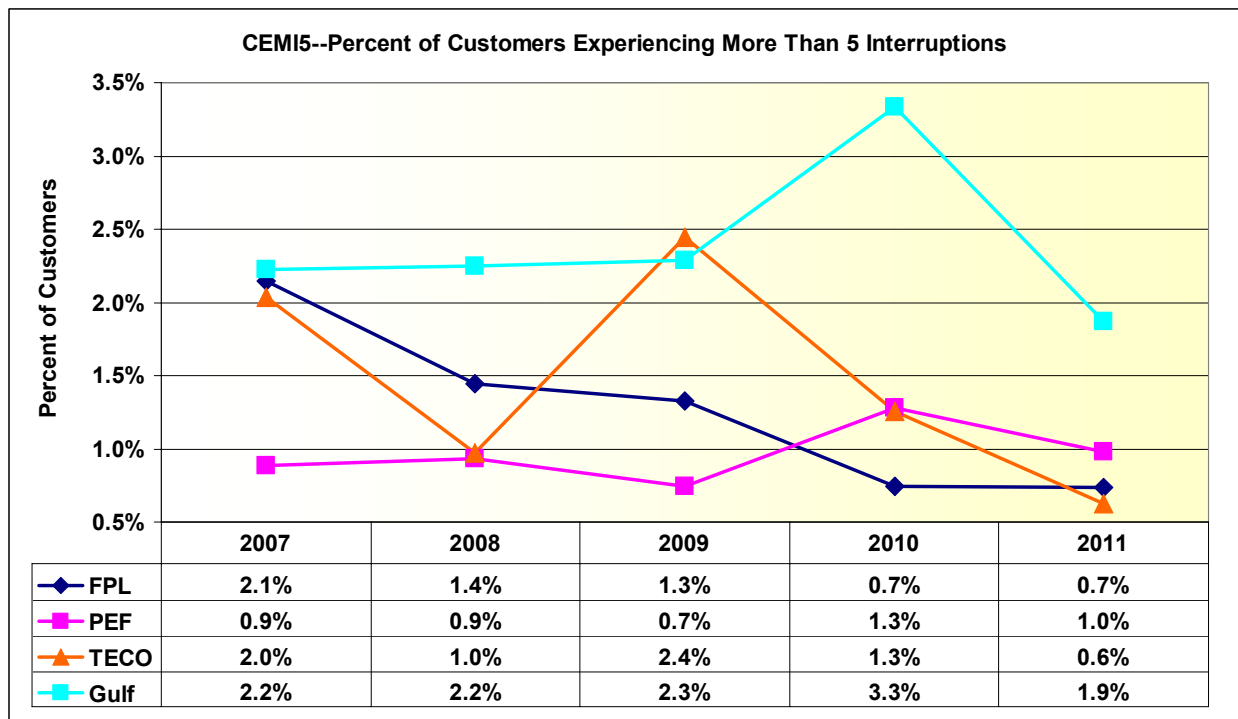
**Figure 4-5. Percent of Customers with More Than Five Interruptions (Adjusted CEMI5)**

**Figure 4-5** is a five-year graph of the adjusted CEMI5 for FPL, Gulf, PEF and TECO. CEMI5 is a percentage. It represents the number of customers that experienced more than five service interruptions in the year divided by the total number of customers. The adjusted CEMI5 decreased to 1.9 percent for Gulf in 2011 compared to 3.3 percent in 2010. FPL's CEMI5 stayed the same for 2011 and 2010. PEF's trend continues upward and even though the 2011 CEMI5 decreased, compared to 2010. TECO's CEMI5 had a significant decrease in the percent of customers experiencing more than five interruptions in 2011 from its 2010 results.

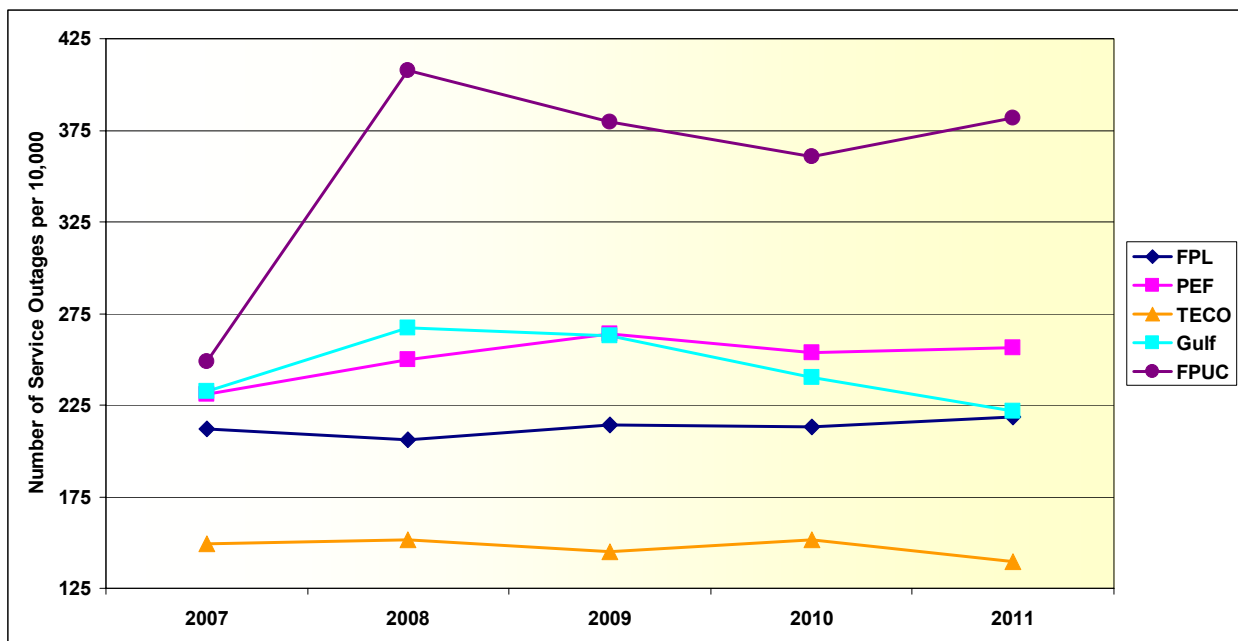
**Figure 4-6. Number of Outages per 10,000 Customers (Adjusted)**

**Figure 4-6** shows the number of outages per 10,000 customers on an adjusted basis for the five IOUs over the last five years. The graph explains each utility's adjusted data concerning the number of outage events and the total number of customers on an annual basis. The number of FPL outages increased to 98,780 from 95,654 in 2010 and the number of outages per 10,000 customers increased slightly for the five-year period. TECO's results remain flat for the five-year period. PEF's number of outages rose slightly for 2011 and is trending upwards for the five-year period. Gulf's number of outages have been decreasing since 2008 and continue to trend downwards. FPUC's results increased sharply in 2008, declined in 2009 and 2010, and then increased again for 2011. Due to the small customer base, the line graph for FPUC could be subject to greater volatility.
