*Florida's*  
*Investor-Owned*  
*Electric Utilities*

*2 0 1 1*  
*Service Reliability reports*

Florida Public Service Commission  
Division of ENGINEERING

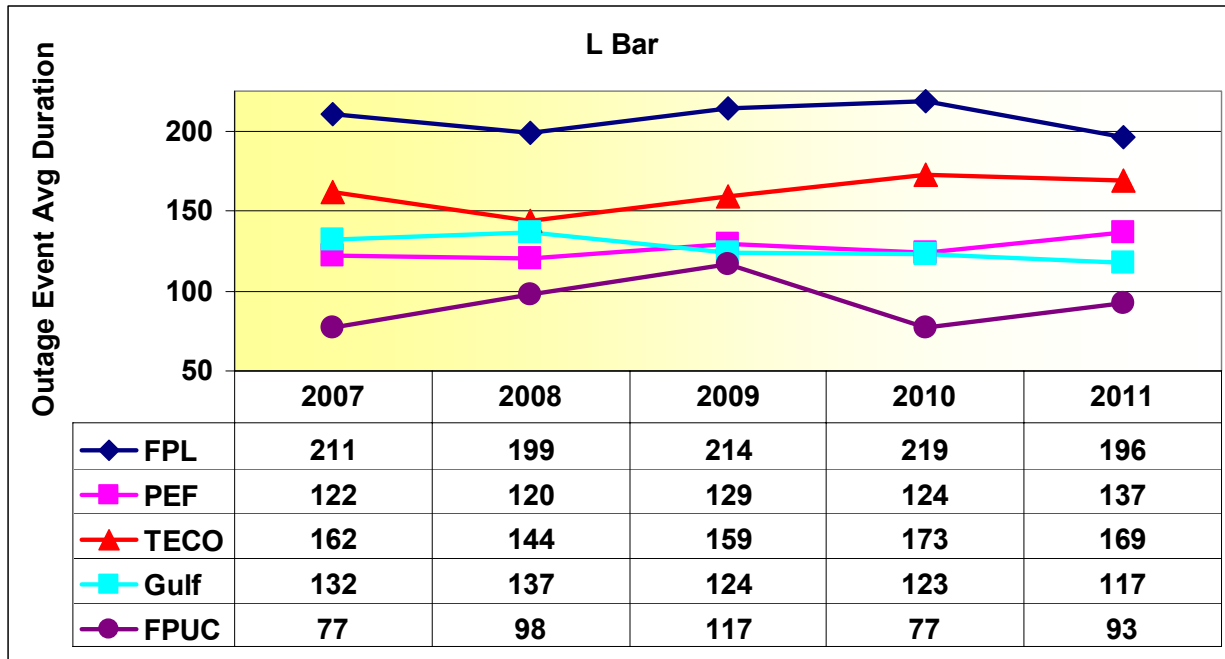
Figure 4-7. Average Duration of Outage Events (Adjusted L-Bar)

Figure 4-7 represents the average duration of outage events (Adjusted L-Bar) for each IOU. FPL's average outage duration remains higher than the other IOUs and appears to be increasing with the category "Equipment Failure" representing approximately 35 percent of FPL's outages. Correspondingly, PEF's outages appear to be increasing with 34.1 percent of the outages attributed to animals (18.3%) and all other (15.8%). Gulf and TECO L-Bar values decreased in 2011. FPUC's L Bar increased in 2011 with vegetation representing 32.6 percent of the outages.

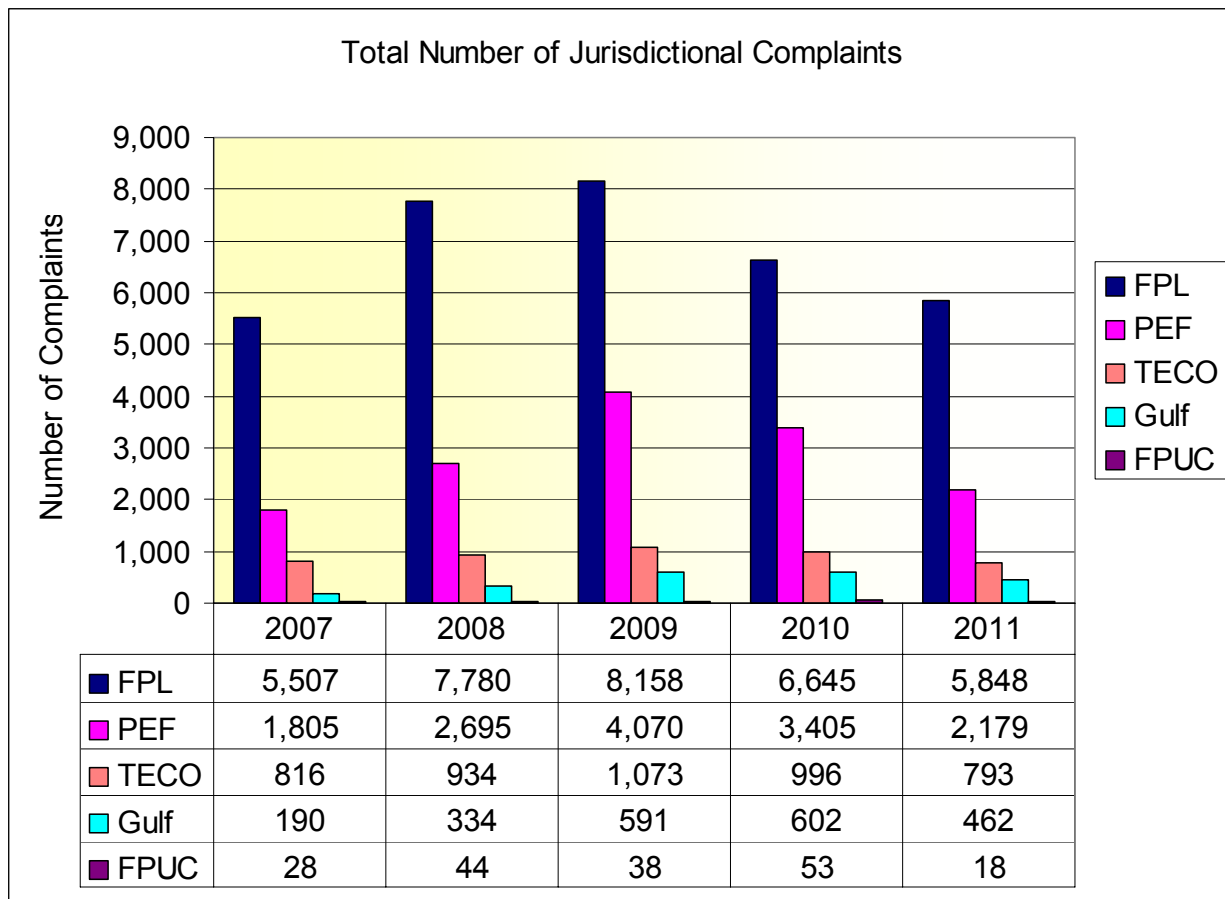
**Figure 4-8. TOTAL NUMBER OF JURISDICTIONAL COMPLAINTS**

Figures 4-8, 4-9, and 4-10 represent consumer complaint data that was extracted from the Commission’s Consumer Activity Tracking System (CATS). Each consumer complaint received by the Commission is assigned an alphanumeric category after the complaint is resolved. Reliability related complaints have 15 specific category types and typically pertain to trees, safety, repairs, frequent outages and momentary service interruptions. The “quality of service” category was established in July 2003, resulting in a shift of some complaints that previously would have been coded in another complaint category<sup>32</sup>.

Figure 4-8 shows the total number of jurisdictional complaints for each IOU. In comparing the number of complaints by the different companies, the total number of customers should be considered. FPL is showing more complaints, but FPL also has more customers than the other companies.

FPL's reliability related complaints percentage received by the Commission in 2011 was 0.7 percent, which was the same amount reported in 2010. FPL's reliability related complaints are trending downward and represents continuing improvement as shown in **Figure 4-8**.

The percentage of complaints reported to the Commission for Gulf that are reliability related increased slightly to 0.4 percent from 0.0 percent in 2010, and for the last five years has remained relatively flat. The highest percent of total complaints that are reliability related occurred in 2008 at 0.9 percent. Overall, Gulf has the lowest percentage of total complaints that are reliability related as shown in **Figure 4-8**.

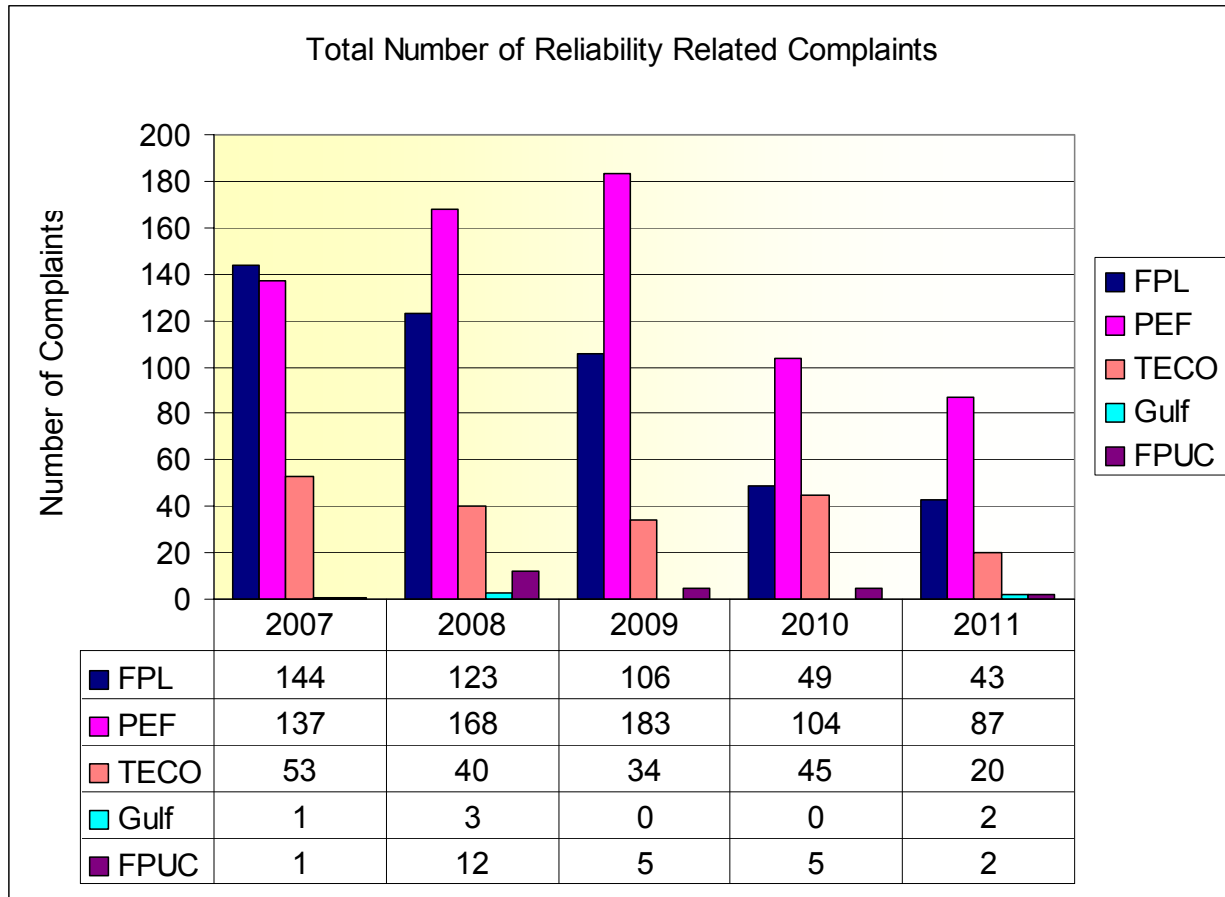
**Figure 4-9. TOTAL NUMBER OF RELIABILITY RELATED complaints**

**Figure 4-9** charts the total number of reliability related complaints for the IOUs. PEF is showing the largest amount of reliability complaints for four years over the five year period of 2007 through 2011 with Gulf showing the least amount for three years over the same period. All the companies are trending downwards in the number of reliability complaints per year.

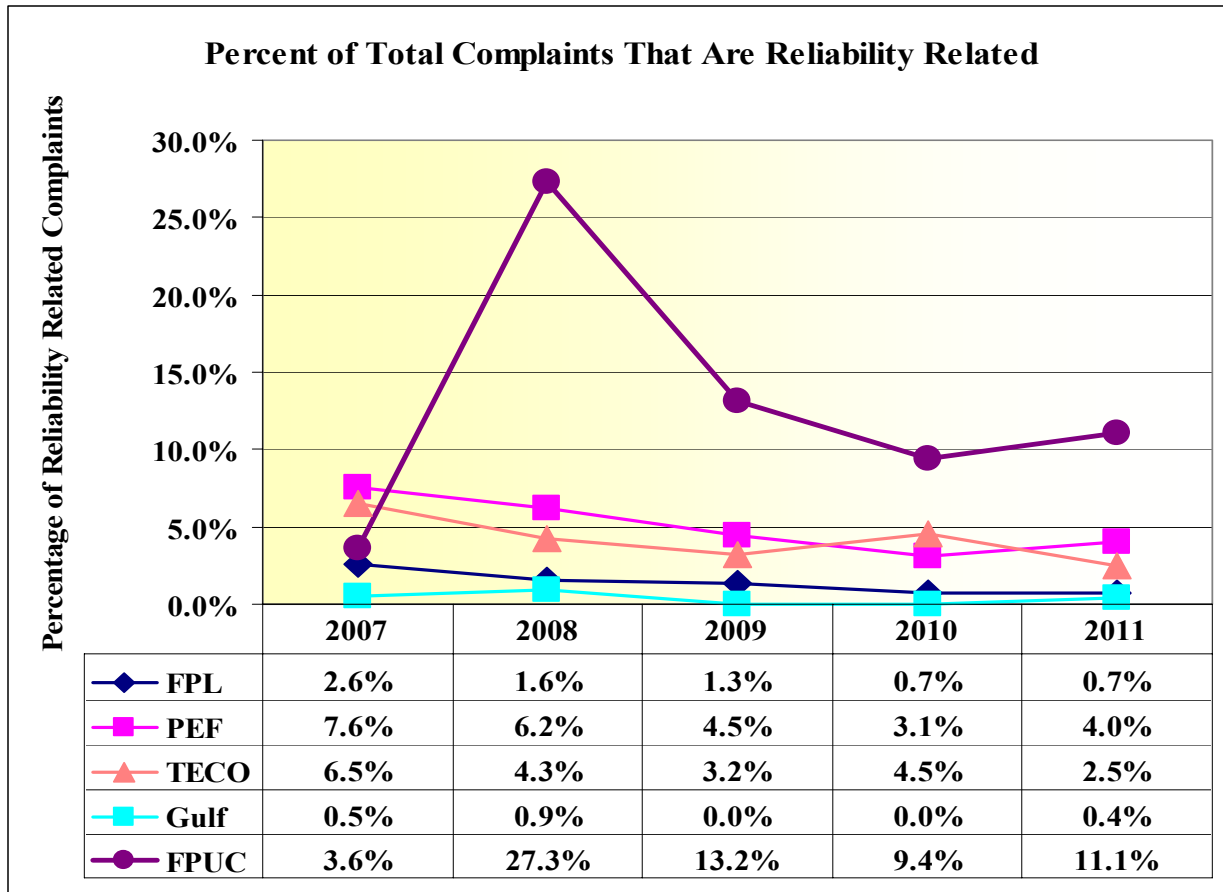
**Figure 4-10. PERCENT OF COMPLAINTS THAT ARE RELIABILITY RELATED**

**Figure 4-10** shows the percentage of reliability related customer complaints in relation to the total number of complaints for each IOU. All the companies appear to be trending downwards. The percentages of FPUC compared to the other companies appears high, however FPUC has fewer customers and fewer complaints in total.
