# GATOR WATERWORKS, INC.

***Re: Docket No. 20190114-WU – Application for staff assisted rate case in Alachua County by Gator Waterworks, Inc. – FDEP Sanitary Survey Inspection***

**Re: Gator Waterworks Water System  
PWS ID No. 2010612  
Alachua County – Drinking Water**

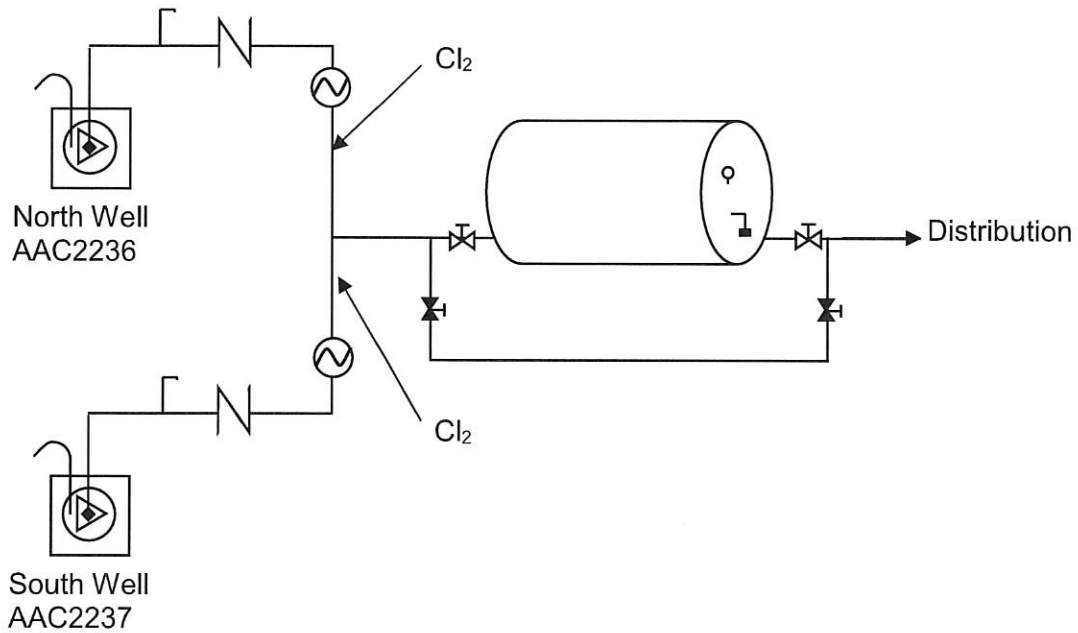
**SCHEMATIC (not to scale):**

SCHEMATIC KEY			
Well with Submersible pump		Check Valve	
Hydropneumatic Tank		Valves (open/closed)	Well vent
Hydropneumatic tank w/ HBVB POE tap, Pressure gauge, and sight glass		Raw tap

#	Deficiency	Rule Reference	Corrective Action	Severity	Corrected
1	Well casing vent was not downward facing.	62-555.320(8)(c)	Provide a well vent that is at least 12 inches above well pad in a down turned position above the top of the casing and covered by a 24 mesh, corrosion resistant screen.	MIN	RTC 8/1/19
