**Re: Docket No. 20220049-EI: Review of Storm Protection Plan pursuant to Rule 25-6.030,  
F.A.C., Florida Public Utilities Company**

# Florida Public Utilities Company

## Storm Protection Plan 2022 - 2031

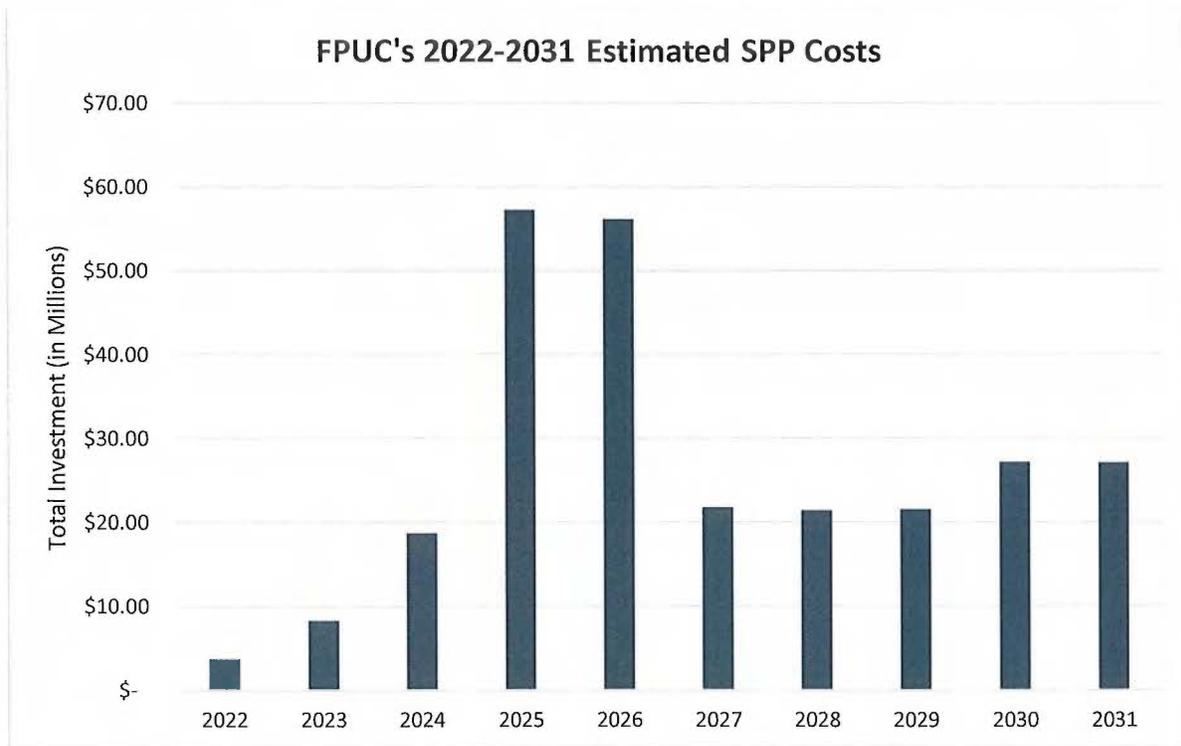
Figure 1 - Ten-year estimated investment profile for SPP Programs<sup>4</sup>

FPUC recognizes the complexities of implementing new programs, the importance of identifying potential pitfalls early, and the validation of initial assumptions. With this in mind, the FPUC SPP ten-year investment plan in the three new Distribution SPP Programs (Overhead Feeder Hardening, Overhead Lateral Hardening, and Overhead Lateral Undergrounding) and Transmission Program (Transmission & Substation Resiliency) includes \$199.4M in Capital investments and O&M expenditures. The implementation plan includes a methodical ramp up of investments that allows for the acquisition of resources, initiation of design activities, the refinement of projects, and the Hurricane Michael cost recovery surcharge to expire<sup>3</sup>. Figure 1 below shows the full SPP 10-year investment plan which includes the \$199.4M in new Transmission and Distribution SPP programs mentioned above, \$30.0M in future Transmission and Distribution (T&D) automation programs yet to be refined, and \$33.8M for T&D Vegetation Management & Transmission System Inspection and Hardening activities. Figure 2 below, details the breakdown by Program type for the \$30.7M in the first three years of the plan within the approximately \$263.2M SPP 10-year investment. As expected with these types of programs and as detailed within Figures 1 and 2, most of these investments are split between the Overhead Lateral Undergrounding and Transmission/Substation Resiliency programs.

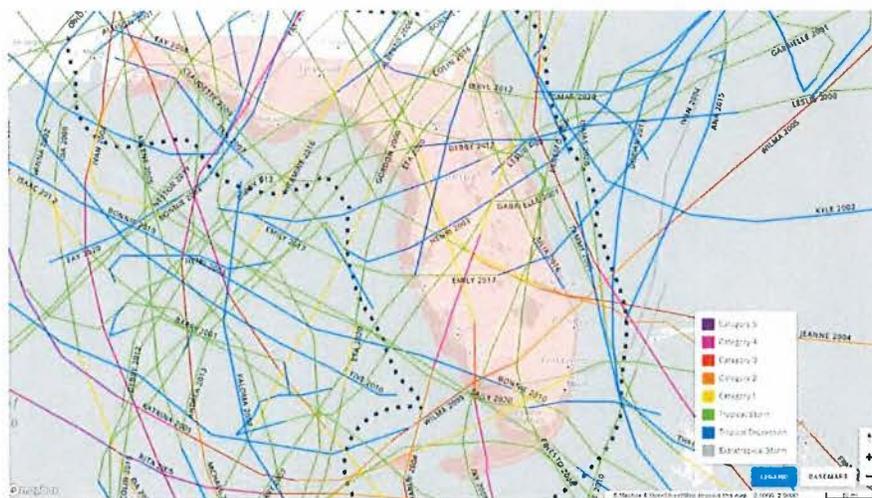
Figure 3 - Florida 20-year tropical event path

The propensity of hurricanes to come near or impact the State of Florida is not uncommon. The National Oceanographic and Atmospheric Administration (NOAA) has recorded 406 Tropical events (from Extratropical Storms to Category 5 hurricanes) coming within 50 miles of the Florida coast in their historical archives; 57 of which within the last 20 years (Figure 3). While most of these storms had isolated and scattered impact to Florida communities or more specifically the electric utility infrastructure within those communities, others such as Hurricanes Charley, Wilma, Irma, Michael, and others have left a much deeper impact in the wake of their path.

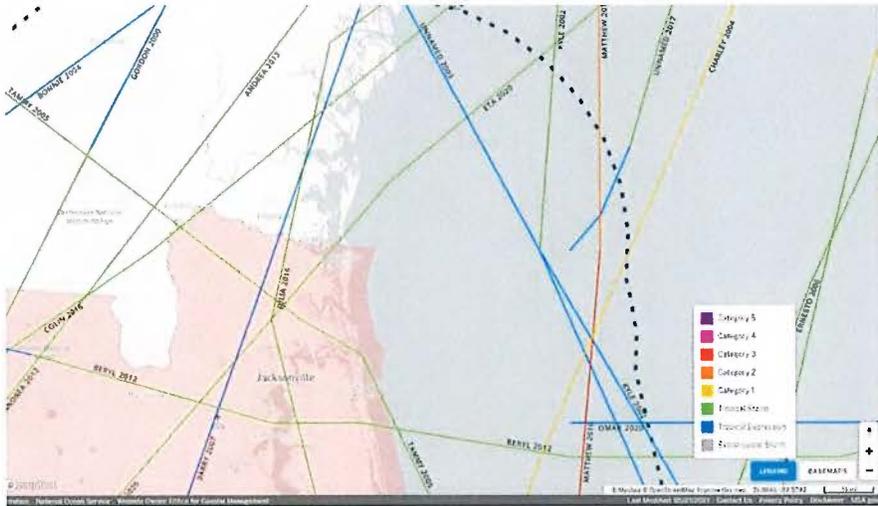
Figure 4 - Northeast Florida 20-year tropical event path

FPUC provides electric utility service to two distinct and non-contiguous areas of Florida; the geographical location of which, outside of Hurricane Michael in 2018, has isolated the FPUC territory from the direct path of a Category 1 or stronger weather event (Figure 4 and Figure 5). Nonetheless, the path of a hurricane is unpredictable and preparations ahead of hurricane season and when a potential threat looms in the Atlantic Ocean or the Gulf of Mexico, are essential in ensuring the continued electric service reliability when customers need it most. Although Hurricane Michael is the only notable direct impact to FPUC territory in recent history, both divisions have been impacted by tornadoes spawned by the outer bands of nearby hurricanes. For this reason, prudent and necessary investments must be made to strengthen the resiliency of the electric grid and reduce storm restoration costs associated with either the planning for potential impact or the recovery from it.

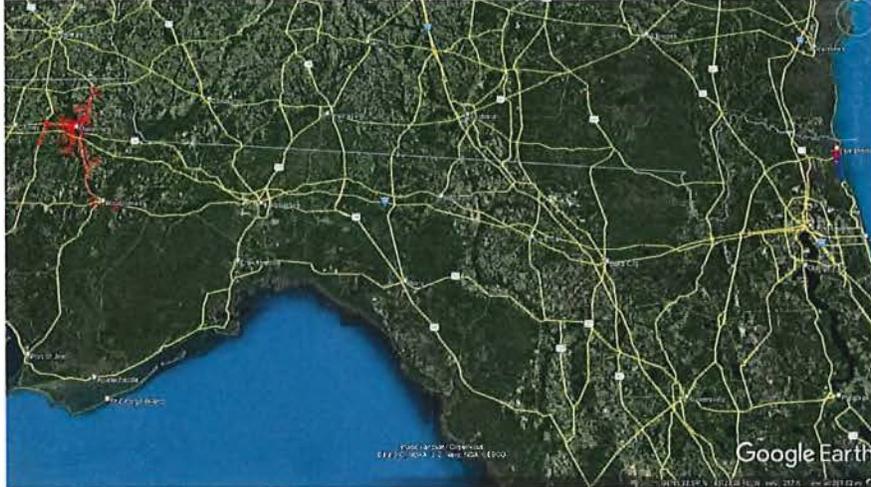
Figure 6 - FPUC separation of service areas

As mentioned above, FPUC has two distinct electric divisions that are not physically connected at the distribution level. The Northwest (NW) Division, also referred to as Marianna, and the Northeast (NE) Division, also referred to as Fernandina Beach are approximately 250 miles apart (Figure 6).

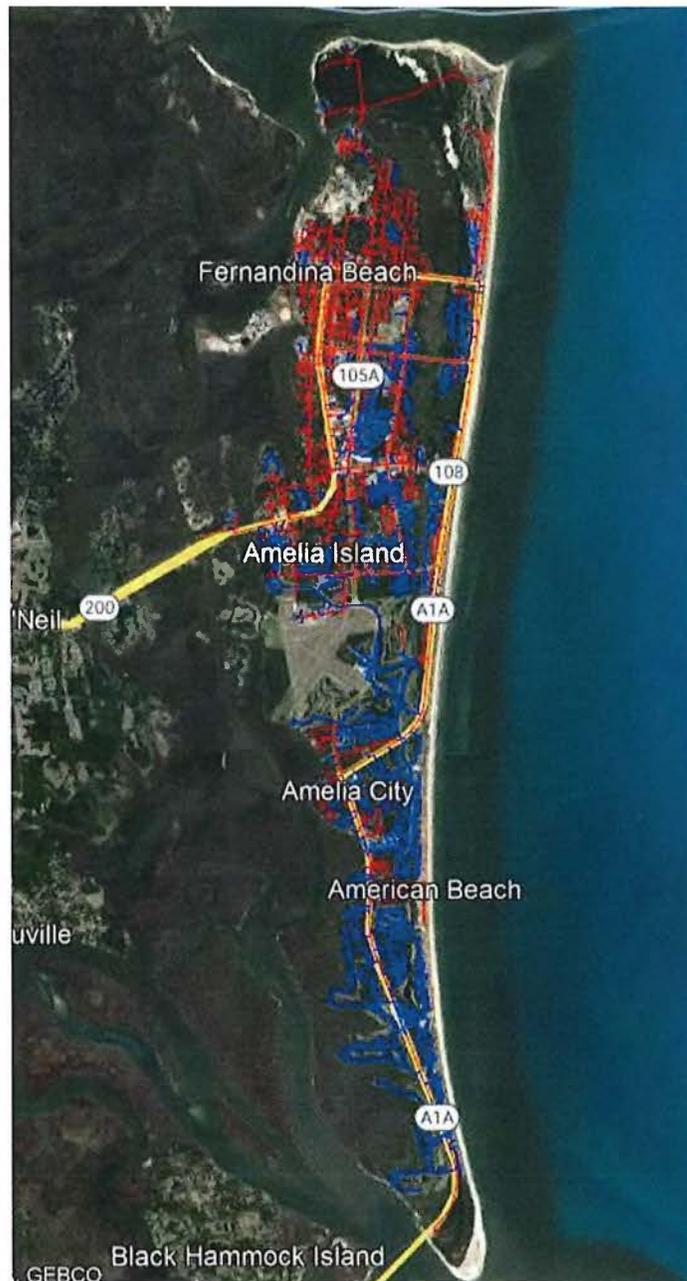
Figure 7 - FPUC NE Division service area

Due to their separation, the geographical location, and the architectural influences of their surrounding communities, the two divisions differ in their electrical characteristics. The NE division, located in Amelia Island in the North easternmost part of the State, serves approximately 17,000 customers. Approximately 60% of the distribution system in this division is of underground (UG) construction with the majority of the overhead facilities located along the northwestern part of the island (Figure 7).

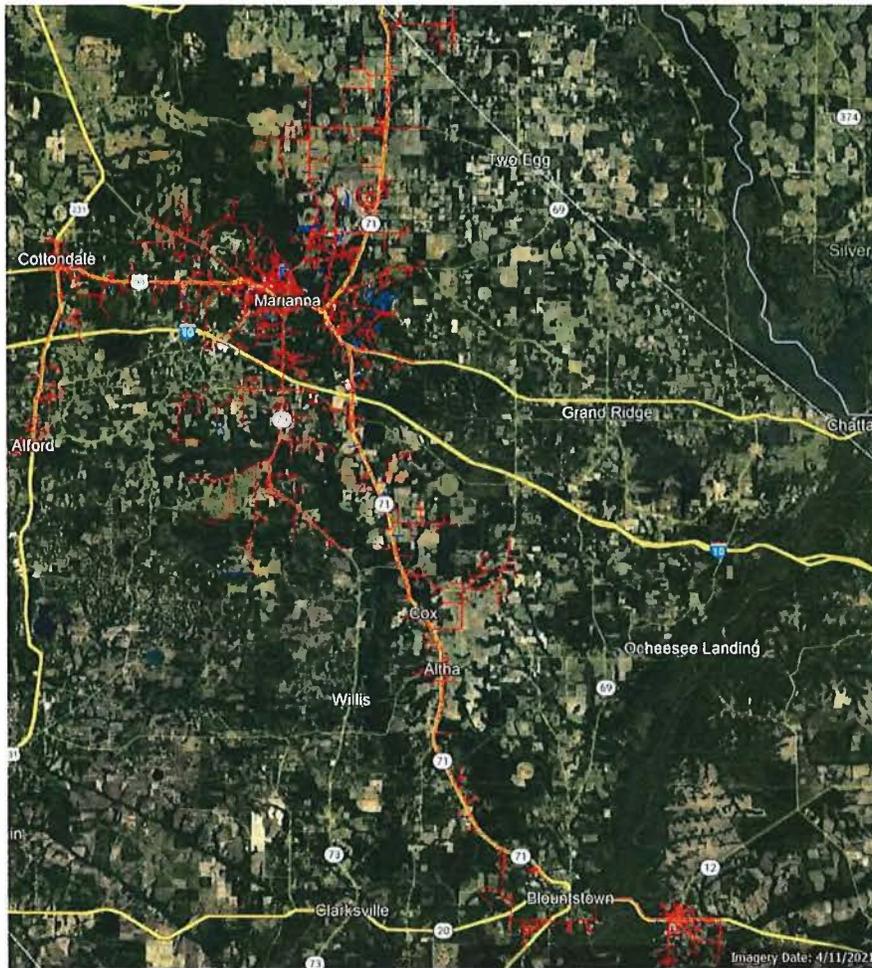
Figure 8 - FPUC NW Division service area

The NW division serves approximately 12,000 customers in parts of Jackson, Calhoun, and Liberty counties along the Florida panhandle. Approximately 94% of the distribution system in this division is of overhead (OH) construction with the majority of the UG facilities located along isolated neighborhoods or certain commercial establishments (Figure 8). FPUC does not own nor operate any Transmission facilities in this Division<sup>5</sup>.

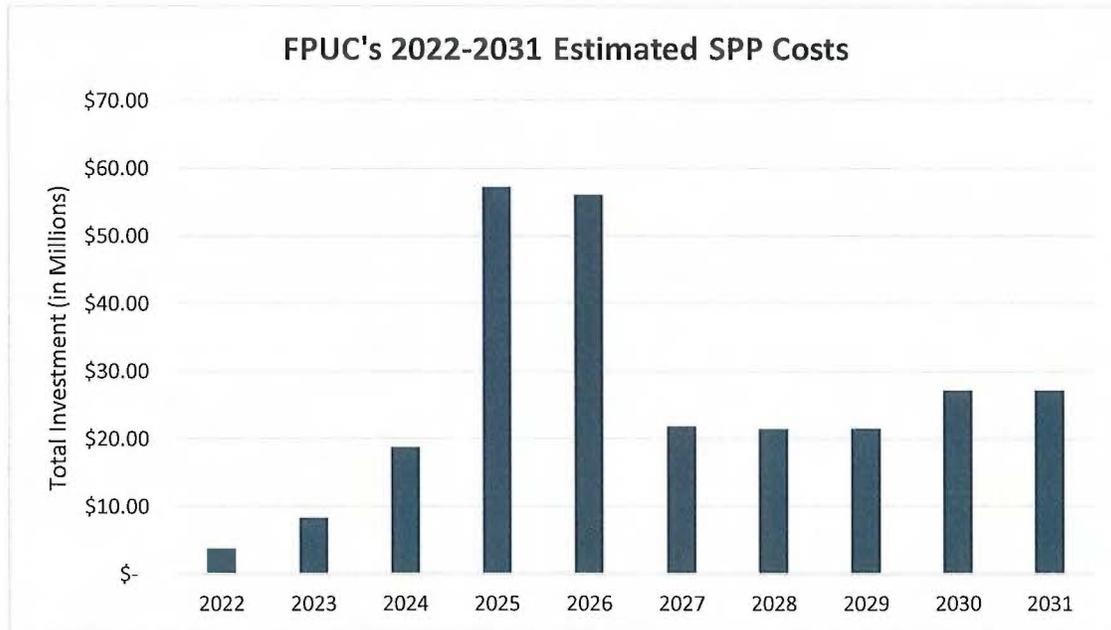
Figure 9 - Ten-year estimated investment profile for SPP Programs<sup>7</sup>

FPUC’s full 10-year estimated investment plan is shown in Figure 9 below and outlines the methodical ramp-up in investments over the first three years of the plan. This ramp-up ensures the alignment of materials and resources as well as facilitates the capturing of lessons learned from the rollout of these new programs and the implementation of these lessons learned into later years for added program execution efficiencies. A detailed breakdown for the first three years of the plan is subsequently shown in Figure 10 and Table 1.

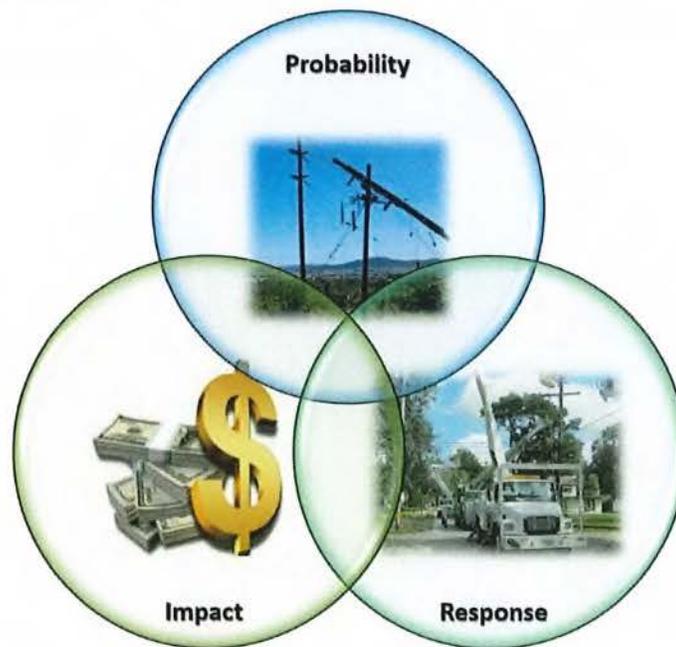
This Resiliency Risk Model evaluates risks and an electric system’s resiliency against such risk by leveraging an algorithm that assesses a balanced approach between probability, response, and impact.

- Probability
  - o The probability or likelihood that an extreme weather condition event will cause damage to existing utility infrastructure.
- Response
  - o The utility's ability to appropriately respond to and recover from infrastructure damage caused by an extreme weather condition.
- Impact
  - o The societal impact of the extreme weather condition caused electrical outage to the community being affected.

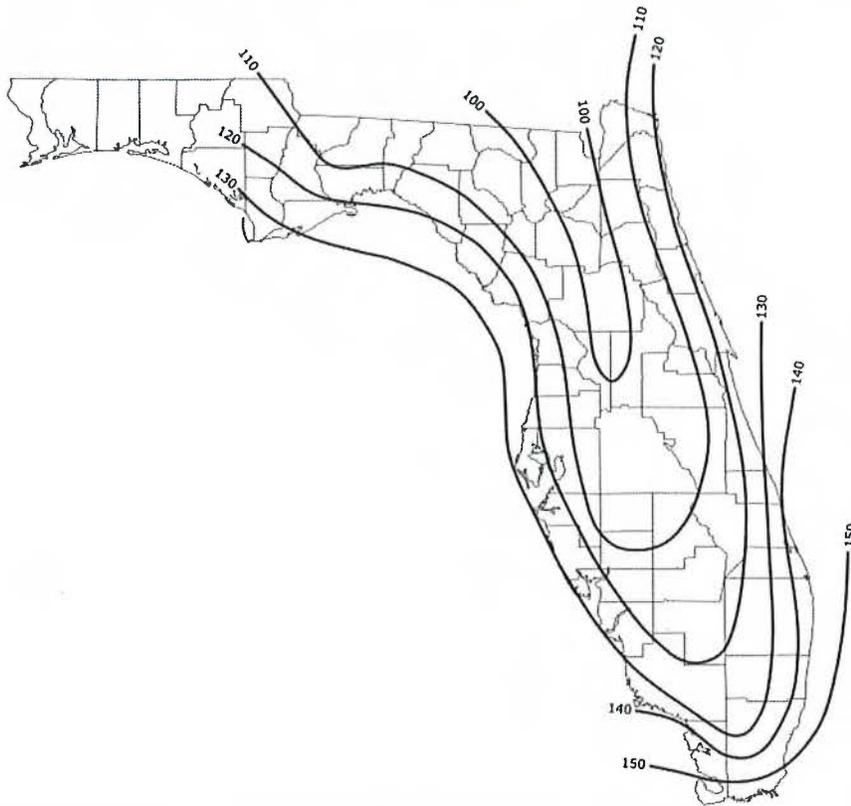
Figure 11 - Florida NESC extreme wind zones

Wind probability calculations for the model are derived from Extreme Wind loading zones outlined in NESC 250C (Figure 11 below). The zones were developed by the American Society of Civil Engineers (ASCE) in their 74 standards that and were adopted by the NESC as design standards for structures greater than 60 feet in height. FPUC applies this standard (along with NESC Grade B) in the construction of overhead distribution facilities less than 60 feet in height when building to or strengthening existing facilities to extreme wind standards such as those in Feeder Hardening projects. Consistent with NESC 250C, FPUC has applied the 130mph zone to all facilities in the NE Division and the 120mph standard to all facilities located in the NW Division as the extreme wind loading criteria for each respective division.

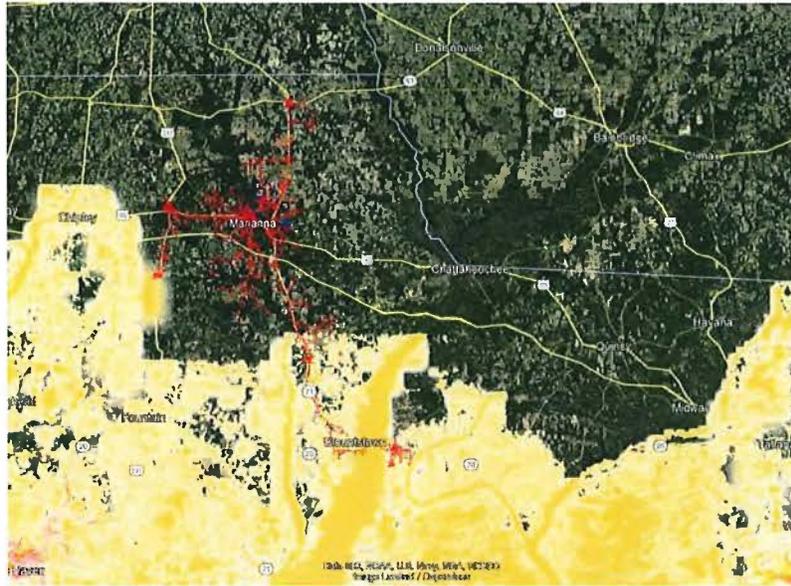
Figure 12- NOAA Coastal Flood Exposure Map - NW Division

As shown in Figure 12, FPUC’s NW Division has minimal flood hazard potential across most of the territory except for facilities serving communities located near the Apalachicola River (Blountstown and Bristol). Storm Surge and Flood Hazard potential varies greatly in the NE Division as shown in Figure 13.

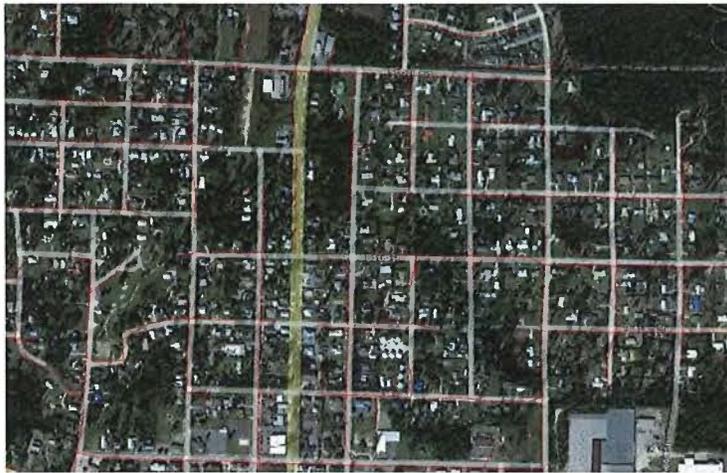
Figure 14 - Accessible Areas - NW Division

FPUC system-specific GIS data was overlaid on top of aerial/satellite imagery as shown in Figures 14 and 15 to determine their accessibility (ability for FPUC to easily access utility assets with standard trucks and tools). Inaccessible areas, such as those shown in Figure 15, take longer to restore due to the inability to leverage truck and tools specially designed to provide efficiencies in the construction and maintenance of electric grids.

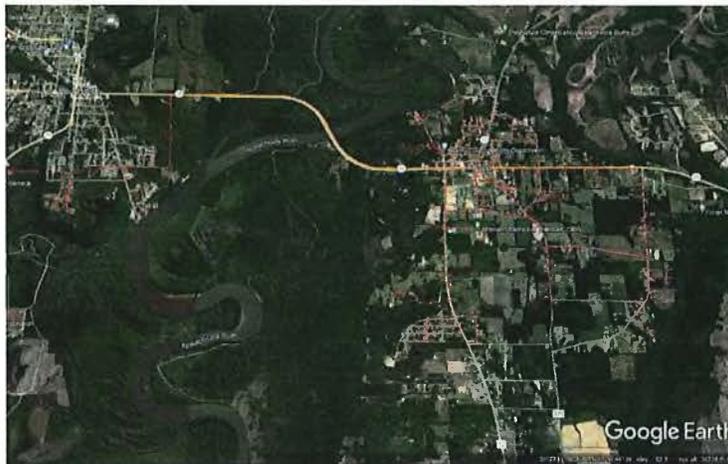
Figure 16 - Radial service to Liberty County customers

As mentioned earlier, it is practically and prudently impossible to eliminate all outages associated with extreme weather events. The ability to restore and recover unaffected areas of the distribution grid is essential in minimizing the customer impact associated with these events. This can prove to be problematic in more rural areas of a utility’s service territory, particularly at the tail end of a distribution circuit. FPUC’s service to customers in Liberty County, Florida is an example of this scenario where customers are served from a single overhead feeder that spans across the Apalachicola River. FPUC GIS data, electrical connectivity models, and discussions with FPUC personnel were leveraged to identify areas of the FPUC territory with this type of risk (Figure 16).

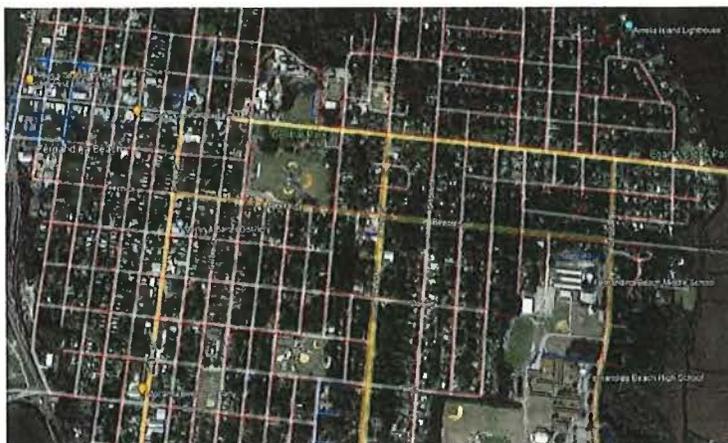
Figure 17 - Fernandina Beach Historic District - NE Division

In the NE Division, an overlay of FPUC GIS system specific data against aerial/satellite imagery was used to determine approximate vegetation exposure for each analyzed scenario as shown in Figure 15 along Fernandina Beach’s Historic District.

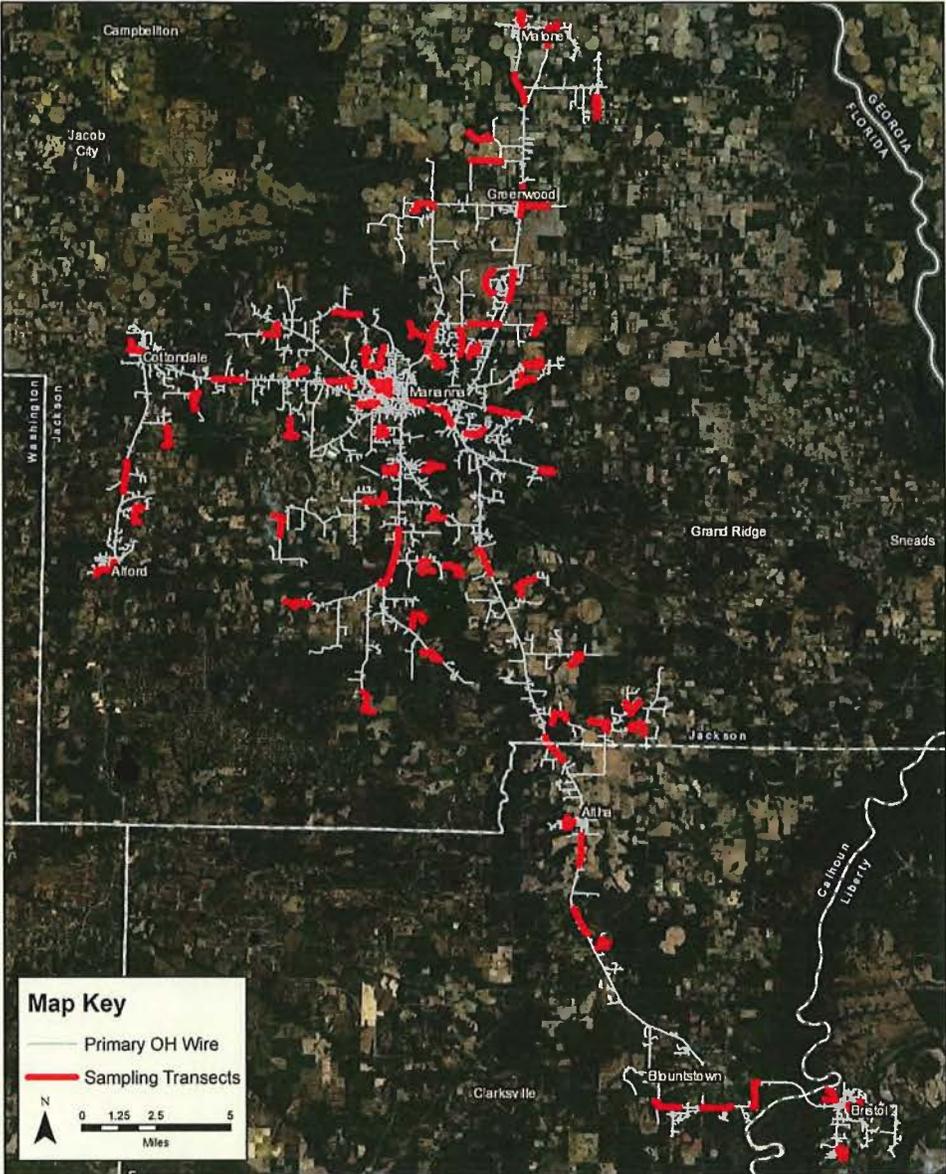
**Data Sampling Transects**

This map provides an overview of the sample areas and their even distribution across the FPU system. Tree/Wire interface data was used in excluding areas that do not require line clearance activities. Sample plots are placed randomly across the system in location with Tree/Wire Interface without bias to accessibility or work type.

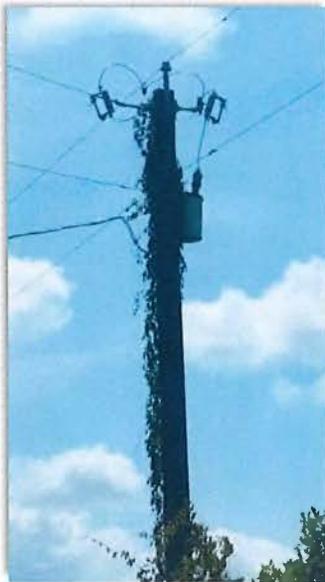
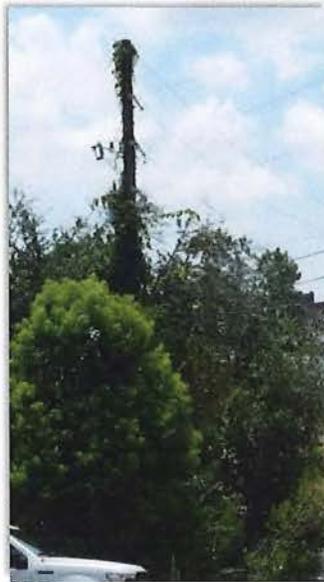
190 vine locations have been identified in the 62 sample areas. Of these locations, 148 are located on single phase and 42 are on three phase. Vine locations are spread evenly across the system. Residential areas account for 91 occurrences (48%), Agriculture account for 84 (44%) and commercial had 15 (8%).

FPU system has an average of 3.06 vines per mile or estimated 1882 locations. This data shows the importance of the implementation of a Vine program on FPU System. A vine program can be easily integrated into a robust herbicide program.

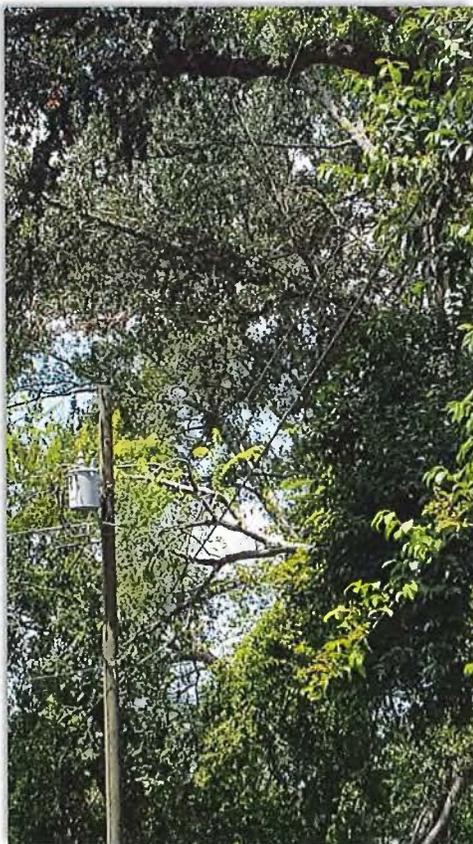
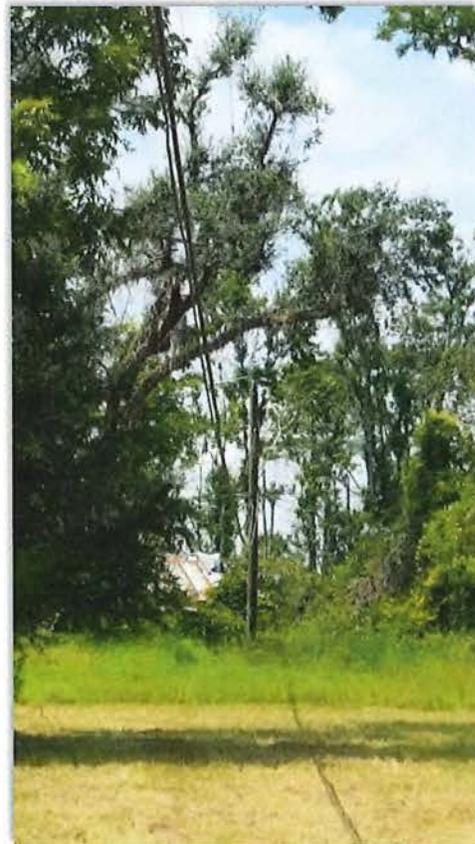
Documented overhang is vegetation directly above conductors that is not in compliance with FPU line clearance specifications. Thirty-two of the 40 single phase samples (76%) and 8 of the twenty 3-phase (40%) had at least one occurrence in the sample area. Compliance with ANSI-A300 standards and cycle-based trimming would result in a reduction in occurrences and vegetation related outages.

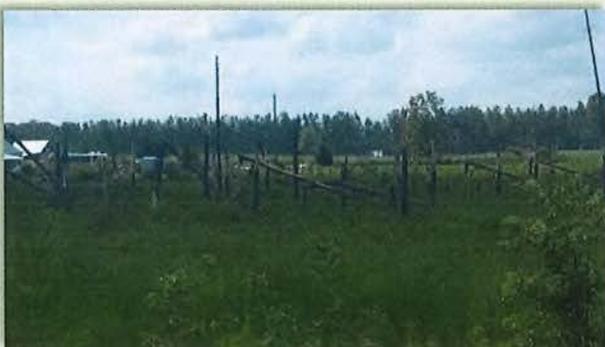
While conducting the Tree/Wire Interface assessment, The DRG GIS dept has identified additional areas with storm damage have been identified from aerial photography. An additional 58.46 miles have been determined to have "storm damage". Storm Damage areas is defined as areas with trees that have broken tops, leaning or damaged in other ways.

While this mileage is in addition to the TIF miles, It represents the damage caused by Hurricane Michael in 2018. While all of the areas may not have vegetation deemed hazardous to the electrical system, It represents the widespread damage due to Hurricane Michael in 2018.

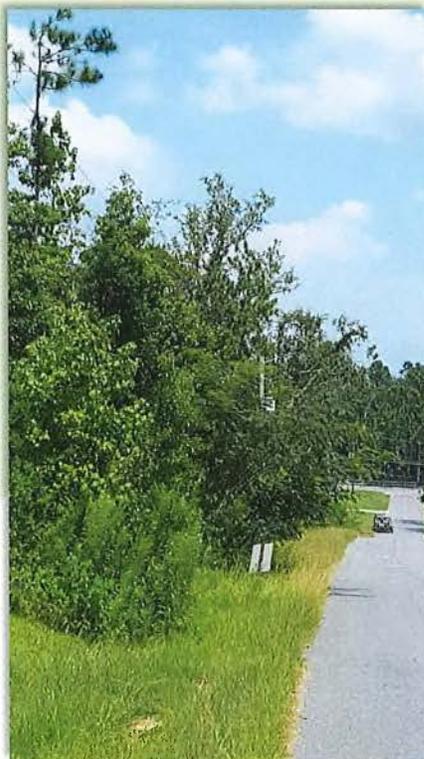
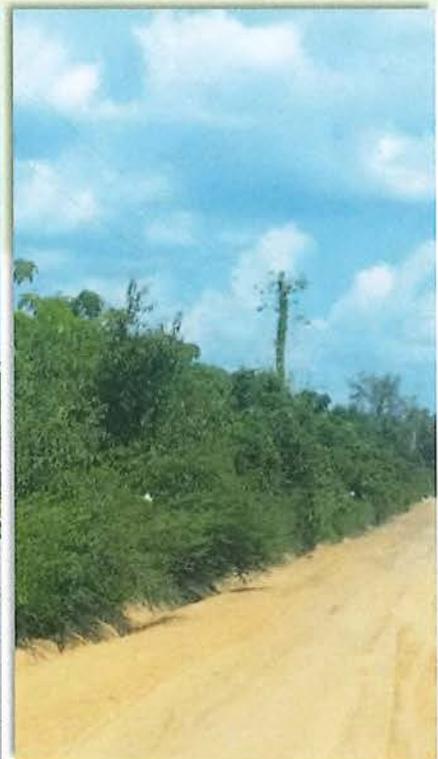
Trapped trees are any small tree or Brush that has the potential to contact conductors and has its upward growth pushed toward conductors. Trapped trees are excellent candidates for removal. Removal of trapped trees can reduce future workloads by number of trees to trim and disposal of debris generated for trimming activities. Trapped trees can be addressed by manual removal, mowing operations or herbicide application. If trapped trees are removed manually or by mowing operation, it is recommended to follow up with an herbicide stump treatment to minimize future regrowth and future workloads.

Most occurrences with Trapped Trees are mainly concentrated in Residential (27%) and Agricultural (31%) areas. Most occurrences of trapped trees have not been planted by property owners. They are volunteers that have been naturally seeded. With proper notification of residential customer, most all would be removed. In agricultural areas, many are located along fence lines and edge of right of ways and should be removed during routine maintenance.

A strong post work audit should be completed to assure all trapped trees have been addressed.
