2 Direct Testimony of P. Mark Cutshaw

4 **Florida Public Utilities Company**

5 **Docket 20220049-EI**

Storm Protection Plan 2022 - 2031

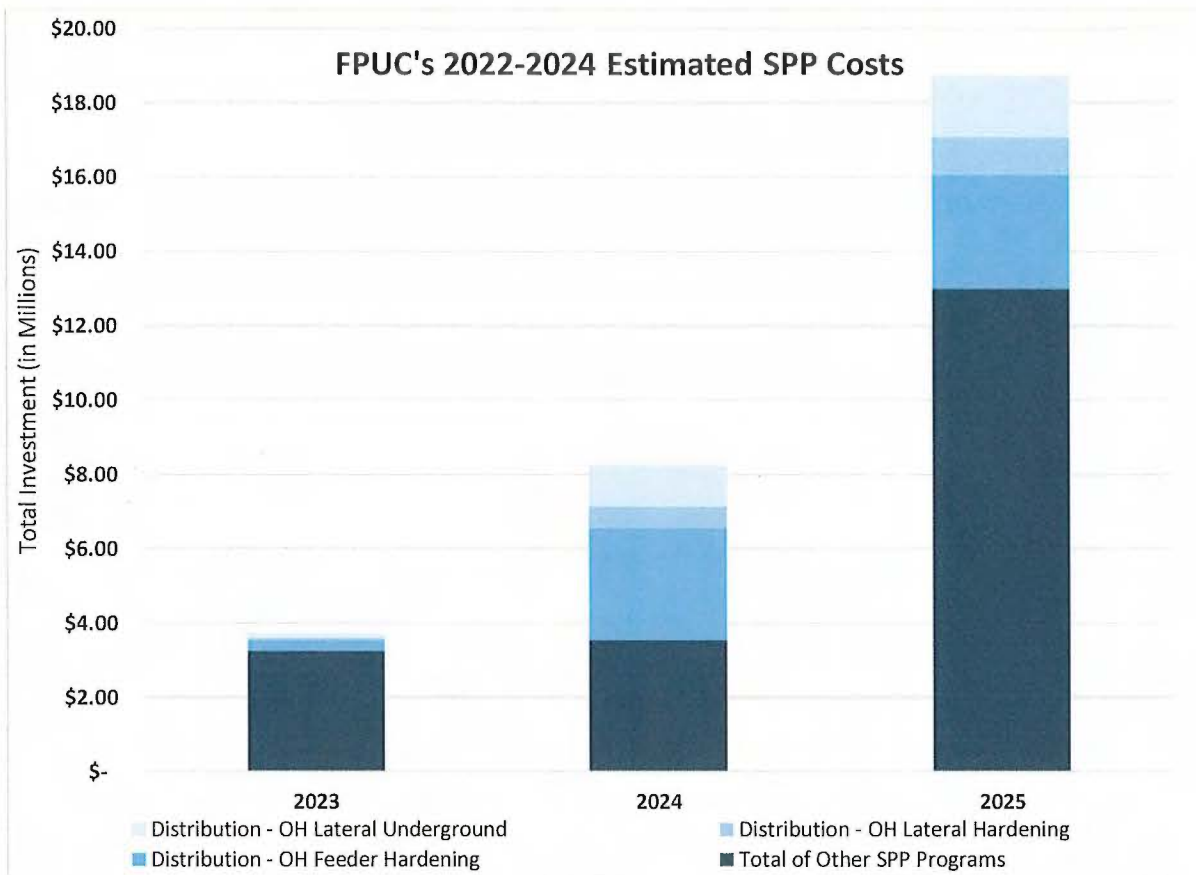
Figure 10 - Three-year estimated investment profile for SPP Programs

FPUC's full 10-year estimated investment plan is shown in Figure 9 below and outlines the methodical ramp-up in investments over the first three years of the plan. This ramp-up ensures the alignment of materials and resources as well as facilitates the capturing of lessons learned from the rollout of these new programs and the implementation of these lessons learned into later years for added program execution efficiencies. A detailed breakdown for the first three years of the plan is subsequently shown in Figure 10 and Table 1.

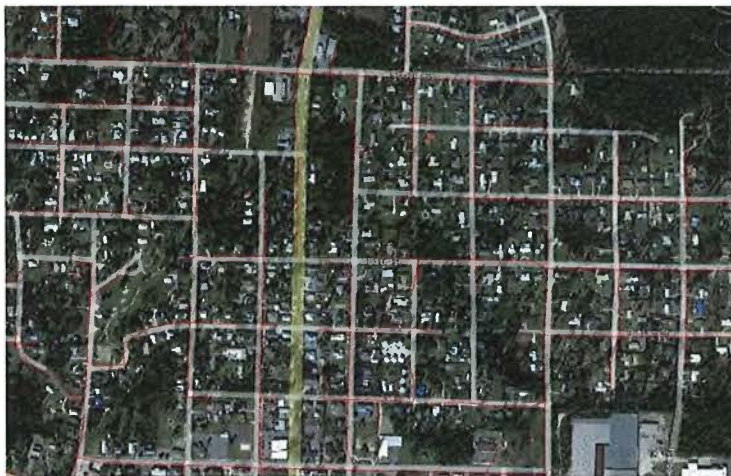
Figure 14 - Accessible Areas - NW Division

FPUC system-specific GIS data was overlaid on top of aerial/satellite imagery as shown in Figures 14 and 15 to determine their accessibility (ability for FPUC to easily access utility assets with standard trucks and tools). Inaccessible areas, such as those shown in Figure 15, take longer to restore due to the inability to leverage truck and tools specially designed to provide efficiencies in the construction and maintenance of electric grids.

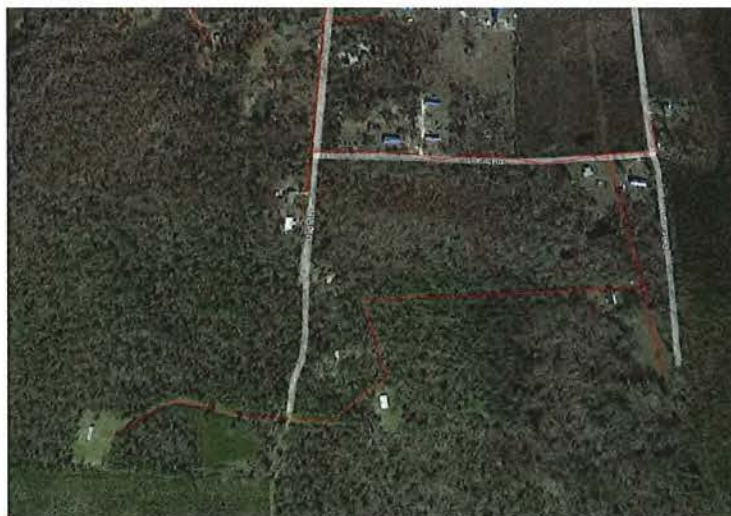
Figure 15 - Inaccessible Area - NW Division

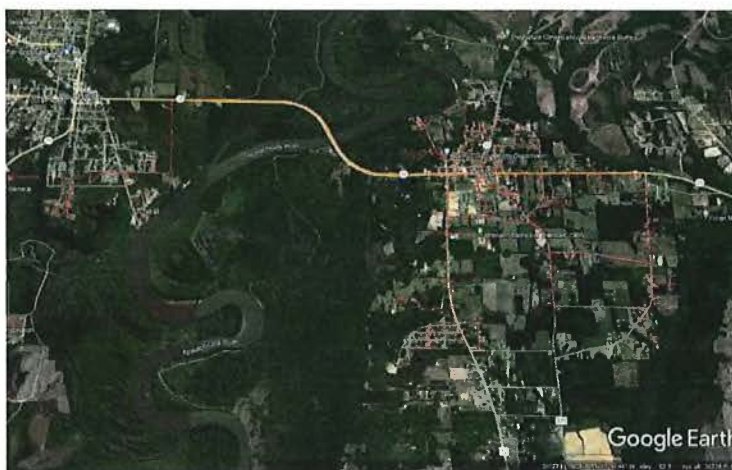
Figure 16 - Radial service to Liberty County customers

As mentioned earlier, it is practically and prudently impossible to eliminate all outages associated with extreme weather events. The ability to restore and recover unaffected areas of the distribution grid is essential in minimizing the customer impact associated with these events. This can prove to be problematic in more rural areas of a utility's service territory, particularly at the tail end of a distribution circuit. FPUC's service to customers in Liberty County, Florida is an example of this scenario where customers are served from a single overhead feeder that spans across the Apalachicola River. FPUC GIS data, electrical connectivity models, and discussions with FPUC personnel were leveraged to identify areas of the FPUC territory with this type of risk (Figure 16).

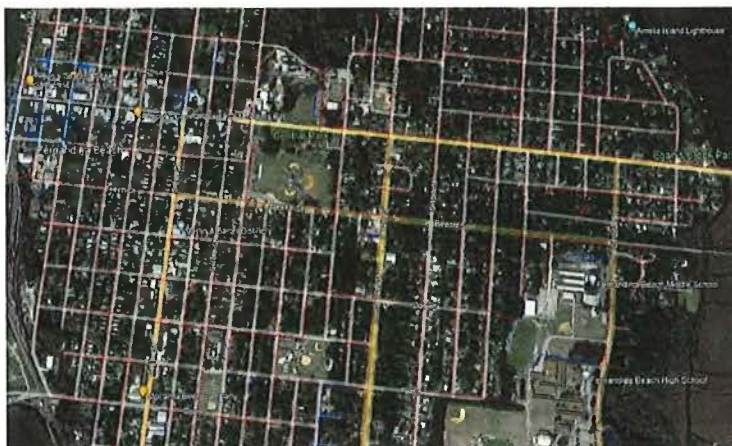
Figure 17 - Fernandina Beach Historic District - NE Division

In the NE Division, an overlay of FPUC GIS system specific data against aerial/satellite imagery was used to determine approximate vegetation exposure for each analyzed scenario as shown in Figure 15 along Fernandina Beach's Historic District.

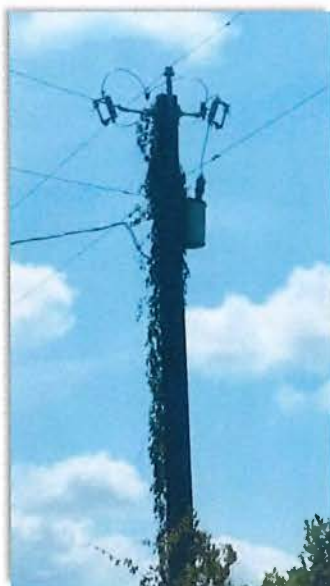
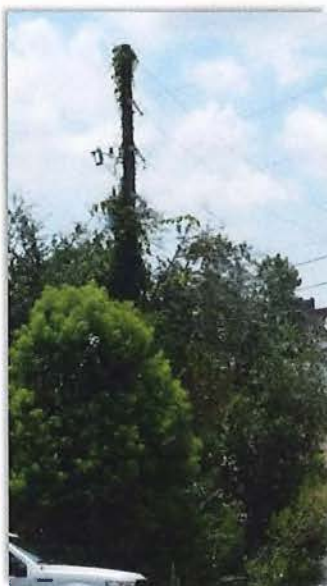
Vines	
1Phase	148
Ag	66
Res	82
Com	0
3 Phase	42
Ag	18
Res	9
Com	15
Total	190

190 vine locations have been identified in the 62 sample areas. Of these locations, 148 are located on single phase and 42 are on three phase. Vine locations are spread evenly across the system. Residential areas account for 91 occurrences (48%), Agriculture account for 84 (44%) and commercial had 15 (8%).

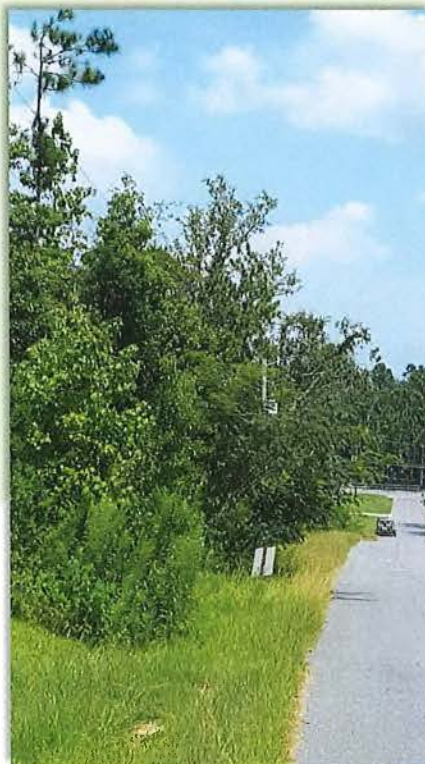
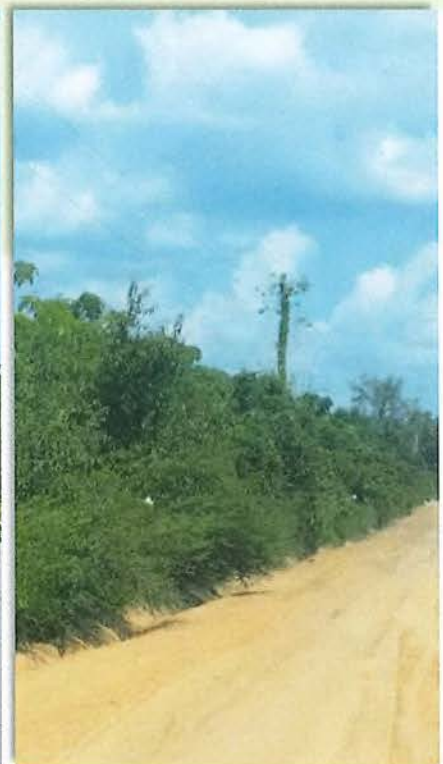
Trapped trees are any small tree or Brush that has the potential to contact conductors and has its upward growth pushed toward conductors. Trapped trees are excellent candidates for removal. Removal of trapped trees can reduce future workloads by number of trees to trim and disposal of debris generated for trimming activities. Trapped trees can be addressed by manual removal, mowing operations or herbicide application. If trapped trees are removed manually or by mowing operation, it is recommended to follow up with an herbicide stump treatment to minimize future regrowth and future workloads.

Most occurrences with Trapped Trees are mainly concentrated in Residential (27%) and Agricultural (31%) areas. Most occurrences of trapped trees have not been planted by property owners. They are volunteers that have been naturally seeded. With proper notification of residential customer, most all would be removed. In agricultural areas, many are located along fence lines and edge of right of ways and should be removed during routine maintenance.

Trapped Trees	TOTALS	Res	Com	Ag
Total Locations	40	17	4	19
All Phasing	62	27.42%	6.45%	30.65%
3 Phase	11	3	4	4
1 phase	29	14	0	15
