2014

STORM IMPLEMENTATION PLAN & ANNUAL RELIABILITY PERFORMANCE REPORTS

2014 Storm Implementation Plan & Annual Reliability Performance Reports

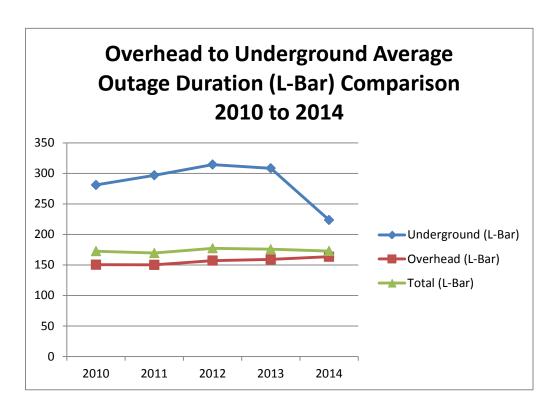
Exhibit 9: Overhead to Underground Outage Duration

Overhead	2010	2011	2012	2013	2014
Number of Outages Events (N)	8,495	8,226	7,838	8,840	8,233
Overhead Average Duration (L-Bar)	150.43	150.11	157.12	159.09	163.52
Average Restoration Time (CAIDI)	86.80	82.65	80.87	85.77	79.08

Underground	2010	2011	2012	2013	2014
Number of Outages Events (N)	1,728	1,249	1,150	1,118	1,513
Underground Average Duration (L-Bar)	281.08	296.94	314.37	308.38	223.59
Average Restoration Time (CAIDI)	237.89	246.51	277.23	261.46	132.80

Tampa Electric tracks outage records in its outage database according to cause and equipment type. These equipment types are designed and associated with the overhead and underground systems. Reporting capability allows the company to track CMI, CI, Number of Outages, Average Duration and CAIDI as referenced in Section C – Overhead to Underground in the Appendix. In addition, separate reporting was undertaken in order to align miles and customers for overhead and underground distribution.
