*Review of
Florida's
Investor-Owned
Electric Utilities*

*2 0 1 4
Service Reliability Reports*

State of Florida
Florida Public Service Commission
Division of Engineering

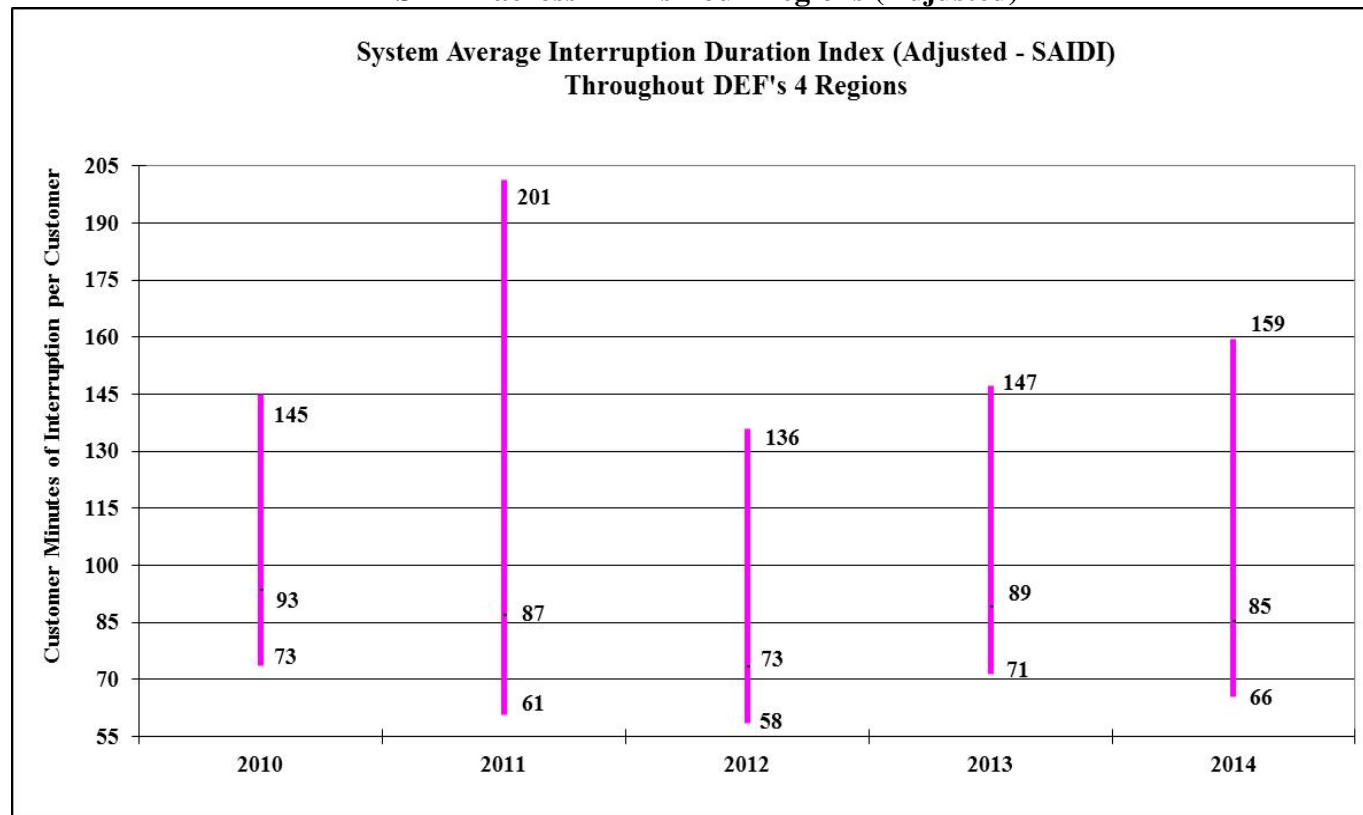
**Figure 3-1.
SAIDI across DEF's Four Regions (Adjusted)**

Figure 3-1 charts the adjusted SAIDI recorded across DEF's system and depicts an increase in the highest value and decreases in the average and lowest values for 2014. DEF reported that in 2014, one tropical storm affected its service territory. DEF also noted that there were three days of extreme weather that were not excludable. These extreme weather events impacted the North Central, North Coastal, and South Central regions.

DEF's service territory is comprised of four regions: North Coastal, South Coastal, North Central, and South Central. **Figure 3-1** illustrates that the North Coastal region continues to report the poorest SAIDI over the last five years, fluctuating between 136 minutes and 201 minutes. While the South Coastal and South Central regions have the best or lowest SAIDI for the same period. The North Coastal region is rural and has more square miles when compared to the other regions. This region is also served by predominantly long circuits with approximately 7,700 miles of overhead and underground main circuits. DEF explained that these factors result in higher exposure to outage causes and higher reliability indices.

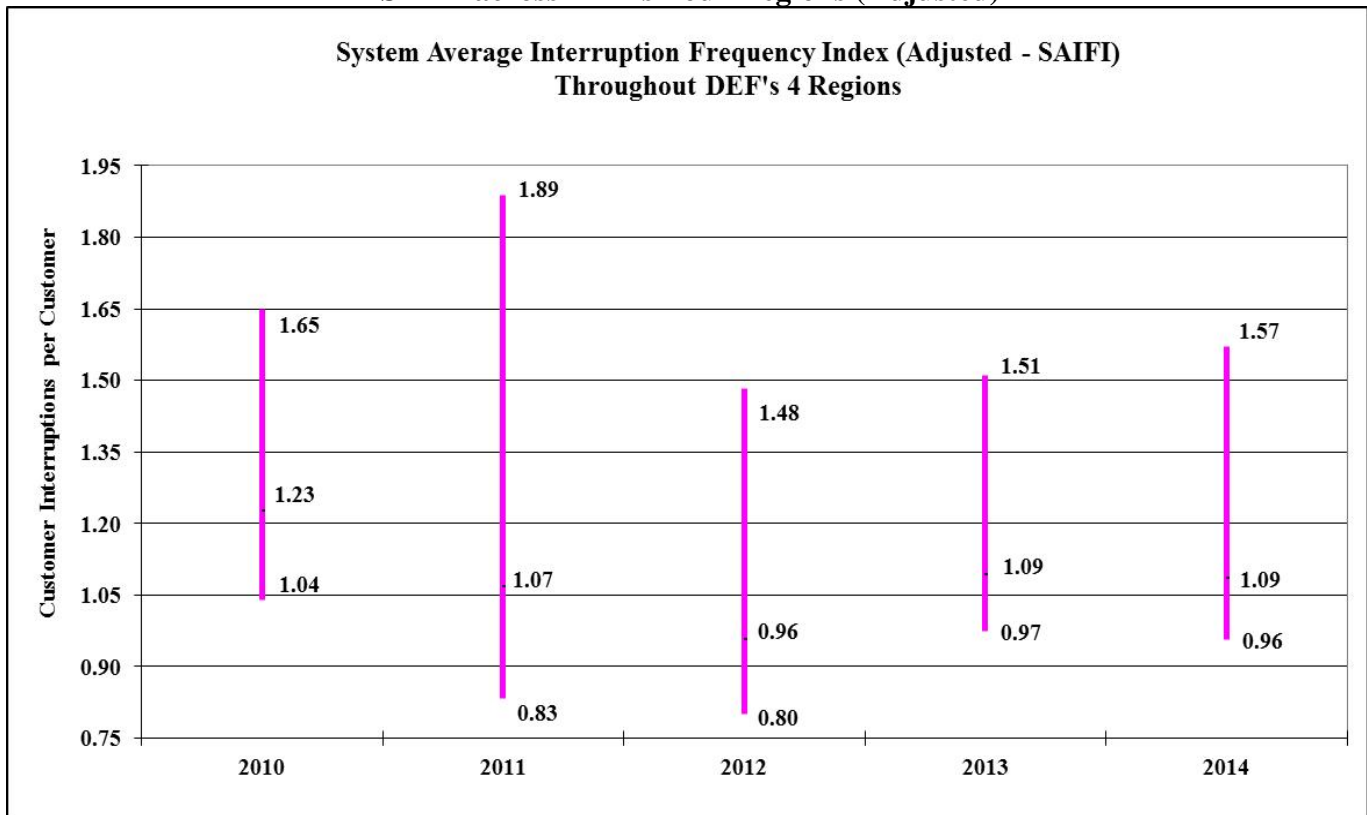
**Figure 3-2.
SAIFI across DEF’s Four Regions (Adjusted)**

Figure 3-2 shows the adjusted SAIFI across DEF’s system. The maximum, minimum, and average SAIFI indexes are trending downward even though there was increase of 4 percent for the maximum value, no change in the average value, and a decrease of 1 percent for the minimum value, in 2014. The South Central region continues to have the lowest number of interruptions, while the North Coastal region continues to have the highest number of interruptions.

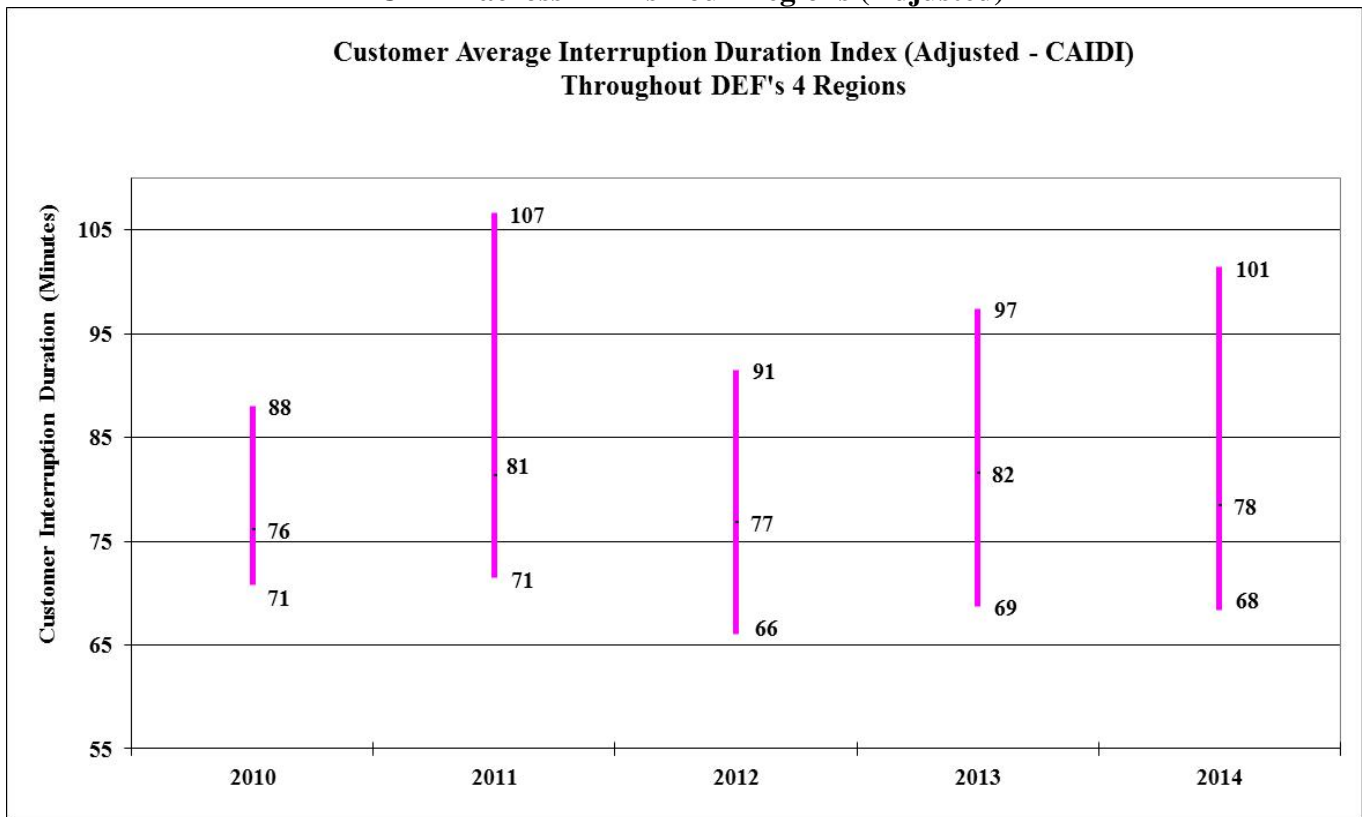
**Figure 3-3.
CAIDI across DEF's Four Regions (Adjusted)**

Figure 3-3 illustrates the CAIDI, or the average number of minutes a customer is without power when a service interruption occurs, for DEF's four regions. DEF's adjusted CAIDI is trending upward for a five-year period from 76 minutes in 2010 to 78 minutes in 2014 even though there was a 5 percent decrease from 82 minutes in 2013 to 78 minutes in 2014. The North Coastal region has continued to have the highest CAIDI level for the past five years with the maximum CAIDI trending upward. The South Coastal and South Central regions have maintained the lowest CAIDI level during the same period with the minimum CAIDI slightly trending downward.

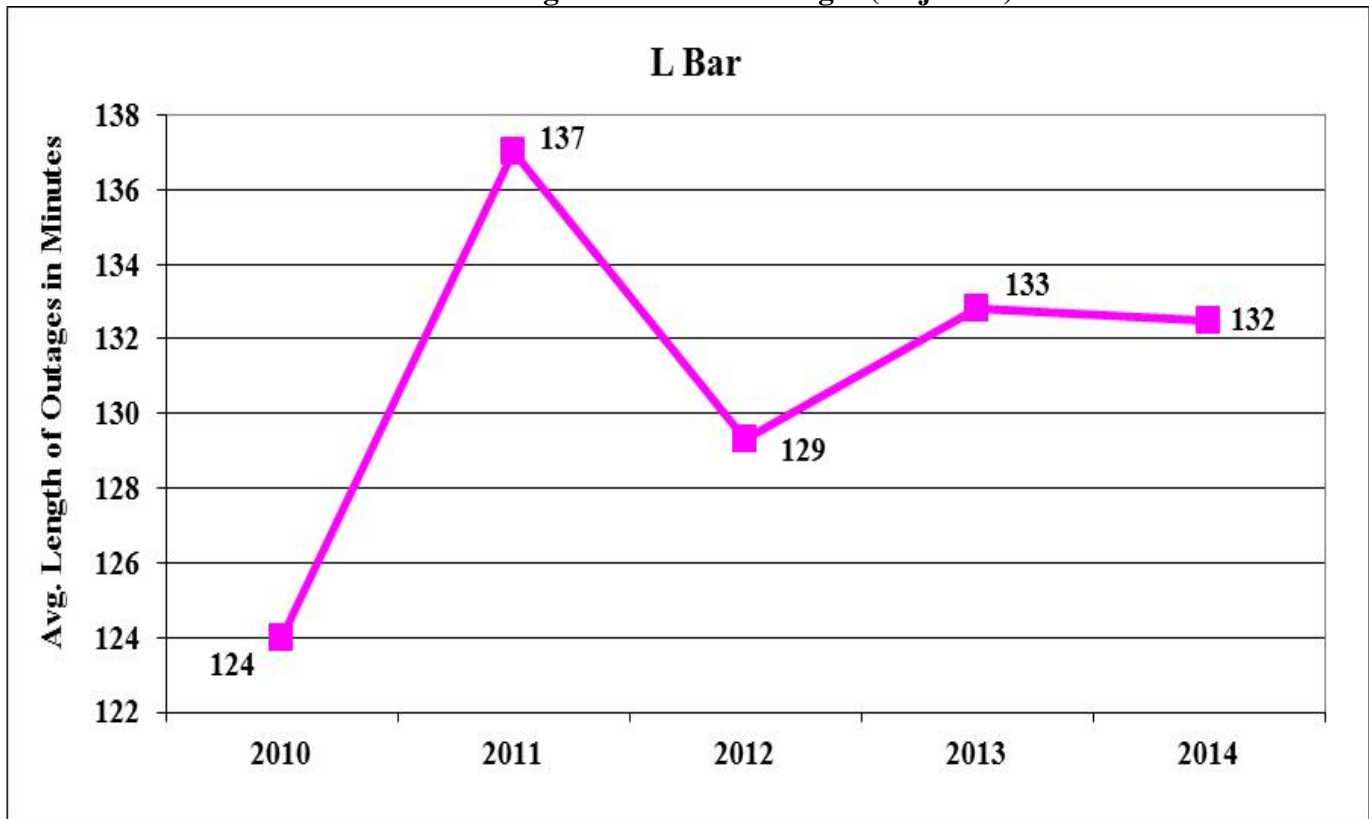
Figure 3-4.
DEF's Average Duration of Outages (Adjusted)

Figure 3-4 is the average length of time DEF spends restoring customers affected by outage events, excluding hurricanes and certain other outage events. This is displayed by the index L-Bar in the graph below. The data demonstrates an overall 6 percent increase of outage durations since 2010, and a 0.8 percent decrease from 2013 to 2014. DEF's overall L-Bar index is trending upward, indicating that DEF is still spending a longer time restoring service from outage events.

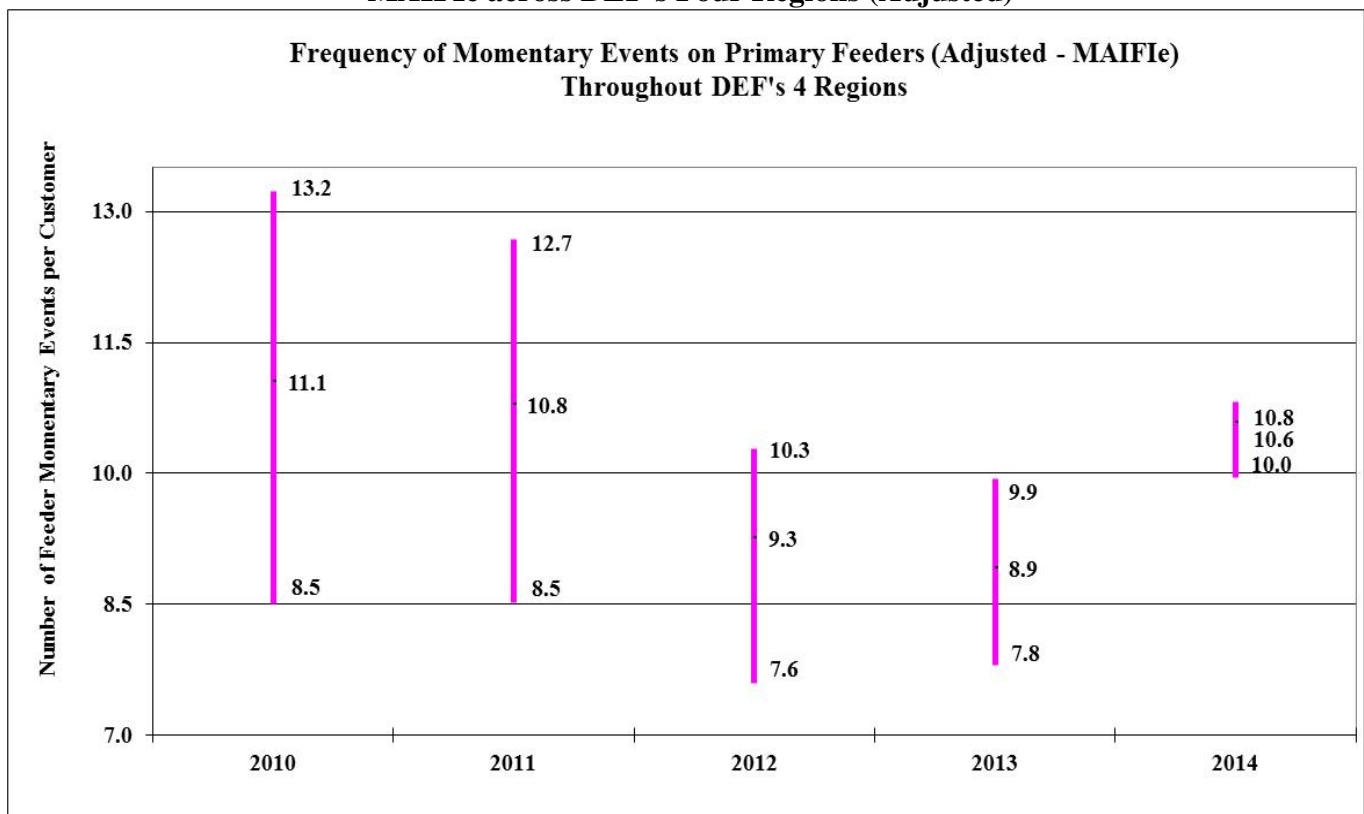
**Figure 3-5.
MAIFIE across DEF's Four Regions (Adjusted)**

Figure 3-5 illustrates the frequency of momentary events on primary circuits for DEF's customers recorded across its system. These momentary events often affect a small group of customers. A review of the supporting data suggests that the MAIFIE results between 2010 and 2014 appear to be trending downward showing improvement even though there was an increase in the average MAIFIE of 16 percent from 2013 to 2014. The North Coastal and South Central regions appear to have the best (lowest) results for the last five years. There was a 22 percent increase for the lowest MAIFIE from 2013 to 2014. The South Coastal and North Central regions appear to have the worst (highest) results for the last five years. There was an 8 percent increase from 2013 to 2014.

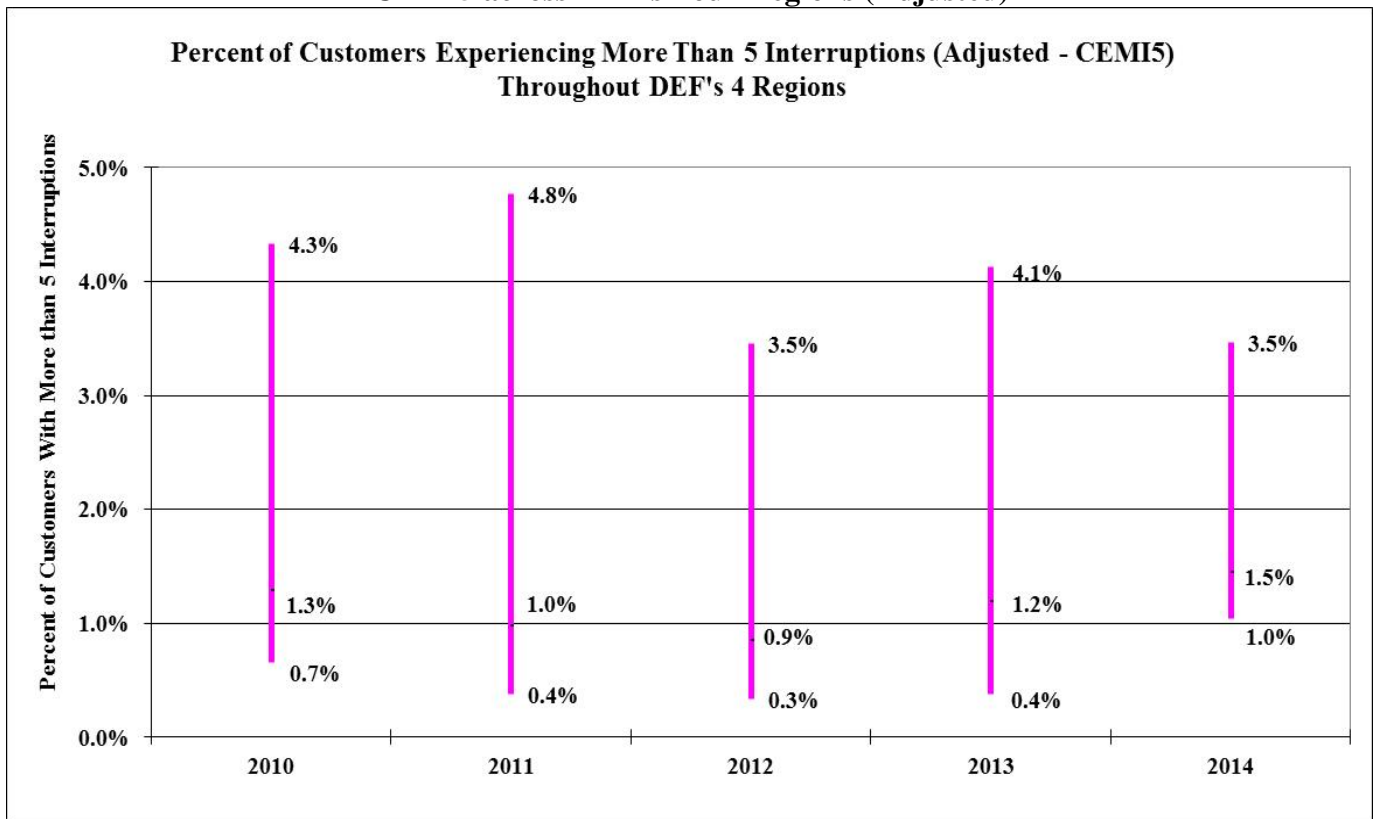
**Figure 3-6.
CEMI5 across DEF’s Four Regions (Adjusted)**

Figure 3-6 charts the percentage of DEF’s customers experiencing more than five interruptions over the last five years. DEF reported an increase in the average CEMI5 performance from 1.2 percent in 2013 to 1.5 percent in 2014. The average CEMI5 is trending upward over the past five years. The South Central region has the lowest reported percentage for all of DEF’s regions and the North Coastal region continues to have the highest reported percentage.

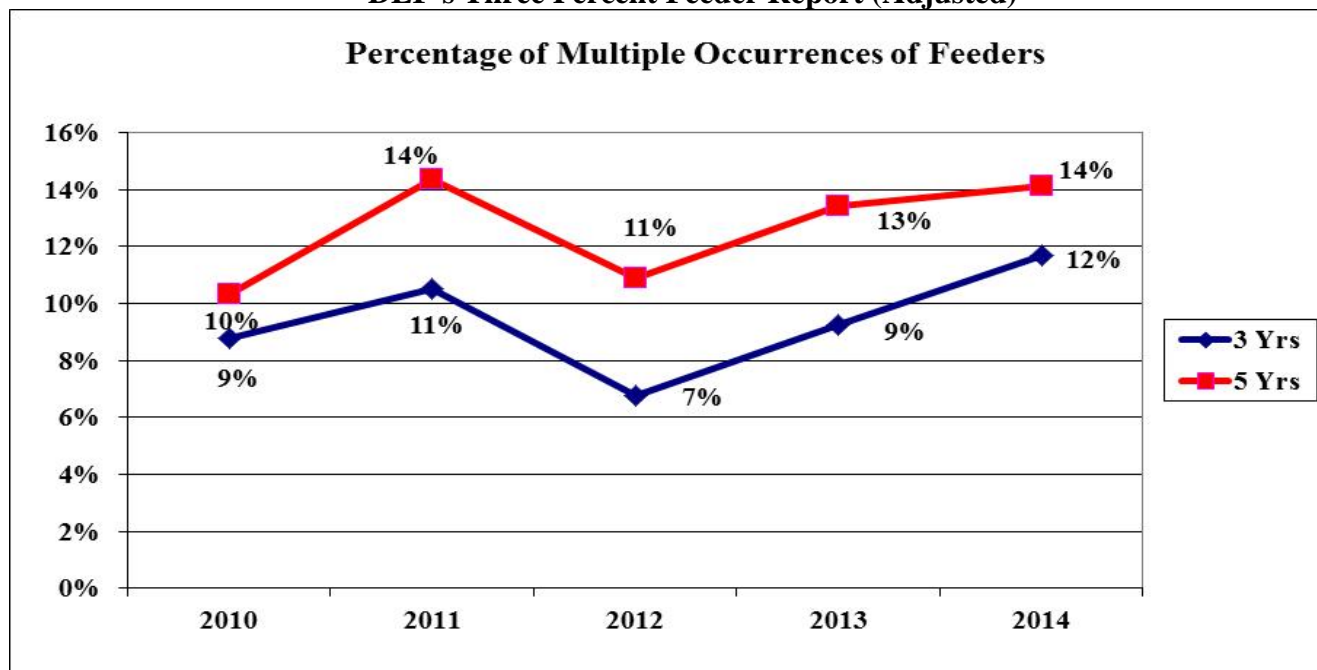
Figure 3-7.
DEF's Three Percent Feeder Report (Adjusted)

Figure 3-7 shows the fraction of multiple occurrences of feeders using a three-year and five-year basis. During the period of 2010 to 2014, the five-year fraction of multiple occurrences is trending upward along with the three-year fraction of multiple occurrences. The Three Percent Feeder Report lists the top three percent of feeders with the most feeder outage events. The fraction of multiple occurrences is calculated from the number of recurrences divided by the number of feeders reported.

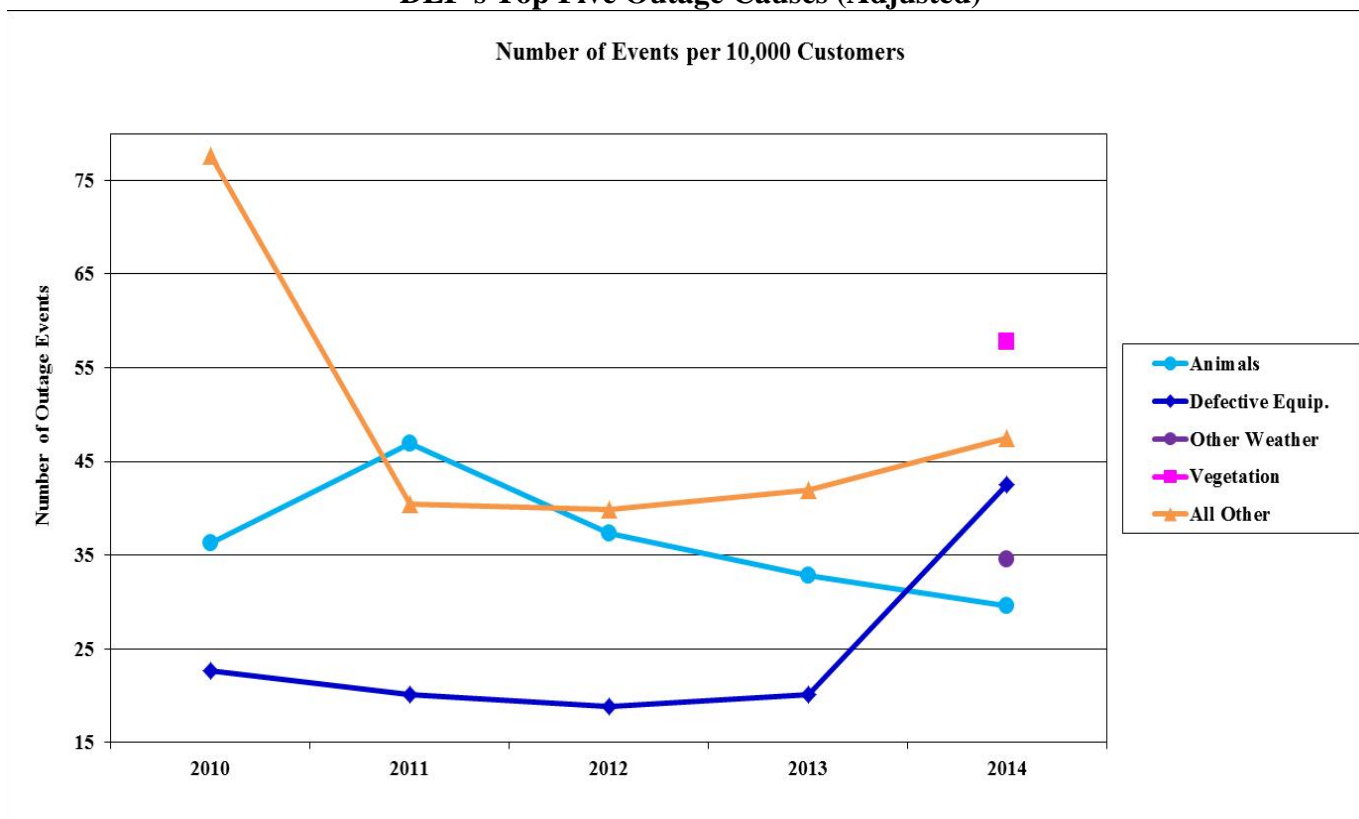
Figure 3-8.
DEF's Top Five Outage Causes (Adjusted)

Figure 3-8 shows the top five causes of outage events on DEF's distribution system normalized to a 10,000-customer base. The figure is based on DEF's adjusted data and represents approximately 88 percent of the top 10 causes of outage events that occurred during 2014. For the five-year period, the top five causes of outage events were Vegetation (24 percent), All Other (20 percent), Defective Equipment (18 percent), Other Weather (14 percent), and Animals (12 percent) on a cumulative basis. Commission staff requested that, beginning with 2014 data, all IOU's use the same outage categories for comparison purposes. As such, the Vegetation, Defective Equipment, and Other Weather now include outage categories that in the past were separately identified. The outage events caused by Animals and All Other are trending downward even though the All Other category had an 11 percent increase in 2014 and the Animals category had an 11 percent decrease. DEF reported that it prioritizes the reliability improvements action plan by balancing historical and current year performance. In addition, current year performance is monitored monthly to identify emergent and seasonal issues including load balancing for cold weather and the need for foot patrols of devices experiencing multiple interruptions.

In **Figure 3-8**, DEF's Top Five Outage Categories, the category Vegetation is in the top spot representing 24 percent of the top 10-outage categories. The next two highest categories were All Other (20 percent) and Defective Equipment (18 percent). Other Weather (14 percent) and Animals (12 percent) are the next two causes of outages. Commission staff requested that, beginning with 2014 data, all IOU's use the same outage categories for comparison purposes. As such, the Vegetation, Defective Equipment, and Other Weather now include outage categories that in the past were separately identified. The Animals outage category decreased in 2014 when compared to the 2013 data and is trending downward for the five-year period of 2010 to 2014. The All Other category had an increase between 2013 and 2014 but is trending downward for the same five-year period.

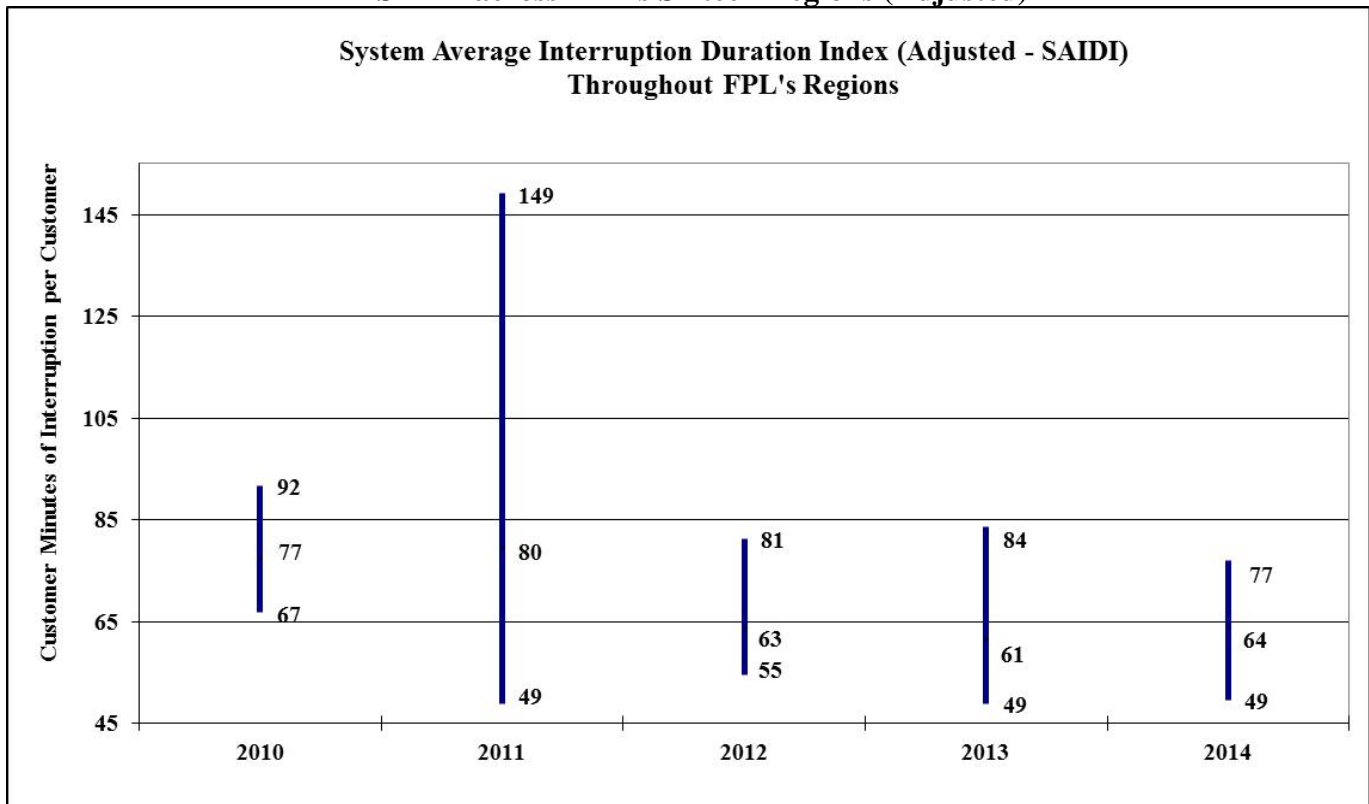
Figure 3-9.
SAIDI across FPL's Sixteen Regions (Adjusted)

Figure 3-9 shows the highest, average, and lowest adjusted SAIDI recorded across FPL's system that encompasses four management regions with 16 service areas. The highest and lowest SAIDI values are the values reported for a particular service area. FPL had an overall increase of three minutes (5 percent) to the average SAIDI results for 2014 compared to 2013. The average SAIDI appears to be trending downward over the five-year period of 2010 to 2014. The West Palm region continues to have the best SAIDI results.

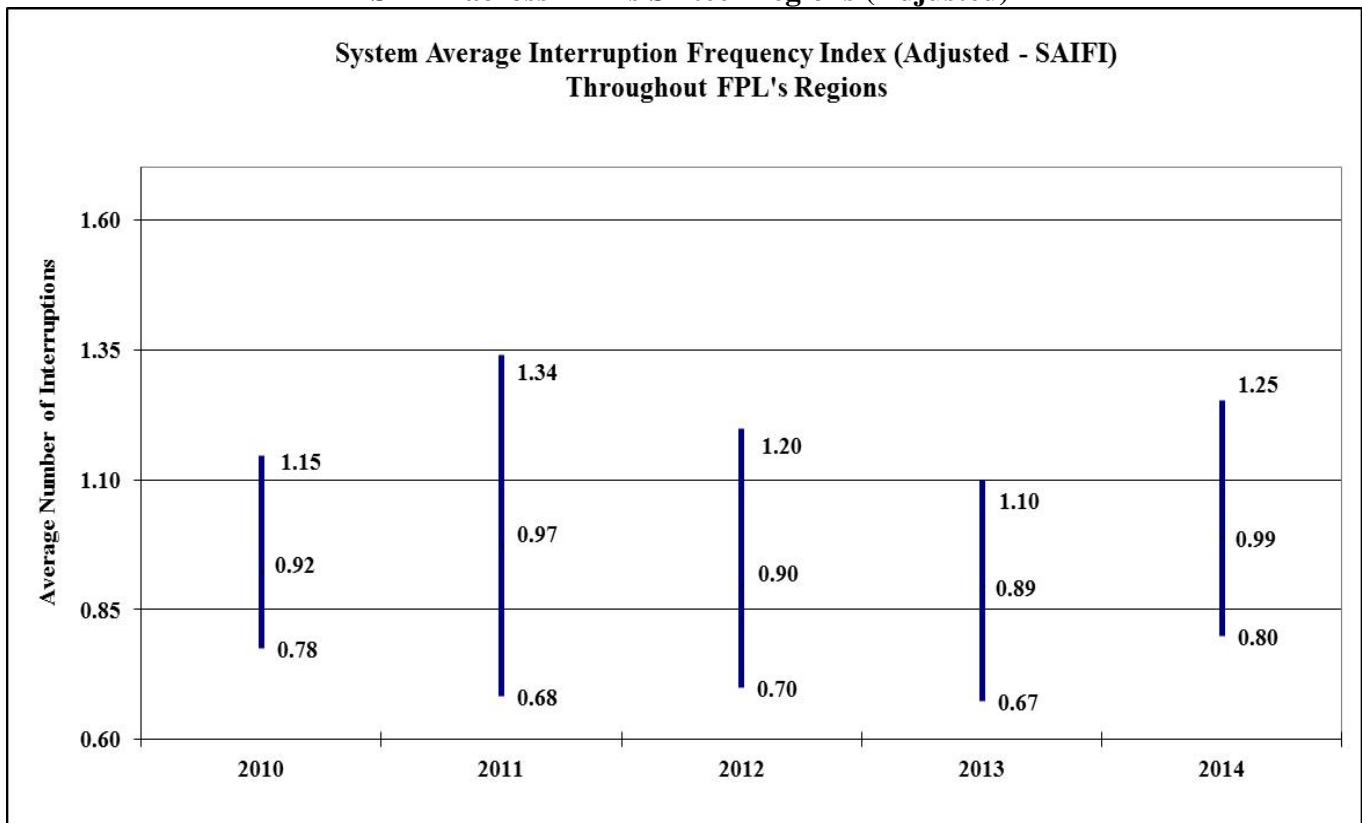
**Figure 3-10.
SAIFI across FPL's Sixteen regions (Adjusted)**

Figure 3-10 is a chart of the highest, average, and lowest adjusted SAIFI across FPL's system. FPL had an increase in the system average results to 0.99 outages in 2014, compared to 0.89 outages in 2013, which is a 10 percent increase. FPL reported an increase in the highest SAIFI of 1.25 interruptions in 2014 compared to 1.10 interruptions in 2013. The region reporting the lowest adjusted SAIFI for 2014 was Central Dade, again, at 0.80 interruptions compared to 0.67 interruptions in 2013. The highest and lowest SAIFI appear to be relatively flat as the average SAIFI is slightly trending upward. The 2014 average SAIFI results are the highest (worst) for the five-year period of 2010 to 2014.

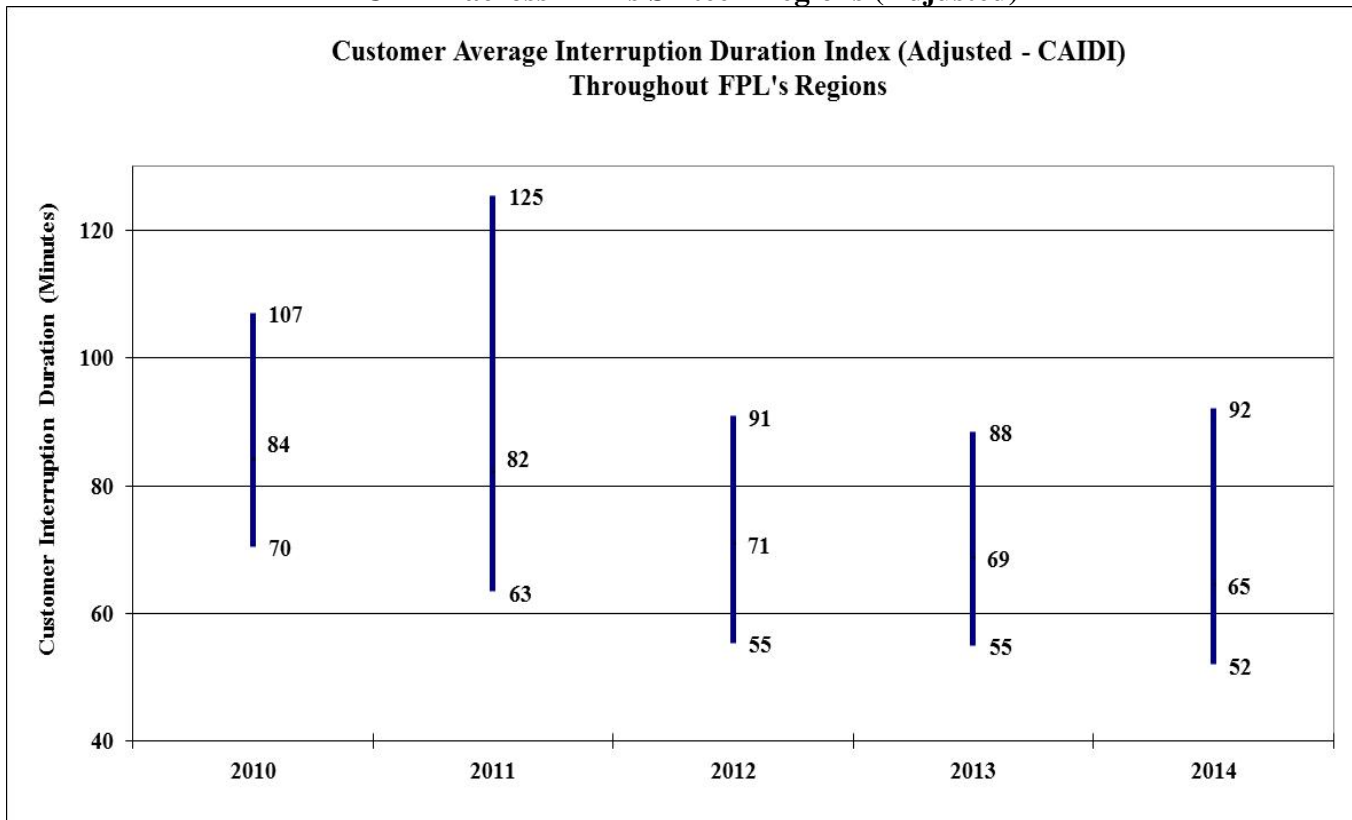
**Figure 3-11.
CAIDI across FPL’s Sixteen Regions (Adjusted)**

Figure 3-11 is a chart of FPL’s highest, average, and lowest CAIDI expressed in minutes. FPL’s adjusted average CAIDI has dropped approximately 6 percent from 69 minutes in 2013, to 65 minutes in 2014. The average duration of CAIDI is trending downward. For 2014, the Boca Raton service area once again reported the lowest duration of CAIDI at 52 minutes, which was a decrease from 55 minutes in 2013. The highest duration of CAIDI was 92 minutes for the North Dade service area for 2013, which is 4 percent higher than the highest CAIDI minutes in 2013.

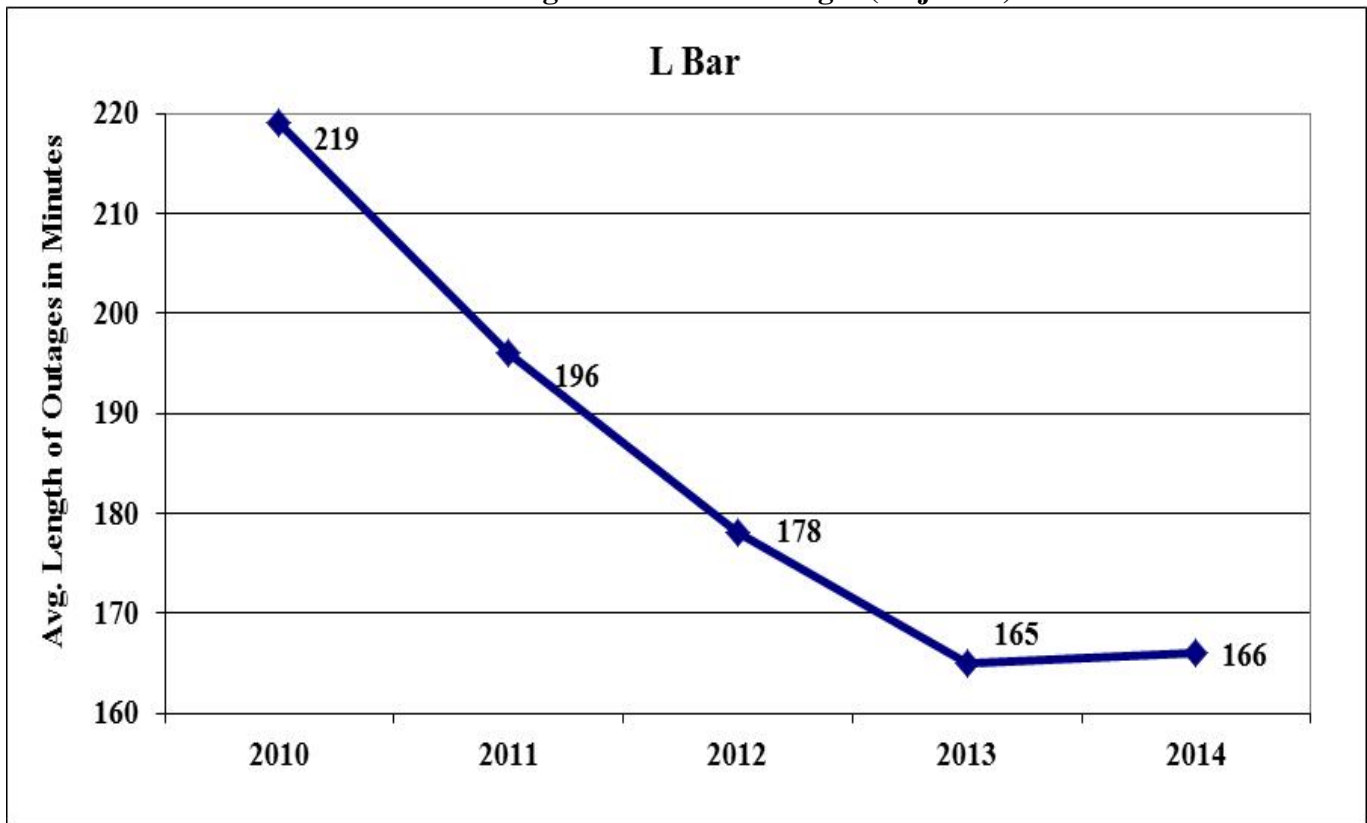
Figure 3-12.
FPL's Average Duration of Outages (Adjusted)

Figure 3-12 depicts the average length of time that FPL spends recovering from outage events, excluding hurricanes and other extreme outage events and is the index known as L-Bar (Average Service Restoration Time). FPL had a 0.6 percent increase in L-Bar from 165 minutes in 2013, to 166 minutes in 2014. There is a 24 percent overall decrease since 2010, indicating FPL is spending shorter times restoring service.

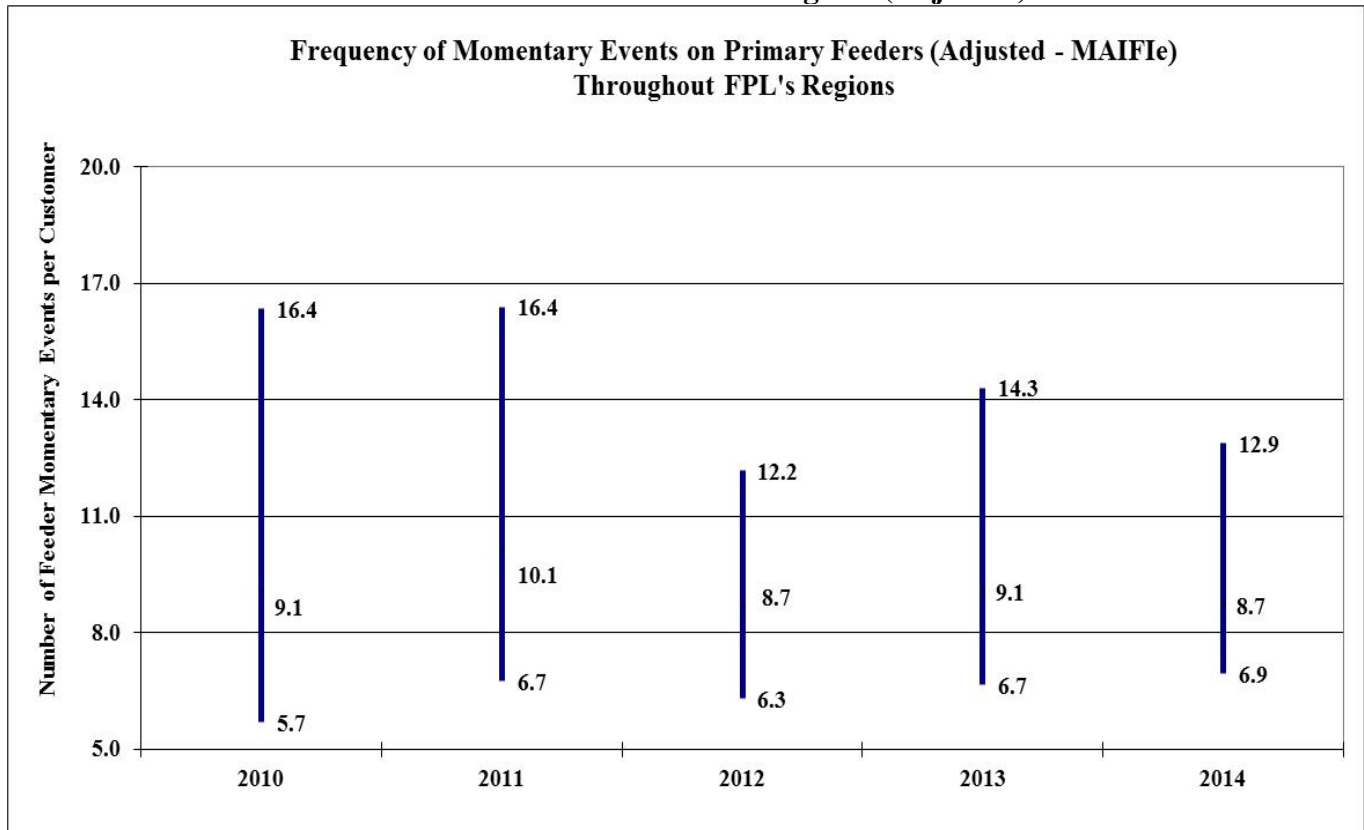
**Figure 3-13.
MAIFie across FPL’s Sixteen Regions (Adjusted)**

Figure 3-13 is the highest, average, and lowest adjusted MAIFie recorded across FPL’s system. FPL’s Toledo Blade, Treasure Coast, North Florida, and Wingate service areas have experienced the least reliable MAIFie results of the 16 service areas of FPL since 2010. The Pompano, Central Dade, and Naples service areas had the fewest momentary events since 2010. The results have been trending downward (improving) over the last five years. There is a 4 percent decrease in the average MAIFie results from 2013 to 2014.

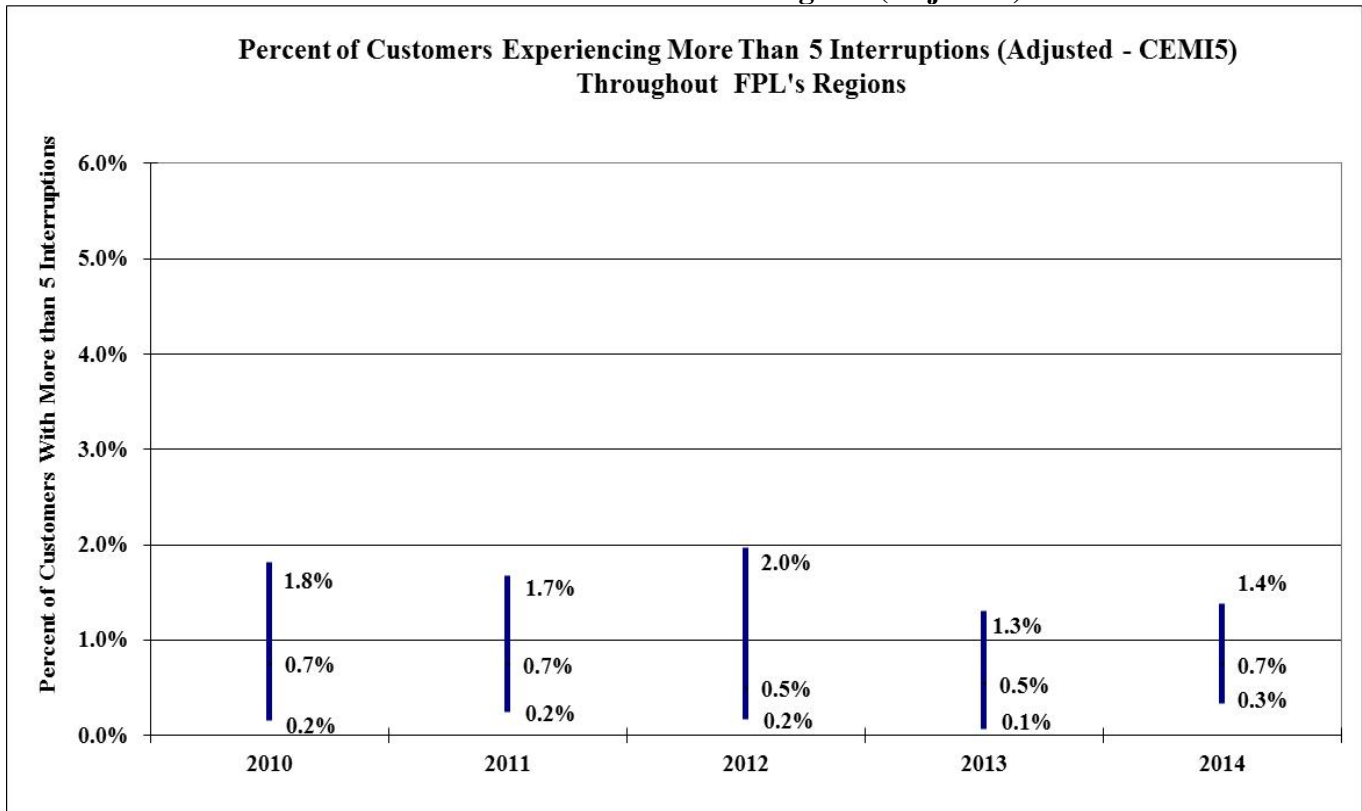
**Figure 3-14.
CEMI5 across FPL’s Sixteen Regions (Adjusted)**

Figure 3-14 shows the highest, average, and lowest adjusted CEMI5. FPL’s customers with more than five interruptions per year appear to be decreasing and trending downward. The service areas experiencing the highest CEMI5 over the five-year period appear to fluctuate among North Florida, West Dade, Boca Raton, and West Palm. Pompano, Central Dade, and Brevard are reported as having the lowest percentages in the last five years. The average CEMI5 result for 2014 was 0.7 percent compared to 0.5 percent in 2013.

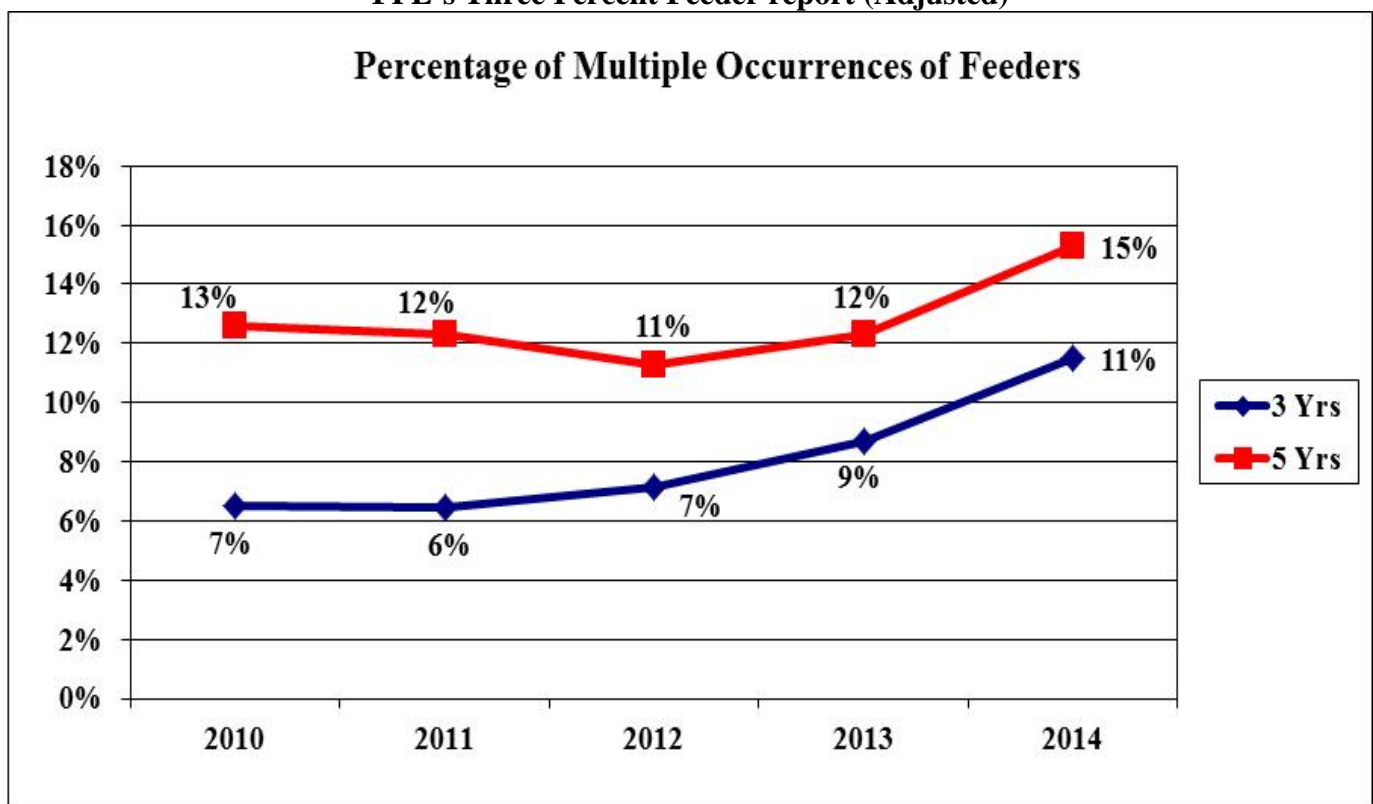
Figure 3-15.
FPL's Three Percent Feeder report (Adjusted)

Figure 3-15 is a graphical representation of the percentage of multiple occurrences of FPL's feeders and is derived from The Three Percent Feeder Report, which is a listing of the top three percent of problem feeders reported by the utility. The fraction of multiple occurrences is calculated from the number of recurrences divided by the number of feeders reported. The three-year percentage increased from 9 percent in 2013 to 11 percent in 2014. The five-year percentage also increased from 12 percent in 2013 to 15 percent in 2014. Both the five-year percentage and the three-year percentage appear to be trending upward.

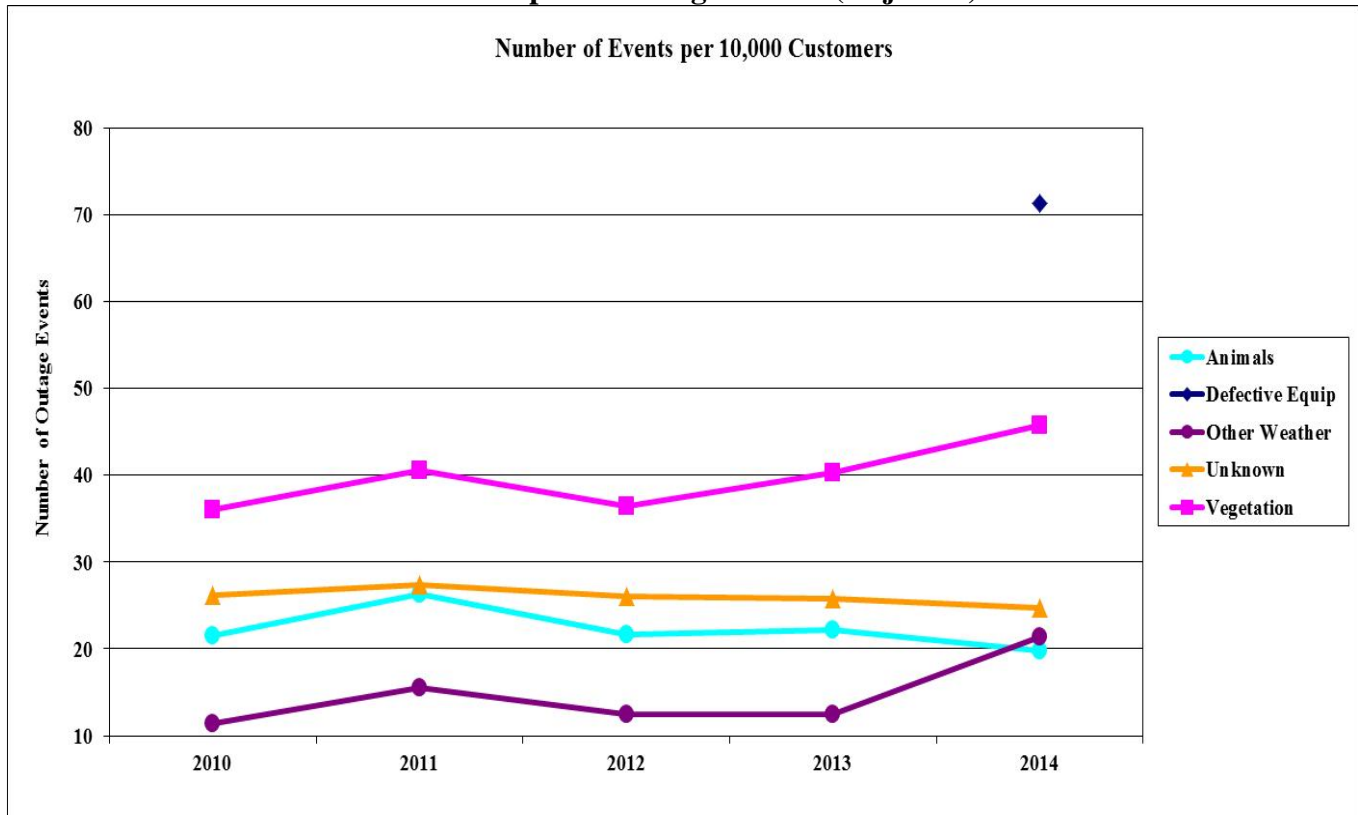
Figure 3-16.
FPL's Top Five Outage Causes (Adjusted)

Figure 3-16 depicts the top five causes of outage events on FPL's distribution system normalized to a 10,000-customer base. The graph is based on FPL's adjusted data of the top 10 causes of outage events. For the five-year period, the five top causes of outage events included Defective Equipment (33 percent), Vegetation (19 percent), Unknown (12 percent), Animals (11 percent), and Other Weather (6 percent) on a cumulative basis. The data shows an increasing trend in outage events caused by Vegetation and Other Weather. The number of outages increased for both categories from 2013 to 2014. The outage events due to Animals are trending downward. The Defective Equipment category dominates the highest percentage of outage causes throughout the FPL regions. Starting in 2014, Defective Equipment includes Equipment Failure, Equipment Connect and Dig-in, which were all separate categories, in prior years. The outage events due to Unknown continue to remain relatively flat over the five-year period.

Defective Equipment (33 percent) and Vegetation (21 percent) outages are the leading causes of the number of outage events per customer for 2014. Starting in 2014, Defective Equipment includes Equipment Failure, Equipment Connect and Dig-in, which were all separate categories, in prior years. The outages caused by vegetation are addressed through FPL's Vegetation Management Program. The next three outage causes are Unknown (12 percent), Other Causes (10 percent), and Animals (9 percent). Analysis of **Figure 3-16** shows an increasing trend in the number of outage events attributed to Vegetation, causing the number of outages to increase by 8 percent from 2013 to 2014. The analysis shows a decreasing trend in the number of outage events caused by Animals, causing the number of outages to decrease by 14 percent from 2013 to 2014 and an increasing trend of outage events by Other Weather, causing an increase of 40 percent from 2013 to 2014. The analysis shows that the trend for the Unknown category is flat even though there was a decrease in outages of 7 percent.

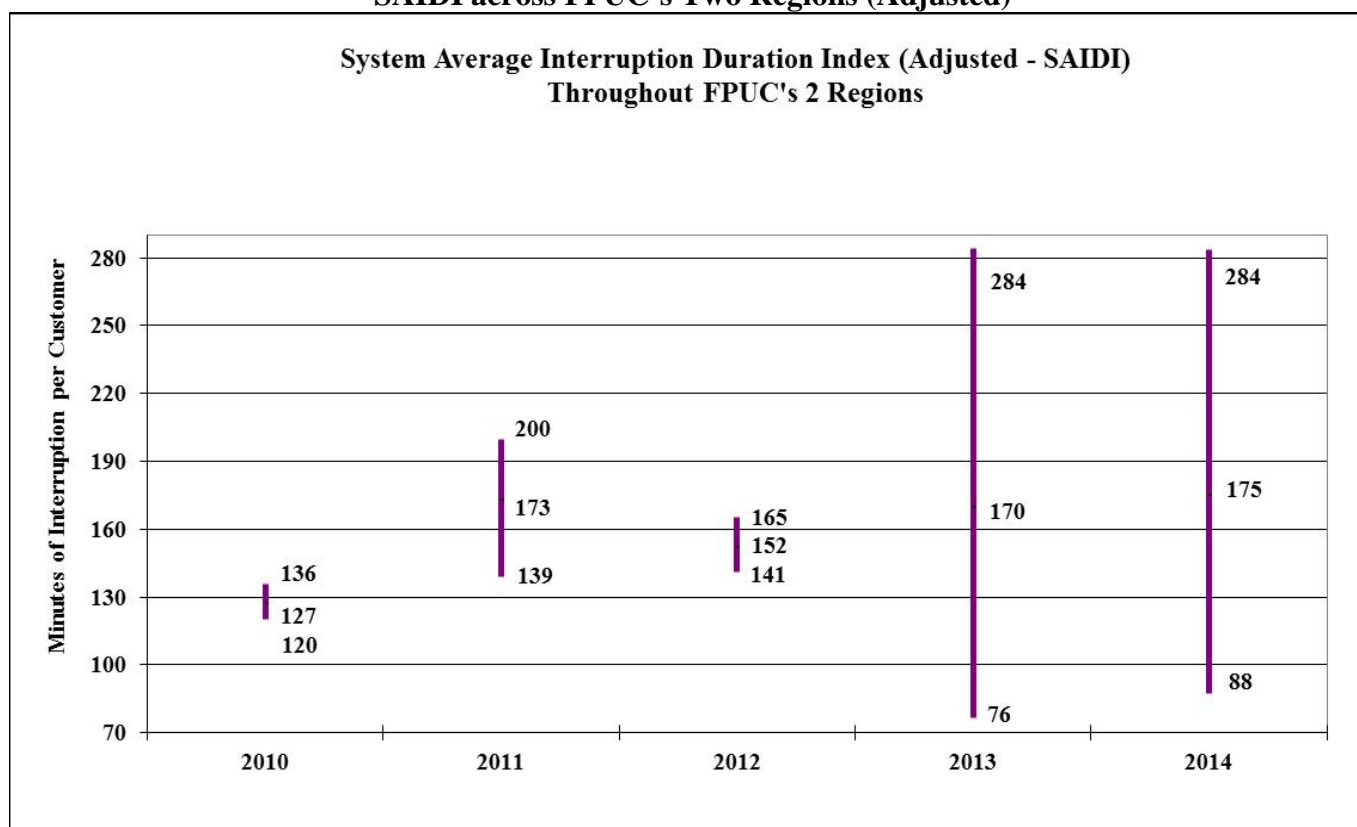
Figure 3-17.
SAIDI across FPUC's Two Regions (Adjusted)

Figure 3-17 shows the highest, average, and lowest adjusted SAIDI values recorded by FPUC's system. The data shows the average SAIDI index is trending upward for the five-year period of 2010 to 2014 and there was a 3 percent increase from 2013 to 2014. FPUC's 2014 Reliability Report notes that the reliability indicators continue to be heavily influenced by the weather and the small size of the territories.
