*Review of
Florida's
Investor-Owned
Electric Utilities*

*2 0 1 4
Service Reliability Reports*

State of Florida
Florida Public Service Commission
Division of Engineering

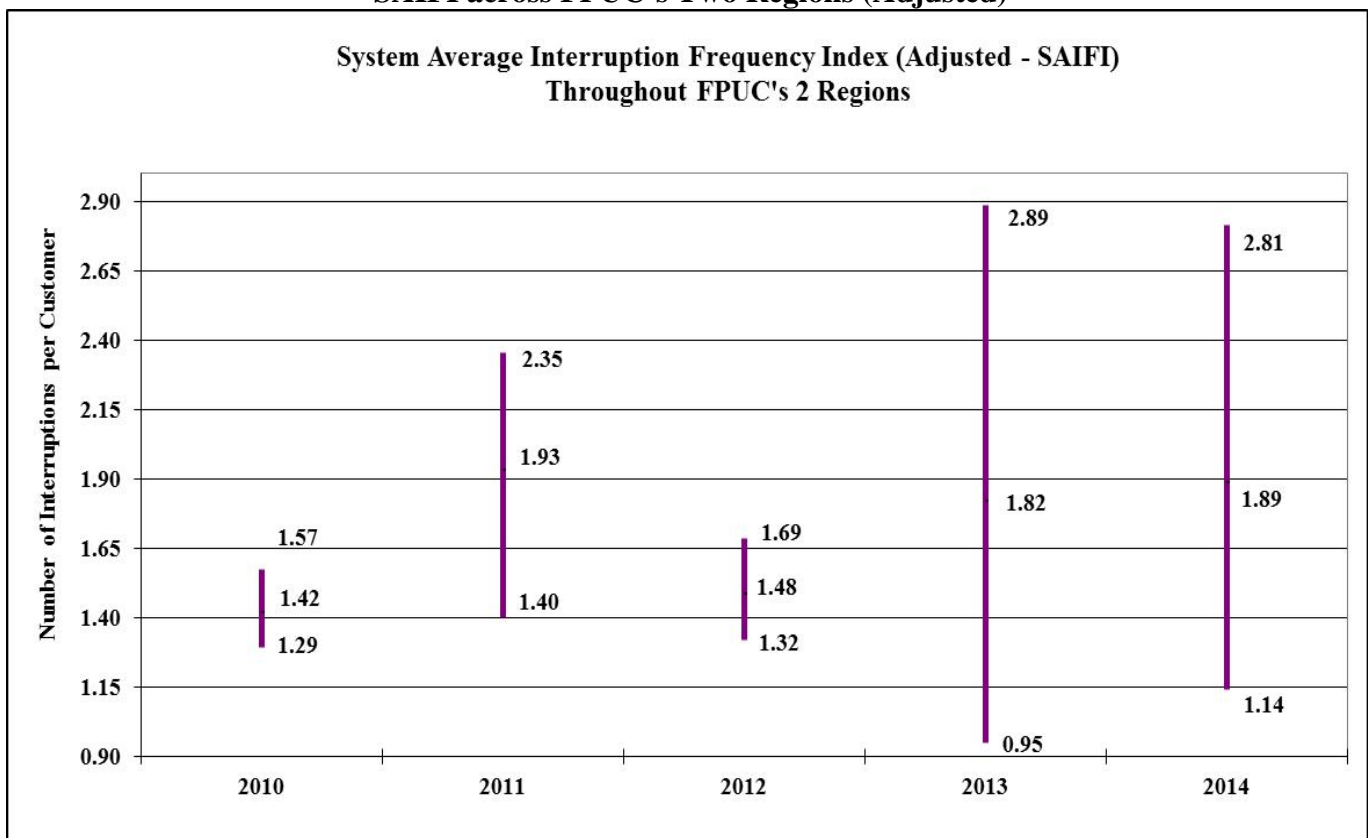
Figure 3-18.
SAIFI across FPUC’s Two Regions (Adjusted)

Figure 3-18 shows the adjusted SAIFI across FPUC’s two divisions. The data depicts a 4 percent increase in the 2014 average SAIFI reliability index from 2013. The data for the minimum SAIFI index is trending downward over the five-year period of 2010 to 2014 as the trend line for the average SAIFI and maximum SAIFI indices are trending upward for the same period.

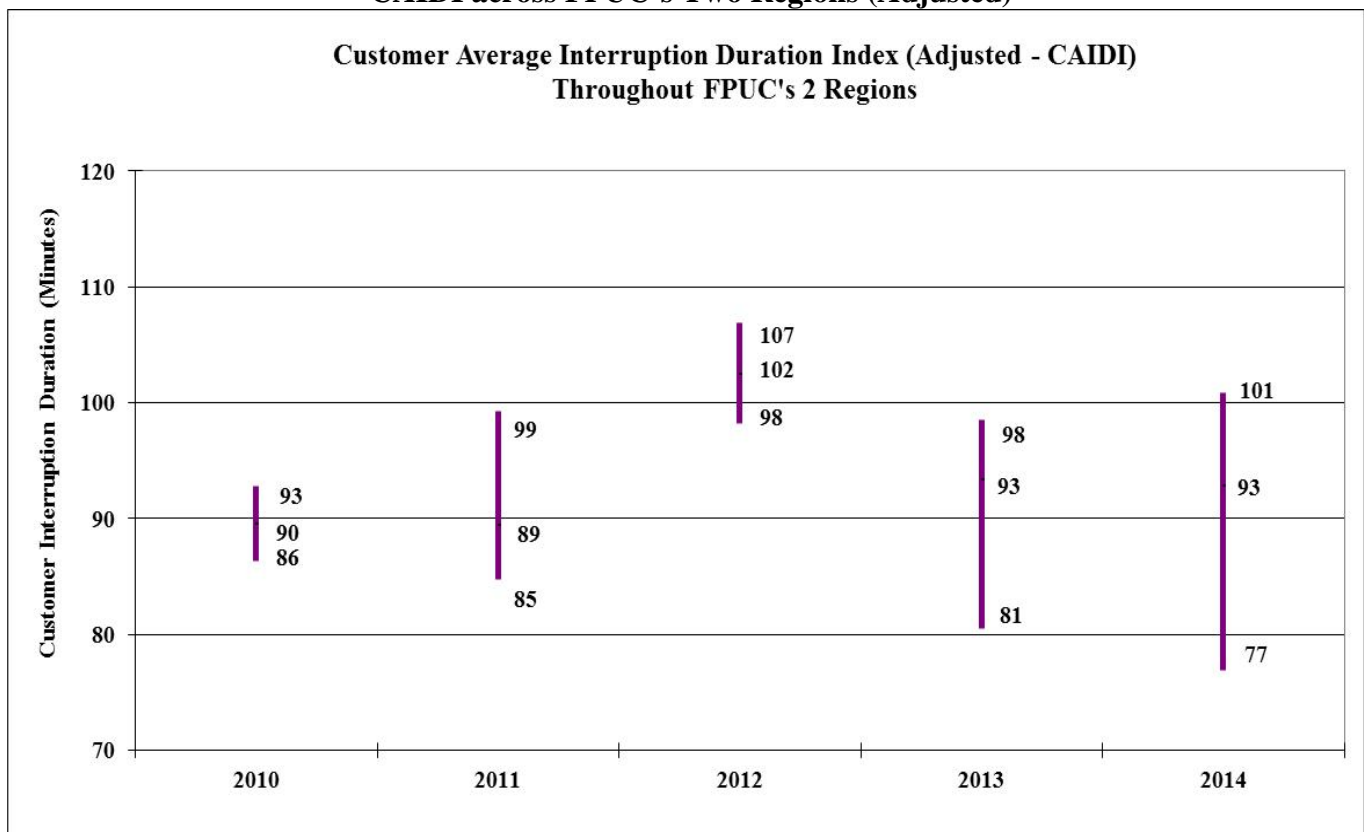
**Figure 3-19.
CAIDI across FPUC's Two Regions (Adjusted)**

Figure 3-19 shows the highest, average, and lowest adjusted CAIDI values across FPUC's system. FPUC's data shows the average CAIDI value is the same for 2014 as it was for 2013. For the past five years, the maximum CAIDI index and the average CAIDI index are trending upward as the minimum CAIDI index is trending downward.

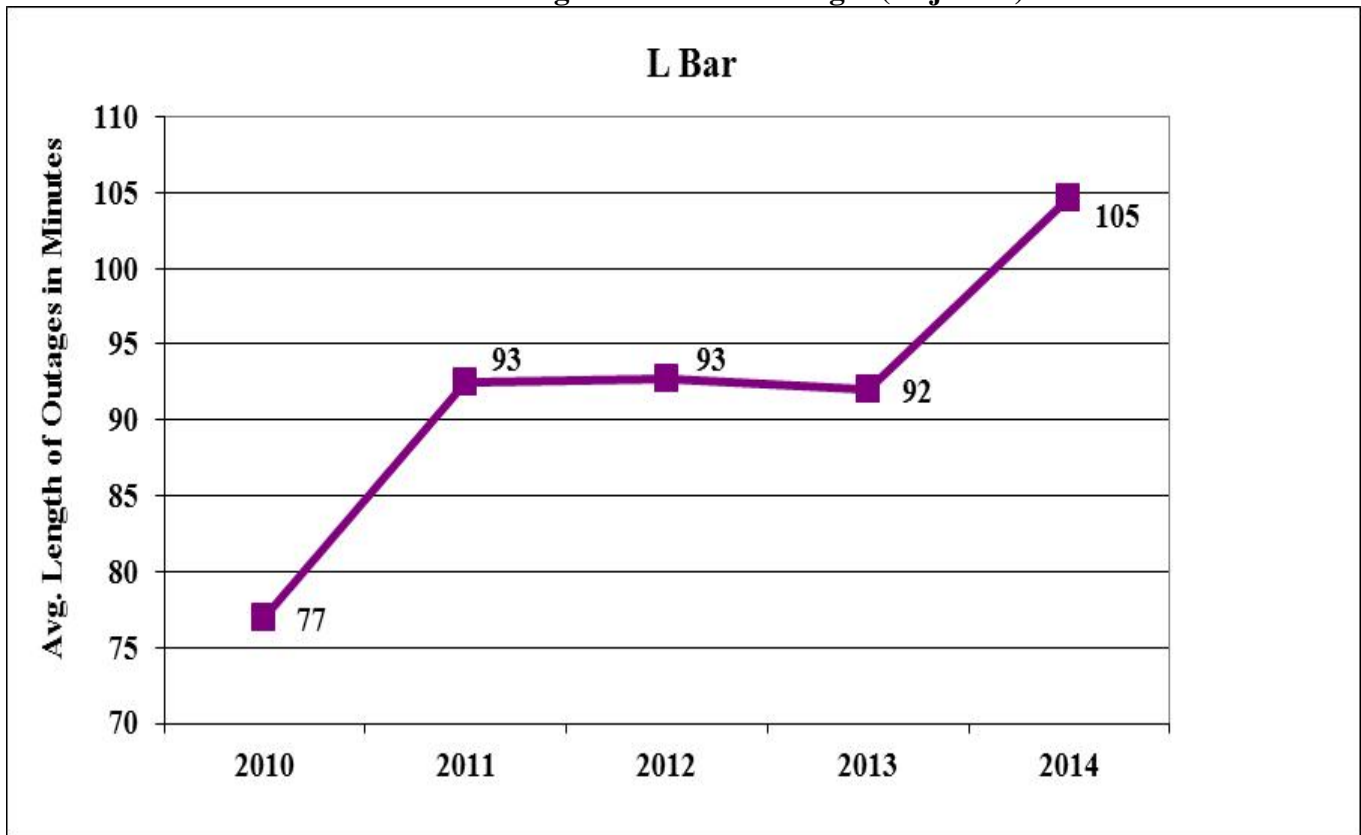
Figure 3-20.
FPUC's Average Duration of Outages (Adjusted)

Figure 3-20 is the average length of time FPUC spends recovering from outage events (adjusted L-Bar). There was a 12 percent increase in the L-Bar value from 2013 to 2014. The data for the five-year period of 2010 to 2014 suggests that the L-Bar index is trending upward indicating FPUC is taking more time to restore service after an outage event.

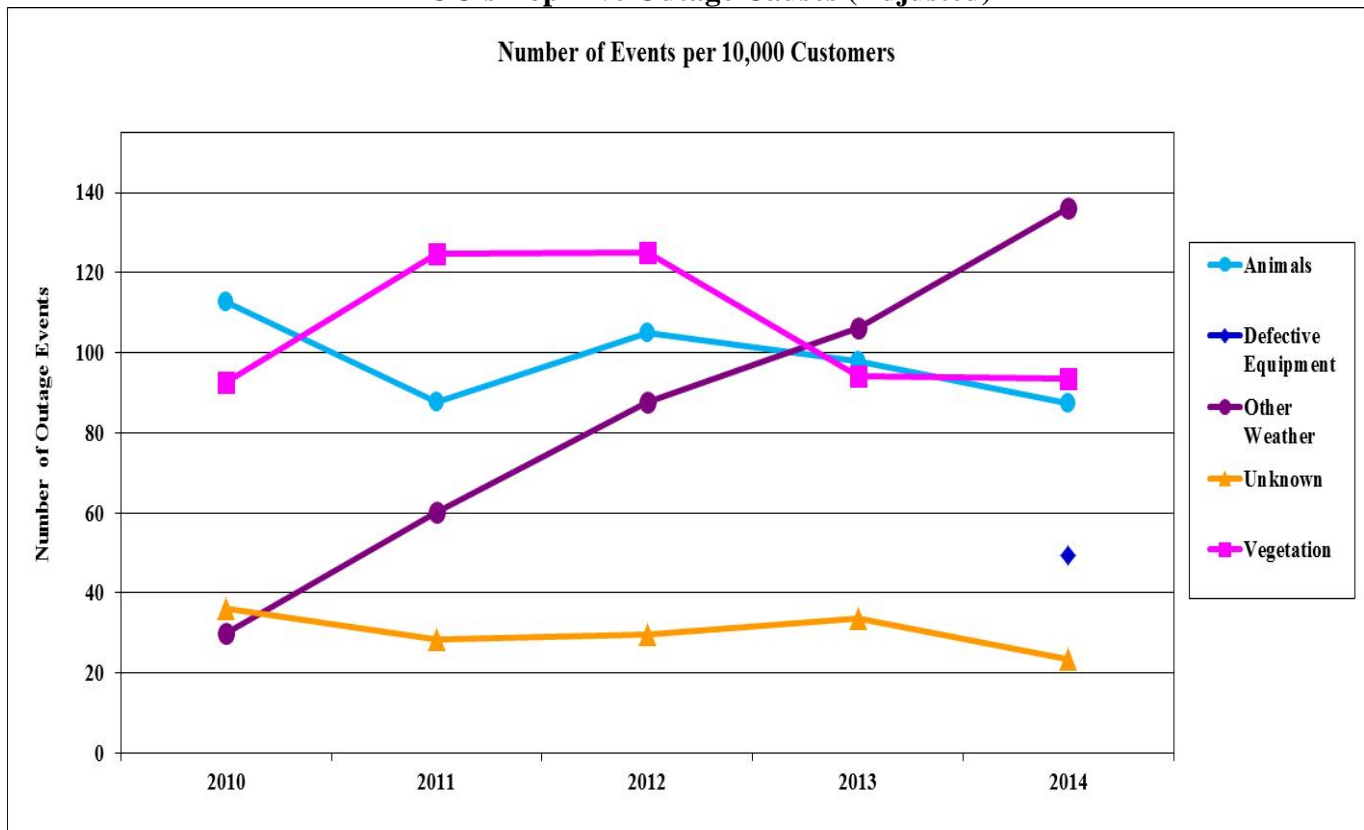
Figure 3-21.
FPUC's Top Five Outage Causes (Adjusted)

Figure 3-21 shows the top five causes of outage events on FPUC's distribution system normalized to a 10,000-customer base. The figure is based on FPUC's adjusted data of the top 10 causes of outages. For 2014, the top five causes of outage events were Other Weather (30 percent), Vegetation (21 percent), Animals (20 percent), Defective Equipment (11 percent), and Unknown (5 percent). These five factors represent 87 percent of the total adjusted outage causes in 2014. The cause by Other Weather is trending upward and increased 12 percent from 2013 to 2014. The causes by Animals and Vegetation are trending downward and there were a 20 percent and 12 percent decrease from 2013 to 2014, respectively. The Unknown category caused outages remain relatively flat over the five-year period of 2010 to 2014, even though there was a 39 percent decrease from 2013 to 2014. Beginning with 2014, the Defective Equipment category now includes outage categories that in the past were separately identified.

FPUC's top five causes of outages included Other Weather, Vegetation, Animals, Defective Equipment, and Unknown events. Other Weather (30 percent) related outages were the number one cause of outages for 2014 as shown in **Figure 3-21** followed by Vegetation (21 percent), Animals (20 percent), Defective Equipment (11 percent), and Unknown (5 percent). Animal, Unknown, and Vegetation attributed outages decreased in 2014, as Other Weather caused

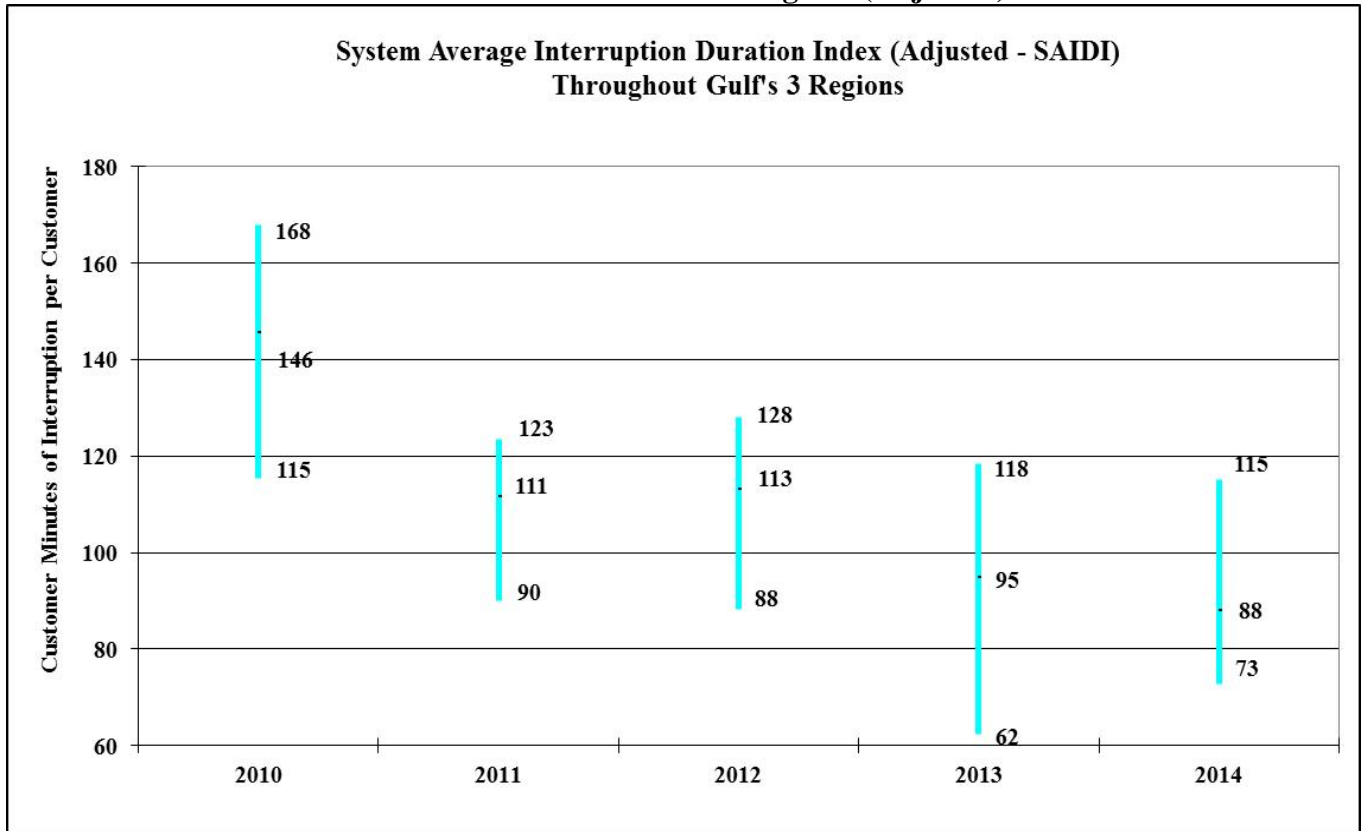
Figure 3-22.
SAIDI across Gulf's Three Regions (Adjusted)

Figure 3-22 illustrates Gulf's SAIDI minutes, or the interruption duration minutes on a system basis. The chart depicts a decrease in the average SAIDI value by 7 minutes in Gulf's combined regions when compared to the 2013 results. Gulf's 2014 average performance was 7 percent better than the 2013 SAIDI results. The highest SAIDI value for the past five years has fluctuated between the three regions as the Central and Eastern districts have the best or lowest SAIDI values. The maximum, minimum, and average SAIDI indices are continuing to trend downward, showing improvements.

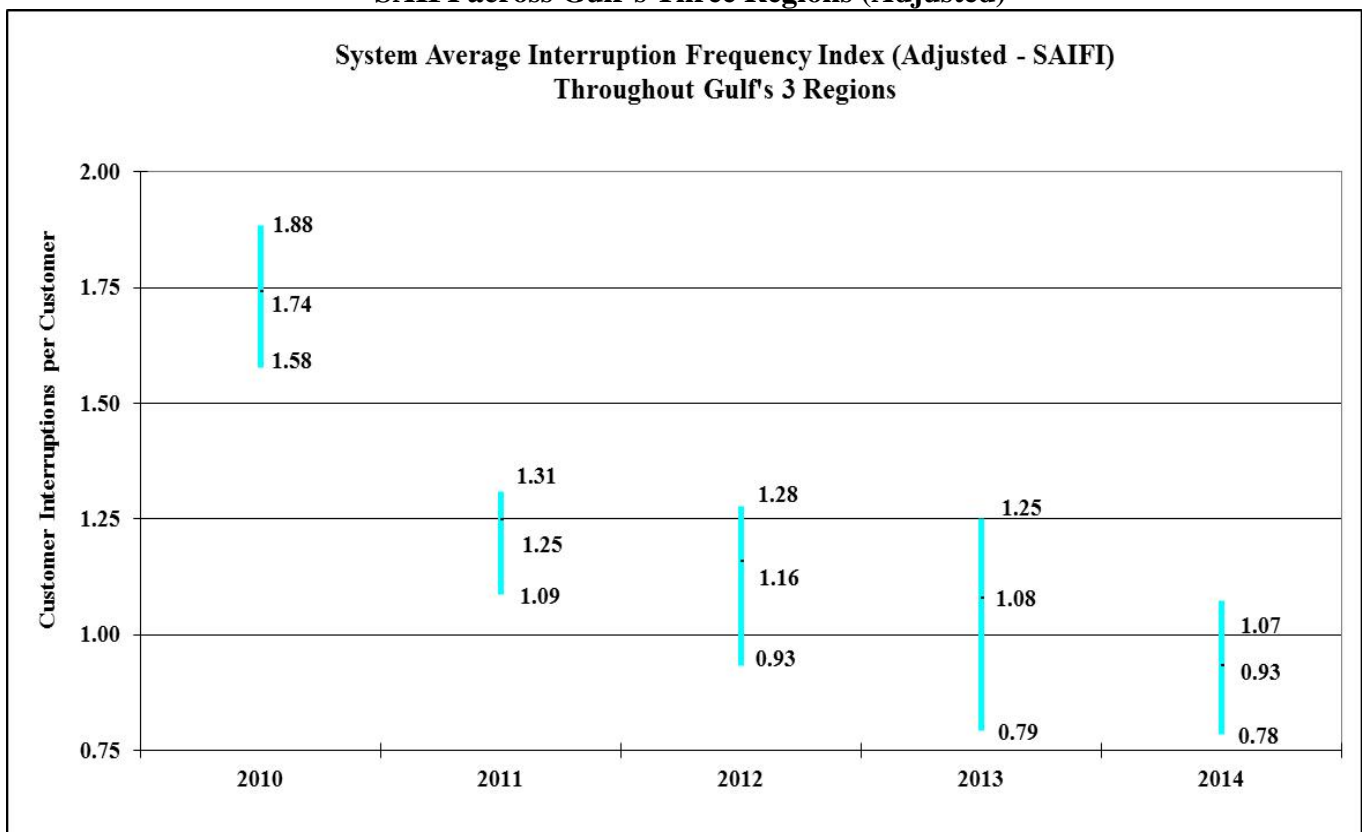
**Figure 3-23.
SAIFI across Gulf’s Three Regions (Adjusted)**

Figure 3-23 illustrates that Gulf’s SAIFI had a 14 percent decrease in 2014 when compared to 2013. The highest SAIFI value for the past five years has fluctuated between the three regions. The lowest values appear to fluctuate between the Central region and the Eastern region. The maximum, minimum, and average SAIFI values still appear to be trending downward.

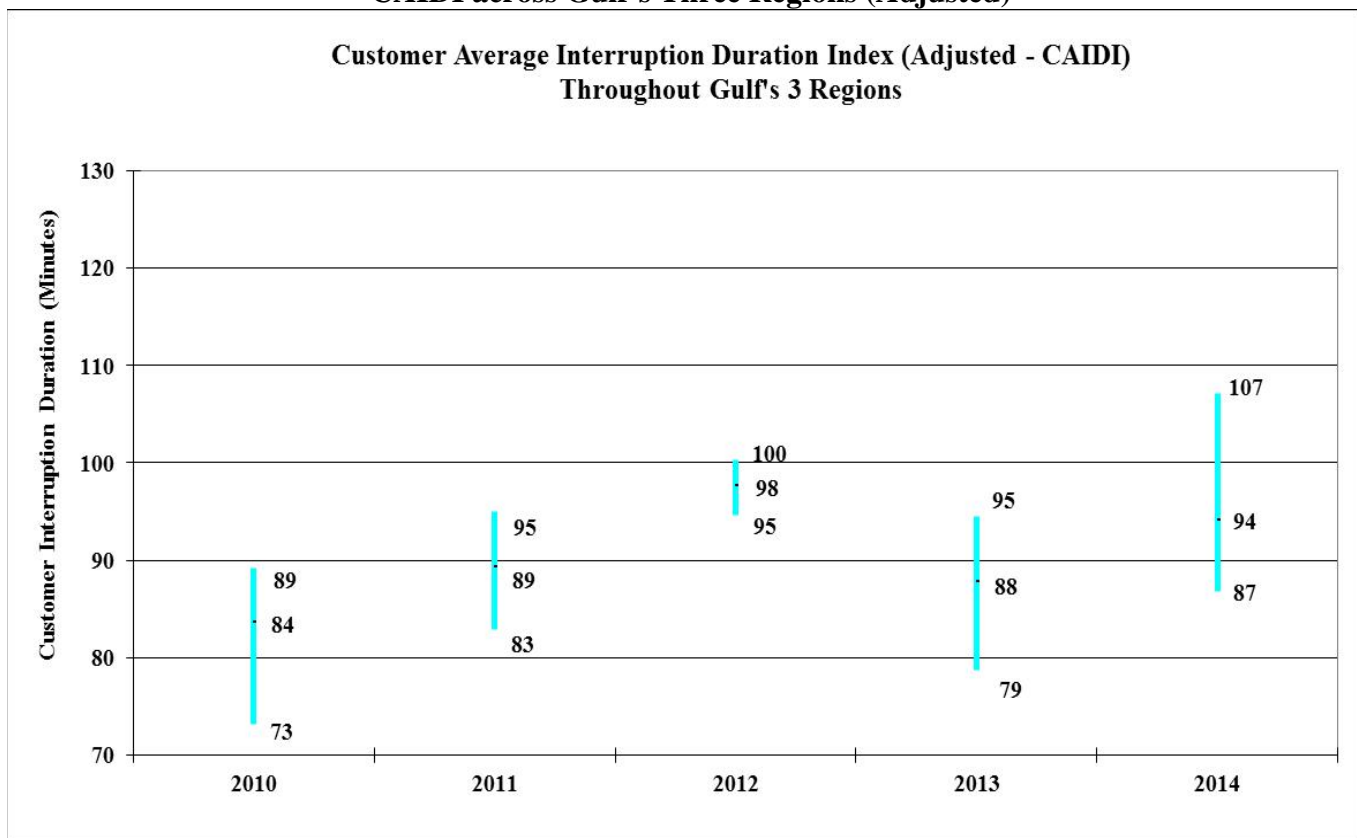
**Figure 3-24.
CAIDI across Gulf’s Three Regions (Adjusted)**

Figure 3-24 is Gulf’s adjusted CAIDI. For 2014, the average CAIDI is 94 minutes and represents a 6 percent increase from the 2013 value of 88 minutes. In 2014, the Central region had the highest CAIDI value, as the Western region had the lowest CAIDI. Staff notes that the maximum, the average, and minimum CAIDI values are trending upward.

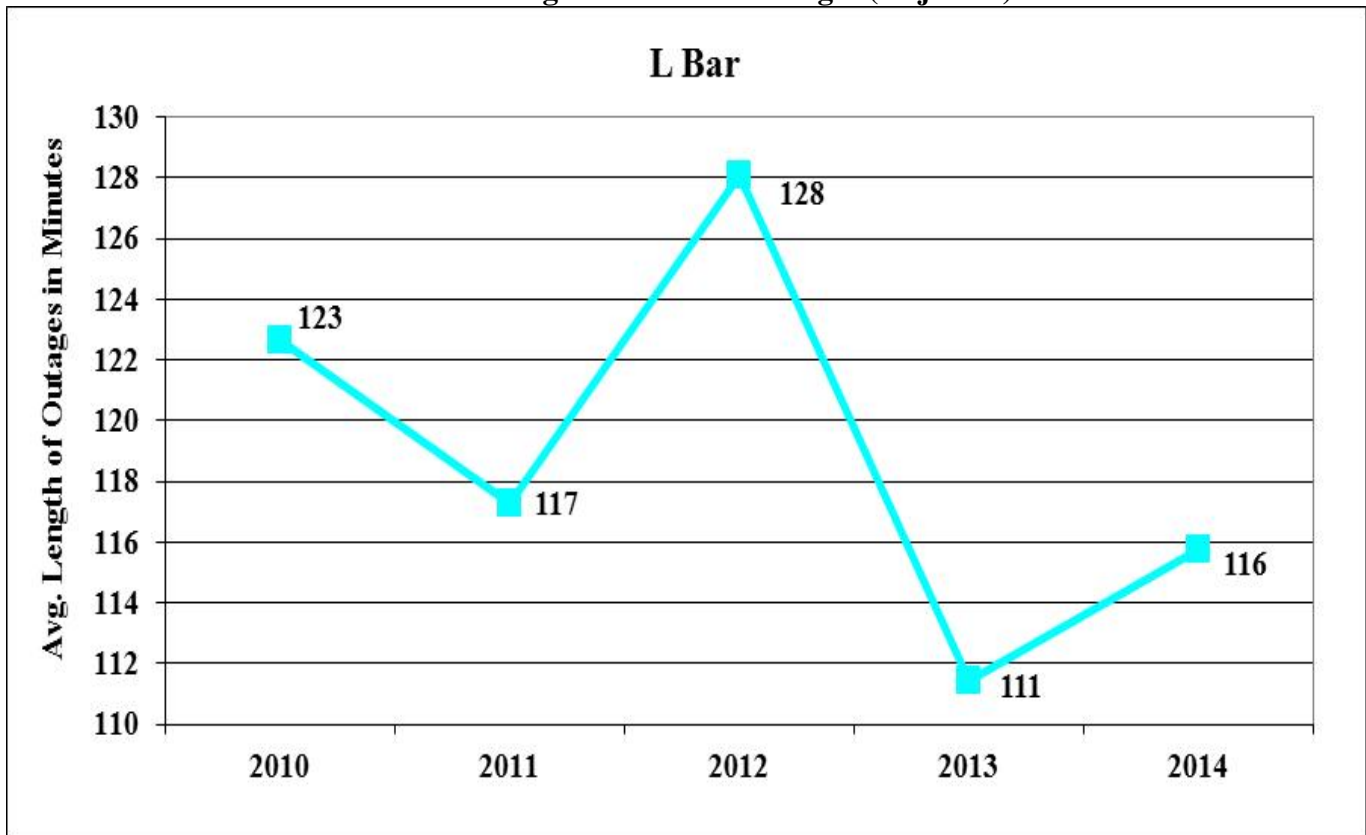
Figure 3-25.
Gulf's Average Duration of Outages (Adjusted)

Figure 3-25 illustrates Gulf's L-Bar or the average length of time Gulf spends recovering from outage events, excluding hurricanes and other allowable excluded outage events. Gulf's L-Bar showed a 4 percent increase from 2013 to 2014. The data for the five-year period of 2010 to 2014 still shows a downward trend.

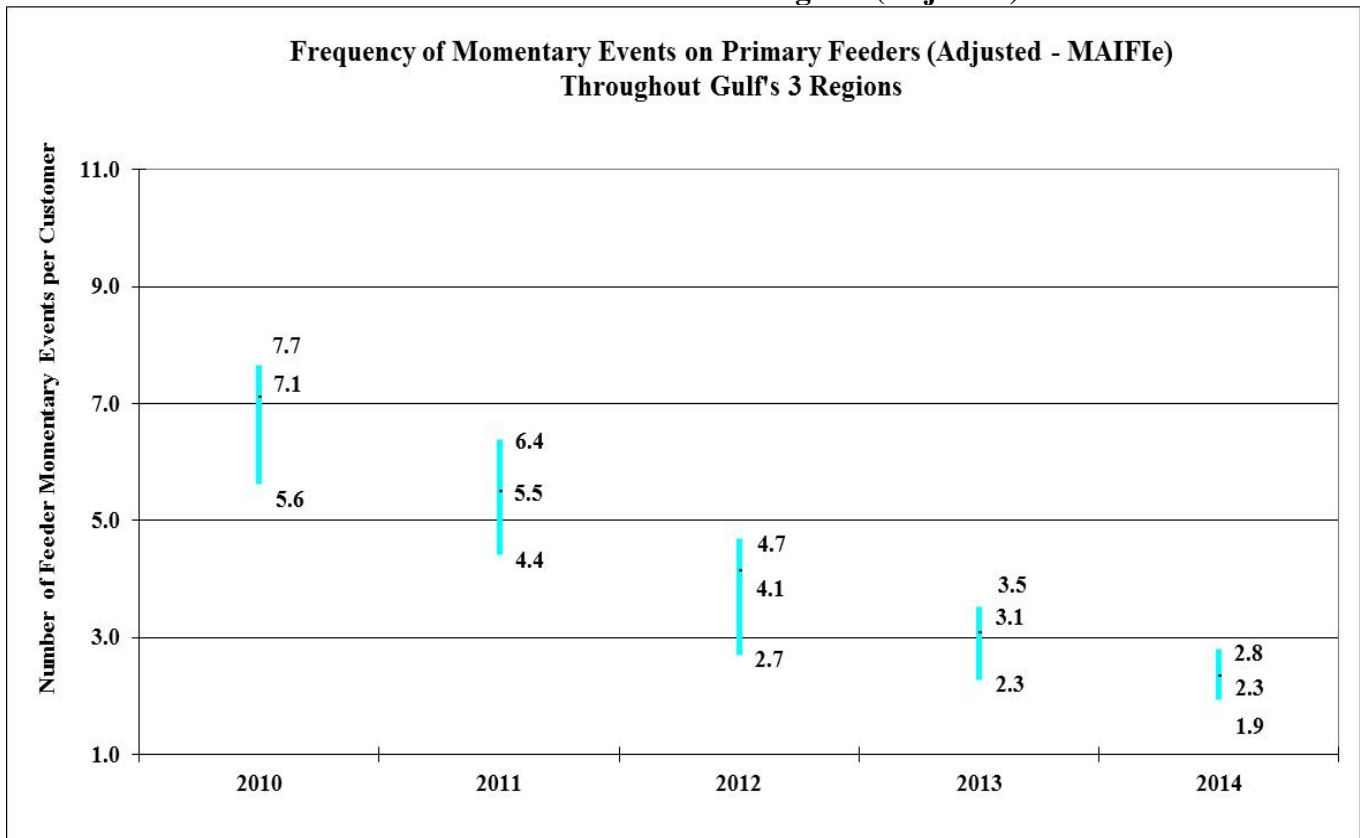
**Figure 3-26.
MAIFle across Gulf’s Three Regions (Adjusted)**

Figure 3-26 is the adjusted MAIFle recorded across Gulf’s system. The adjusted MAIFle results by region show that the Eastern region once again had the lowest frequency of momentary events on primary feeders. The Central region has the highest MAIFle index in 2014, with a 17 percent improvement when compared to 2013. The data suggests that the highest, average, and lowest MAIFle are all continuing to trend downward, suggesting improvement.

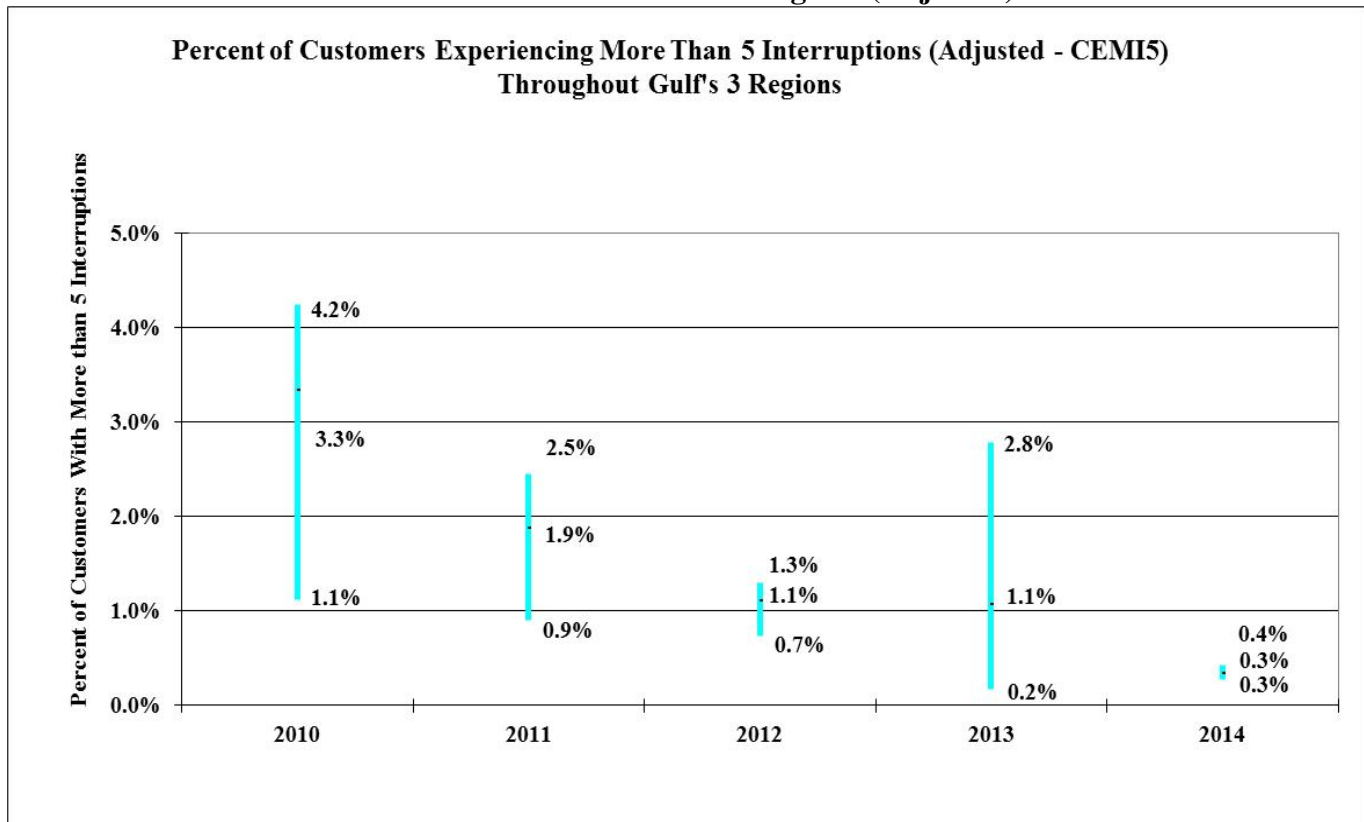
Figure 3-27.
CEMI5 across Gulf's Three Regions (Adjusted)

Figure 3-27 shows the highest, average, and lowest adjusted CEMI5 across Gulf's Western, Central, and Eastern regions. Gulf's 2014 results illustrate a 73 percent decrease in the average CEMI5 percentage when compared to 2013. The average, lowest, and highest CEMI5 appears to still be trending downward over the five-year period of 2010 to 2014, suggesting that the percentage of Gulf's customers experiencing more than five interruptions is decreasing and improving.

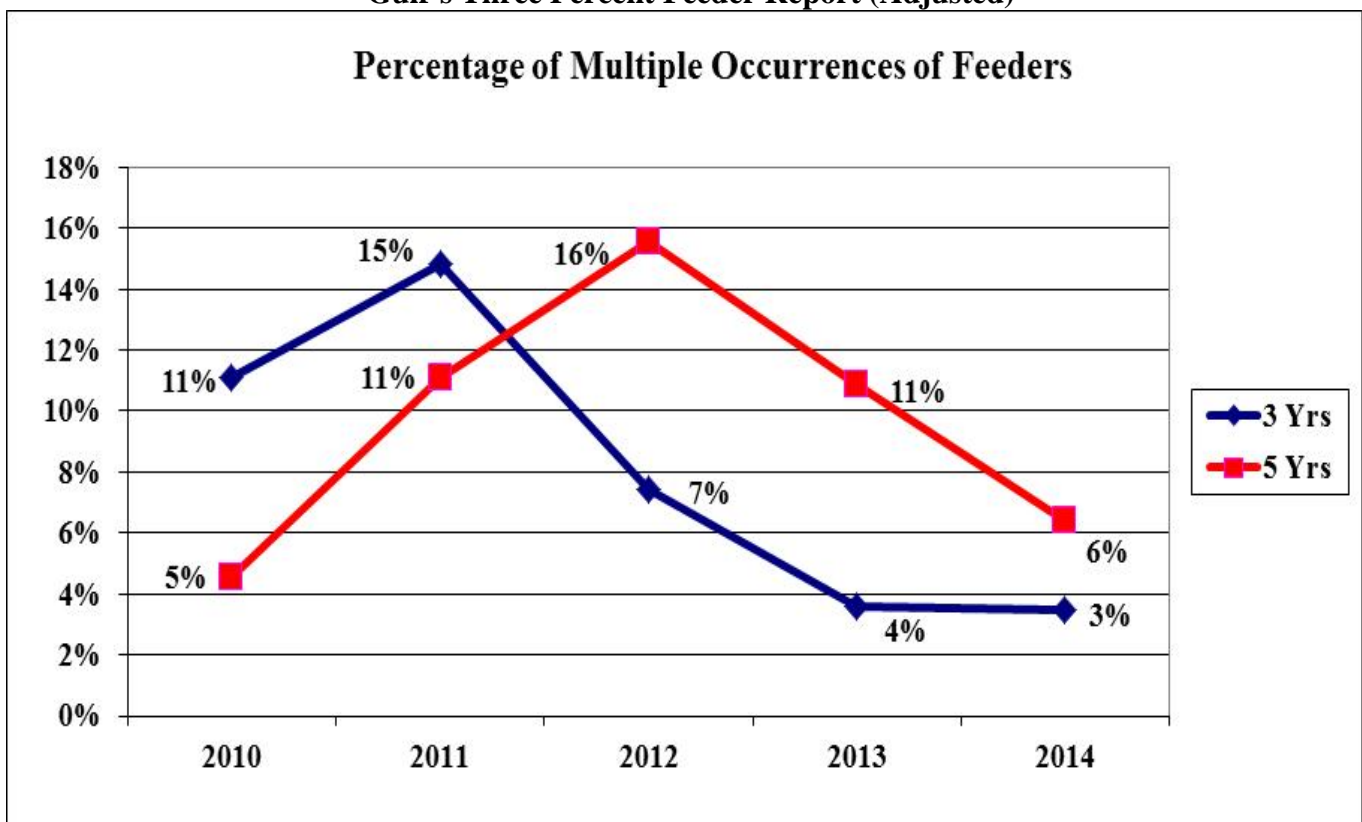
Figure 3-28.
Gulf's Three Percent Feeder Report (Adjusted)

Figure 3-28 shows the multiple occurrences of feeders using the utility's Three Percent Feeder Report and is analyzed on a three- and five-year basis. The Three Percent Feeder Report is a listing of the top three percent of feeders that have the most feeder outage events. The supporting data illustrates that the five-year multiple occurrences have decreased from 11 percent to 6 percent from 2013 to 2014 along with the three-year multiple occurrences, which decreased from 4 percent to 3 percent. The five-year period of 2010 to 2014 indicates overall that the five-year index is slightly trending upward even though there was a decrease in percentages from 2013 to 2014. The three-year multiple occurrences index continues to trend downward.

Staff notes there was one feeder on the Actual and Adjusted Three Percent Feeder Report for 2014. Gulf explained that there were four outages on this feeder that occurred on the same day. Gulf determined the outages were caused by lightning strikes and there was damage to both the wire and an insulator. All repairs were completed in December 2014. Gulf will perform an additional review of this feeder to determine if there are any other improvement opportunities.

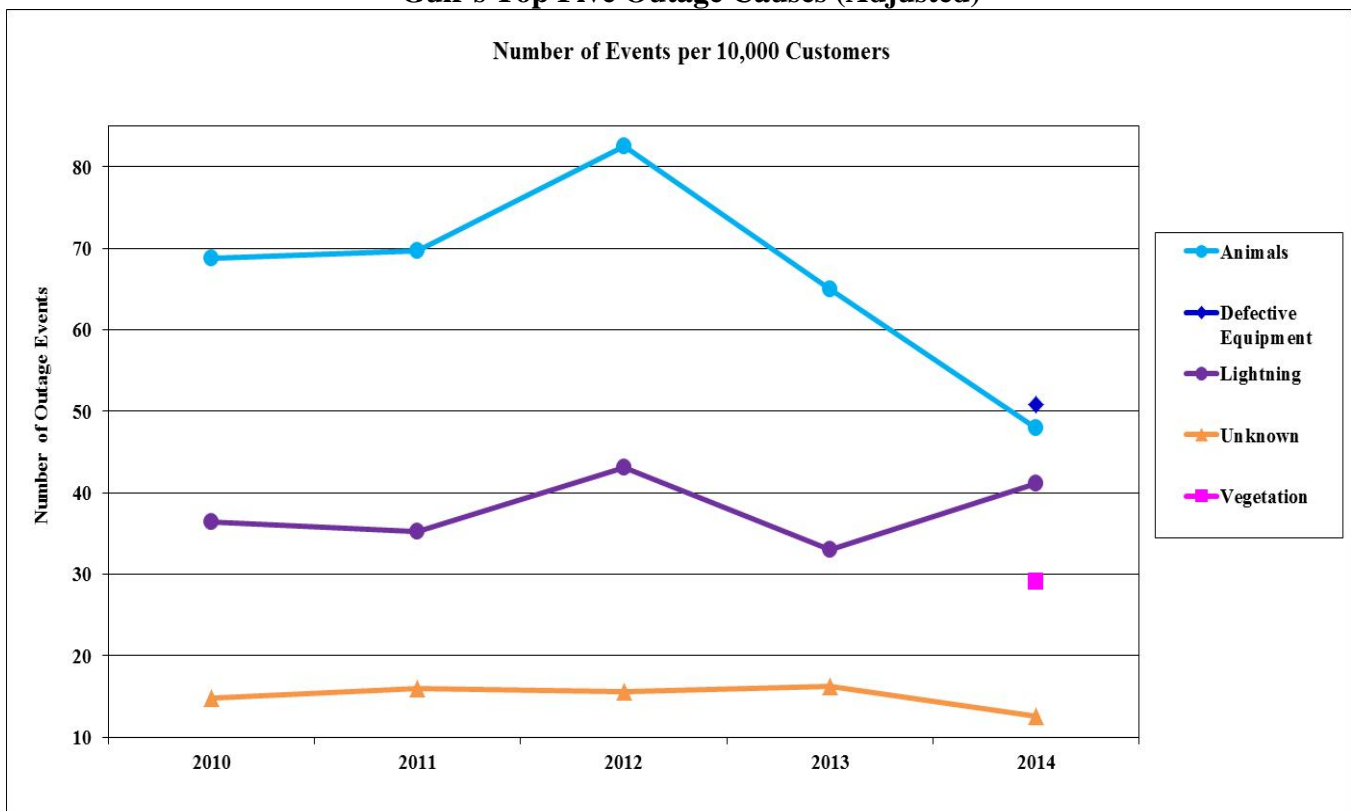
Figure 3-29.
Gulf’s Top Five Outage Causes (Adjusted)

Figure 3-29 is a graph of the top five causes of outage events on Gulf’s distribution system normalized to a 10,000-customer base. The figure is based on Gulf’s adjusted data of the top 10 causes of outage events and represents 89 percent of the total adjusted outage events that occurred during 2014. The top five causes of outage events were Defective Equipment (25 percent), Animals (24 percent), Lightning (20 percent), Vegetation (14 percent), and Unknown Causes (6 percent). The percentage of outages due to Defective Equipment was the highest cause of outages. As the number of outage events due to Animals is trending downward, the number of outage events due to Unknown causes has remained relatively flat. The number of outage events due to Lightning is trending upward. The Defective Equipment and Vegetation categories now include outage categories that in the past were separately identified. To improve reliability, Gulf is replacing arresters, installing animals guards, replacing damaged or cut grounds, and using AMI data to replace transformers that may fail in the future.

Gulf's top five causes of outages were listed as Defective Equipment, Animals, Lightning, Vegetation, and Unknown. Defective Equipment (25 percent) caused outages was the number one cause of outages followed by Animals (24 percent), Lightning (20 percent), Vegetation (14 percent), and Unknown (6 percent). The number of outages decreased for two of the top five outage categories in 2014 when compared to 2013, which were outages due to Animals and Unknown as shown in **Figure 3-29**. The Defective Equipment and Vegetation categories now include outage categories that in the past were separately identified.

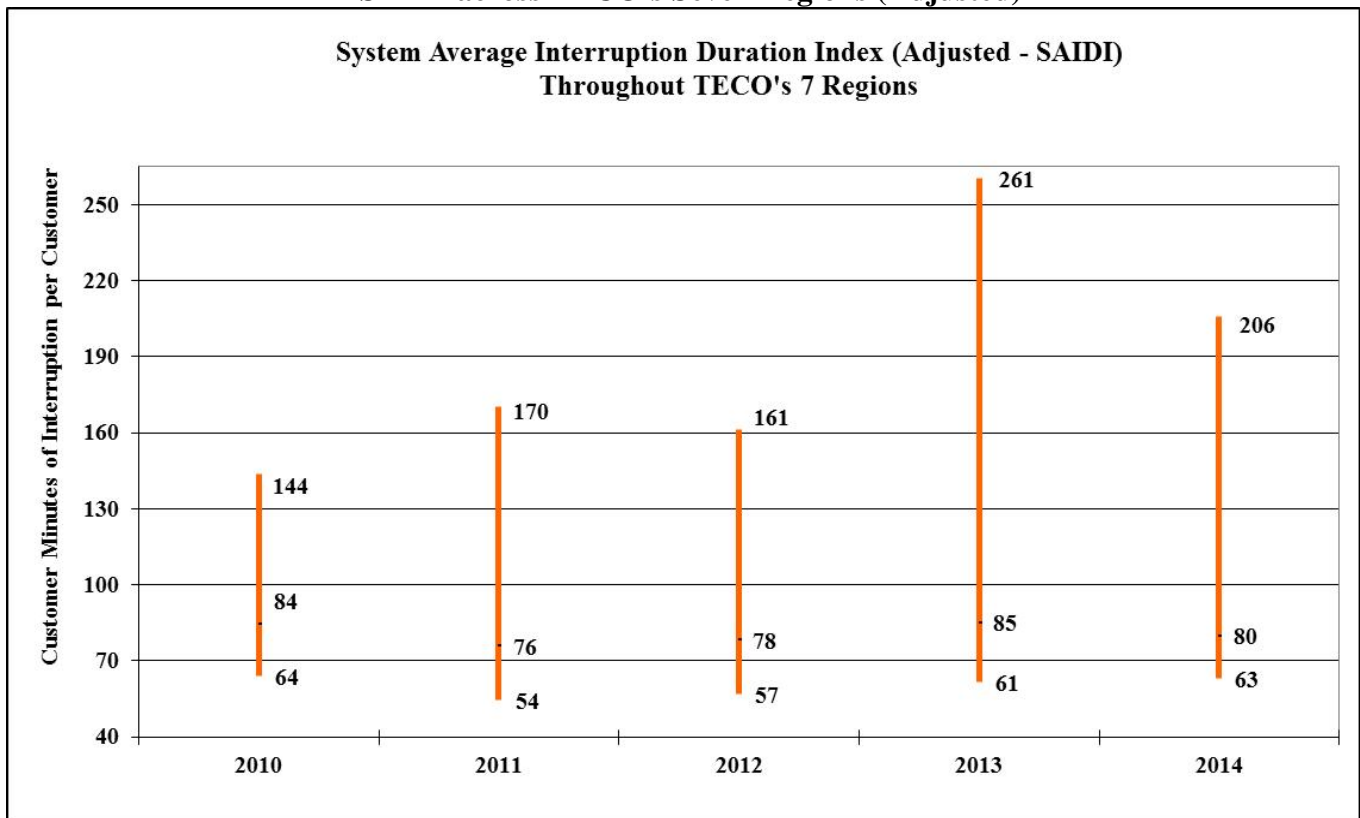
Figure 3-30.
SAIDI across TECO's Seven Regions (Adjusted)

Figure 3-30 shows the adjusted SAIDI values recorded by TECO's system. Two of the seven TECO regions had an increase in SAIDI performance during 2014, with Plant City and Dade City having the highest SAIDI performance results for the five-year period of 2010 to 2014. The lowest SAIDI index for the seven regions appears to be staying relatively flat. The average SAIDI index decreased 6 percent from 2013 to 2014 and appears to also be relatively flat. The Central, Eastern, and Winter Haven regions recorded the lowest SAIDI indices for the five-year period. Dade City, Plant City, and South Hillsborough regions have the fewest customers and represent the most rural, lowest customer density per line mile in comparison to the other four TECO divisions.

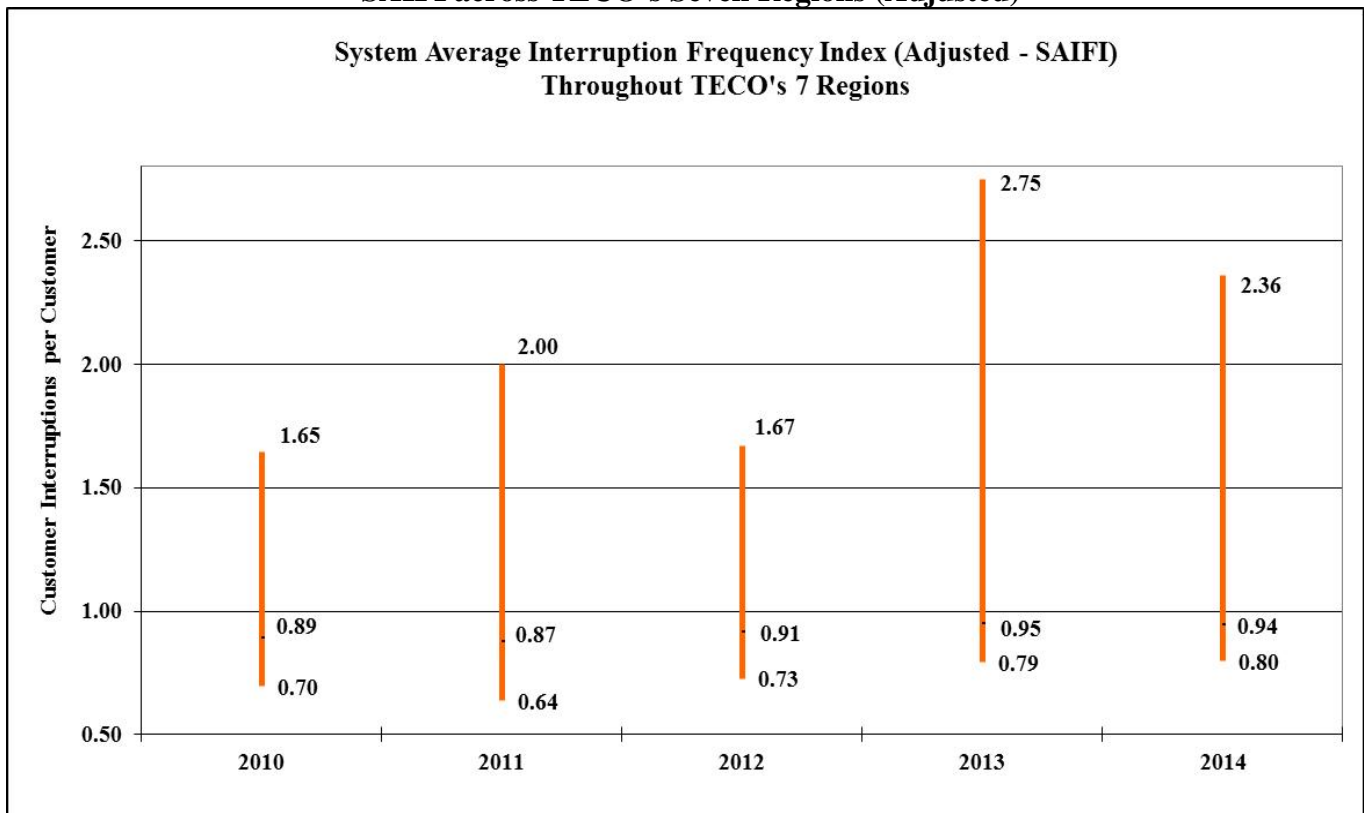
**Figure 3-31.
SAIFI across TECO's Seven Regions (Adjusted)**

Figures 3-31 illustrates TECO's adjusted frequency of interruptions per customer reported by the system. TECO's data represents a 1 percent decrease in the SAIFI average from 0.95 interruptions in 2013 to 0.94 interruptions in 2014. TECO's Dade City region continues to have the highest frequency of service interruptions when compared to TECO's other regions. The maximum, minimum, and average SAIFI are all trending upward.

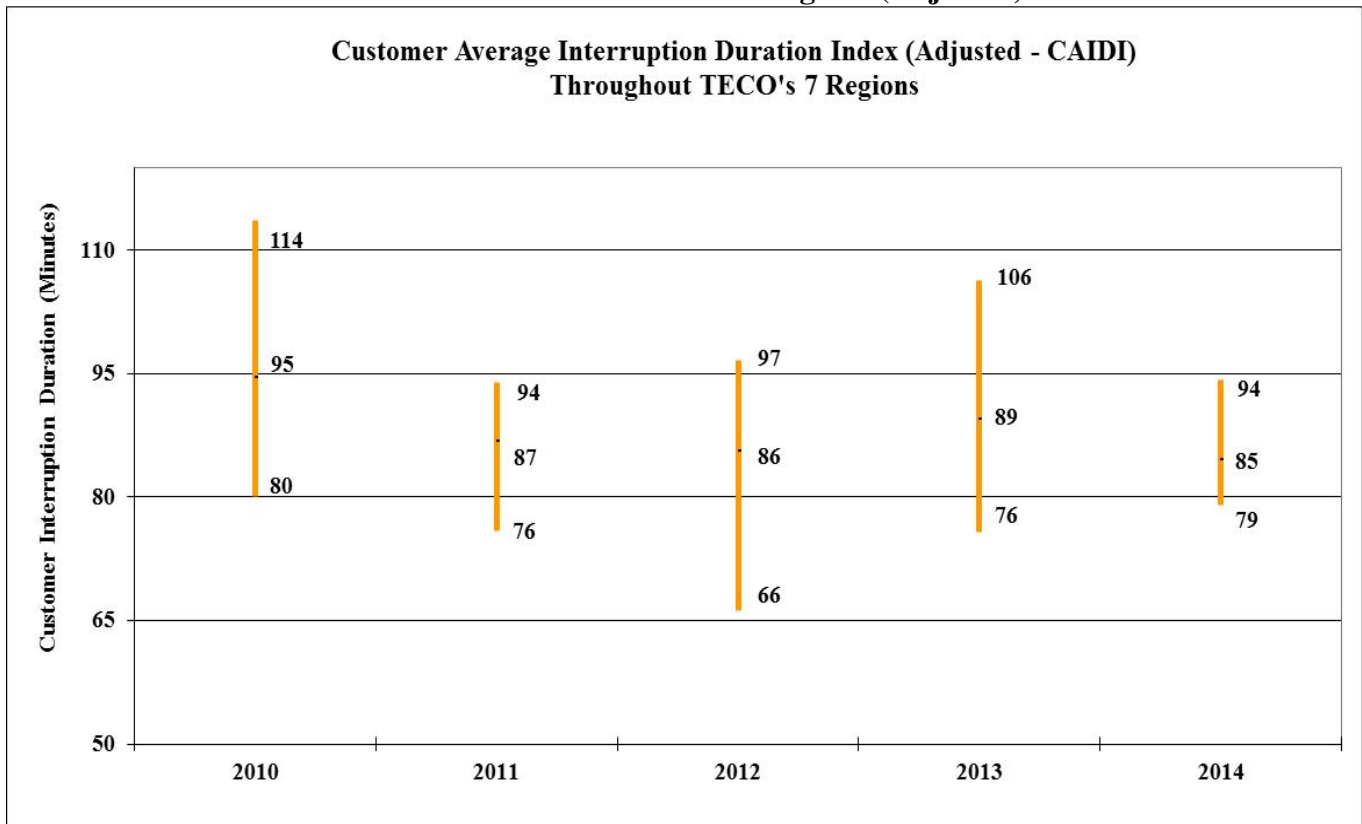
Figure 3-32.
CAIDI across TECO's Seven Regions (Adjusted)

Figure 3-32 charts the length of time that a typical TECO customer experiences an outage, which is known as CAIDI. The highest CAIDI minutes do not appear to be confined to any particular service area. Winter Haven, Eastern, and Central regions have had the lowest (best) results for the last five years. The average CAIDI is trending downward at this time suggesting TECO's customers are experiencing shorter lasting outages. There was a 4 percent decrease in the average CAIDI when comparing 2013 to 2014.

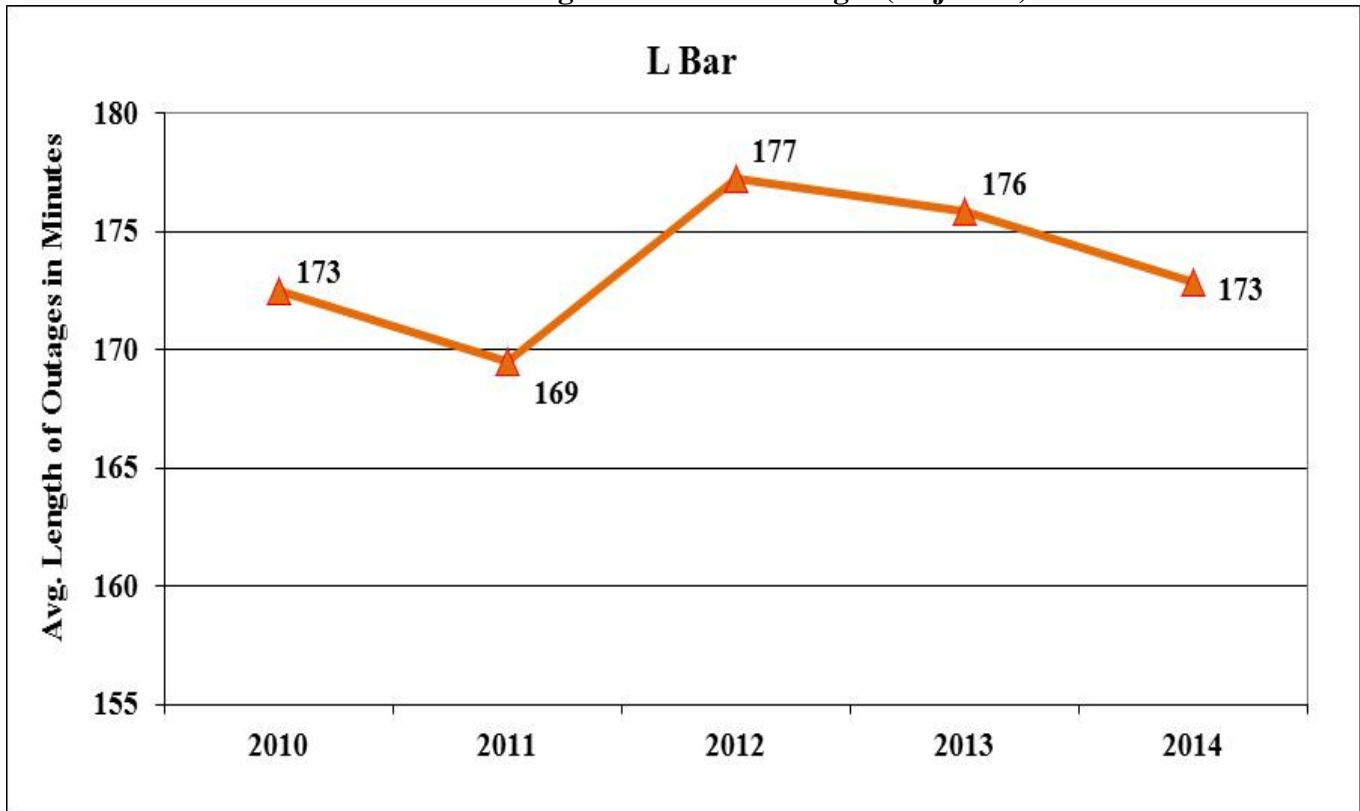
Figure 3-33.
TECO's Average Duration of Outages (Adjusted)

Figure 3-33 denotes a 2 percent decrease in outage durations for the period from 2013 to 2014 for TECO. The average length of time TECO spends restoring service to its customers affected by outage events, excluding hurricanes and other allowable excluded outage events is shown in the index L-Bar. The L-Bar index continues to be trending upward for the five-year period of 2010 to 2014, suggesting longer restoral times even though there was a decrease in the L-bar index from 2013 to 2014.

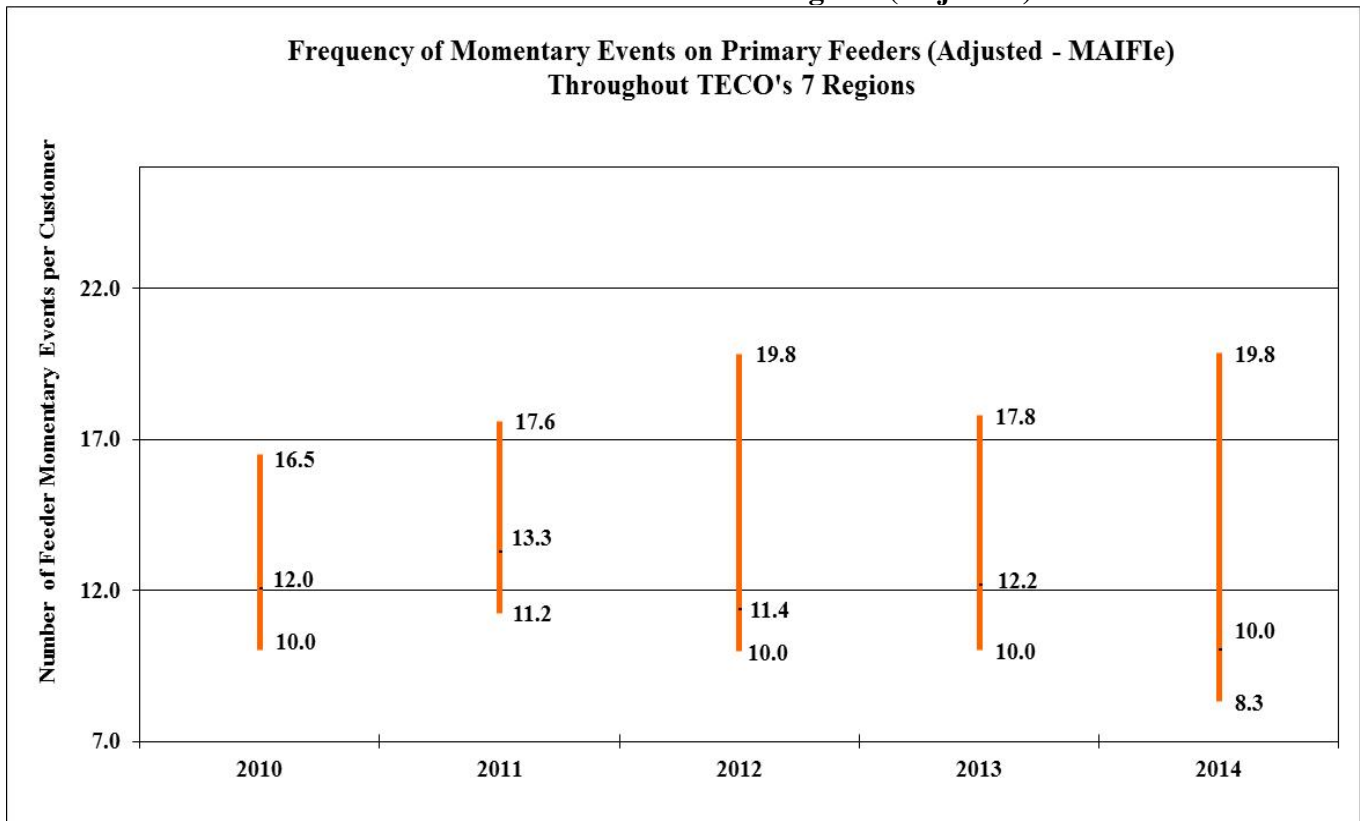
**Figure 3-34.
MAIFIE across TECO’s Seven Regions (Adjusted)**

Figure 3-34 illustrates TECO’s number of momentary events on primary circuits per customer recorded across its system. In 2014, the MAIFIE performance improved over the 2013 results in all regions except Dade City. The average MAIFIE decreased 18 percent from 2013 to 2014. **Figure 3-34** shows that the average MAIFIE is trending downward, which suggest an improvement in performance over the five-year period of 2010 to 2014.
