*Review of
Florida's
Investor-Owned
Electric Utilities*

*2 0 1 4
Service Reliability Reports*

State of Florida
Florida Public Service Commission
Division of Engineering

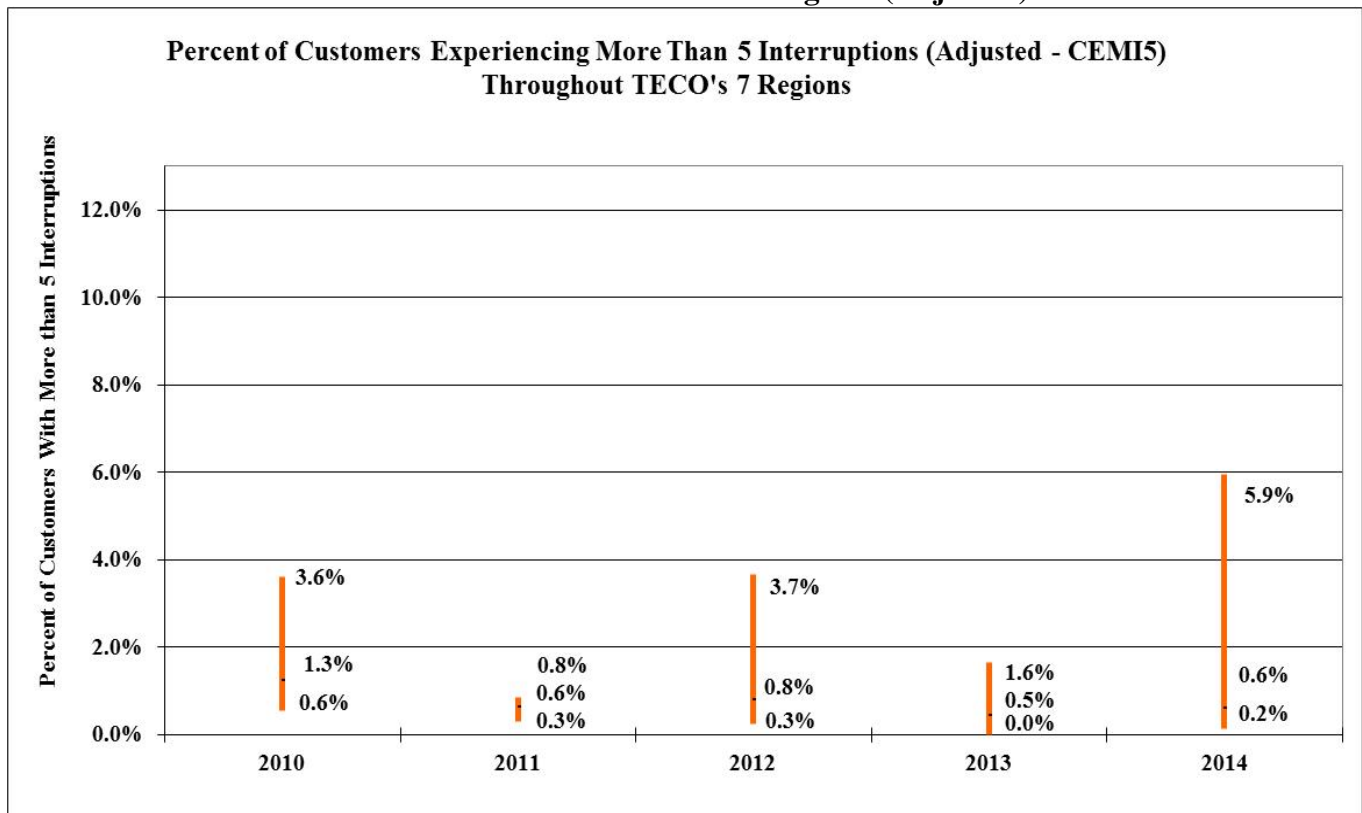
Figure 3-35.
CEMI5 across TECO’s Seven Regions (Adjusted)

Figure 3-35 shows the percent of TECO’s customers experiencing more than five interruptions. Four regions in TECO’s territory experienced a decrease in the CEMI5 results for 2014. The Central, Dade City, and Winter Haven regions experienced an increase in the CEMI5 index. Dade City reported the highest CEMI5 percentage for 2014. With TECO’s results for this index varying for the past five years, the average CEMI5 index still appears to be trending downward suggesting improvement. There was a 16 percent increase in the average CEMI5 index from 2013 to 2014.

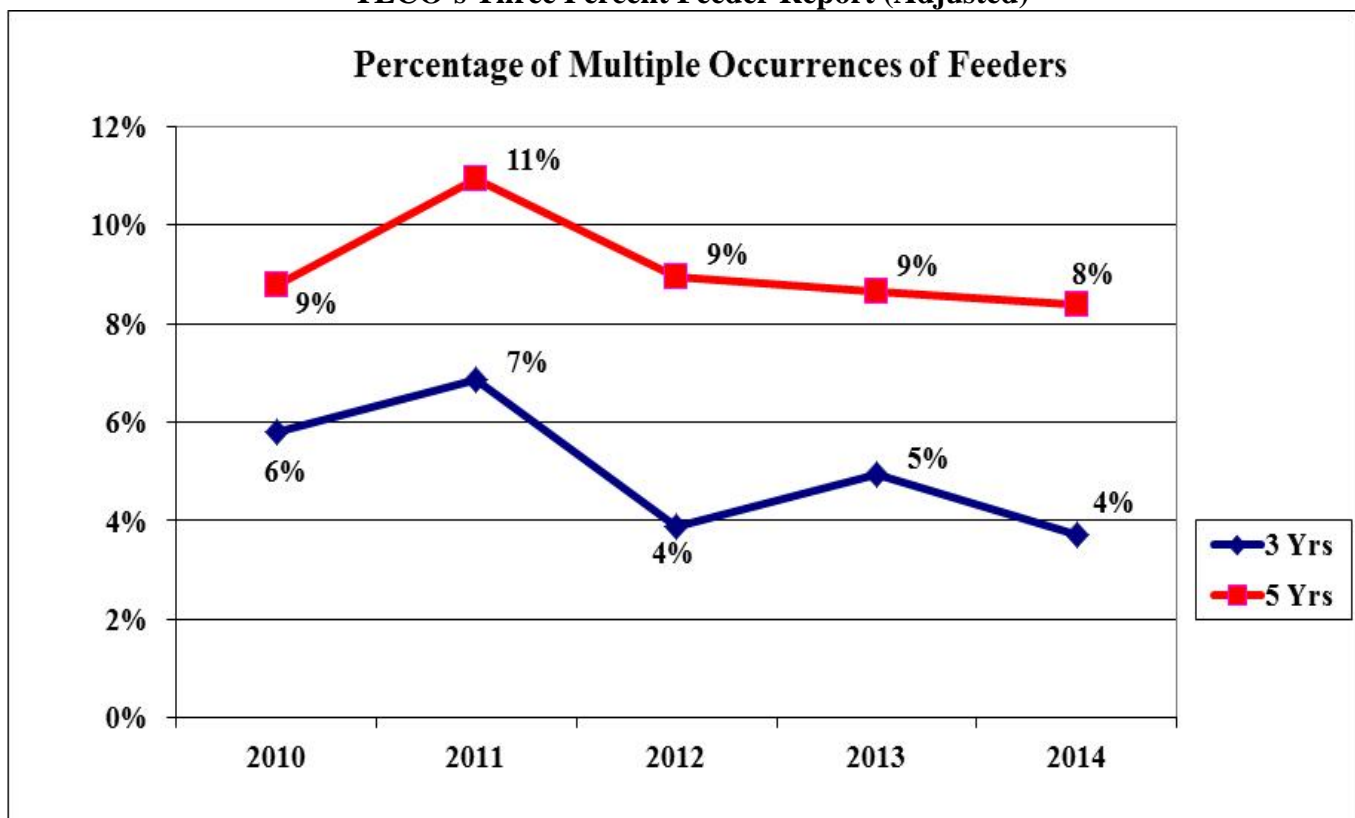
Figure 3-36.
TECO's Three Percent Feeder Report (Adjusted)

Figure 3-36 represents an analysis of TECO's top three percent of problem feeders that have reoccurred (appeared on the Three Percent Feeder Report) on a five-year and three-year basis. The graph is developed using the number of recurrences divided by the number of feeders reported. The five-year average of outages per feeder decreased by 11 percent from 2013 to 2014 and the three-year average of outages also decreased from 5 percent in 2013 to 4 percent in 2014. Both the five-year average of outages per feeder and the three-year average of outages appear to be trending downward for the five-year period of 2010 to 2014.

Staff notes that one feeder was on the Three Percent Feeder Report for three years, the last two years consecutively. Four circuit outages were reported for this feeder. In 2014, the corrective action undertaken by TECO included: hotspot tree trimming, installation of avian protection, pole replacement, replacing fused cutouts, switches, and lightning arresters. TECO stated that it will continue to monitor circuit outage performance as part of its daily and ongoing review of system reliability and will respond accordingly at a regional level.

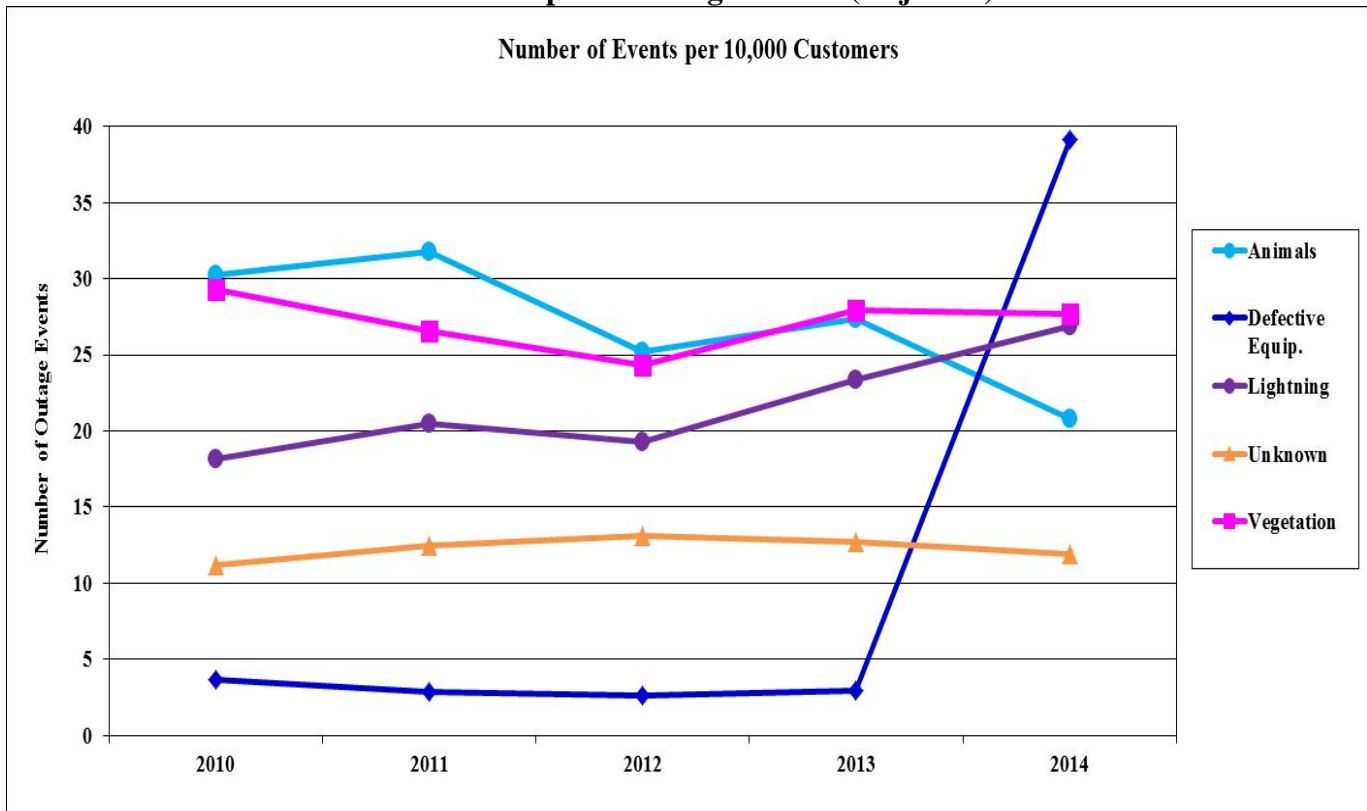
Figure 3-37.
TECO's Top Five Outage Causes (Adjusted)

Figure 3-37 shows the top five causes of outage events on TECO's distribution system normalized to a 10,000-customer base. The figure is based on TECO's adjusted data of the top 10 causes of outage events and represents 93 percent of the total outage events that occurred during 2014. For the five-year period, the five top causes of outage events included Defective Equipment (29 percent), Vegetation (20 percent), Lightning (20 percent), Animals (15 percent), and Unknown Causes (9 percent) on a cumulative basis. Defective equipment is the highest cause of outages for 2014. Beginning in 2014, the Defective Equipment category now includes outage categories that in the past were separately identified, which explains the increase. Vegetation and Lightning causes are the next two top problem areas for TECO. The outages due to Vegetation increased 3 percent from 2013 to 2014. The outages from Lightning increased 16 percent for the same time period. The numbers of outages due to Lightning and Unknown causes are trending upward while the number of outages due to Vegetation is remaining relatively flat. The number of outages due to Animals is trending downward.

Defective Equipment (29 percent) and Vegetation (20 percent) were the largest contributors to TECO's causes of outage events followed by Lightning (20 percent), Animals (15 percent), and Unknown (9 percent). **Figure 3-37** illustrates the top five outage causes showing Vegetation related causes are remaining relatively flat, even though there was a decrease of 1 percent from the previous year. Lightning and Unknown related causes are trending upward. Lightning related causes had a 13 percent increase for 2014 from 2013 and Unknown causes had a 6 percent decrease for the same timeframe. Animal related causes are trending downward and decreased by 24 percent from the previous year. Beginning in 2014, the Defective Equipment category now includes outage categories that in the past were separately identified.

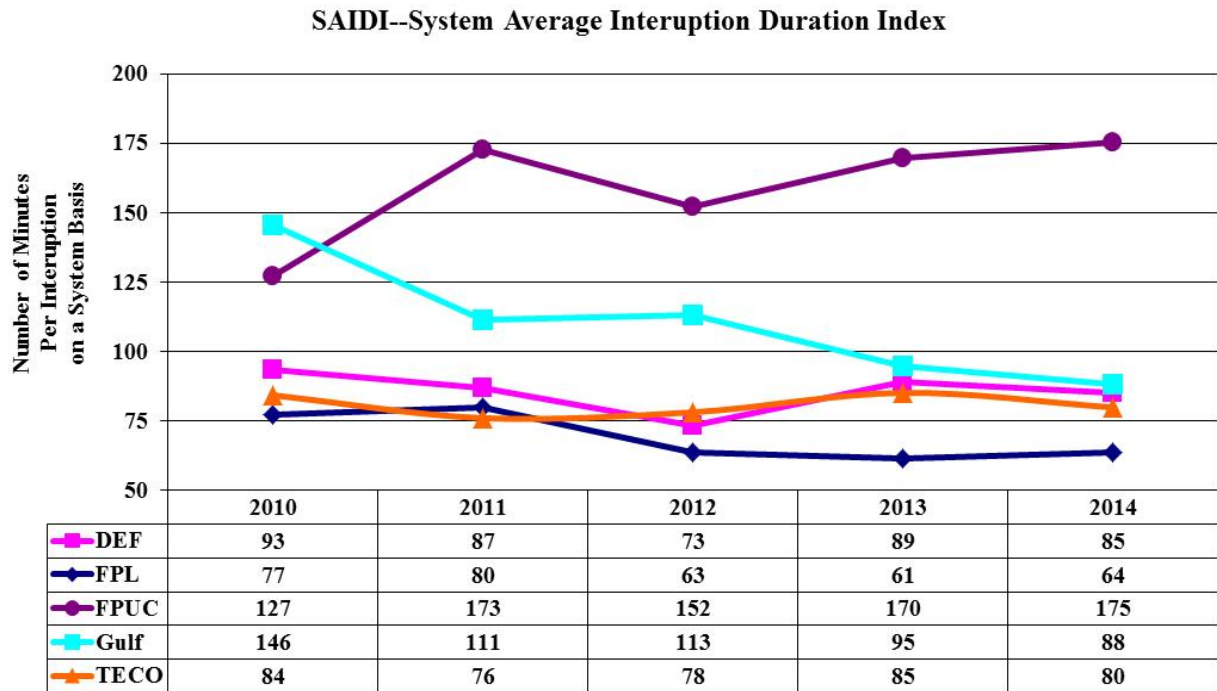
**Figure 4-1.
System Average Interruption Duration (Adjusted SAIDI)**

Figure 4-1 indicates that FPUC's SAIDI trend has gradually risen since 2010. TECO's trend has been primarily flat while DEF, FPL, and Gulf appear to be trending downward. Comparing 2013 SAIDI indices to 2014 SAIDI indices, DEF, Gulf, and TECO's indices have fallen 4 percent, 7 percent, and 6 percent respectively. FPL and FPUC's SAIDI indices have risen 5 percent, and 3 percent, respectively, from 2013 to 2014.

SAIDI is the duration of an interruption per retail customer served within a specified area of service over a given period. It is determined by dividing the total Customer Minutes of Interruption by total Number of Customers Served for the respective area of service.

The inter-utility trend comparison focuses on a graphical presentation that combines all of the IOUs' distribution reliability indices for the years 2010 to 2014. **Figures 4-1** through **4-3** apply to all five utilities while **Figures 4-4** and **4-5** do not apply to FPUC because it is not required to report MAIFle and CEMI5 due to the size of its customer base. The adjusted data is used in generating the indices in this report and is based on the exclusion of certain events allowed by Rule 25-6.0455(4), F.A.C. Generalizations can be drawn from the side-by-side comparisons; however, any generalizations should be used with caution due to the differing sizes of the distribution systems, the degree of automation, and the number of customers. The indices are unique to each IOU.

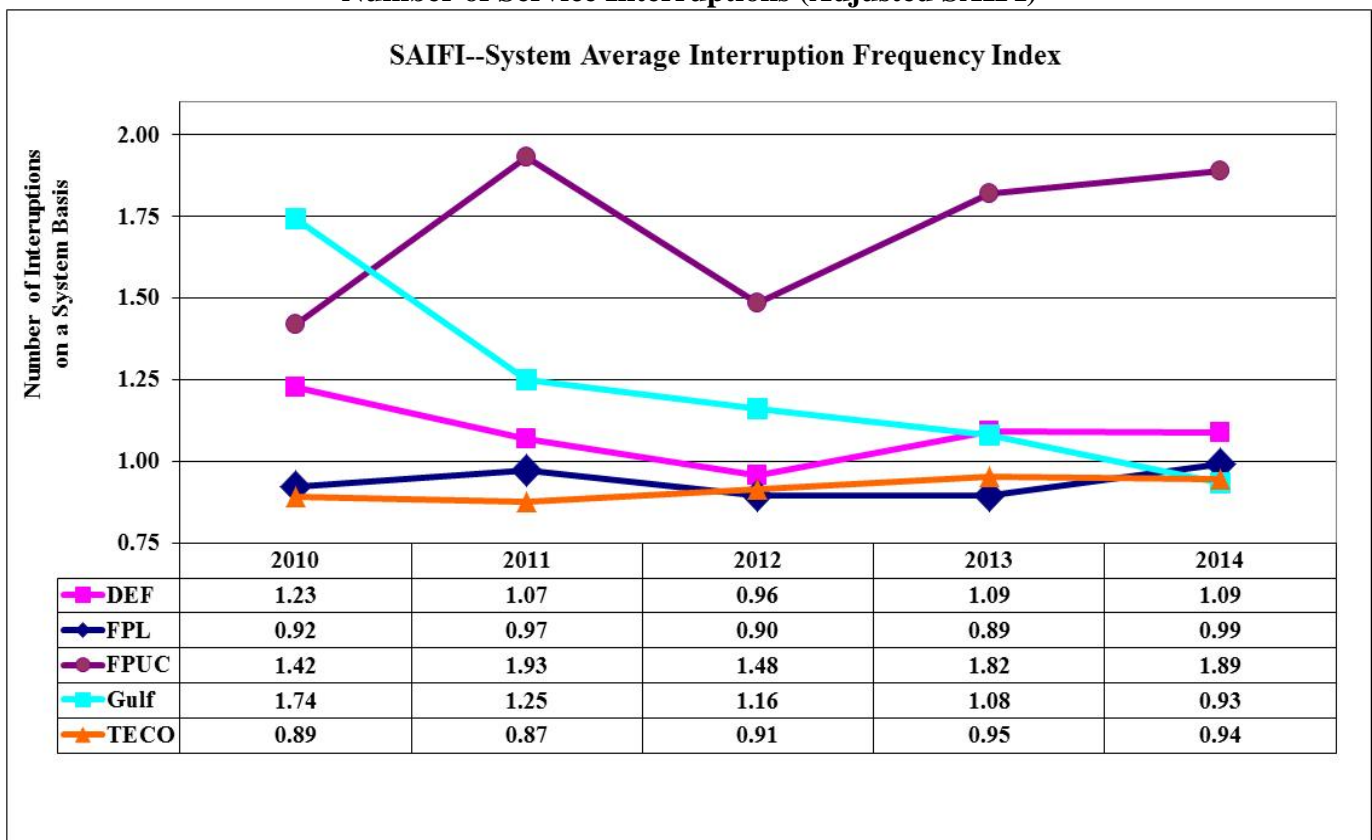
Figure 4-2.
Number of Service Interruptions (Adjusted SAIFI)

Figure 4-2 is a five-year graph of the adjusted SAIFI for each IOU. The 2014 data shows Gulf and TECO's SAIFI indices decreased (improved) from the 2013 results as FPL and FPUC's SAIFI indices increased. DEF's 2014 SAIFI index was the same as the 2013 SAIFI index. Over the five-year period of 2010 to 2014, FPL, FPUC and TECO's SAIFI indices are all trending upward. DEF and Gulf's SAIFI index is trending downward for the period of 2010 to 2014.

SAIFI is the average number of service interruptions per retail customer within a specified area of service over a given period. It is determined by dividing the Sum of Service (aka Customer) Interruptions (CI) by the total Number of Customers Served for the respective area of service.

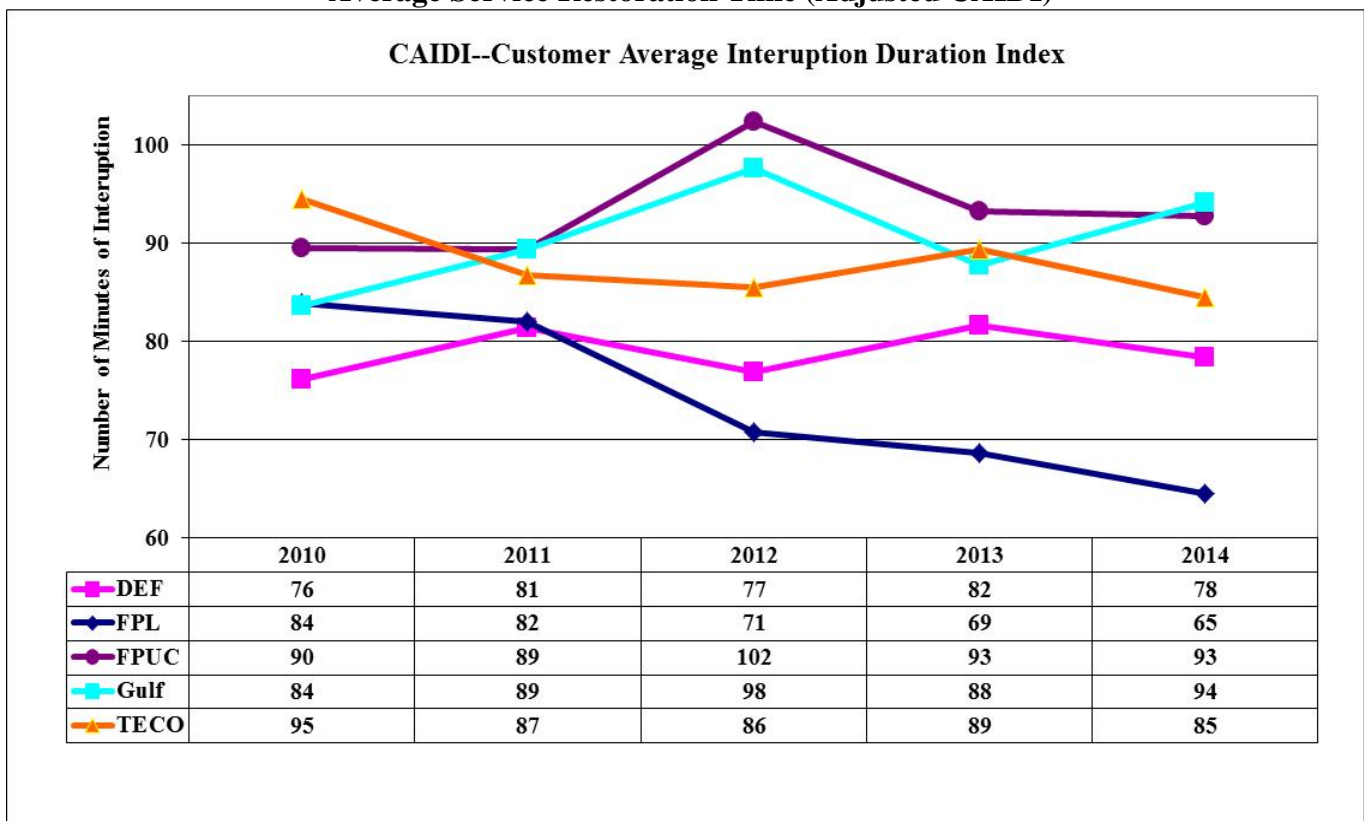
Figure 4-3.
Average Service Restoration Time (Adjusted CAIDI)

Figure 4-3 is a five-year graph of the adjusted CAIDI for each IOU. DEF, FPL, and TECO had a decrease in the CAIDI from 2013 to 2014 while Gulf had an increase in the CAIDI. FPUC's 2014 CAIDI index was the same as the 2013 CAIDI index. FPL and TECO's CAIDI indices are trending downward for the five-year period of 2010 to 2014. DEF, FPUC, and Gulf's CAIDI indices are trending upward for the same period.

CAIDI is the average interruption duration or the time to restore service to interrupted customers. CAIDI is calculated by dividing the total system CMI by the number of customer interruptions, which is also SAIDI, divided by SAIFI.

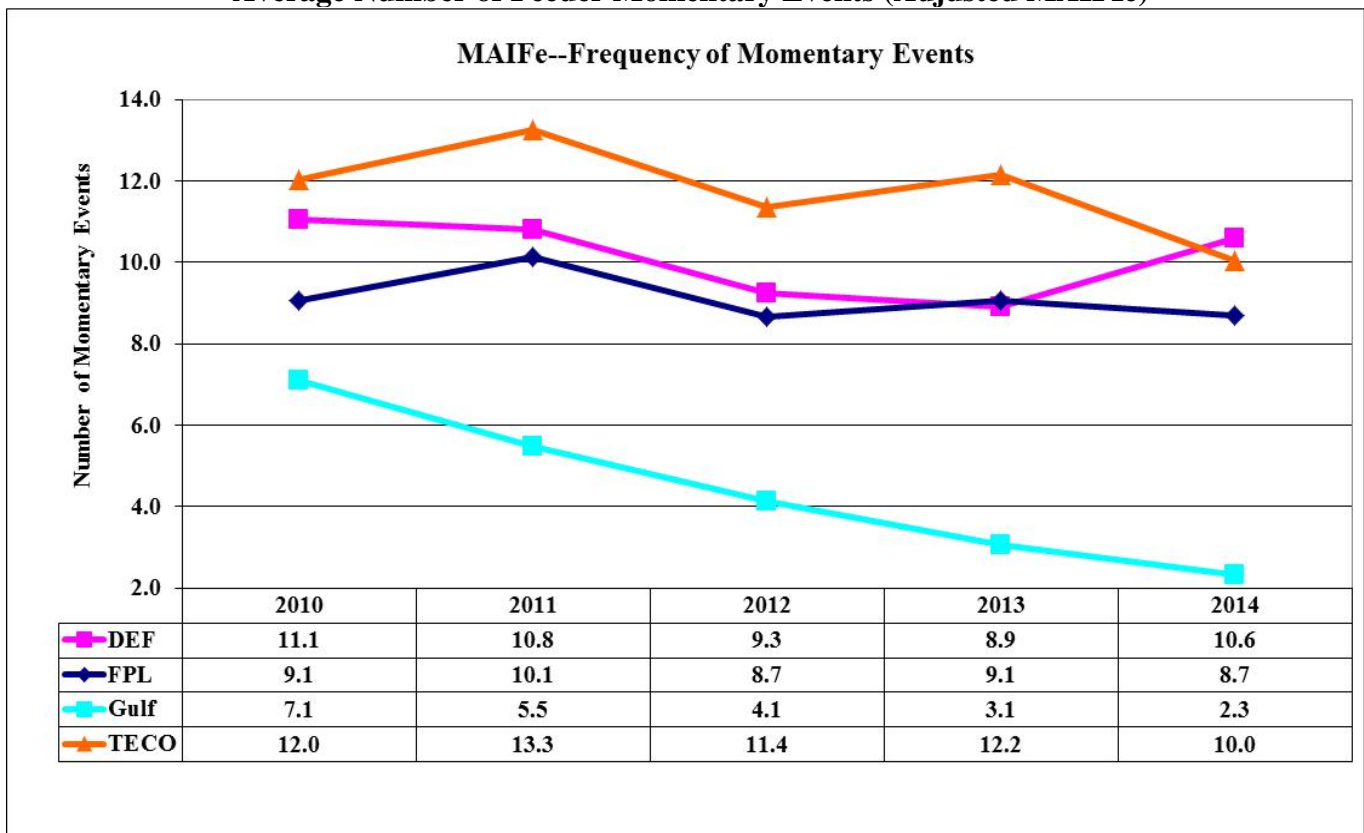
Figure 4-4.
Average Number of Feeder Momentary Events (Adjusted MAIFle)

Figure 4-4 shows a five-year graph of the adjusted MAIFle for DEF, FPL, Gulf, and TECO. DEF, FPL, Gulf and TECO's MAIFle indices are all trending downward for the five-year period of 2010 to 2014. Comparing the MAIFle for 2013 to 2014, FPL decreased by 4 percent, Gulf decreased by 26 percent and TECO decreased by 18 percent. DEF increased the MAIFle index by 16 percent. FPUC is exempt from reporting MAIFle and CEMI5 because it has fewer than 50,000 customers.

MAIFle is the average frequency of momentary interruptions or the number of times there is a loss of service of less than one minute. MAIFle is calculated by dividing the number of momentary interruptions events recorded on primary circuits (CME) by the number of customers served.

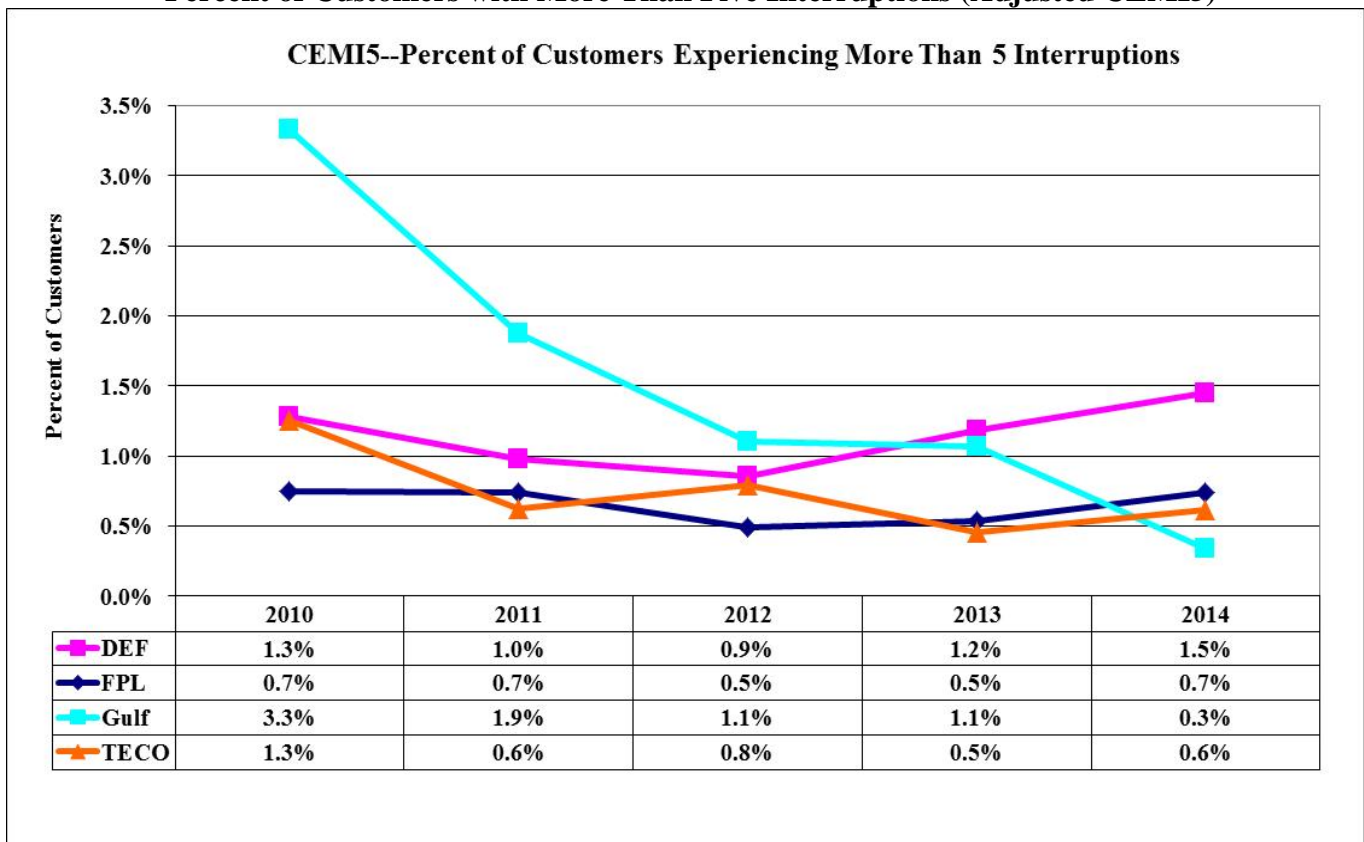
Figure 4-5.
Percent of Customers with More Than Five Interruptions (Adjusted CEMI5)

Figure 4-5 is a five-year graph of the adjusted CEMI5 for FPL, Gulf, DEF, and TECO. CEMI5 is a percentage. It represents the number of customers that experienced more than five service interruptions in the year divided by the total number of customers. In 2014, DEF, FPL, and TECO's CEMI5 percent increased to 1.5 percent, 0.7 percent, and 0.6 percent, respectively from 1.2 percent, 0.5 percent, and 0.5 percent, in 2013. FPL and TECO are trending downward as DEF is trending upward for the period of 2010 to 2014. Gulf's CEMI5 had a 73 percent decrease in the percent of customers experiencing more than five interruptions in 2014 compared to its 2013 results. Gulf's CEMI5 index is trending downward for the five-year period.

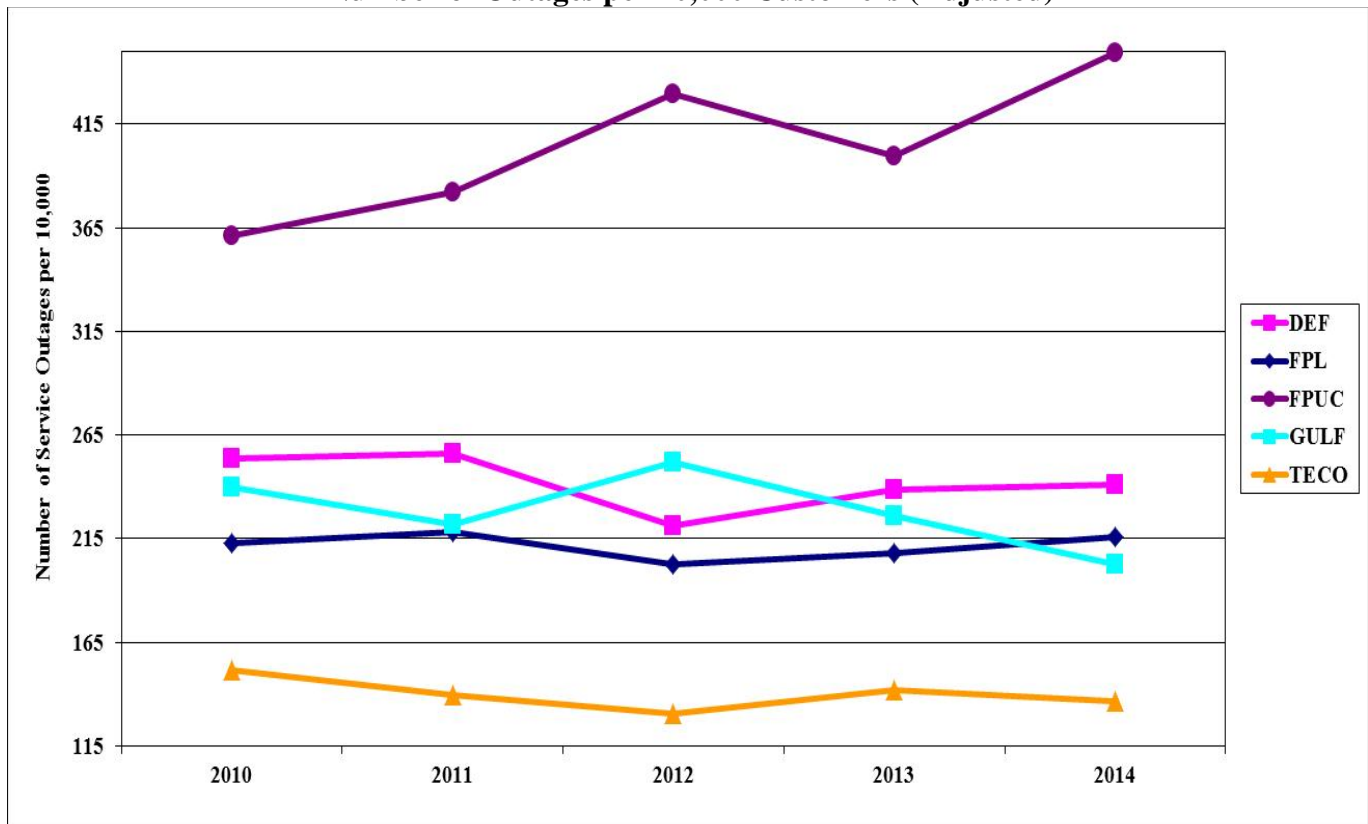
Figure 4-6.
Number of Outages per 10,000 Customers (Adjusted)

Figure 4-6 shows the number of outages per 10,000 customers on an adjusted basis for the five IOUs over the last five years. The graph displays each utility's adjusted data concerning the number of outage events and the total number of customers on an annual basis. The number of FPL outages increased from 96,842 in 2013 to 101,981 in 2014, and the number of outages per 10,000 customers are trending upward for the five-year period. TECO's results are trending downward for the five-year period. DEF's number of outages increased for 2014 and the results are trending upward for the five-year period. Gulf's number of outages decreased for 2014, and continues to trend downward for the five-year period. FPUC's results increased for 2010 to 2012, decreased for 2012 and 2013, and then increased again for 2013 to 2014. Due to the small customer base, the line graph for FPUC could be subject to greater volatility.

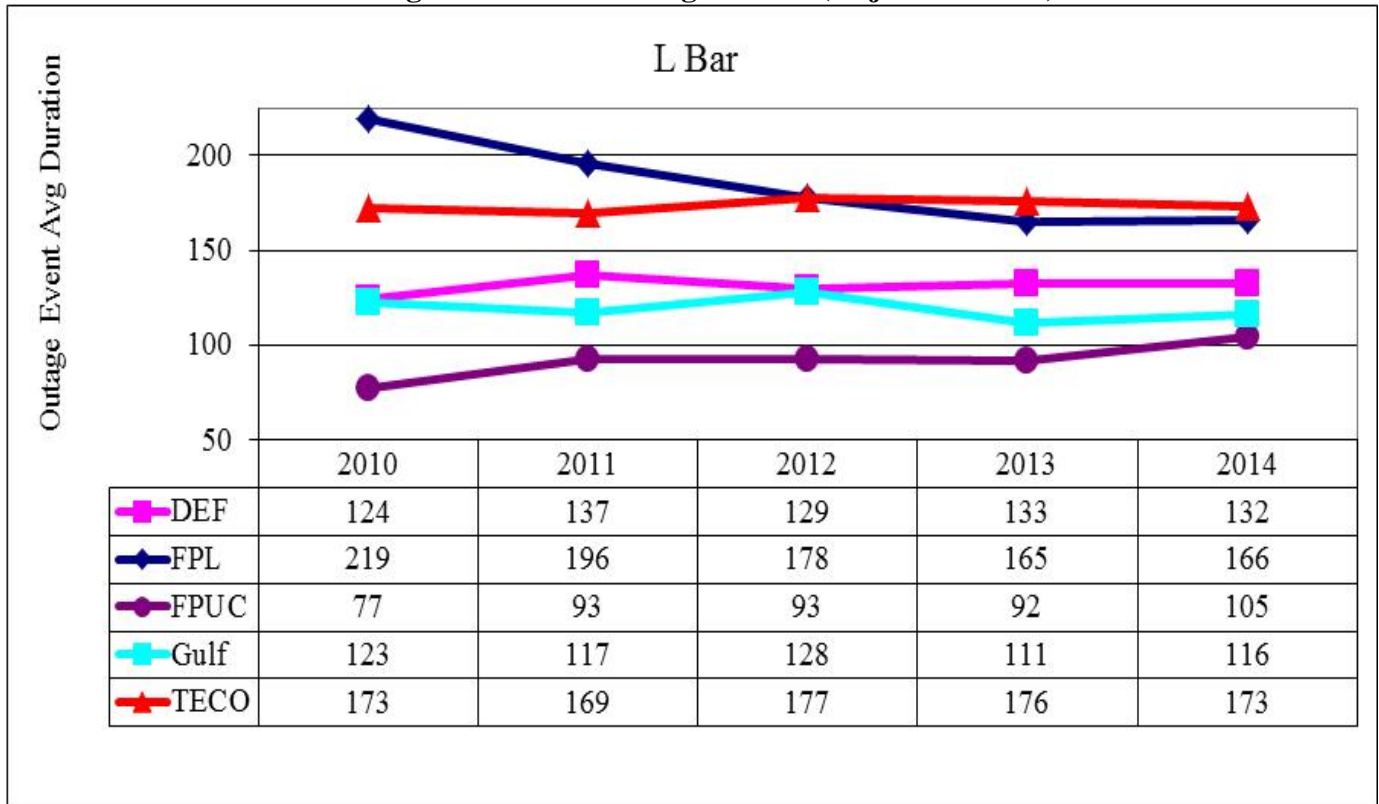
Figure 4-7.
Average Duration of Outage Events (Adjusted L-Bar)

Figure 4-7 represents the average duration of outage events (Adjusted L-Bar) for each IOU. From the data shown, it appears that the utilities are more consistent with their restoral times for 2014 when compared to 2010.

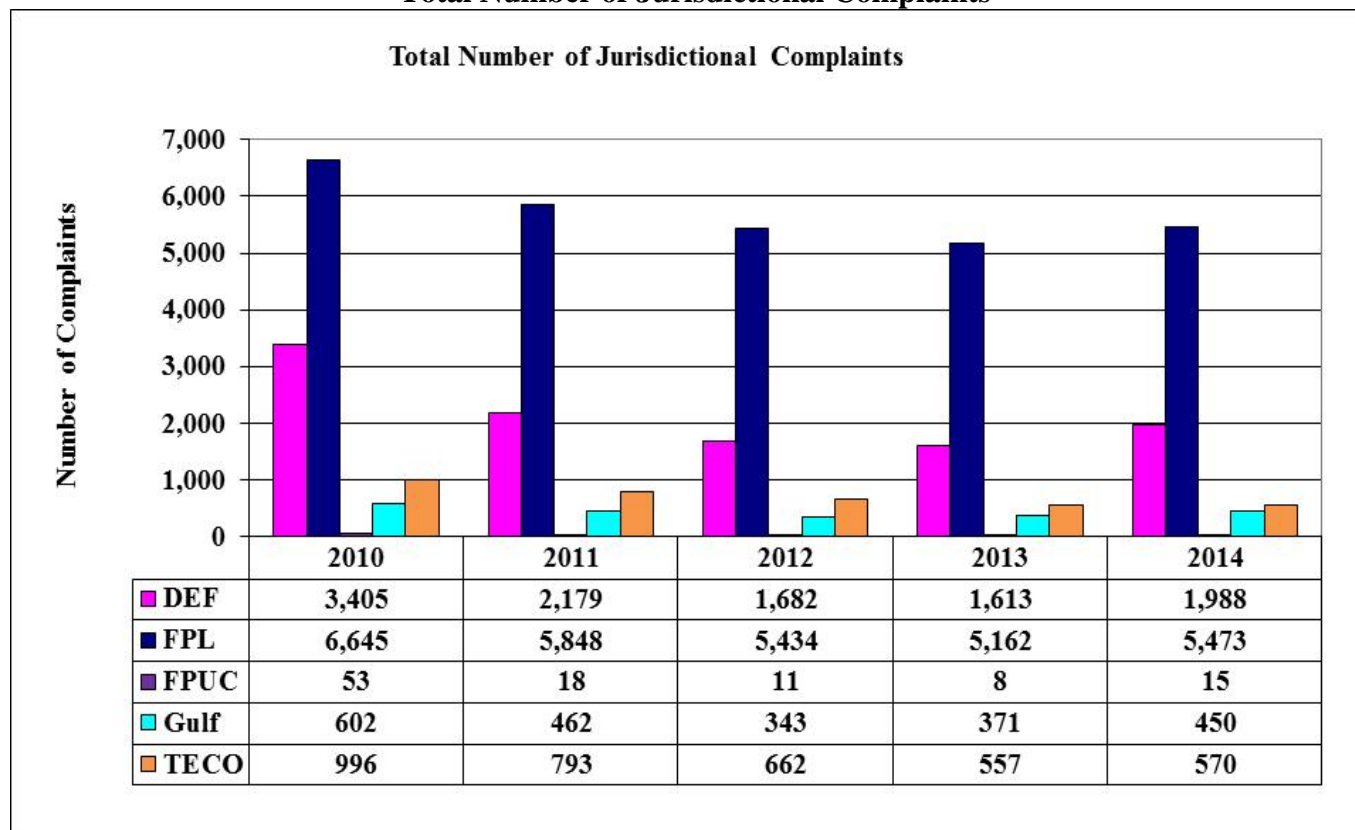
Figure 4-8.
Total Number of Jurisdictional Complaints

Figure 4-8 shows the total number of jurisdictional complaints¹⁷ for each IOU. In comparing the number of complaints by the different companies, the total number of customers should be considered. FPL has the higher number of complaints, but FPL also has more customers than the other companies.

Figures 4-8, 4-9, 4-10, and 4-11 represent consumer complaint data that was extracted from the Commission's Consumer Activity Tracking System (CATS). Each consumer complaint received by the Commission is assigned a code after the complaint is resolved. Reliability related complaints have 10 specific category types and typically pertain to Trees, Safety, Repairs, Frequent Outages, and Momentary Service Interruptions.

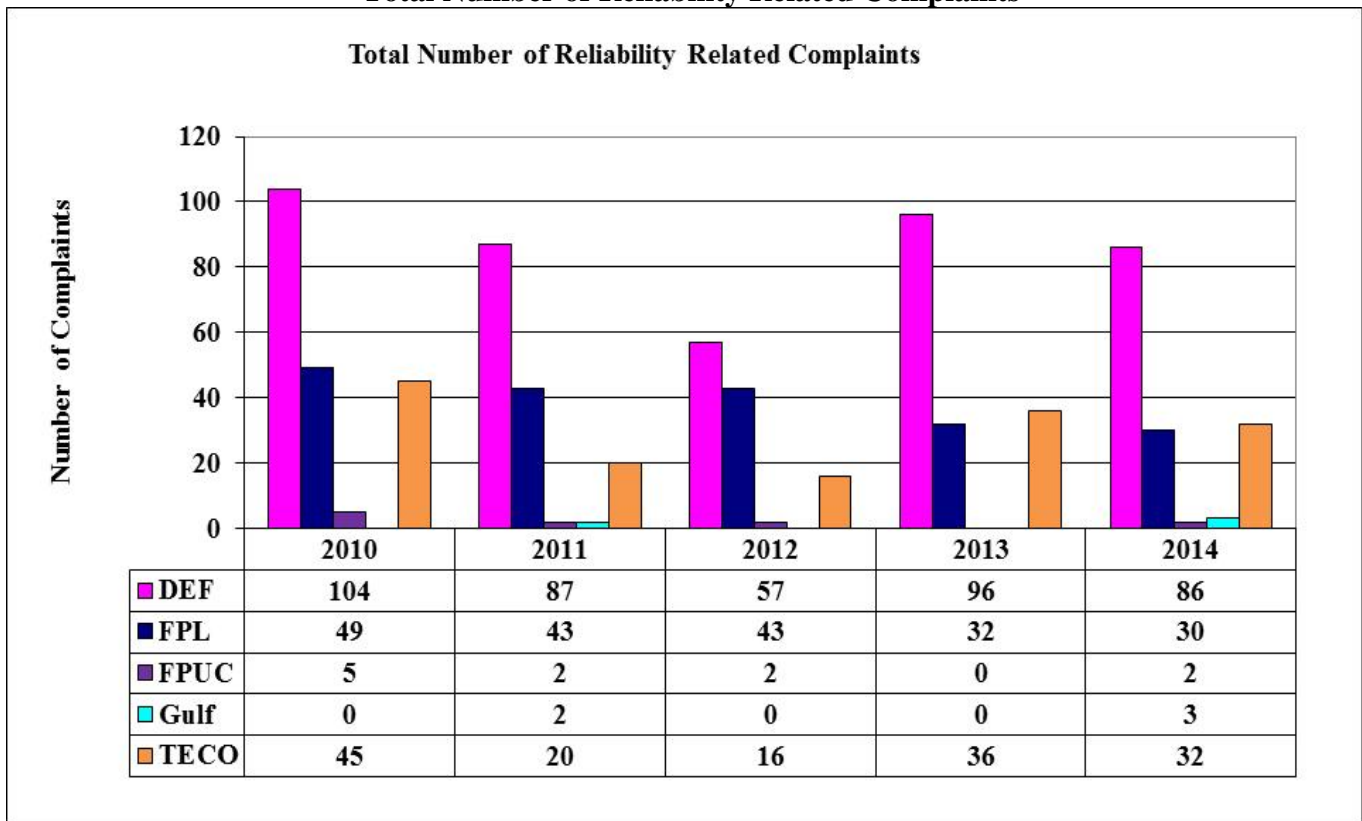
Figure 4-9.
Total Number of Reliability Related Complaints

Figure 4-9 charts the total number of reliability related complaints for the IOUs. DEF is showing the largest amount of reliability complaints for the five-year period of 2010 to 2014 with Gulf showing the least amount for three of the last five years. All the companies continue to be trending downward in the number of reliability complaints except for Gulf who is staying relatively flat.

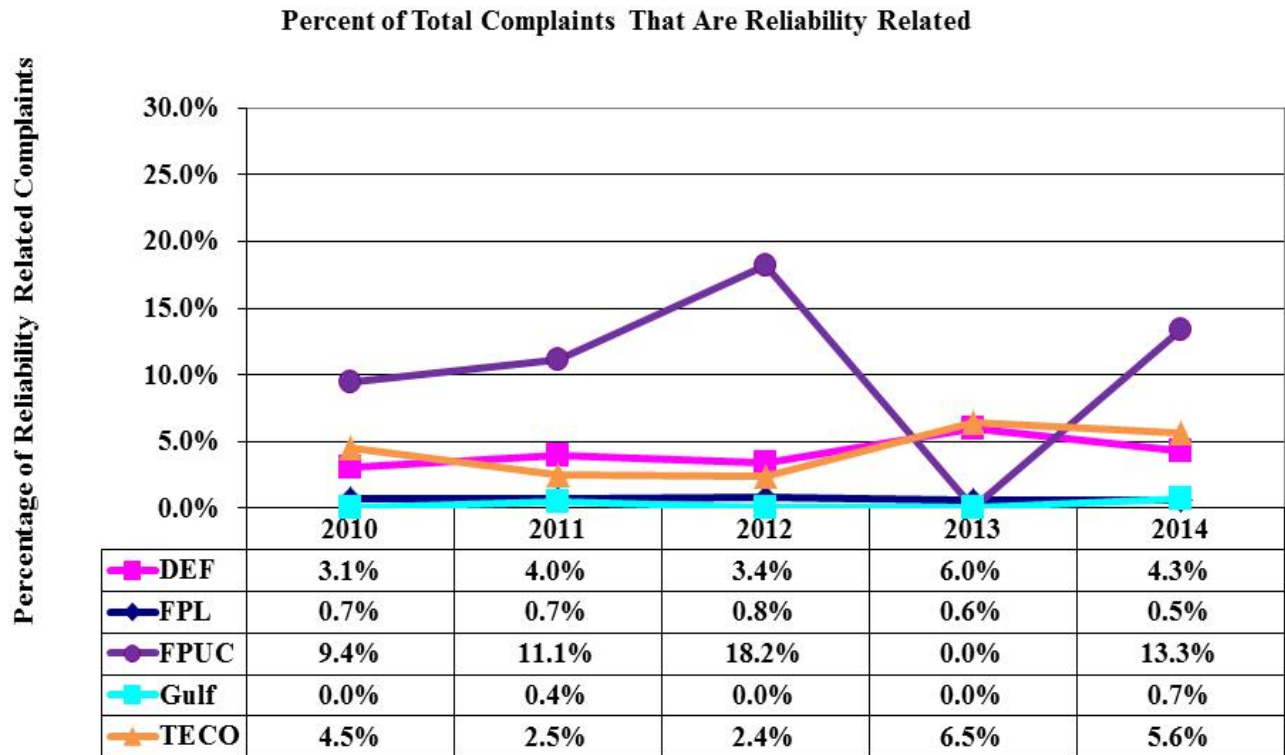
**Figure 4-10.
Percent of Complaints that are Reliability Related**

Figure 4-10 shows the percentage of reliability related customer complaints in relation to the total number of complaints for each IOU. FPL and Gulf's trends continue to be relatively flat while FPUC is trending slightly downward. DEF and TECO are continuing to trend slightly upward. The percentages of FPUC complaints compared to the other companies appears high, however FPUC has fewer customers and fewer complaints in total.

FPL's reliability related complaints percentage received by the Commission in 2014 was 0.5 percent, which was lower than 0.6 percent in 2013. FPL's reliability related complaints trend is relatively flat as shown in **Figure 4-10**, even with the decrease this year.

The percentage of complaints reported to the Commission against Gulf that were reliability related was 0.7 percent in 2014. This was the highest percent of total complaints for the five-year period of 2010 to 2014. Overall, Gulf has the lowest percentage of total complaints that are reliability related as shown in **Figure 4-10**.

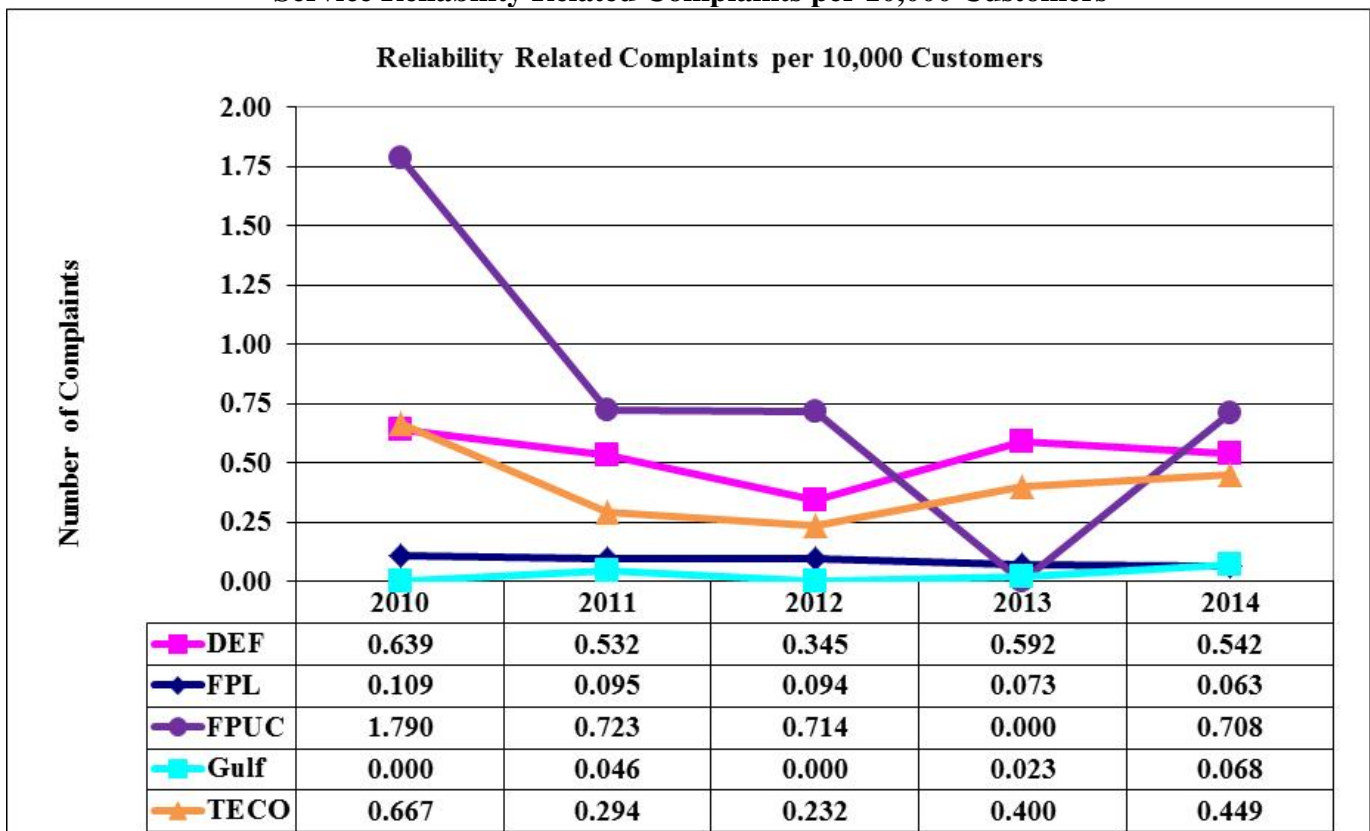
Figure 4-11.
Service Reliability Related Complaints per 10,000 Customers

Figure 4-11 charts the volume of reliability related complaints per 10,000 customers for the IOUs. The volume of service reliability complaints is normalized to a 10,000-customer base for comparative purposes. This is calculated for each IOU by dividing the total number of reliability complaints reported to the Commission by the total number of utility's customers. This fraction is then multiplies by 10,000 for graphing purposes.

All the IOUs have less than one reliability complaint per 10,000 customers since 2011. For the five-year period, FPL, DEF, TECO, and FPUC continue to trend downward. Gulf has the fewest reliability complaints in comparison to the other utilities and continues to stay relatively flat. The volatility of FPUC's results can be attributed to its small customer base, which typically averages 28,000 customers.
