*Review of
Florida's
Investor-Owned
Electric Utilities*

*2 0 1 8
Service Reliability Reports*

State of Florida
Florida Public Service Commission
Division of Engineering

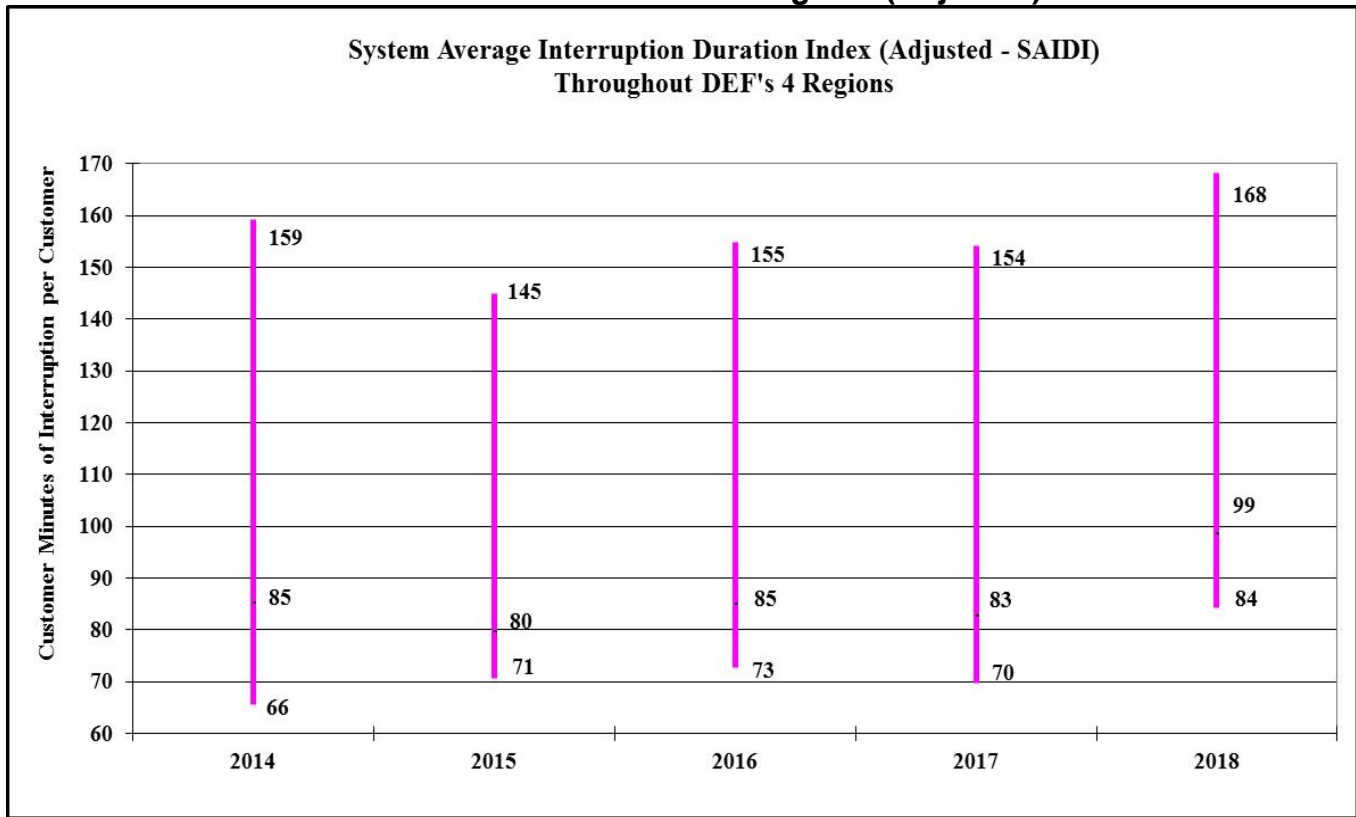
**Figure 3-1
SAIDI across DEF's Four Regions (Adjusted)**

Figure 3-1 charts the adjusted SAIDI recorded across DEF's system and depicts increases in the lowest, the average, and highest values for 2018. DEF reported that 2018 presented the Utility with a major storm affecting the panhandle and resulting in significant damage to infrastructure. DEF notes that there were 10 days in 2018 that had weather-related outages from afternoon thunderstorms, which caused more than 50 percent of customer outages on those days. In addition, there were two days in 2018 that resulted in equipment failure adding to its SAIDI minutes.

DEF's service territory is comprised of four regions: North Coastal, South Coastal, North Central, and South Central. **Figure 3-1** illustrates that the North Coastal region continues to report the poorest SAIDI over the last five years, fluctuating between 145 minutes and 168 minutes. While the South Coastal and South Central regions have the best or lowest SAIDI for the same period. The North Coastal region is predominantly a rural area and has more square miles when compared to the other regions. This region is also served by predominantly long circuits with approximately 7,700 miles of overhead and underground main circuits. DEF explained that these factors result in higher exposure to outage causes and higher reliability indices.

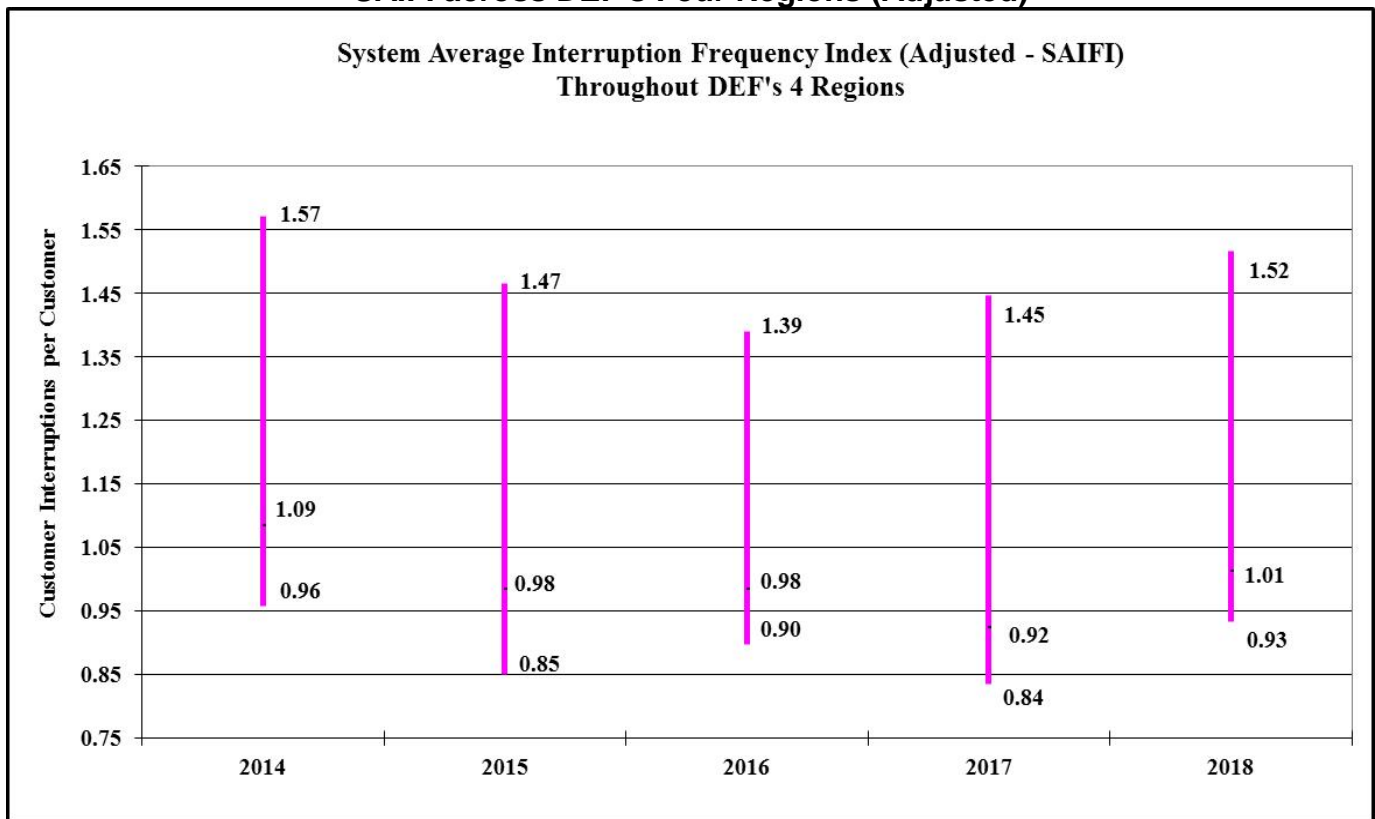
**Figure 3-2
SAIFI across DEF’s Four Regions (Adjusted)**

Figure 3-2 shows the adjusted SAIFI across DEF’s system. The minimum, maximum, and average SAIFI indexes are trending downward even though there were increases in 2018. The increases were 11 percent for the minimum value, 10 percent for the average value, and 5 percent for the maximum value. The South Central region had the lowest number of interruptions, while the North Coastal region continues to have the highest number of interruptions.

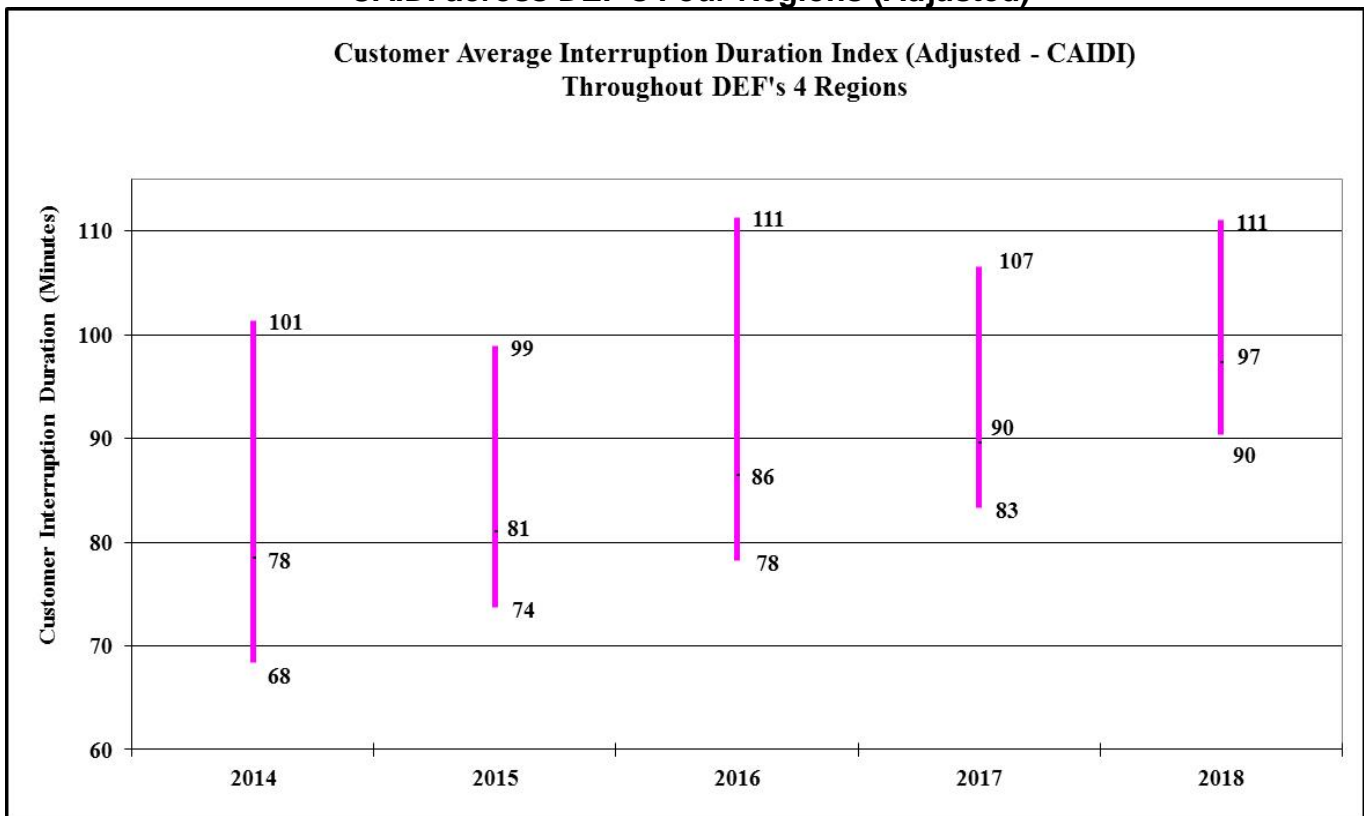
**Figure 3-3
CAIDI across DEF's Four Regions (Adjusted)**

Figure 3-3 illustrates the CAIDI, or the average number of minutes a customer is without power when a service interruption occurs, for DEF's four regions. DEF's adjusted CAIDI is increasing for a five-year period from 78 minutes in 2014 to 97 minutes in 2018. The North Coastal region has continued to have the highest CAIDI level for the past five years with the maximum CAIDI trending upward. The South Central region had the lowest CAIDI level during the same period with the minimum CAIDI trending upward.

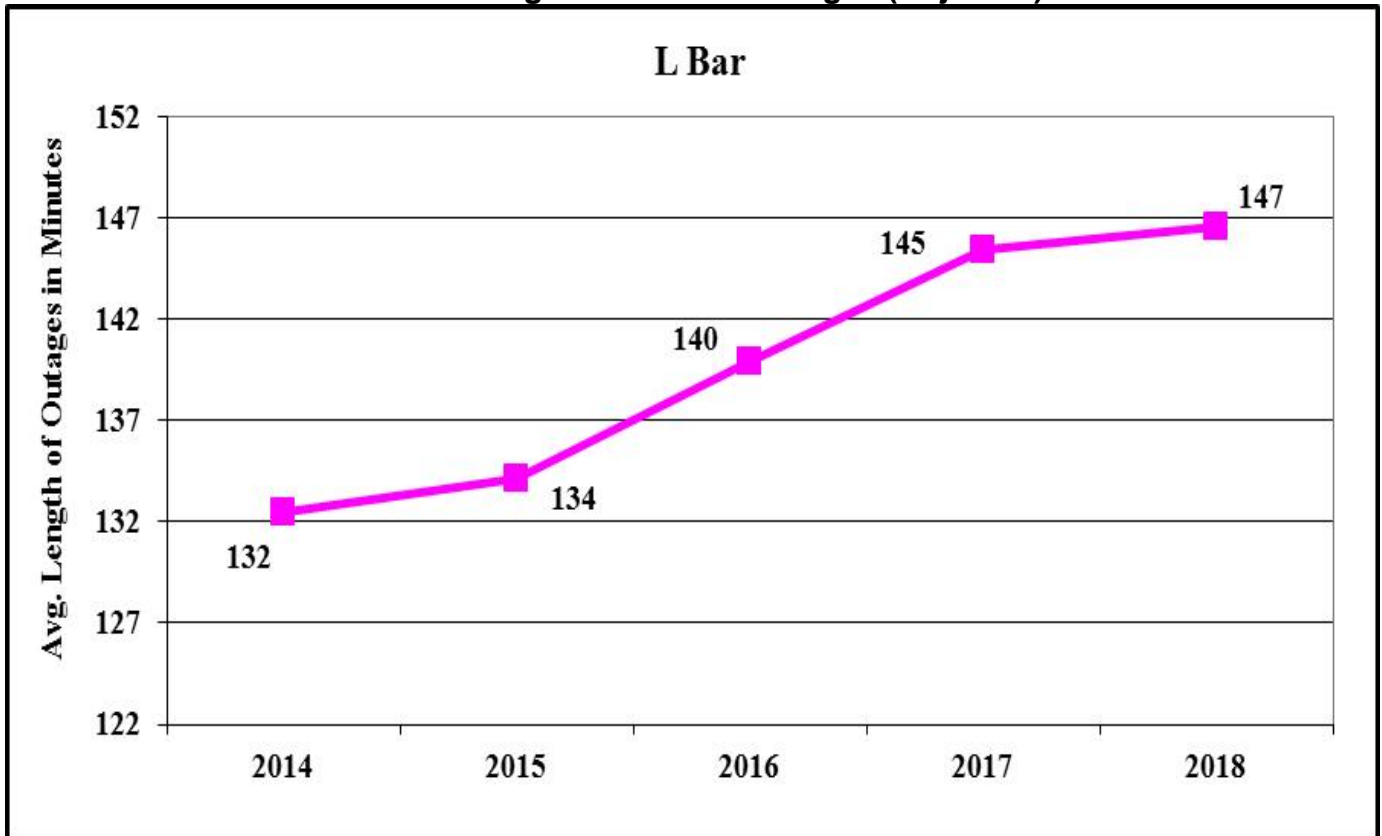
Figure 3-4
DEF's Average Duration of Outages (Adjusted)

Figure 3-4 is the average length of time DEF spends restoring customers affected by outage events, excluding hurricanes and certain other outage events. This is displayed by the index L-Bar in the graph below. The data demonstrates an overall 11 percent increase of outage durations since 2014, and a 1.4 percent increase from 2017 to 2018. DEF's overall L-Bar index is trending upward, indicating that DEF is spending more time restoring service from outage events.

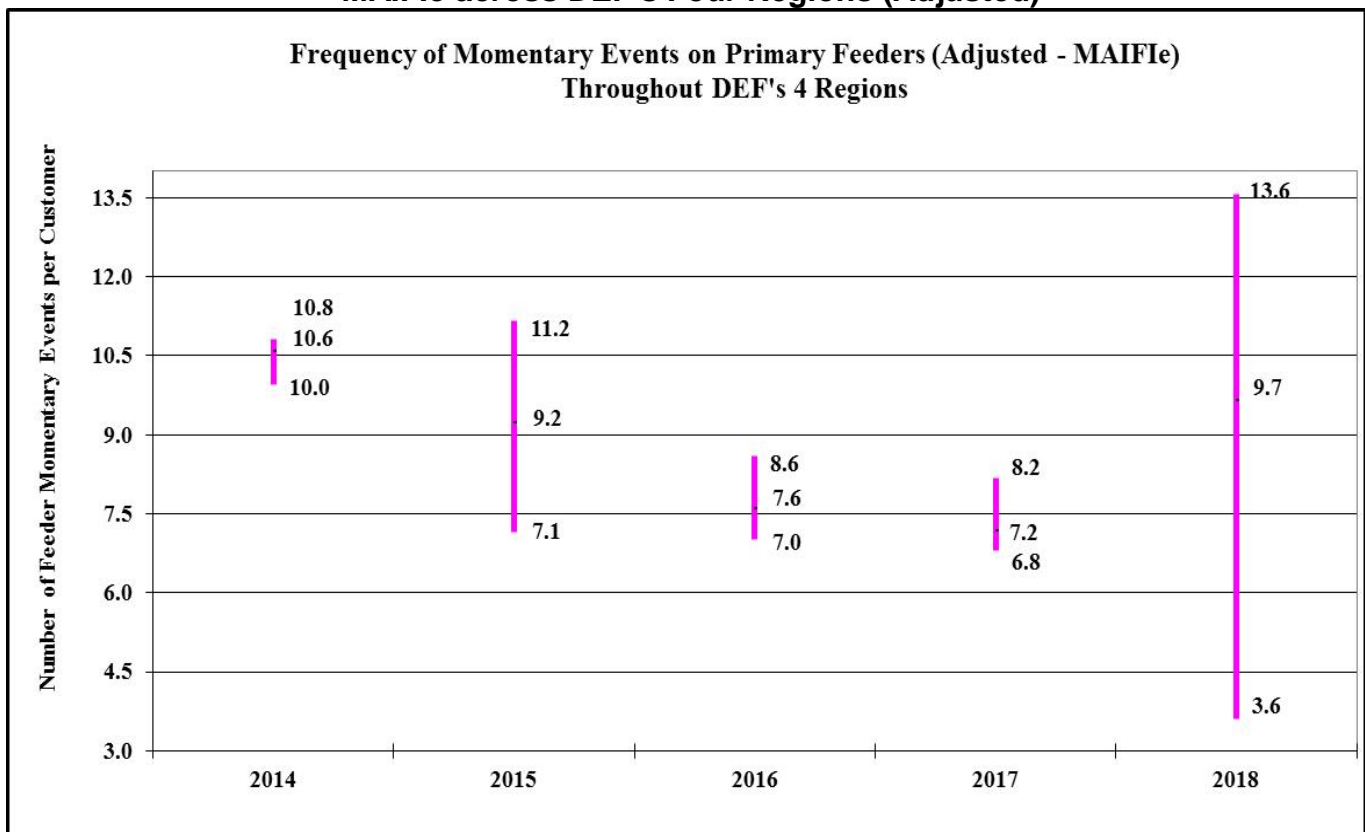
**Figure 3-5
MAIFle across DEF's Four Regions (Adjusted)**

Figure 3-5 illustrates the frequency of momentary events on primary circuits for DEF's customers recorded across its system. These momentary events often affect a small group of customers. A review of the supporting data suggests that the MAIFle results between 2014 and 2018 appear to be trending downward showing improvement even though there was an increase in the average MAIFle of 35 percent from 2017 to 2018. All four regions appear to fluctuate between having the best (lowest) results to having the worst (highest) results. There was a 47 percent decrease for the lowest MAIFle from 2017 to 2018 and there was a 66 percent increase from 2017 to 2018.

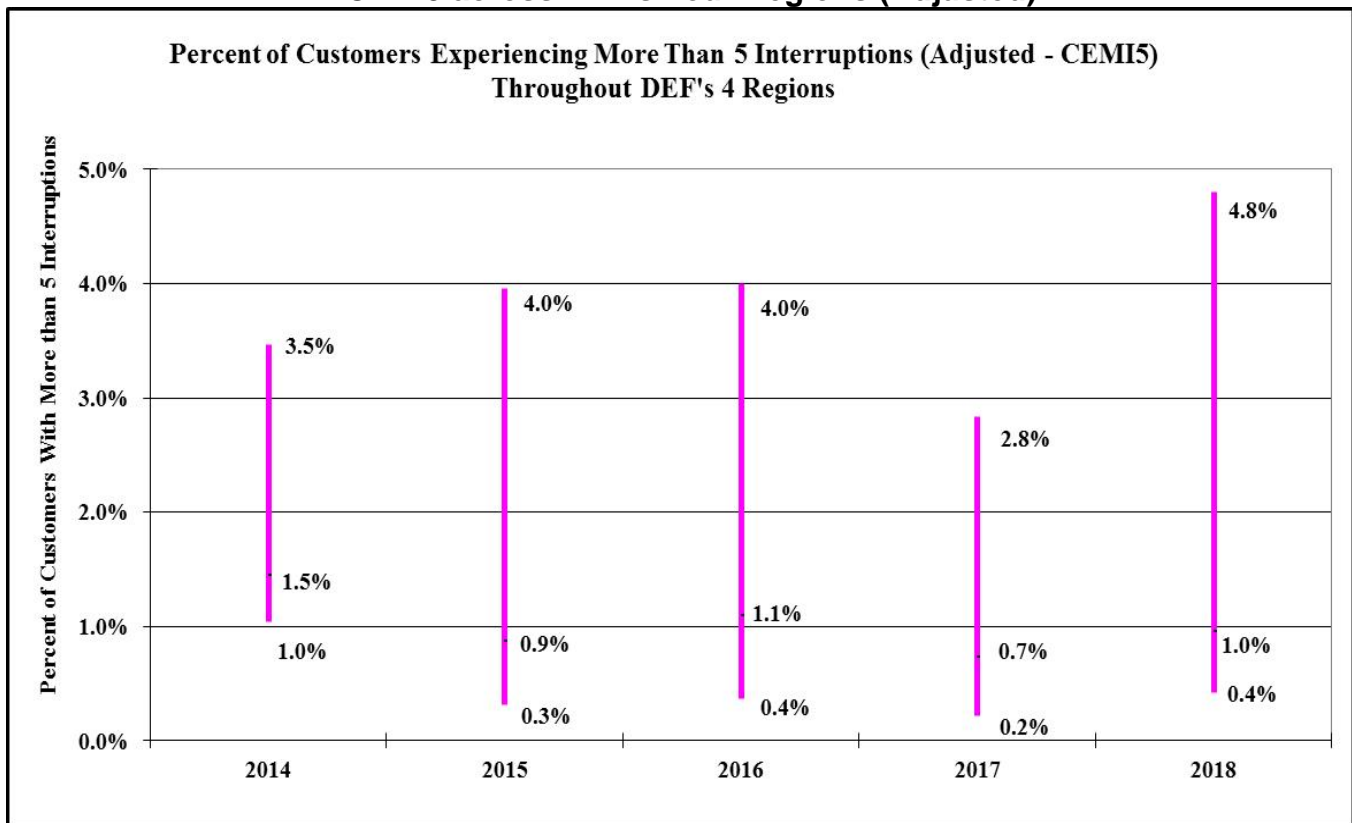
**Figure 3-6
CEMI5 across DEF’s Four Regions (Adjusted)**

Figure 3-6 charts the percentage of DEF’s customers experiencing more than five interruptions over the last five years. DEF reported an increase in the average CEMI5 performance from 0.7 percent in 2017 to 1.0 percent in 2018. The average CEMI5 is trending downward over the past five years. The North Central region has the lowest reported percentage for all of DEF’s regions and the North Coastal region continues to have the highest reported percentage.

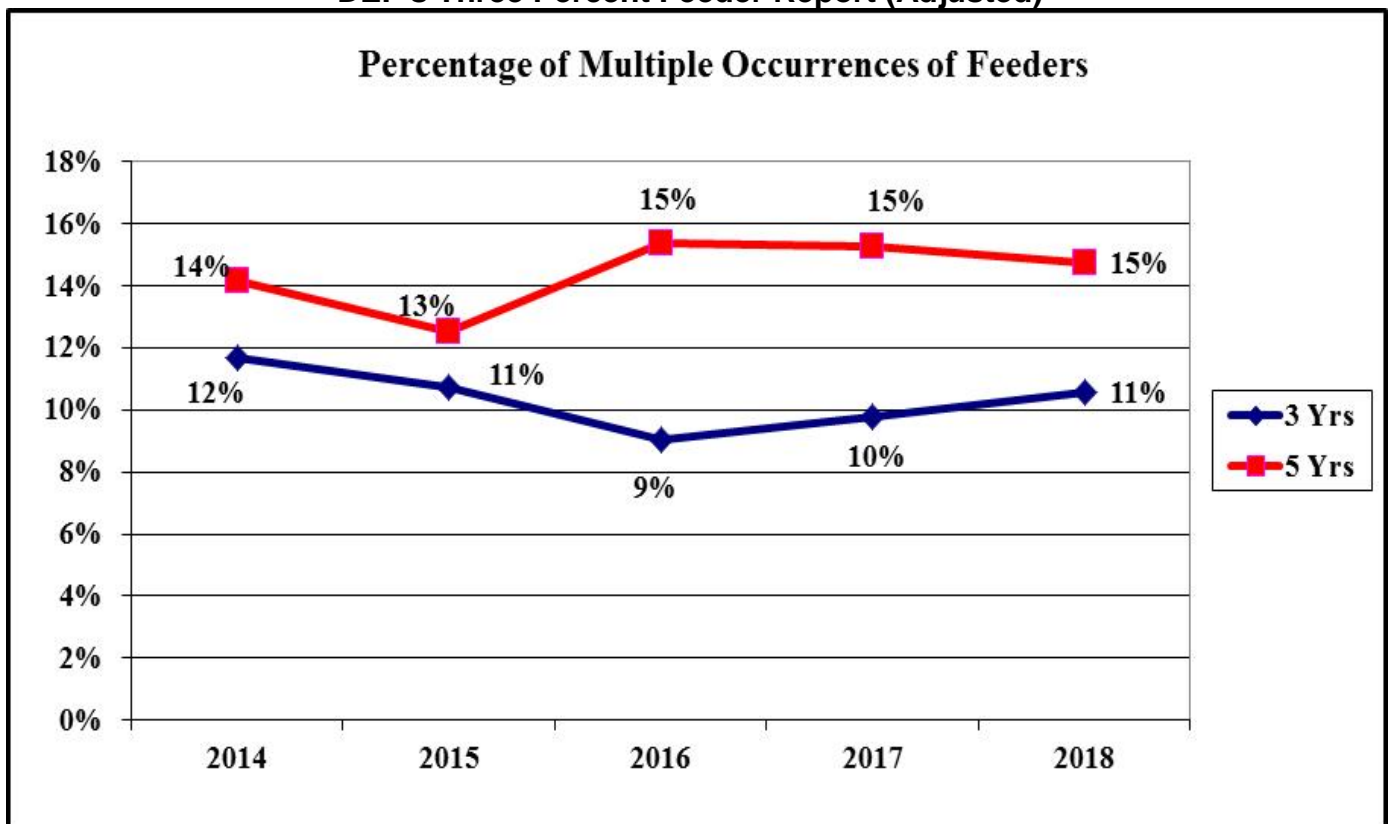
Figure 3-7
DEF's Three Percent Feeder Report (Adjusted)

Figure 3-7 shows the fraction of multiple occurrences of feeders using a three-year and five-year basis. During the period of 2014 to 2018, the five-year fraction of multiple occurrences is trending upward as the three-year fraction of multiple occurrences is trending downward. The Three Percent Feeder Report lists the top 3 percent of feeders with the most feeder outage events. The fraction of multiple occurrences is calculated from the number of recurrences divided by the number of feeders reported.

Four of DEF's feeders have been on the Three Percent Feeder Report for the last two years consecutively. The outages varied from equipment failure, a pole that burnt in half, vehicular accident, vegetation, and thunderstorms. DEF replaced the failing equipment, trimmed trees, and performed infrared scans on the feeders. All issues found during the infrared scans were corrected. All four feeders have projects planned to improve reliability. The projects range from replacing wooden poles with fiberglass poles (in heavy woodpecker population areas) to storm hardening projects such as DEF's Deteriorated Conductor Program and Transformer Retrofit Program.

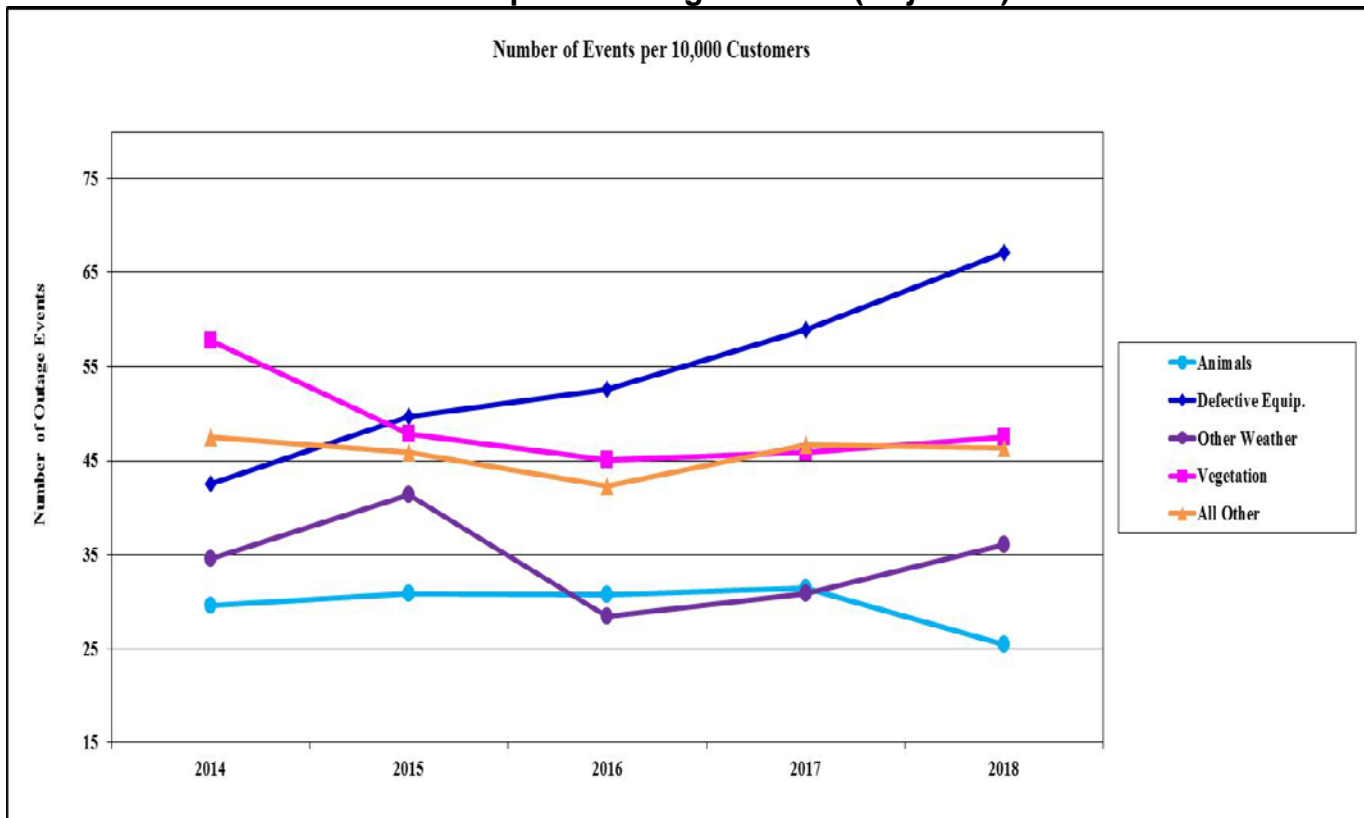
Figure 3-8
DEF’s Top Five Outage Causes (Adjusted)

Figure 3-8 shows the top five causes of outage events on DEF’s distribution system normalized to a 10,000-customer base. The figure is based on DEF’s adjusted data and represents approximately 93 percent of the top 10 causes of outage events that occurred during 2018. For the five-year period, the top five causes of outage events were “Defective Equipment” (28 percent), “Vegetation” (20 percent), “Other Causes” (19 percent), “Other Weather” (15 percent), and “Animals” (11 percent) on a cumulative basis. The outage events caused by “Vegetation”, “Other Causes,” and “Other Weather” are trending downward even though the “Vegetation” category had a 5 percent increase, “Other Causes” category had a 0.3 percent increase and “Other Weather” category had an 18 percent increase in 2018. DEF reported that it prioritizes the reliability improvements action plan by balancing historical and current year performance. In addition, current year performance is monitored monthly to identify emergent and seasonal issues including load balancing for cold weather and the need for foot patrols of devices experiencing multiple interruptions.

To address outages related to “Defective Equipment,” DEF is continuing to invest in proactive system maintenance activities, such as pole replacements, padmounted transformer replacements, and underground cable replacements. In 2018, DEF continued investing in proactive switchgear replacements, overhead transformer retrofits, and other reliability programs.

In **Figure 3-8**, DEF’s Top Five Outage Categories, the category “Defective Equipment” is in the top spot representing 28 percent of the top 10 outage categories. The subsequent categories were “Vegetation” (20 percent) and “Other Causes” (19 percent), followed by “Other Weather” (15 percent) and “Animals” (11 percent). The “Vegetation,” “Other Causes,” and “Other Weather” outage categories are trending downward for the five-year period of 2014 to 2018 even though the “Other Weather” category had a 18 percent increase in 2018, the “Vegetation” category had a 5 percent increase, and the “Other Cause” category had a 0.3 percent increase. The “Defective Equipment” category had an increase between 2017 and 2018 and continued to trend upward for the five-year period. The “Animals” category had a decrease in 2018 and is trending downward for the five-year period.

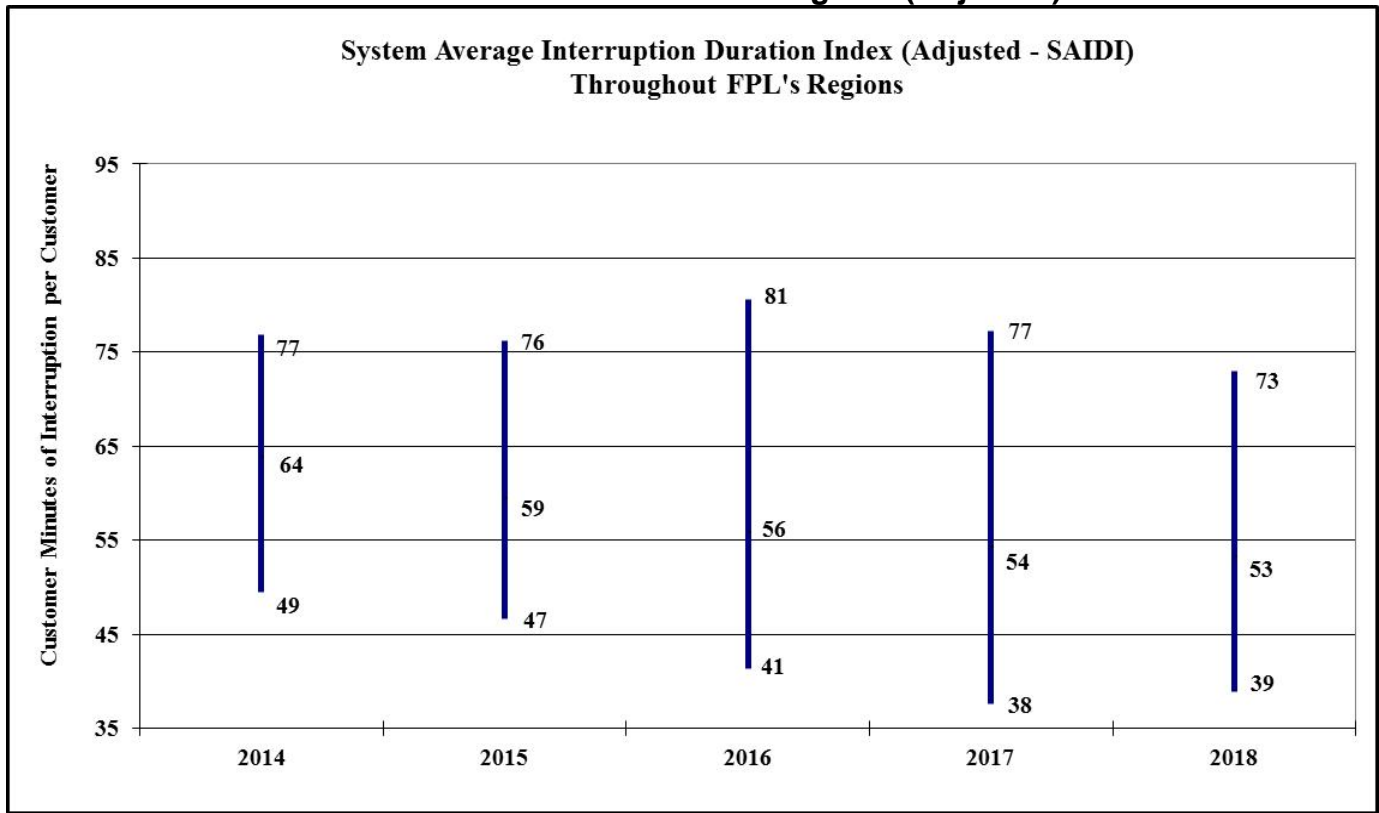
**Figure 3-9
SAIDI across FPL's Sixteen Regions (Adjusted)**

Figure 3-9 shows the highest, average, and lowest adjusted SAIDI recorded across FPL's system that encompasses four management regions with 16 service areas. The highest and lowest SAIDI values are the values reported for a particular service area. FPL had an overall decrease of 1 minute (2 percent) to its average SAIDI results for 2018 compared to 2017. The average SAIDI appears to be trending downward over the five-year period of 2014 to 2018. The Pompano region, which is also the North Broward region, has the best SAIDI results for two out of the five years. FPL changed the names of three regions to be consistent with the other FPL regions. Pompano became North Broward, Wingate became Central Broward, and Gulf Stream became South Broward.

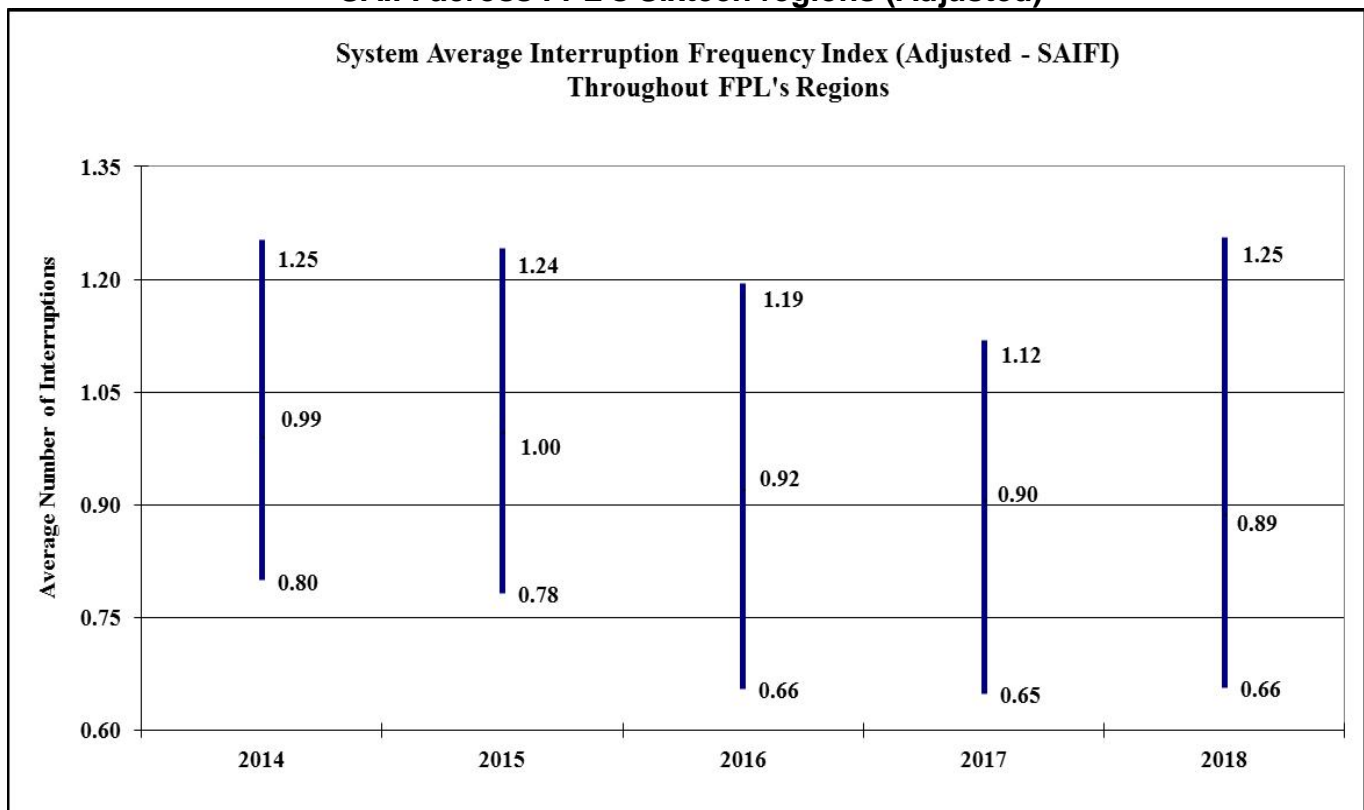
Figure 3-10
SAIFI across FPL's Sixteen regions (Adjusted)

Figure 3-10 is a chart of the highest, average, and lowest adjusted SAIFI across FPL's system. FPL had a decrease in the system average results to 0.89 outages in 2018, compared to 0.90 outages in 2017, which is a 1 percent decrease. FPL reported an increase in the highest SAIFI of 1.25 interruptions in 2018 compared to 1.12 interruptions in 2017. The region reporting the lowest adjusted SAIFI for 2018 was North Broward at 0.66 interruptions compared to 0.65 interruptions in the same region in 2017. The highest, average, and lowest SAIFI appear to be trending downward during the period of 2014 to 2018.

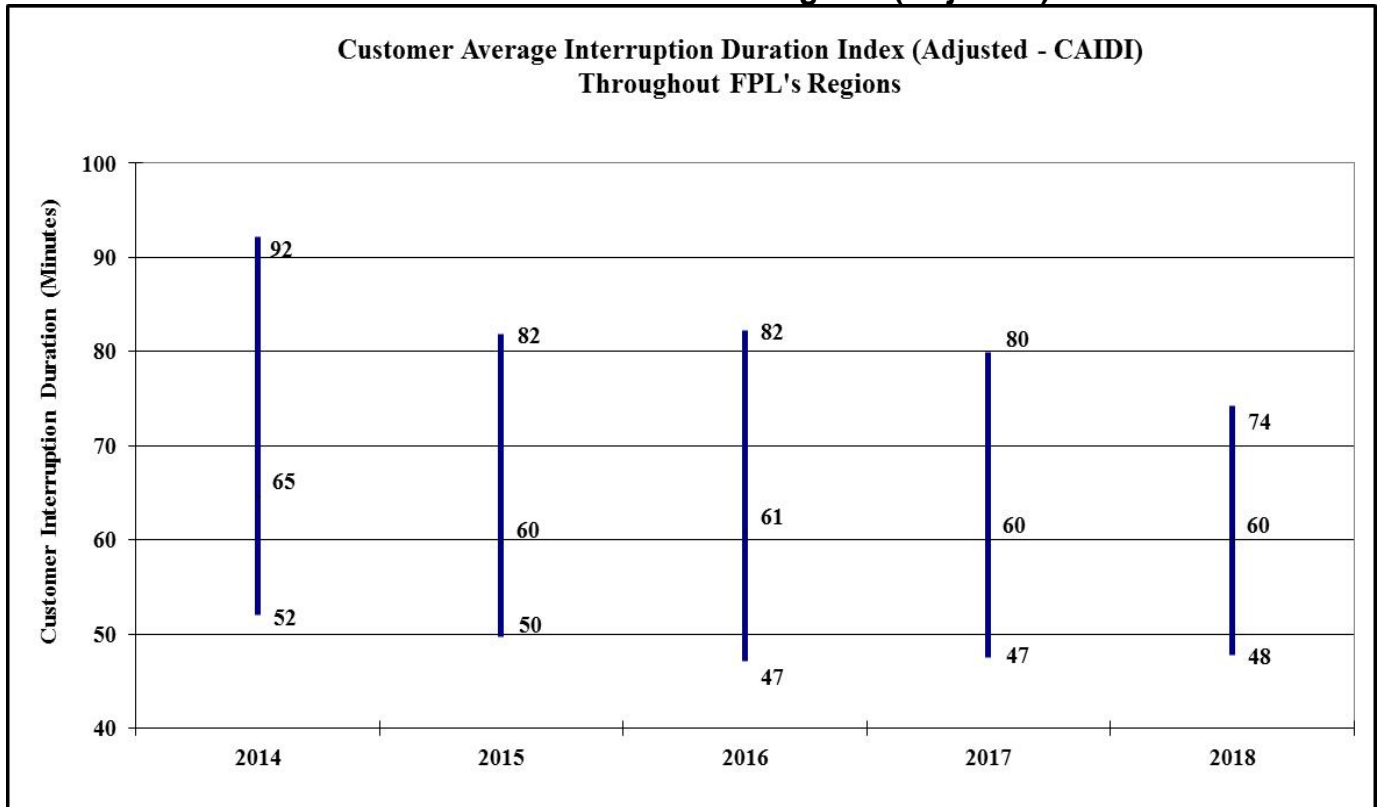
Figure 3-11
CAIDI across FPL’s Sixteen Regions (Adjusted)

Figure 3-11 depicts FPL’s highest, average, and lowest CAIDI expressed in minutes. FPL’s adjusted average CAIDI did not decrease or increase and remained at 60 minutes for both 2017 and 2018. The average duration of CAIDI is trending downward. For 2018, the West Palm service area reported the lowest duration of CAIDI at 48 minutes. The highest duration of CAIDI was 74 minutes for the North Dade service area for 2018, which is a decrease from the recorded 80 minutes in 2017.

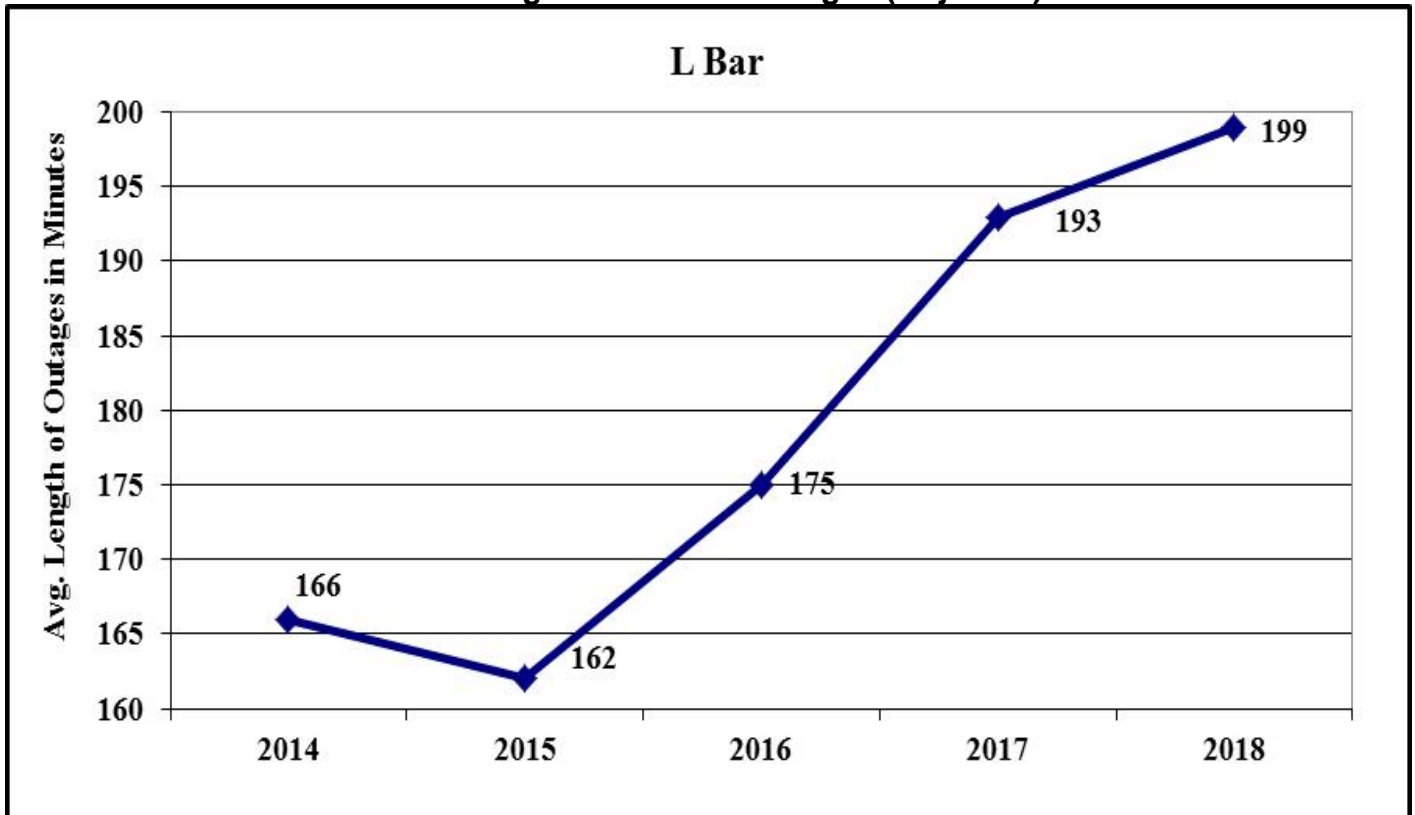
Figure 3-12
FPL's Average Duration of Outages (Adjusted)

Figure 3-12 depicts the average length of time that FPL spends recovering from outage events, excluding hurricanes and other extreme outage events and is the index known as L-Bar (Average Service Restoration Time). FPL had a 3 percent increase in L-Bar from 193 minutes in 2017 to 199 minutes in 2018. There is a 19.8 percent overall increase since 2014 and the L-Bar is trending upward, indicating FPL is spending more time restoring service to the last customer for that given outage.

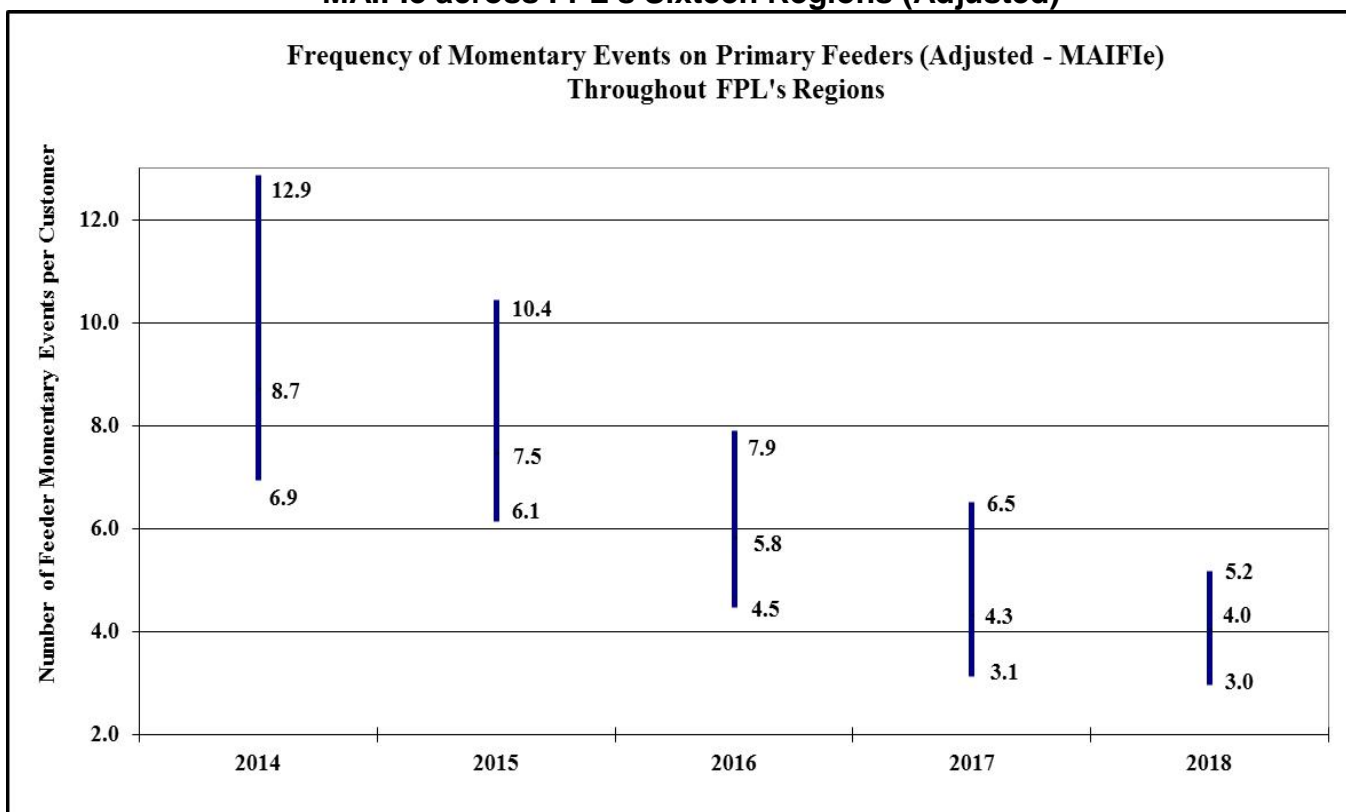
Figure 3-13
MAIFle across FPL's Sixteen Regions (Adjusted)

Figure 3-13 is the highest, average, and lowest adjusted MAIFle recorded across FPL's system. FPL's Wingate and Toledo Blade service areas have experienced the least reliable MAIFle results of the 16 service areas of FPL since 2014. The Pompano, Central Dade, and Manasota service areas had the fewest momentary events since 2014. The results have been trending downward (improving) over the last five years. There is a 7 percent decrease in the average MAIFle results from 2017 to 2018. As a note, FPL calculates MAIFle differently. Specifically, if a feeder begins in one region and crosses another region, all customers on that feeder are impacted by the MAIFle event and are counted in the starting region. Therefore, the number of customers per region will be different.

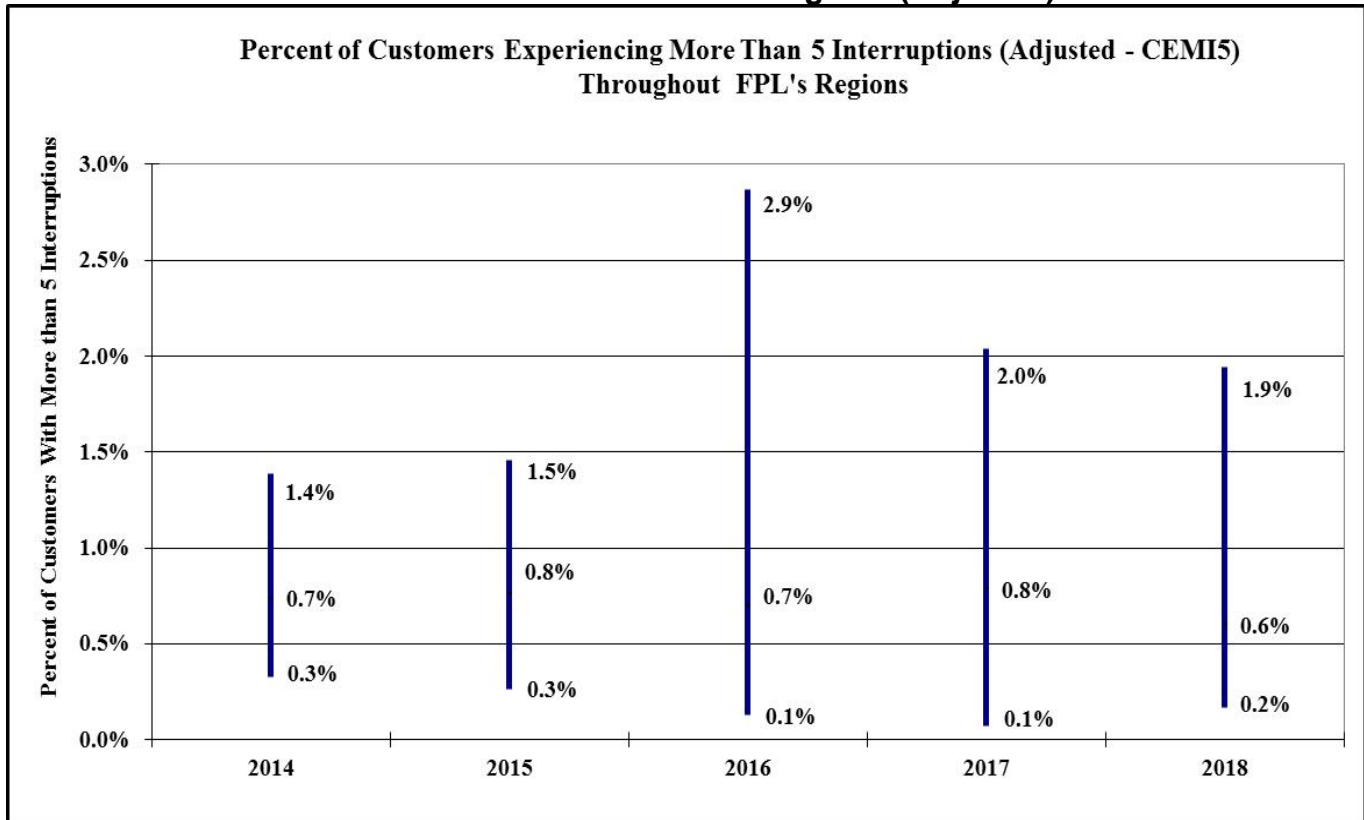
**Figure 3-14
CEMI5 across FPL's Sixteen Regions (Adjusted)**

Figure 3-14 shows the highest, average, and lowest adjusted CEMI5. FPL's customers with more than five interruptions per year appear to be slightly trending downward. The service areas experiencing the highest CEMI5 over the five-year period appear to fluctuate among West Dade, Treasure Coast, West Palm, and Toledo Blade. Pompano, South Broward (Gulf Stream), and Brevard are reported as having the lowest percentages in the last five years. The average CEMI5 result for 2018 was 0.6 percent compared to 0.8 percent in 2017.

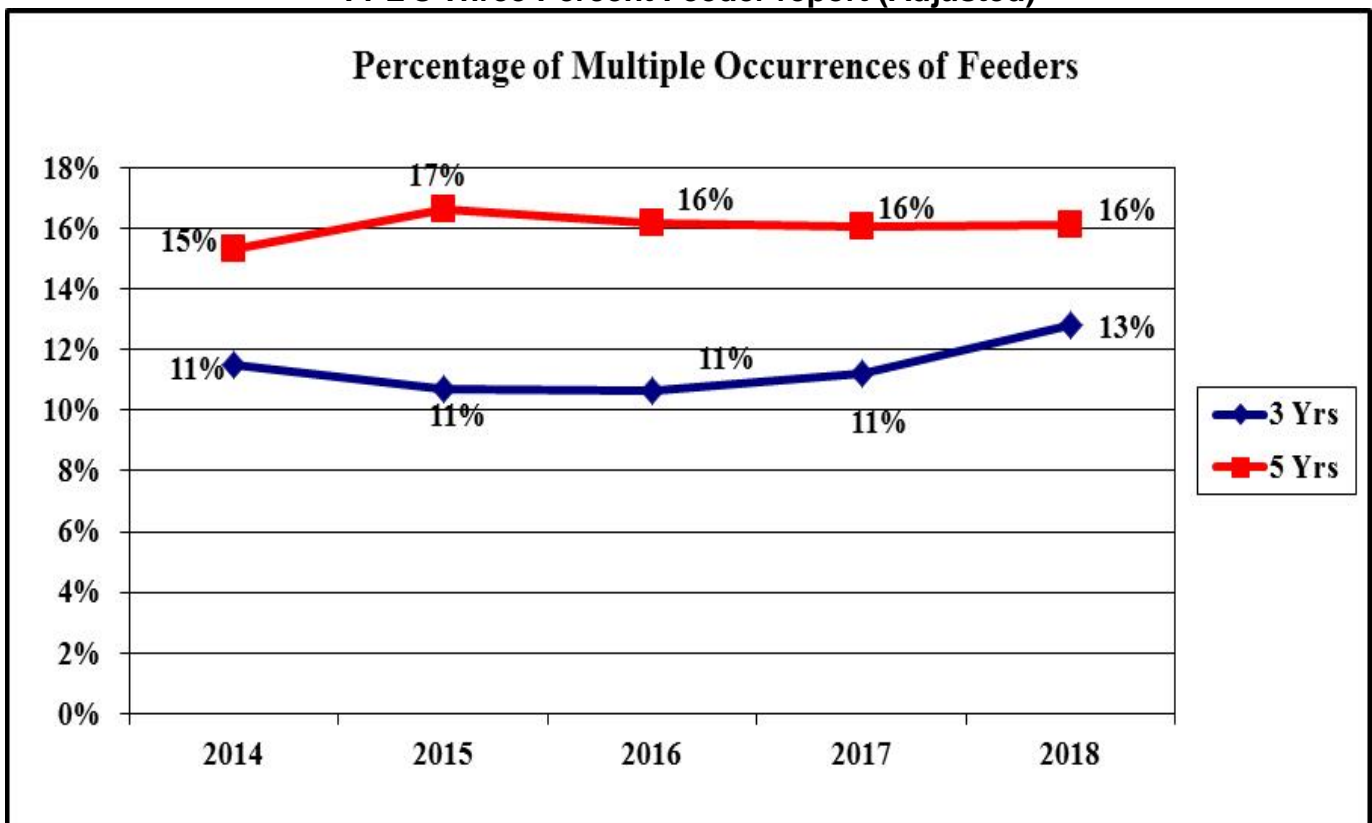
Figure 3-15
FPL's Three Percent Feeder report (Adjusted)

Figure 3-15 is a graphical representation of the percentage of multiple occurrences of FPL's feeders and is derived from The Three Percent Feeder Report, which is a listing of the top three percent of problem feeders reported by the Utility. The fraction of multiple occurrences is calculated from the number of recurrences divided by the number of feeders reported. The three-year percentage had an increase to 13 percent in 2018 from 11 percent in 2017. The five-year percentage was 16 percent in 2017 and 2018. Both the five-year percentage and the three-year percentage appear to be trending upward.

Staff notes ten feeders were on the Three Percent Feeder Report the last two years. FPL reported that visual assessment follow-up work is scheduled for one feeder, five feeders will be hardened, automated feeder switches will be installed on three feeders, and vegetation trimming will occur on eight of the ten feeders. FPL also reported that in 2017 and 2018, over 325 miles of trimming was performed on these 10 feeders which have nearly 200 miles of overhead facilities.

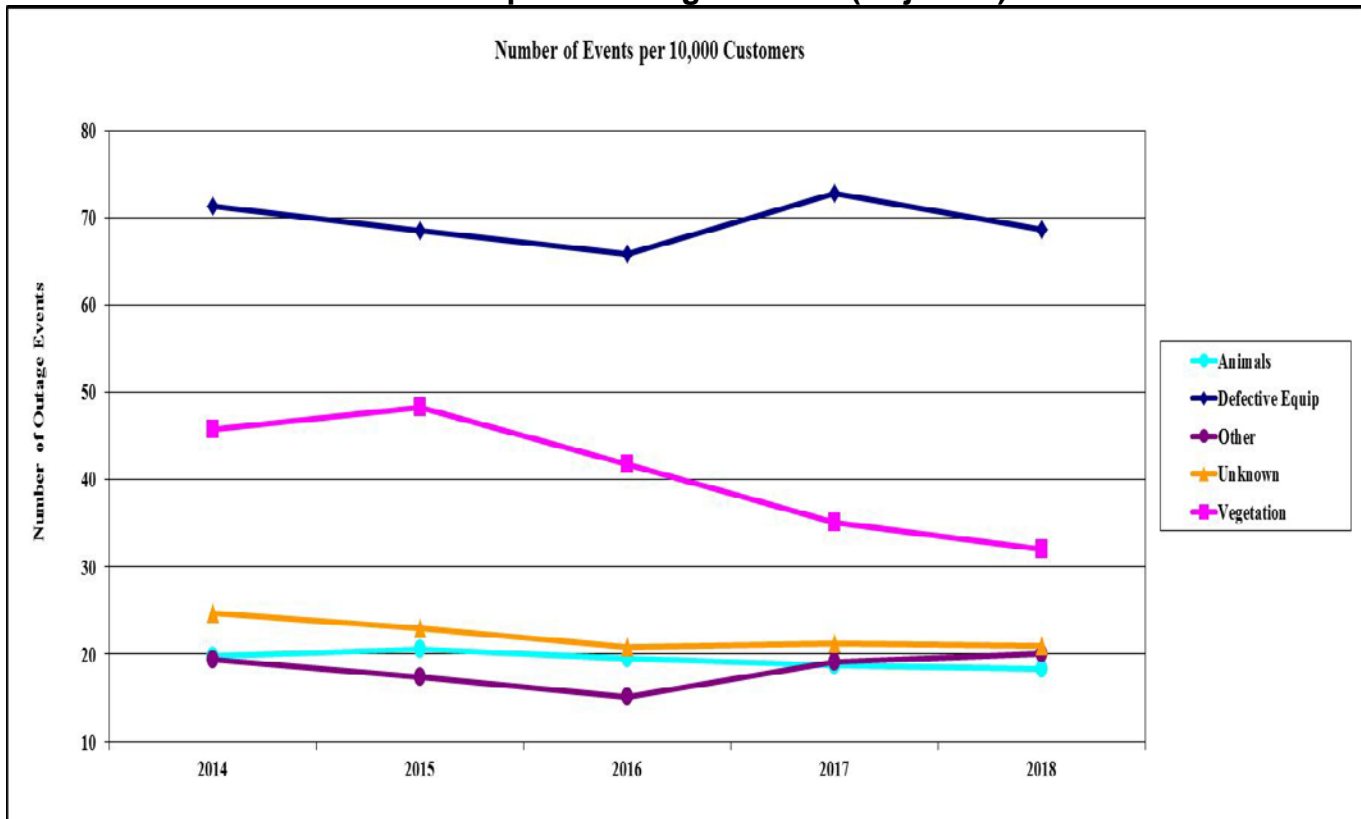
Figure 3-16
FPL’s Top Five Outage Causes (Adjusted)

Figure 3-16 depicts the top five causes of outage events on FPL’s distribution system normalized to a 10,000-customer base. The graph is based on FPL’s adjusted data of the top 10 causes of outage events. For the five-year period, the five top causes of outage events included “Defective Equipment” (37 percent), “Vegetation” (17 percent), “Unknown Causes” (11 percent), “Other Causes” (11 percent), and “Animals” (10 percent) on a cumulative basis. The outage events due to “Vegetation” and “Unknown Causes” are trending downward as the “Defective Equipment” and “Animals” categories are trending slightly downward. The category “Other Causes” is slightly trending upward. The category “Defective Equipment” dominates the highest percentage of outage causes throughout the FPL regions even though there was a 4 percent decrease in the number of outages from 2017 to 2018.

Annually, FPL evaluates its current reliability remediation programs and verifies the program’s need and/or existence. In addition, FPL proposes new reliability remediation programs to improve its reliability performance concentrating on the highest cause codes and those cause codes that have shown trends needing attention. FPL has 16 reliability programs listed for its 2019 budget. The programs include: priority feeder inspection, reduce the number of direct buried feeder and lateral cables, installing, relocating, and maintaining distribution capacitor banks, and replacing oil circuit reclosers with electronic reclosers. Twelve programs are designed to help improve the “Defective Equipment” cause code. Five programs will help to improve the “Other Causes” cause codes, which had an increase in 2018.

"Defective Equipment" (37 percent) and "Vegetation" (17 percent) outages were the leading causes of outage events per customer for 2018. The next three outage causes are "Unknown Causes" (11 percent), "Other Causes" (11 percent), and "Animals" (10 percent). **Figure 3-16** shows an increasing trend in the number of outage events attributed to "Other Cause," which had increased by 6 percent from 2017 to 2018. The analysis shows a decrease in the number of outage events caused by "Defective Equipment," "Vegetation," "Unknown Causes," and "Animals." The number of outages decreased by 8 percent for "Vegetation" and "Unknown Causes" decreased by 0.4 percent from 2017 to 2018. The analysis shows that the "Animals" category is trending downward with a decrease in outages of 1 percent and the "Defective Equipment" category experienced a decrease in outages of 4 percent.
