*Review of
Florida's
Investor-Owned
Electric Utilities*

*2 0 1 8
Service Reliability Reports*

State of Florida
Florida Public Service Commission
Division of Engineering

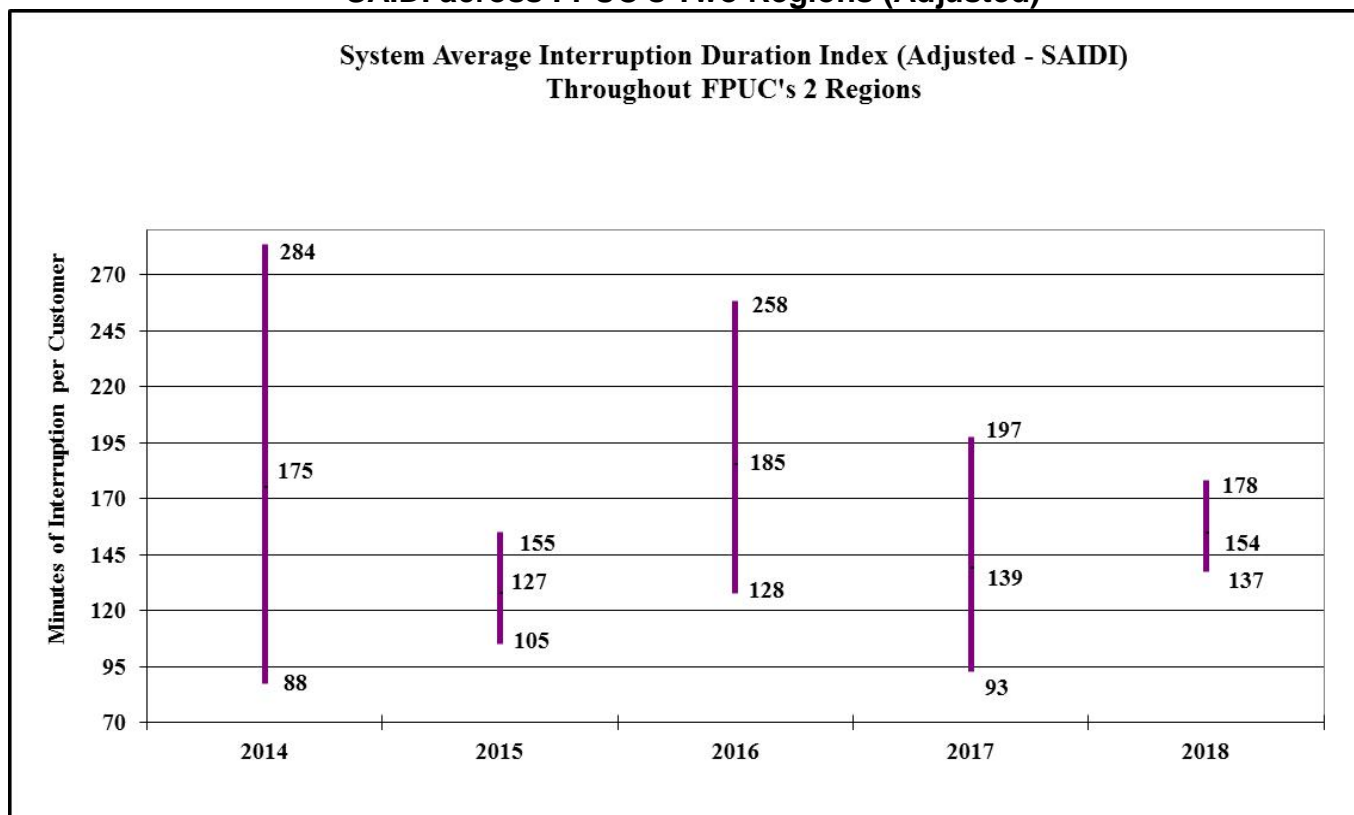
Figure 3-17
SAIDI across FPUC's Two Regions (Adjusted)

Figure 3-17 shows the highest, average, and lowest adjusted SAIDI values recorded by FPUC's system. The data shows the average SAIDI index is trending downward for the five-year period of 2014 to 2018 even though there was an 11 percent increase from 2017 to 2018.

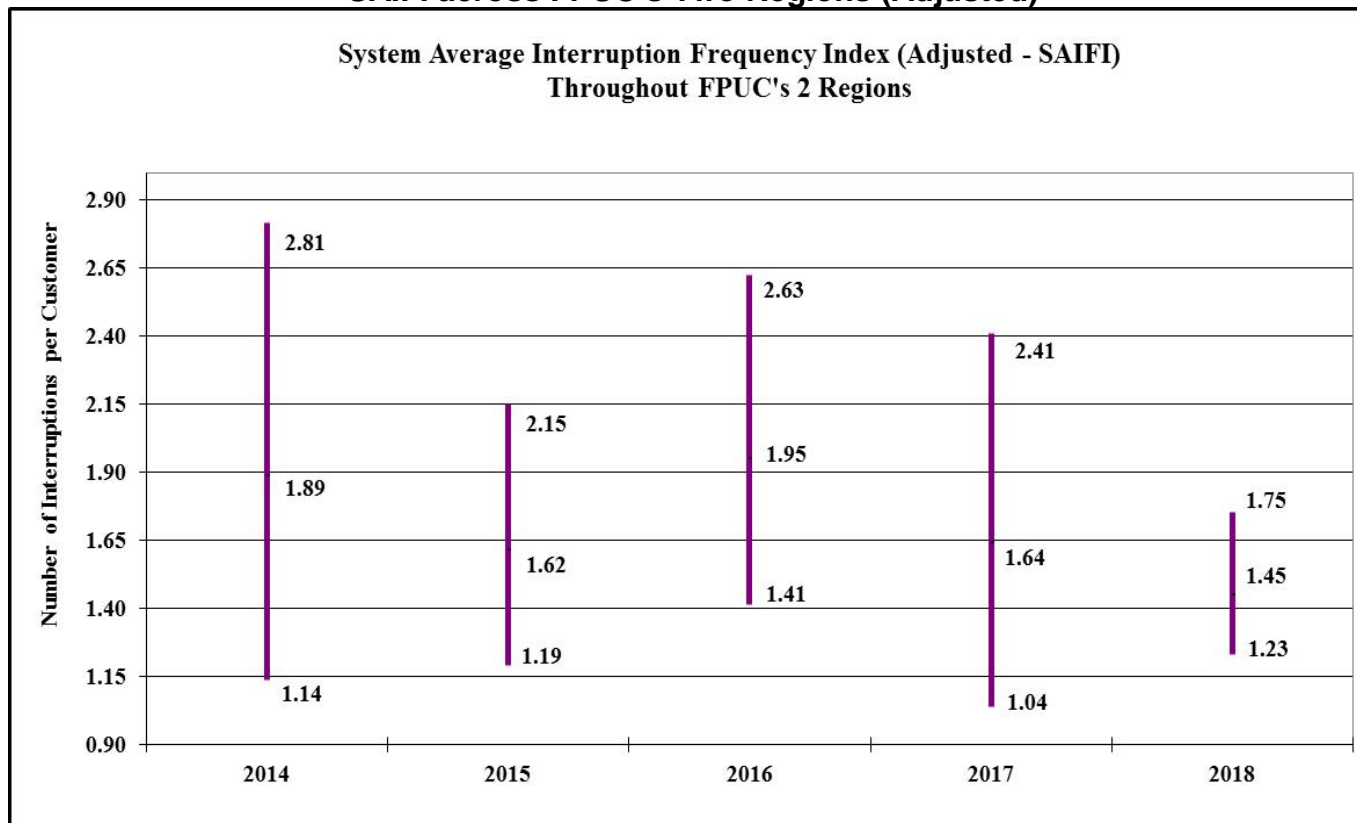
Figure 3-18
SAIFI across FPUC’s Two Regions (Adjusted)

Figure 3-18 shows the adjusted SAIFI across FPUC’s two divisions. The data depicts a 12 percent decrease in the 2018 average SAIFI reliability index from 2017. The data for the average and maximum SAIFI values are trending downward as the minimum SAIFI value is trending upward over the five-year period of 2014 to 2018.

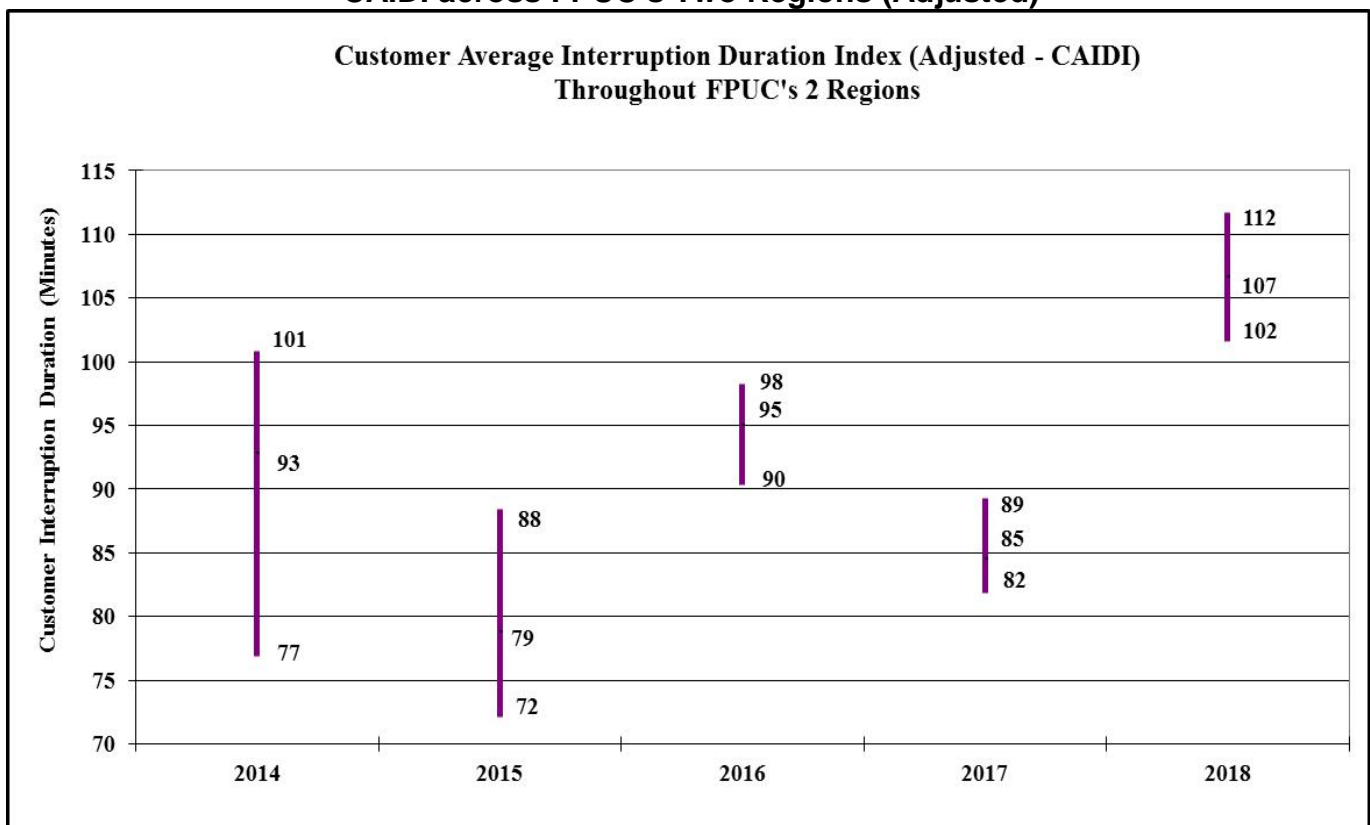
**Figure 3-19
CAIDI across FPUC's Two Regions (Adjusted)**

Figure 3-19 shows the highest, average, and lowest adjusted CAIDI values across FPUC's system. FPUC's data shows the average CAIDI value increased by 26 percent for 2018 (107 minutes) when compared to 2017 (85 minutes). For the past five years, the maximum, the minimum, and the average CAIDI values are trending upward.

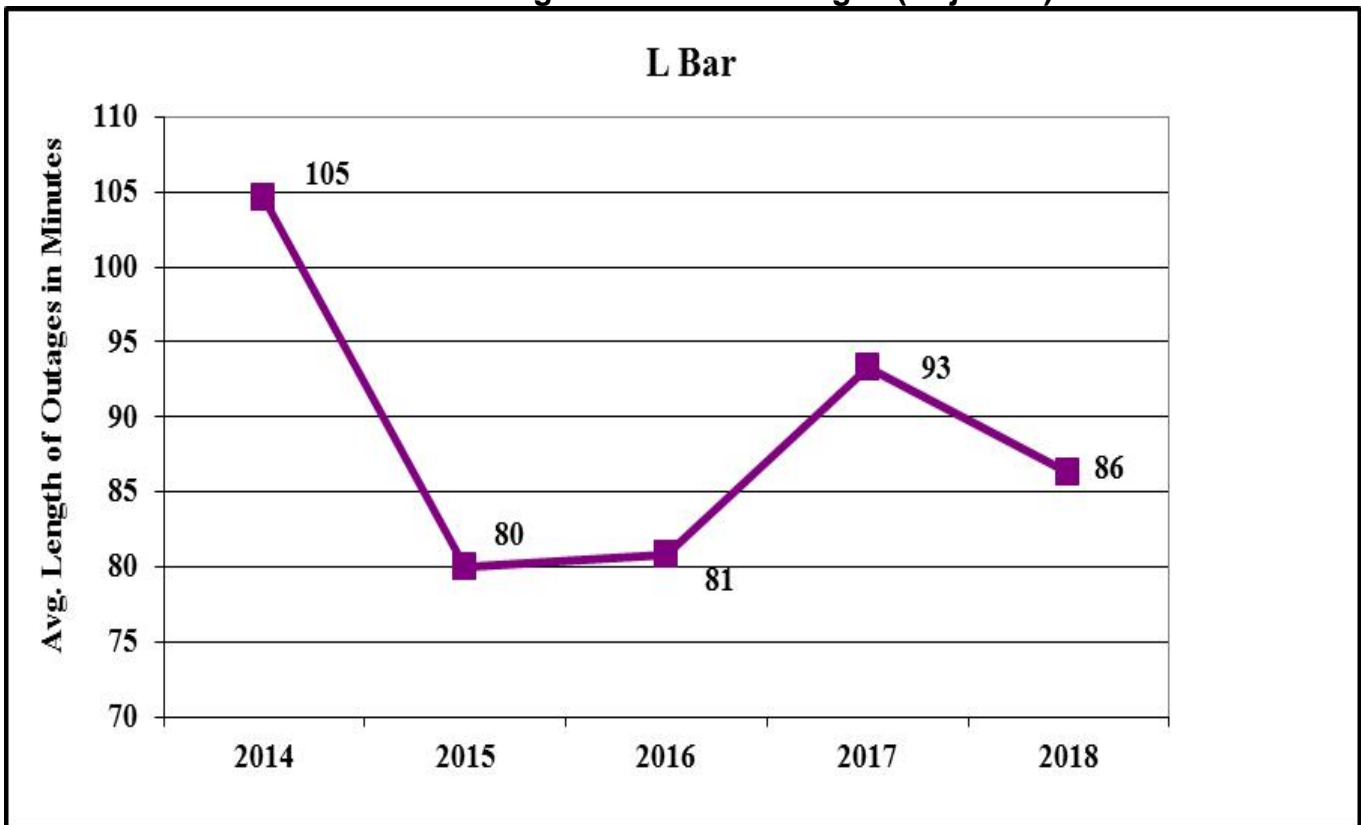
Figure 3-20
FPUC's Average Duration of Outages (Adjusted)

Figure 3-20 is the average length of time FPUC spends recovering from outage events (adjusted L-Bar). There was an 8 percent decrease in the L-Bar value from 2017 to 2018. The data for the five-year period of 2014 to 2018 suggests that the L-Bar index is trending downward indicating FPUC is taking less time to restore service after an outage event.

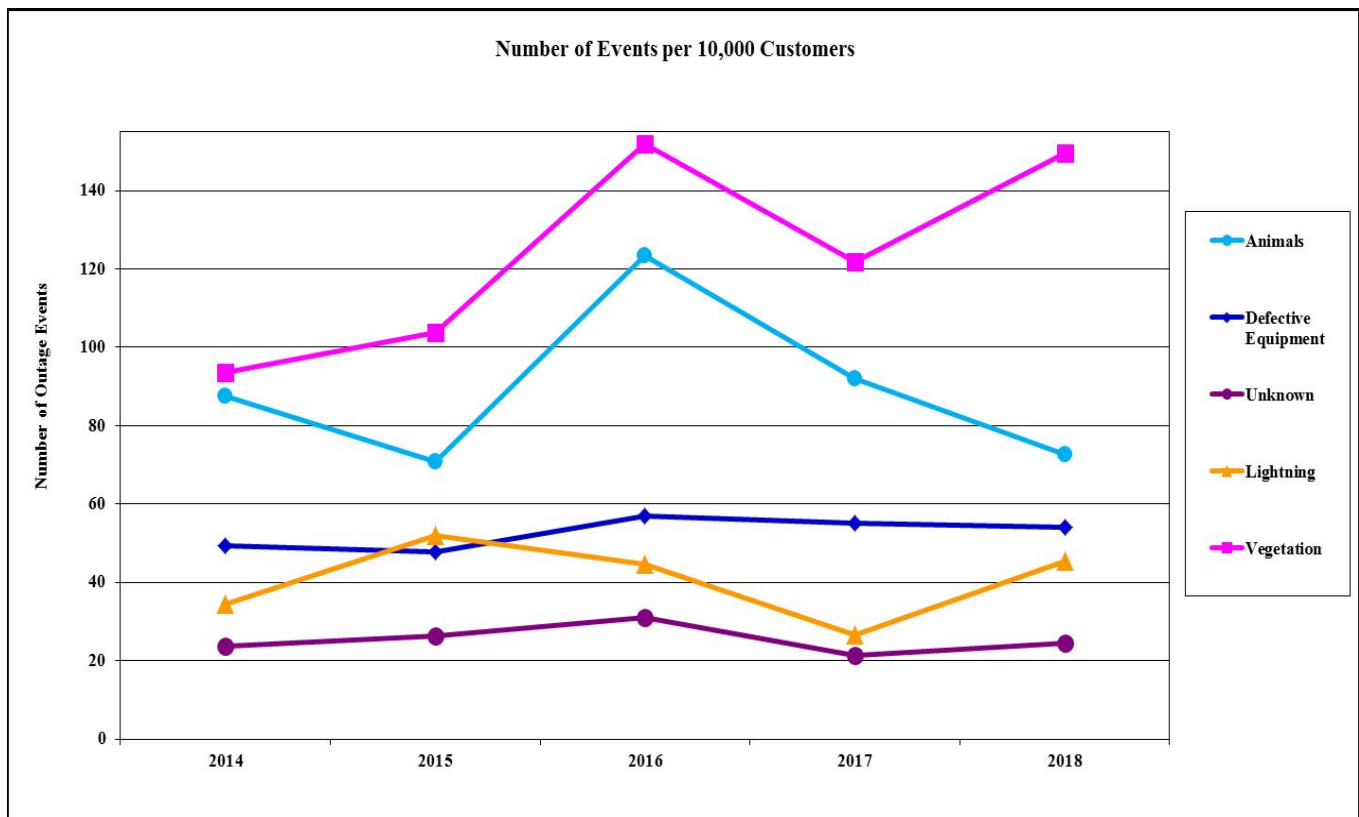
Figure 3-21
FPUC’s Top Five Outage Causes (Adjusted)

Figure 3-21 shows the top five causes of outage events on FPUC’s distribution system normalized to a 10,000-customer base. The figure is based on FPUC’s adjusted data of the top 10 causes of outages. For 2018, the top five causes of outage events were “Vegetation” (38 percent), “Animals” (18 percent), “Defective Equipment” (14 percent), “Lightning” (12 percent), and “Unknown” (6 percent). These five factors represent 88 percent of the total adjusted outage causes in 2018. The “Lightning” category is relatively flat even though there was a 66 percent increase from 2017 to 2018. The causes by “Defective Equipment,” “Unknown,” and “Vegetation” are also trending upward. “Defective Equipment” decreased 5 percent from 2017 to 2018. The “Unknown” and “Vegetation” category increased 11 percent and 19 percent during the same time period, respectively. The “Animals” category caused outages is trending downward over the five-year period of 2014 to 2018 and there was a 24 percent decrease from 2017 to 2018.

FPUC's top five causes of outages included "Vegetation," "Animals," "Defective Equipment," "Lightning," and "Unknown" events. As shown in **Figure 3-21**, "Vegetation" (38 percent) was the number one cause of outages in 2018 followed by "Animals" (18 percent), "Defective Equipment" (14 percent), "Lightning" (12 percent), and "Unknown" (6 percent). "Animals," and "Defective Equipment" attributed outages decreased in 2018, as "Vegetation," "Lightning," and "Unknown" caused outages increased.

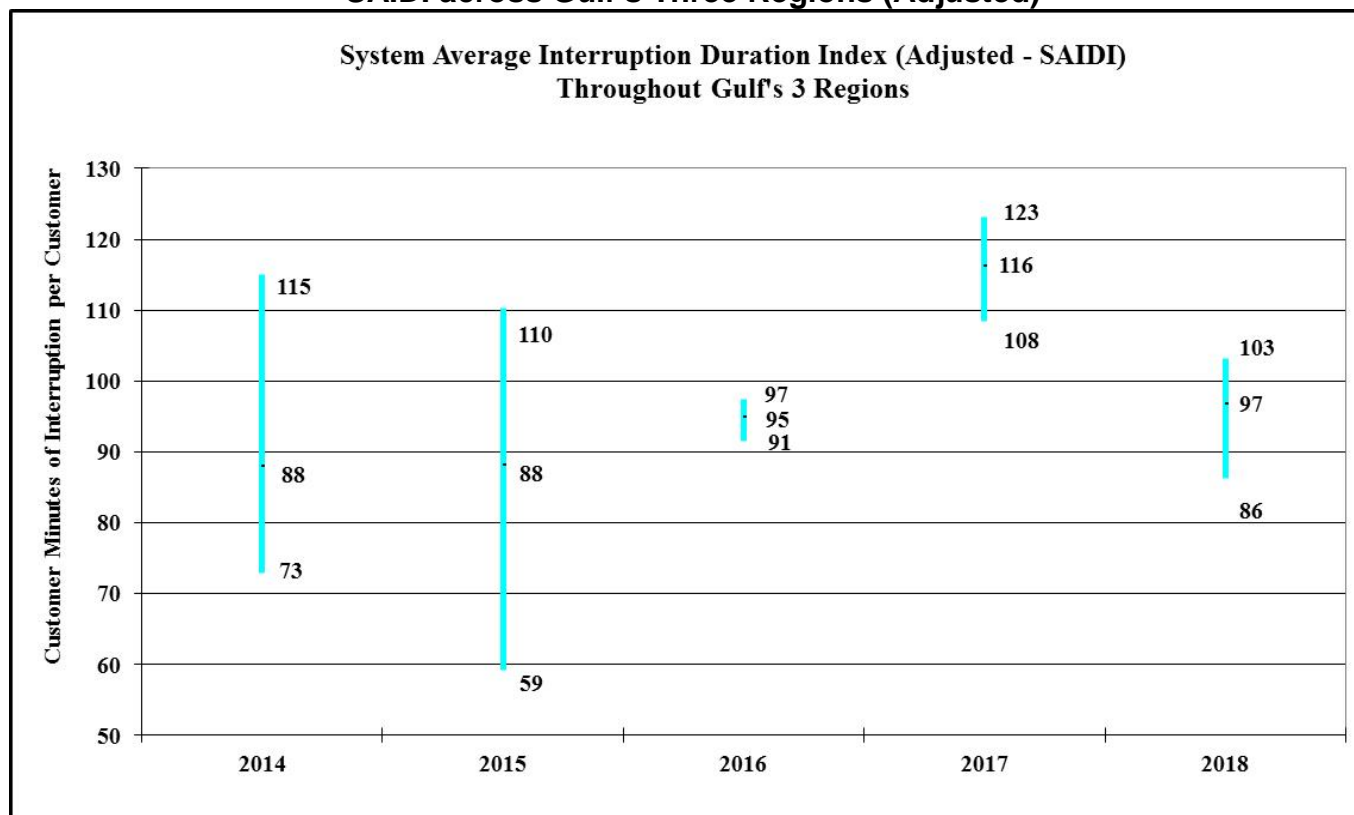
Figure 3-22
SAIDI across Gulf's Three Regions (Adjusted)

Figure 3-22 illustrates Gulf's SAIDI minutes, or the interruption duration minutes on a system basis. The chart depicts a 16 percent decrease in the average SAIDI in Gulf's combined regions when compared to the 2017 results. Gulf's 2018 average performance was 97 minutes compared to 116 minutes in 2017. The highest SAIDI value for 2018 was the Eastern region as the Central region had the best or lowest SAIDI value. The maximum SAIDI index is trending downward, as the minimum and average SAIDI indices are trending upward.

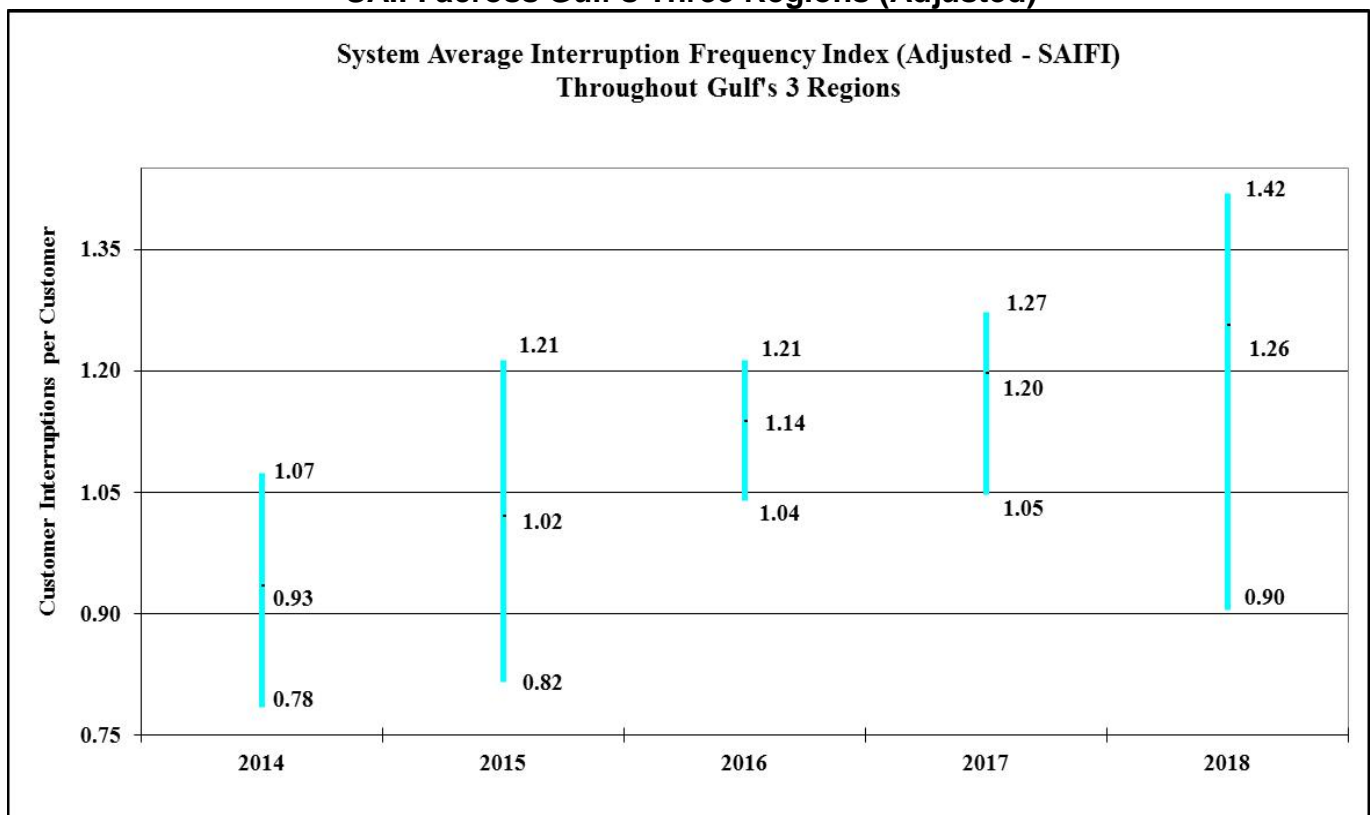
Figure 3-23
SAIFI across Gulf's Three Regions (Adjusted)

Figure 3-23 illustrates that Gulf's SAIFI had a 5 percent increase in 2018 when compared to 2017. The highest SAIFI value for the past five years has fluctuated between the three regions. The lowest values appear to fluctuate between the Central region and the Eastern region. The maximum, average, and minimum SAIFI values appear to be trending upward.

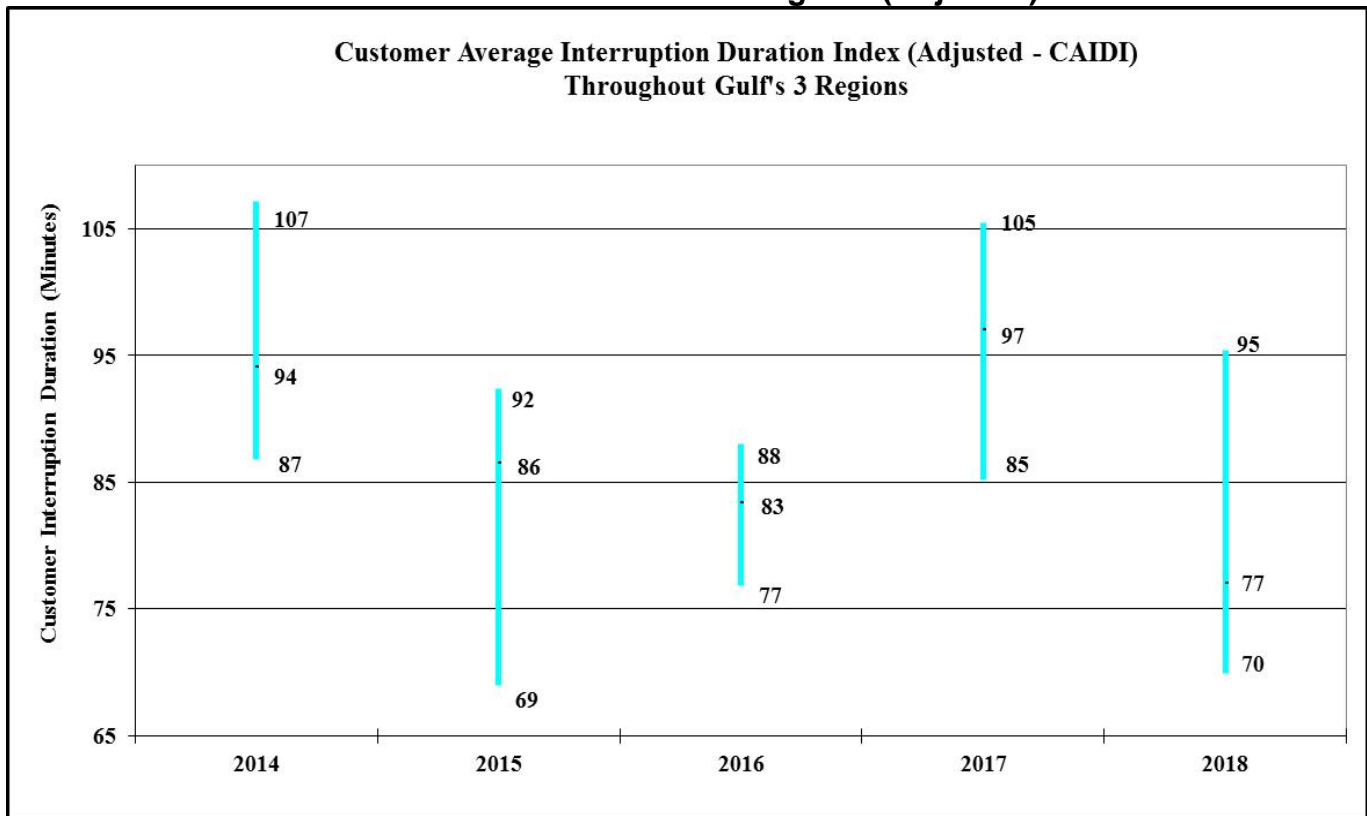
**Figure 3-24
CAIDI across Gulf's Three Regions (Adjusted)**

Figure 3-24 is Gulf's adjusted CAIDI. For 2018, the average CAIDI is 77 minutes and represents a 21 percent decrease from the 2017 value of 97 minutes. In 2018, the Central region continued to have the highest CAIDI value, as the Western region had the lowest CAIDI. Staff notes that the average, the maximum and the minimum CAIDI values are trending downward.

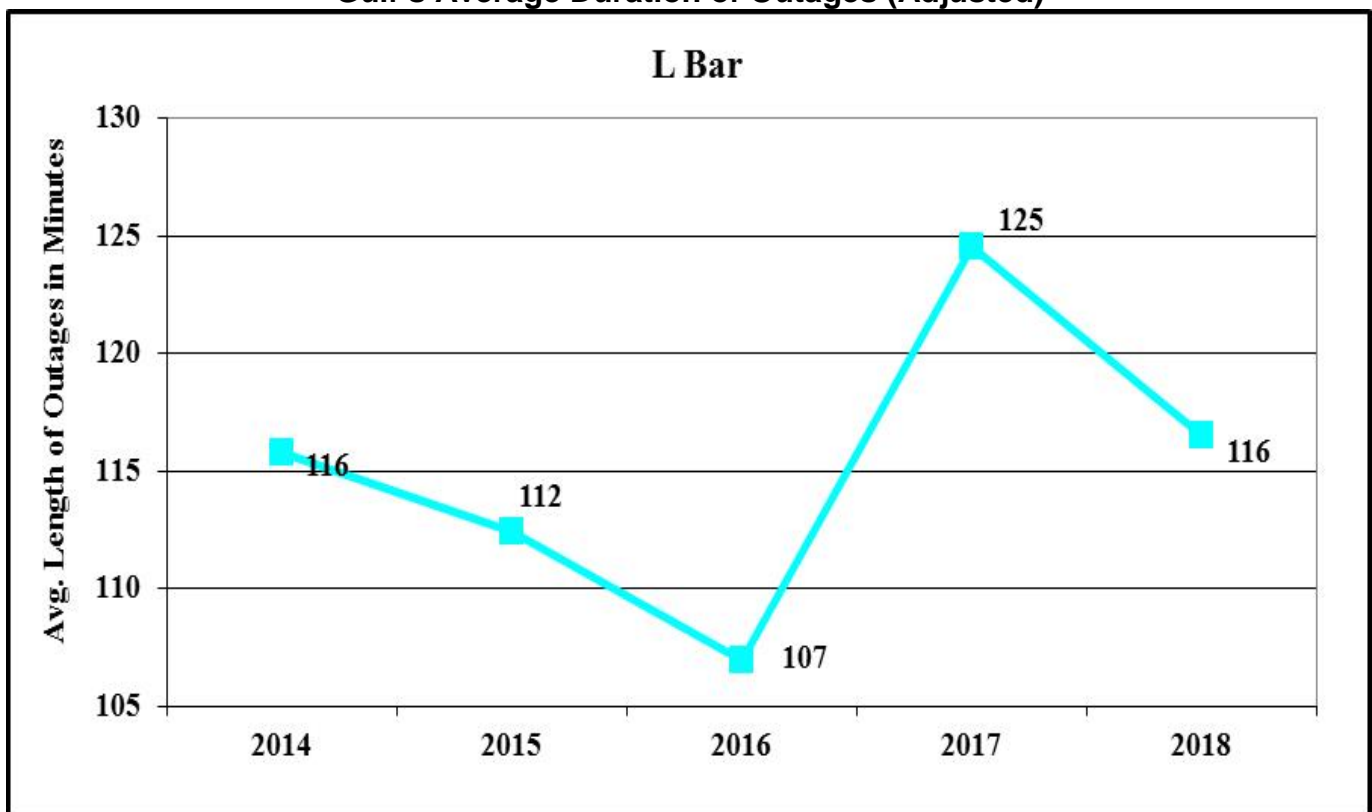
Figure 3-25
Gulf's Average Duration of Outages (Adjusted)

Figure 3-25 illustrates Gulf's L-Bar or the average length of time Gulf spends recovering from outage events, excluding hurricanes and other allowable excluded outage events. Gulf's L-Bar showed a 7 percent decrease from 2017 to 2018. However, the data for the five-year period of 2014 to 2018 shows an upward trend.

Gulf reported that all three of its regions experienced outages due to four non-excludable severe thunderstorms. These severe thunderstorms occurred on June 10, June 28, June 30, and December 1, 2018. During these events, a combined 554 outage events occurred. In addition, a hard freeze, that occurred on January 18, 2018, affected all three regions. A combined total of 59 outage events were a result of this hard freeze.

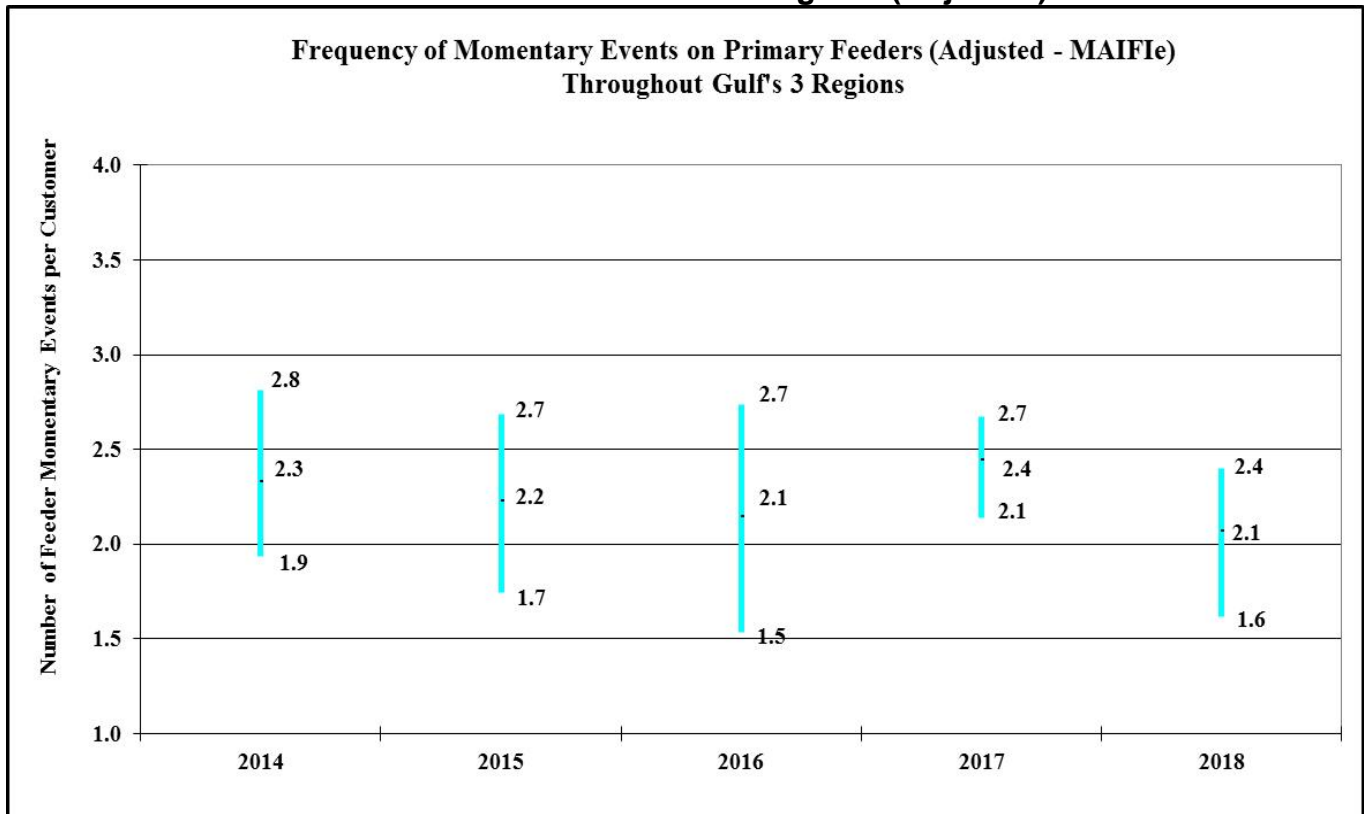
Figure 3-26
MAIFle across Gulf’s Three Regions (Adjusted)

Figure 3-26 is the adjusted MAIFle recorded across Gulf’s system. The adjusted MAIFle results by region show that the Central region had the lowest frequency of momentary events on primary feeders. The Western region has the highest MAIFle index in 2018. The average MAIFle showed a 13 percent decrease when compared to 2017. The data suggest that the highest, average, and lowest MAIFle are all continuing to trend downward, suggesting improvement.

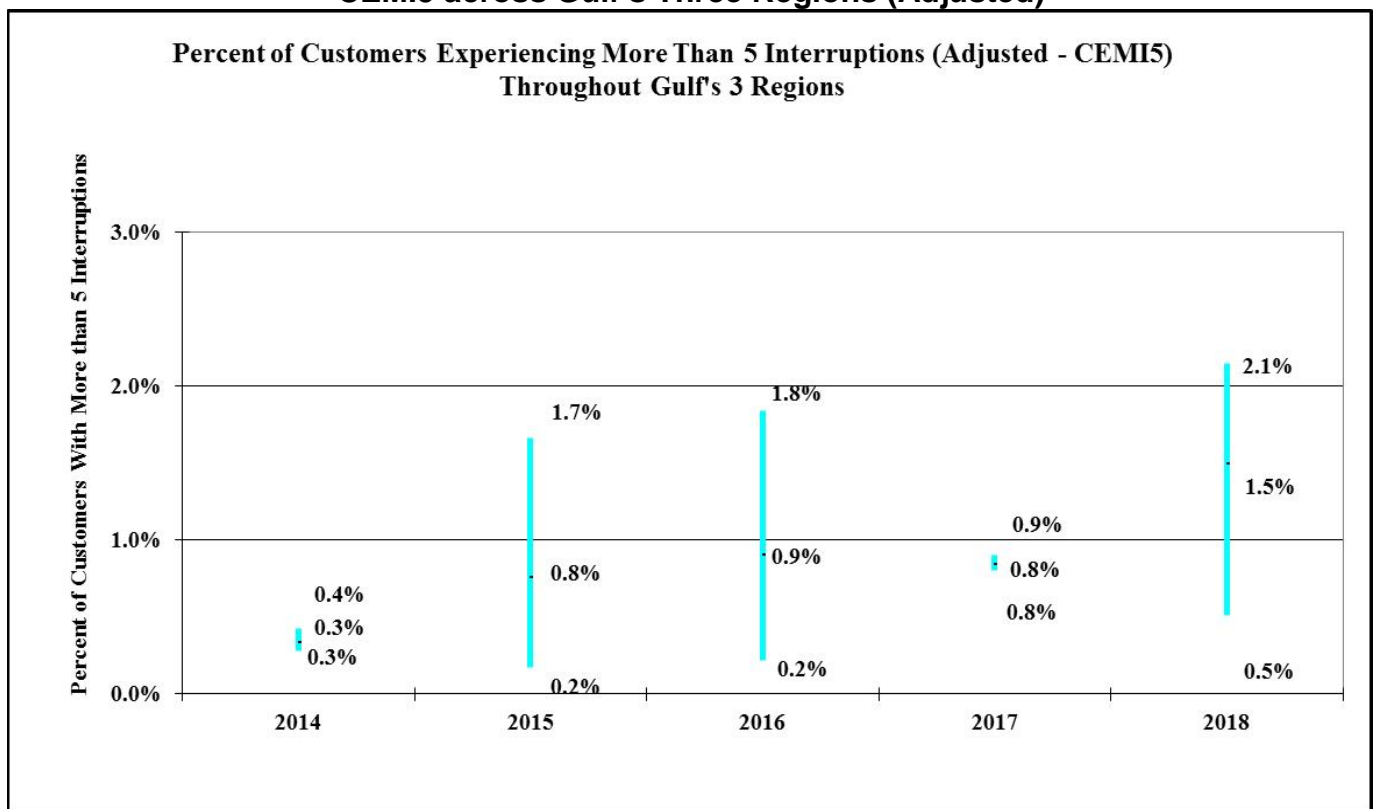
Figure 3-27
CEMI5 across Gulf's Three Regions (Adjusted)

Figure 3-27 shows the highest, average, and lowest adjusted CEMI5 across Gulf's Western, Central, and Eastern regions. Gulf's 2018 results illustrate an 88 percent increase in the average CEMI5 percentage when compared to 2017. The maximum, average, and minimum CEMI5 all appear to be trending upward over the five-year period of 2014 to 2018.

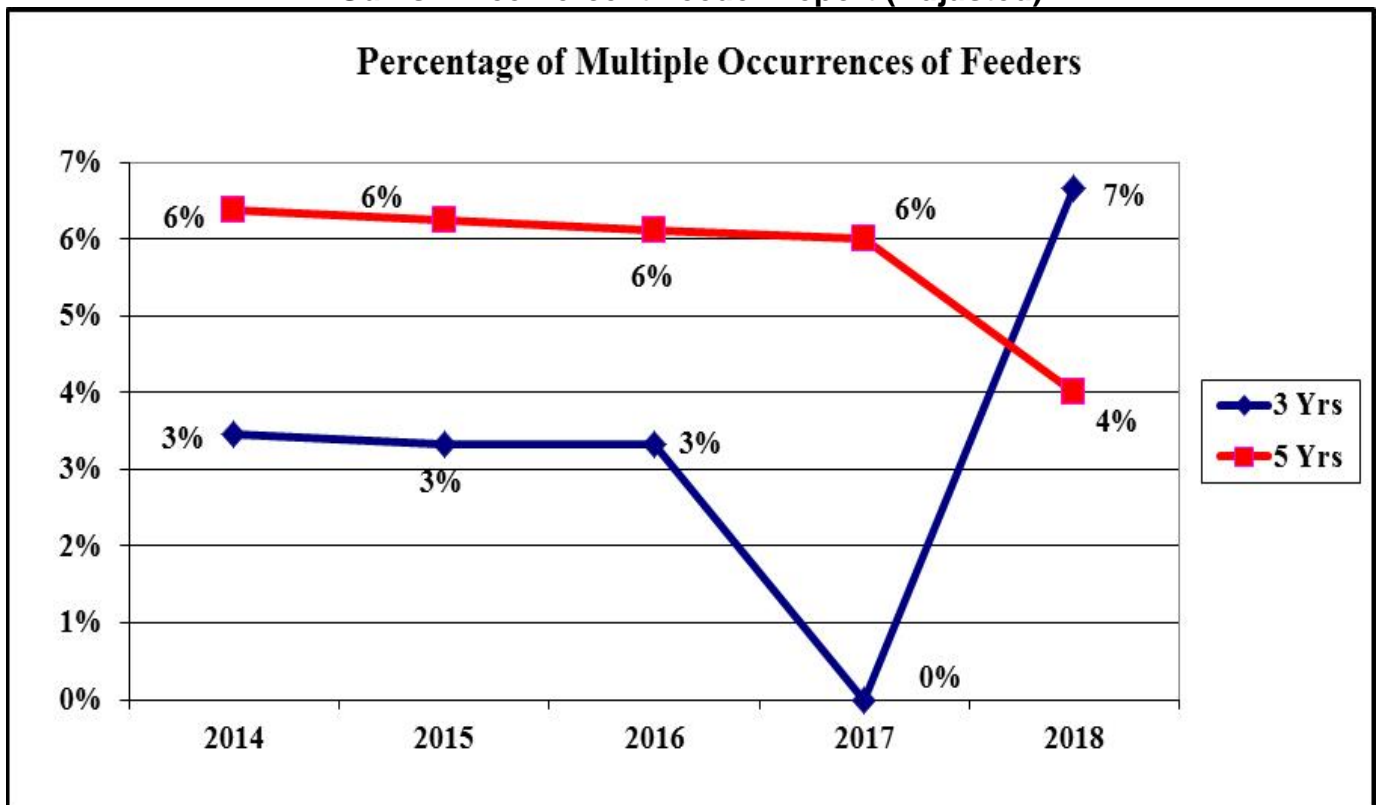
Figure 3-28
Gulf's Three Percent Feeder Report (Adjusted)

Figure 3-28 shows the multiple occurrences of feeders using the Utility's Three Percent Feeder Report and is analyzed on a three- and five-year basis. The Three Percent Feeder Report is a listing of the top 3 percent of feeders that have the most feeder outage events. The supporting data illustrates that the five-year multiple occurrences decreased by 33 percent from 2017 to 2018 as the three-year multiple occurrences increased. The five-year period of 2014 to 2018 indicates overall that the five-year index is trending downward, as the three-year multiple occurrences index is trending upward.

There were 10 feeders on the Three Percent Feeder Report. Gulf reported that the three top causes of the outages associated with the 10 feeders listed were defective equipment, lightning, and vegetation. Gulf has a program for addressing these feeder issues called the Outage Mitigation Program. This Program addresses the root cause of the outages and develops a work plan to replace and/or repair system devices and material to prevent future outages. Part of this Program includes visual and infrared feeder patrols of the system, analysis of outage and fault data, coordination studies, and vegetation trimming.

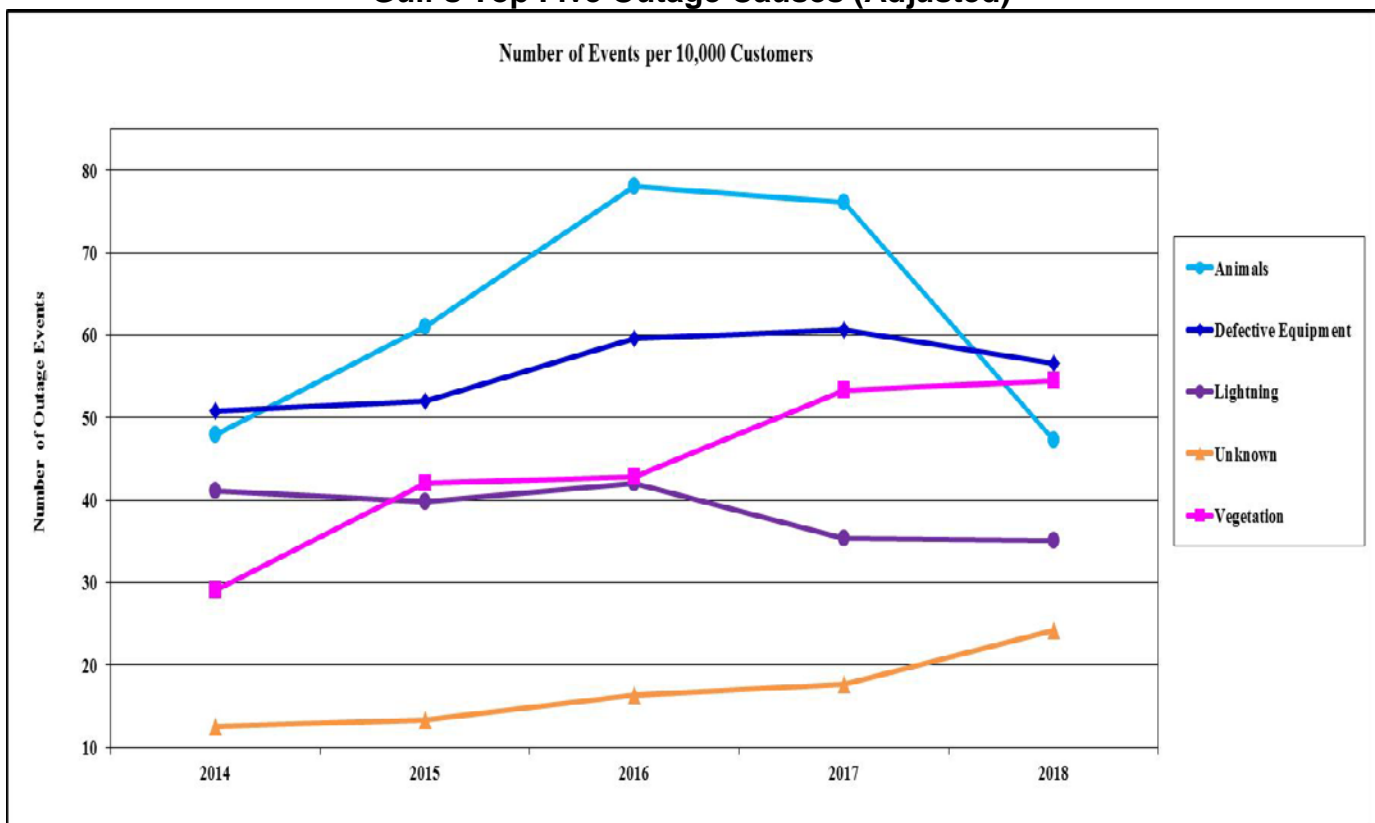
Figure 3-29
Gulf’s Top Five Outage Causes (Adjusted)

Figure 3-29 shows the top five causes of outage events on Gulf’s distribution system normalized to a 10,000-customer base. The figure is based on Gulf’s adjusted data of the top 10 causes of outage events and represents 90 percent of the total adjusted outage events that occurred during 2018. The top five causes of outage events were “Defective Equipment” (24 percent), “Vegetation” (23 percent), “Animals” (20 percent), “Lightning” (15 percent), and “Unknown Causes” (10 percent). The percentage of outages due to “Defective Equipment” was the highest cause of outages. The number of outage events due to “Defective Equipment” is trending upward even though there was a 7 percent decrease in 2018. The numbers of outage events due to “Animals”, “Vegetation,” and “Unknown Causes” are trending upward. The number of outages due to “Lightning” is trending downward. Gulf continues to focus its process improvement efforts on the system wide top outage causes through its existing programs and storm hardening efforts.

Gulf's top five causes of outages were "Defective Equipment" (24 percent), "Vegetation" (23 percent), "Animals" (20 percent), "Lightning" (15 percent), and "Unknown Causes" (10 percent). As shown in **Figure 3-29**, the number of outages decreased for "Defective Equipment," "Animals," and "Lightning" in 2018 when compared to 2017.

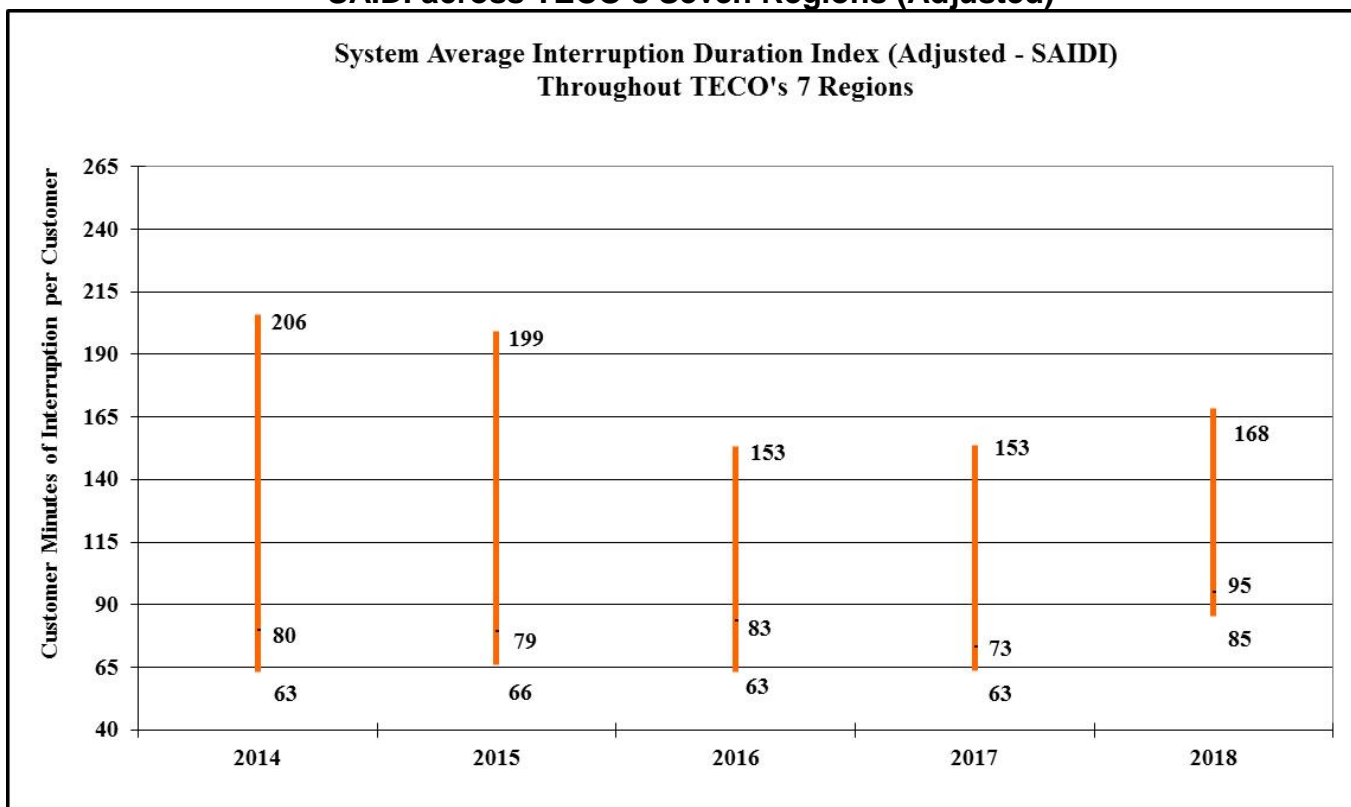
Figure 3-30
SAIDI across TECO's Seven Regions (Adjusted)

Figure 3-30 shows the adjusted SAIDI values recorded by TECO's system. None of the seven TECO regions had improvements in SAIDI performance during 2018, with the Eastern region having the lowest SAIDI performance results. The Dade City region continues to have the poorest SAIDI performance results for the five-year period of 2014 to 2018. The lowest SAIDI index for the seven regions appears to be trending upward. The average SAIDI index increased 30 percent from 2017 to 2018. This index appears to also be trending upward. The Central, Eastern, and Winter Haven regions recorded the lowest SAIDI indices for the five-year period. Dade City, Plant City, and South Hillsborough regions have the fewest customers and represent the most rural, lowest customer density per line mile in comparison to the other four TECO divisions.

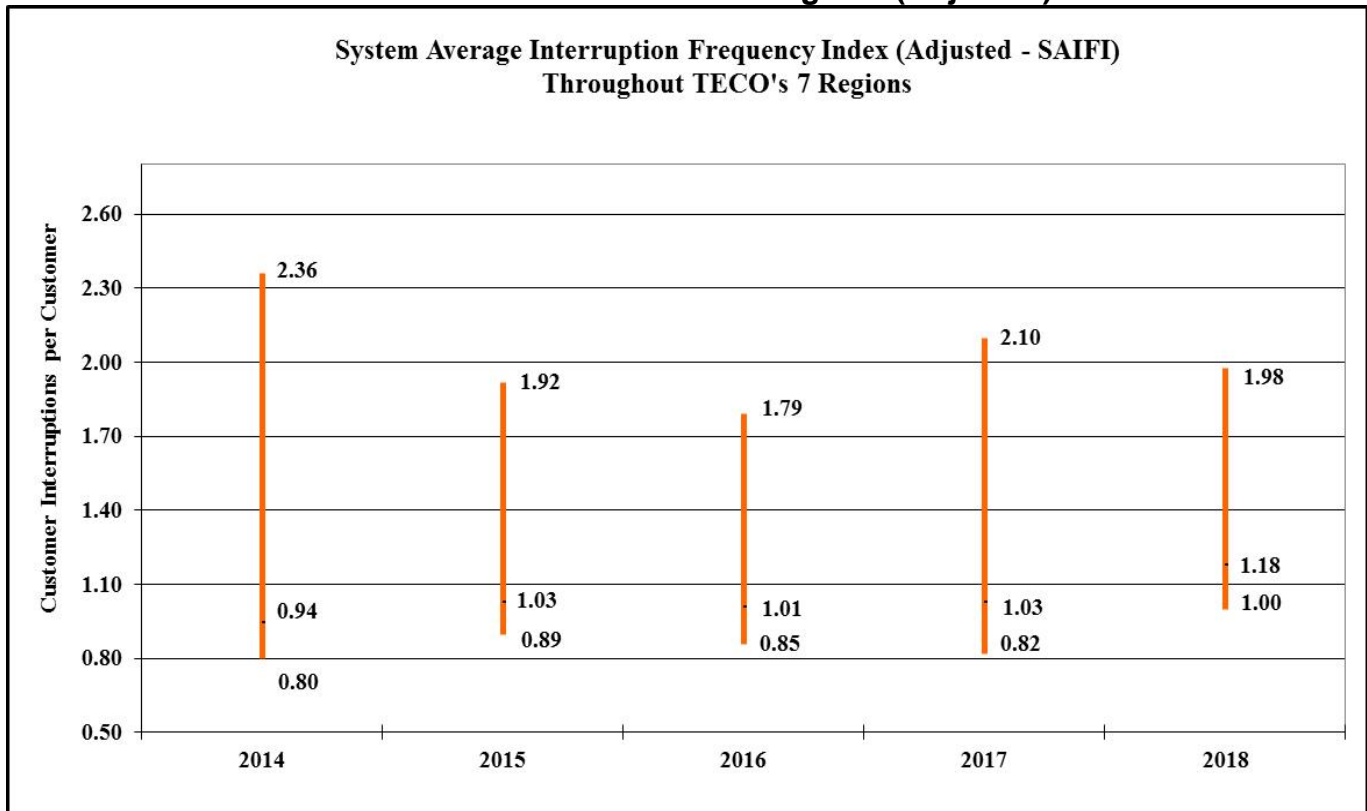
Figure 3-31
SAIFI across TECO's Seven Regions (Adjusted)

Figures 3-31 illustrates TECO's adjusted frequency of interruptions per customer reported by the system. TECO's data represent a 15 percent increase in the SAIFI average from 1.03 interruptions in 2017 to 1.18 interruptions in 2018. TECO's Dade City region continues to have the highest frequency of service interruptions when compared to TECO's other regions. The minimum and average SAIFI are trending upward while the maximum SAIFI is trending downward.

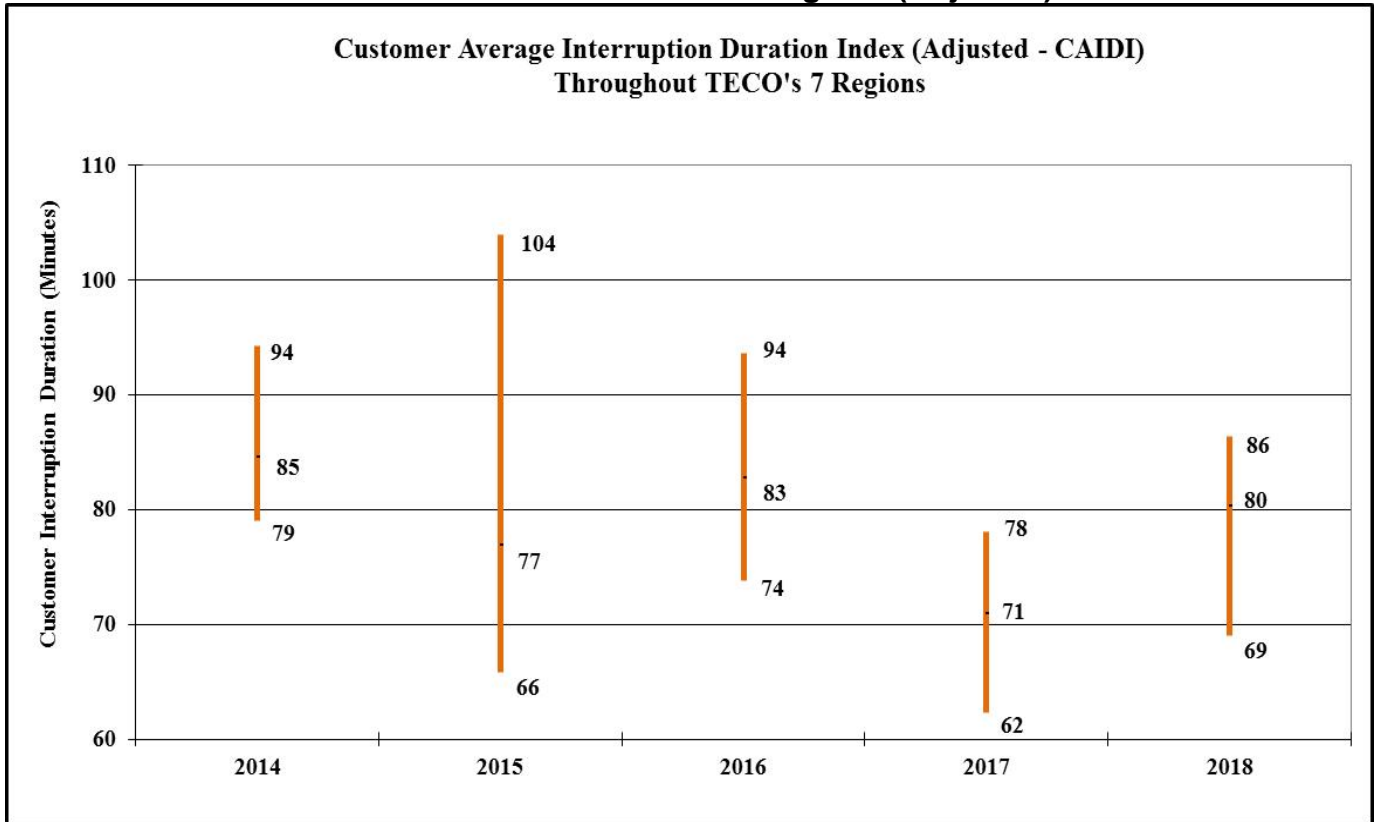
Figure 3-32
CAIDI across TECO's Seven Regions (Adjusted)

Figure 3-32 charts the length of time that a typical TECO customer experiences an outage, which is known as CAIDI. The highest CAIDI minutes appear to be confined to the Dade City, Plant City, and Western regions. Winter Haven and Central regions have had the lowest (best) results for the last five years. The average CAIDI is trending downward at this time suggesting TECO's customers are experiencing shorter outages, notwithstanding the 13 percent increase in the average CAIDI when comparing 2017 to 2018.

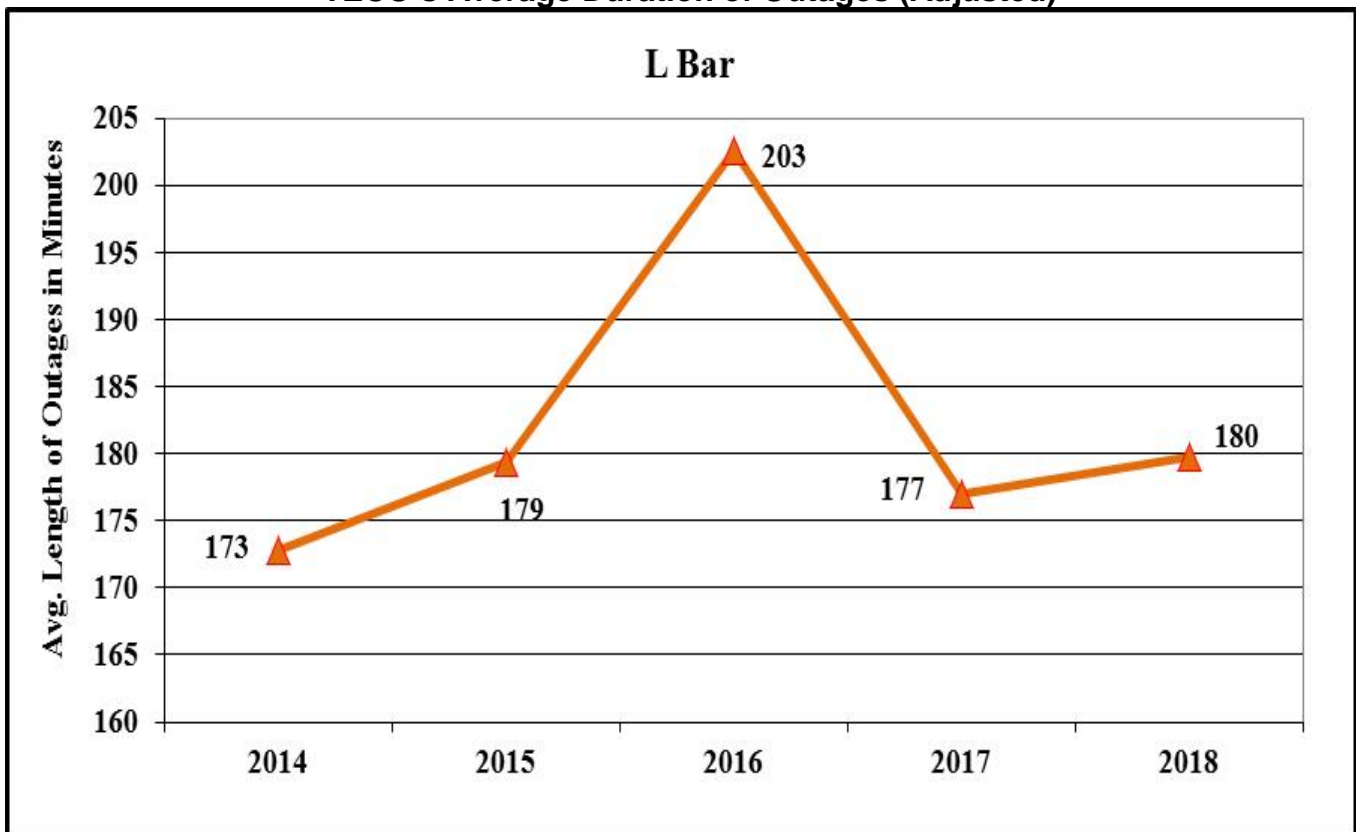
Figure 3-33
TECO's Average Duration of Outages (Adjusted)

Figure 3-33 denotes a 1.7 percent increase in outage durations for the period from 2017 to 2018 for TECO. The average length of time TECO spends restoring service to its customers affected by outage events, excluding hurricanes and other allowable excluded outage events is shown in the L-Bar index. The L-Bar index continues to be trending upward for the five-year period of 2014 to 2018, suggesting longer restoral times.
