*Review of
Florida's
Investor-Owned
Electric Utilities*

*2 0 1 8
Service Reliability Reports*

State of Florida
Florida Public Service Commission
Division of Engineering

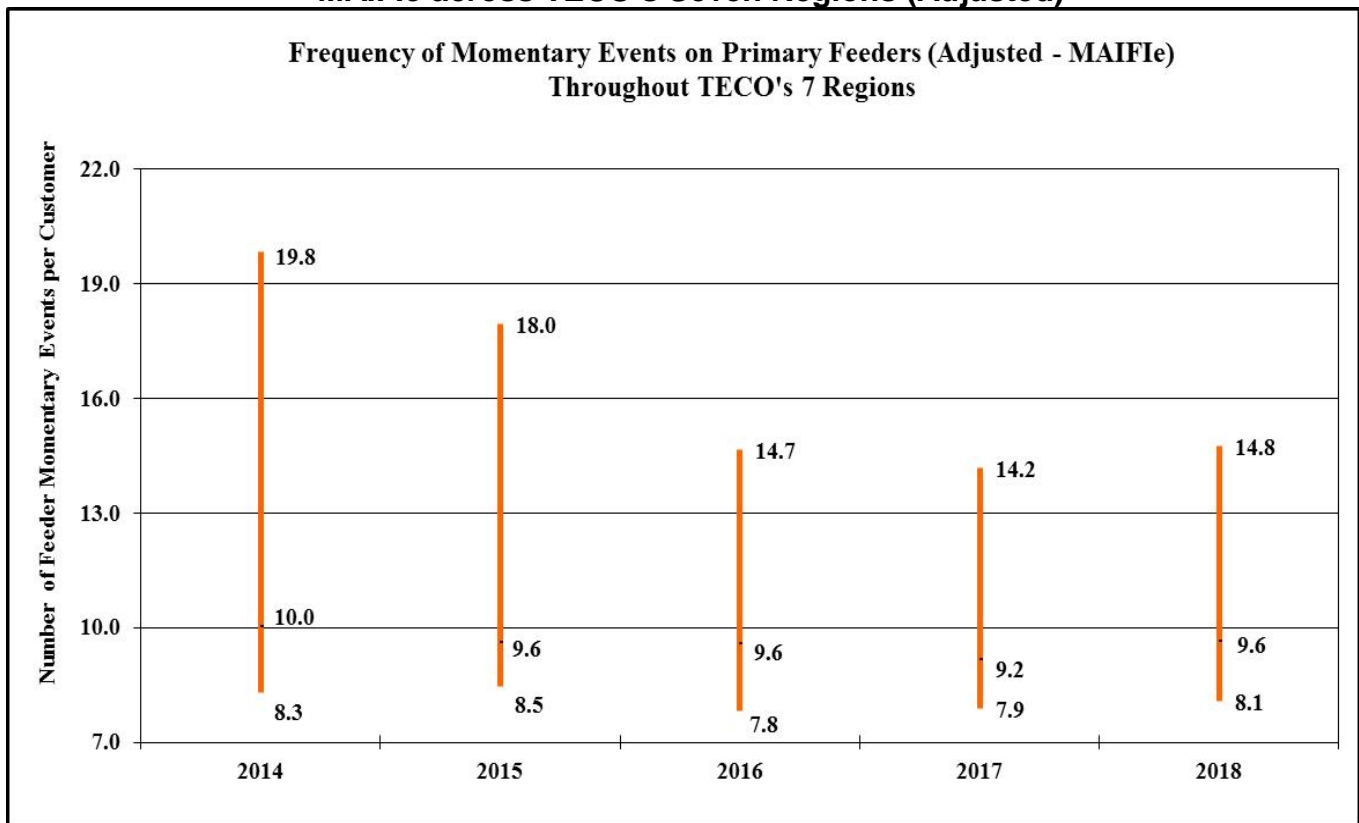
**Figure 3-34
MAIFle across TECO’s Seven Regions (Adjusted)**

Figure 3-34 illustrates TECO’s number of momentary events on primary circuits per customer recorded across its system. In 2018, the MAIFle performance declined over the 2017 results in all regions except Western. The average MAIFle increased by 4 percent from 2017 to 2018. Figure 3-34 also indicates that the average MAIFle is trending downward, which suggest an improvement in performance over the five-year period of 2014 to 2018.

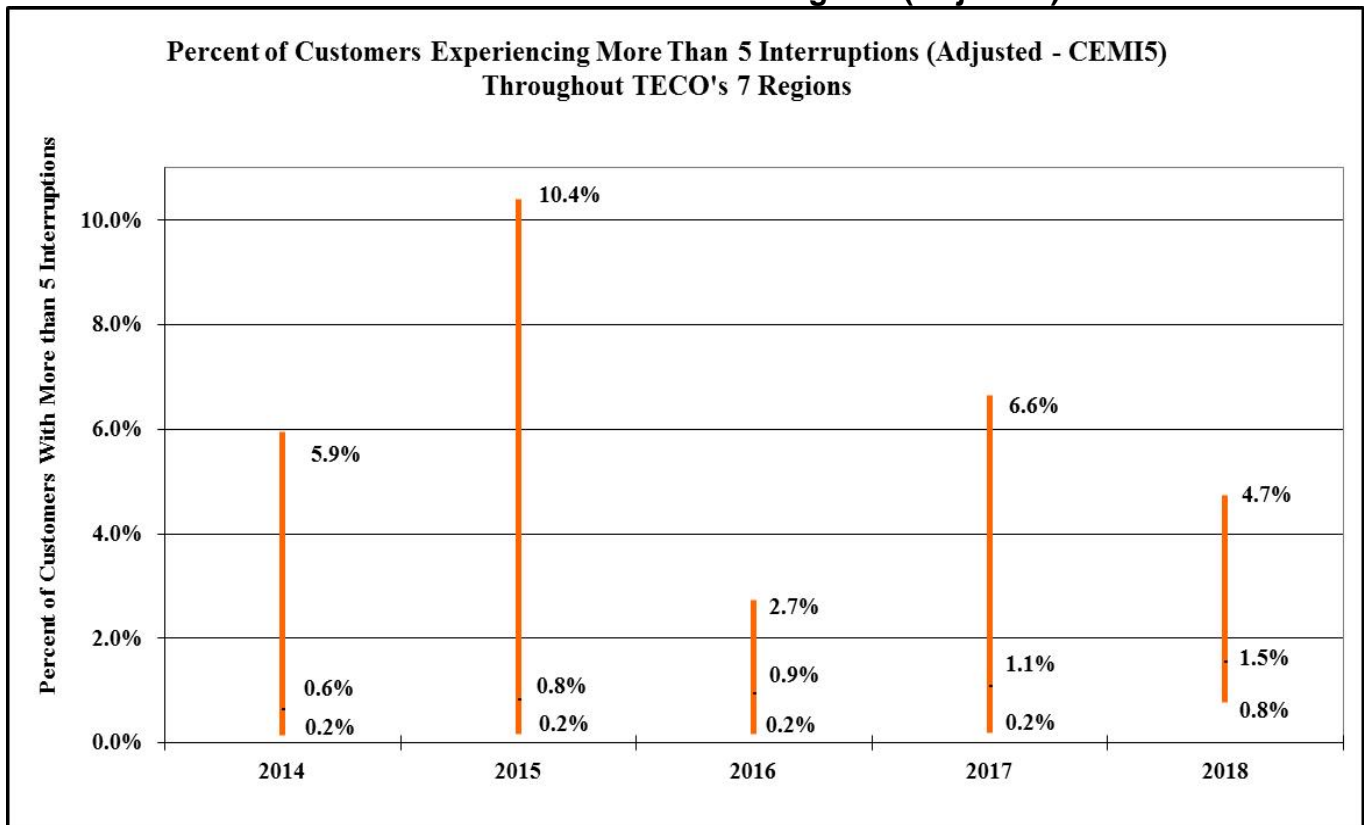
Figure 3-35
CEMI5 across TECO’s Seven Regions (Adjusted)

Figure 3-35 indicates that the percent of TECO’s customers experiencing more than five interruptions. Three regions in TECO’s territory experienced a decrease in the CEMI5 results for 2018. The Central, South Hillsborough, Western, and Winter Haven regions experienced an increase in the CEMI5 index. Even with improvement, Dade City reported the highest CEMI5 percentage for 2018. With TECO’s results for this index varying for the past five years, the average CEMI5 index appears to be trending upward indicating a decline in performance. There was a 36 percent increase in the average CEMI5 index from 2017 to 2018.

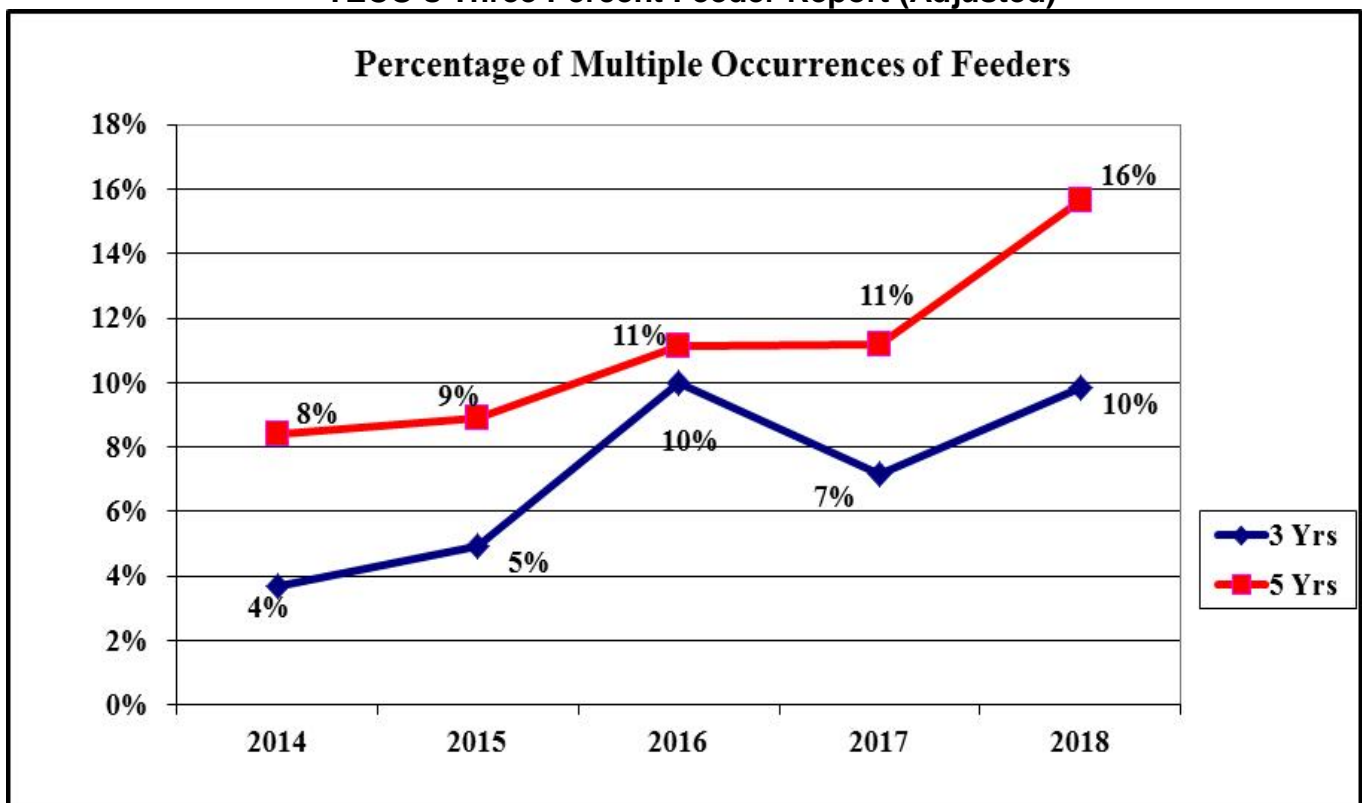
Figure 3-36
TECO's Three Percent Feeder Report (Adjusted)

Figure 3-36 represents an analysis of TECO's top 3 percent of problem feeders that have reoccurred (appeared on the Three Percent Feeder Report) on a five-year and three-year basis. The graph is developed using the number of recurrences divided by the number of feeders reported. The five-year average of outages per feeder increased by 45 percent from 2017 to 2018. The three-year average of outages also increased by 43 percent from 7 percent in 2017 to 10 percent in 2018. Both the five-year average of outages per feeder and the three-year average of outages appear to continue to trend upward for the five-year period of 2014 to 2018.

Staff notes that there was one feeder on the Three Percent Feeder Report for the last two years consecutively. Five circuit outages were reported for this feeder in 2018. The causes for the outages varied from tree limb debris to vehicle accidents that resulted in electrical wire/pole damage. This feeder will have tree trimming completed in 2019 and reliability improvements (e.g., three-phase main-feeder reclosers, TripSavers, and lightning arresters) completed in 2020. TECO stated that it will continue to monitor circuit outage performance as part of its daily and ongoing review of system reliability and will respond accordingly at a regional level.

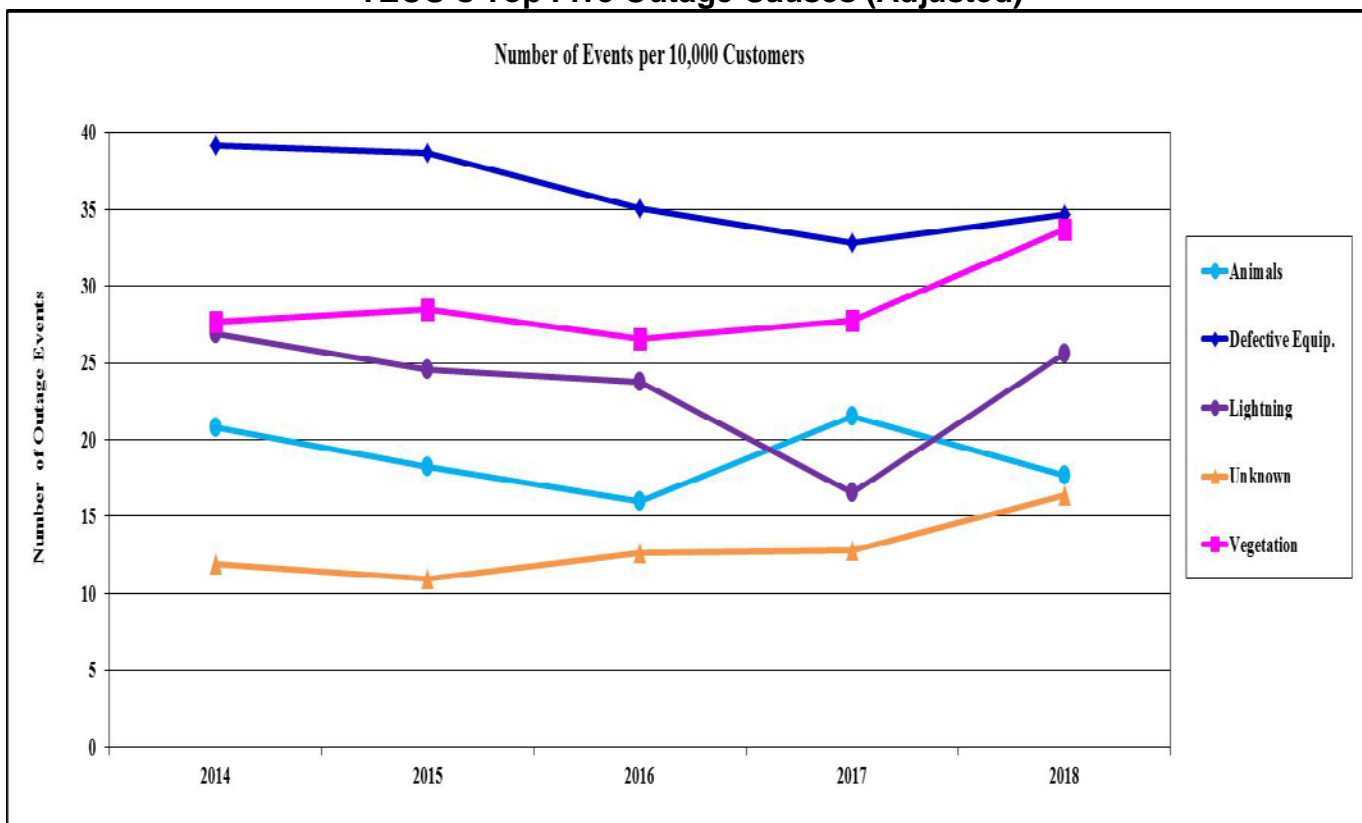
Figure 3-37
TECO’s Top Five Outage Causes (Adjusted)

Figure 3-37 indicates that the top five causes of outage events on TECO’s distribution system normalized to a 10,000-customer base. The figure is based on TECO’s adjusted data of the top 10 causes of outage events and represents 89 percent of the total outage events that occurred during 2018. For the five-year period, the five top causes of outage events included “Defective Equipment” (24 percent), “Vegetation” (24 percent), “Lightning” (18 percent), “Animals” (12 percent), and “Unknown Causes” (11 percent) on a cumulative basis. “Defective Equipment” is the highest cause of outages for 2018. “Vegetation” and “Lightning” causes are the next two top problem areas for TECO. The outages due to “Vegetation” increased 24 percent from 2017 to 2018. The outages from “Lightning” increased 58 percent for the same time period. The numbers of outages due to “Defective Equipment,” “Lightning,” and “Animals” causes are trending downward while the number of outages due to “Vegetation” and “Unknown Causes” are trending upward.

“Defective Equipment” (24 percent) and “Vegetation” (24 percent) were the largest contributors to TECO’s causes of outage events followed by “Lightning” (18 percent), “Animals” (12 percent), and “Unknown Causes” (11 percent). **Figure 3-37** illustrates the top five outage causes. “Defective Equipment,” the leading cause of outages, has been trending downward since 2014 even though “Defective Equipment” had an 8 percent increase in outages when compared to the previous year. “Animal” and “Lightning” related causes are also trending downward. “Vegetation” and “Unknown Causes” related causes are trending upward with increases of 24 percent and 31 percent, respectively, in 2018.

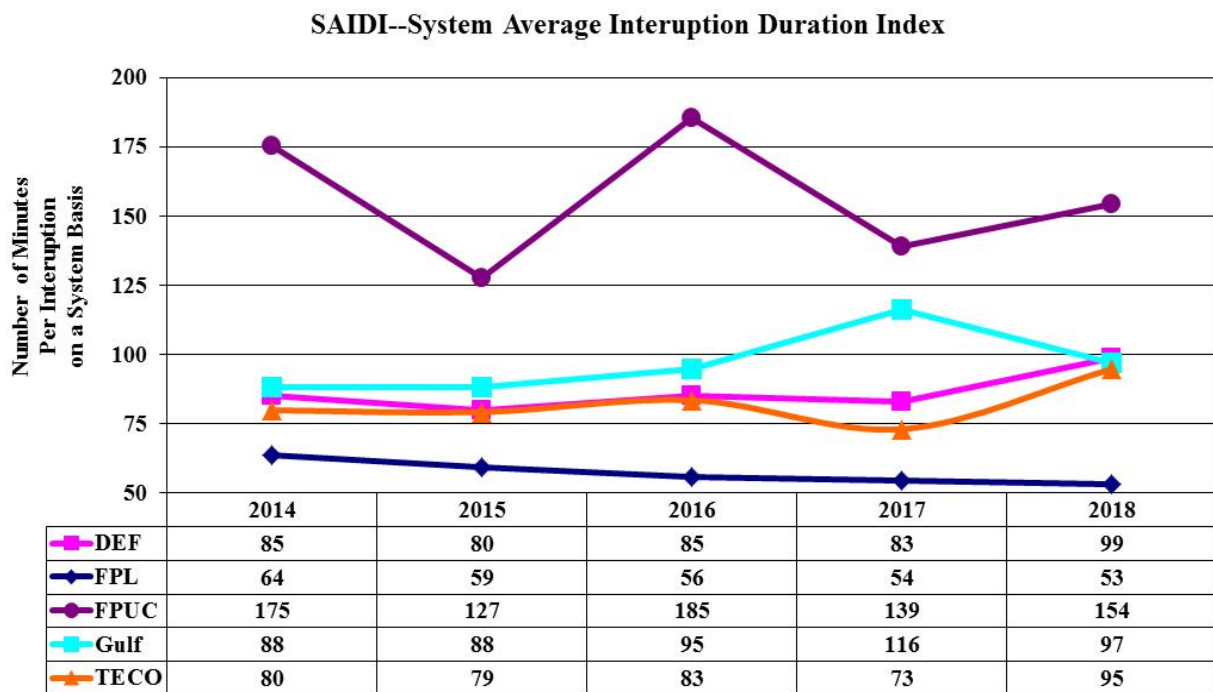
**Figure 4-1
System Average Interruption Duration (Adjusted SAIDI)**

Figure 4-1 indicates that DEF's, Gulf's, and TECO's SAIDI trend has risen since 2014, while FPL and FPUC are trending downward. Comparing 2017 SAIDI values to 2018 SAIDI indices, FPL and Gulf have improved as the other utilities declined in performance. Gulf's SAIDI value decreased 16 percent and FPL decreased 2 percent from 2017 to 2018. DEF's SAIDI value has increased 19 percent, FPUC increased 11 percent, and TECO increased 30 percent from 2017 to 2018.

SAIDI is the average amount of time a customer is out of service per retail customers served within a specified area of service over a given period. It is determined by dividing the total Customer Minutes of Interruption by total Number of Customers Served for the respective area of service.

The inter-utility trend comparison focuses on a graphical presentation that combines all of the IOUs' distribution reliability indices for the years 2014 to 2018. **Figures 4-1** through **4-3** apply to all five utilities while **Figures 4-4** and **4-5** do not apply to FPUC because it is not required to report MAIFle and CEMI5 due to the size of its customer base. The adjusted data is used in generating the indices in this report and is based on the exclusion of certain events allowed by Rule 25-6.0455(4), F.A.C. Generalizations can be drawn from the side-by-side comparisons; however, any generalizations should be used with caution due to the differing sizes of the distribution systems, the degree of automation, and the number of customers. The indices are unique to each IOU.

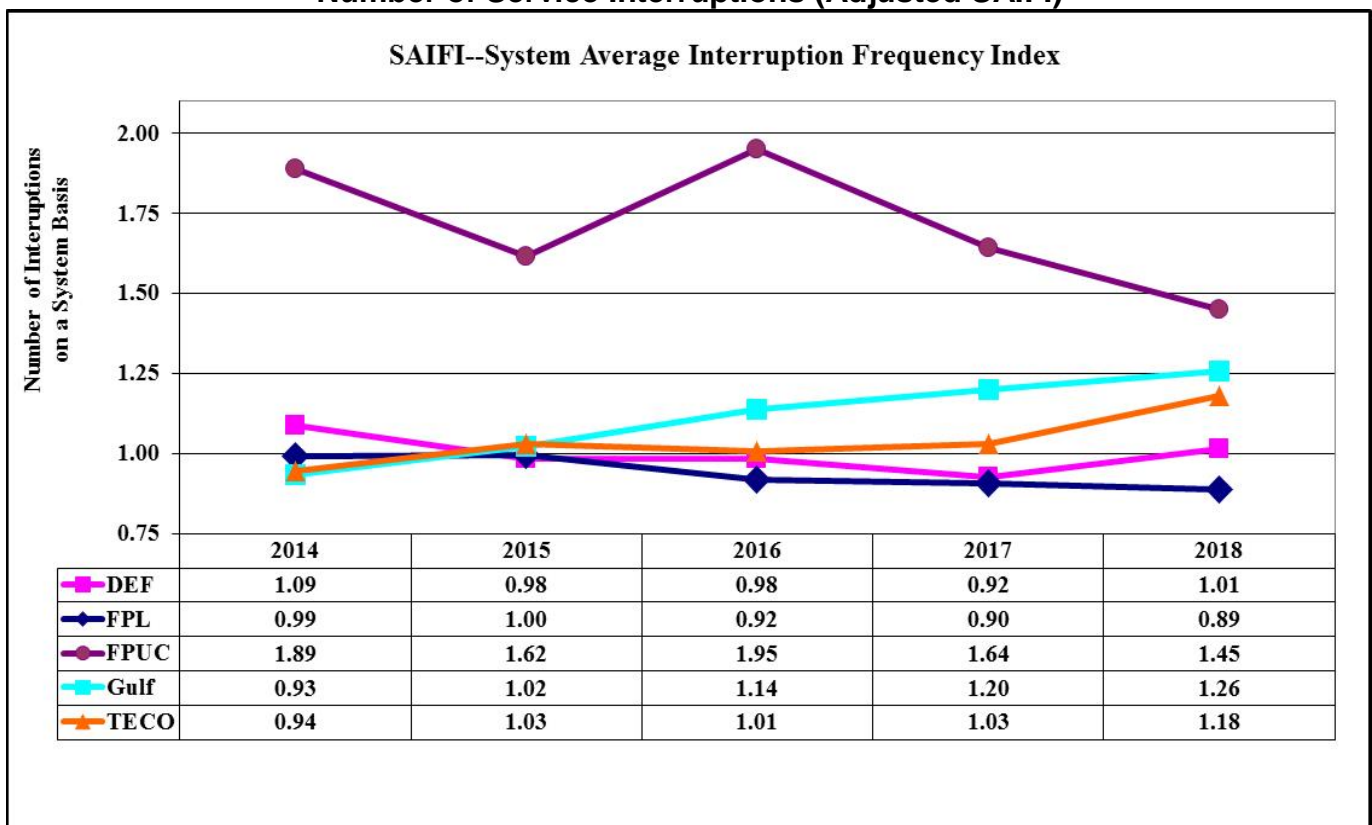
Figure 4-2
Number of Service Interruptions (Adjusted SAIFI)

Figure 4-2 shows a five-year graph of the adjusted SAIFI for each IOU. The 2018 data shows FPL and FPUC's SAIFI values decreased (improved) from the 2017 results as DEF, Gulf and TECO's SAIFI values increased. Over the five-year period of 2014 to 2018, Gulf and TECO's SAIFI values are all trending upward. DEF, FPL and FPUC's SAIFI value is trending downward for the period of 2014 to 2018.

SAIFI is the average number of service interruptions per retail customer within a specified area of service over a given period. It is determined by dividing the Sum of Service (a/k/a Customer) Interruptions (CI) by the total Number of Customers Served for the respective area of service.

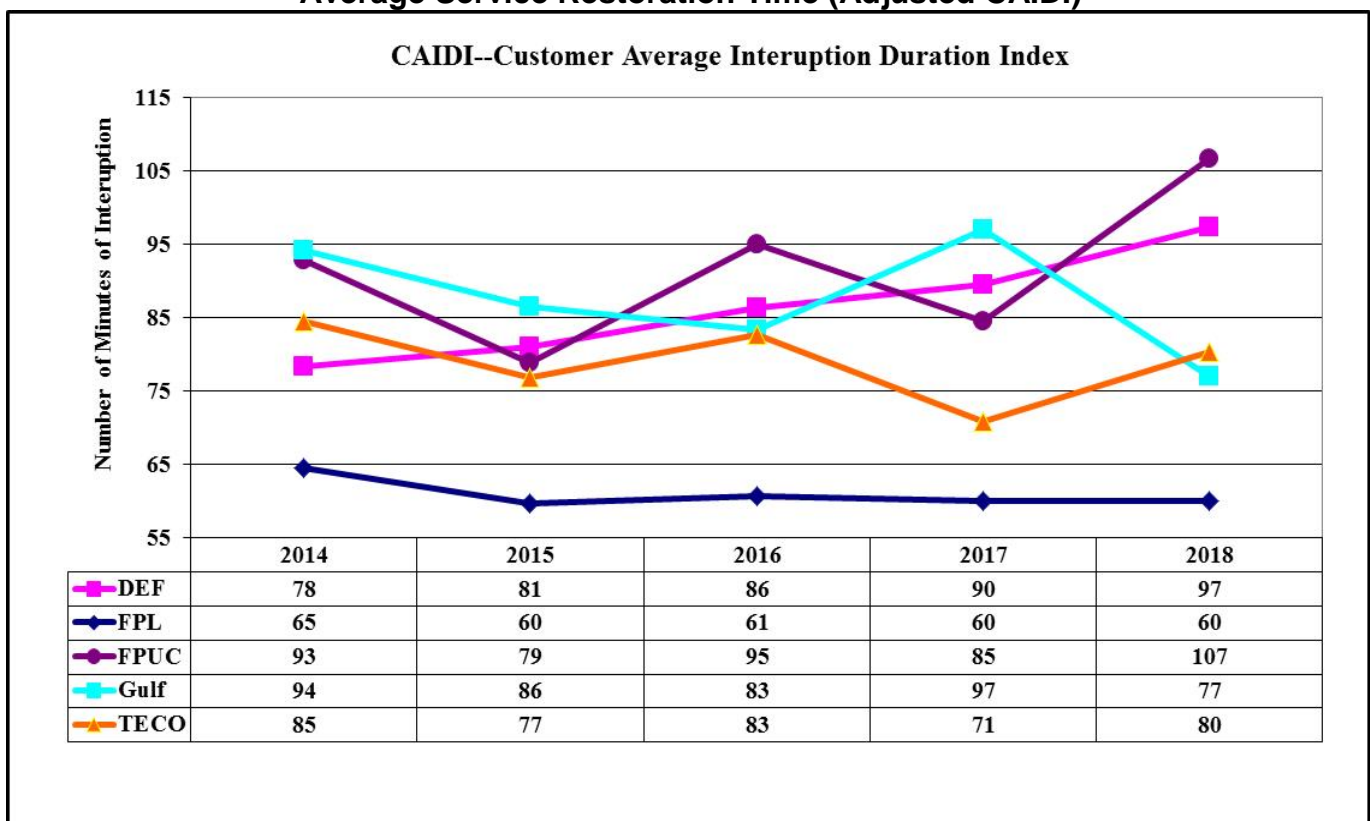
Figure 4-3
Average Service Restoration Time (Adjusted CAIDI)

Figure 4-3 shows a five-year graph of the adjusted CAIDI for each IOU. DEF, FPUC, and TECO had an increase in the CAIDI from 2017 to 2018 while Gulf had a decrease in the CAIDI. FPL's CAIDI value was the same for 2018 as it was for 2017. All utilities, except DEF and FPUC, CAIDI values are trending downward for the five-year period of 2014 to 2018. DEF's and FPUC's CAIDI value is trending upward for the same period.

CAIDI is the average interruption duration or the time to restore service to interrupted customers. CAIDI is calculated by dividing the total system CMI by the number of customer interruptions, which is also SAIDI, divided by SAIFI.

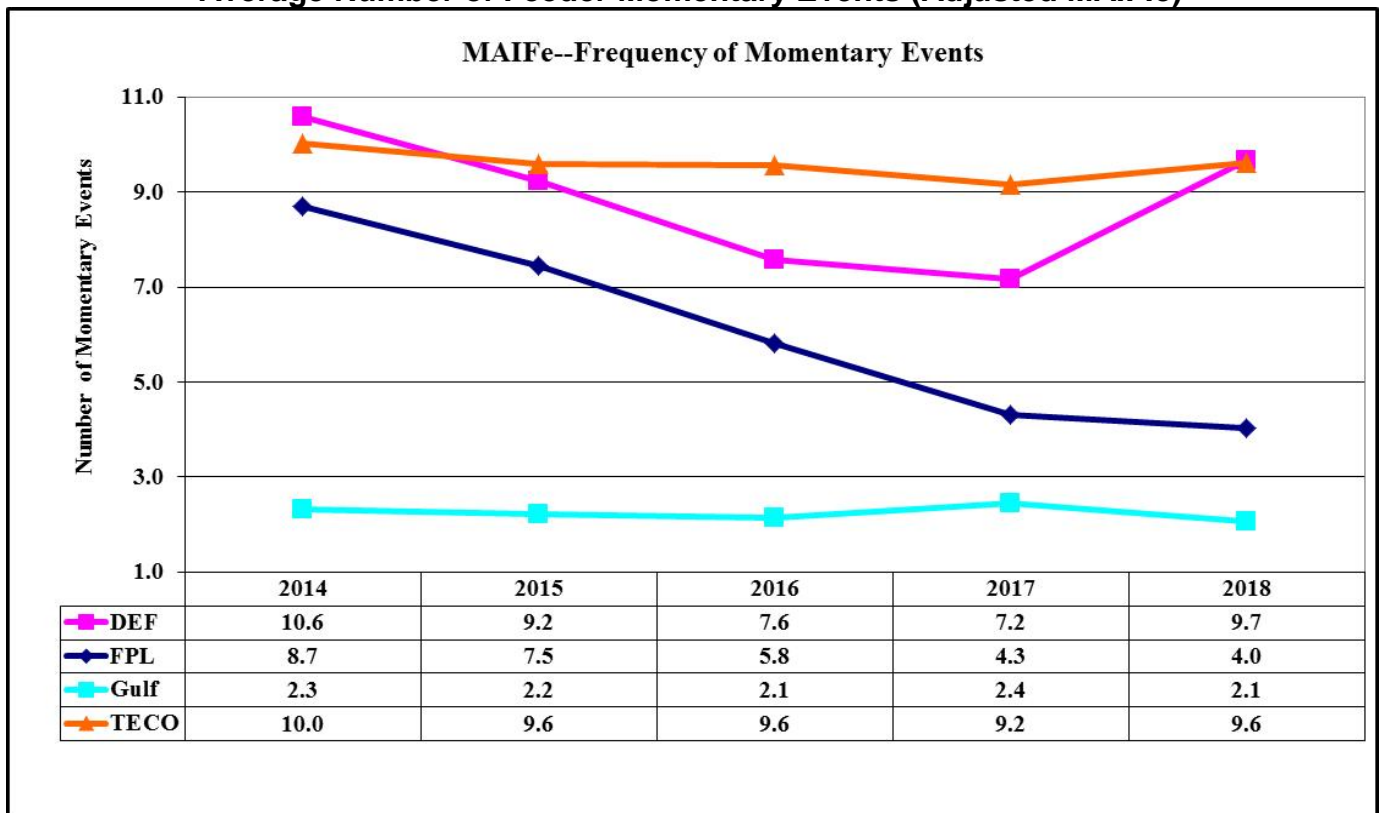
Figure 4-4
Average Number of Feeder Momentary Events (Adjusted MAIFle)

Figure 4-4 shows a five-year graph of the adjusted MAIFle for DEF, FPL, Gulf, and TECO. DEF, FPL, and TECO's MAIFle indices are all trending downward for the five-year period of 2014 to 2018. Gulf's MAIFI appears relatively flat for the five-year period. Comparing the MAIFle for 2017 to 2018, DEF increased by 35 percent, FPL decreased by 7 percent, Gulf decreased by 13 percent and TECO increased by 4 percent. FPUC is exempt from reporting MAIFle and CEMI5 because it has fewer than 50,000 customers.

MAIFle is the average frequency of momentary interruptions events or the number of times there is a loss of service of less than one minute. MAIFle is calculated by dividing the number of momentary interruptions events recorded on primary circuits (CME) by the number of customers served.

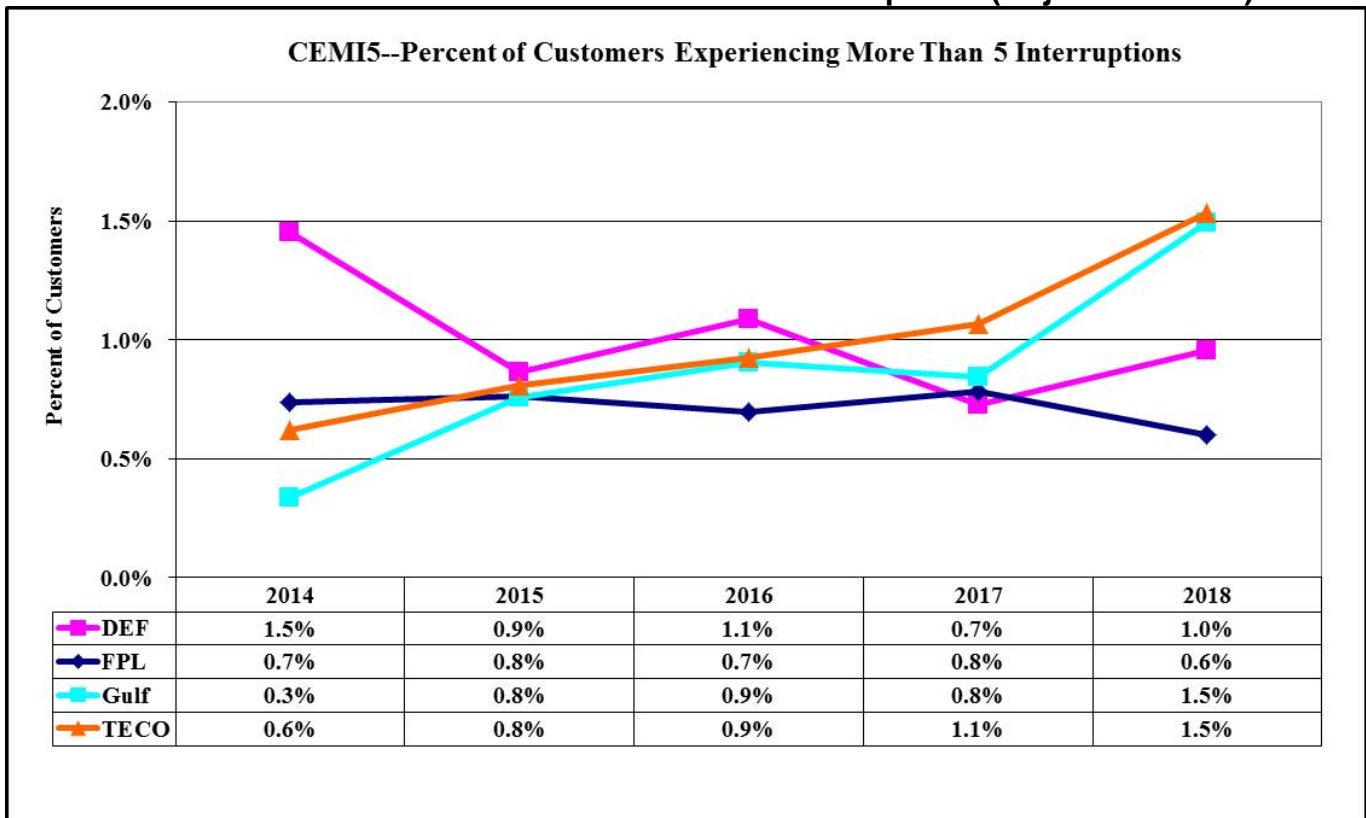
Figure 4-5
Percent of Customers with More Than Five Interruptions (Adjusted CEMI5)

Figure 4-5 shows a five-year graph of the adjusted CEMI5 for FPL, Gulf, DEF, and TECO. CEMI5 is a percentage. It represents the number of customers that experienced more than five service interruptions in the year divided by the total number of customers. In 2018, DEF, Gulf and TECO's CEMI5 percent increased to 1.0 percent from 0.7 percent in 2017 for DEF, 1.5 percent from 0.8 percent in 2017 for Gulf, and 1.5 percent from 1.1 percent in 2017 for TECO. FPL decreased from 0.8 percent in 2017 to 0.6 percent in 2018. DEF and FPL are trending downward as Gulf and TECO are trending upward for the period of 2014 to 2018.

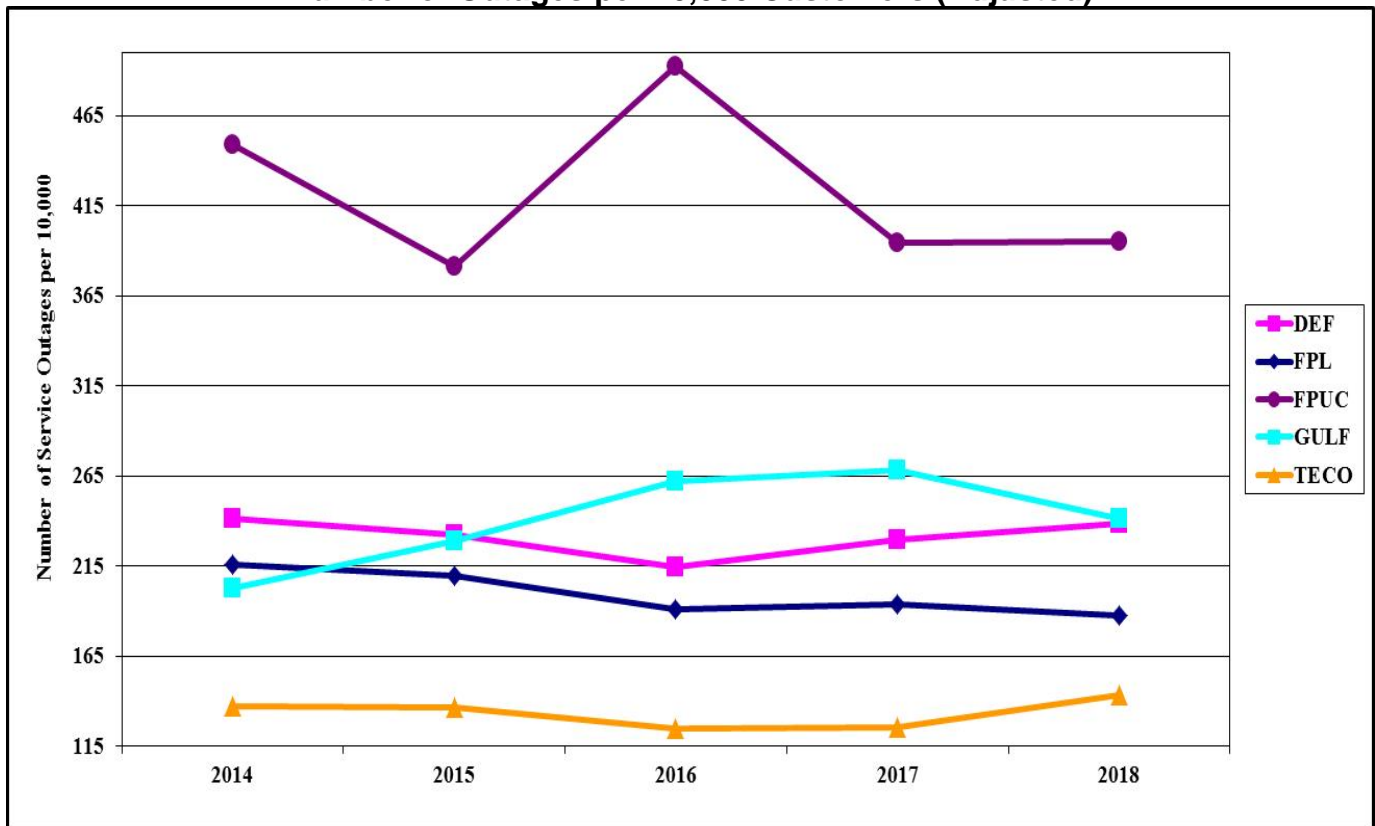
Figure 4-6
Number of Outages per 10,000 Customers (Adjusted)

Figure 4-6 shows the number of outages per 10,000 customers on an adjusted basis for the five IOUs over the last five years. The graph displays each utility's adjusted data concerning the number of outage events and the total number of customers on an annual basis. The number of FPL outages decreased from 95,077 in 2017 to 93,306 in 2018, and the number of outages per 10,000 customers is trending downward for the five-year period. TECO's results are trending downward for the five-year period. DEF's number of outages increased for 2018 and the results are relatively flat for the five-year period. Gulf's number of outages decreased for 2018, and is trending upward for the five-year period. FPUC's results decreased for 2014 to 2015, increased for 2015 to 2016, decreased for 2016 to 2017, and decreased for 2017 to 2018. Due to its small customer base, FPUC's number of outages per 10,000 customers may be more volatile.

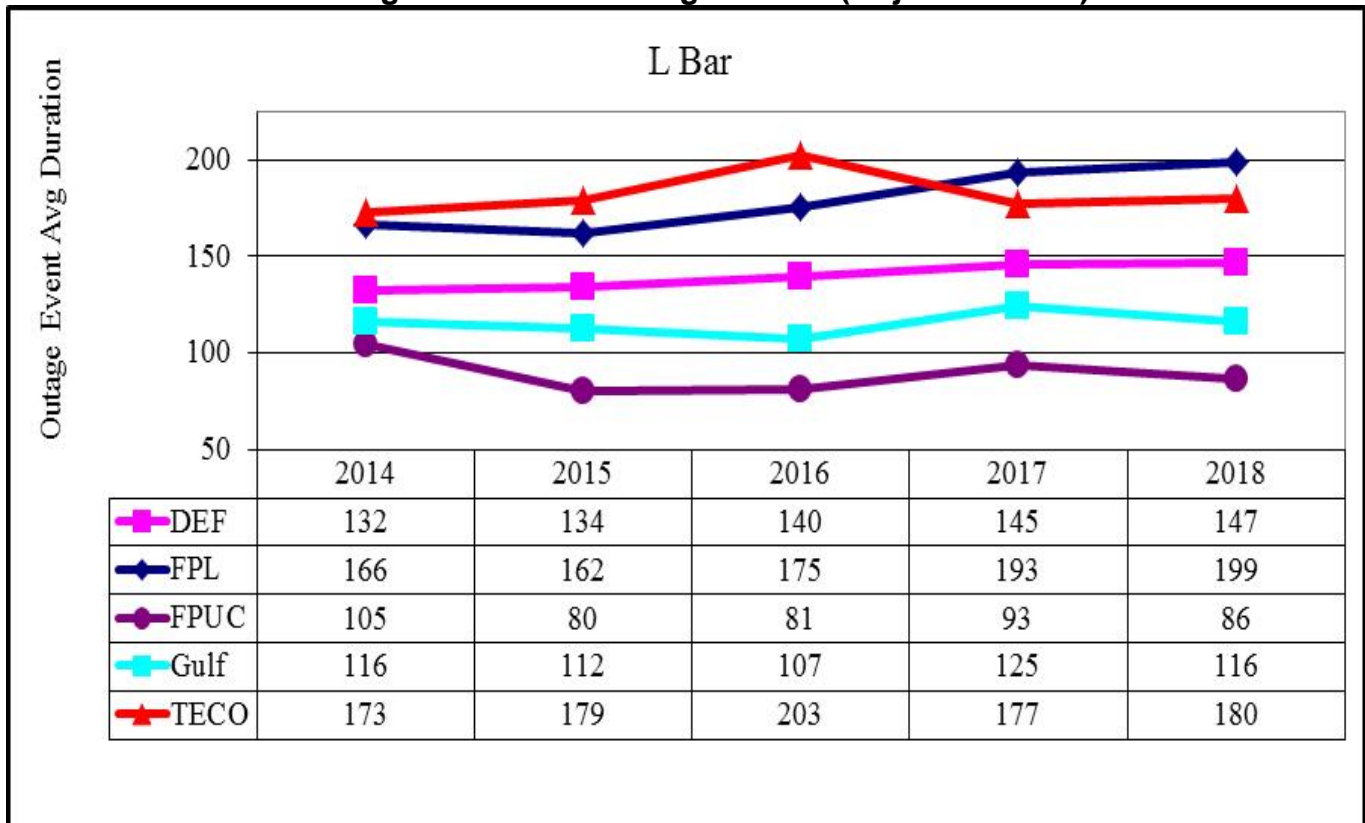
Figure 4-7
Average Duration of Outage Events (Adjusted L-Bar)

Figure 4-7 represents the average duration of outage events (Adjusted L-Bar) for each IOU. From the data shown, it appears that the utilities have been consistent with their restoral times for the five-year period of 2014 to 2018, even with increases from 2017 to 2018.

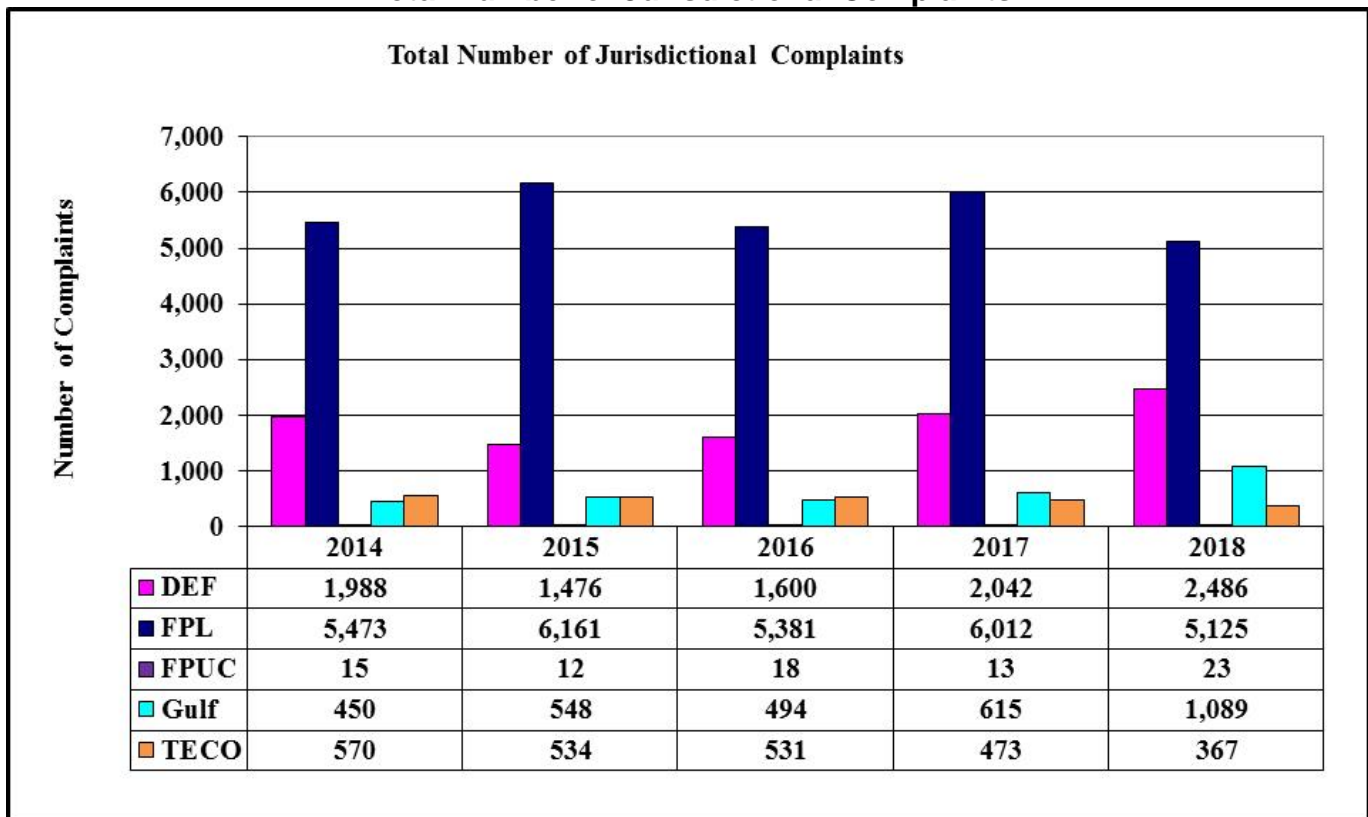
Figure 4-8
Total Number of Jurisdictional Complaints

Figure 4-8 shows the total number of jurisdictional complaints¹⁶ for each IOU. In comparing the number of complaints by the different companies, the total number of customers should be considered. FPL has the higher number of complaints, but FPL also has more customers than the other companies.

Figures 4-8, 4-9, 4-10, and 4-11 represent consumer complaint data that was extracted from the Commission’s Consumer Activity Tracking System (CATS). Each consumer complaint received by the Commission is assigned a code after the complaint is resolved. Reliability related complaints have 10 specific category types and typically pertain to “Trees,” “Safety,” “Repairs,” “Frequent Outages,” and “Momentary Service Interruptions.”

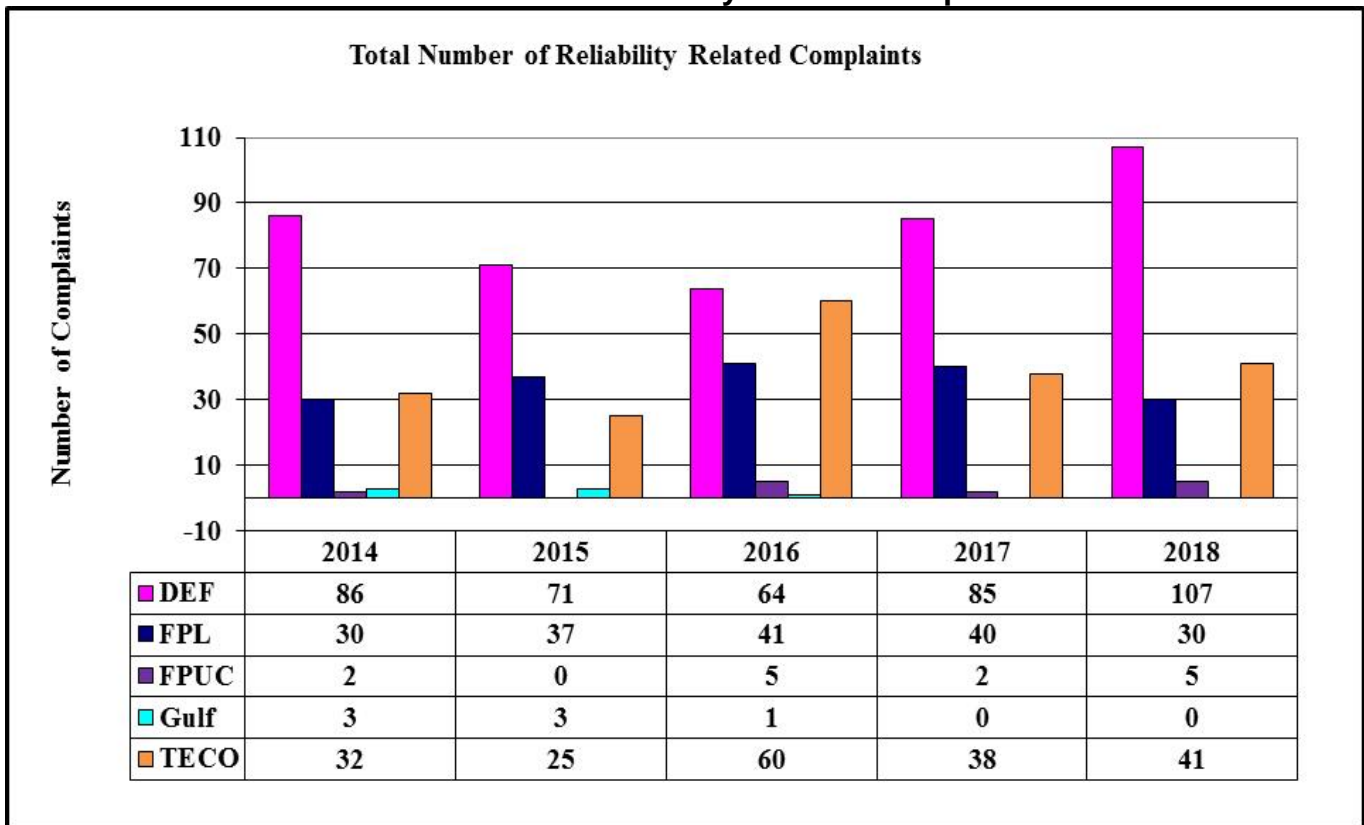
Figure 4-9
Total Number of Reliability Related Complaints

Figure 4-9 charts the total number of reliability related complaints for the IOUs. DEF is showing the largest amount of reliability complaints for the five-year period of 2014 to 2018 with FPUC and Gulf showing the least amount. Gulf is trending downward in the number of reliability complaints, while DEF, FPL, FPUC, and TECO are trending upward.

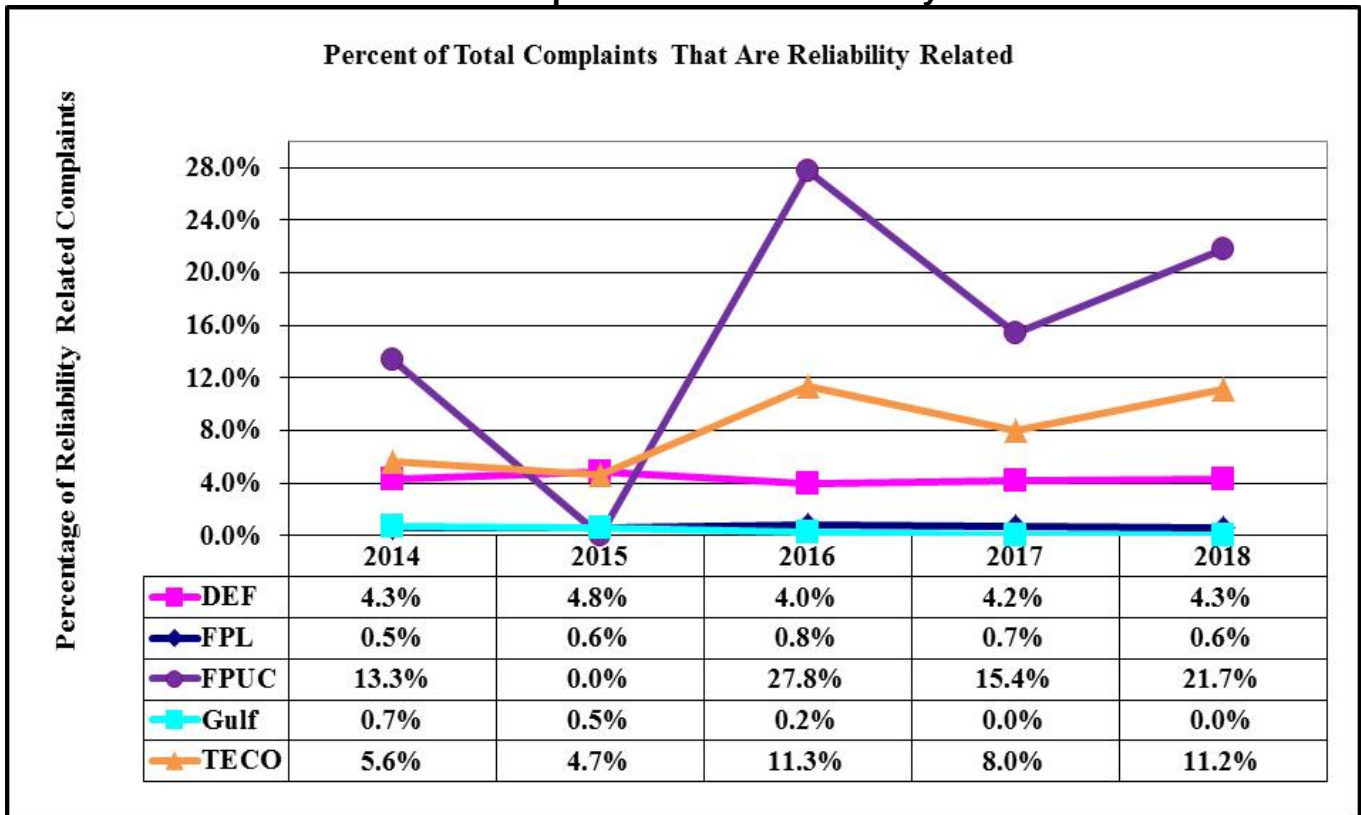
Figure 4-10
Percent of Complaints that are Reliability Related

Figure 4-10 shows the percentage of reliability related customer complaints in relation to the total number of complaints for each IOU. DEF and Gulf appear to be trending downward as FPL, FPUC and TECO are trending upward. The percentages of FPUC complaints compared to the other companies appears high, however FPUC has fewer customers and fewer complaints in total.

Complaints related to FPL's reliability decreased by 0.1 percent from 2017 to 2018. FPL's reliability related complaints appear to be relatively flat as shown in **Figure 4-10**, even with the decrease in 2018.

There were no complaints reported to the Commission against Gulf that were reliability related in 2018. Gulf's percentage of total complaints for the five-year period of 2014 to 2018 has remained relatively flat. Overall, as shown in **Figure 4-10**, Gulf has the lowest percentage of total complaints related to reliability.

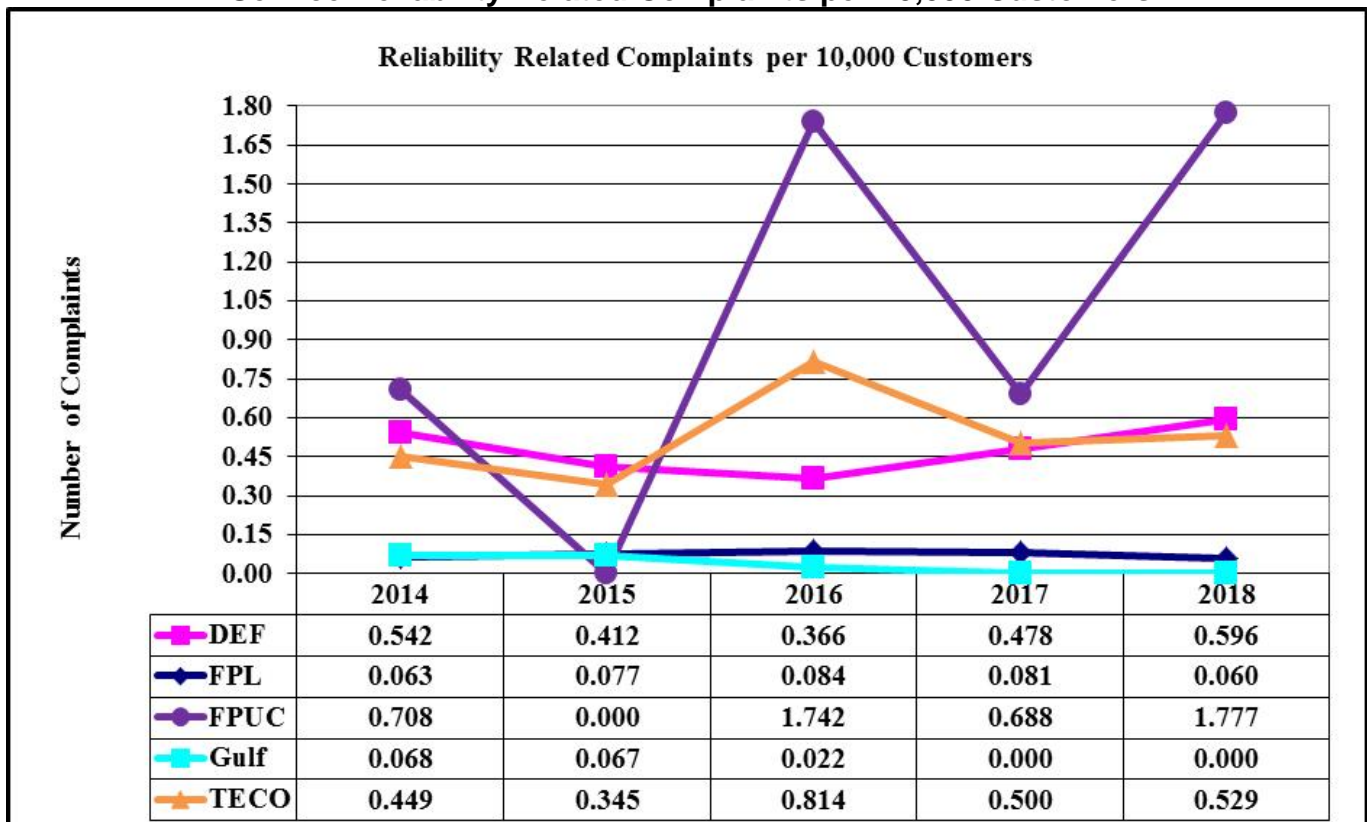
Figure 4-11
Service Reliability Related Complaints per 10,000 Customers

Figure 4-11 charts the volume of reliability related complaints per 10,000 customers for the IOUs. The volume of service reliability complaints is normalized to a 10,000-customer base for comparative purposes. This is calculated for each IOU by dividing the total number of reliability complaints reported to the Commission by the total number of the utility's customers. This fraction is then multiplied by 10,000 for graphing purposes.

All the IOUs have less than one reliability complaint per 10,000 customers since 2014 except FPUC. For the five-year period, Gulf is trending downward as FPL is staying relatively flat. DEF, FPUC, and TECO are trending upward for the five-year period. The volatility of FPUC's results can be attributed to its small customer base, which typically averages 28,500 customers.
