Re: Docket No. 140135-WS - Application for increase in water and wastewater rates in Pasco County by Labrador Utilities, Inc. Our File No. 30057.216

Tank Inspection Report

Utilities Inc
 Labrador Tank
 Liquid Engineering Corporation 38368B

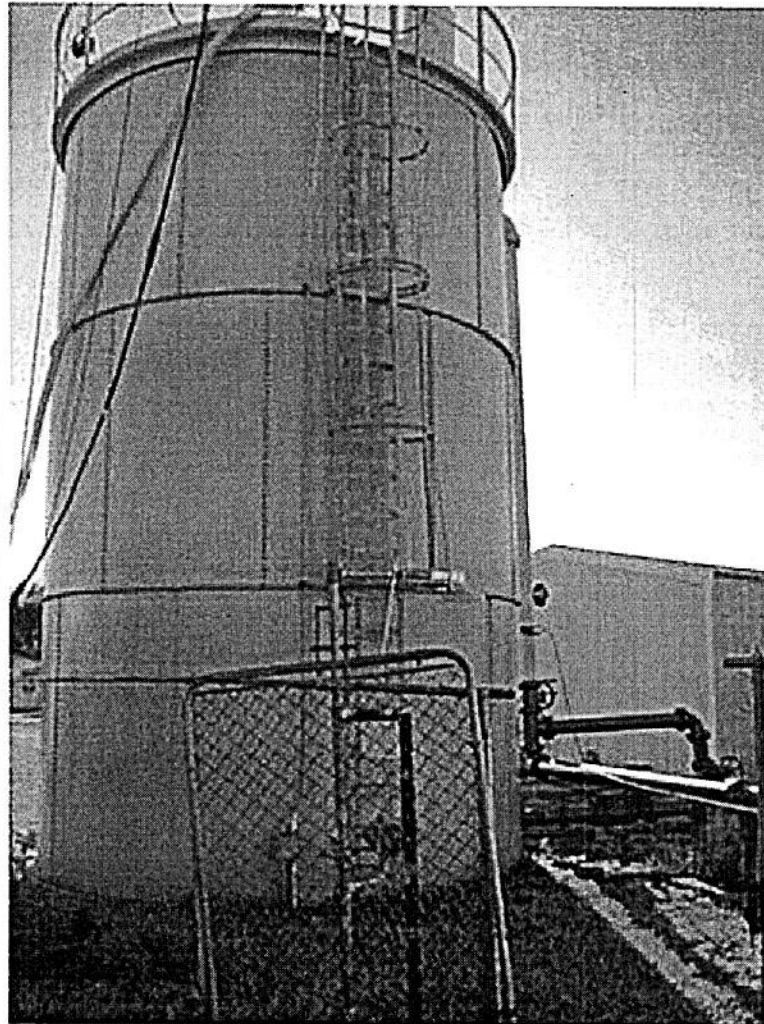
This report is a supplement to the visual and video inspection undertaken for Utilities Inc by Liquid Engineering Corporation of Billings, MT. The Labrador tank is an on-grade water storage tank. The tank has a 34,000-gallon capacity with an overall height of 28 feet and a diameter of approximately 15 feet. The tank is founded on a concrete base.
