**Re: Docket No. 20240001-EI**

Please find enclosed for filing in the above referenced docket the Direct Testimony and Exhibits of Richard Polich, P.E. This filing is being made via the Florida Public Service Commission's Web Based Electronic Filing portal.

1 **VI. ASSESSMENT OF OUTAGES AND DERATES IMPACT ON**  
2 **REPLACEMENT POWER COSTS**

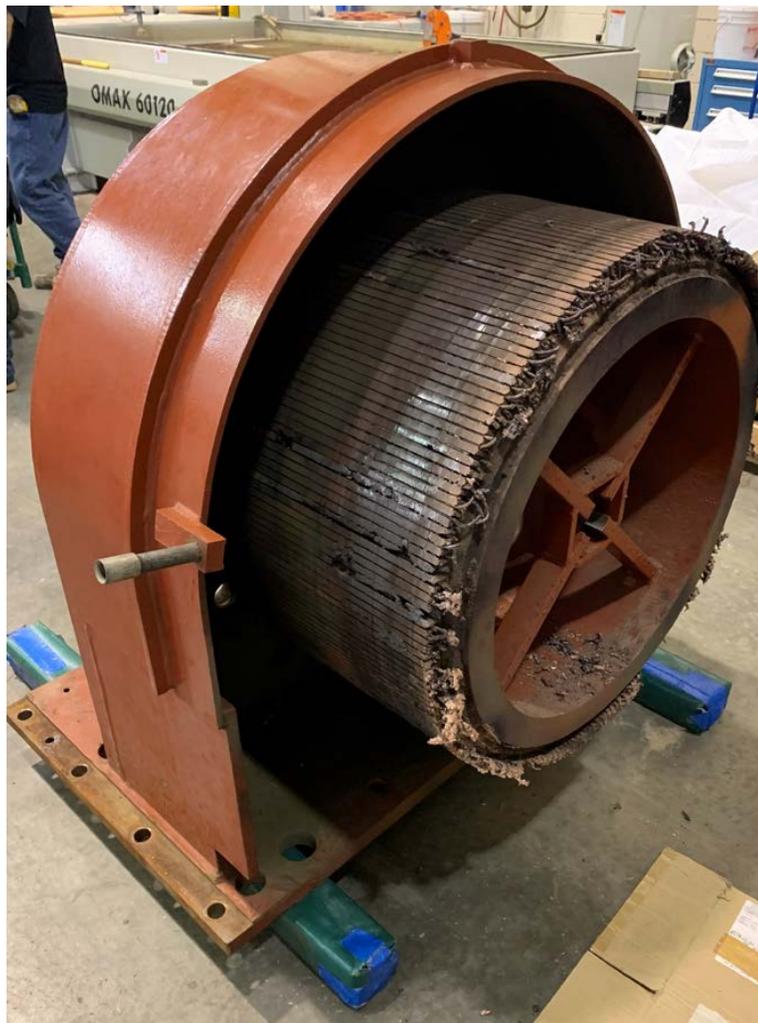
Fig. 5 U4 PMG Stator Removed

12 A. Upon disassembling the exciter the investigation revealed water intrusion and  
13 found that the PMG was damaged. The root cause team found the failure of the  
14 PMG was likely due to a culmination of age-related breakdown of the PMG stator  
15 winding insulation, along with water intrusion due to inadequate sealing of the

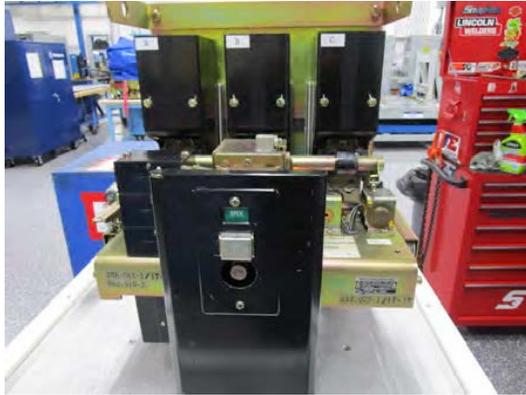
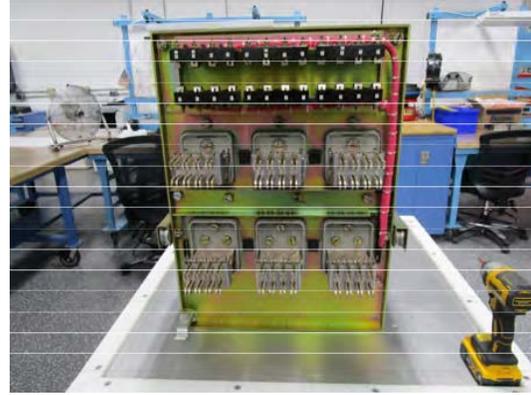
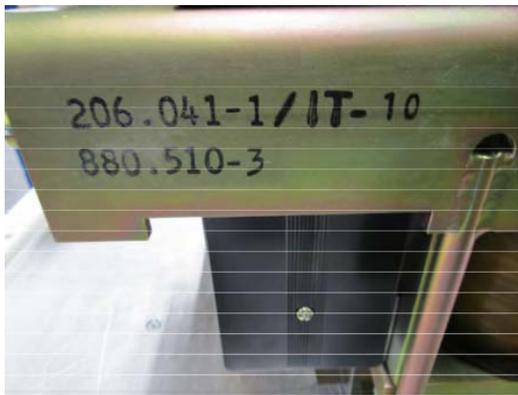
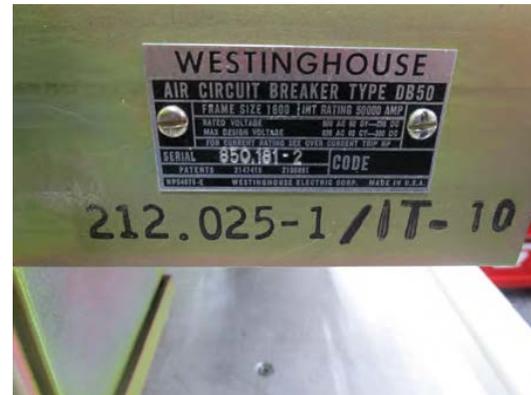
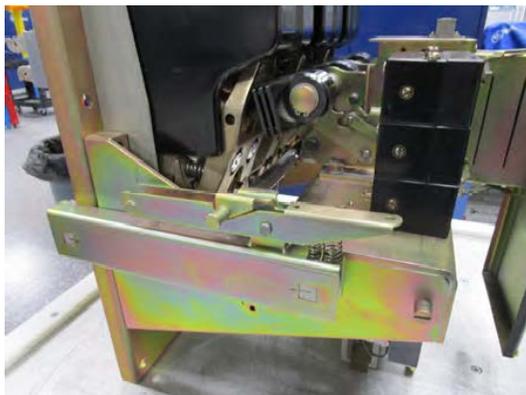
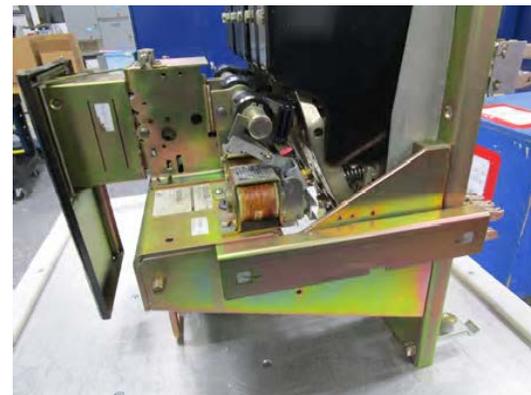
This breaker was received looking as it had just been refurbished, there were no visible areas of concern.

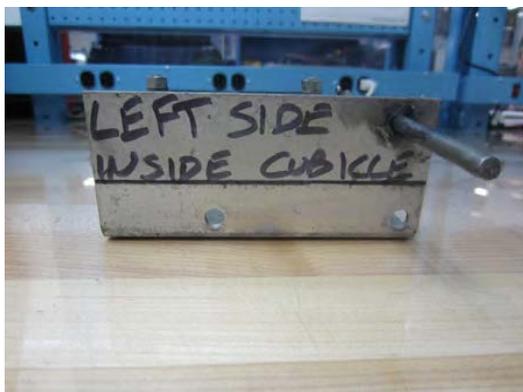
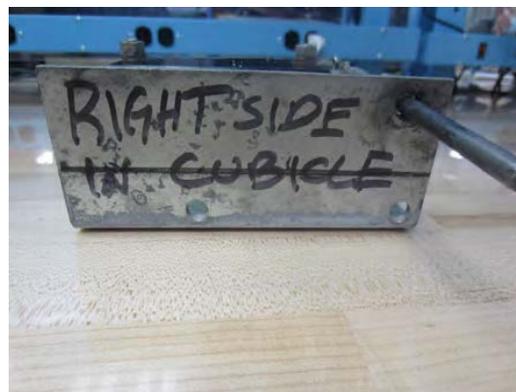
These cell switches were received and looked like they were the original switches provided with the switchgear. The switch plungers were improperly lubricated, and the plunger return spring was not lubricated.

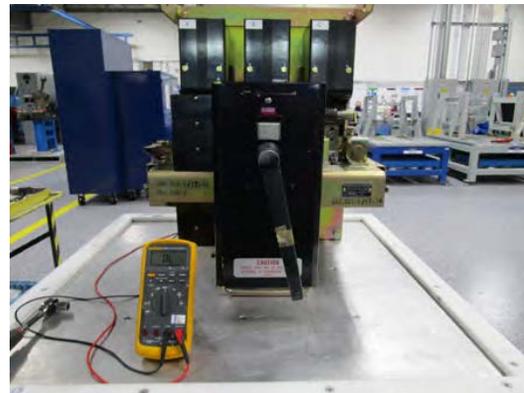
Breaker Closed, Switch Contact Open

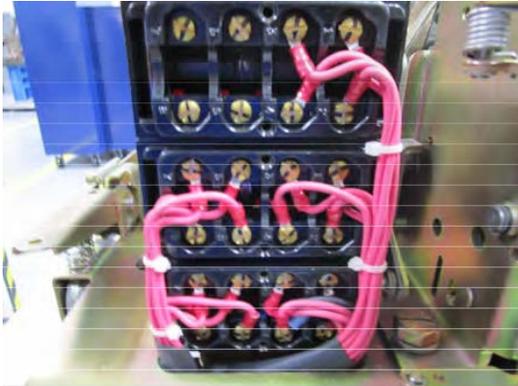
The front auxiliary switch covers were removed, and the switches were visually inspected. No concerns were found, and the switch contacts appeared to be properly lubricated.

Front of Auxiliary Switches

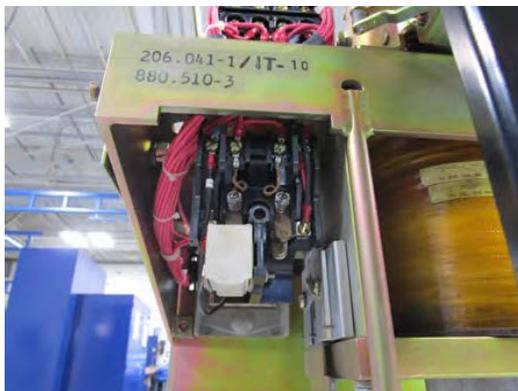
The front cover of the control relay was removed, and the relay was visually inspected, no concerns were found.

Control Relay with Front Cover Removed

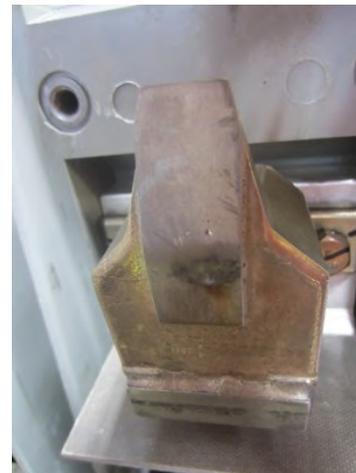
**Stationary Arcing Contacts**

These values were greater than expected. Photos were taken of these contacts and then the contacts were cleaned with Scotchbrite and isopropyl alcohol. Additional photos were taken to show the cleaned contacts.

After receiving values greater than expected the pole bases will need to be disassembled and cleaned as a standard part of a DB breaker refurbishment. These values are not a concern for the tripping of the breaker, simply that the contacts were slightly oxidized. After applying operating current to the pole bases the oxidation would burn off and the breaker would operate fine.

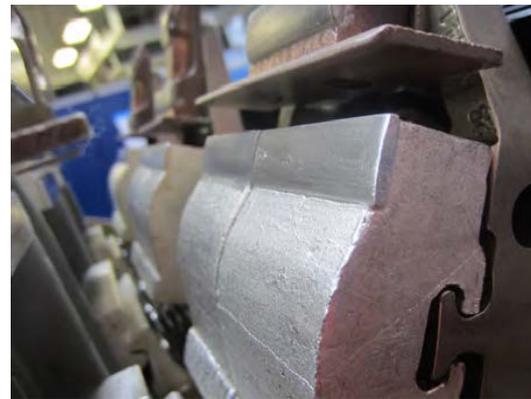
Cleaned Contacts

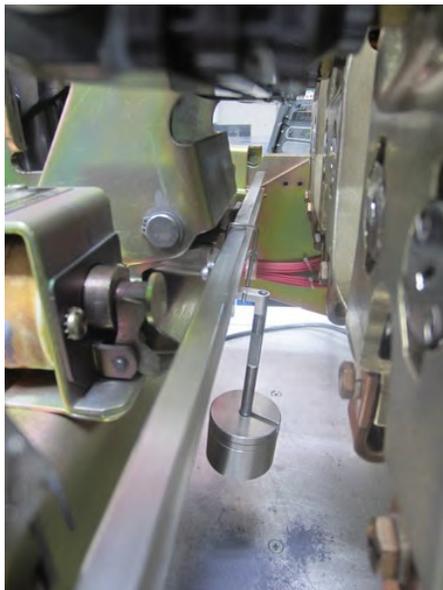
After this weight was established the weight was removed and the breaker was closed with 125 V DC, the weight was added back onto the trip bar and the STA was energized with 69 V DC, thus tripping the breaker showing margin in the weight that the STA is able to pull with the minimum voltage applied. The breaker was successfully tripped 3 times with this setup. A photo has been provided to show the weight hung of the trip bar.

Additional Weight Added to the Operating Mechanism Trip Bar

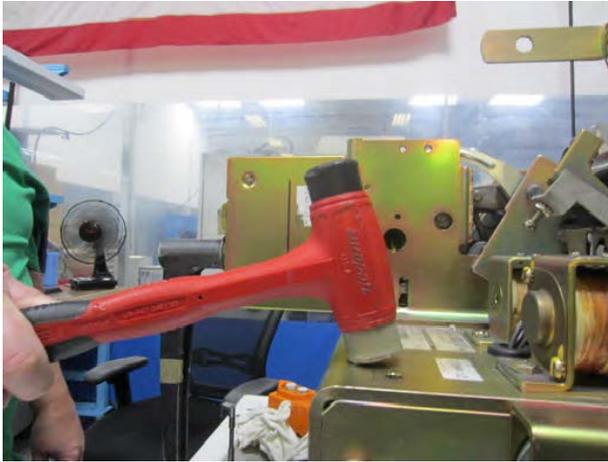
The UVTA was again energized with 125 V DC and the breaker was closed with 125 V DC. A plastic head hammer was used to shock the breaker platform in an attempt to shock out the UVTA or cause the breaker to trip open. A photo of this is provided below. The UVTA did not release and the breaker did not open.

The UVTA and breaker operated successfully. Cycles added to the UVTA – 17.

Breaker Platform Shock Test Timing tests were performed on this breaker:

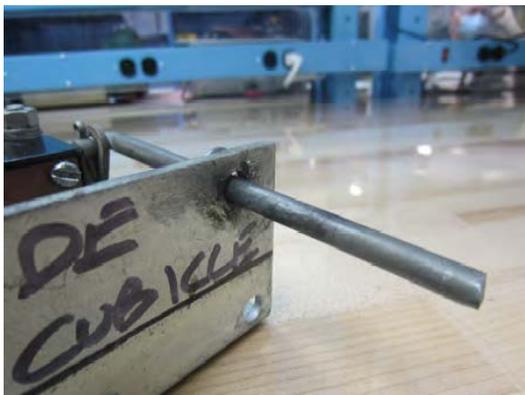
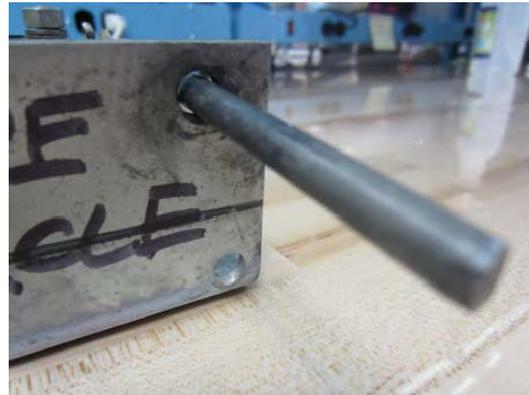
The push rod of the cell switches were lubricated with a foreign lubrication and the return springs were not lubricated with anything. These two locations are to be lubricated with Molybdenum Disulfide in Isopropyl Alcohol (53701GW) lubricant during maintenance intervals.

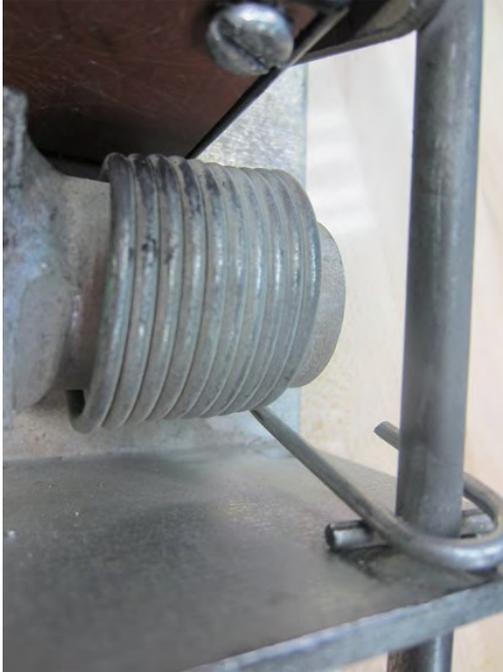
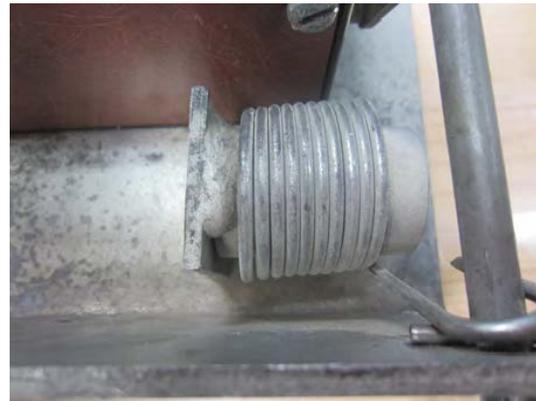
The front switch covers were removed and both switches appeared to have grease that had hardened on the contacts.

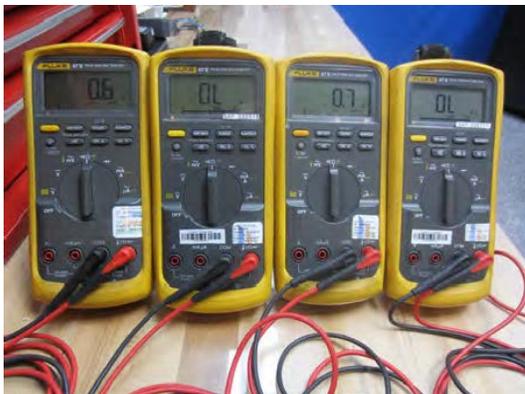
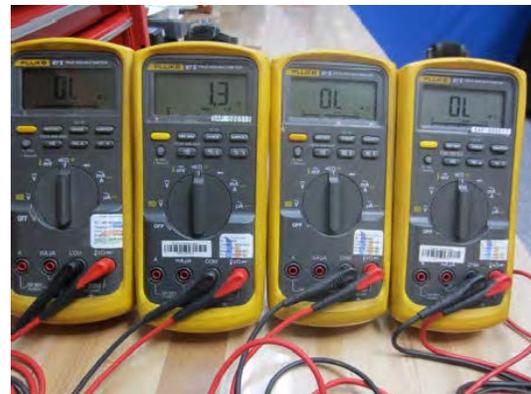
The single contact that was monitored worked 100% of the time. Four multimeters were then connected to each of the 4 switches. The switch was cycled and the switch at the end (switch terminals 7 & 8) remained open in both states of the switch as shown in these photos.

Breaker Open Switch Position  
(Plunger Not Actuated)

Breaker Closed Switch Position  
(Plunger Actuated)

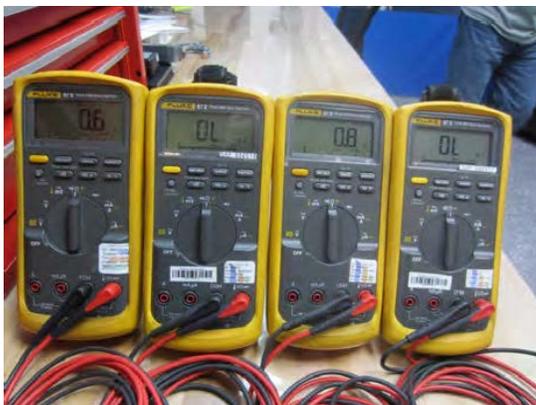
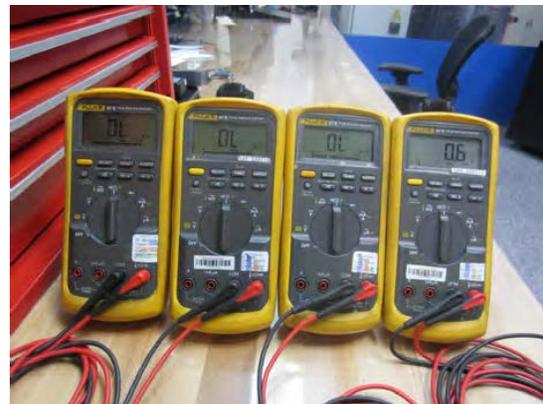
The single contact that was monitored worked 100% of the time. Four multimeters were then connected to each of the 4 switches. The switch was cycled and the switch at the end (switch terminals 3 & 4) remained open in both states of the switch as shown in these photos.

Breaker Open Switch Position

Breaker Closed Switch Position

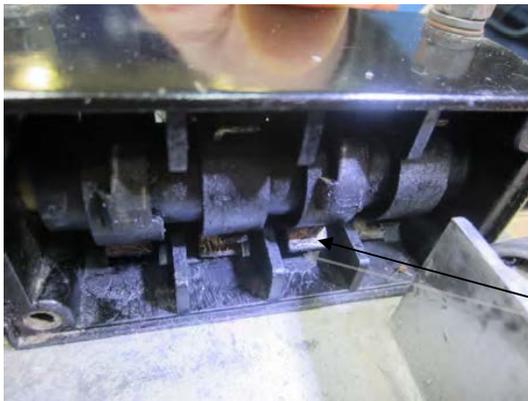
Switch Contact 2, Terminal 4

The rear cover of the switch was removed, the contact rotor can be seen moving. The resistance was then measured between the terminal screws and the stationary contacts. It was a closed circuit between terminal 3 and the top stationary contact, it was an open circuit between terminal 4 and the bottom stationary contact. The switch plunger was cycled 50 times while monitoring the switch contacts. Switch contacts 1, 3 and 4 changed state each time the plunger was cycled. Switch contact 2 (terminals 3 & 4) remained open for each of the cycles. The bottom stationary contact associated with terminal 4 appears to be out of place as seen in the photo below.

Terminal 4,  
Stationary Contact

The cell switches appeared to be original supplied equipment. They were not properly maintained, and the hardened lubrication could cause the stationary contacts to become dislodged, as documented above. In addition, to contributing to the dislodging the stationary contacts, excess or dry grease can cause improper indications from the switch contacts. This could be considered a possible cause of failure.

It is recommended that all original cell switches be replaced and after the cell switches are replaced that they be maintained to the requirements provided in the Maintenance Program Manual for Westinghouse Safety Related Type DB Circuit Breakers and Associated Switchgear, Revision 1, July 2011.

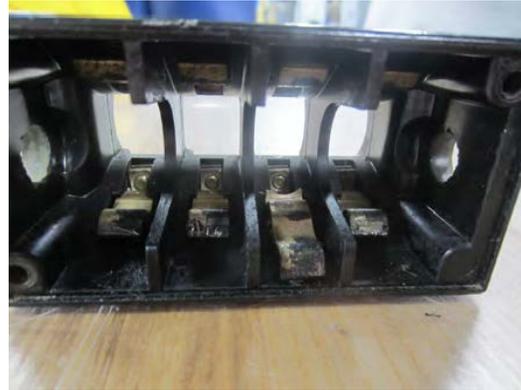
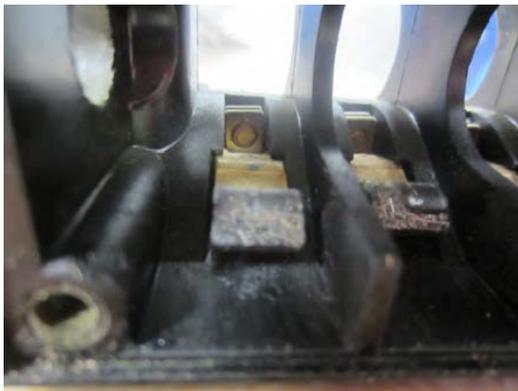
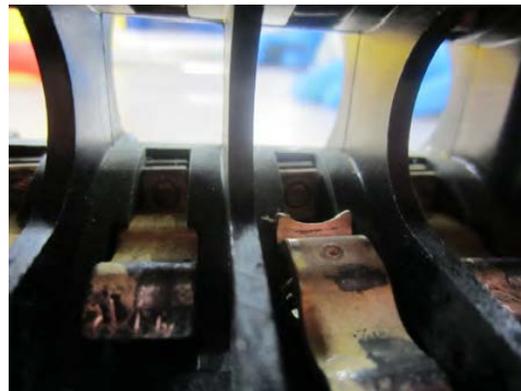
The switch rotors were removed from each of the switches and the bottom stationary contact finger in each case had come loose from the terminal point as shown here (left-hand switch and right)

If these were the original cell switches that were provided with the switchgear, it is recommended that they be replaced with safety related switch assemblies provided by Westinghouse Electric Company.

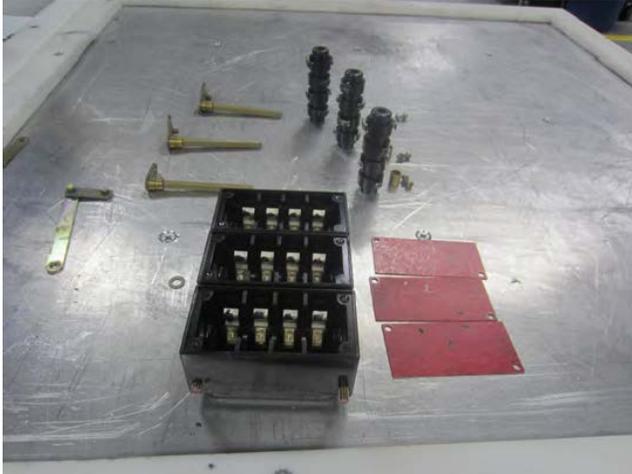
Disassembled Auxiliary Switches No issues were found with the auxiliary switch assembly.

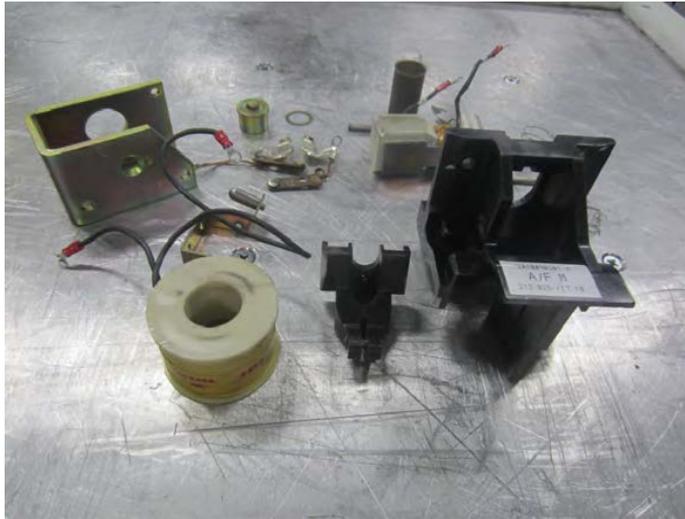
Disassembled Control Relay No issues were found with the control relay assembly.

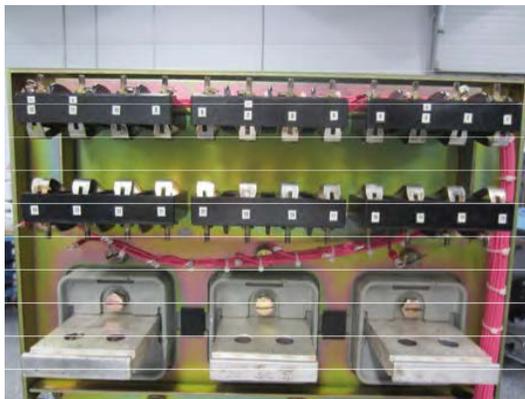
No issues were found with the secondary contact assembly.

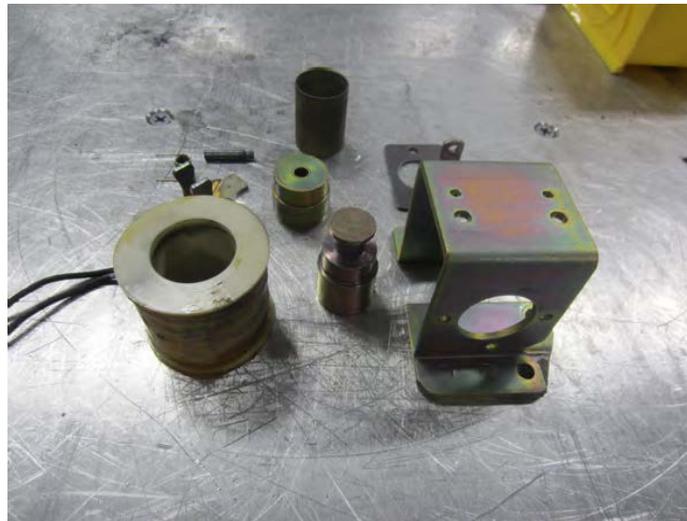
Disassembled STA

The STA was visually inspected and disassembled, no issues were found.

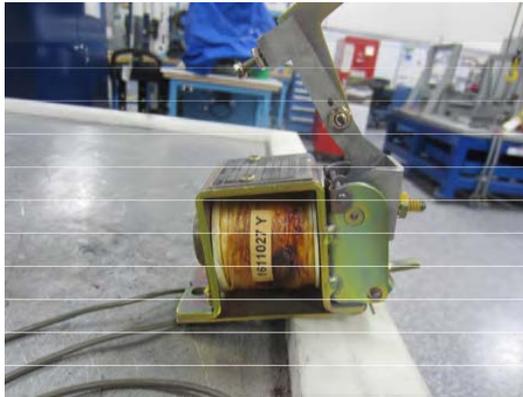
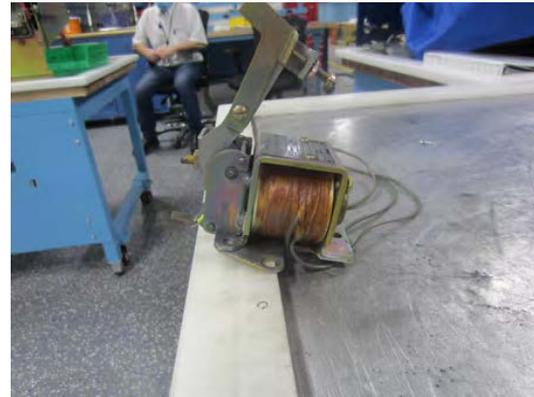
The visual inspection of the UVTA did not provide anything to be concerned about.

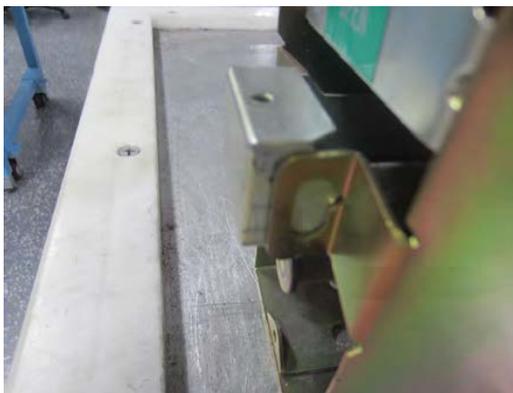
In either of these two positions above the Push to Trip lever would not make contact with the rear of the trip pan.

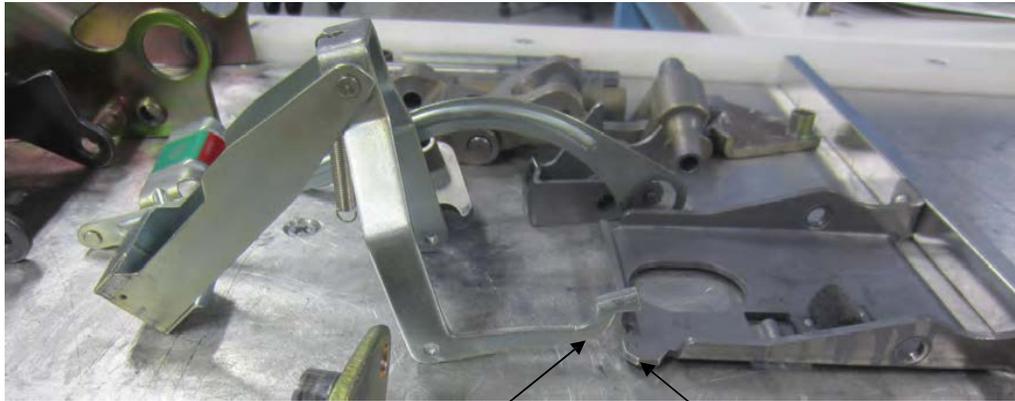
Push to Trip Lever Arm

Rear of Trip Pan

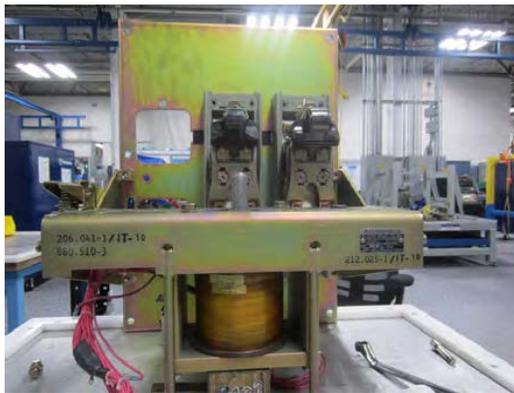
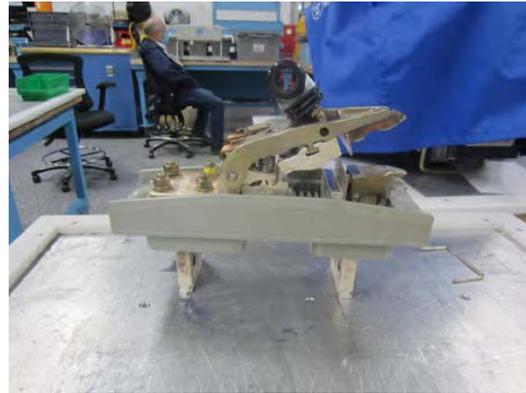
The pole bases were removed one at a time and were not disassembled at this time.

Phase 'A' Removed

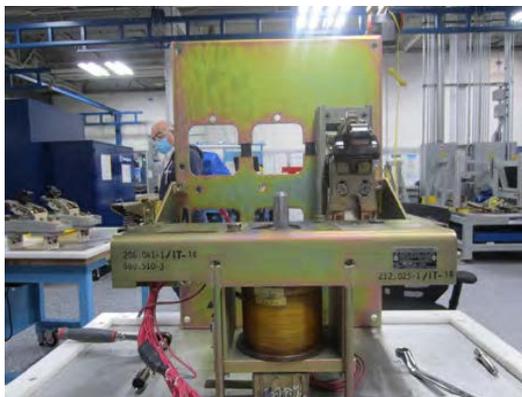
Phase 'B' Removed

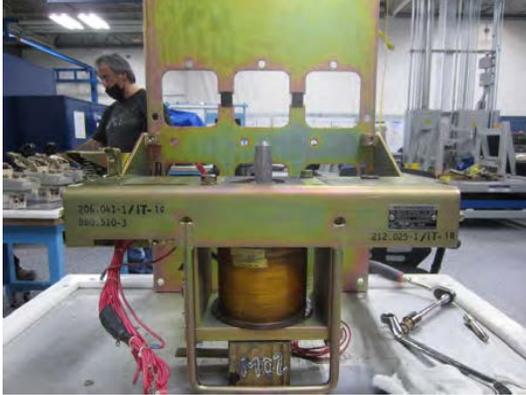
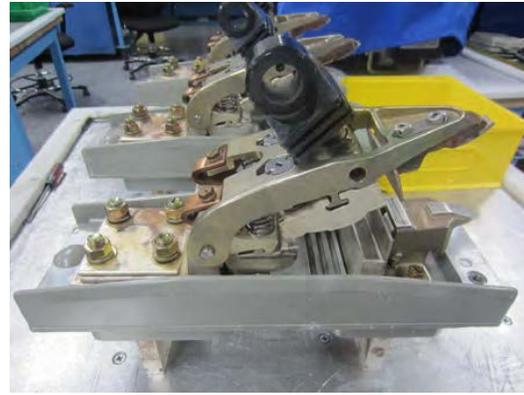
Phase 'C' Removed

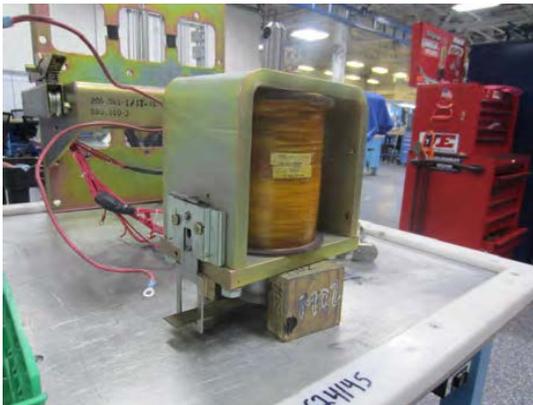
The closing solenoid was removed, and the closing solenoid relay release window assembly was removed and disassembled.

Closing Solenoid Assembly

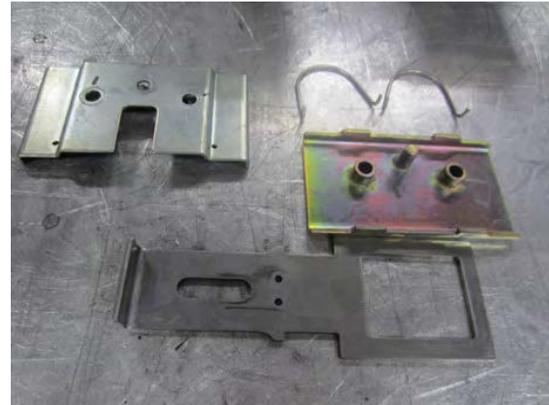
Closing Solenoid Relay Release Window Disassembled No

areas of concern were found with these items.

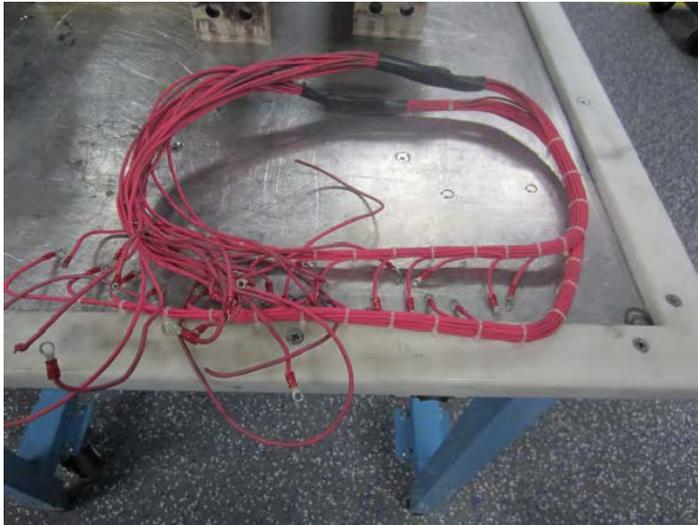
Breaker Wiring Harness

No areas of concern were found with the wiring harness or any of the terminations. 23-

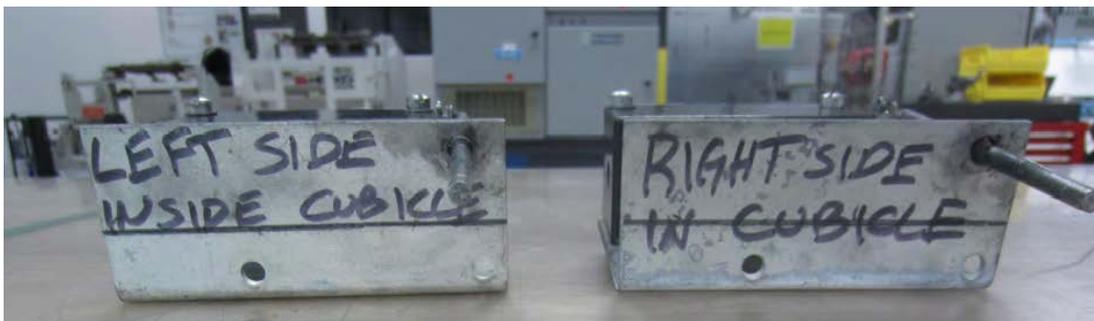
The left-side switch and right-side switch were properly assembled with all of the stationary fingers securely in place. The switch contacts were cleaned and properly lubricated during the assembly and each switch was mounted back onto the base plate and the plunger was attached to complete the assembly. Both the front and rear covers remained off of the switches so that the contacts could be monitored. Photos of the switches are provided:

Left-Side and Right-Side Switches

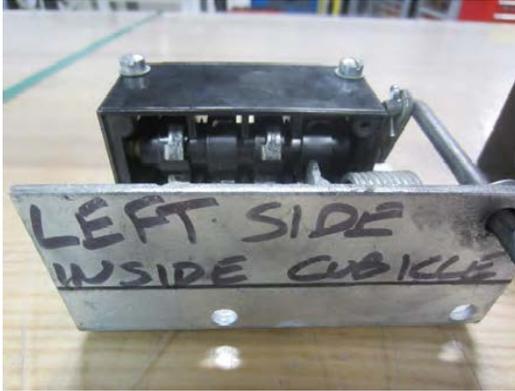
Left-Side Switch

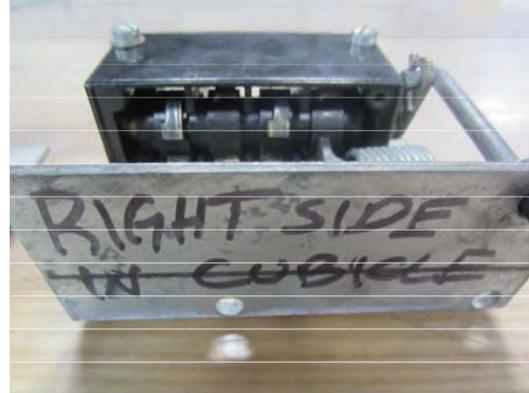
Right Side Switch

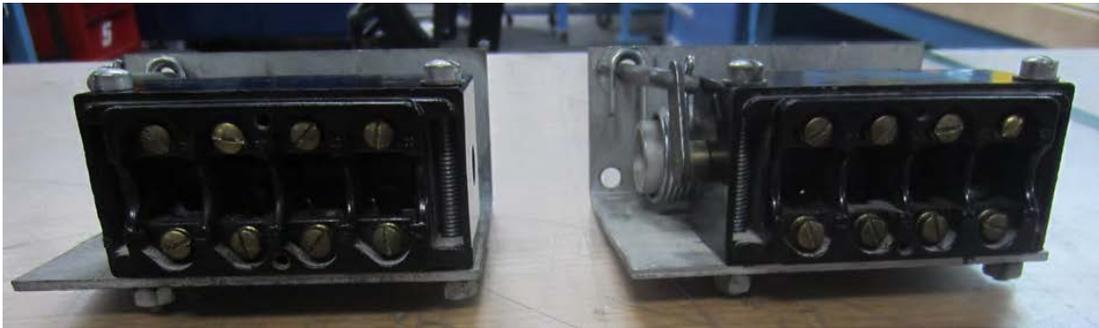
Right-Side Switch Rear

Left Side Switch Rear

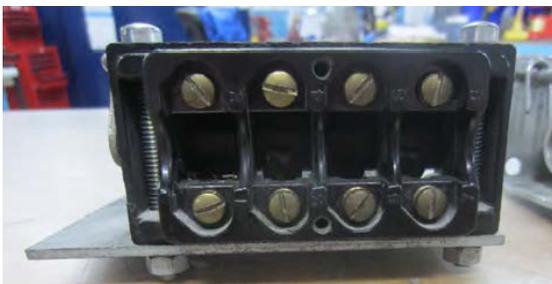
Right-Side Switch Rear

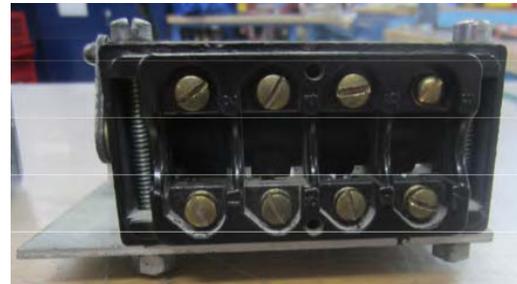
Left Side Switch Rear

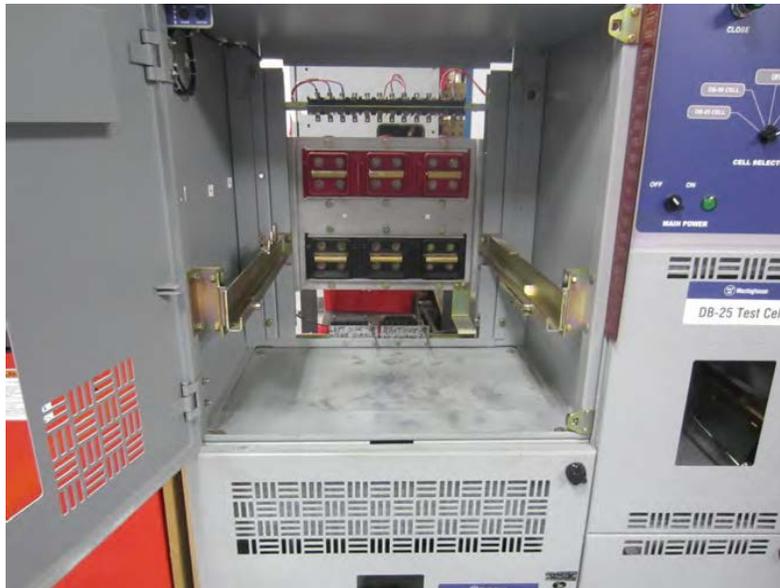
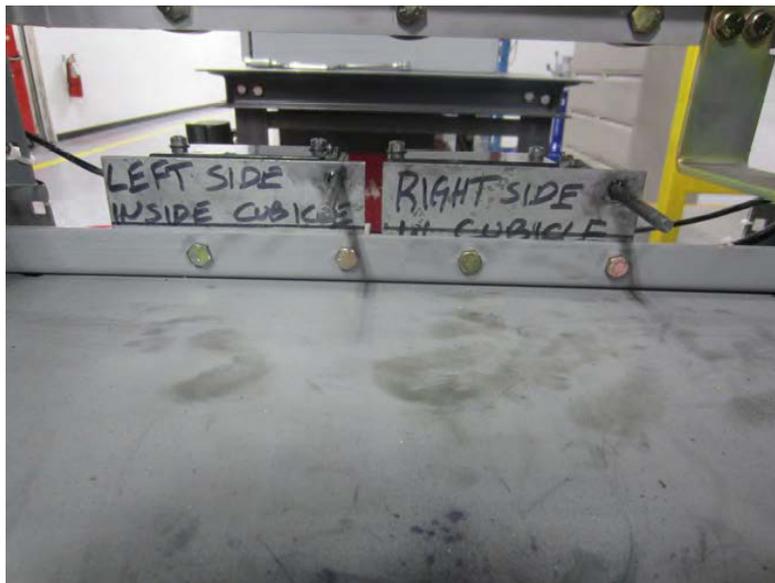
Left-Side Switch and Right-Side Switch Installed in Test Cell

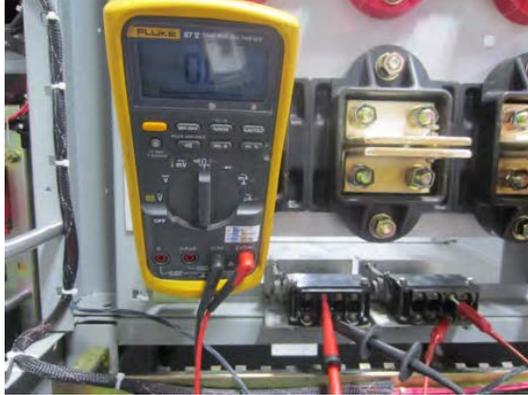
Right-Side Switch Monitoring (NO)

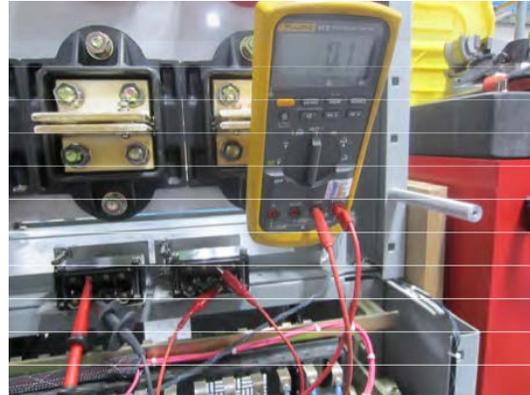
Left-Side Switch Monitoring (NC)

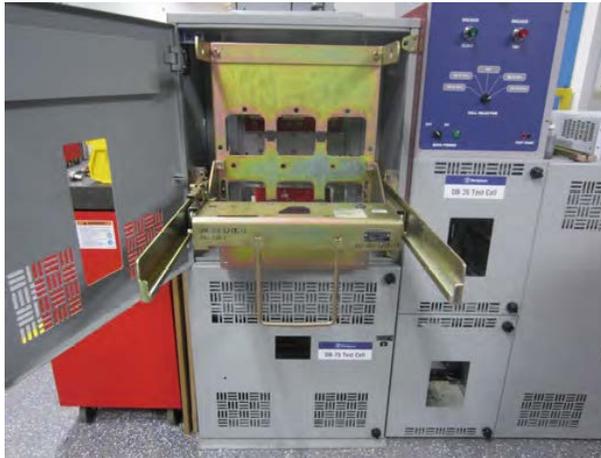
Breaker Frame on Test Cell Rails

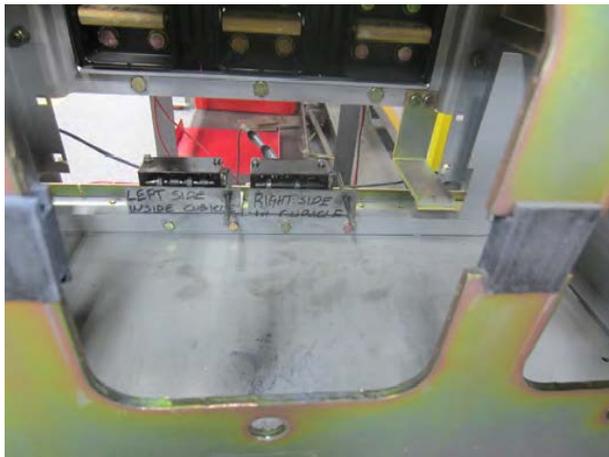
Cell Switches shown through Breaker Rear Panel

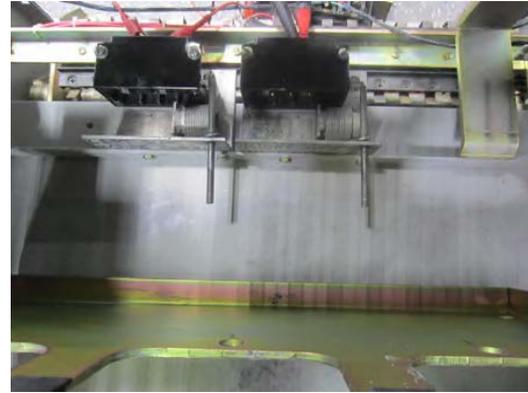
Breaker Frame Located before the Cell Positioning Stop Bracket

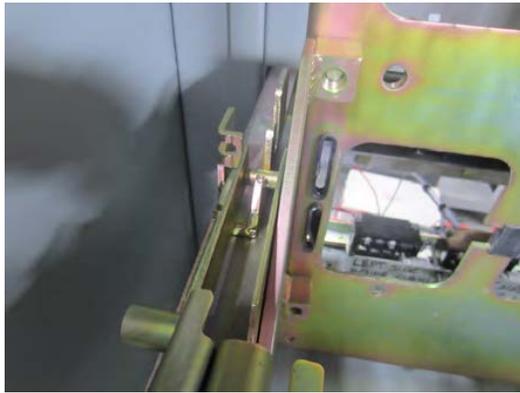
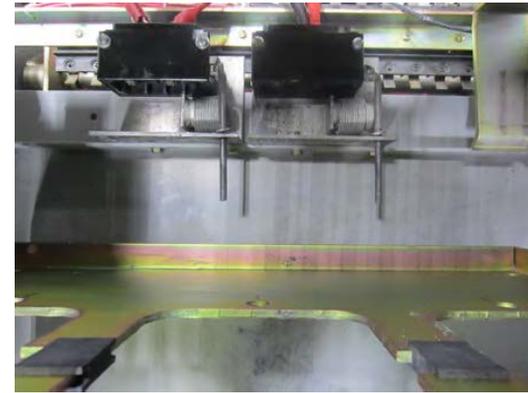
Breaker Frame Located in the Disconnect Position Stop Bracket

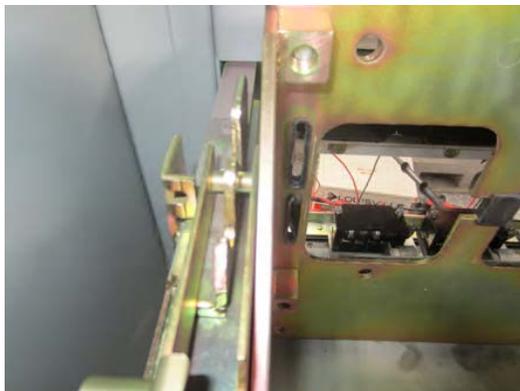
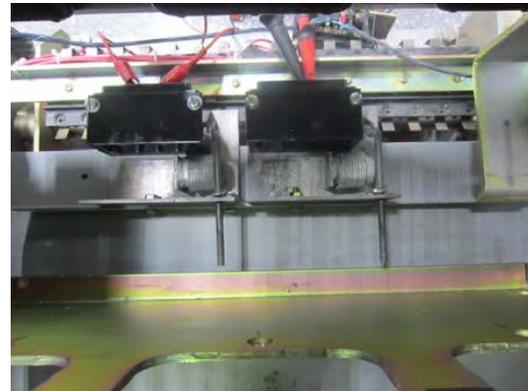
Breaker Frame Located in the Test Position Stop Bracket

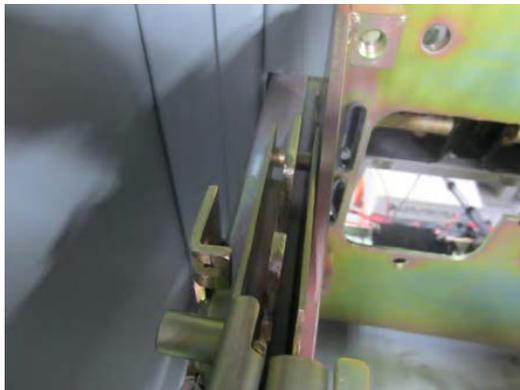
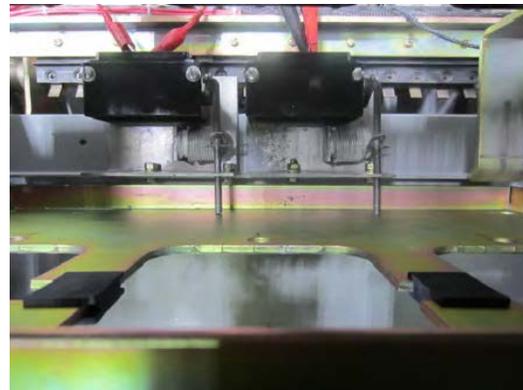
Breaker Frame Located in the Connect Position Stop Bracket

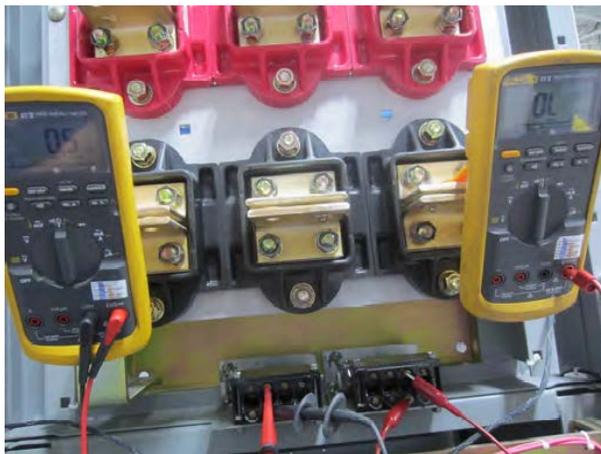
Switch Monitoring Shows a Change of State
