**TECO's Responses OPC's Third Request
to Produce Documents, No. 11.**

**TAMPA ELECTRIC COMPANY
DOCKET NO. 20220001-EI
OPC'S THIRD REQUEST FOR
PRODUCTION OF DOCUMENTS
DOCUMENT NO. 11
BATES PAGES: 1-1472
FILED: AUGUST 10, 2022**

PK1 – Forced Major Outage High Potential
Date: 11/29/2021

Polk Power Station

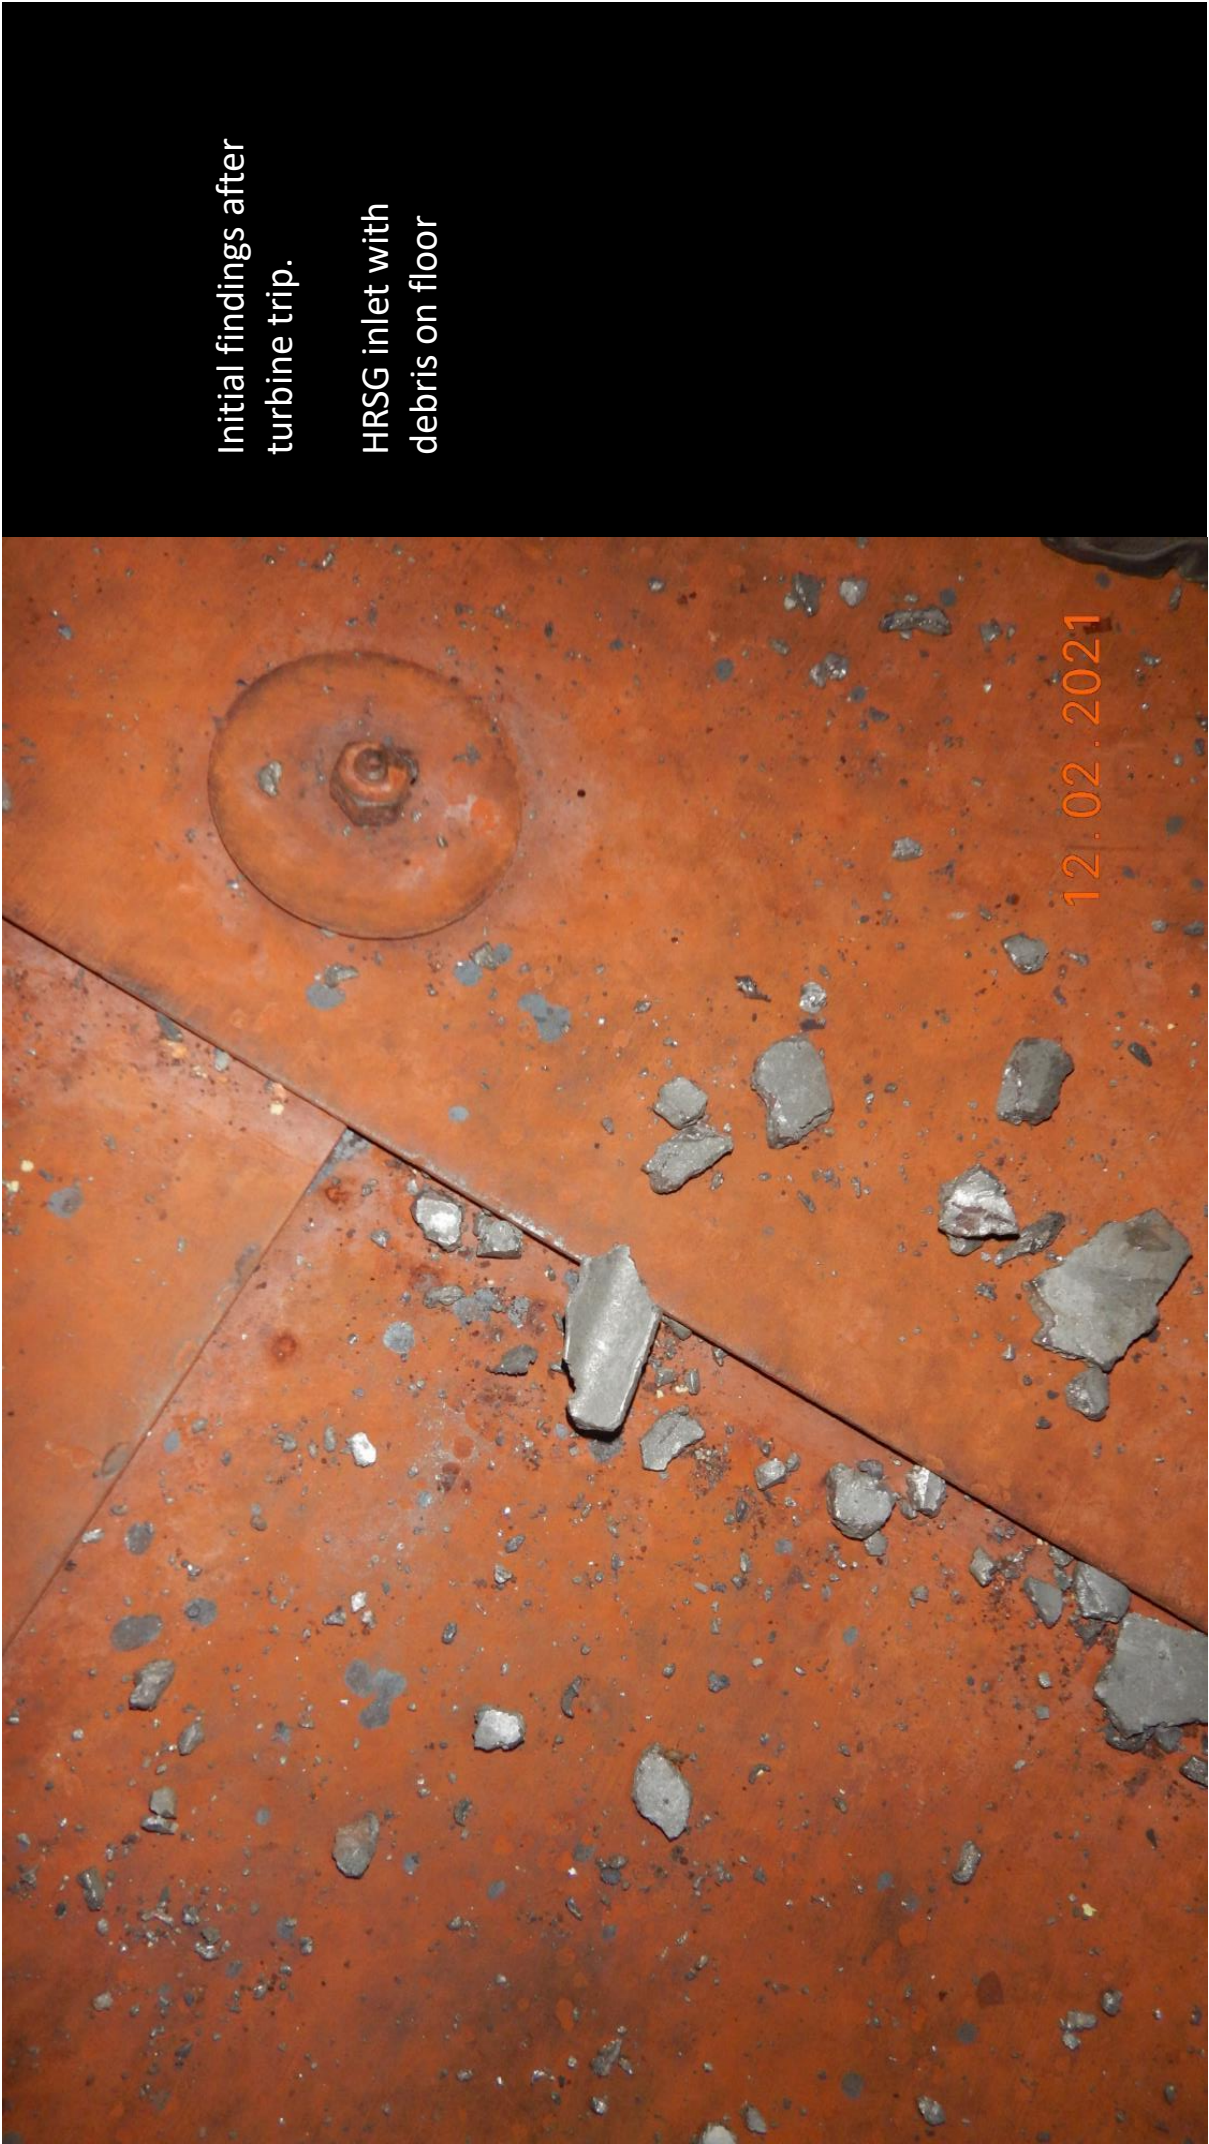
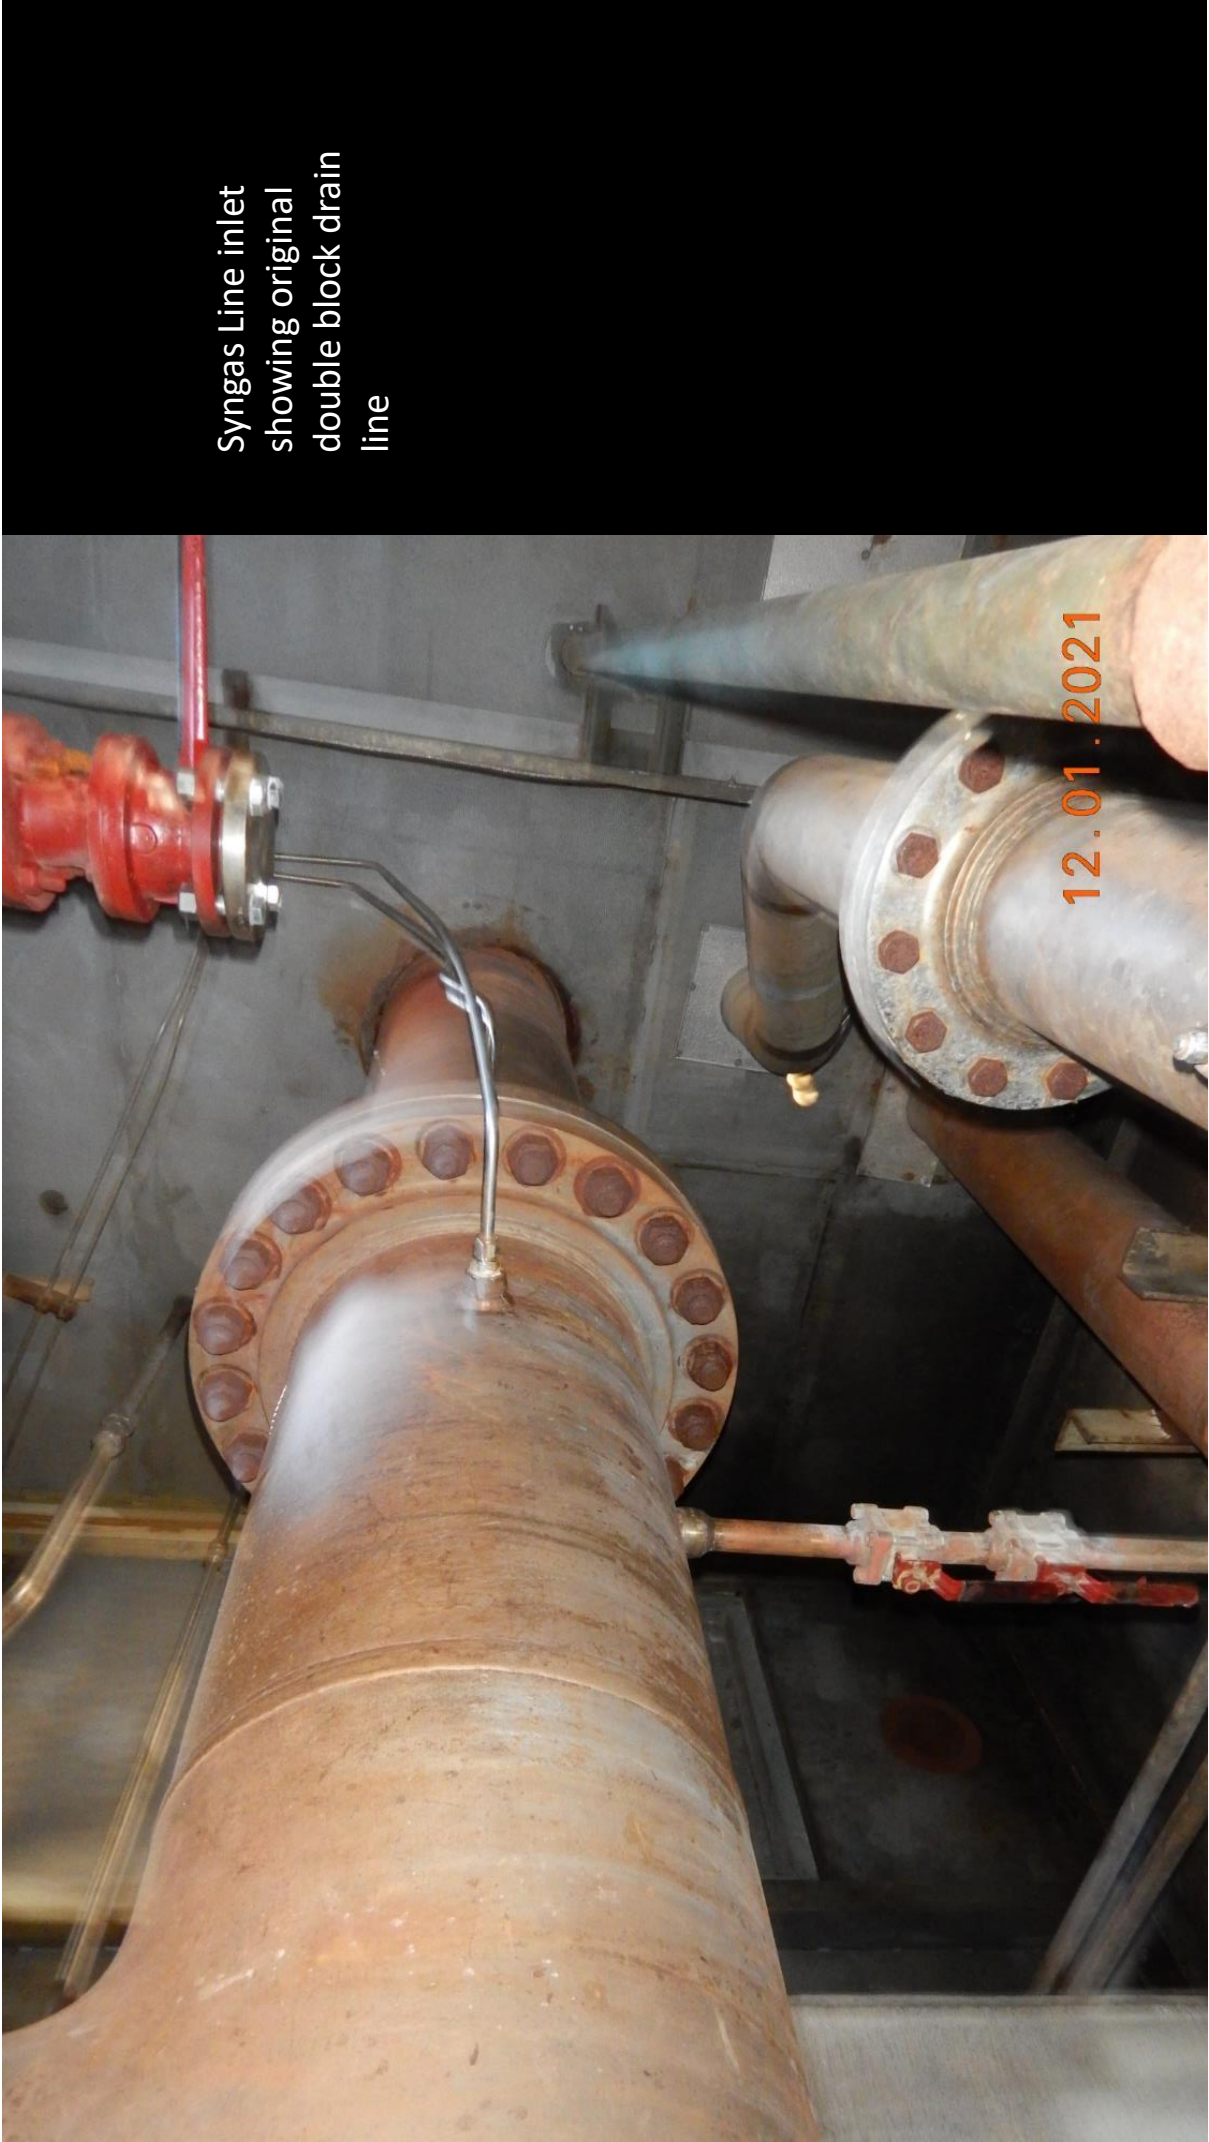
Syngas Line Ring
Header

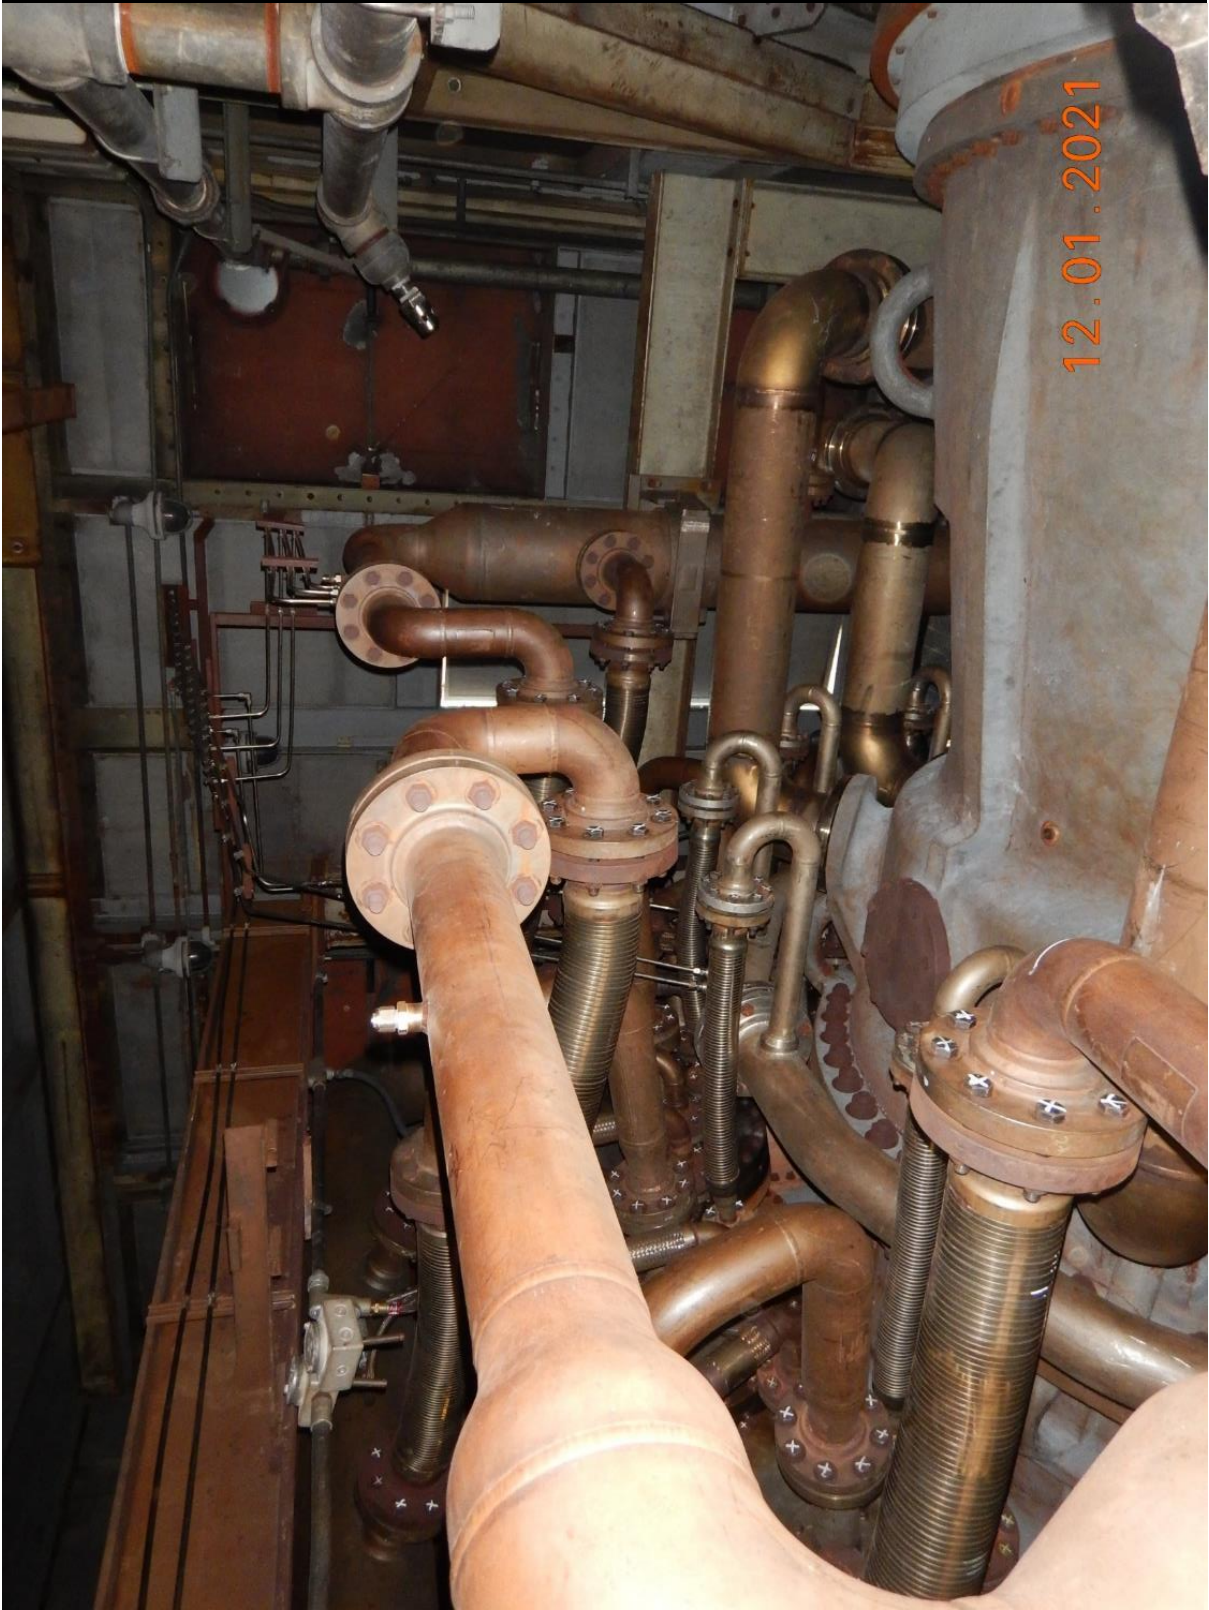
Drain for water wash
Drains from syngas
lowpoint

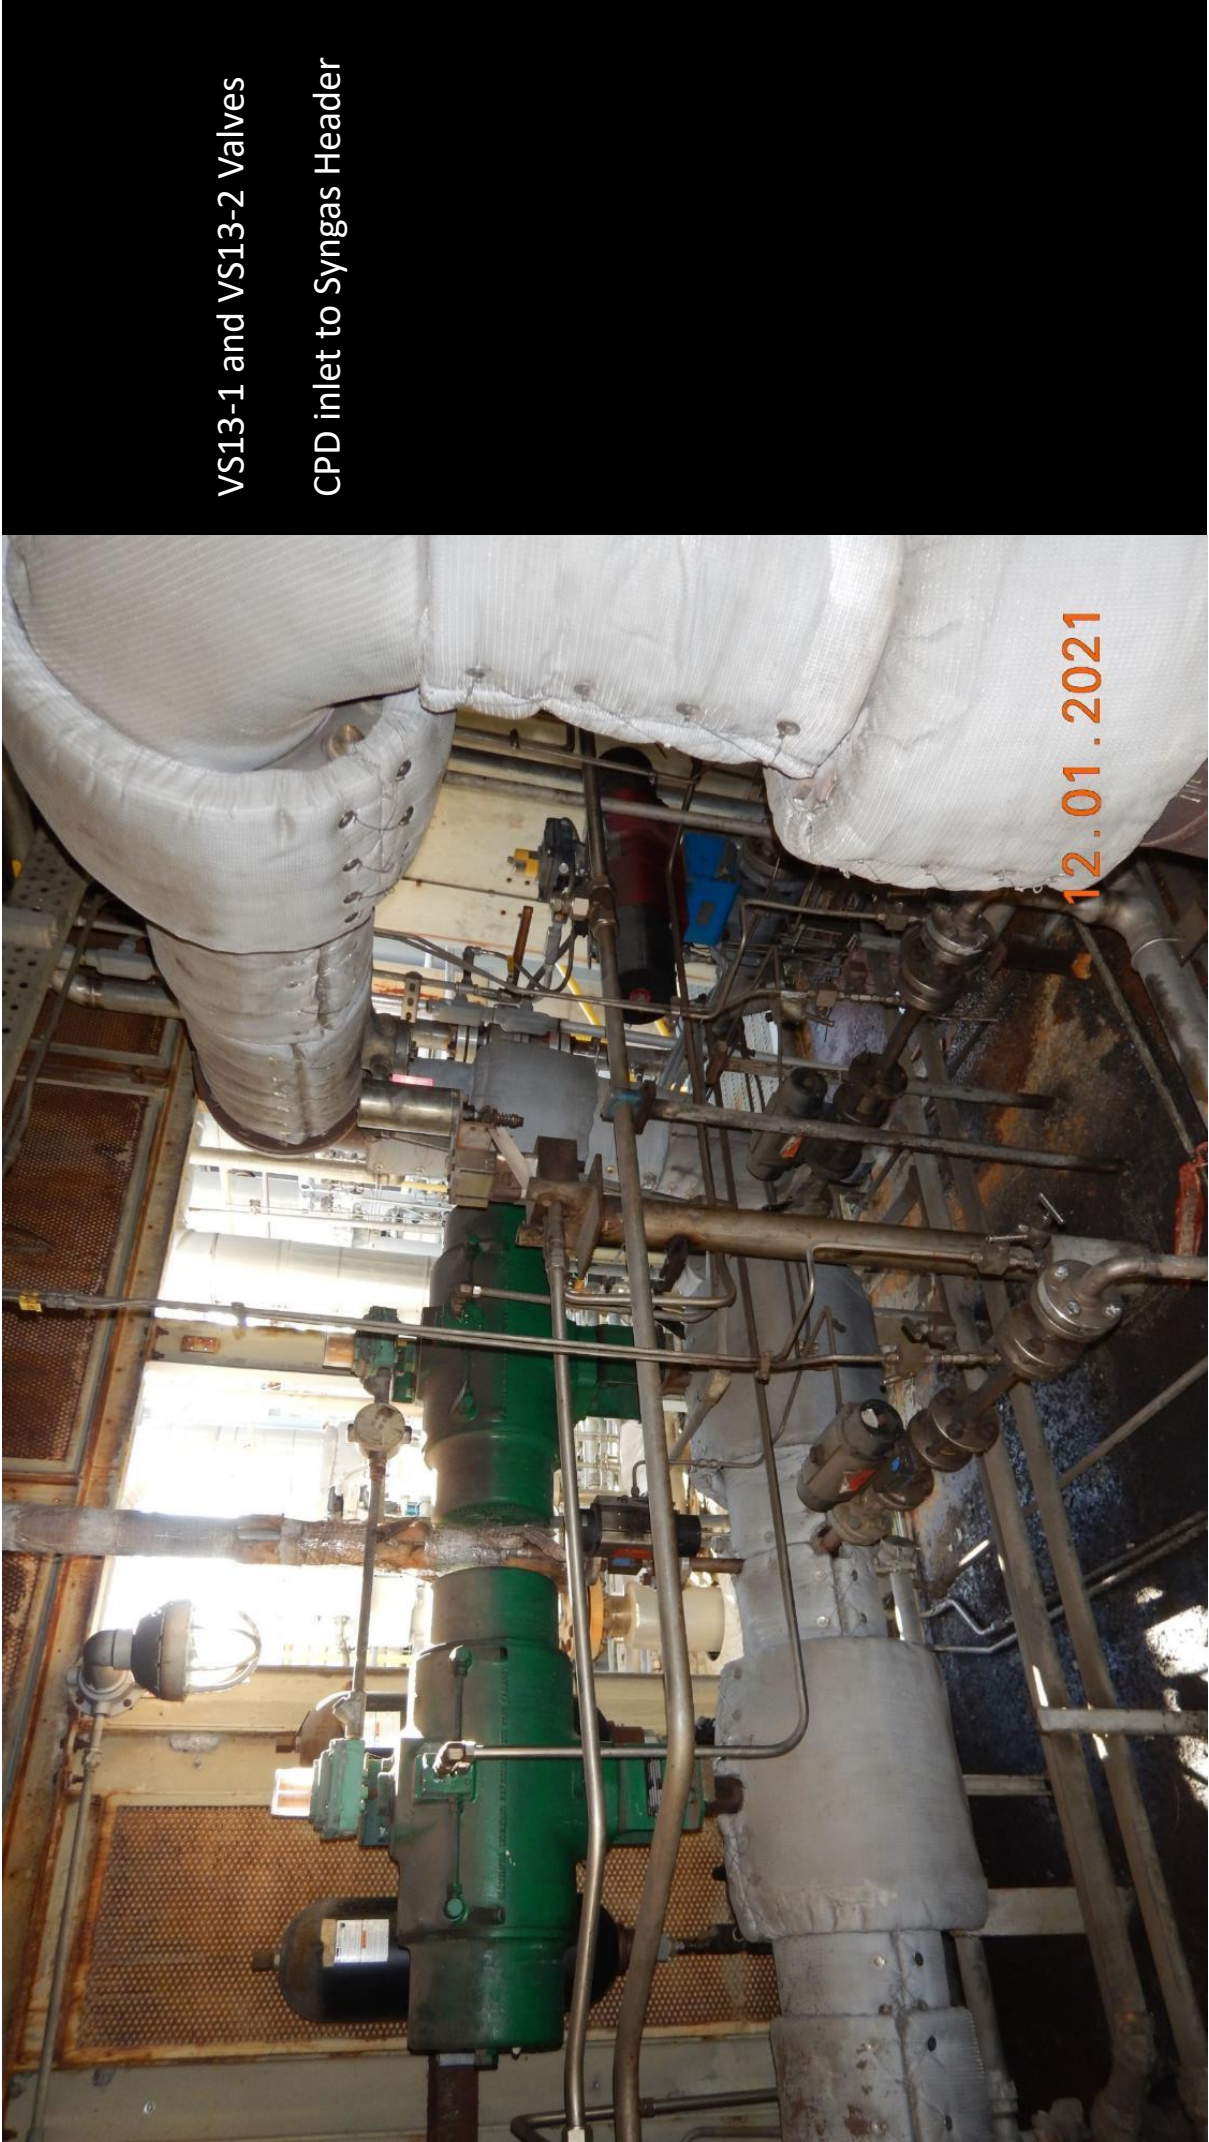
Syngas Line showing both
Syngas block valves and
control valves

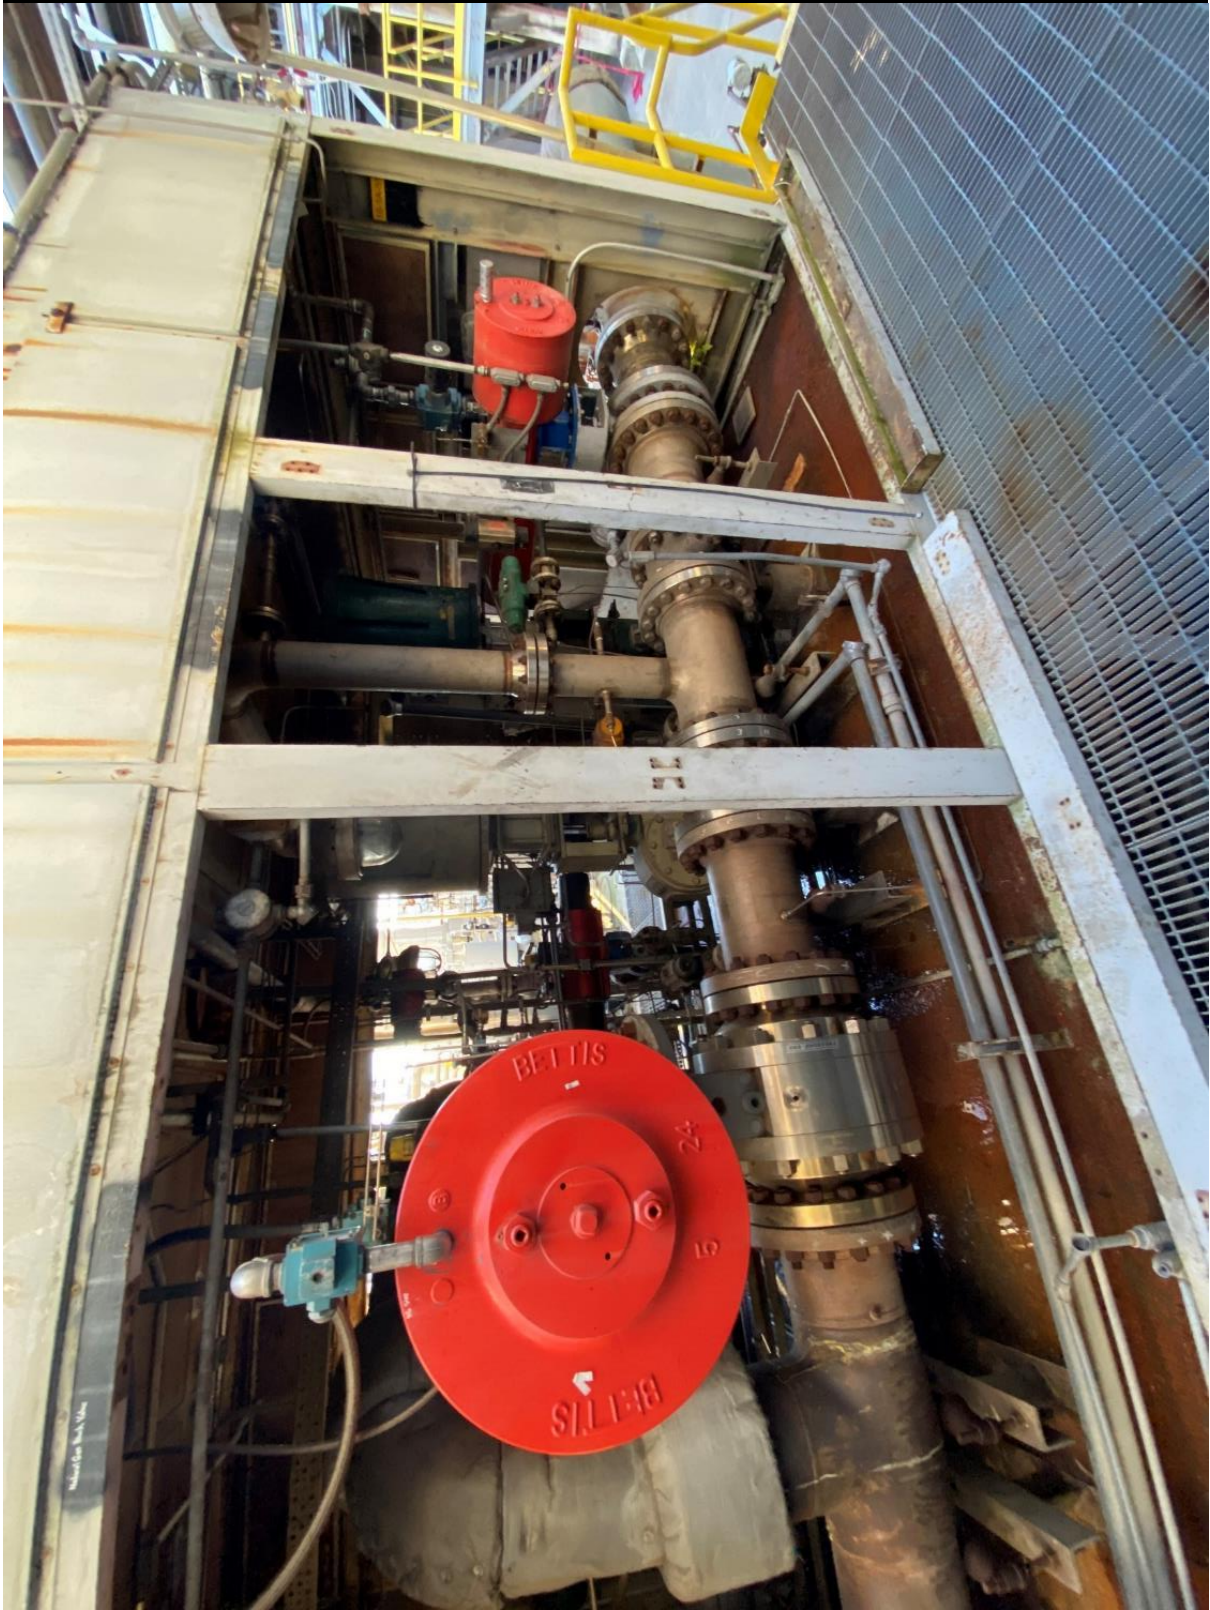
Syngas Line showing both
Syngas block valves and
control valves

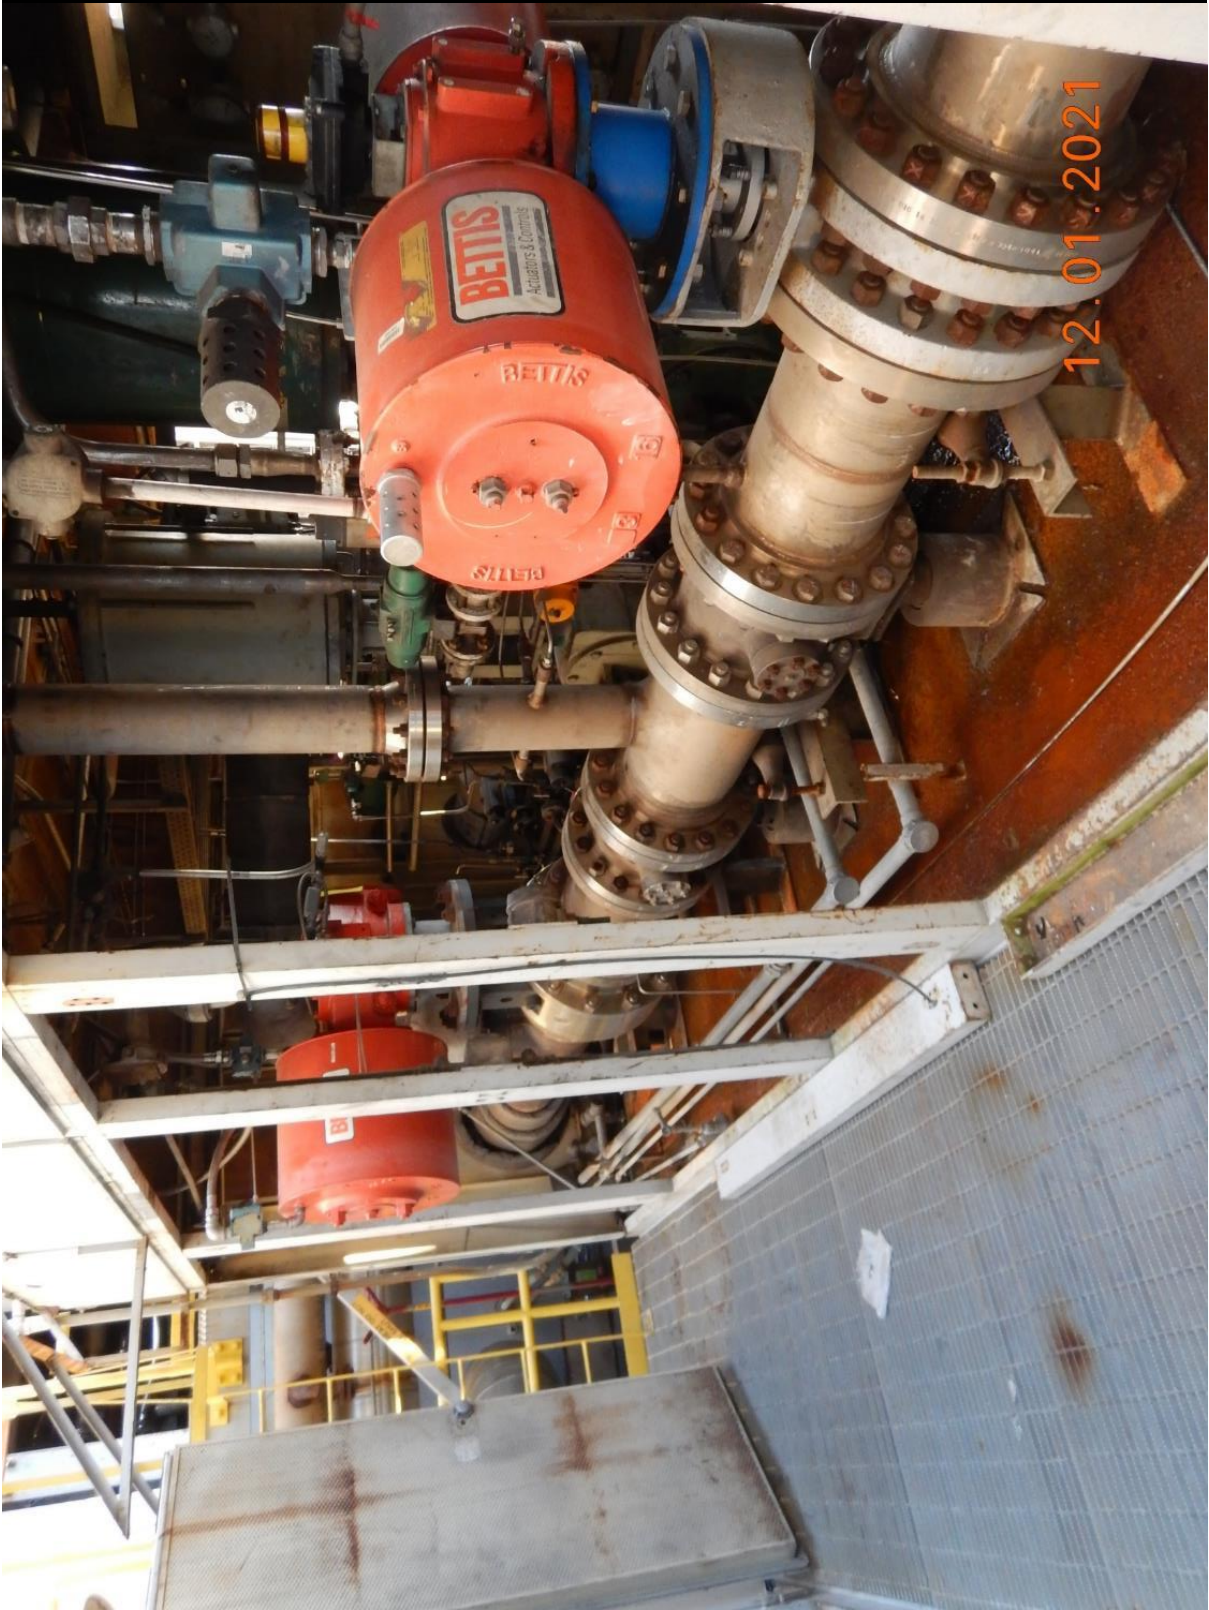
Water draining from P2 cavity

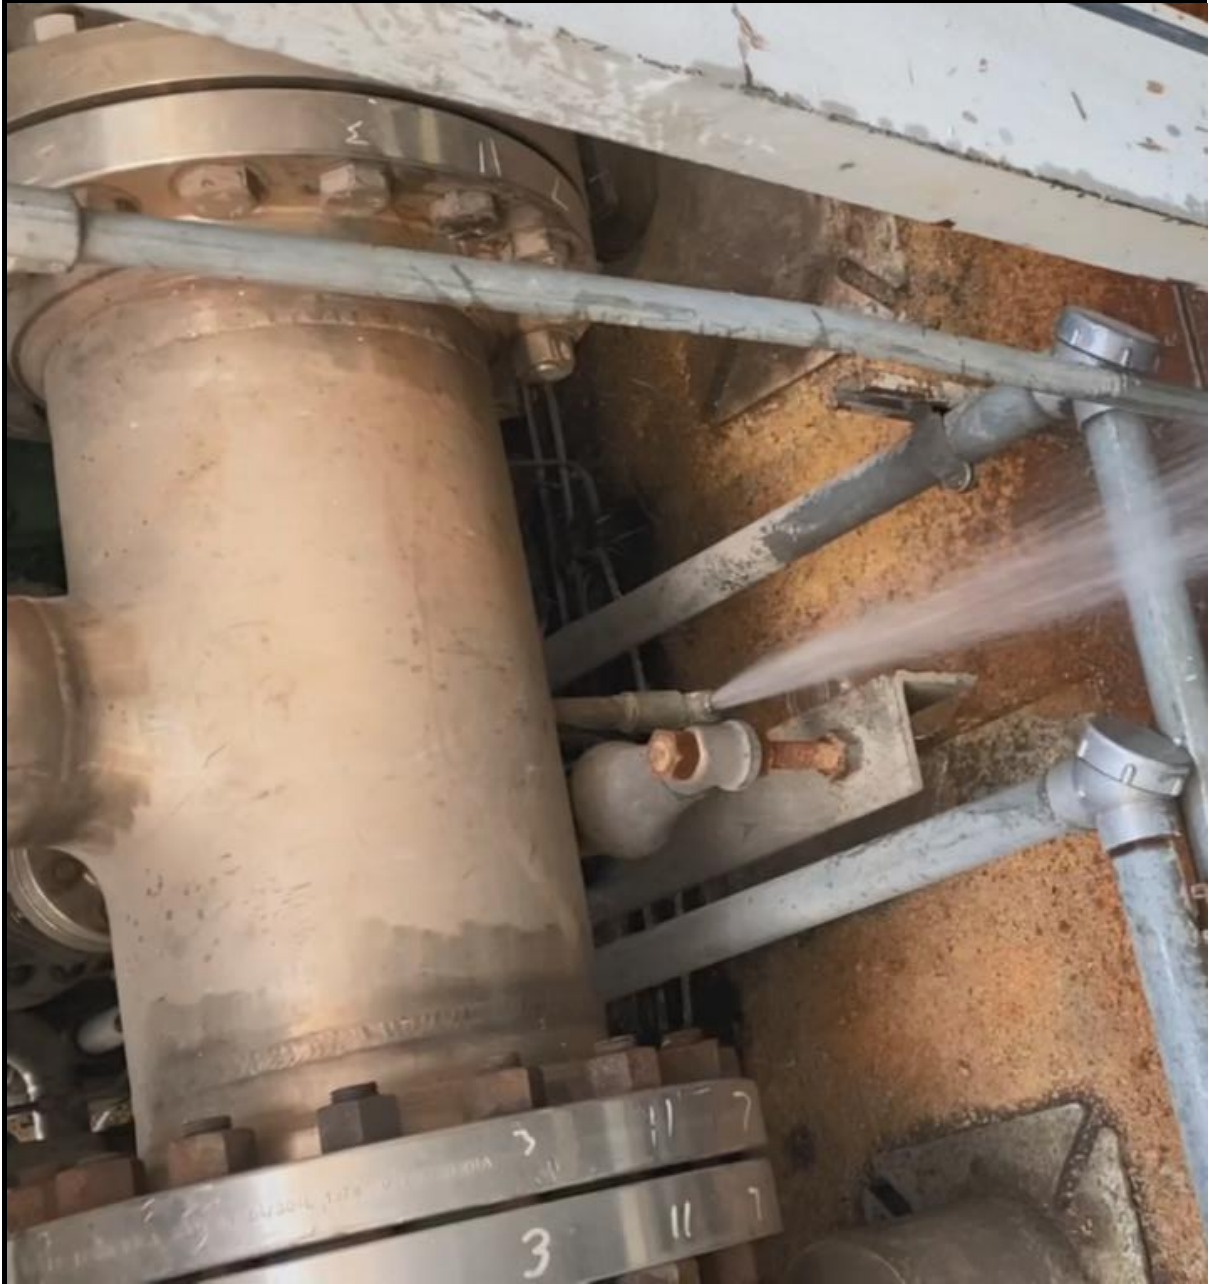
Head pressure in P2 Cavity
12psi equates to 27 FT

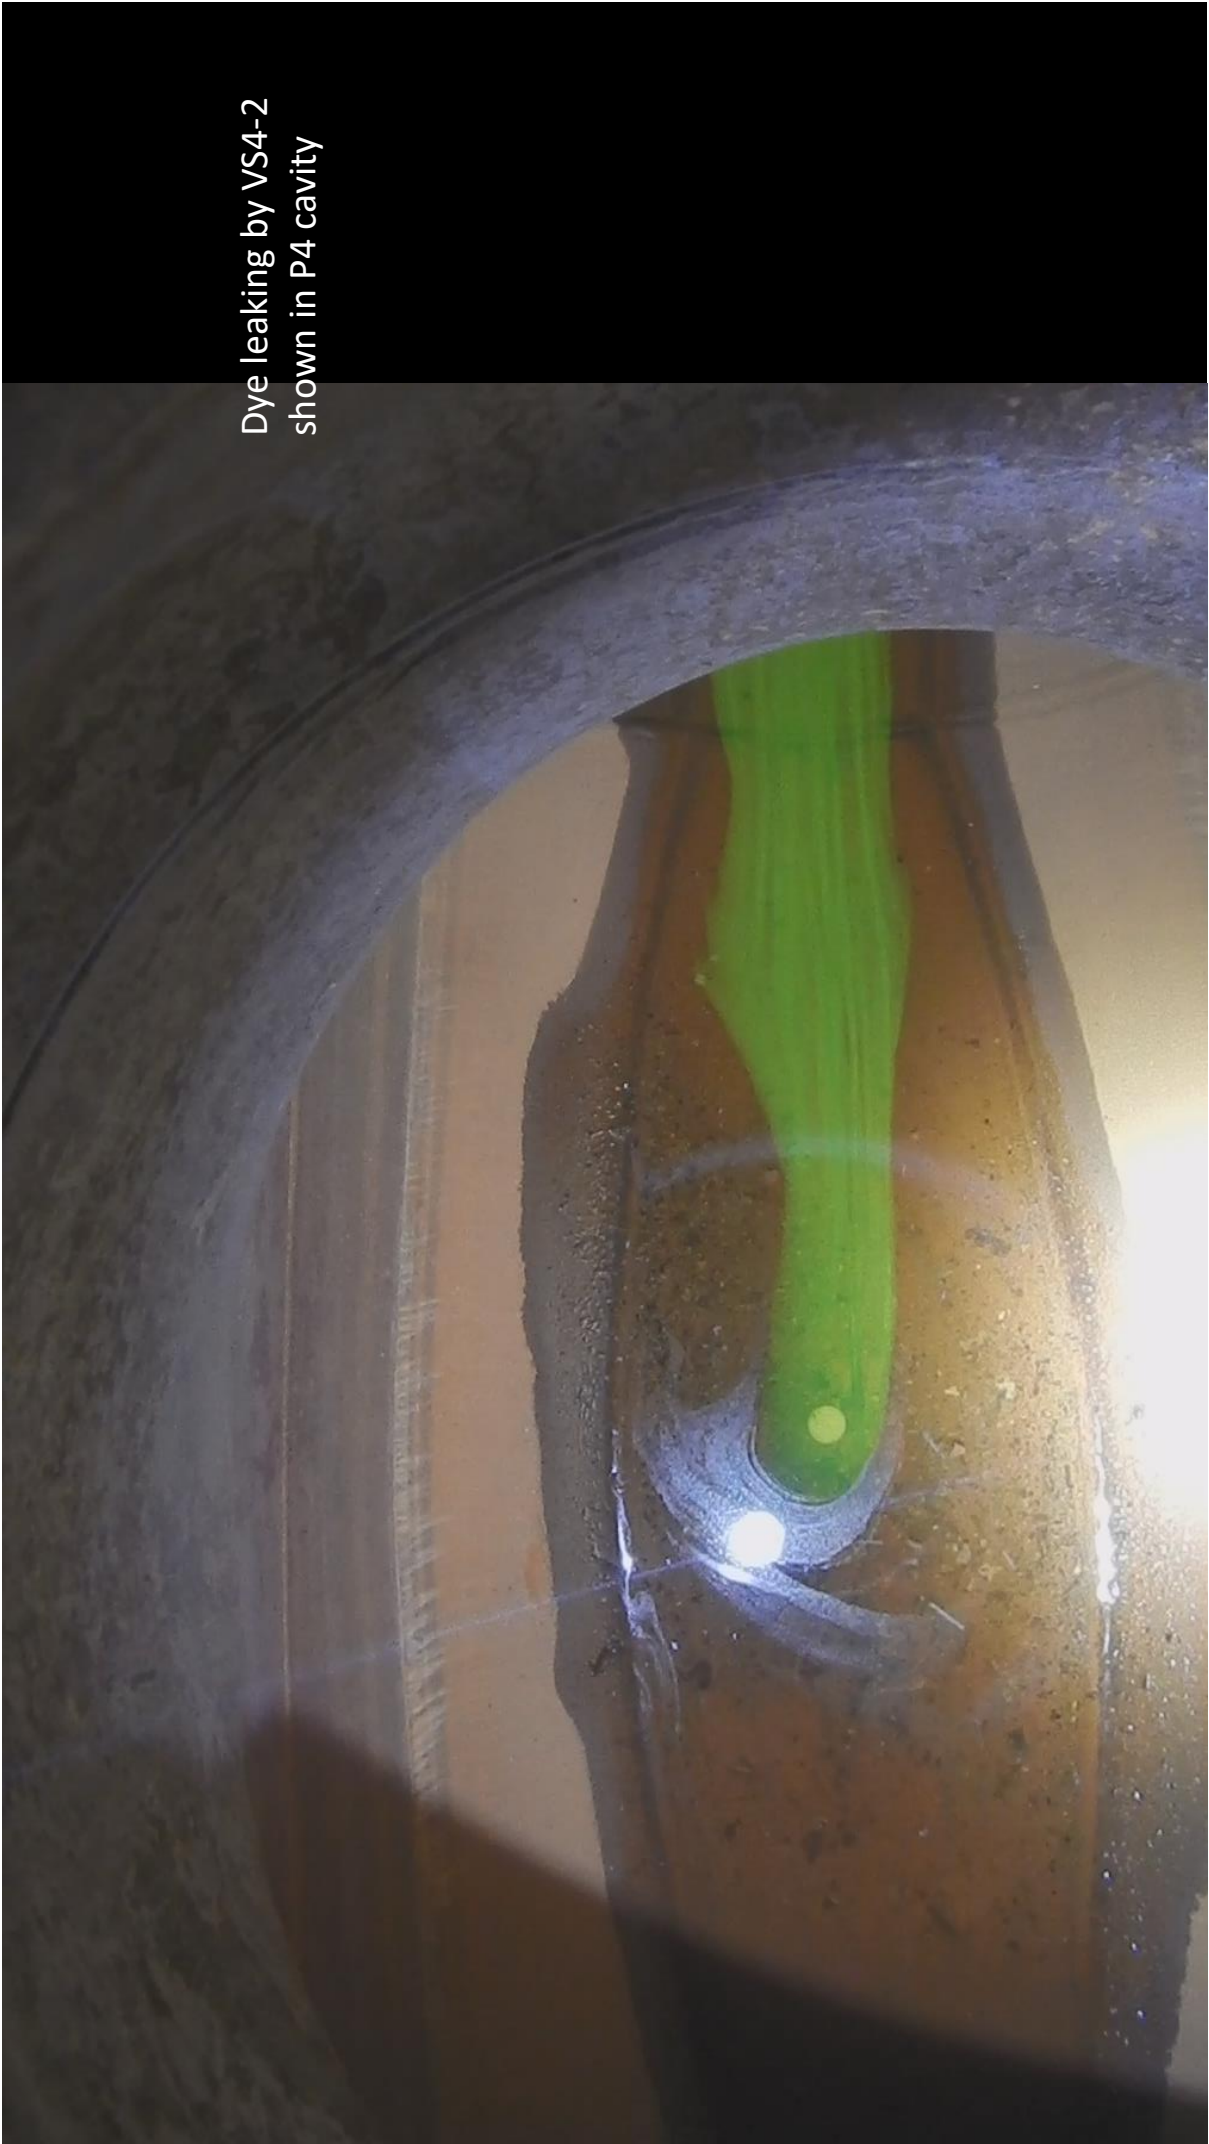
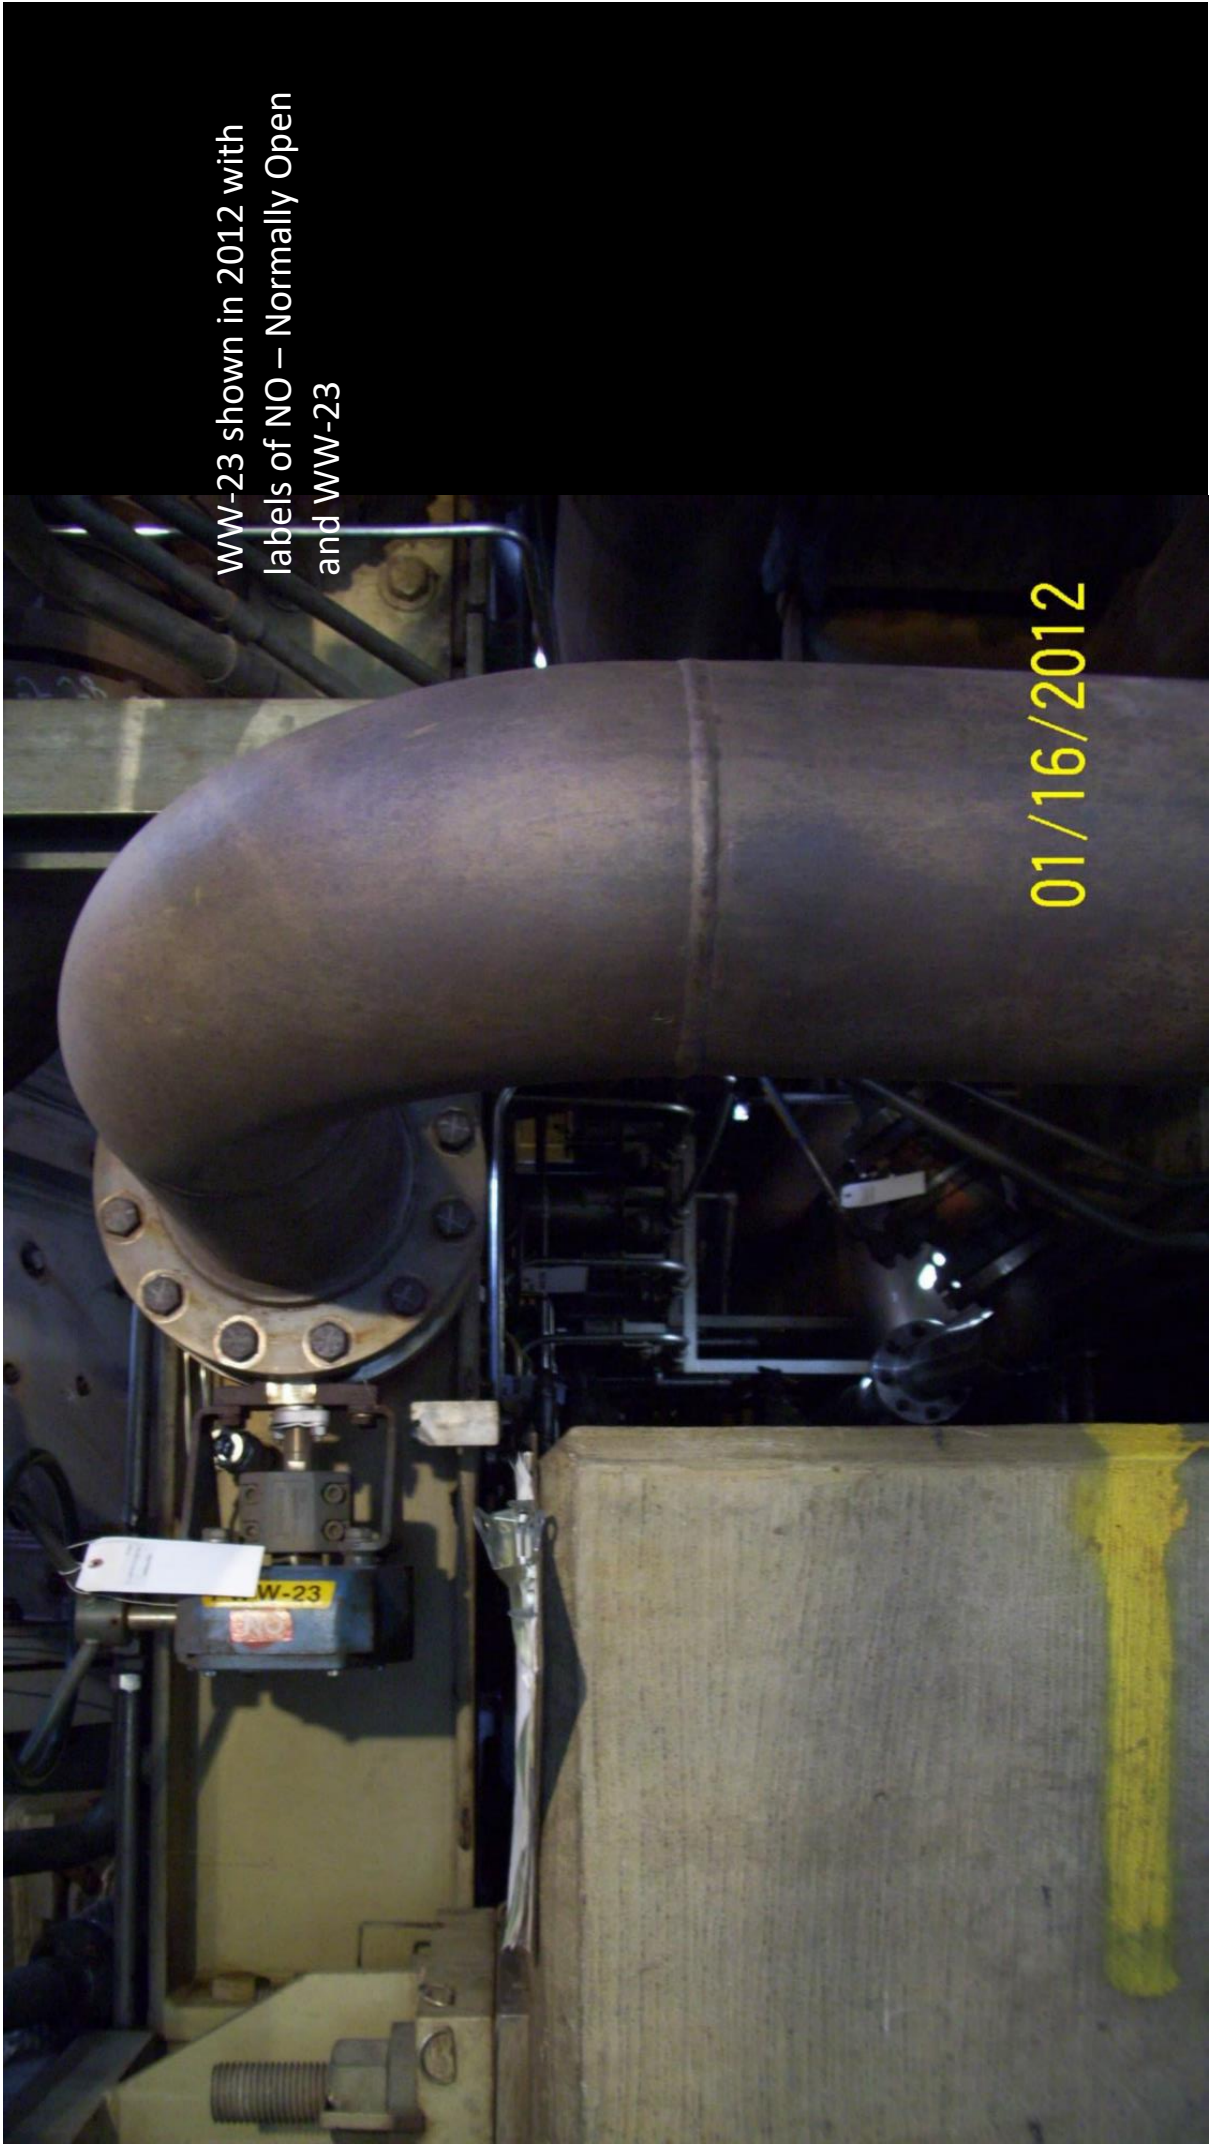
01/16/2012

WW-23 shown in 2012 with
labels of NO – Normally Open
and WW-23
